**Air Branch Inspection Report**  
**Unannounced Full Compliance Evaluation (FCE)**  
**Salina Municipal Solid Waste Landfill**  
4292 S Burma Road  
Salina, Kansas 67401  
FRS# 110012154685

**Inspection Date(s):**  
March 8, 2022

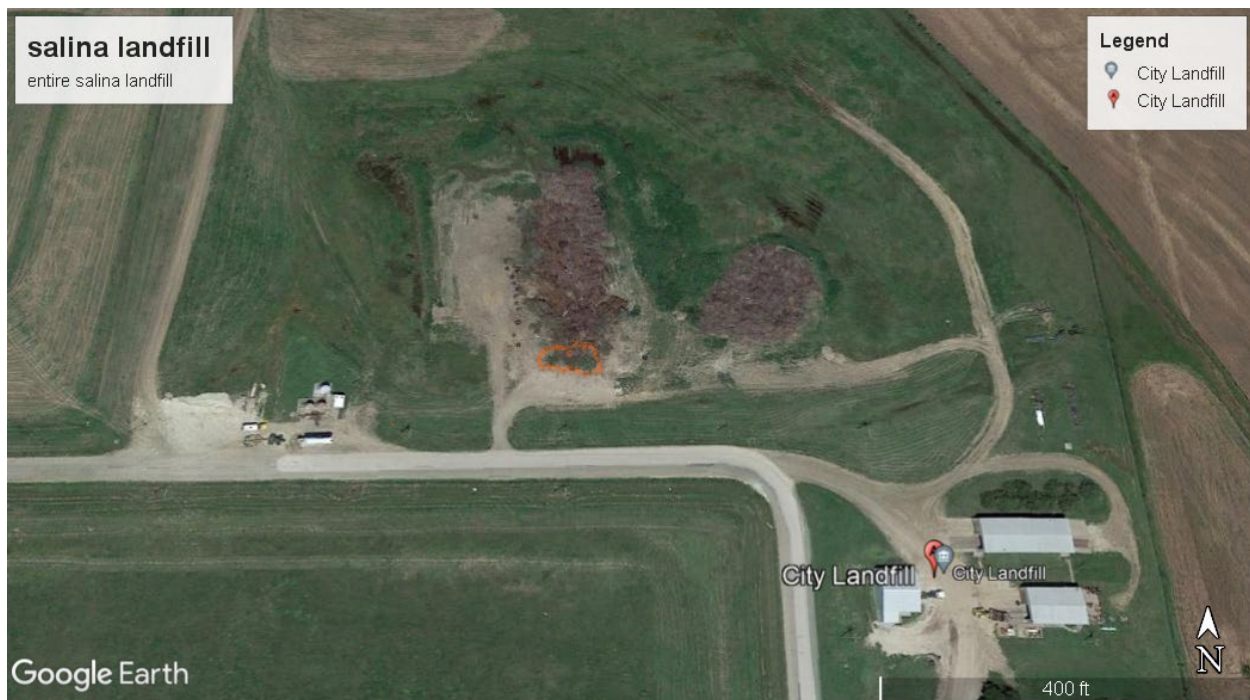
**Figure 1. On-site burning area**

Mr. Couch informed us that Britt Keller would be able to help with our inspection intentions and when Mr. Keller arrived, I re-iterated our purpose. Mr. Keller led us to the landfill burn site where they were actively burning yard waste (**Appendix A**, photos 1&2). At 2:10 pm Mr. Hammonds joined the inspection, and we toured the landfill. Due to the nonmethane organic compounds (NMOC) emission rate falling below the 34 Mg/yr threshold, the facility did not trigger the requirement to conduct surface emission monitoring in of 40 CFR Part 62 Subpart OOO [62.16714(e)(2)]. Mr. Terriquez did use the Forward Looking Infrared (FLIR) camera to observe parts of cells 2A and 2B. While touring the landfill I asked Mr. Hammonds questions pertaining to landfill operations, the NMOC calculation and values, and how the landfill maintains cover integrity. We completed the landfill walkthrough at 3:00 pm and returned to the Salina Landfill office to obtain and review records. Ms. Fair departed the facility at this time.
