INSPECTION REPORT

| Type of Inspection | Focused Compliance Inspection (FCI) | |
| Facility or Site Name | Southern Devall | |

APPENDIX 1.  
PHOTOGRAPH LOG

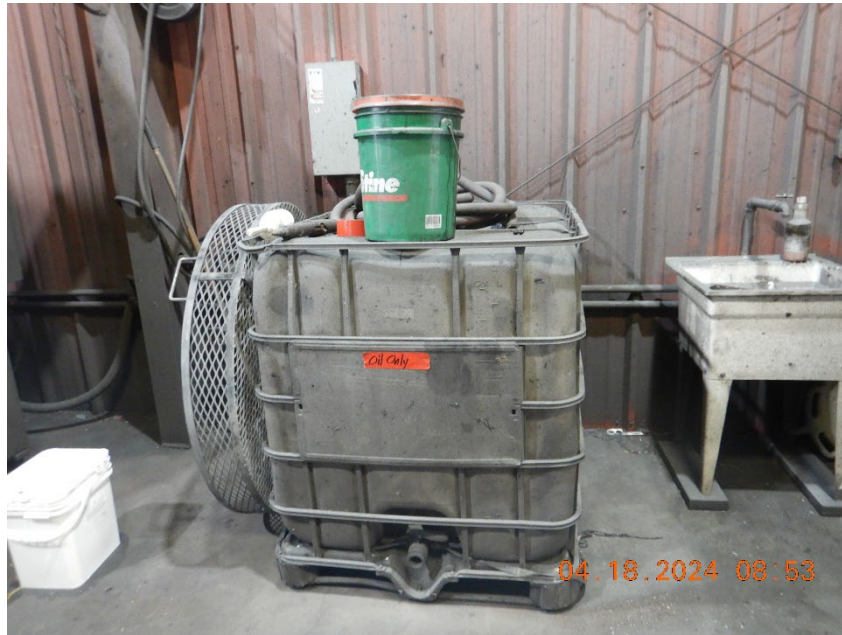
Photo No. 1

Description: Used oil tote labeled as "oil only" in Devall's diesel services building.

| <b>Tenant:</b> Southern Devall | | |
|---|---|---|
| <b>AOC #1</b> – Devall did not clearly label containers used to store used oil with the words “Used Oil.” | <b>Citation:</b> 40 CFR 279.22(c)(1) | Section: 2.10 |

- Used oil tanks and drums were labelled as "oil only" instead of "used oil"
- Used coolant was labelled as "coolant only" rather than "used coolant". These also were not dated.

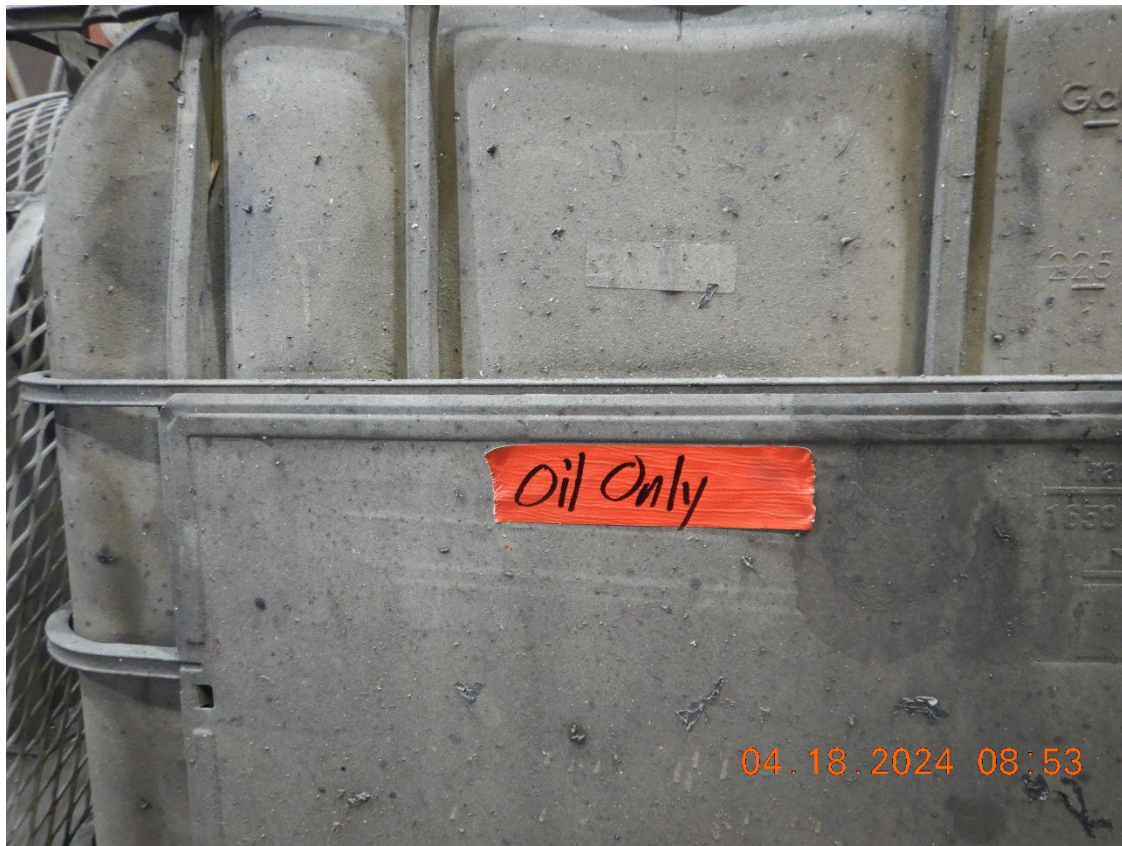
Photo No. 2

Description: Closeup of "oil only" label on used oil tote in Devall's diesel services building.

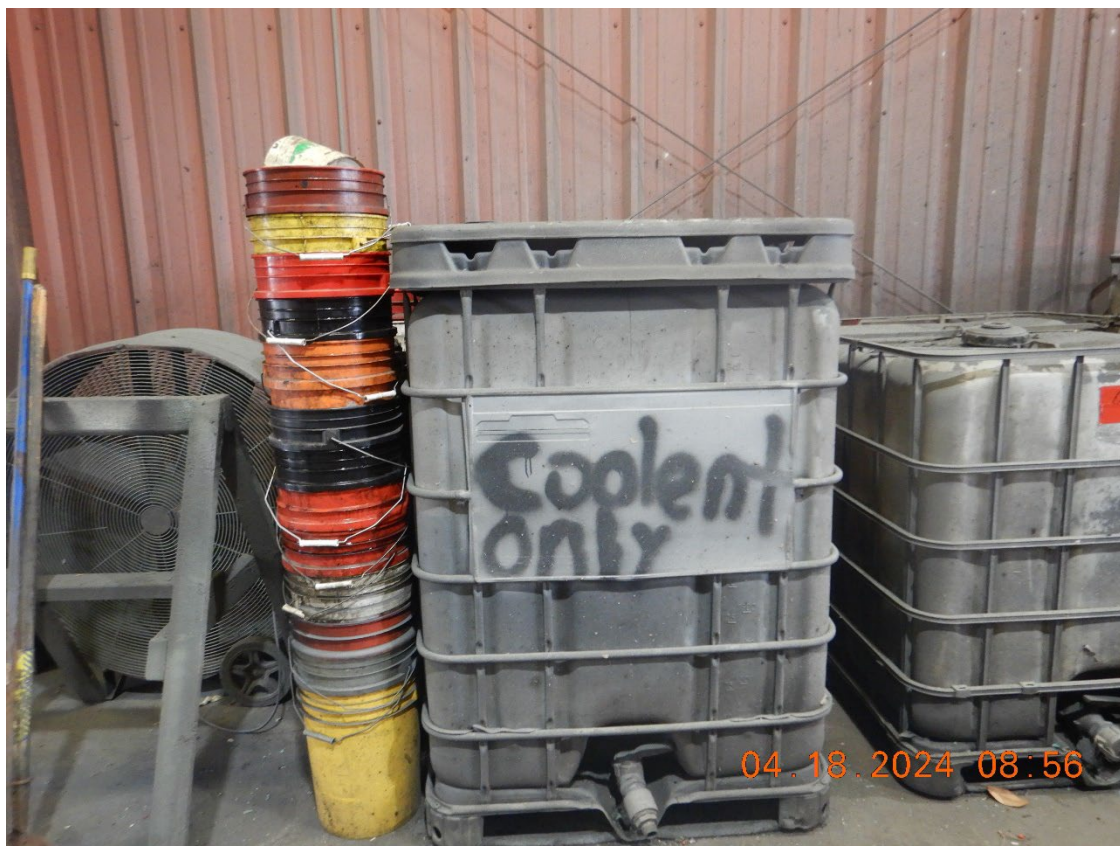
Photo No. 3

Description: Antifreeze tote labeled as "Coolant only" in Devall's diesel services building.

| <b>Tenant:</b> Southern Devall | | |
|---|---|---|
| <b>AOC #2</b> – Devall did not label or mark clearly their used antifreeze with one of the following phrases: "Universal Waste- Antifreeze," or "Waste Antifreeze," or "Used Antifreeze." | <b>Citation:</b> La. Admin. Code tit. 33, § V-3823 A.8. | Section: 2.10 |

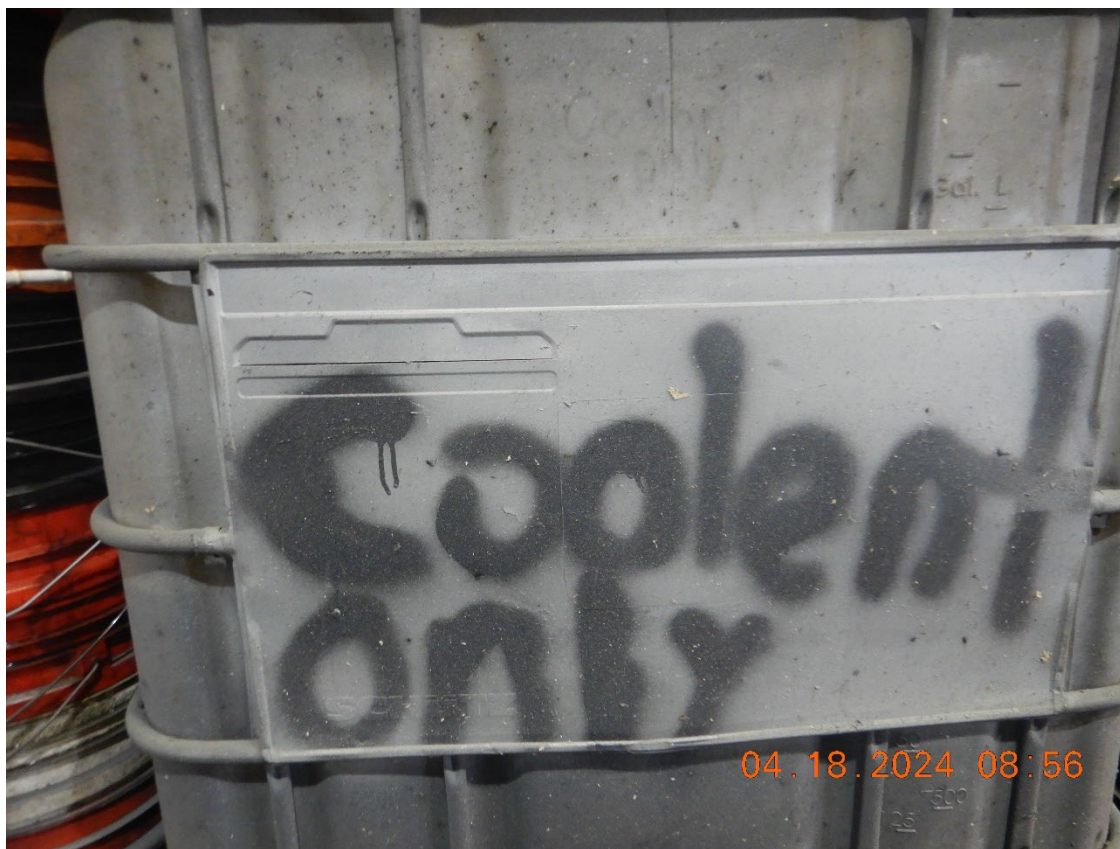
Photo No. 4

Description: Closeup of "Coolant only" label on used antifreeze tote in Devall's diesel services building.

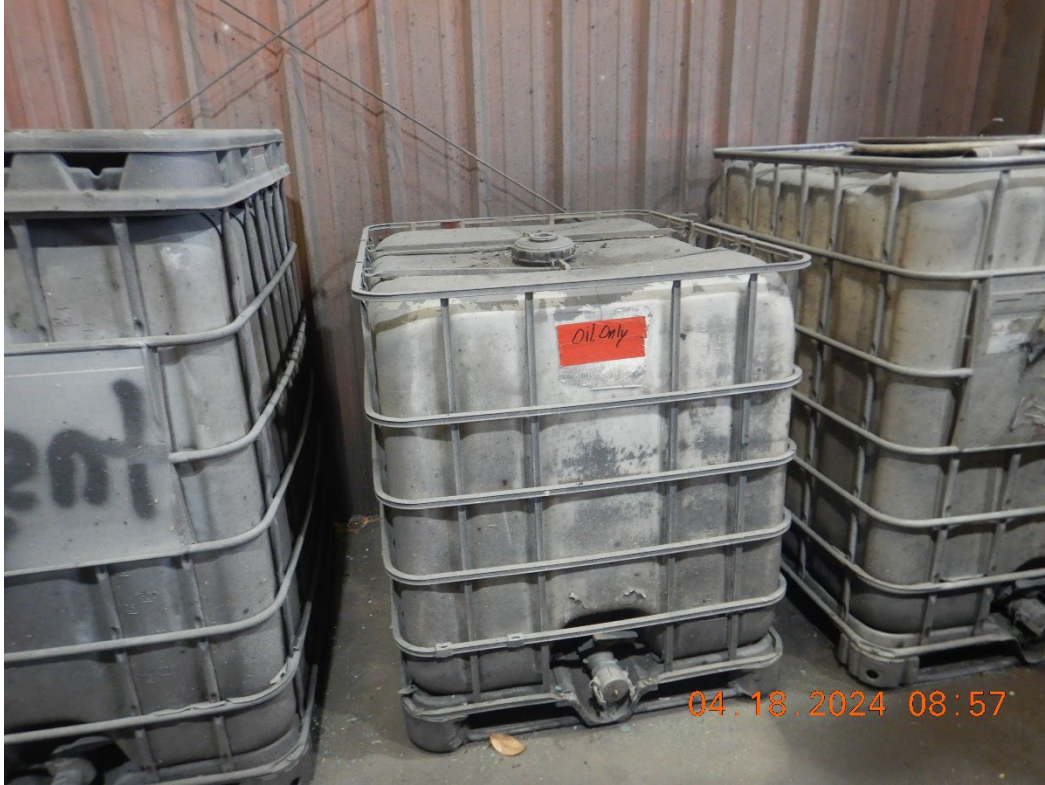
Photo No. 5

Description: Used oil tote labeled as "oil only" in Devall's diesel services building.

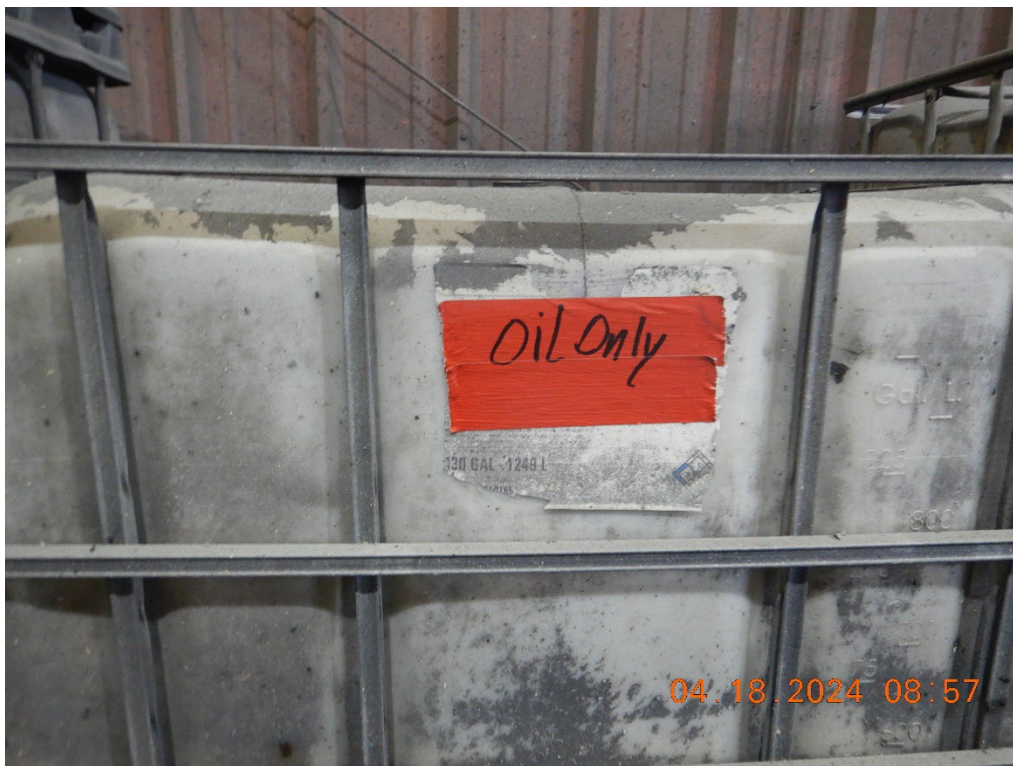
Photo No. 6

Description: Closeup of "oil only" label on a used oil tote in Devall's diesel services building.

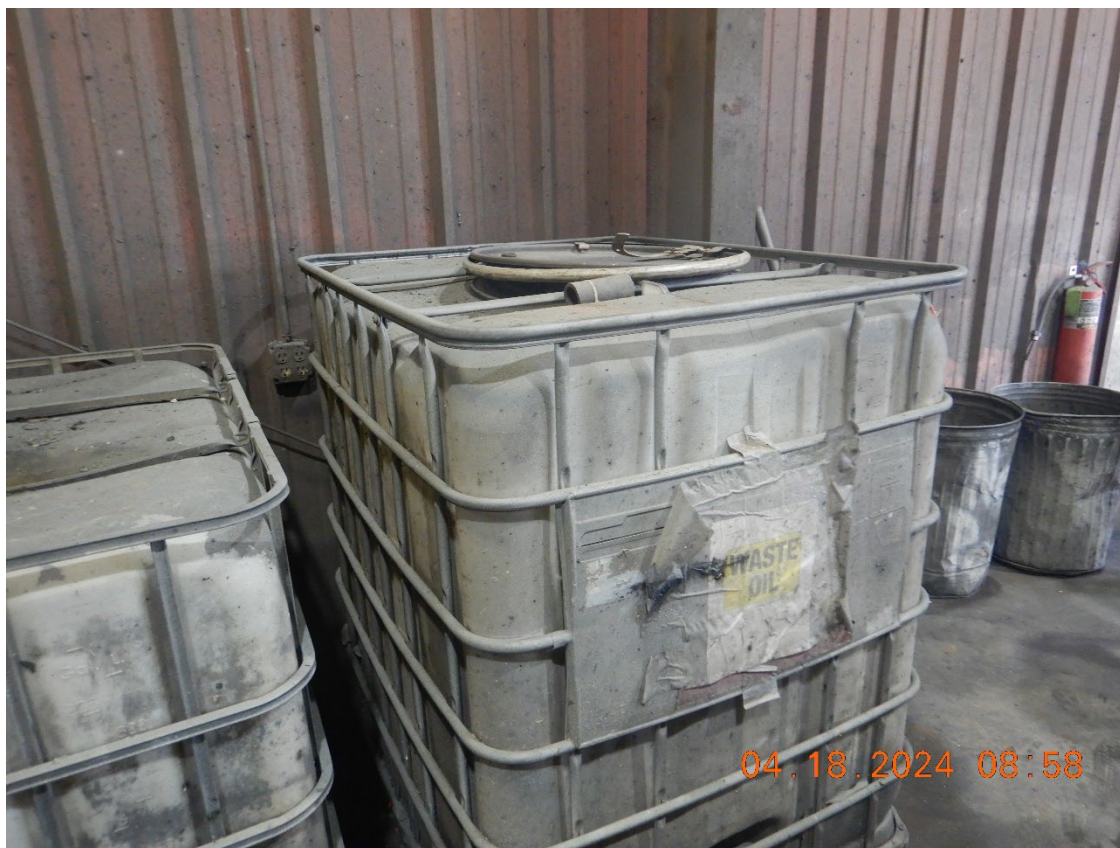
Photo No. 7

Description: Overview of tote for waste oil with a drum lid acting as its cap in Devall's diesel services building.

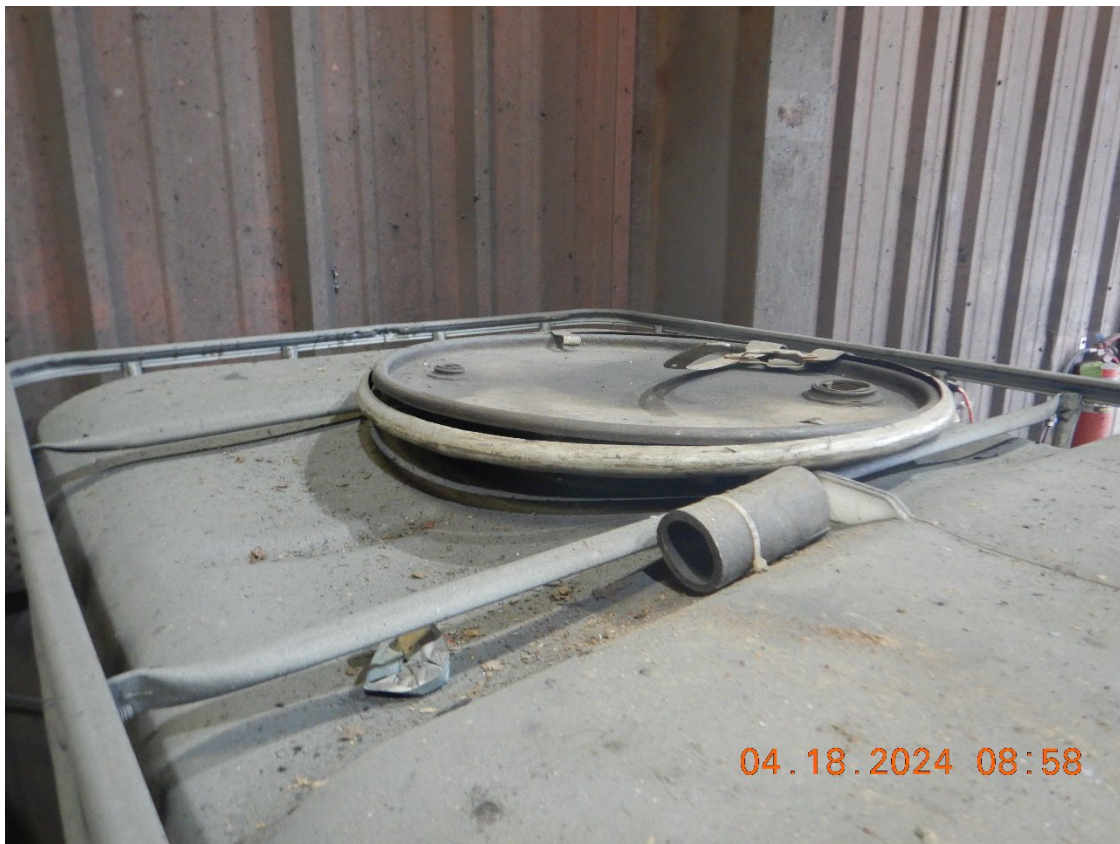
Photo No. 8

Description: Closeup of a drum lid acting as a cap for a tote for waste oil in Devall's diesel services building.

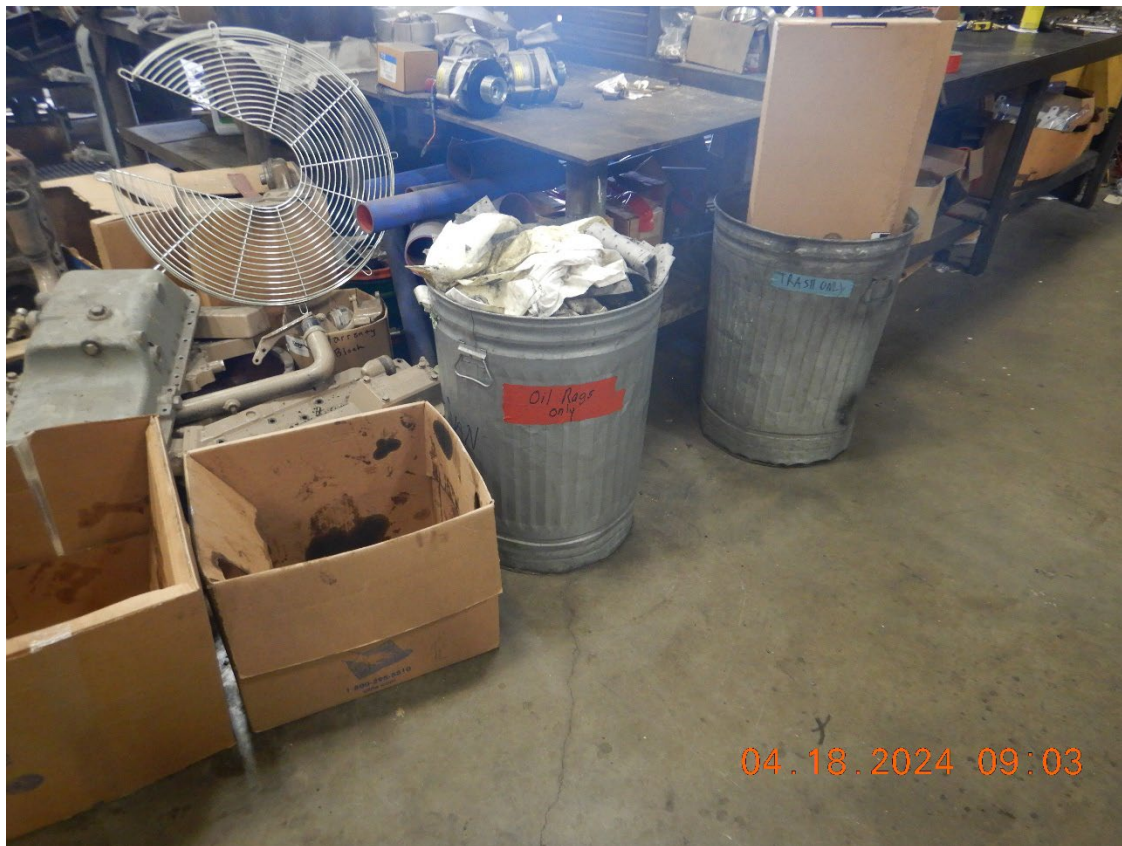
Photo No. 9

Description: Used oil rags container labeled as "oil rags only" in Devall's diesel services building.

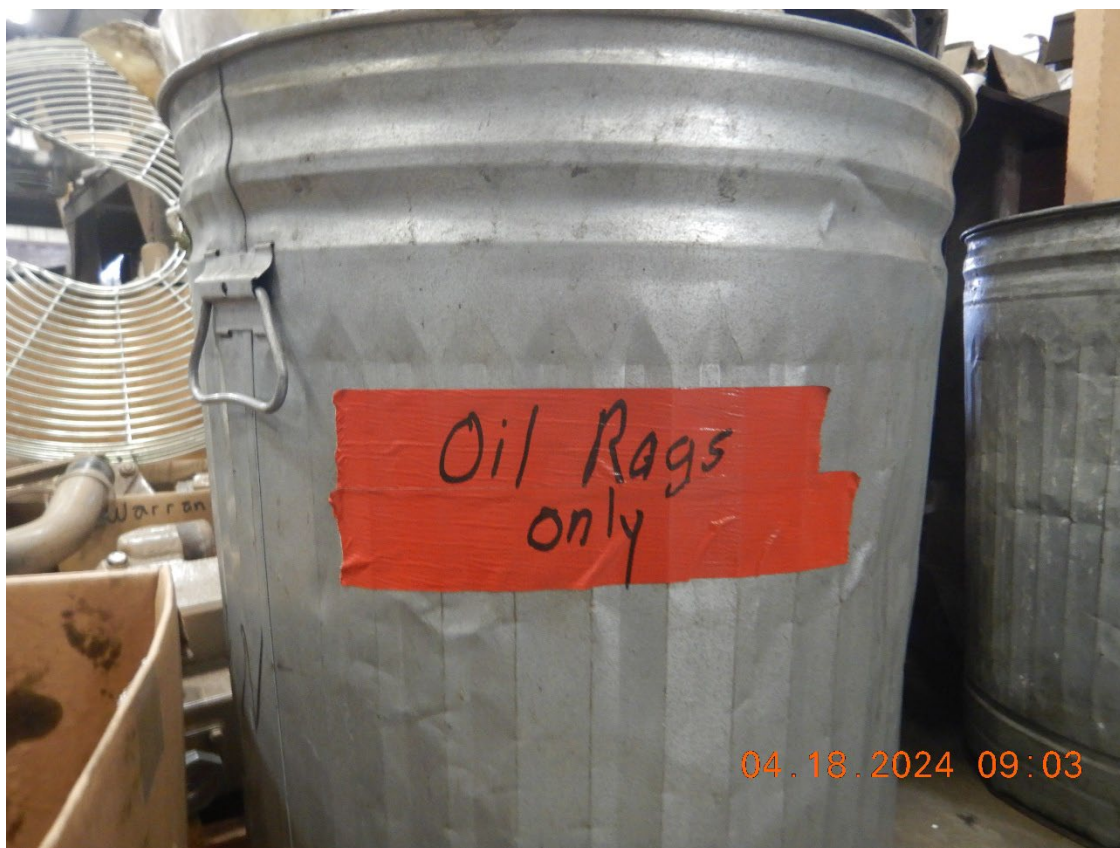
Photo No. 10

Description: Closeup of "oil rags only" label on a used oil rags container in Devall's diesel services building.

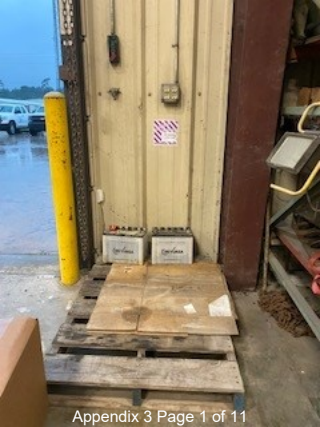
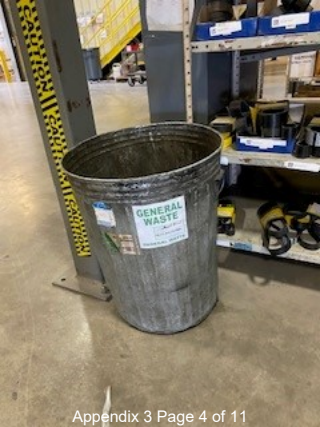
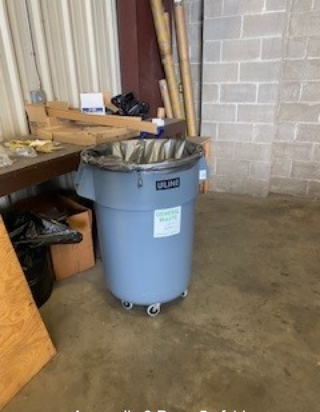
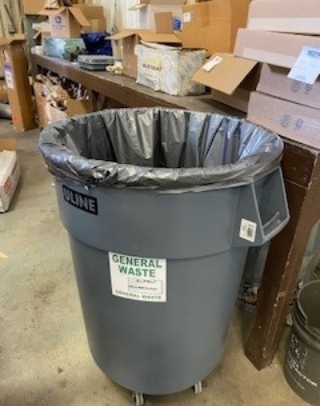
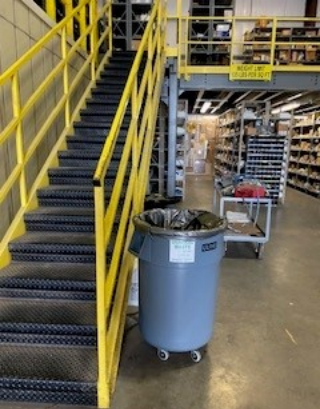
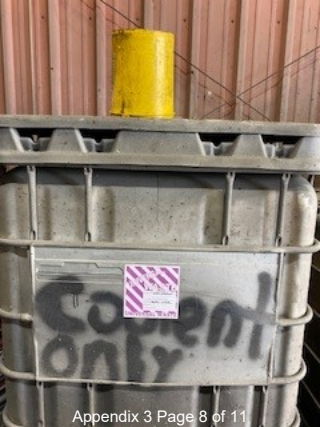
APPENDIX 3.  
FOLLOW-UP PHOTOGRAPHS FROM SOUTHERN DEVAL

Please see the attached requested documents from your site visit a few weeks ago. We've got proper labelling on all containers in the shops as shown in the attached photos.
