## **RCRA Inspection Report**

Wild Flavors & Specialty Ingredients  
Archer Daniels Midland Company  
1261 Pacific Avenue  
Erlanger, Kentucky 41018  
EPA ID: KYR000014910

September 16, 2021 1:50 p.m. – 4:30 p.m.

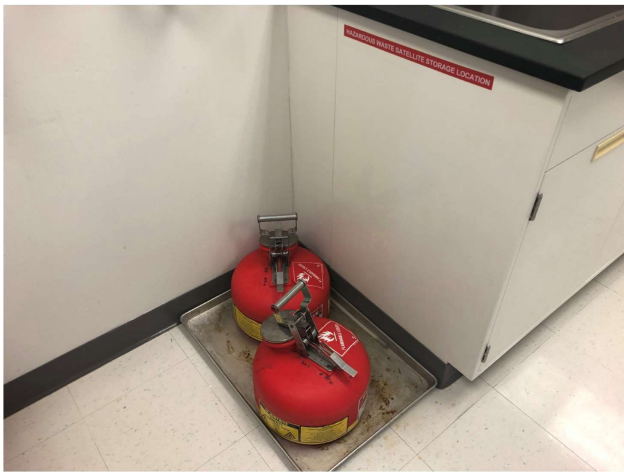
Photo 1: Laboratory 205 SAA.

| Laboratory Room | Number of containers of Hazardous waste | Photo number | Comments: |
|---|---|---|---|
| 205 – 2 <sup>nd</sup> Floor Creation #15 | 2 x 2.5-gallon container | 1 | |

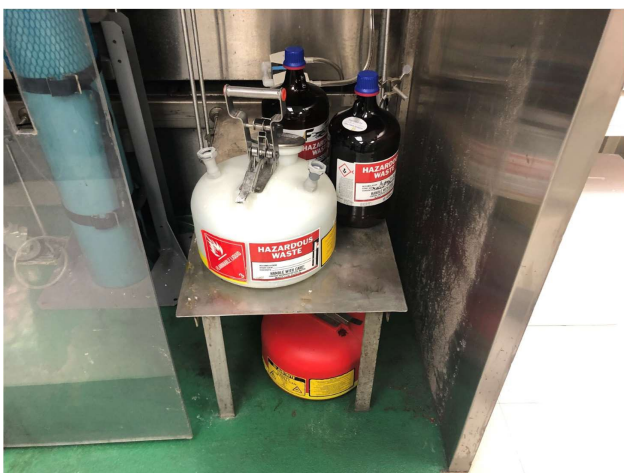
Photo 5: Laboratory 219 Wet Lab SAA.

| Laboratory Room | Number of containers of Hazardous waste | Photo number | Comments: |
|---|---|---|---|
| 219 – Wet Lab A, B, C | 3 x 5-gallon | 5 | |

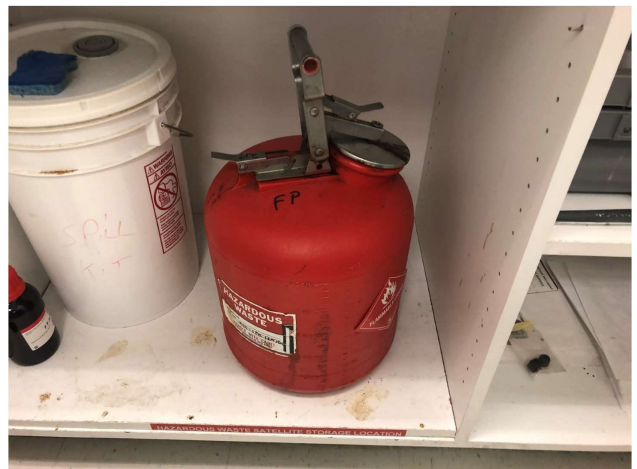
Photo 6: Laboratory 213 SAA.

| Laboratory Room | Number of containers of Hazardous waste | Photo number | Comments: |
|---|---|---|---|
| 213 – 2 <sup>nd</sup> Floor Stink Room | 1 x 5-gallon container | 6 | |

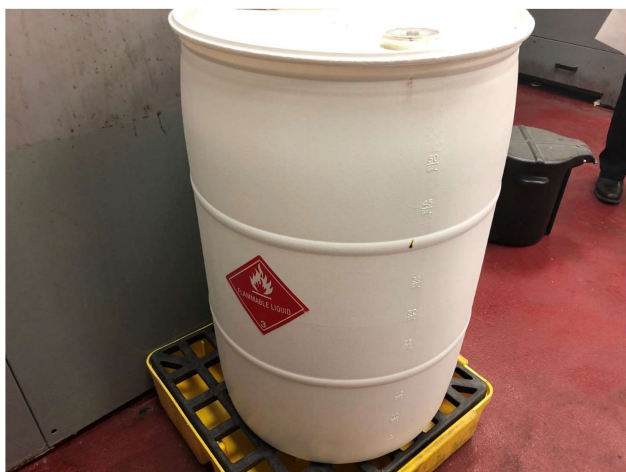
Photo 11: Remstar SAA.

| Laboratory Room | Number of containers of Hazardous waste | Photo number | Comments: |
|---|---|---|---|
| Remstar SAA | 1 x 55-gallon White poly container | 10-11 | |

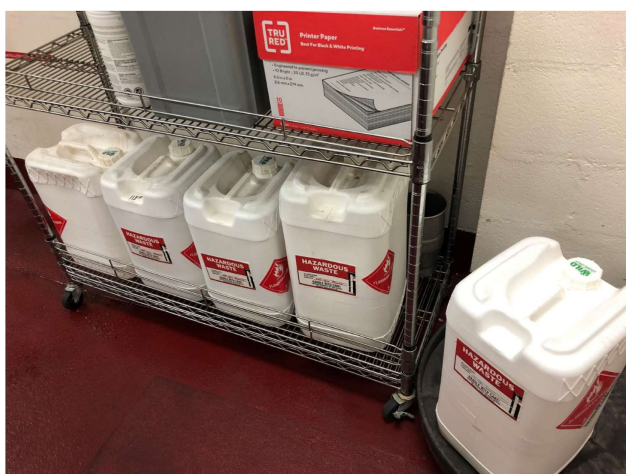
Photo 12: Robot Area SAA.

| Laboratory Room | Number of containers of Hazardous waste | Photo number | Comments: |
|---|---|---|---|
| Robot Area | 5 5-gallon poly containers | 12 | |

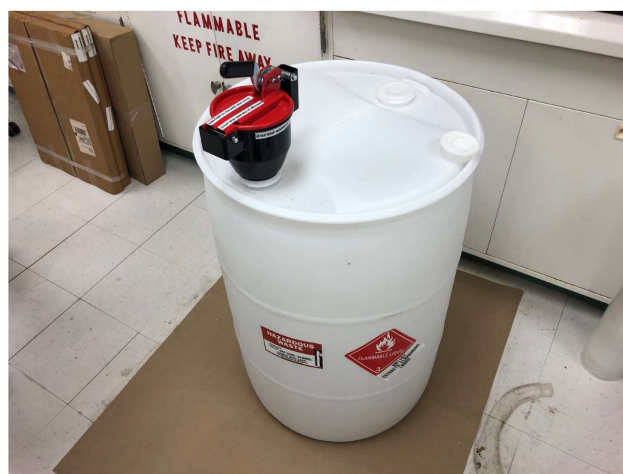
Photo 15: Laboratory 226 SAA.

| Laboratory Room | Number of containers of Hazardous waste | Photo number | Comments: |
|---|---|---|---|
| 226 – QC Culi 55 and Silver | 1 x 55-gallon container with funnel | 15 | This container had dried waste that had dripped down the side of the container making reading the label difficult but not impossible. |

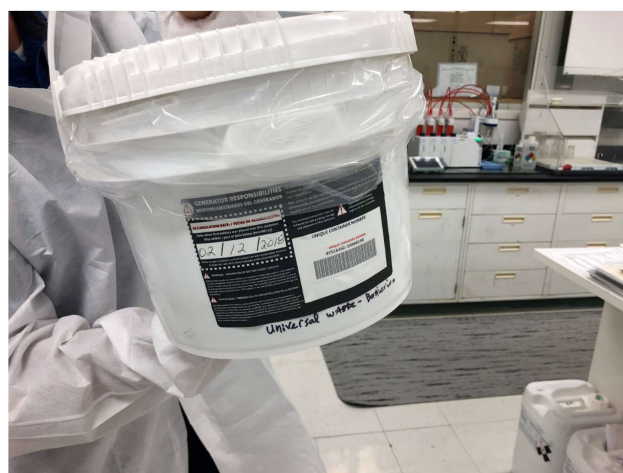
Photo 16: Laboratory 226 SAA.

| Laboratory Room | Number of containers of Hazardous waste | Photo number | Comments: |
|---|---|---|---|
| | 1 x 2.5-gallon recycle pack | 16 | The 2.5-gallon container held primarily alkaline batteries but also held one 3 V universal waste battery. This container was dated 2/12/2018 (> 1 year). |

Wild Flavors manages universal waste batteries in Laboratory 226. One 2.5-gallon plastic bucket of Universal Waste batteries, which was closed and marked with an accumulation start date, was labeled universal waste batteries. Upon inspection, the container contained one 3V universal waste battery. The date observed on this container of batteries was 2/12/2018. Subsequent to the inspection Wild Flavors documented that this universal waste battery was shipped off site.

**Pursuant to 401 KAR 39:080 Section 3(1) [40 C.F.R. § 273.15(a), a SQHUW may accumulate universal waste no longer than one year from the date the universal waste is generated , or received from another handler, unless other requirements of paragraph (b) of this section are met.**

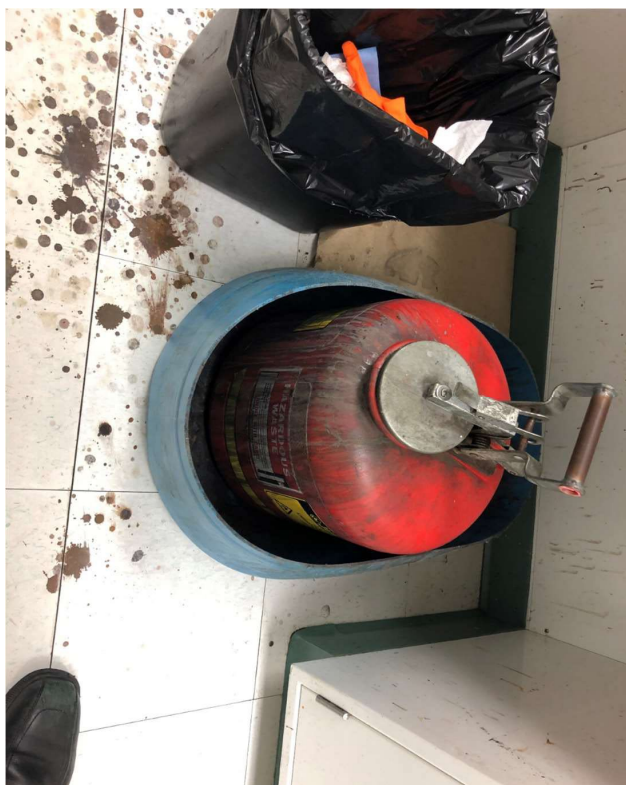
Photo 17: Laboratory 226 SAA.

| Laboratory Room | Number of containers of Hazardous waste | Photo number | Comments: |
|---|---|---|---|
| | 1 x 5-gallon | 17-19 | The label of the 5-gallon container was partially covered with waste drips. There |

| | | | was also waste spilled on the ground around this container. |

**Pursuant to 401 KAR 39:080 Section 1(1) [40 C.F.R. § 262.17(a)(6)], which incorporates 401 KAR 39:080 Section 1(1) [40 C.F.R. § 262.251], and is a condition of the LQG Permit Exemption, a generator is required to maintain and operate its facility to minimize the possibility of a fire, explosion, or any unplanned sudden or non-sudden release of hazardous waste or hazardous waste constituents to air, soil, or surface water which could threaten human health or the environment.**
