## REGION 10 Enforcement Division

### INSPECTION REPORT

| <b>Company Name:</b> | Foundation Health Partners | | |
| <b>Facility or Site Name:</b> | Fairbanks Memorial Hospital | | |

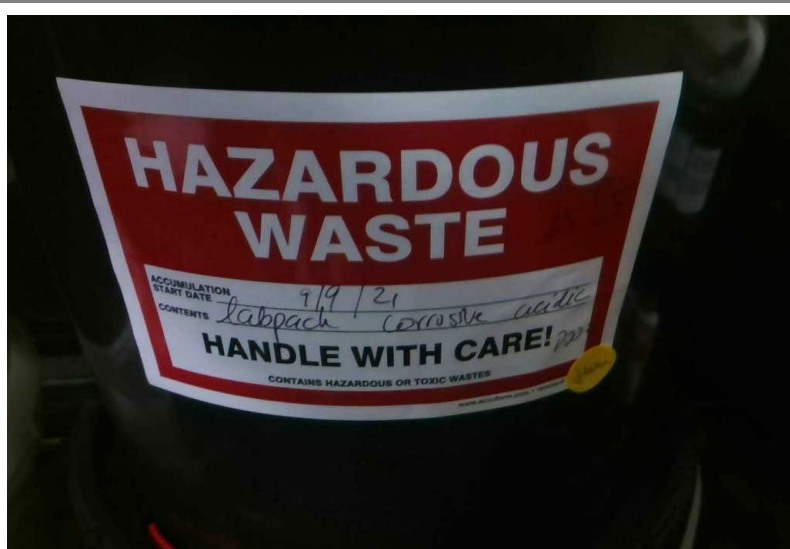
| IMG-202205111421122112385748.jpg |

| Close-up view of a waste container that is not marked with a hazard indicator. |

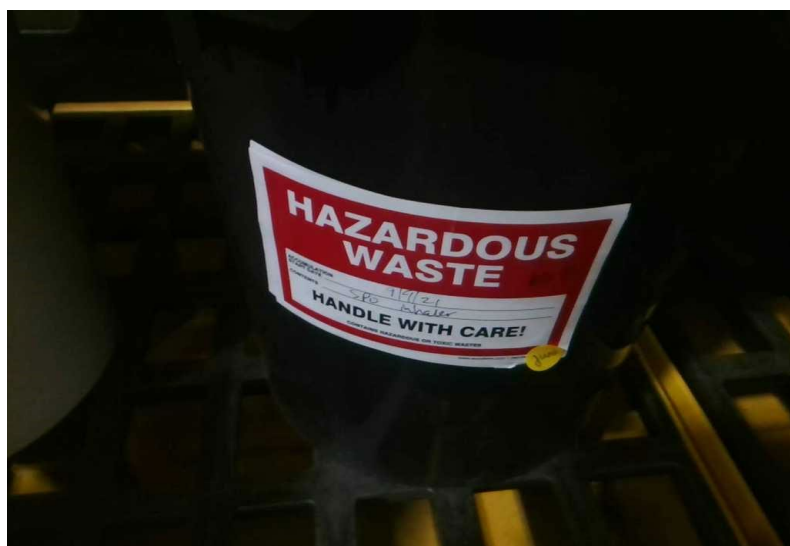
| IMG-202205111421572157301437.jpg |

| Close-up view of a waste container that is not marked with a hazard indicator. |

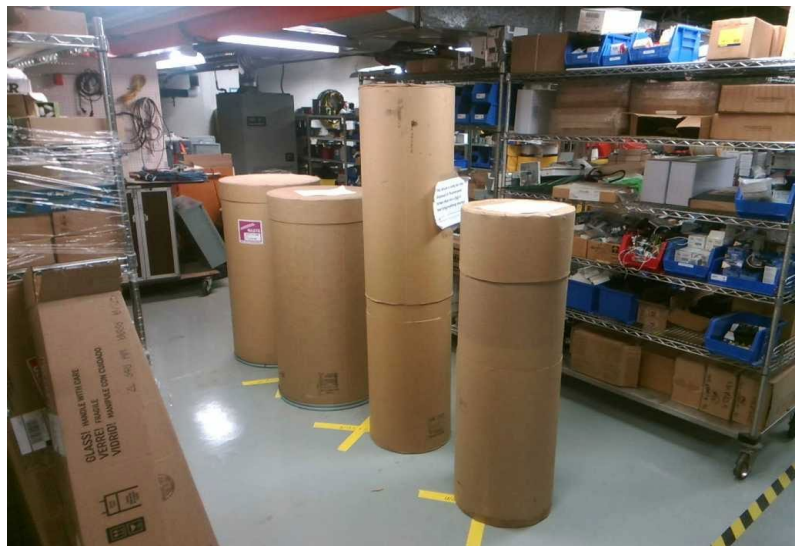
IMG-202205111528342834647231.jpg

Close-up view of container of universal waste lamps.

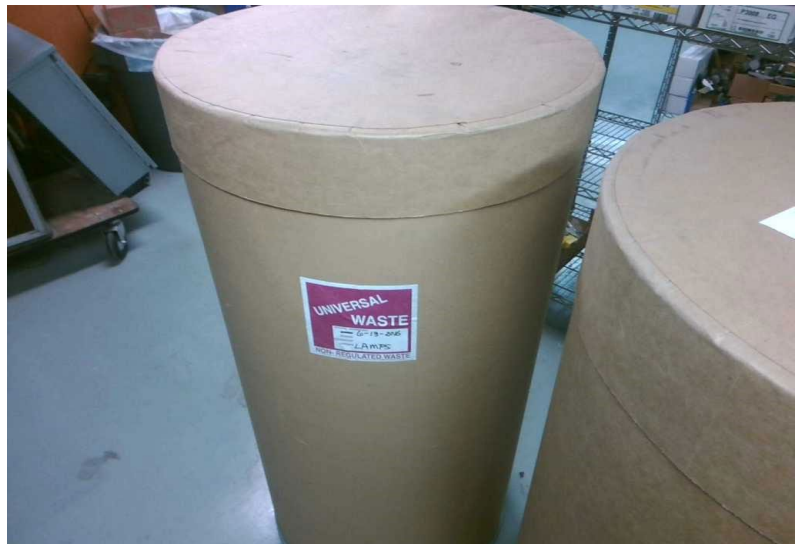
IMG-202205111528482848719656.jpg

Close-up view of the label on the container of universal waste lamps, showing a date of 6/13/2016.

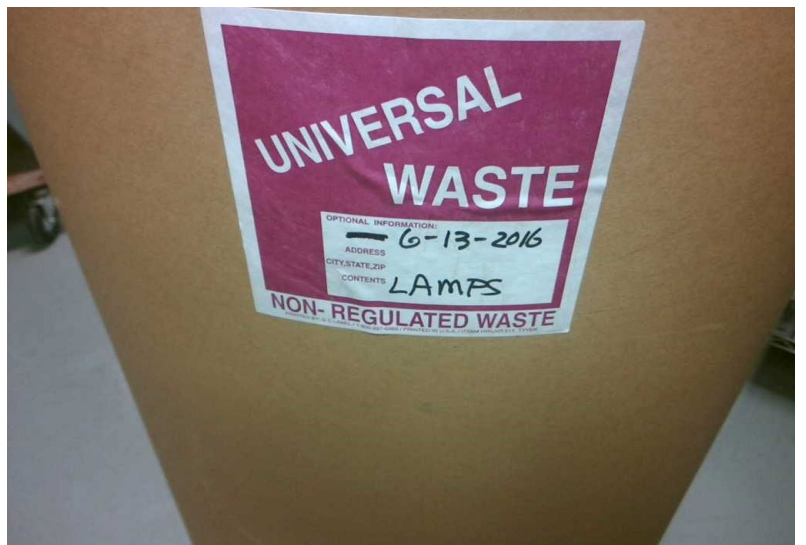
| IMG-202205111529192919824563.jpg |

| View of a container, seen here in the center, that contains waste fluorescent lamps. The container is not labeled as universal waste lamps and not dated. |

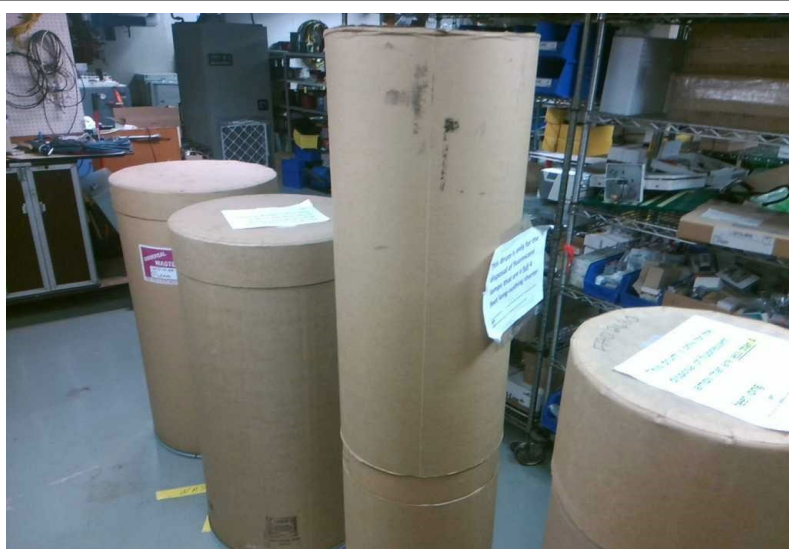
| IMG-202205111529352935924296.jpg |

| Another view of the same container, seen here in the center, that contains waste fluorescent lamps. The container is not labeled as universal waste lamps and not dated. |

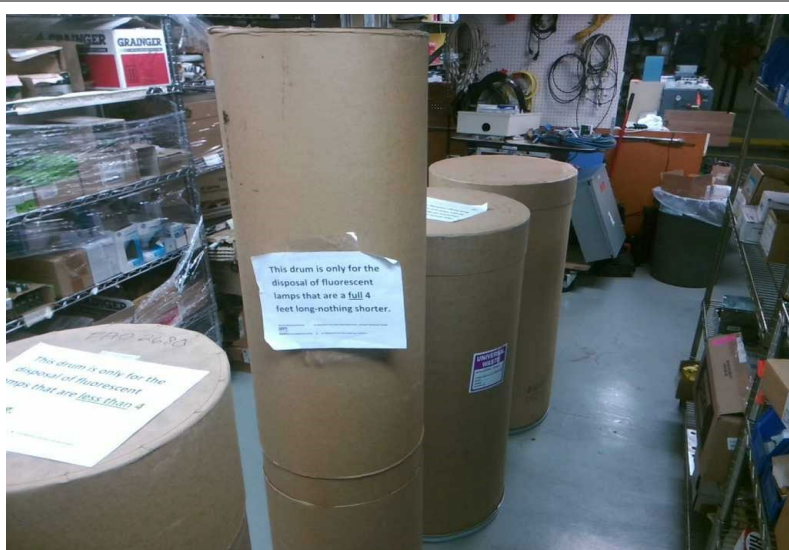
| IMG-202205111529492949723032.jpg |

| Close-up view of the backside of the same container, seen here in the center, that contains waste fluorescent lamps. The container is not labeled as universal waste lamps and not dated. |

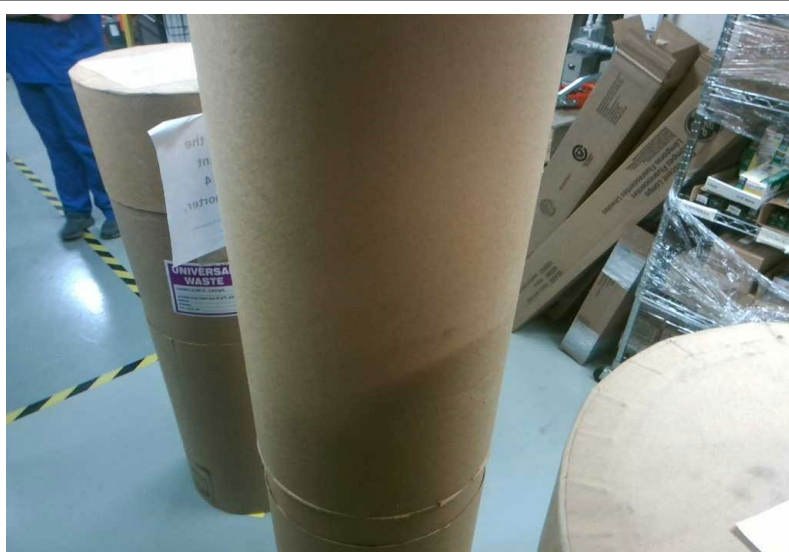
IMG-202205111024342434731175.jpg

View of HWPharms container that is not closed and not dated.

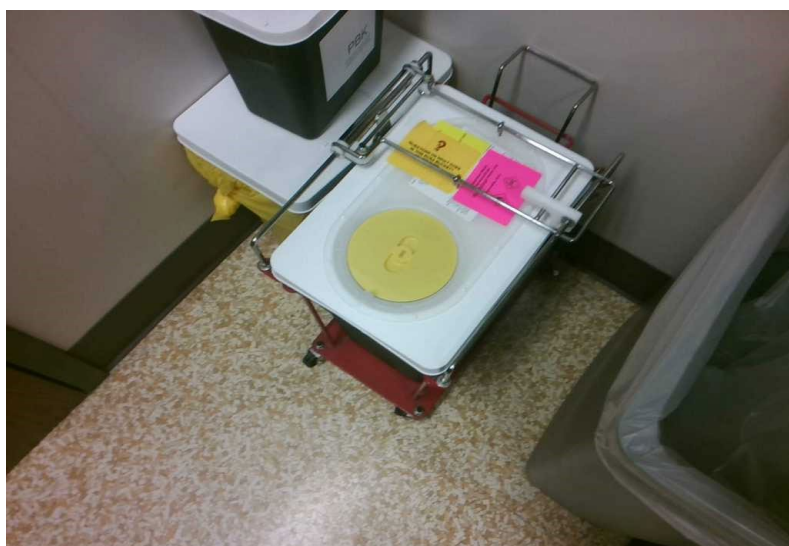
| IMG-202205111027442744515780.jpg |

| View of P-listed waste SAA container that is not labeled with the words "Hazardous Waste" or marked with a hazard indicator. |

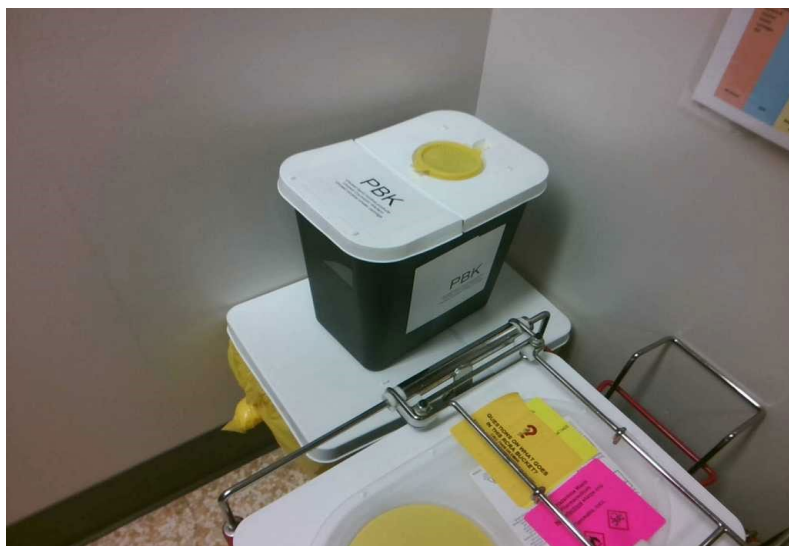
| IMG-20220511103502352515150.jpg |

| View of P-listed waste SAA container that is not closed and not marked with a hazard indicator. |

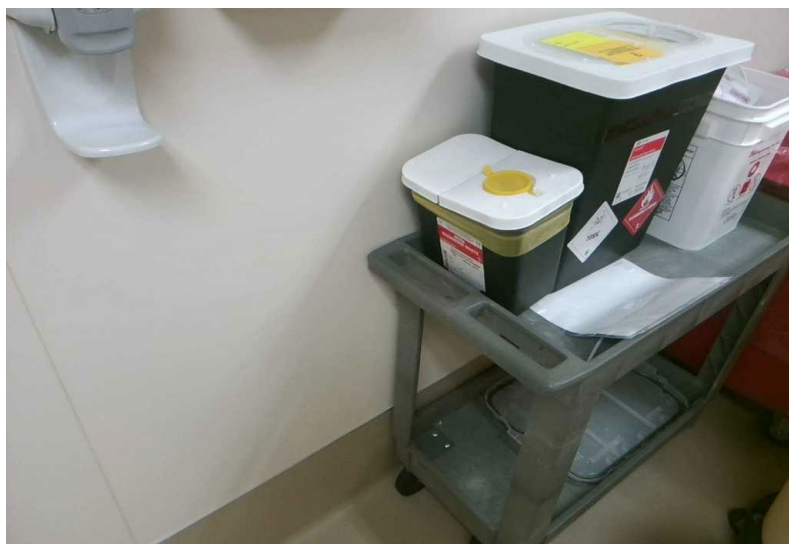
| IMG-20220511103509359553591.jpg |

| Close-up view of P-listed waste SAA container that is not closed and not marked with a hazard indicator. |

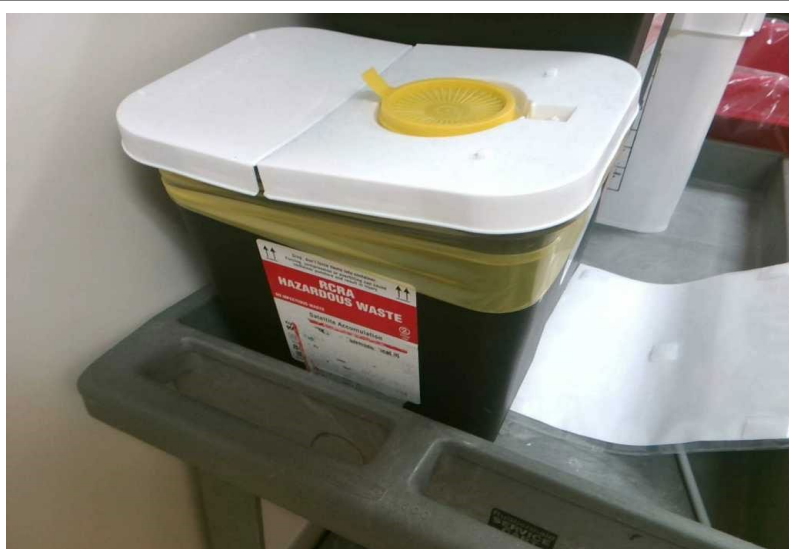
| IMG-202205111035163516371072.jpg |

| Another close-up view of P-listed waste SAA container that is not closed and not marked with a hazard indicator. |

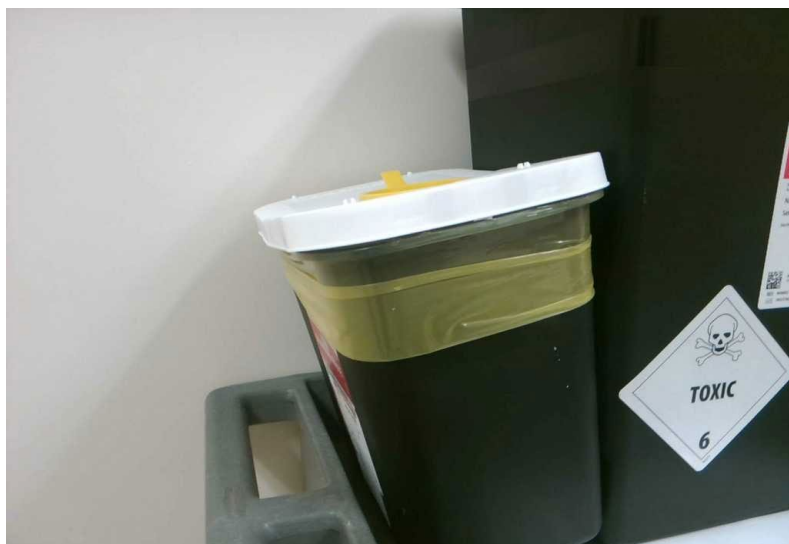
| IMG-202205111035433543538354.jpg |

| Another close-up view of P-listed waste SAA container that is not closed and not marked with a hazard indicator. |

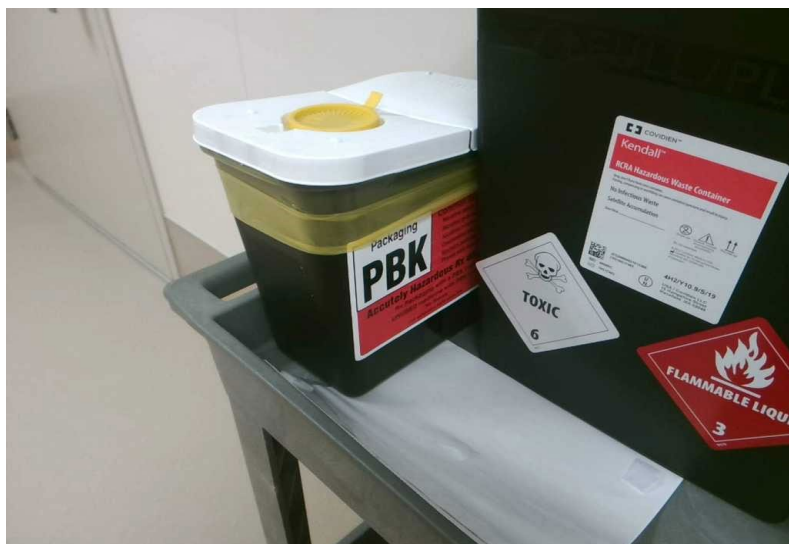
| IMG-202205111037173717536832.jpg |

| View of HWPharms container that is not closed, not labeled with the words "Hazardous Waste Pharmaceuticals," and not dated. |

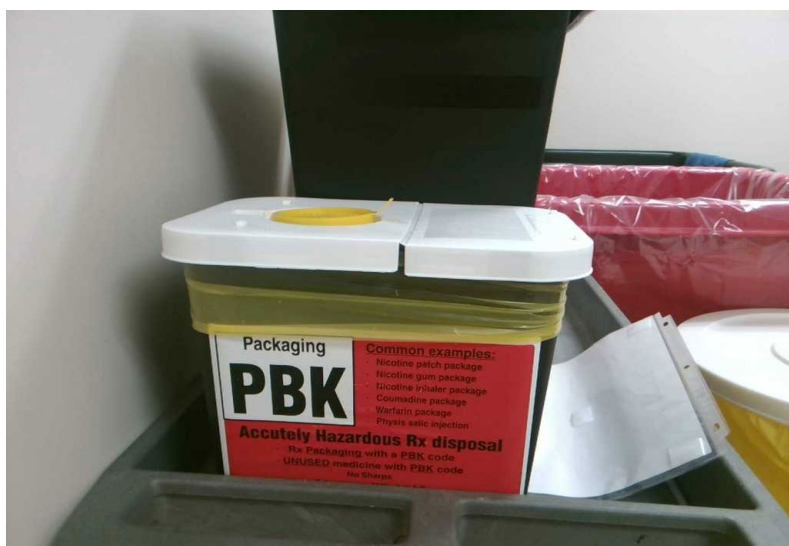
| IMG-202205111016341634133990.jpg |

| View of the contents of SAA container for P-listed waste that was not closed, not labeled with the words "Hazardous Waste," and not marked with a hazard indicator. It also contained trace chemo waste. |

While in this SAA, I saw that the satellite accumulation container for the accumulation of P-listed hazardous waste was not closed, not labeled with the words "Hazardous Waste," and not marked with a hazard indicator. According to Ms. Guffens, the container also held some trace chemo waste. Ms. Guffens made the comment that since there wasn't an available trace chemo waste container, staff were apparently using P-listed hazardous waste SAA container for trace chemo waste.

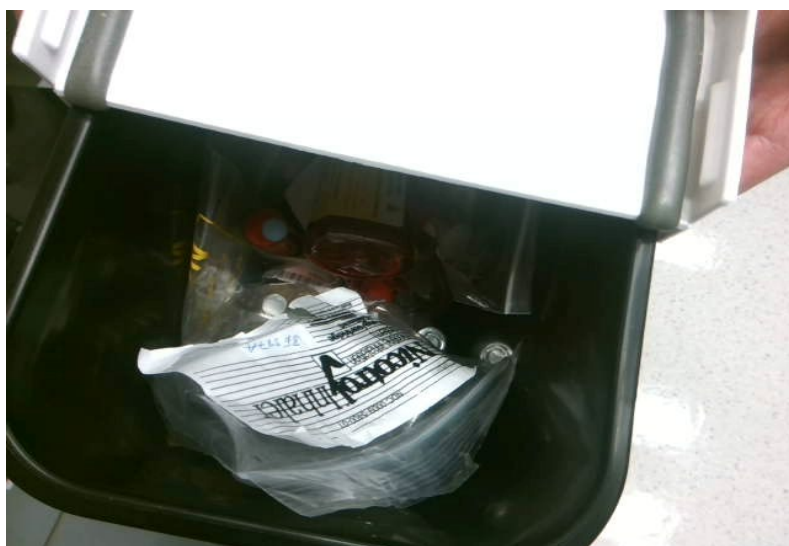
| IMG-202205111016461646172673.jpg |

| Another view of the SAA container for P-listed waste that was not labeled with the words "Hazardous Waste," and not marked with a hazard indicator. It also contained trace chemo waste. |

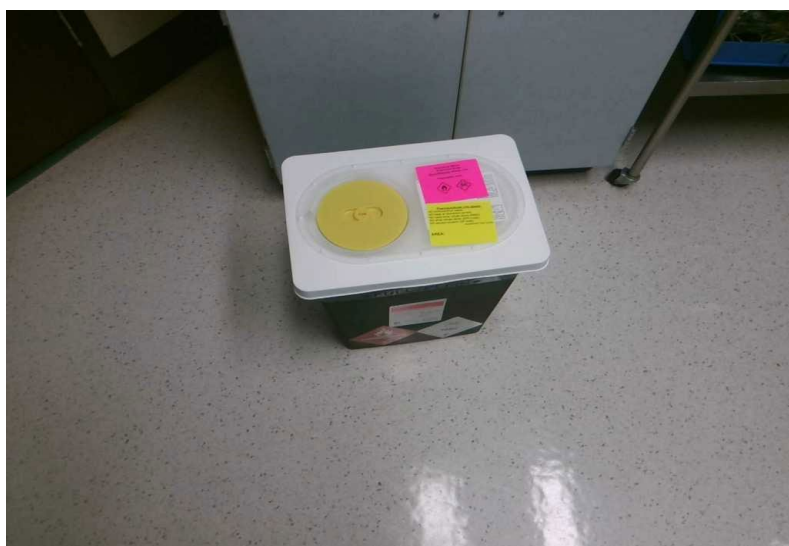
IMG-202205111132133213501921.jpg

View of SAA container for P-listed waste that was not closed, not labeled with the words "Hazardous Waste," and not marked with a hazard indicator.

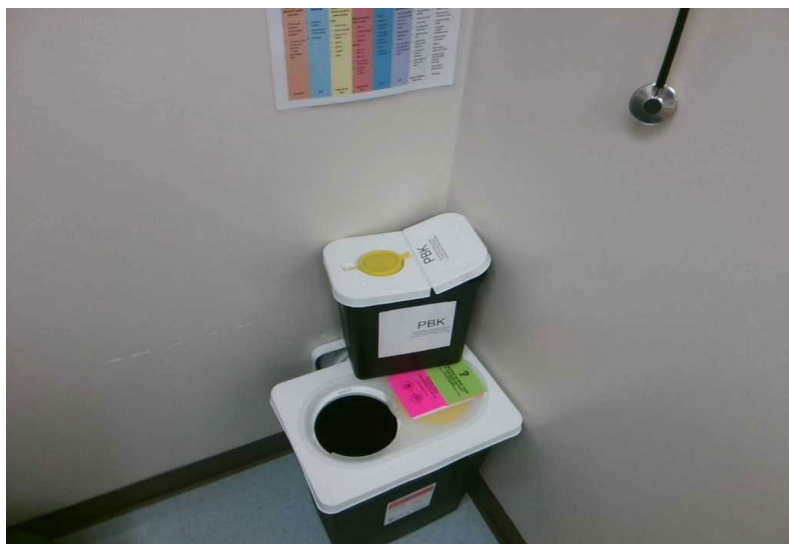
IMG-202205111144344434405524.jpg

Another view of SAA container for P-listed waste that was not closed, not labeled with the words "Hazardous Waste," and not marked with a hazard indicator.

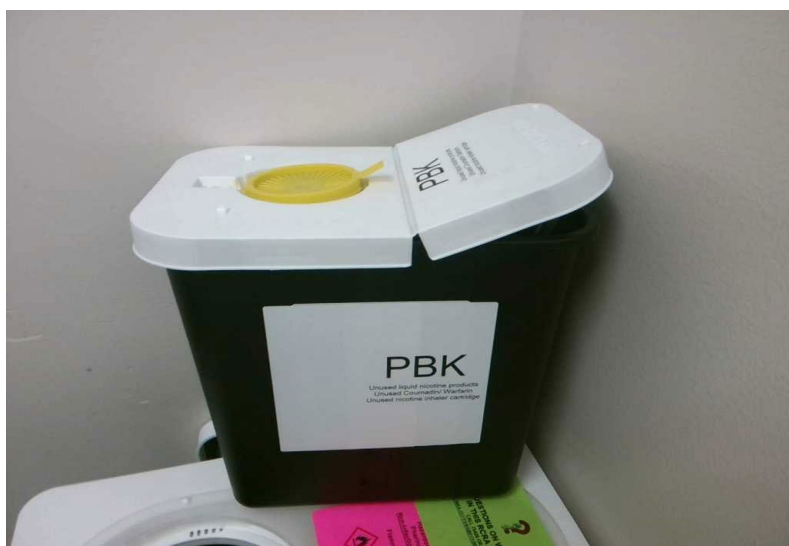
IMG-202205111145464546350595.jpg

View of HWPharms container, beneath P-listed waste SAA container, that is not closed and not dated.

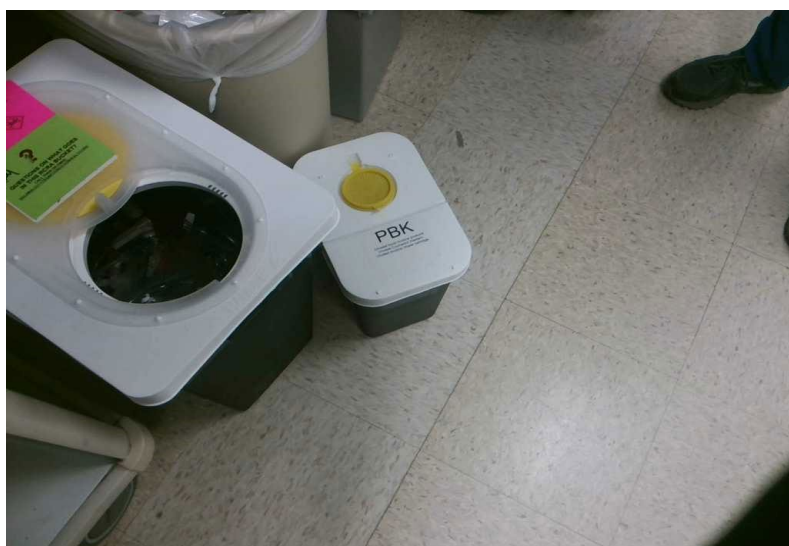
IMG-202205110951295129599530.jpg

Close-up view of the P-listed waste SAA container seen here not labeled with the words "Hazardous Waste" and not marked with a hazard indicator.

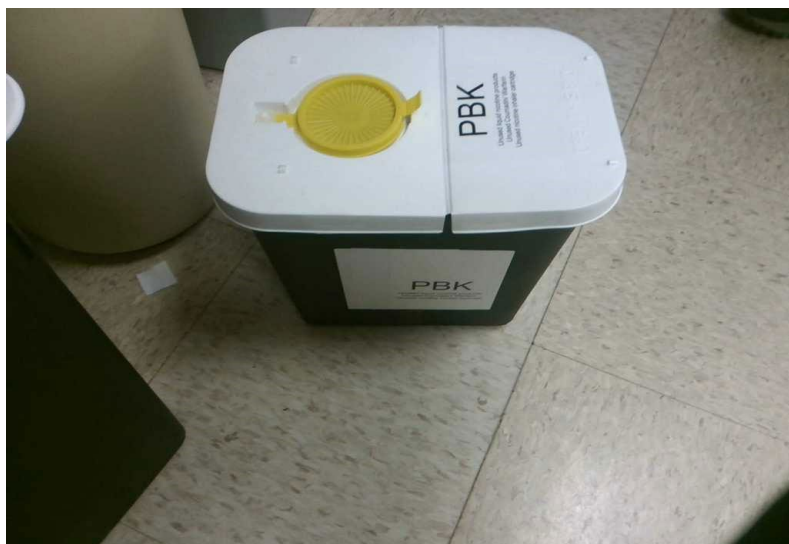
IMG-202205110951415141645918.jpg

Another view of the P-listed waste SAA container seen here not labeled with the words "Hazardous Waste" and not marked with a hazard indicator.

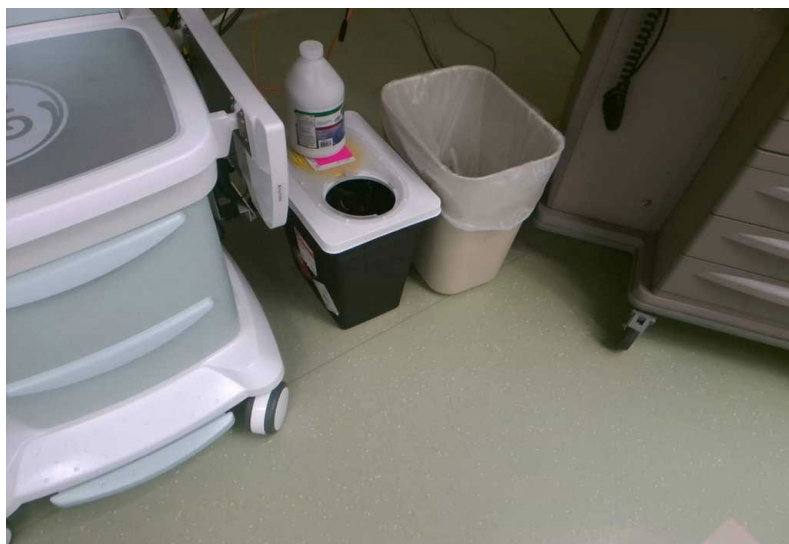
IMG-20220511105301531490148.jpg

Close-up view of HWPharms container, seen here not closed, not labeled with the words "Hazardous Waste Pharmaceuticals," and not dated.

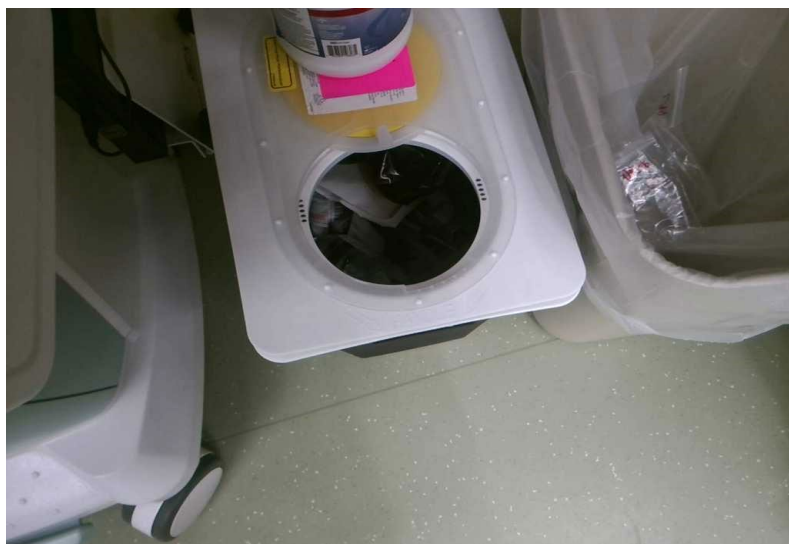
IMG-202205111053525352484732.jpg

View of the HWPharms container shown in IMG-20220511105301531490148.jpg after being closed during the inspection.

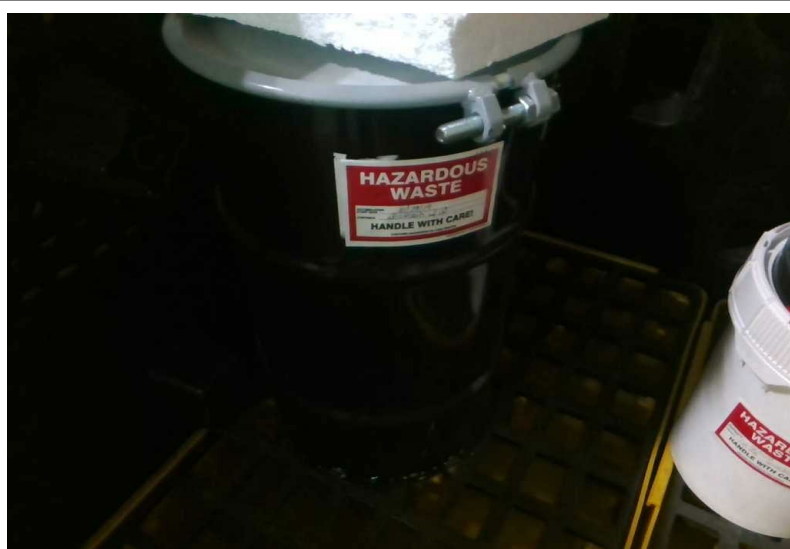
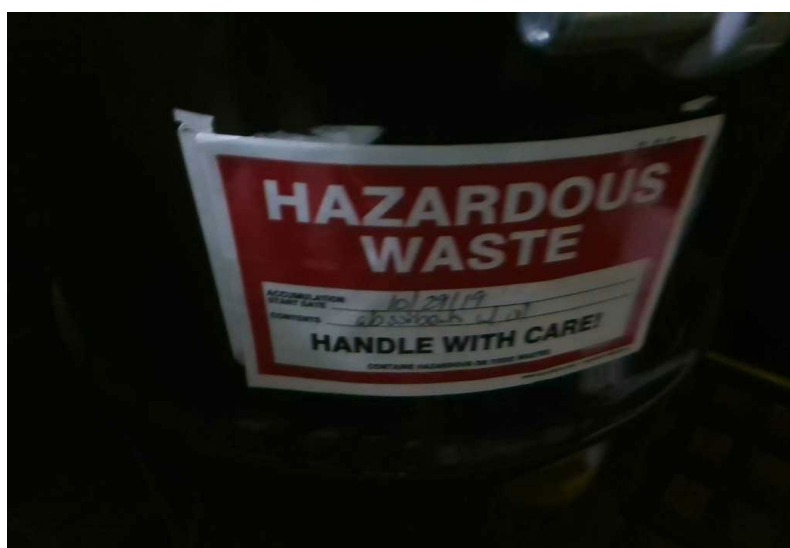
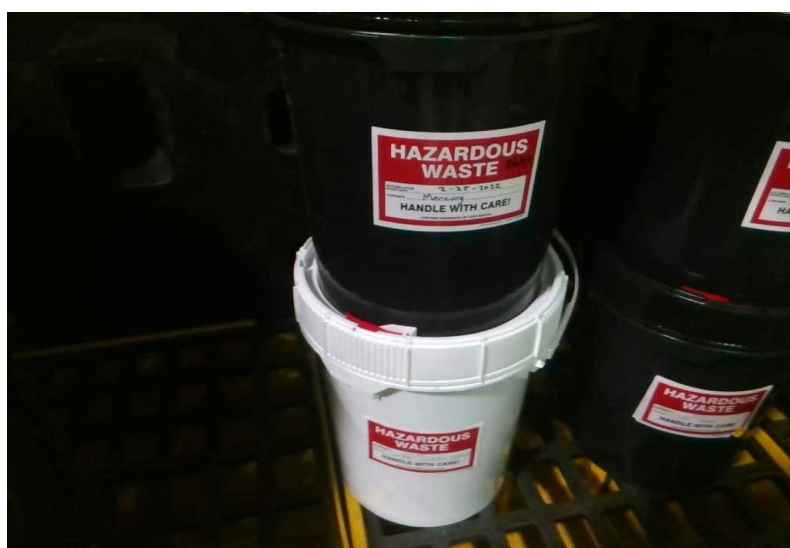
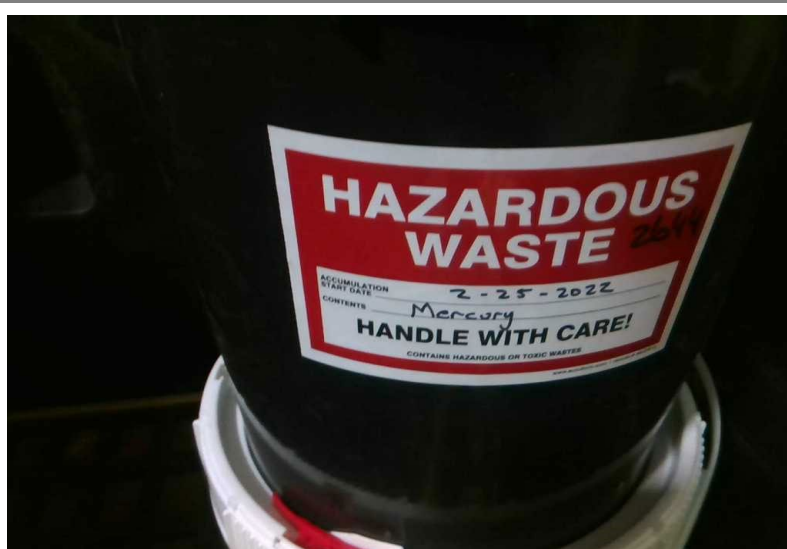
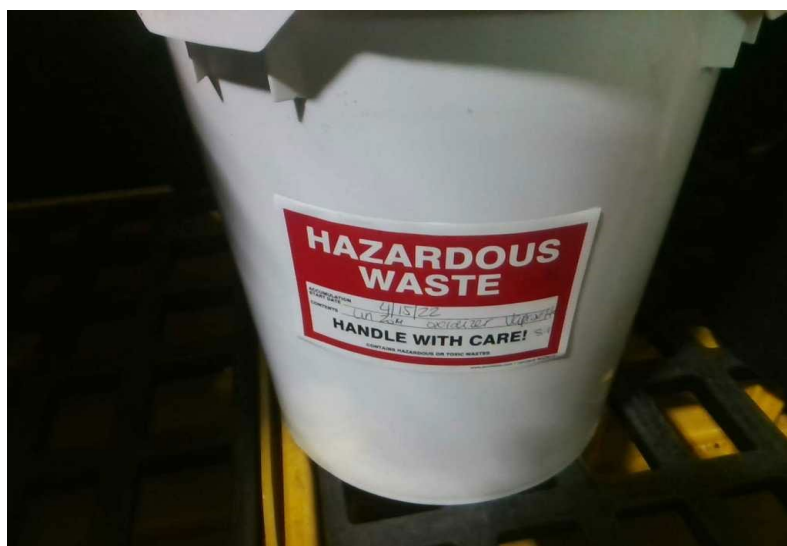
View of the waste containers, showing that they are not marked with hazard indicators.

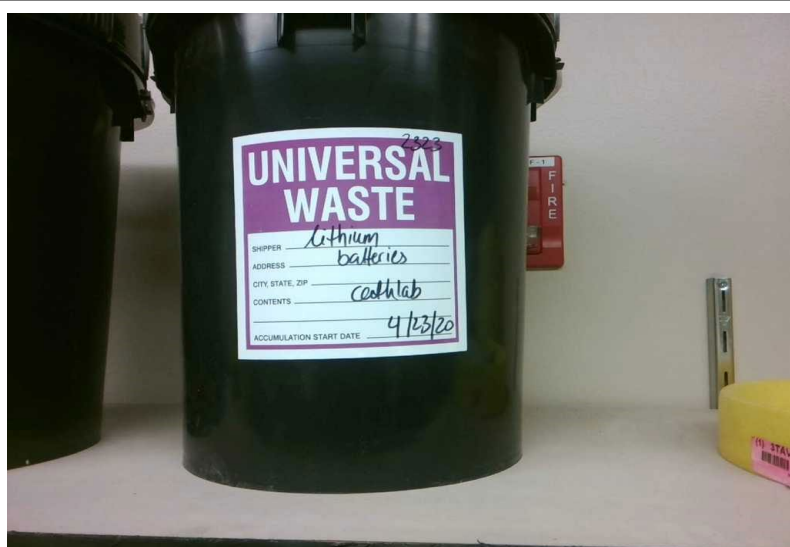
IMG-202205111436183618533145.jpg

View of waste containers that are not marked with hazard indicators.

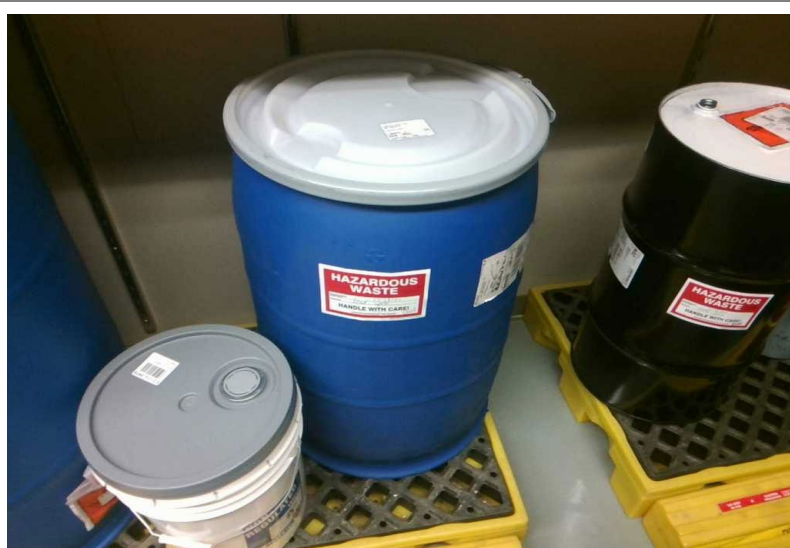
IMG-202205111442544254704780.jpg

Close-up view of the label on the container that held the waste lead apron, showing there is no hazard indicator.

- One, 30-gallon blue poly, containing a waste lead apron, dated 10/28/21, was not marked with a hazard indicator. Ms. Guffens marked the container with a hazard indicator during the inspection.

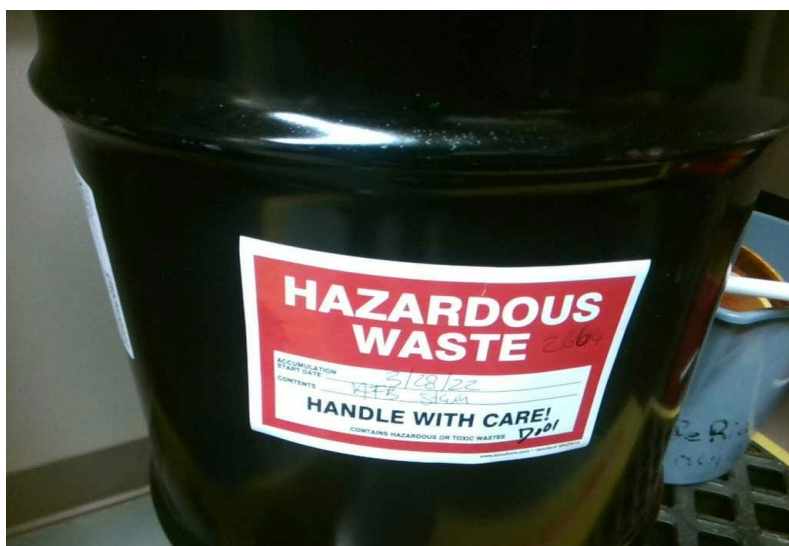
IMG-202205111454525452549573.jpg

Close-up view of black, 5-gallon container, labeled as hazardous waste pending analysis and dated 1/13/22, that is not marked with a hazard indicator.

- One, 5-gallon container of an unknown waste pending analysis, dated 1/13/22, was not marked with a hazard indicator. Ms. Guffens marked the container with a hazard indicator during the inspection.

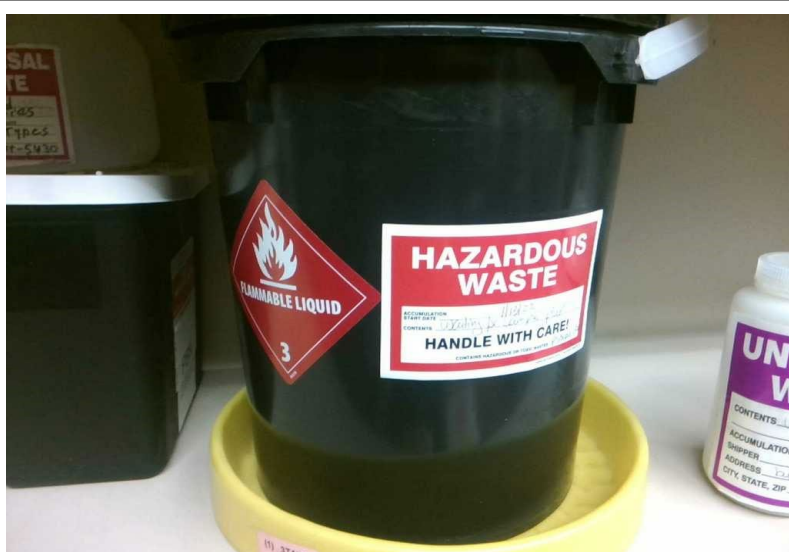
| IMG-20220511150158158665454.jpg |

| Close-up view of the two containers, seen here against the wall and in the center of the photo. |

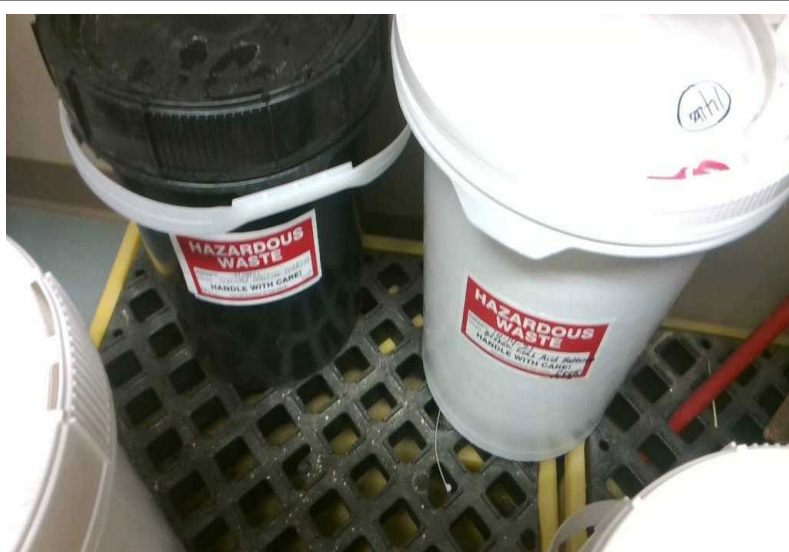
| IMG-20220511150218218886565.jpg |

| Close-up view of the labeling on the container of the corroded alkaline batteries. |

- One, 5-gallon container of waste corroded alkaline batteries, dated 8/29/21, was not marked with a hazard indicator. Ms. Guffens marked the container with a hazard indicator during the inspection.

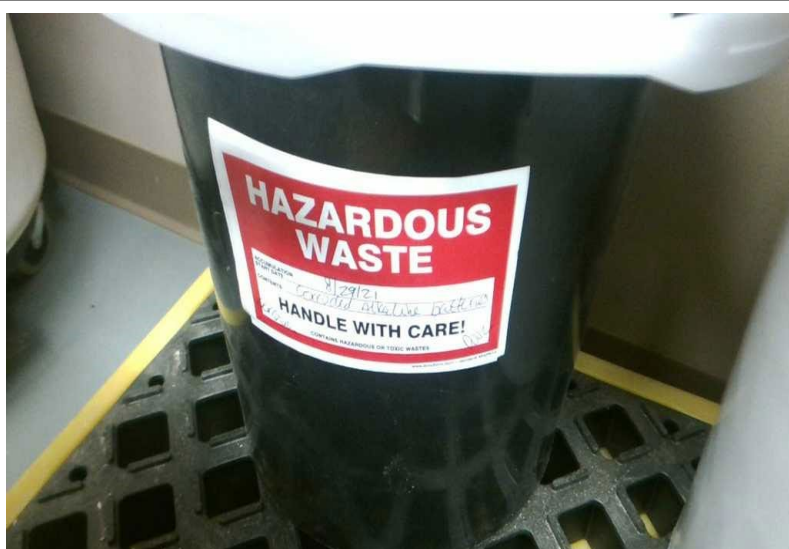
| IMG-20220511150225225804624.jpg |

| Close-up view of the labeling on the container of the broken lead-acid batteries. |

- One, 7.5-gallon container of waste broken lead-acid batteries, dated 10/14/21, was not marked with a hazard indicator. Ms. Guffens marked the container with a hazard indicator during the inspection.
