## Region 6 - Enforcement & Compliance Assurance Division

### INSPECTION REPORT

| Company Name: | <b>Ardmore Production and Exploration Company</b> | |
| Facility Name: | <b>Ramsey</b> | |

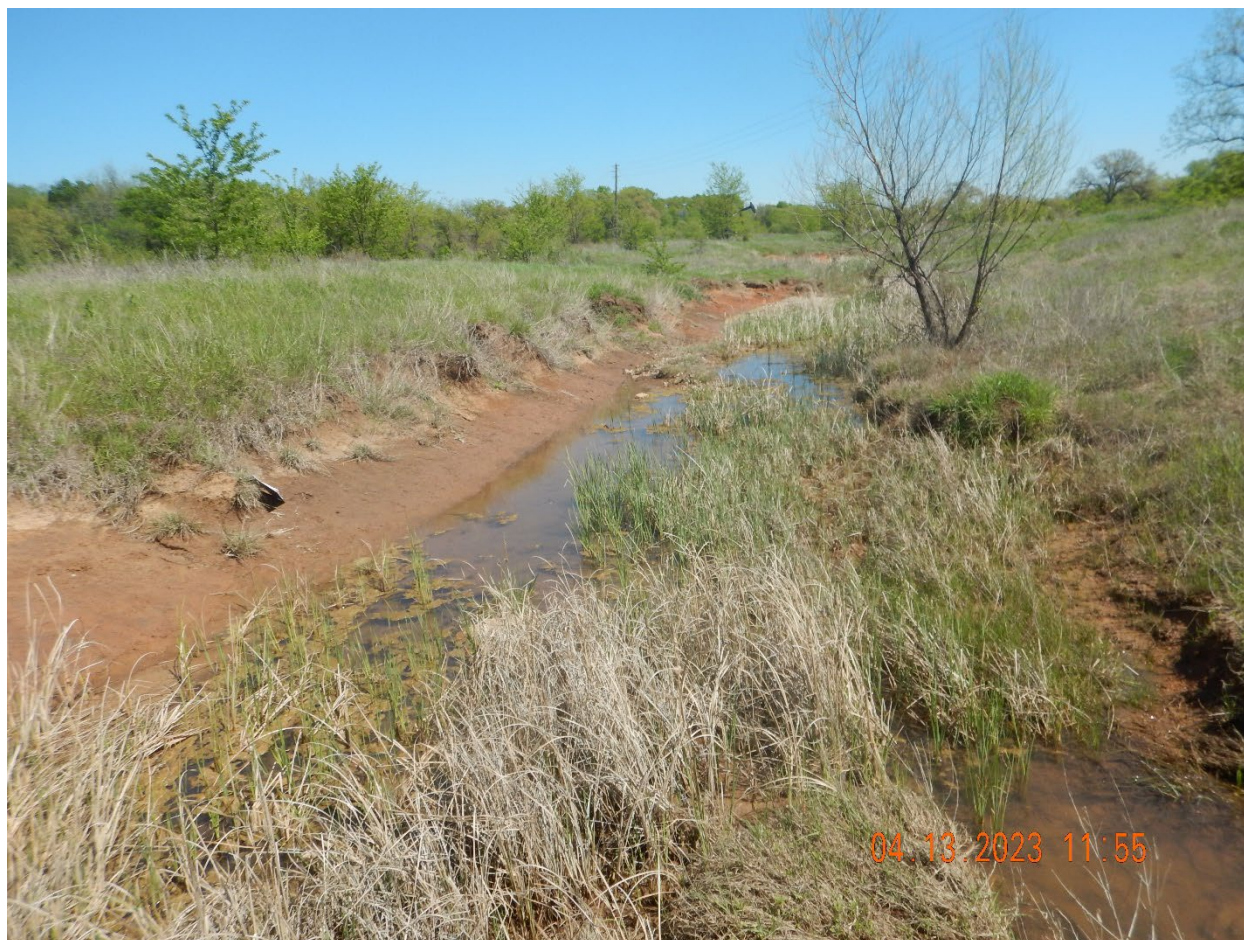
**Description:** This photo shows the location near the road culvert in the tributary of Walnut Creek, approximately 170 feet downstream from the pond during the inspection (*north of the pond*), and the same location as Photo No. 8. This location of the tributary shows bed features (rocks), bank features, and flow conditions during the inspection. This photo shows a downstream view of the tributary from the road culvert location. Some algae growth and riparian vegetation was observed in this part of the tributary as well.

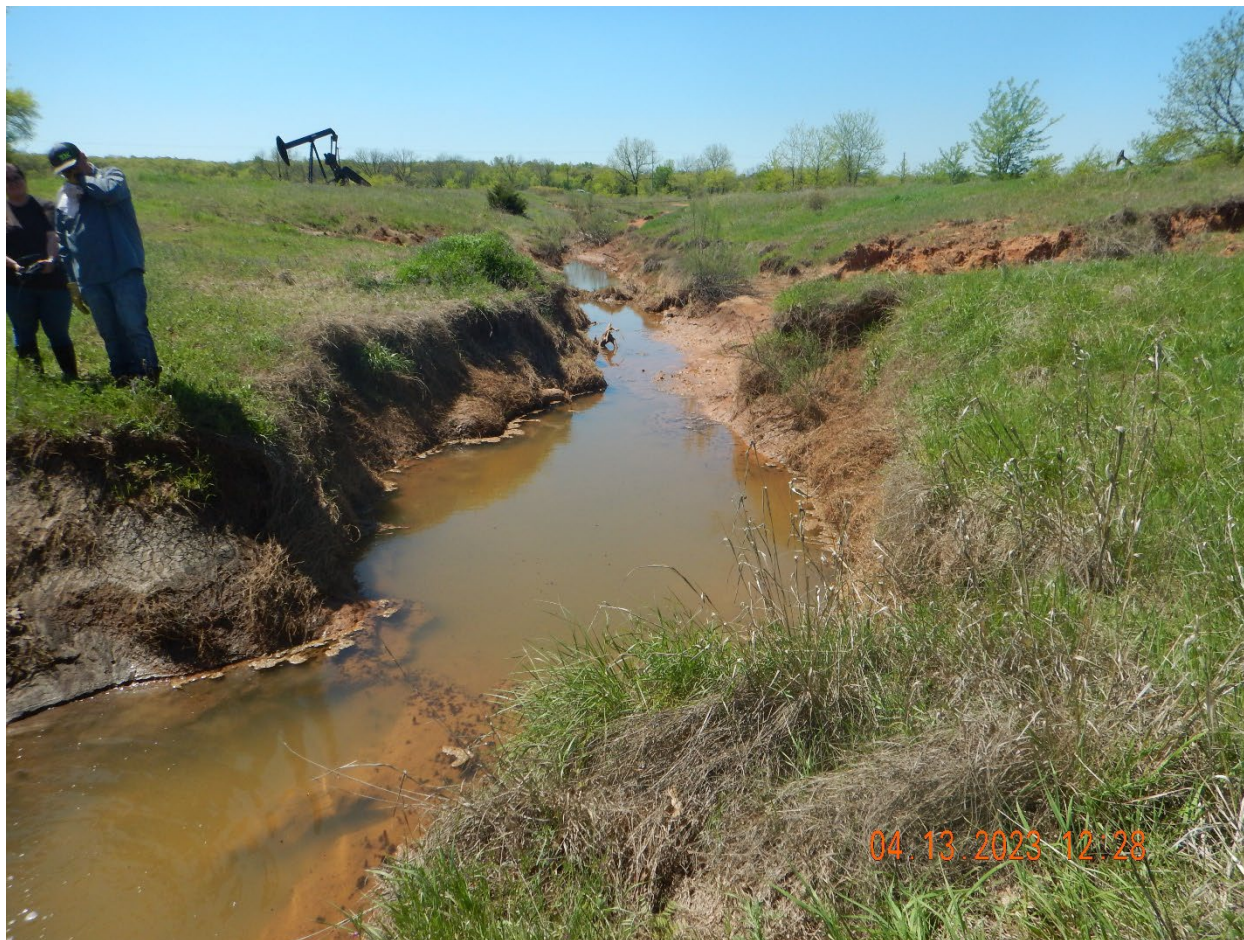
**Description:** This photo showed the tributary location during the inspection approximately 1000 feet downstream from the pond seen in Photo No. 4 of this Appendix. There was some slight black discoloration observed along the banks of the tributary during the inspection, seen towards the bottom left of this photo.

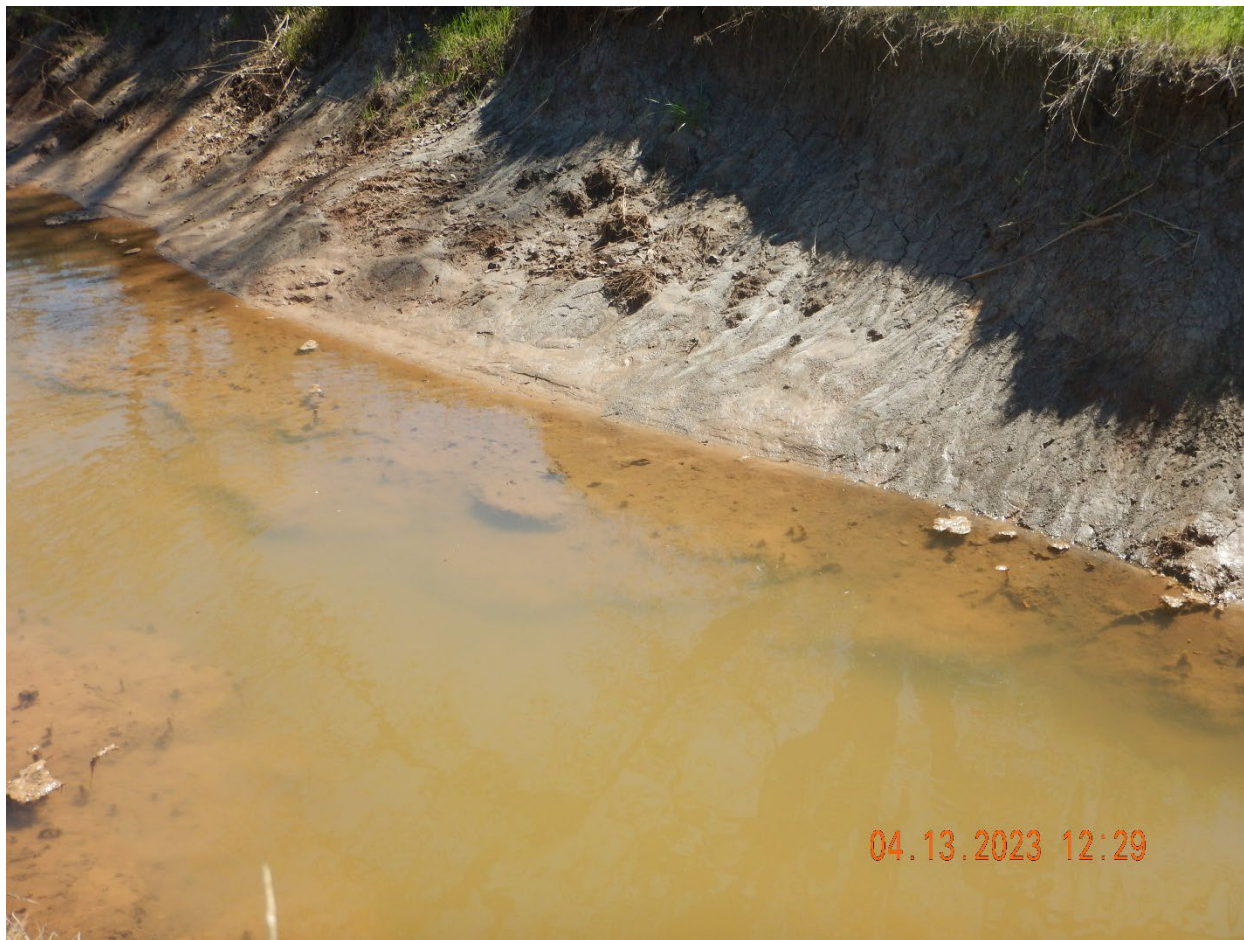
**Description:** This photo showed the tributary location during the inspection approximately 1000 feet downstream from the pond seen in Photo No. 4 of this Appendix. There was some slight black discoloration observed along the banks of the tributary during the inspection, seen along the eastern bank of the tributary at this location.

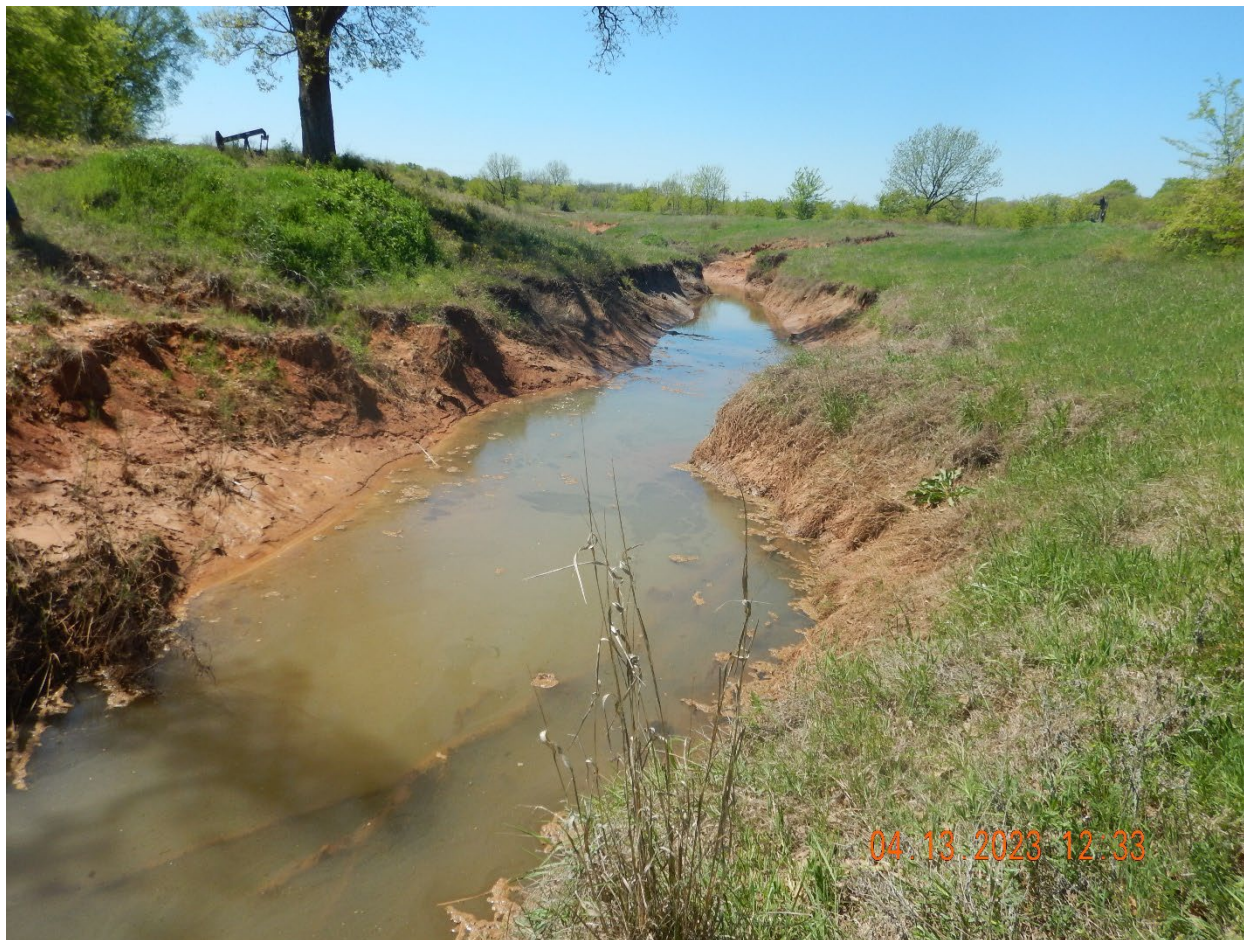
**Description:** This photo showed the tributary location during the inspection approximately 1200 feet downstream from the pond seen in Photo No. 4 of this Appendix. There was bed, bank and some algal growth observed during the inspection. I observed seepage into the tributary on the eastern banks during the inspection.

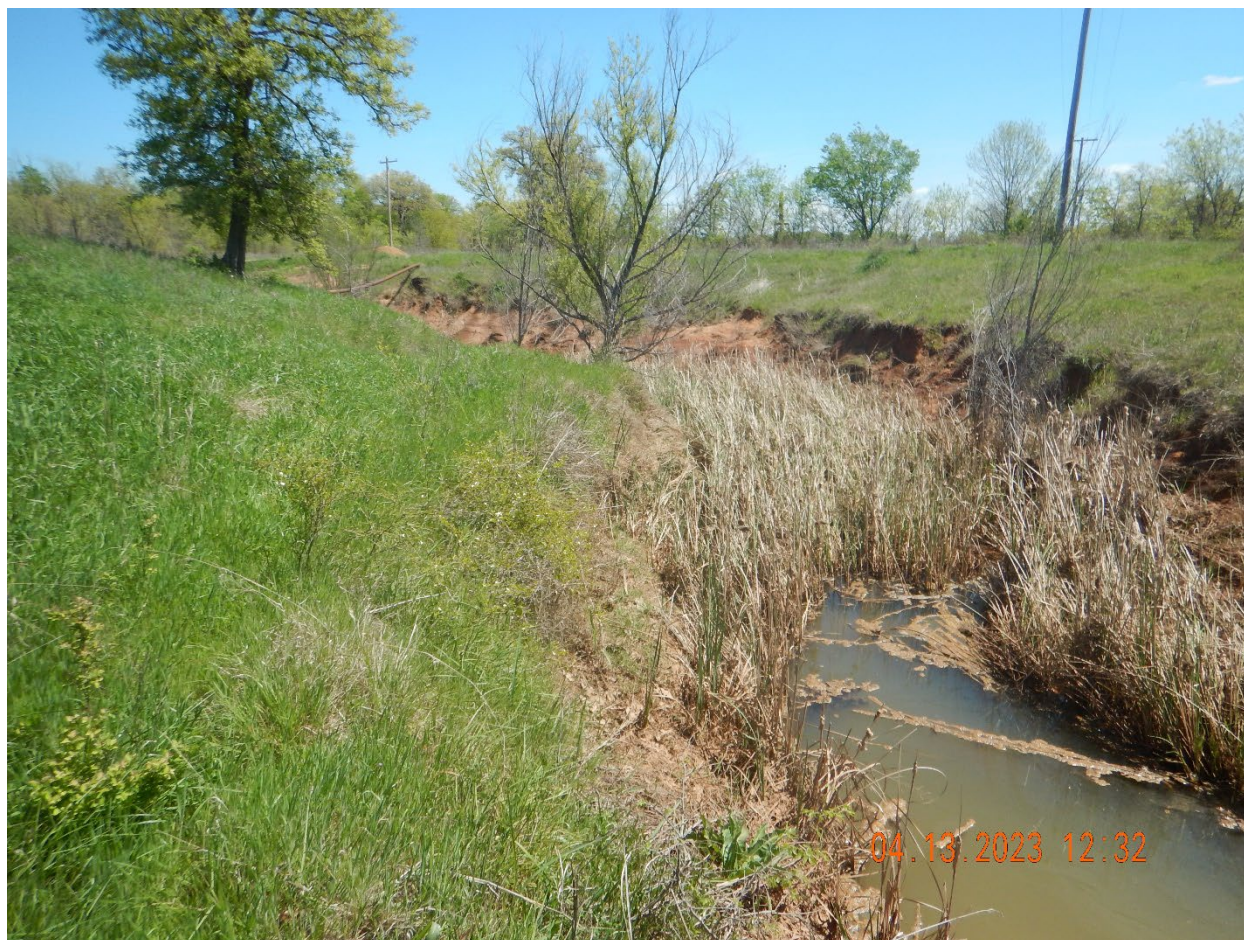
**Description:** This photo showed the tributary location during the inspection approximately 1250 feet downstream from the pond seen in Photo No. 4 of this Appendix. The tributary was flowing during the inspection and riparian vegetation (cattails) were observed at this location.

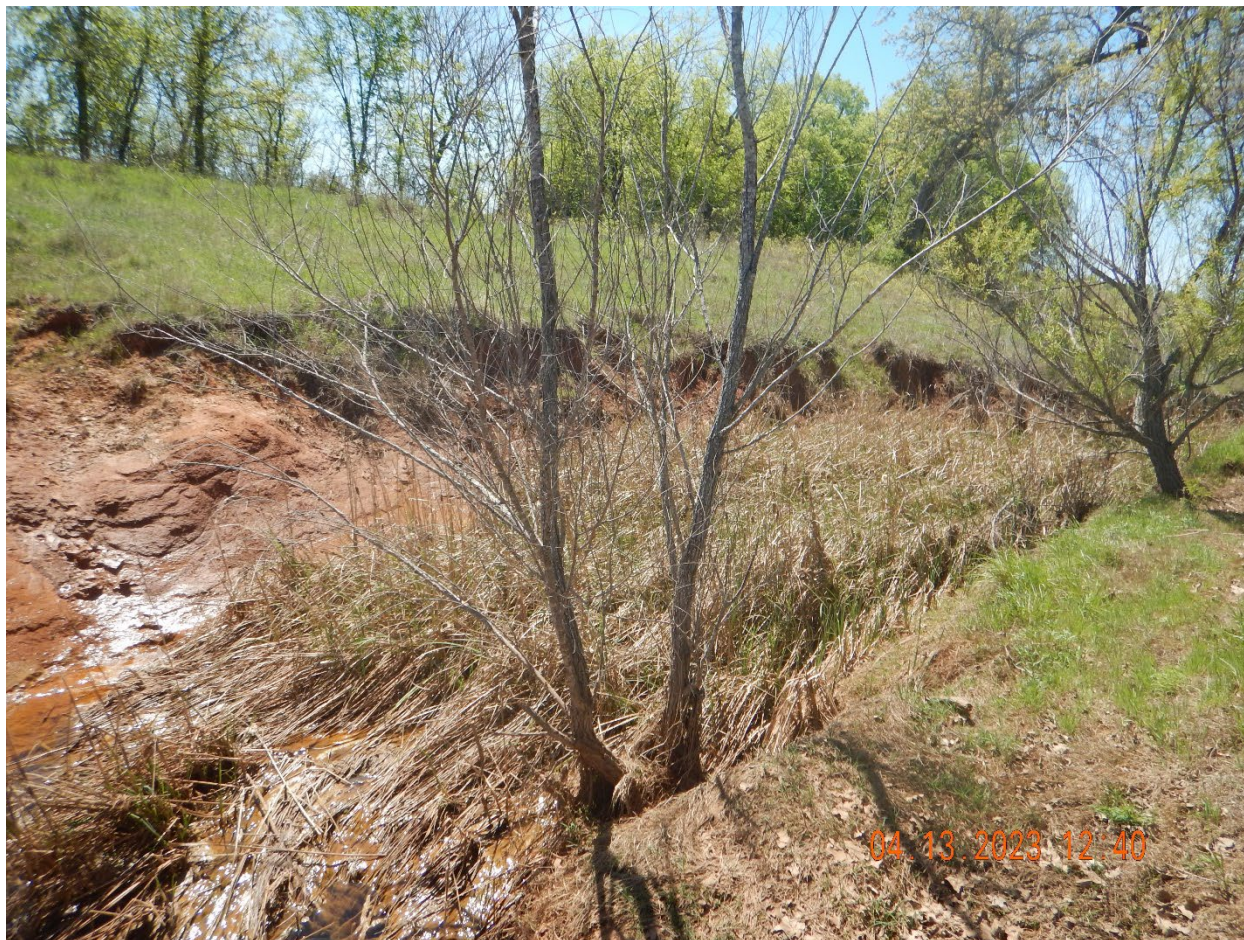
**Description:** This photo showed the tributary location during the inspection approximately 1200 feet downstream from the pond seen in Photo No. 4 of this Appendix. The tributary was flowing during the inspection and riparian vegetation (cattails) were observed at this location. Additionally, some seepage from the tributary bank was observed on the east side.

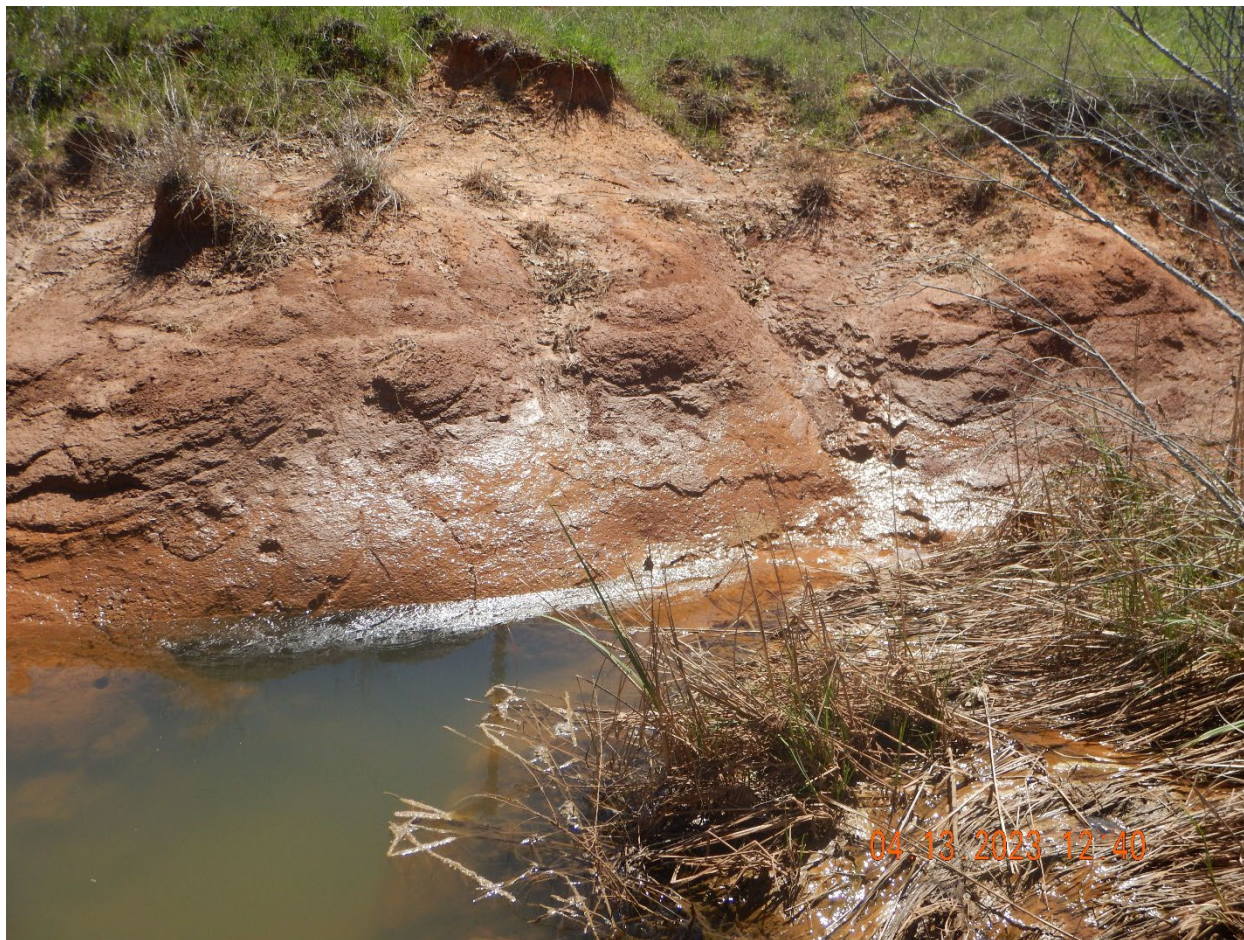
**Description:** This photo showed the tributary location during the inspection approximately 1200 feet downstream from the pond seen in Photo No. 4 of this Appendix. The tributary was flowing during the inspection and riparian vegetation (cattails) were observed at this location. Additionally, some seepage from the tributary bank was observed on the east side.

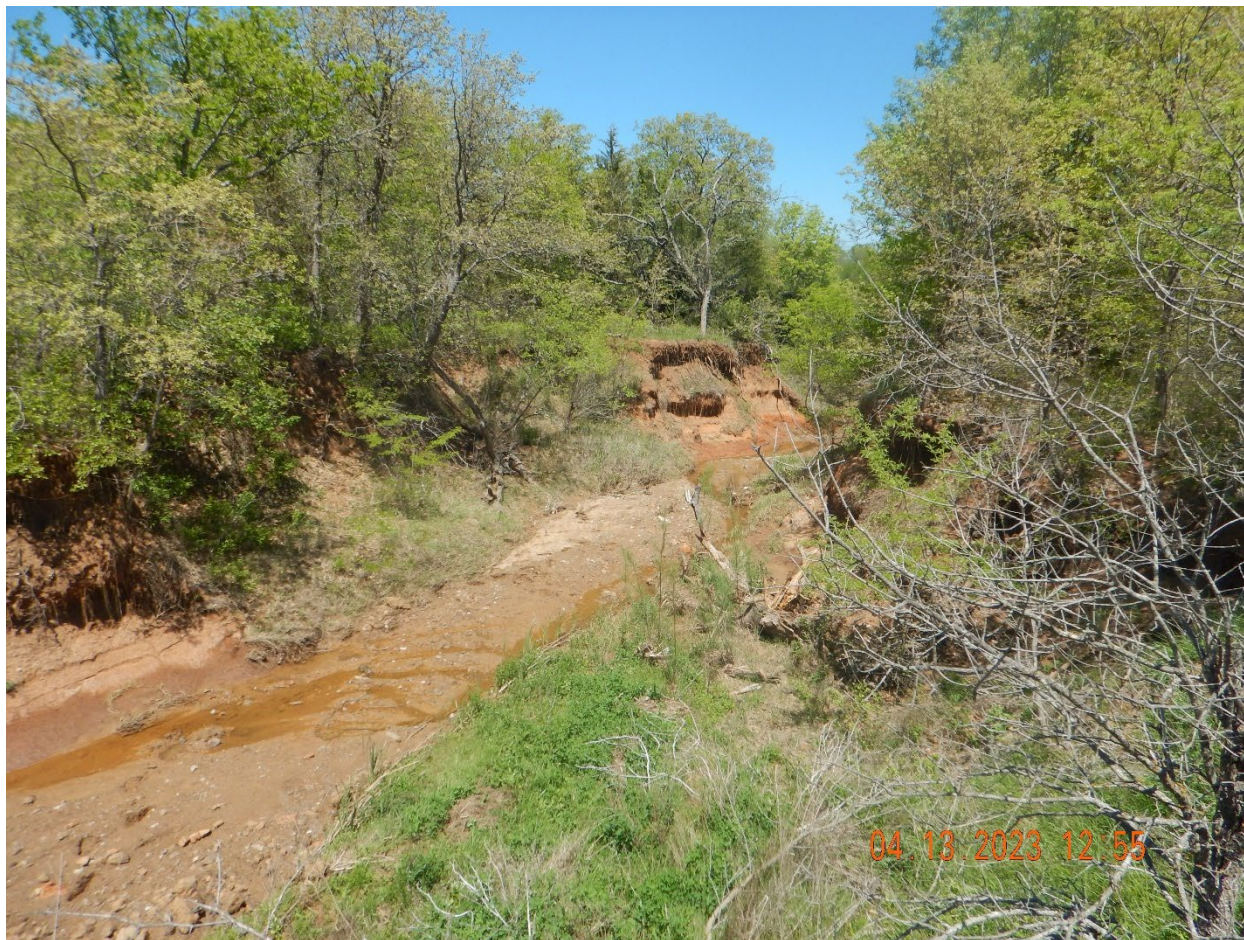
**Description:** This photo showed a downstream view of the tributary about ¼ mile downstream from the pond in Photo No. 4. Bed features, bank features, and riparian vegetation were observed as well as flow in the tributary.

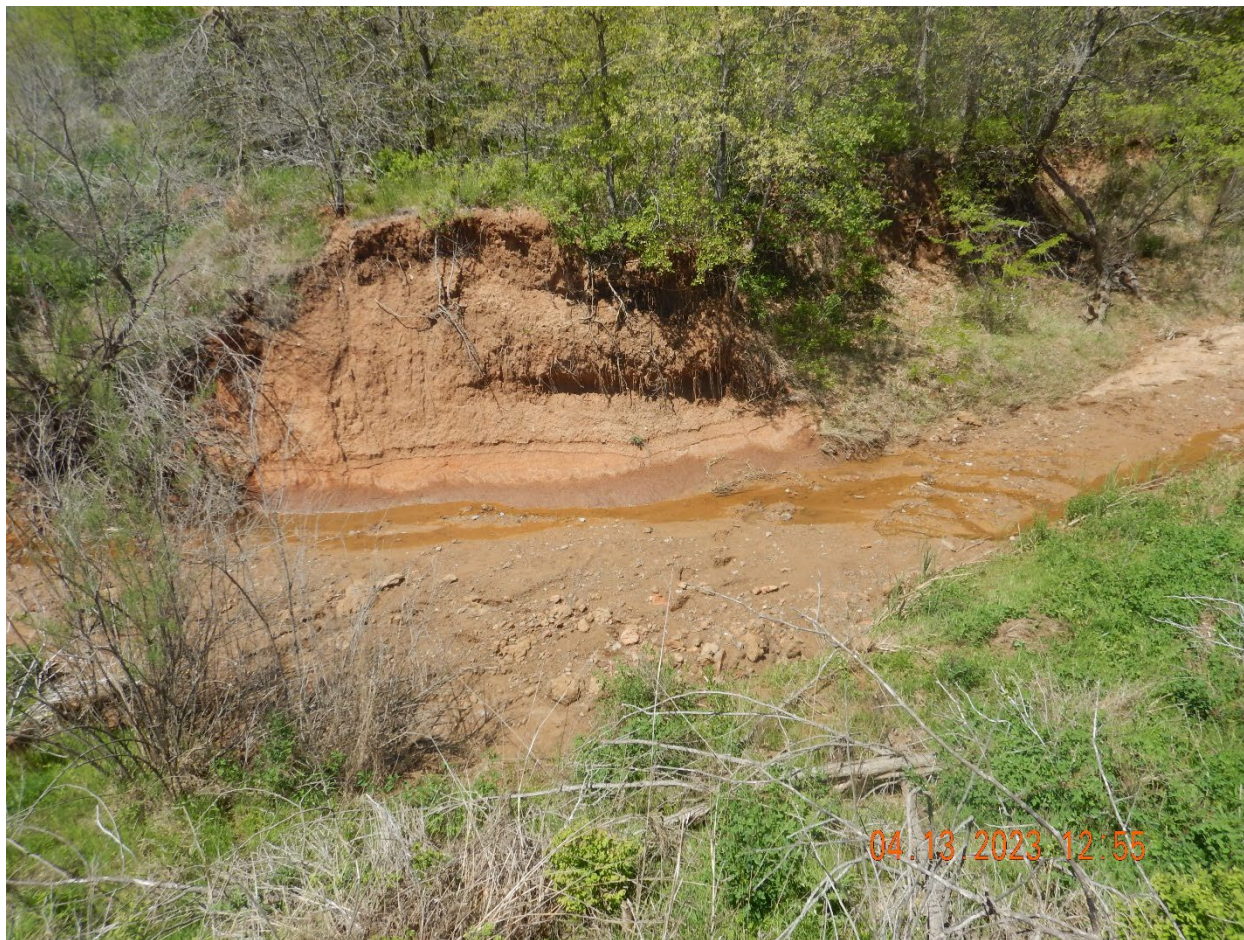
**Description:** This photo showed a side stream profile of the tributary about ¼ mile downstream from the pond in Photo No. 4. Bed features, bank features, and riparian vegetation were observed as well as flow in the tributary.

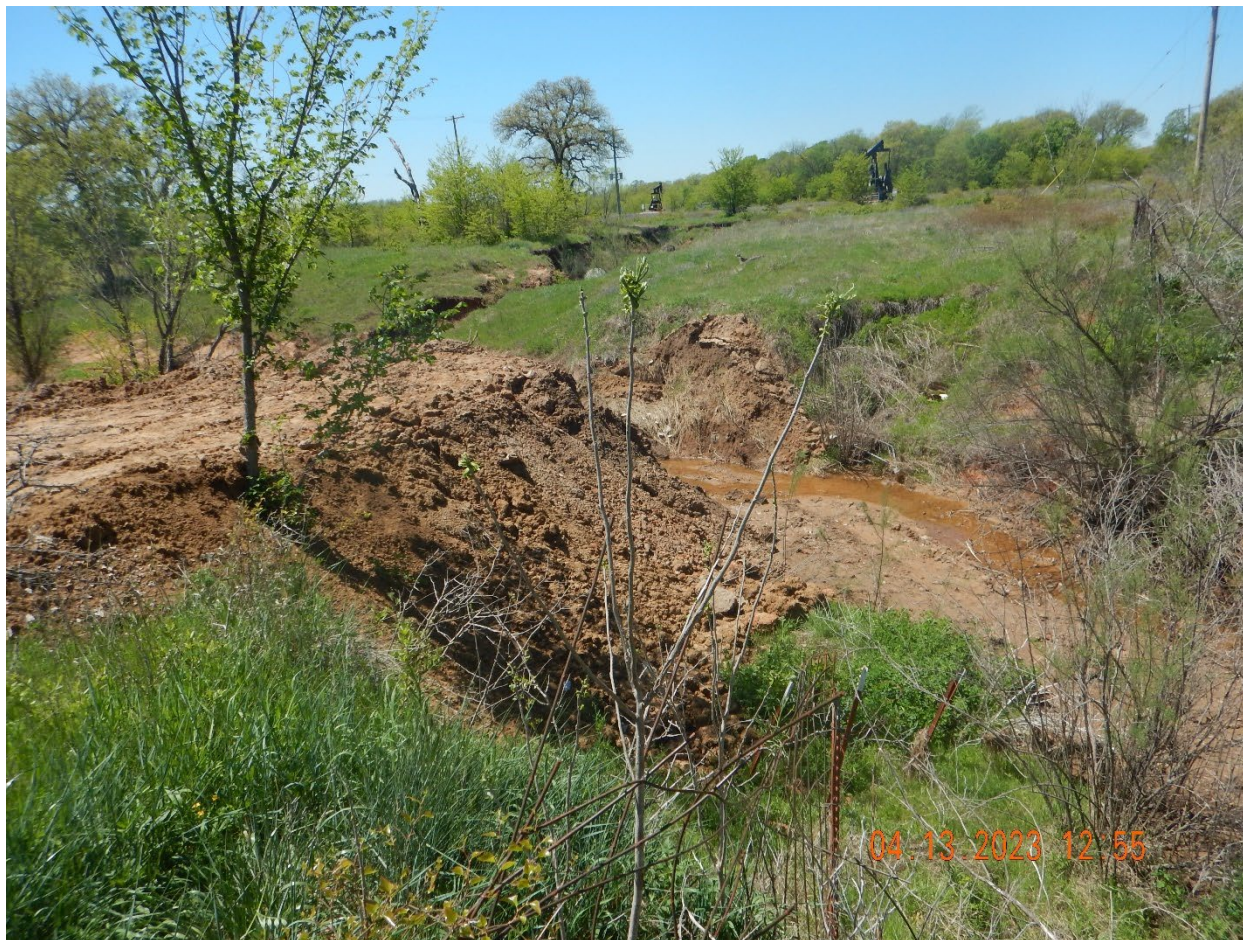
**Description:** This photo showed an upstream view of the tributary about ¼ mile downstream from the pond in Photo No. 4. Bed features, bank features, and riparian vegetation were observed as well as flow in the tributary.

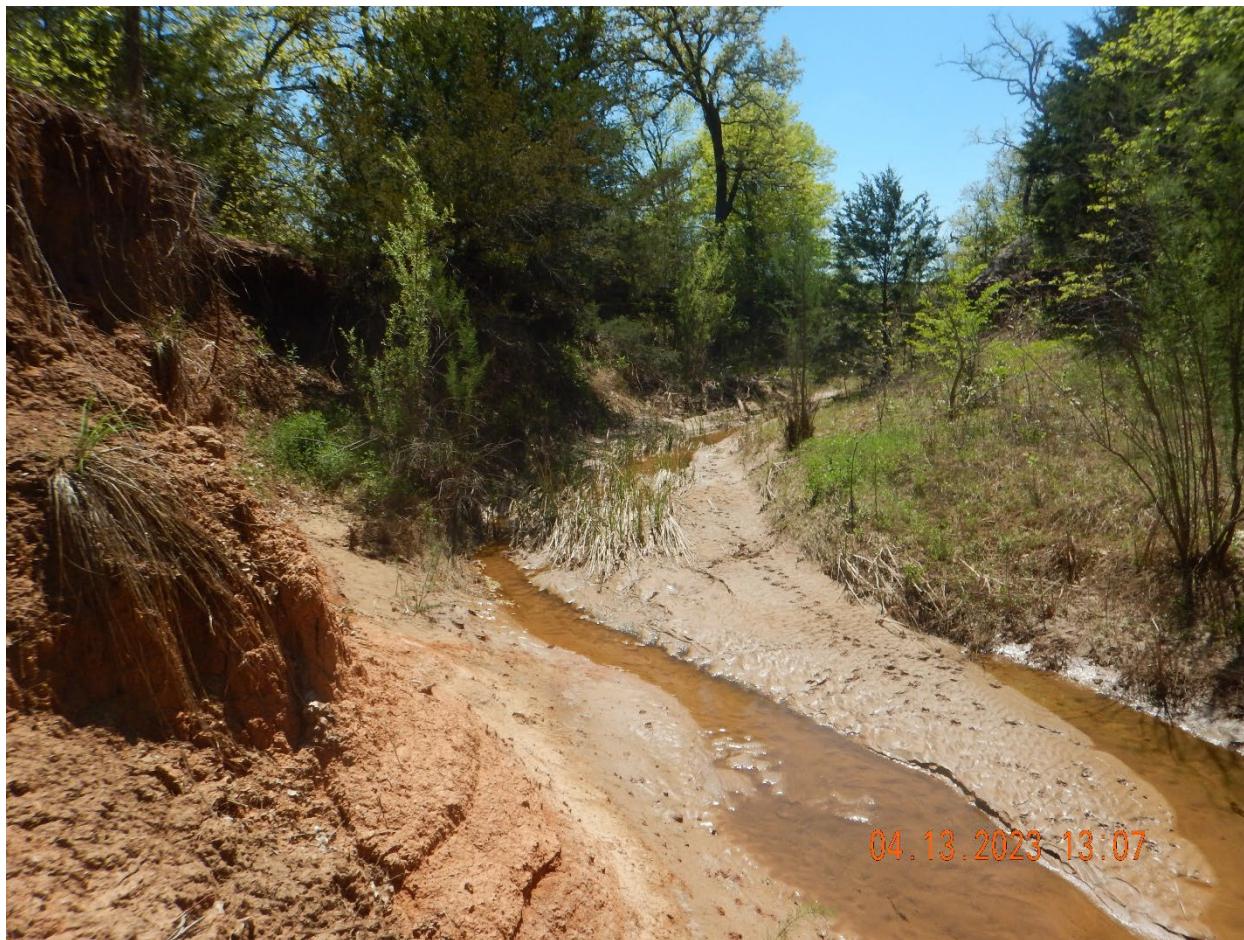
**Description:** This photo showed an upstream view of the tributary over ¼ mile downstream from the pond shown in Photo No. 4. I observed bed features, bank features, and riparian vegetation like cattails in the tributary during the inspection.

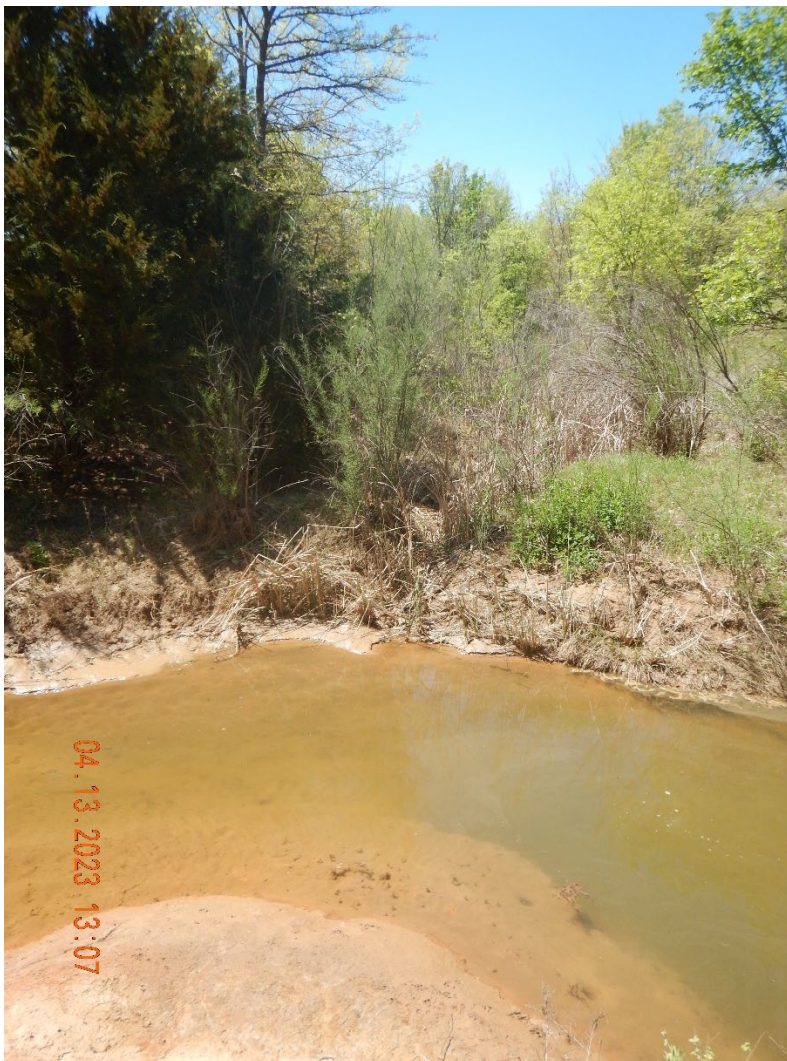
**Photo File Name:** DSCN4845.JPG

**Description:** This photo showed a stream profile view across the tributary over ¼ mile downstream from the pond shown in Photo No. 4. I observed bed features, bank features, and riparian vegetation like cattails in the tributary during the inspection. An additional side tributary was flowing into the main tributary from the west and the confluence was observed here.

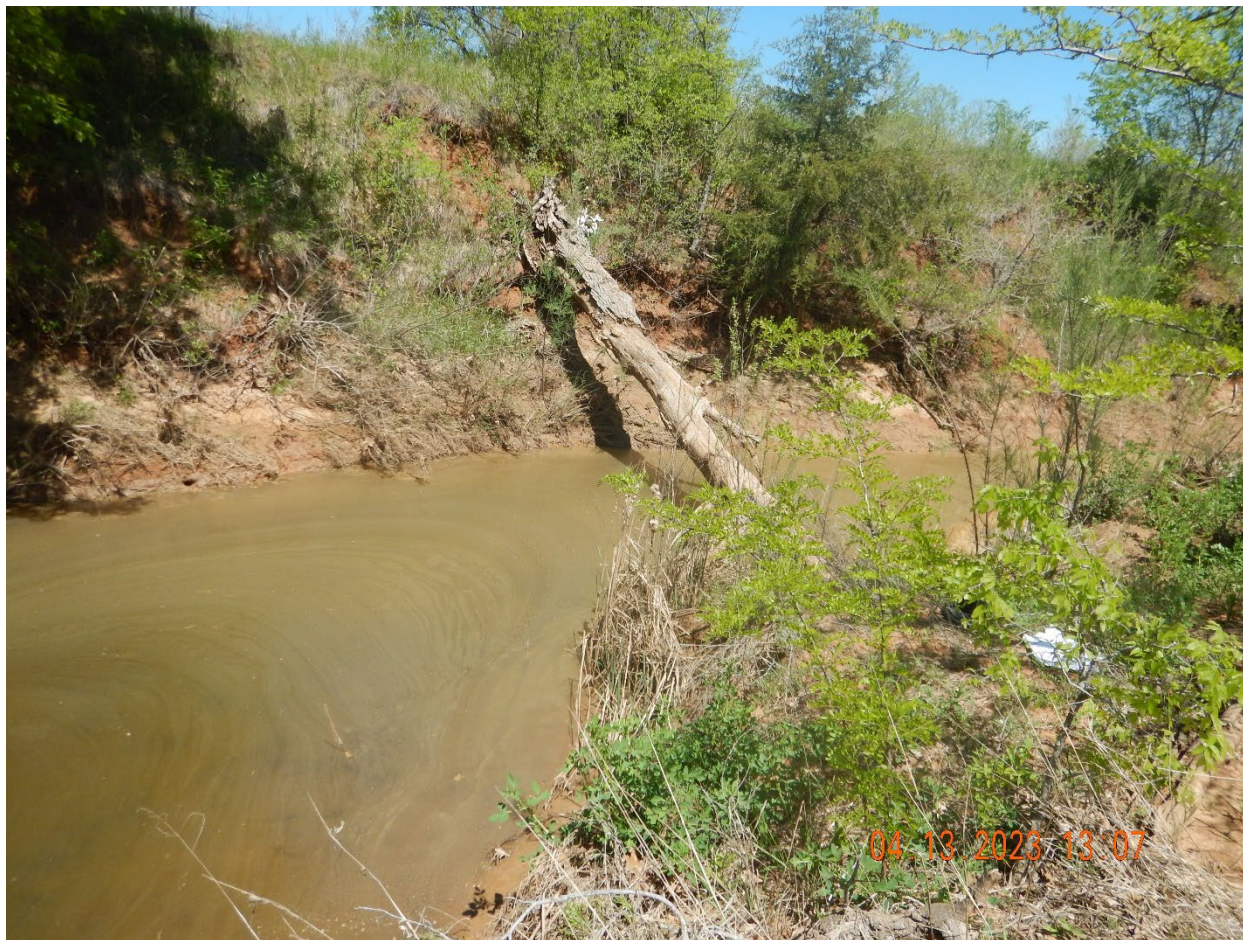
**Photo File Name:** DSCN4846.JPG

**Description:** This photo showed a downstream view of the tributary over ¼ mile downstream from the pond shown in Photo No. 4. I observed bed features, bank features, and riparian vegetation like cattails in the tributary during the inspection. A large tree was observed across the stream bank at this location as well.

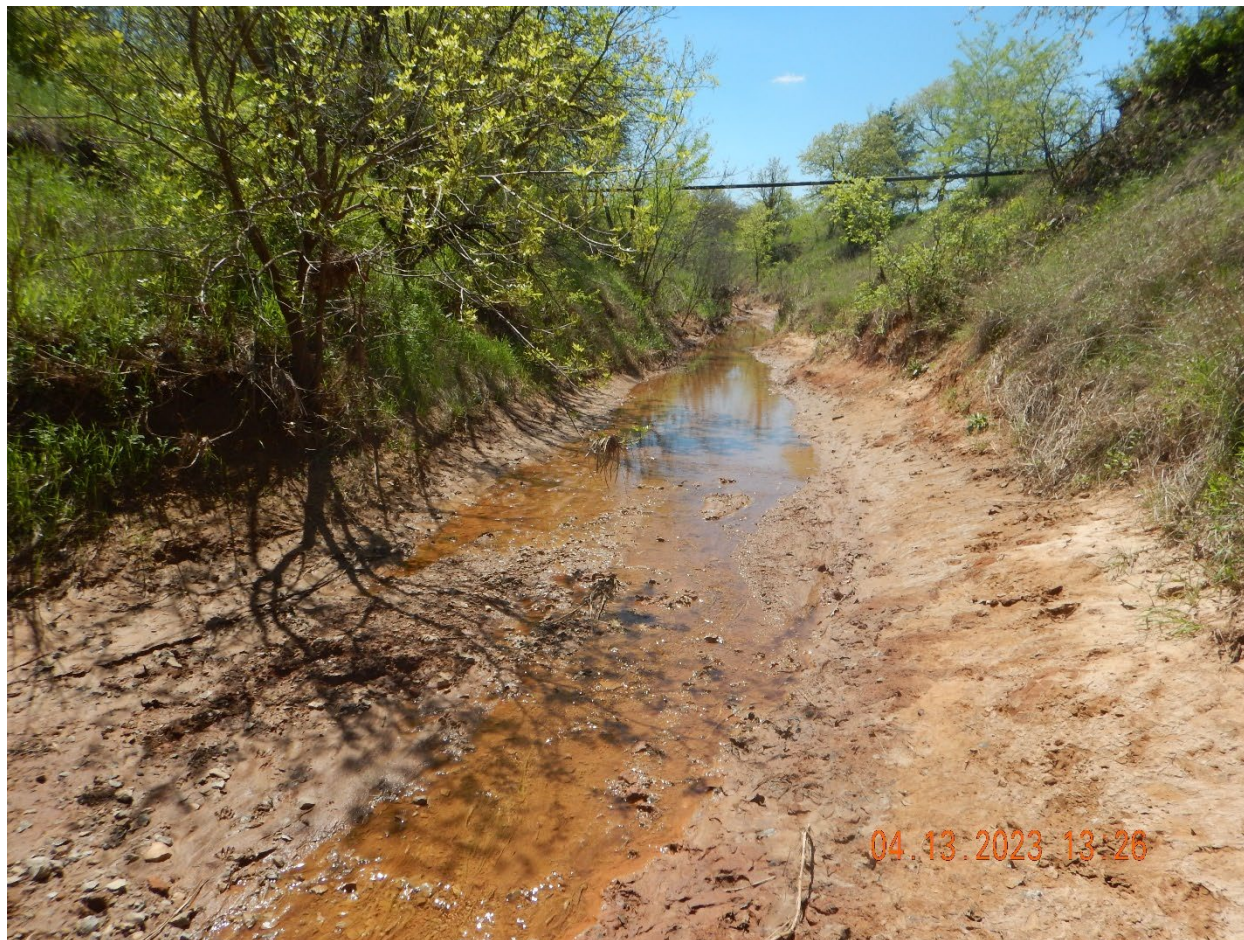
**Photo File Name:** DSCN4861.JPG

**Description:** This photo showed an upstream view of the tributary approximately ½ mile downstream from the pond shown in Photo No. 4. I observed bank features in the tributary at this location. This is referred to by the state representatives on site as the "beaver slide" location in this tributary. I observed minnows and perch at this location in the tributary.

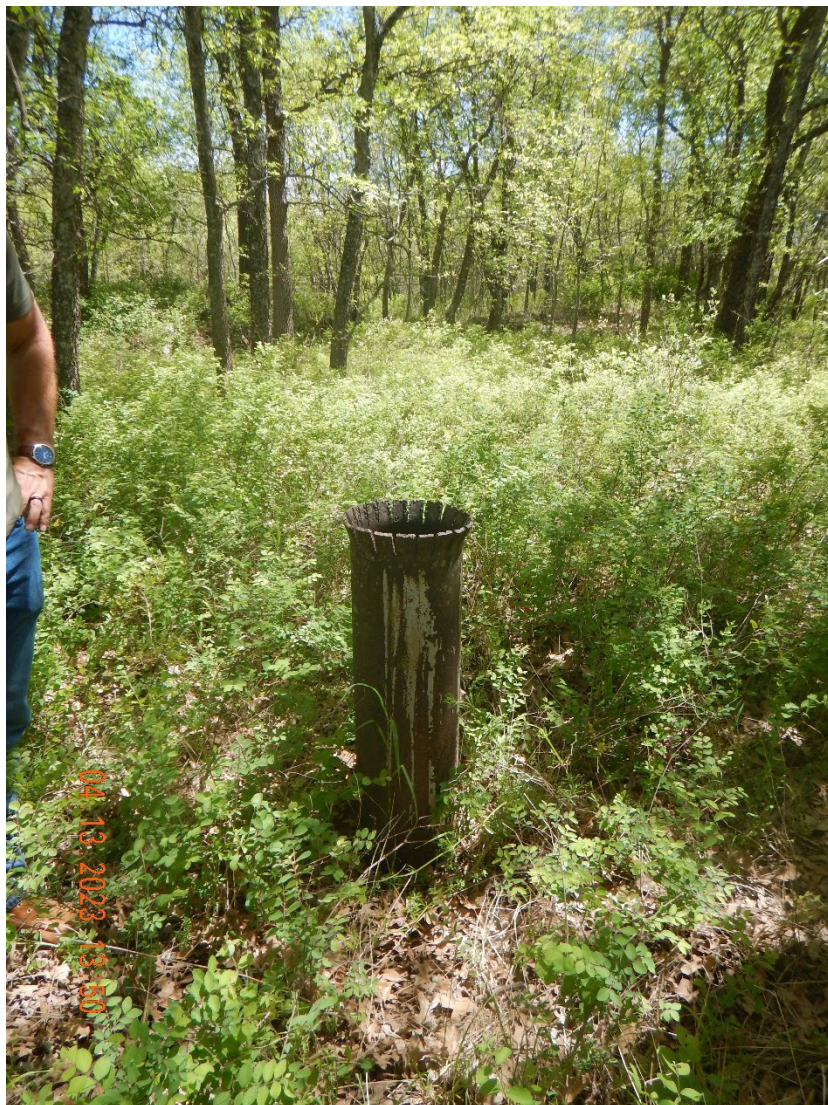
**Description:** This photo shows an abandoned well found near the tributary we were surveying during the inspection. The well appeared to be open to atmosphere. An owner of a well was not identified during the inspection.

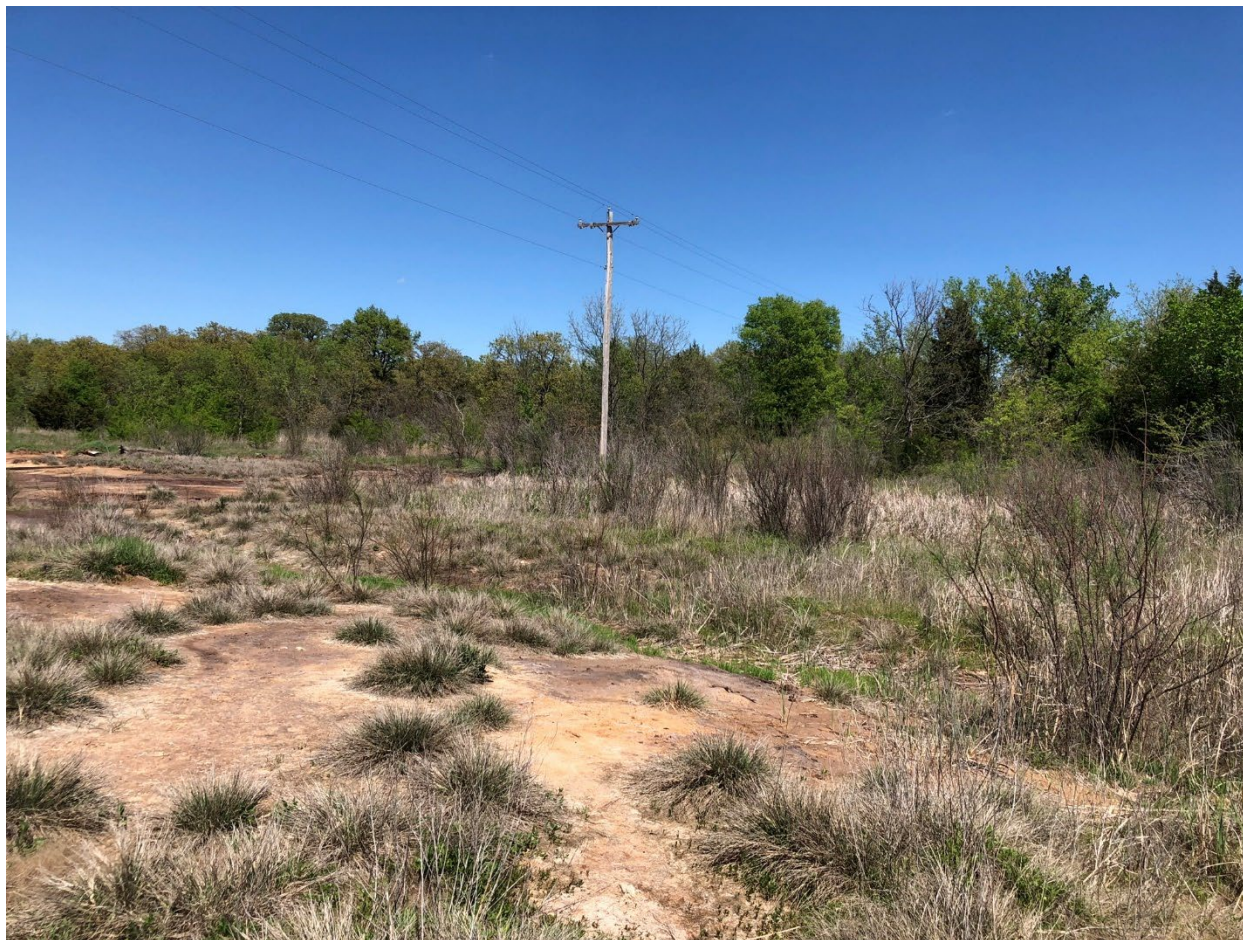
**Photo File Name:** IMG\_2356.JPEG

**Description:** This photo shows a downstream view of the second tributary that we surveyed during the inspection. This location is along the second tributary near the Ramsey #6 well. Additionally, more prolific surface erosion and potential contamination was apparent in this area as observed in this photo. Approximately 3 acres of degraded surface was observed in this area. Soil discoloration, including black soil along the entire tributary were observed. Patches of grass and cattails were observed. This was in an area with both potentially active and historical contamination without proper remediation from historical brine (produced water) and oil field fluids.

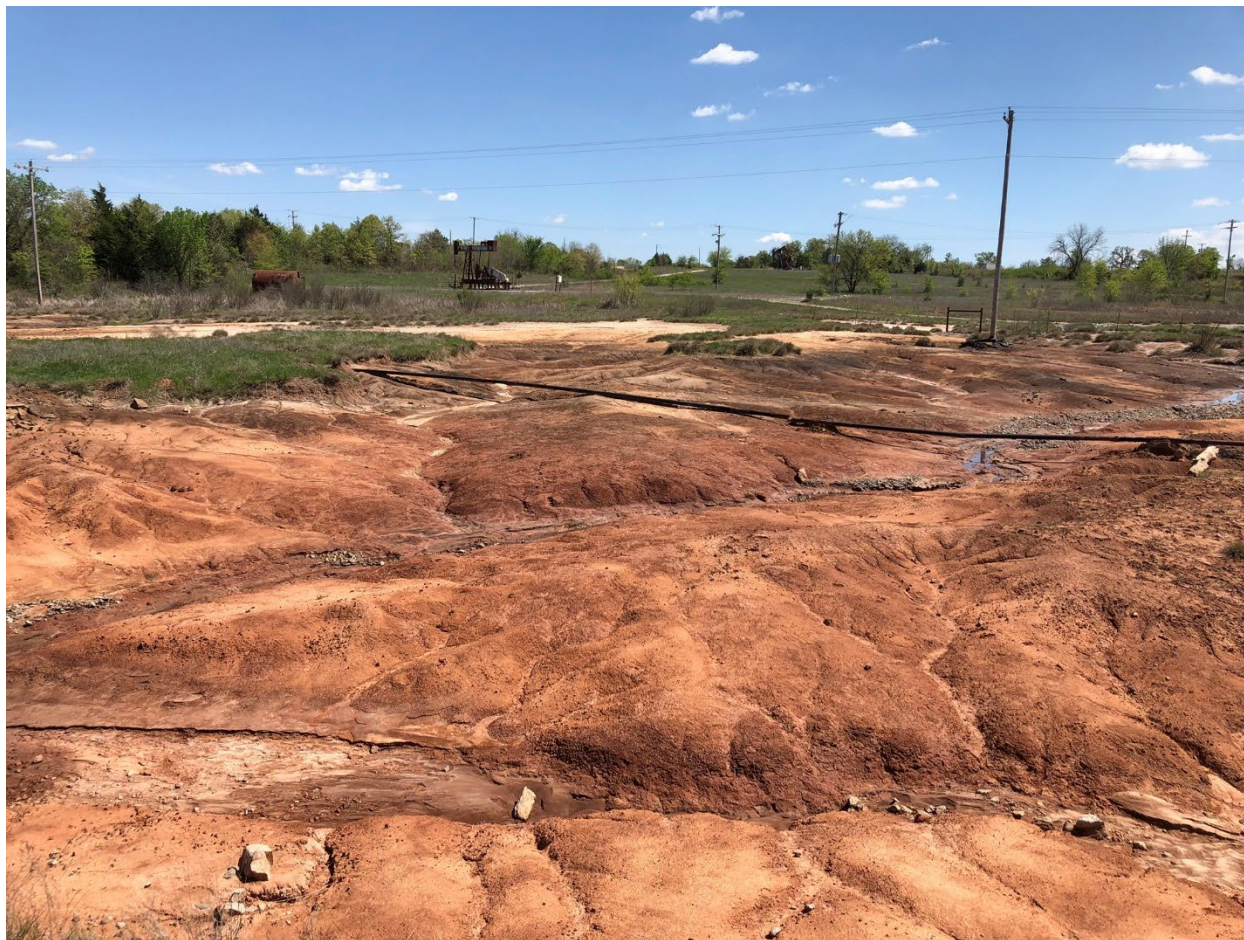
**Photo File Name:** IMG\_2365.JPEG

**Description:** This photo shows a view looking towards the southeast of the western edge of the approximately 3 acres of contaminated area. This location is along the second tributary near the Ramsey #6 well. Prolific surface erosion and potential contamination was apparent in this area as observed in this photo. This was in an area with both potentially active and historical contamination without proper remediation from historical brine (produced water) and oil field fluids.

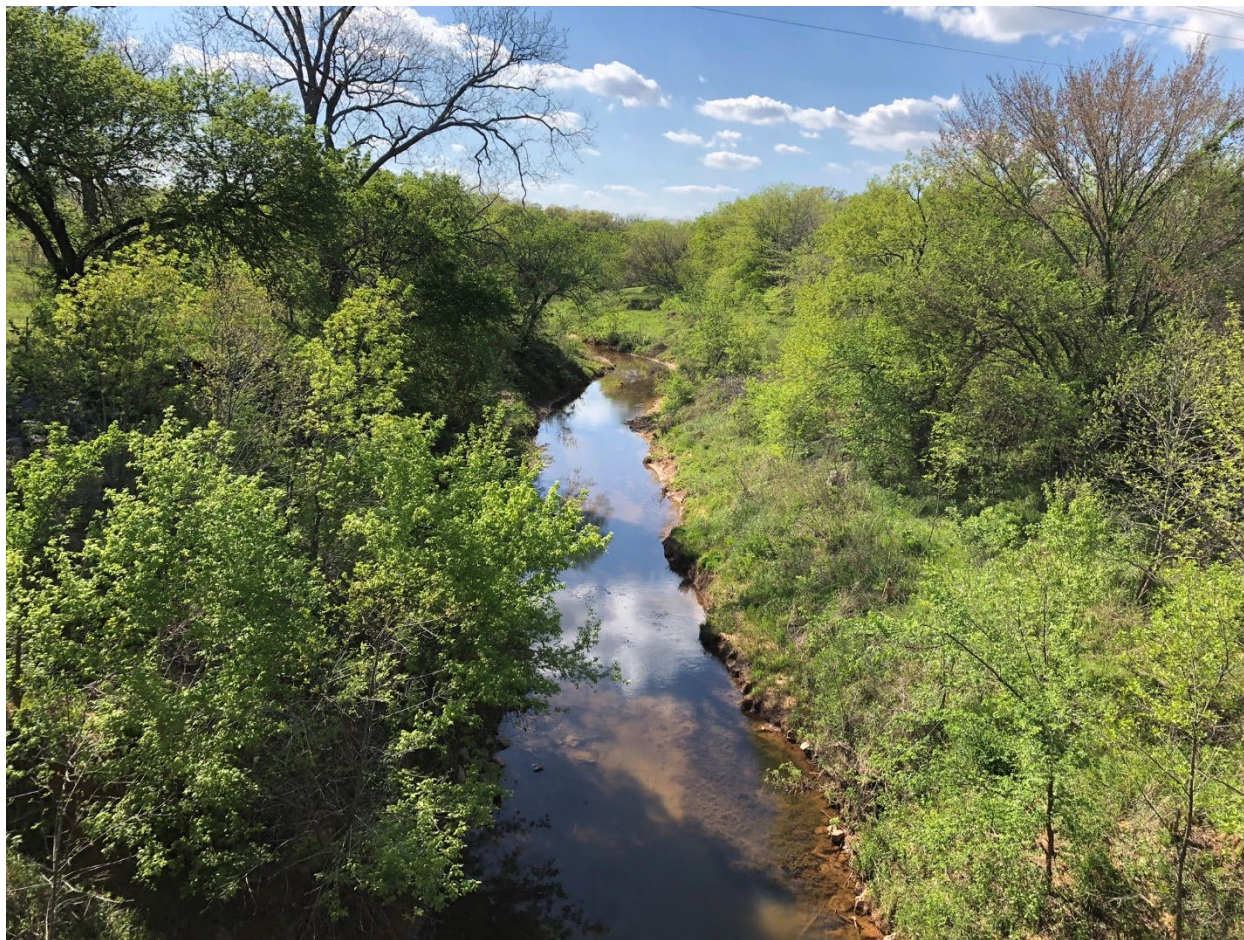
**Photo File Name:** IMG\_2396.JPEG

**Description:** This photo shows an upstream view of Walnut Creek. This location is downstream from the Bayou Unit and documented TDS readings along Walnut Creek. Bed, bank, and riparian vegetation were observed in this location of the creek. We were standing on a large bridge along Texaco Road over the creek at this location.

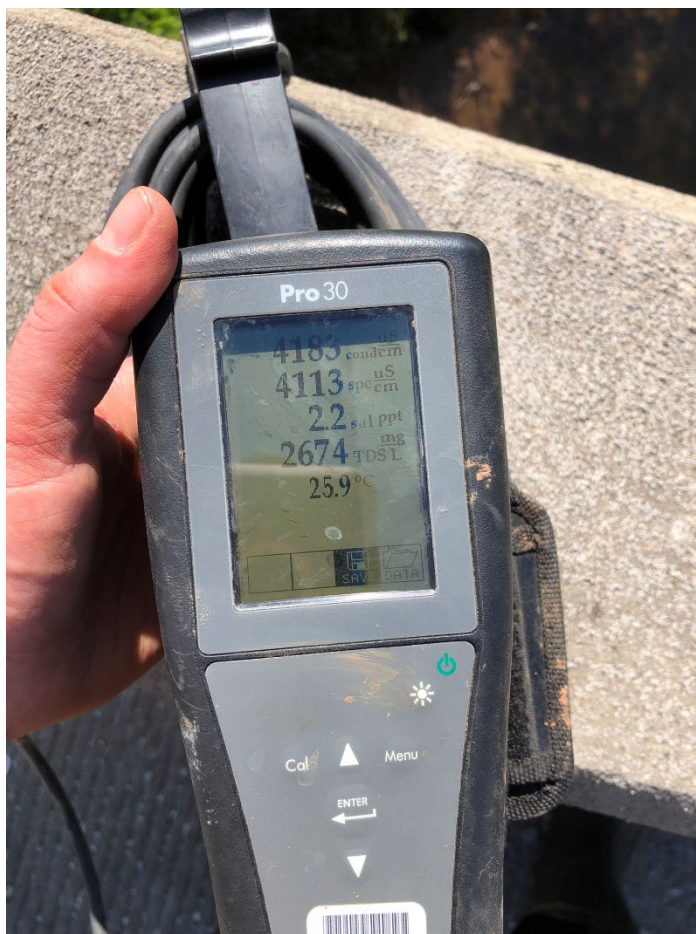
**Photo File Name:** IMG\_2396.JPEG

**Description:** This photo shows a TDS reading of 2,674 mg/L in Walnut Creek at this location. This location is downstream from the Bayou Unit and documented TDS readings along Walnut Creek. Bed, bank, and riparian vegetation were observed in this location of the creek. We were standing on a large bridge along Texaco Road over the creek at this location.
