## **RCRA Inspection Report**

Safety-Kleen Systems, Inc.  
7027 Commercial Drive  
Morrow, GA 30260

EPA ID# GAD981265424

December 14, 2022, 9:06 AM

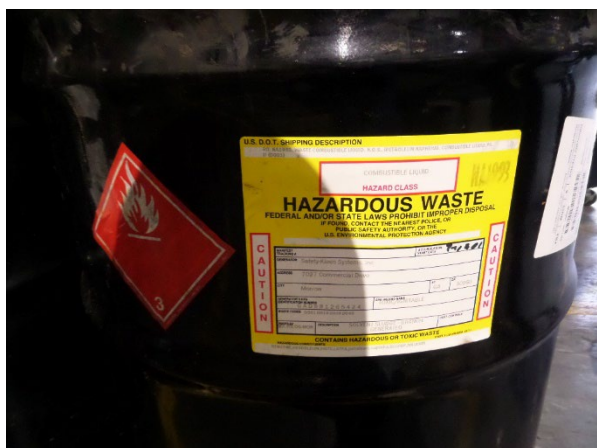
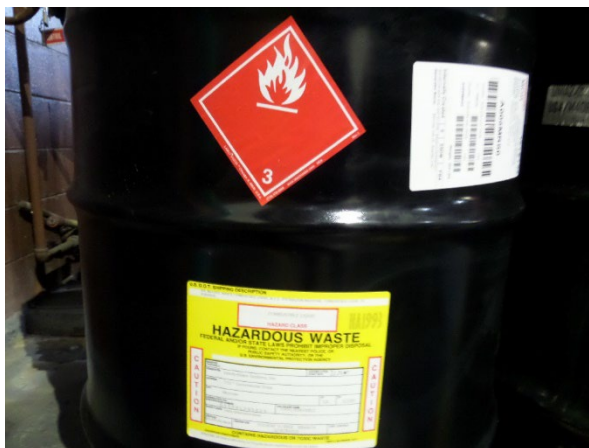
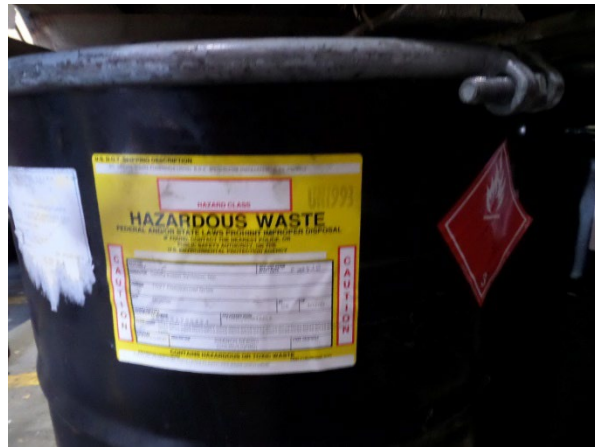
The facility manages a permitted Container Storage Area for managing hazardous waste combustible liquid that is generated by receiving wastes from customer facilities. The inspectors observed four (4) 55-gallon containers in this area (Figures 5, 6, 8, 10). The drums were located on pallets adjacent to the 10-Day Storage Area, and were equipped with drum covers, all of which were closed. The first drum was marked as “SOLVSLDG-MOR,” labeled D001, D018, D039, D040 hazardous waste “Solvent Sludge – Branch Generated,” and identified with a DOT flammable placard (Figure 5). The second drum was marked as “SOLVSLDG-MOR,” labeled D001, D018, D039, D040 hazardous waste “Solvent Sludge – Branch Generated,” and identified with a DOT flammable placard (Figure 7). The third drum was marked as “DEBRISLQ-MOR,” labeled D001, D004-D011, D018, D019, D021-D025, D027-D030, D032-D043, F003, F005 hazardous waste “Branch Debris (Solid/Liquid),” and identified with a DOT flammable placard (Figure 9). The fourth drum was marked as “SOLVSLDG-MOR,” labeled D001, D018, D039, D040 hazardous waste “Solvent Sludge – Branch Generated,” and identified with a DOT flammable placard (Figure 11).

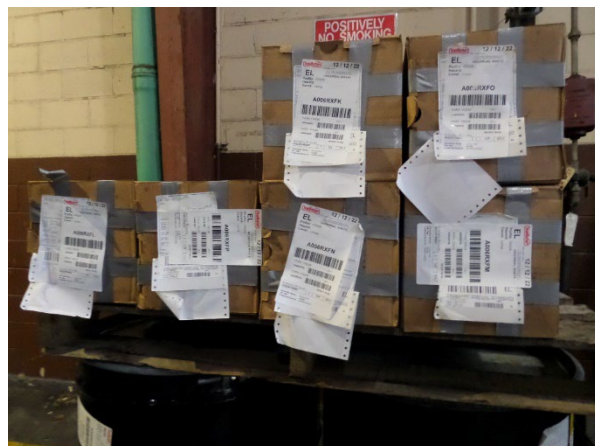
Figure 12: 10:36 AM Container Storage Area

Safety-Kleen manages universal waste lamps in their Container Storage Area. The inspectors observed six (6) containers of universal waste lamps in this area during the inspection. The six (6) 2-foot box containers of lamps were closed and marked with an accumulation start date, were labeled universal waste lamps (Figure 12). The oldest date observed on any container of lamps was December 12, 2022.

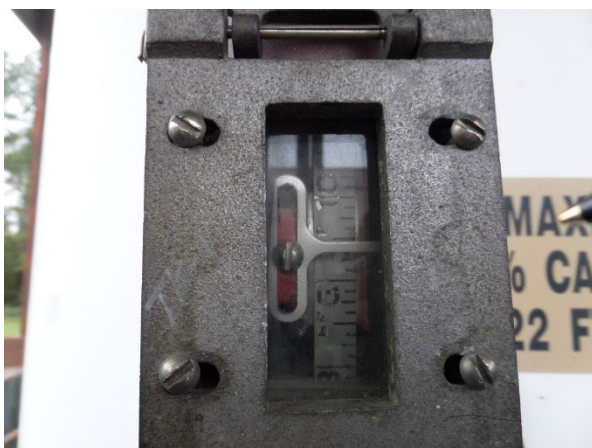
Figure 17: 11:15 AM Tank Farm

A total of five (5) storage tanks were observed; four (4) used oil tanks and one permitted hazardous waste tank. Inspectors observed the hazardous waste tank, labeled hazardous waste and identified with a National Fire Protection Association (NFPA) label. The current reading level for the sight glass was 6 feet 9.5 inches (Figure 17). Inspectors observed multiple instances within the tank farm displaying tags (such as #001, 002, 13, 15, 17, and 18) that were difficult to read due to rust and weathering (Figures 18-22).
