## Clean Water Act Section 404: Site Visit/Case Development

| Site Name | Crystal Valley LLC (Rick Ferguson) | | | | |

| Inspection Purpose | Initial site visit | | |

## Appendix 1

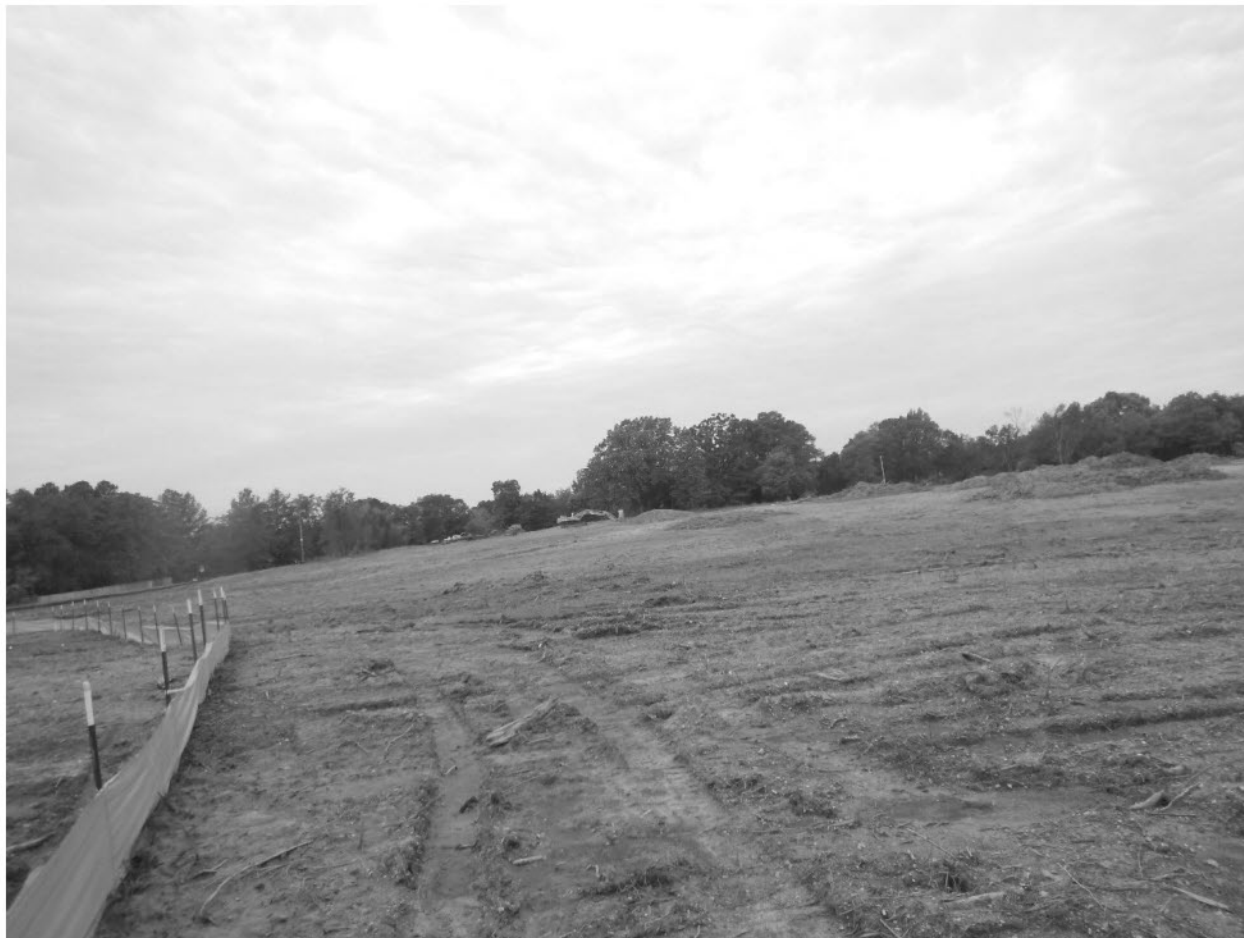
Photo No. 1

| Photo File Name | Date and Time of Photo | Photographer | Description |
|---|---|---|---|
| DSCN6414 | 05/01/2024, 10:38 AM | Chelsey Sherwood | Showing overall project site.<br>Picture taken facing southwest. |

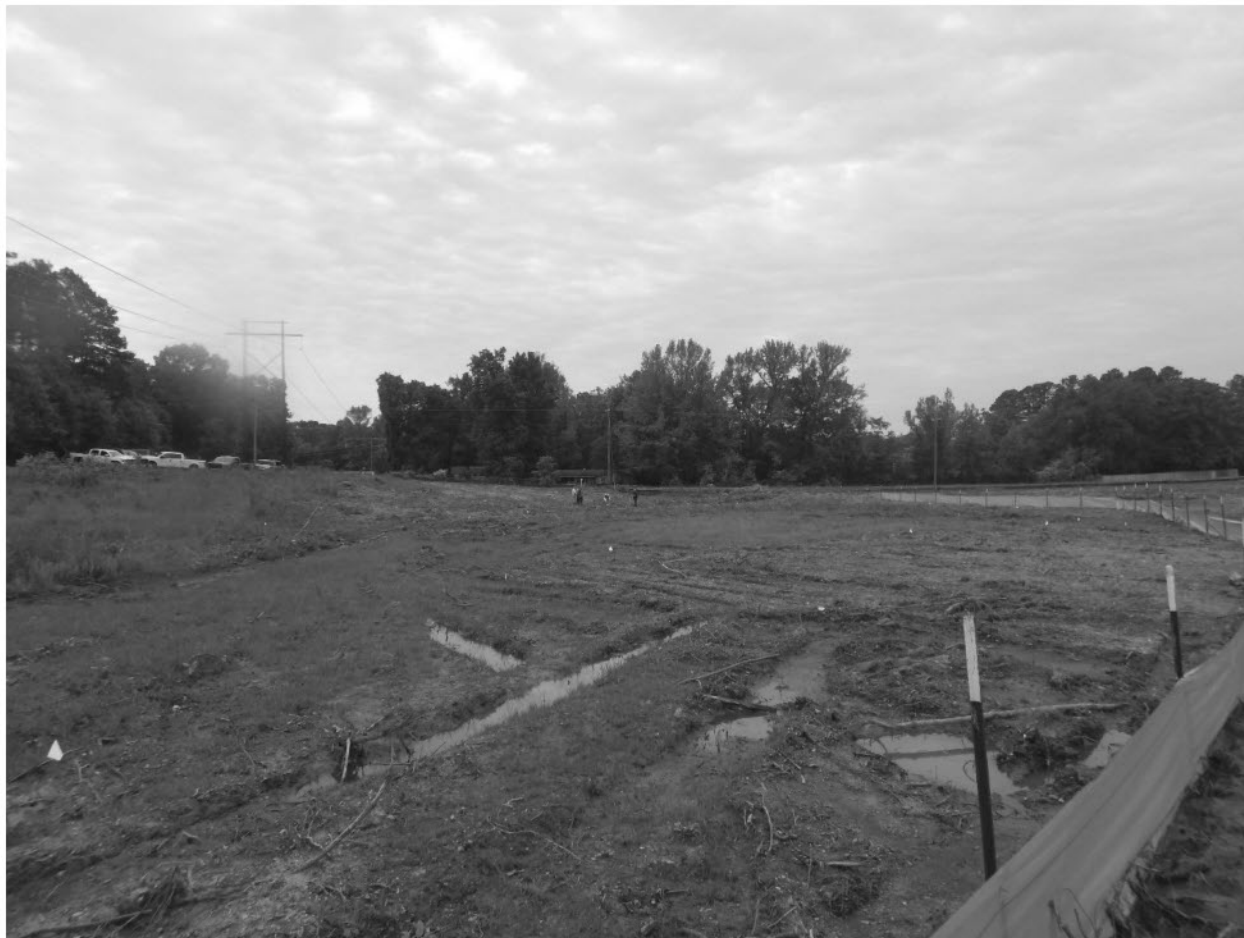
Photo No. 2

| Photo File Name | Date and Time of Photo | Photographer | Description |
|---|---|---|---|
| DSCN6415 | 05/01/2024, 10:38 AM | Chelsey Sherwood | Showing the stream and wetland impacted. Note the white flags delineating the stream and wetland area. Picture taken facing south. |

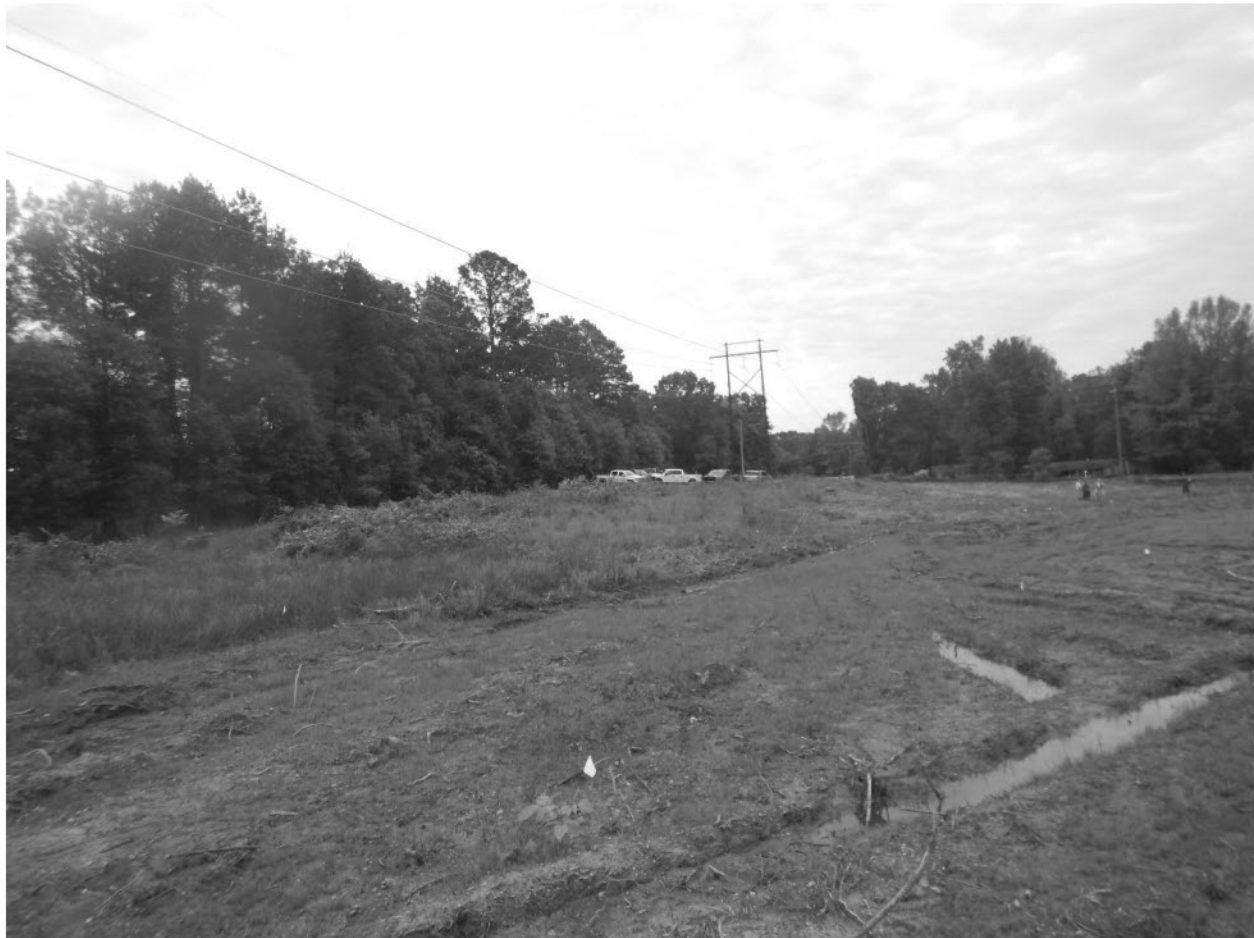
Photo No. 3

| Photo File Name | Date and Time of Photo | Photographer | Description |
|---|---|---|---|
| DSCN6416 | 05/01/2024, 10:39 AM | Chelsey Sherwood | Showing the impacted stream and wetland. Note the white flags delineating the stream and wetland area. Picture taken facing southeast. |

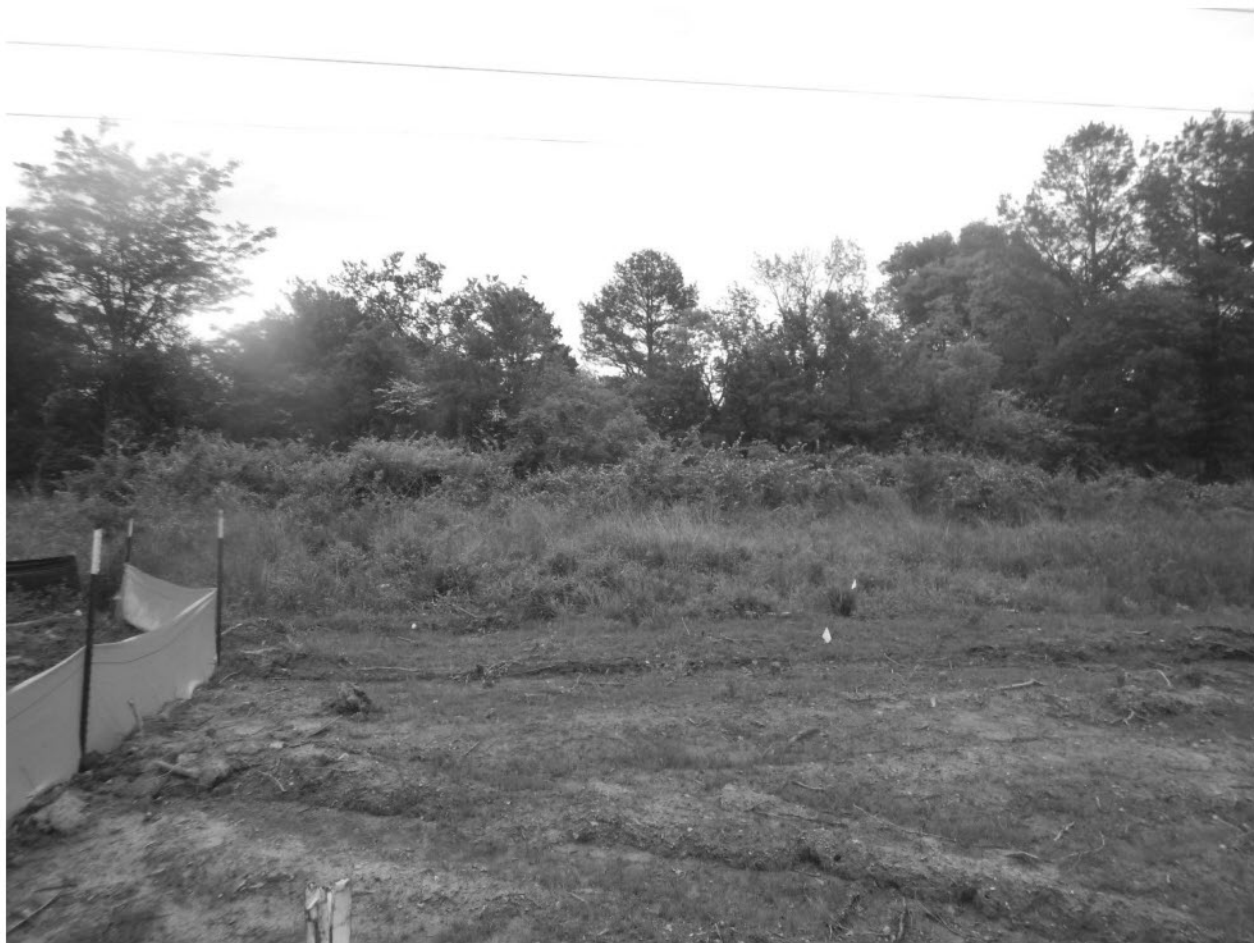
Photo No. 4

| Photo File Name | Date and Time of Photo | Photographer | Description |
|---|---|---|---|
| DSCN6417 | 05/01/2024, 10:39 AM | Chelsey Sherwood | Showing the impacted stream and wetland. Note the white flags delineating the stream and wetland area. Picture taken facing east. |

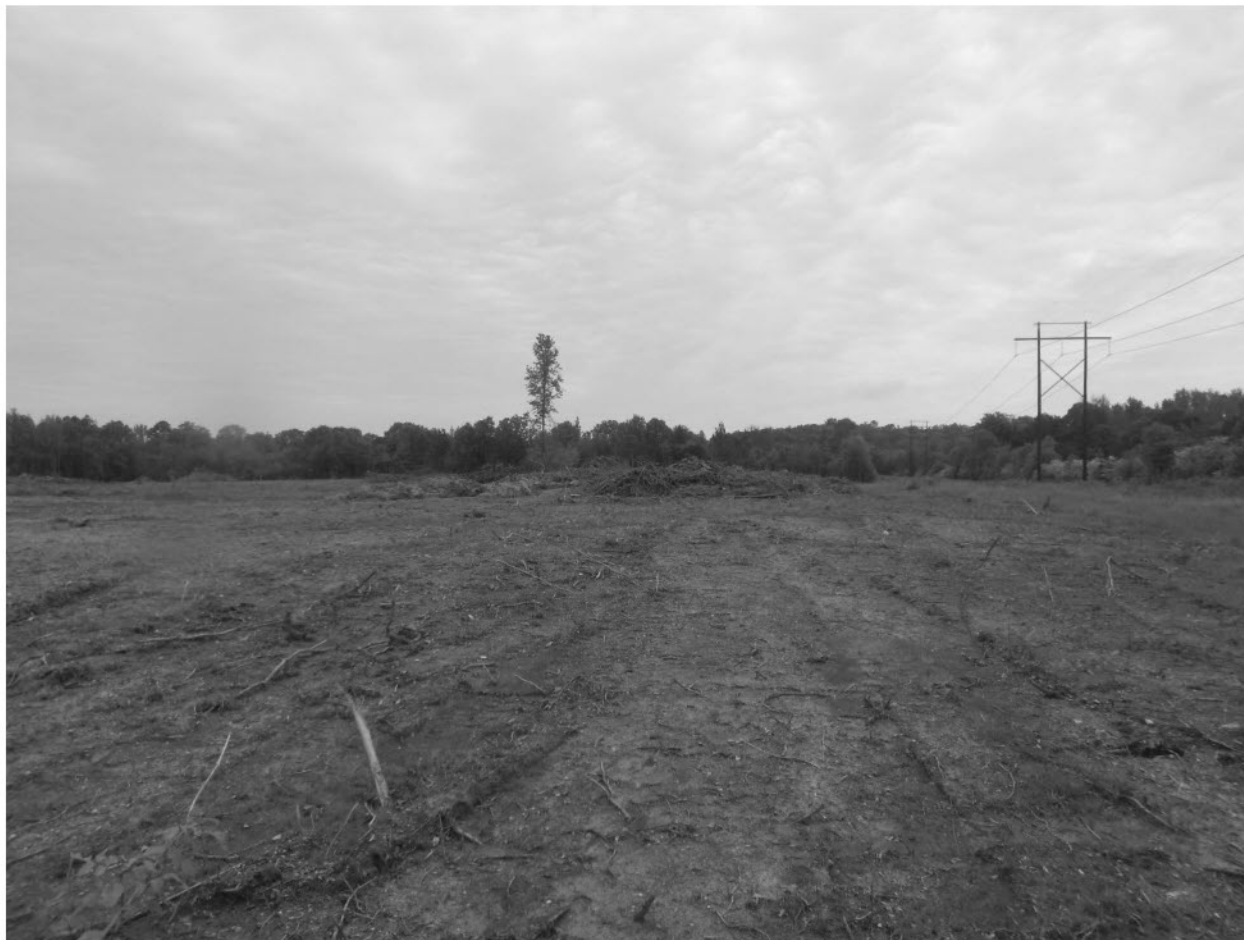
Photo No. 5

| Photo File Name | Date and Time of Photo | Photographer | Description |
|---|---|---|---|
| DSCN6418 | 05/01/2024, 10:39 AM | Chelsey Sherwood | Showing spoil piles and overall project area. Picture taken facing north. |

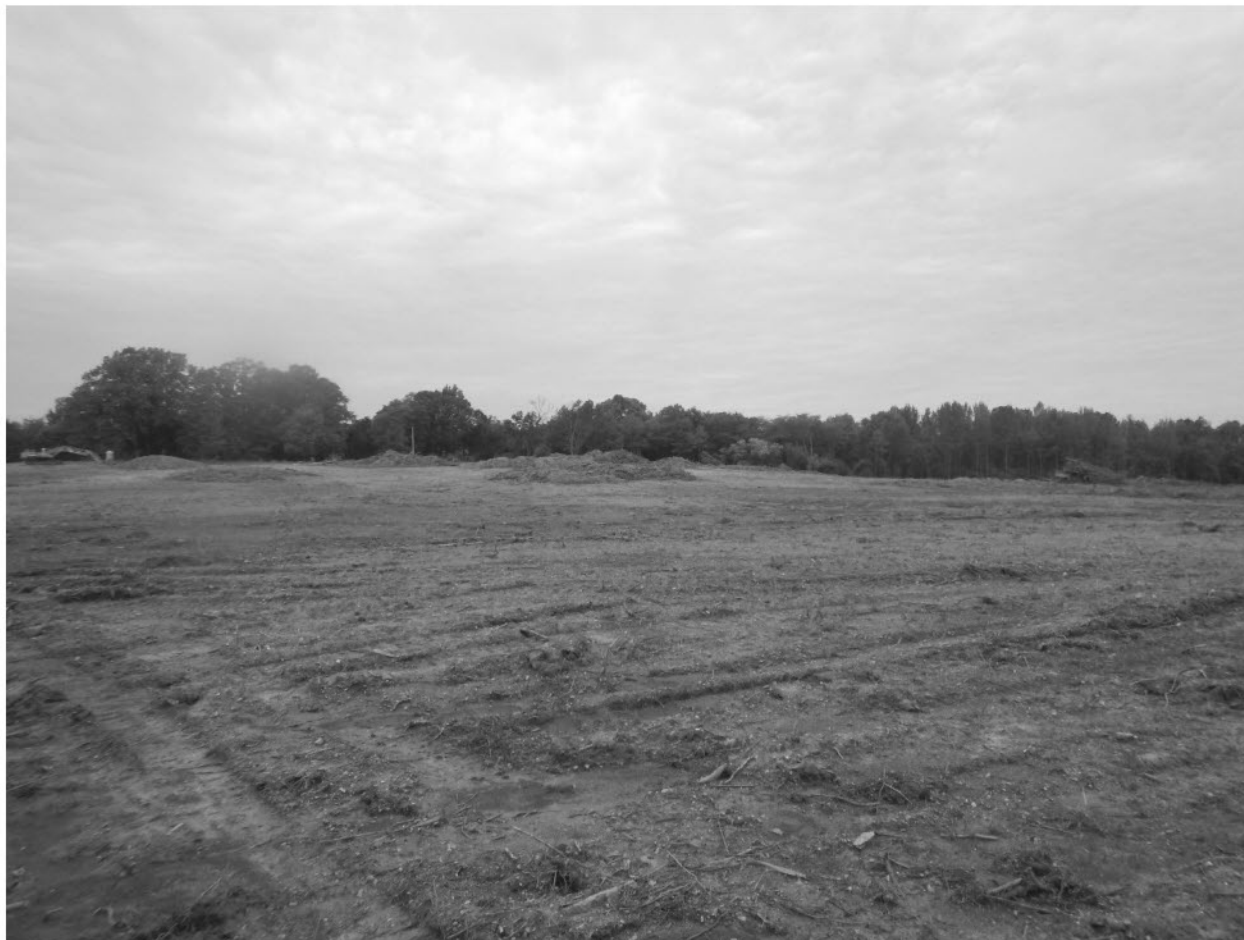
Photo No. 6

| Photo File Name | Date and Time of Photo | Photographer | Description |
|---|---|---|---|
| DSCN6419 | 05/01/2024, 10:39 AM | Chelsey Sherwood | Showing spoil piles and overall project area. Picture taken facing west. |

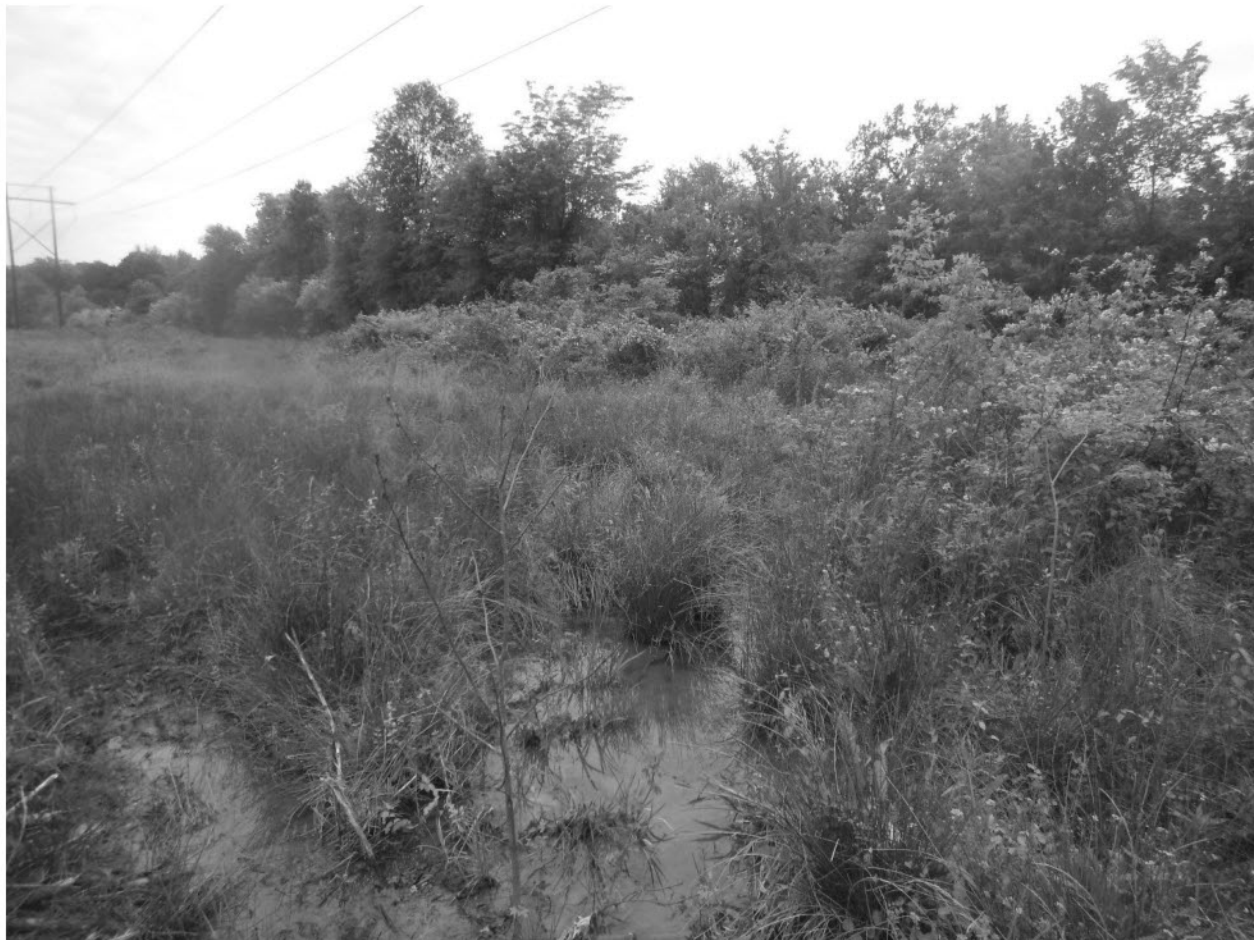
Photo No. 8

| Photo File Name | Date and Time of Photo | Photographer | Description |
|---|---|---|---|
| DSCN6421 | 05/01/2024, 10:42 AM | Chelsey Sherwood | Showing siltation in wetland area. Picture taken facing northeast. |

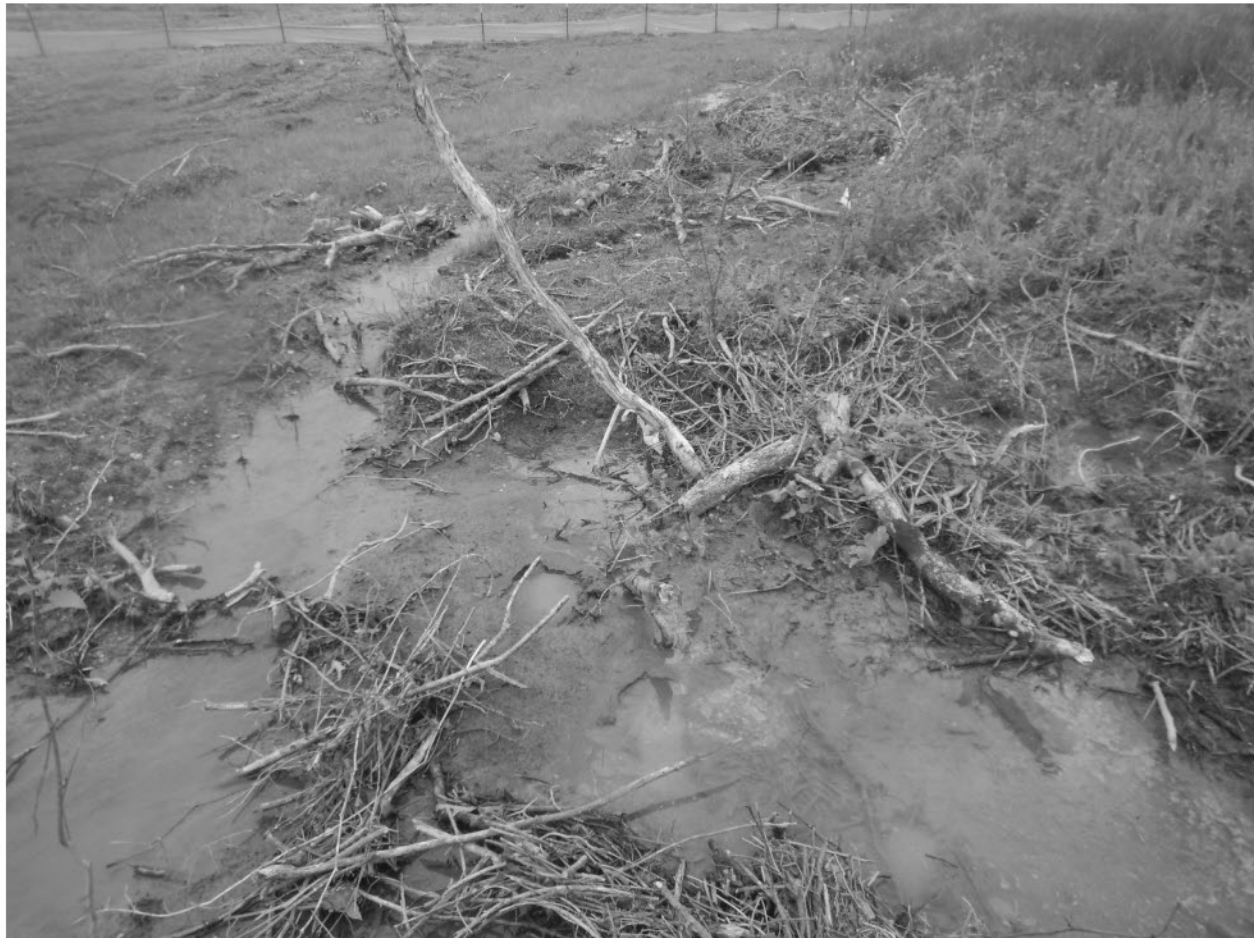
Photo No. 9

| A Section 404 permit was not obtained for the discharge of fill material into streams and wetlands. We observed approximately 450 linear feet of streams and 0.35 acres of wetlands that had been impacted due to the unauthorized activity. We observed the riparian zone was removed up to the stream bank and the stream bank was demolished in areas. We also noted stormwater runoff concerns as there were not BMPs in place. The stream and wetland were heavily silted (approximatley a foot of silt deep in areas). See photos for details. | | | |

| Photo File Name | Date and Time of Photo | Photographer | Description |
|---|---|---|---|
| DSCN6422 | 05/01/2024, 10:47 AM | Chelsey Sherwood | Showing impacted stream and wetland. Note it was heavily silted and approximately a foot deep of silt. Picture taken facing upstream, north. |

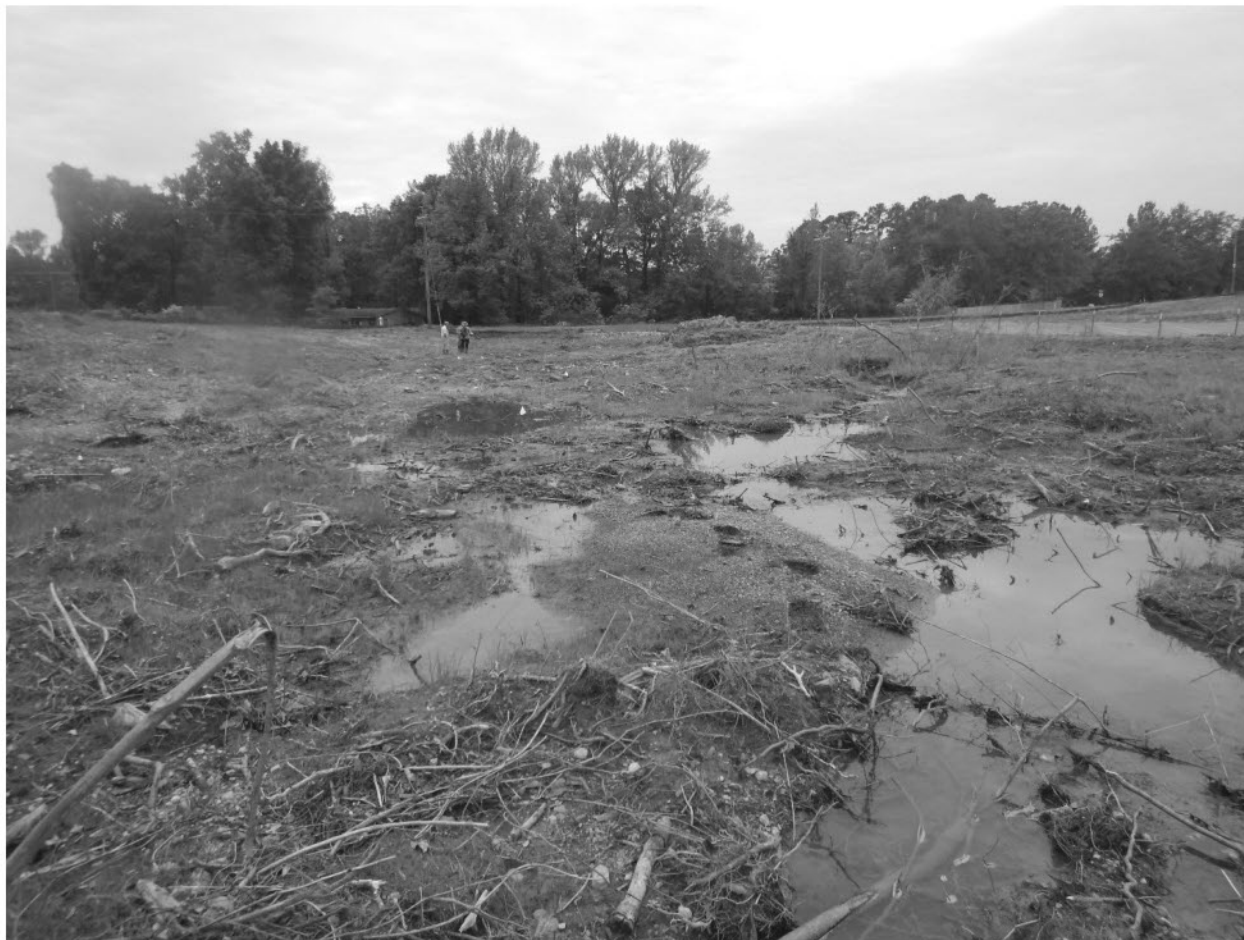
Photo No. 10

| Photo File Name | Date and Time of Photo | Photographer | Description |
|---|---|---|---|
| DSCN6423 | 05/01/2024, 10:53 AM | Chelsey Sherwood | Showing impacted stream and wetland. Note no BMPs in place and it was heavily silted and approximately a foot deep of silt. Picture taken facing downstream, south. |

| I discussed the stream and wetland impacts and concerns related to Section 404 regulations. I also relayed stormwater runoff concerns and Best Management Practices (BMPs) needed to minimize these impacts. | | | |

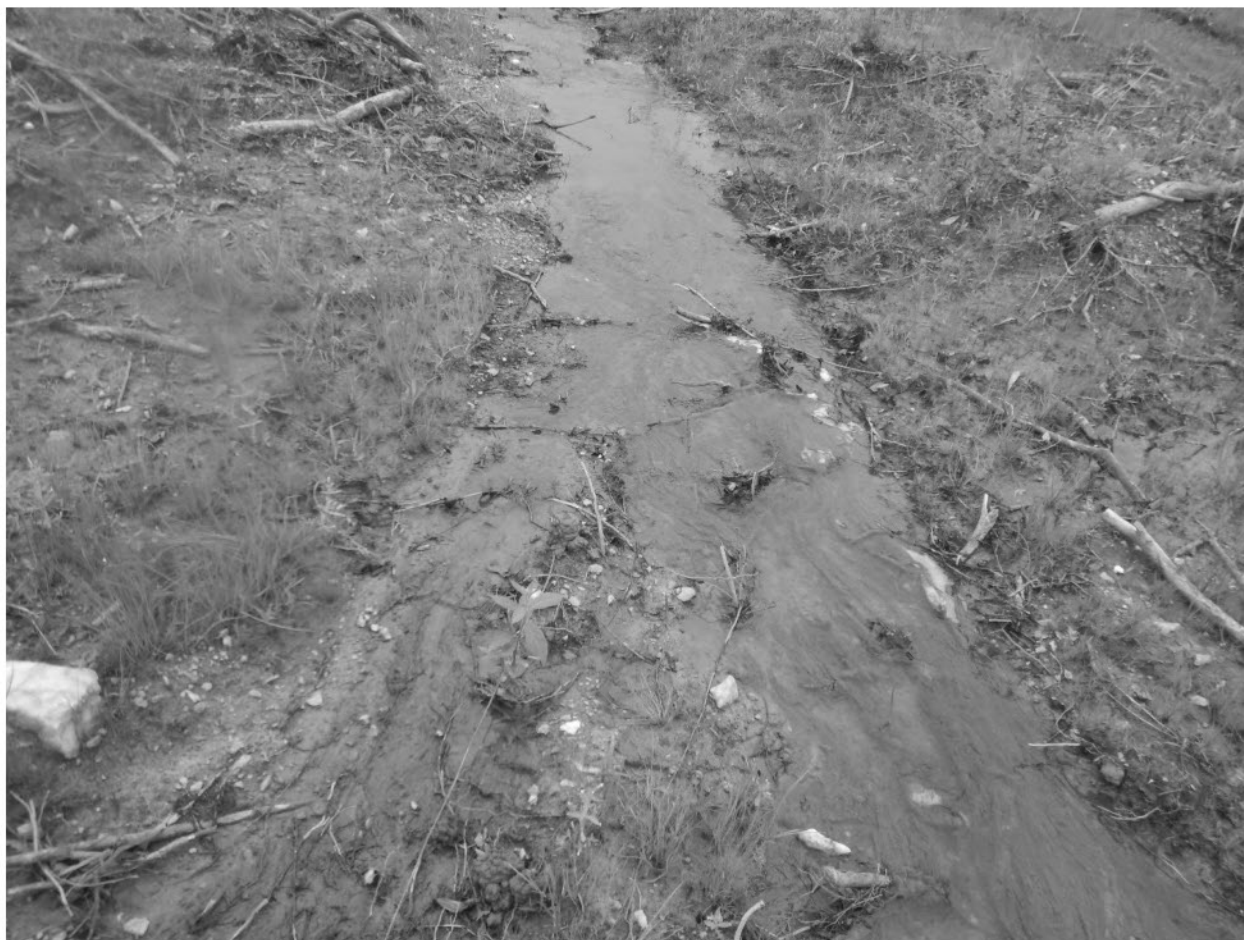
Photo No. 11

| Photo File Name | Date and Time of Photo | Photographer | Description |
|---|---|---|---|
| DSCN6424 | 05/01/2024, 10:57 AM | Chelsey Sherwood | Showing impacted stream and wetland. Note siltation and filamentous algae in the stream. Picture taken facing downstream, southwest. |

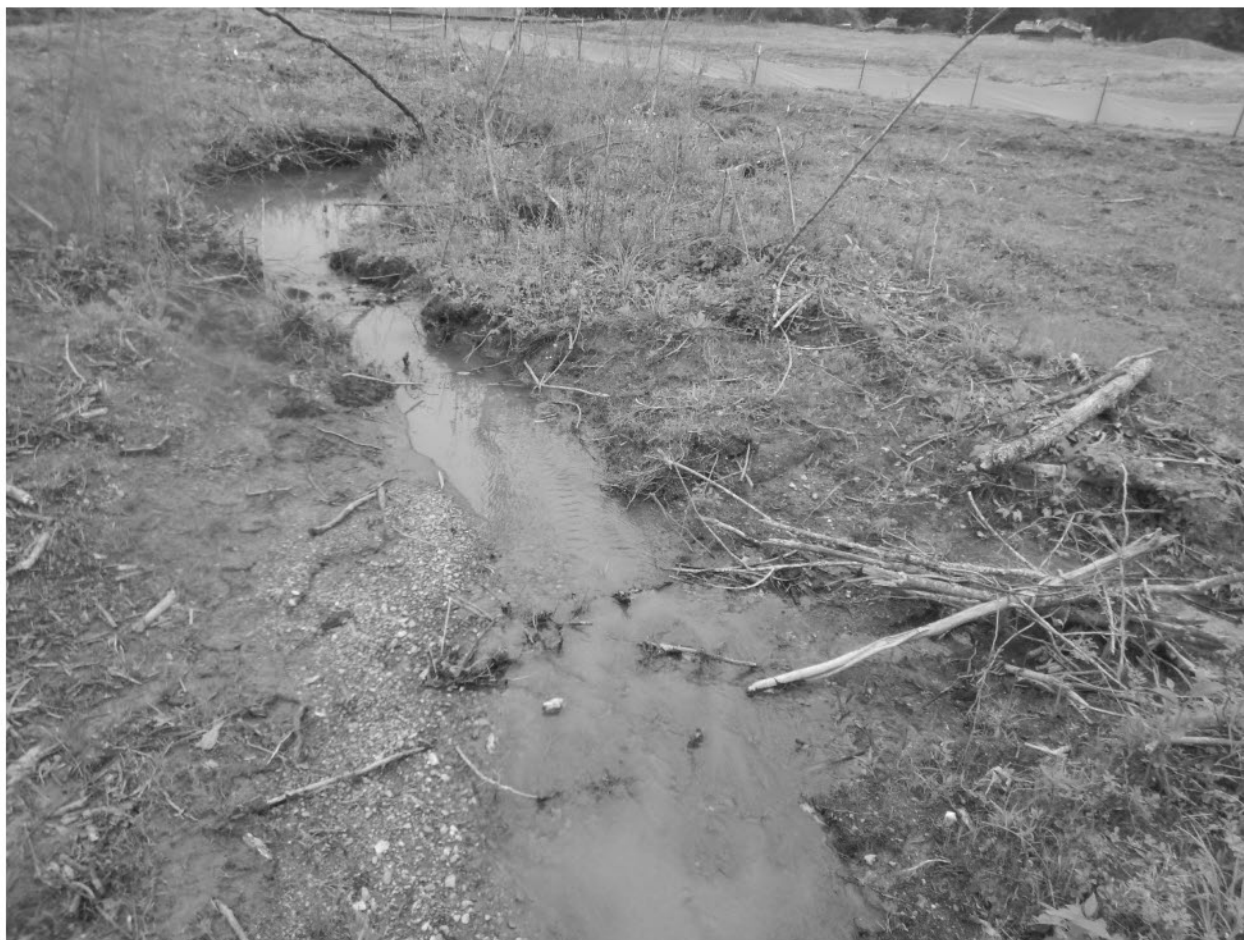
Photo No. 12

| Photo File Name | Date and Time of Photo | Photographer | Description |
|---|---|---|---|
| DSCN6425 | 05/01/2024, 11:00 AM | Chelsey Sherwood | Showing heavily silted stream channel. Note the gravel substrate on river left and orange tinted water on right indicating iron-oxidizing bacteria present. Picture taken facing downstream, southwest. |

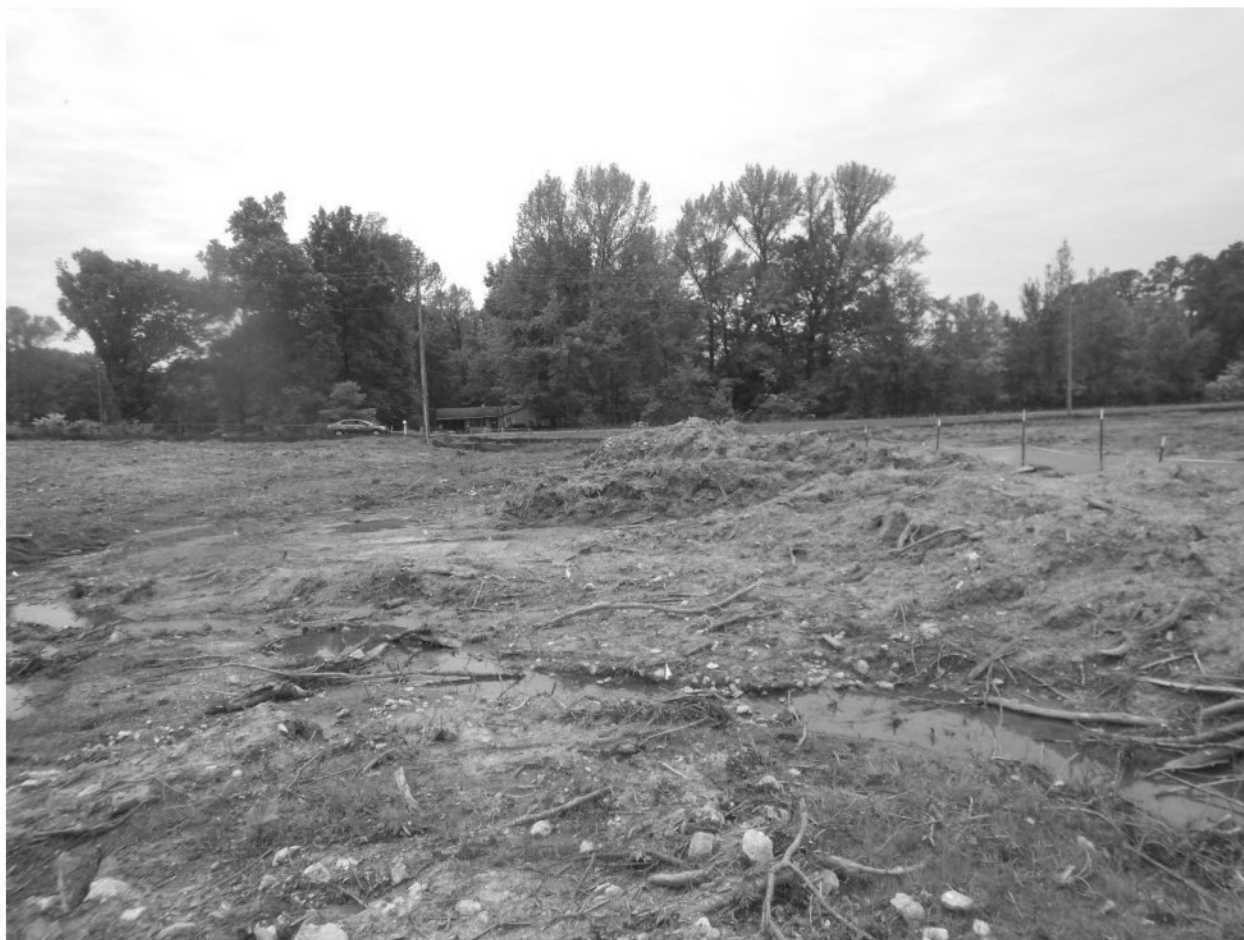
Photo No. 13

| Photo File Name | Date and Time of Photo | Photographer | Description |
|---|---|---|---|
| DSCN6426 | 05/01/2024, 11:06 AM | Chelsey Sherwood | Showing fill material in stream and spoil piles. Note the riparian area has been cleared and stream banks have been demolished. Picture taken facing downstream, south. |

| I relayed that a Section 404 permit needed to be obtained to discharge fill material into Waters of the U.S.. | | | |

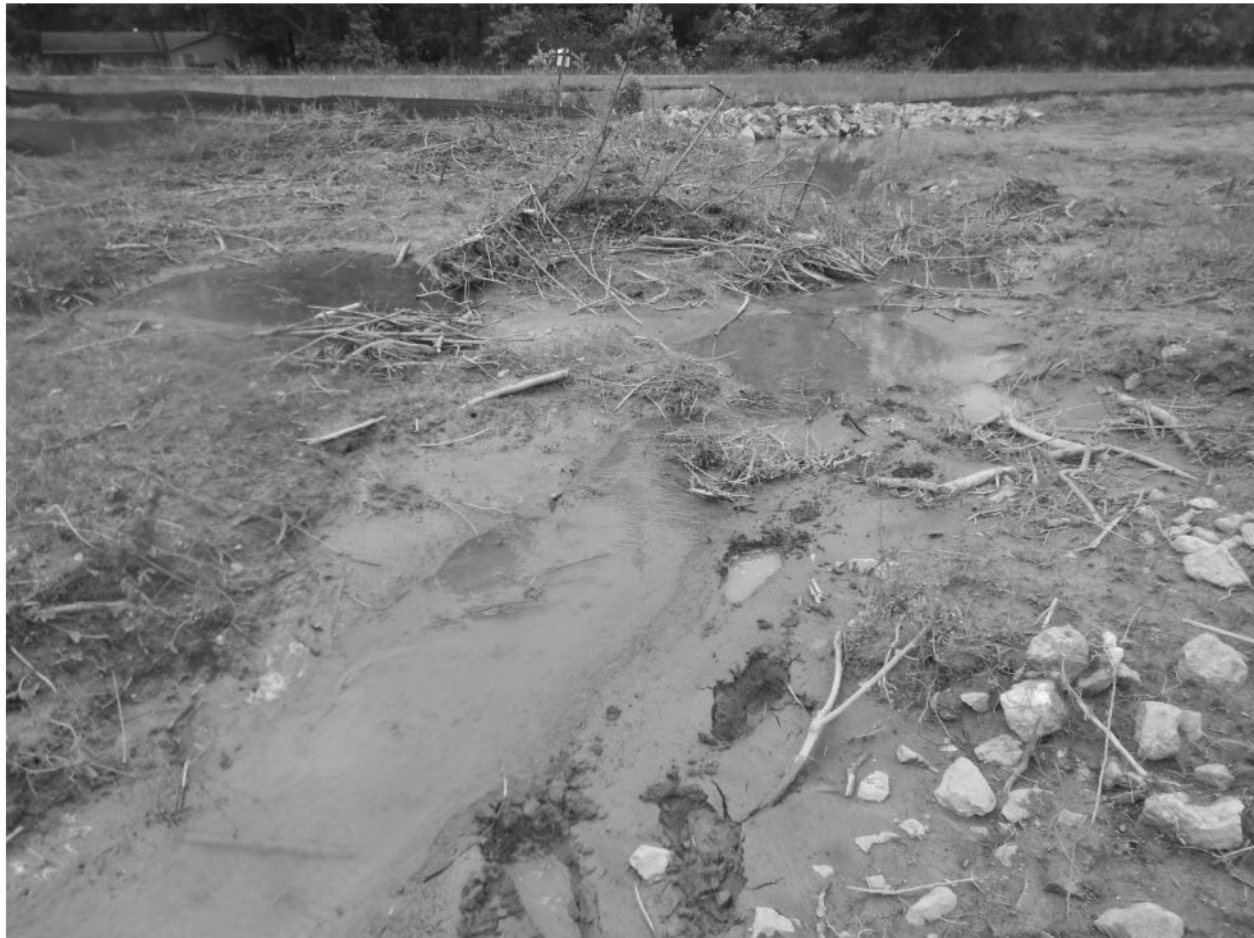
Photo No. 14

| Photo File Name | Date and Time of Photo | Photographer | Description |
|---|---|---|---|
| DSCN6427 | 05/01/2024, 11:09 AM | Chelsey Sherwood | Showing impacted stream. Note approximately a foot deep of silt in stream channel. Picture taken facing downstream, south. |

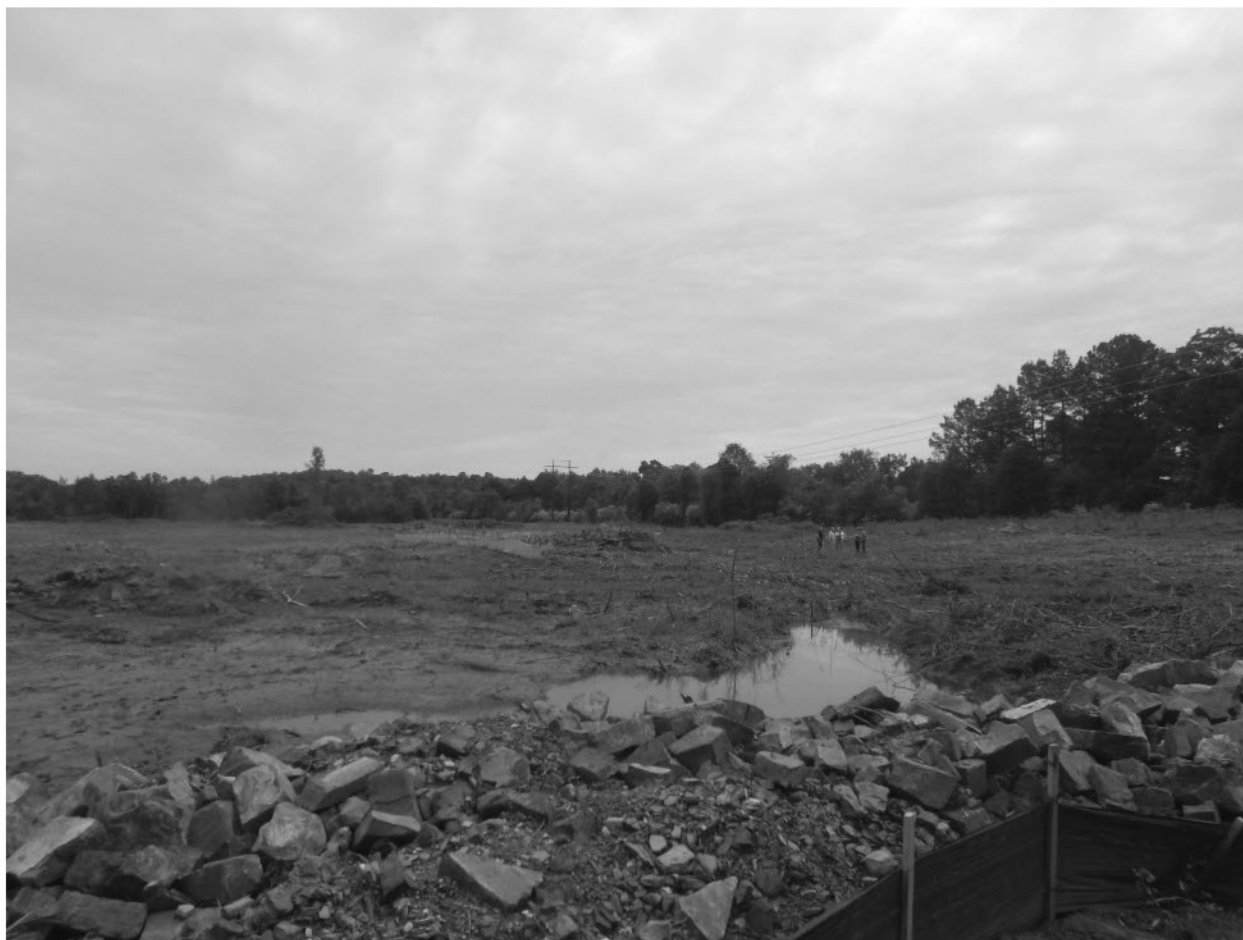
Photo No. 15

| Photo File Name | Date and Time of Photo | Photographer | Description |
|---|---|---|---|
| DSCN6428 | 05/01/2024, 11:14 AM | Chelsey Sherwood | Showing large check dam in stream channel. Picture taken facing upstream, north. |

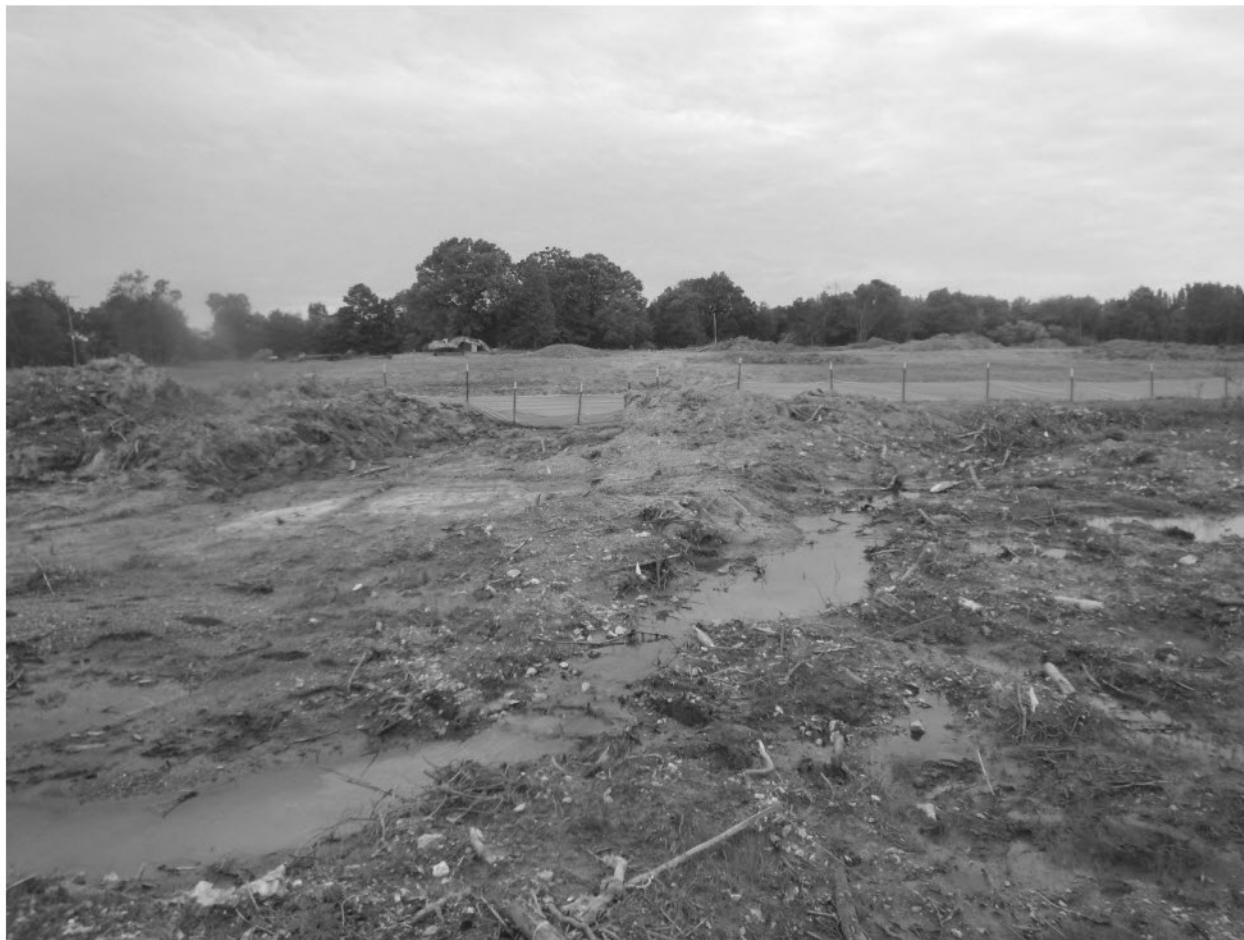
Photo No. 16

| Photo File Name | Date and Time of Photo | Photographer | Description |
|---|---|---|---|
| DSCN6429 | 05/01/2024, 11:19 AM | Chelsey Sherwood | Showing fill material in stream. Picture taken facing west. |

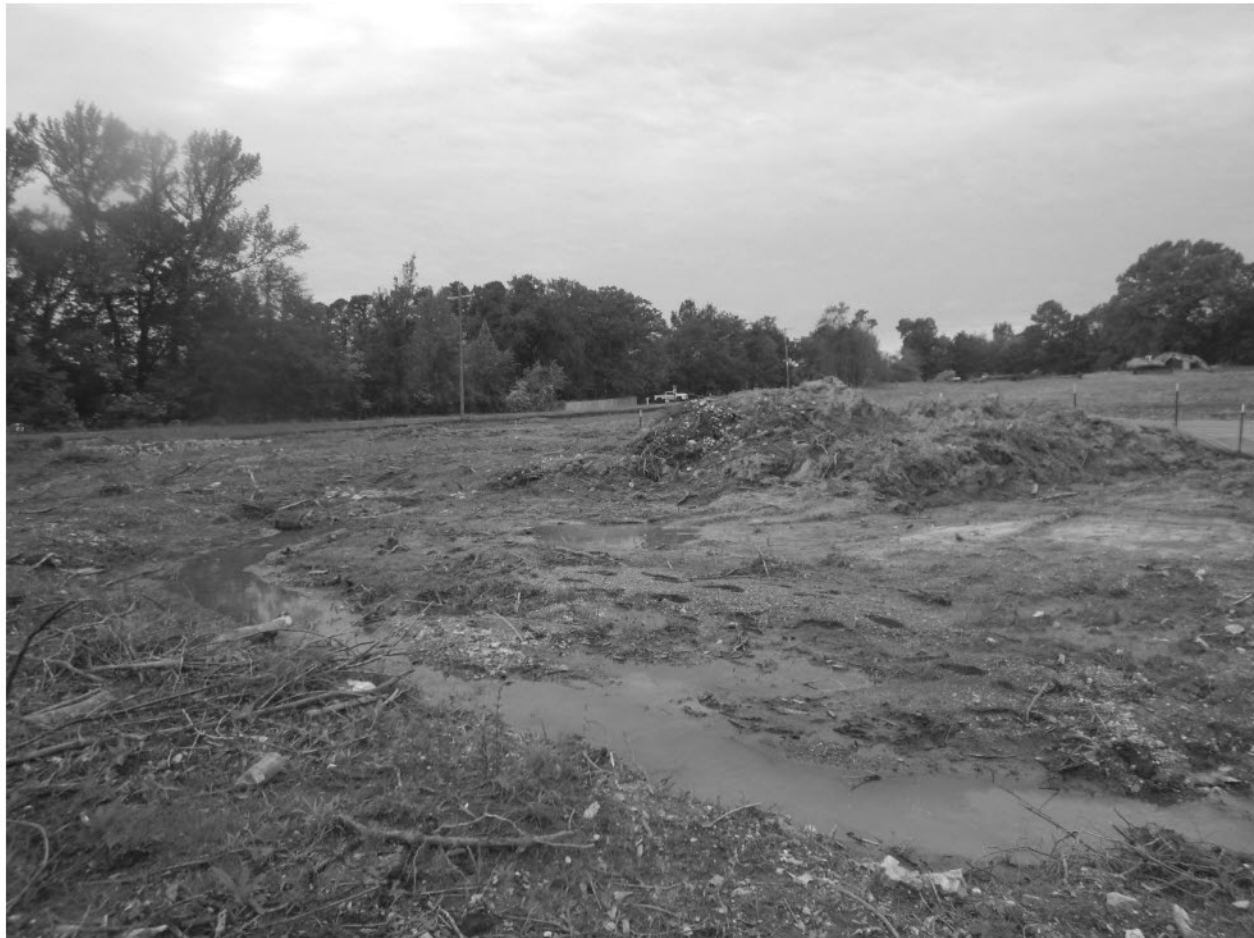
Photo No. 17

| Photo File Name | Date and Time of Photo | Photographer | Description |
|---|---|---|---|
| DSCN6430 | 05/01/2024, 11:19 AM | Chelsey Sherwood | Showing fill material in stream. Picture taken facing southwest. |

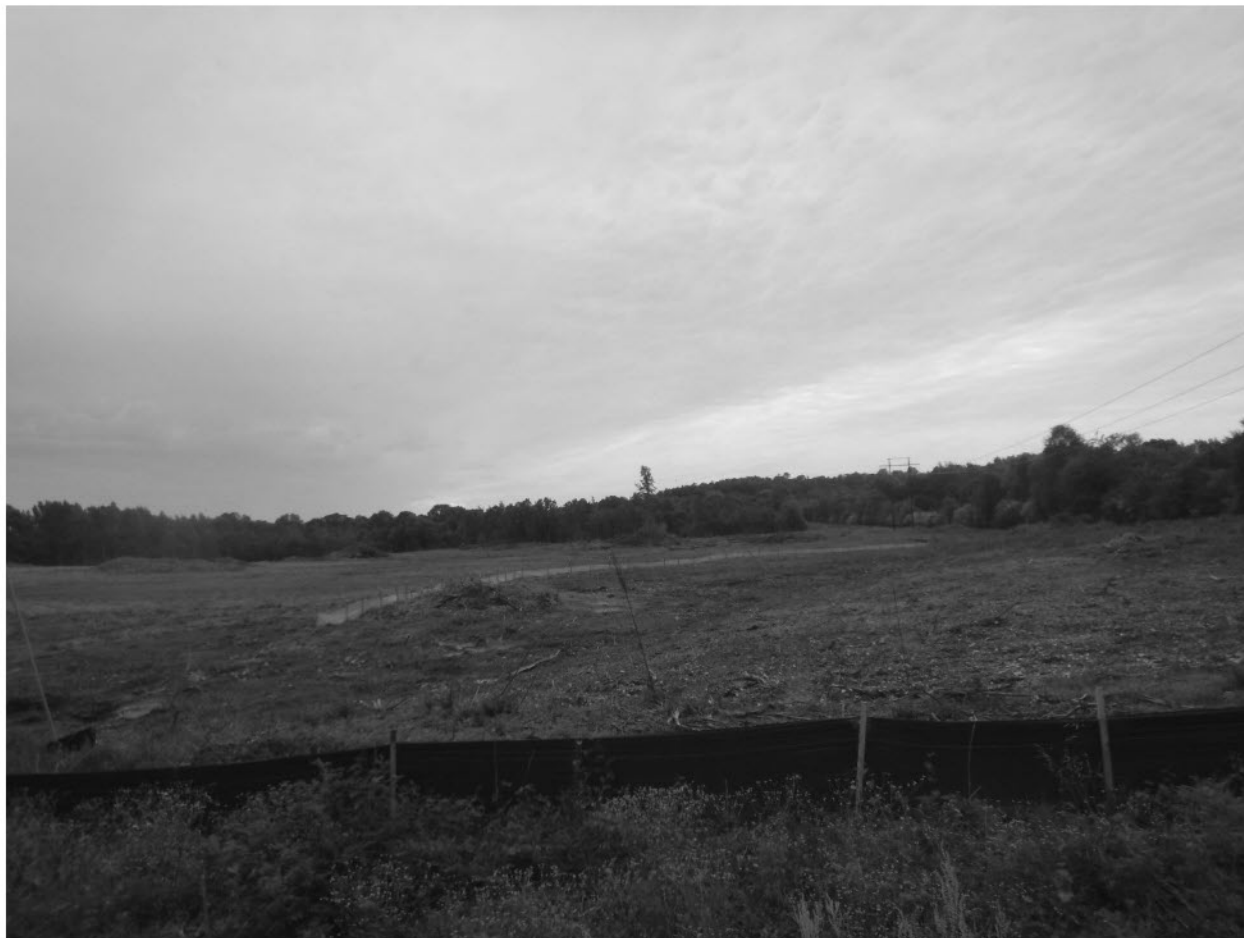
Photo No. 18

| Photo File Name | Date and Time of Photo | Photographer | Description |
|---|---|---|---|
| DSCN6431 | 05/01/2024, 11:56 AM | Chelsey Sherwood | Showing overall impacted stream and wetland area. Note stream and wetland are right of the orange fence. Picture taken facing north. |

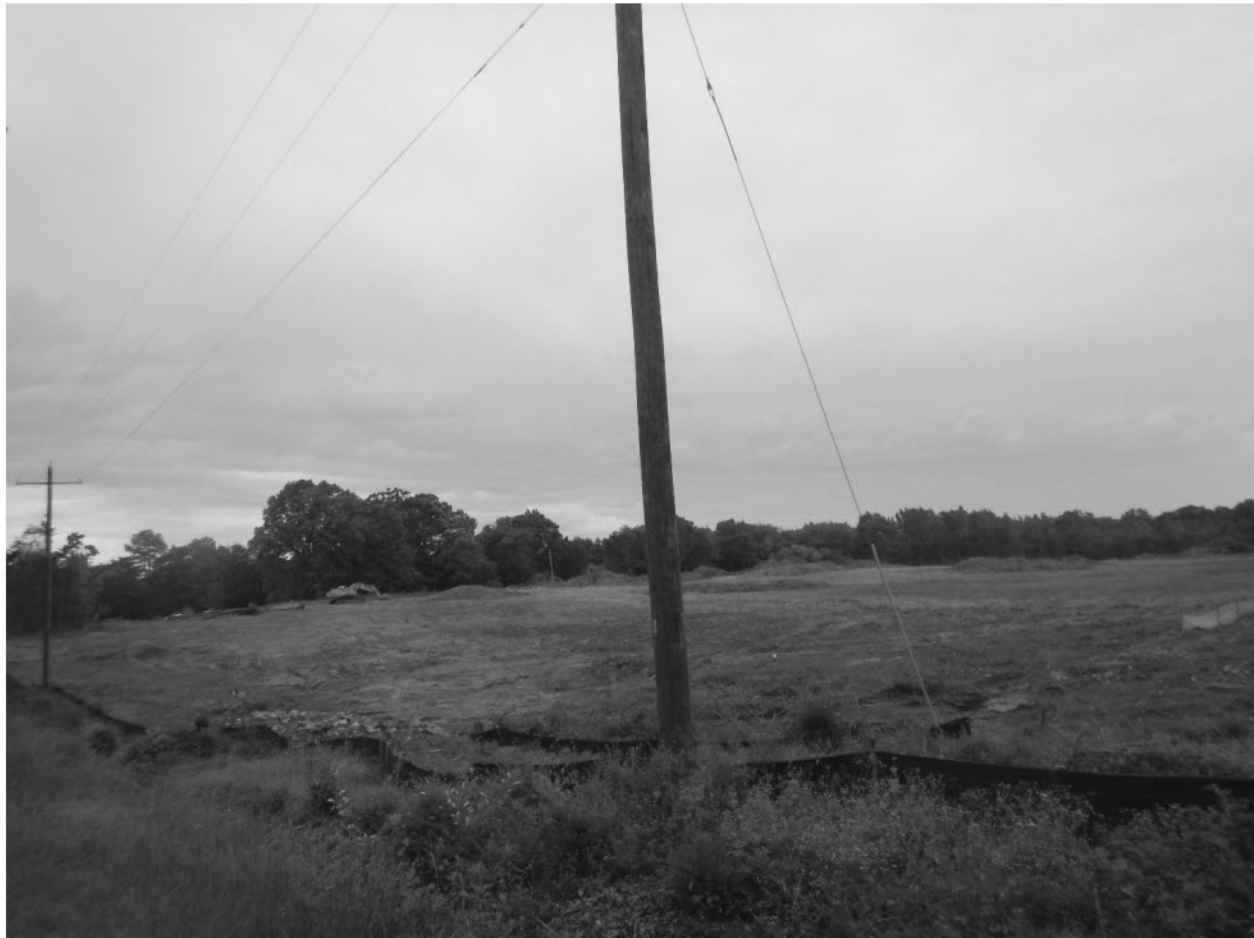
Photo No. 19

| Photo File Name | Date and Time of Photo | Photographer | Description |
|---|---|---|---|
| DSCN6432 | 05/01/2024, 11:56 AM | Chelsey Sherwood | Showing overall project area.<br>Picture taken facing west. |
