## Clean Water Act Section 404: Site Visit/Case Development

| Site Name | Crystal Valley LLC (Rick Ferguson) | | | | |

| Inspection Purpose | Initial site visit | | |

## Appendix 1

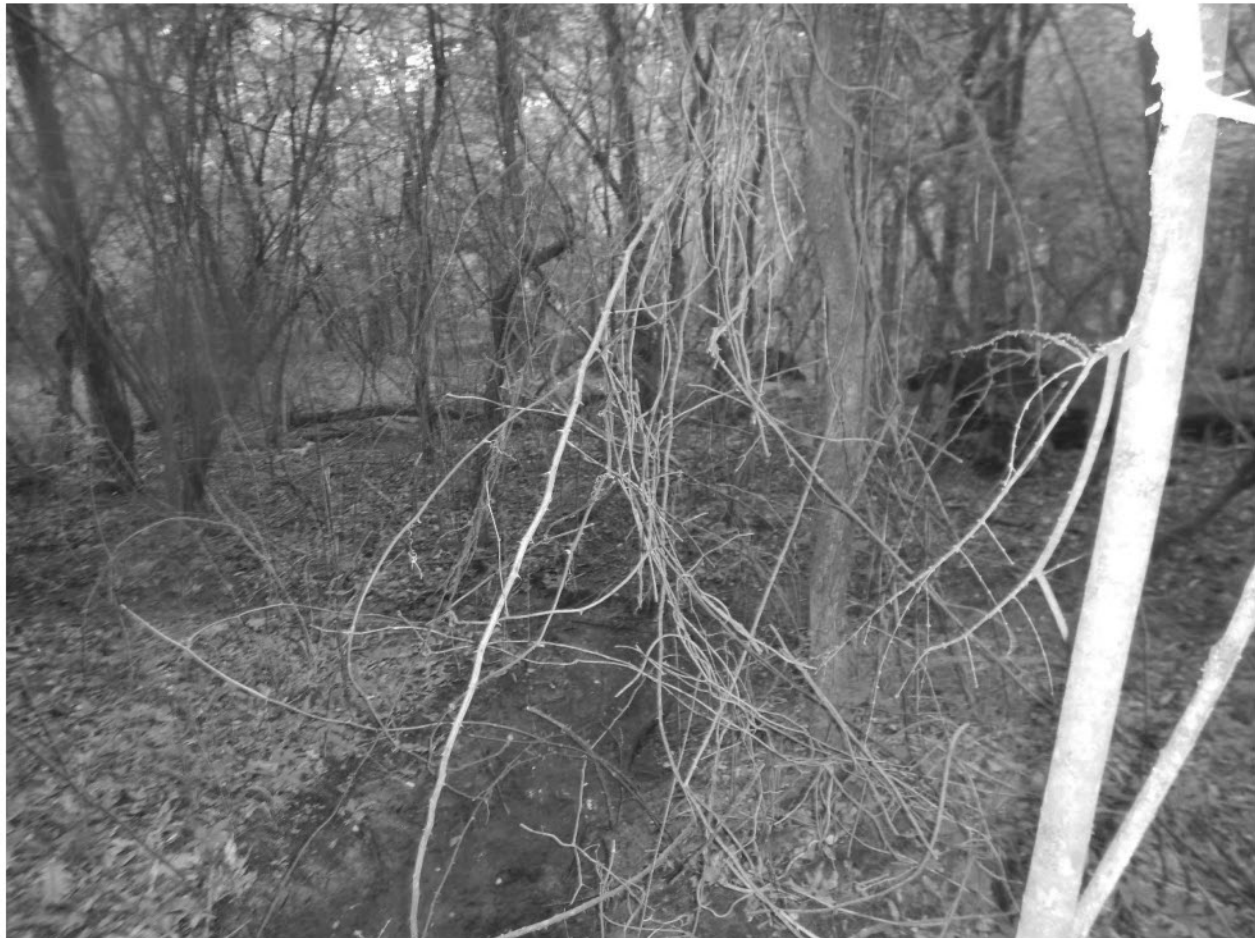
Photo No. 20

| Photo File Name | Date and Time of Photo | Photographer | Description |
|---|---|---|---|
| DSCN6433 | 05/01/2024, 12:13 PM | Chelsey Sherwood | Showing swale connected to wetland (W-1). Picture taken facing west. |

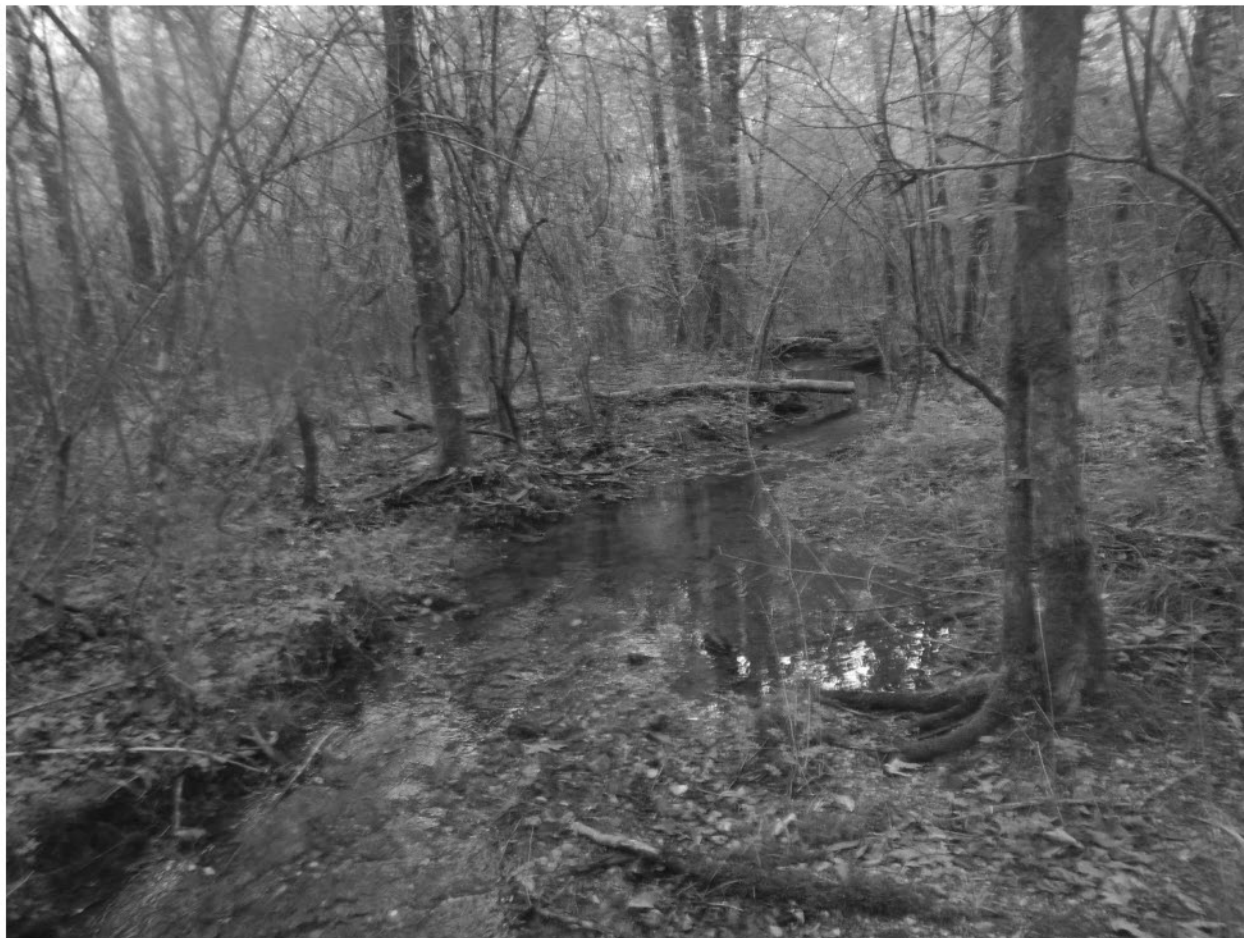
Photo No. 21

| Photo File Name | Date and Time of Photo | Photographer | Description |
|---|---|---|---|
| DSCN6434 | 05/01/2024, 12:18 PM | Chelsey Sherwood | Showing undisturbed stream channel (S-7). Picture taken facing downstream, south. |

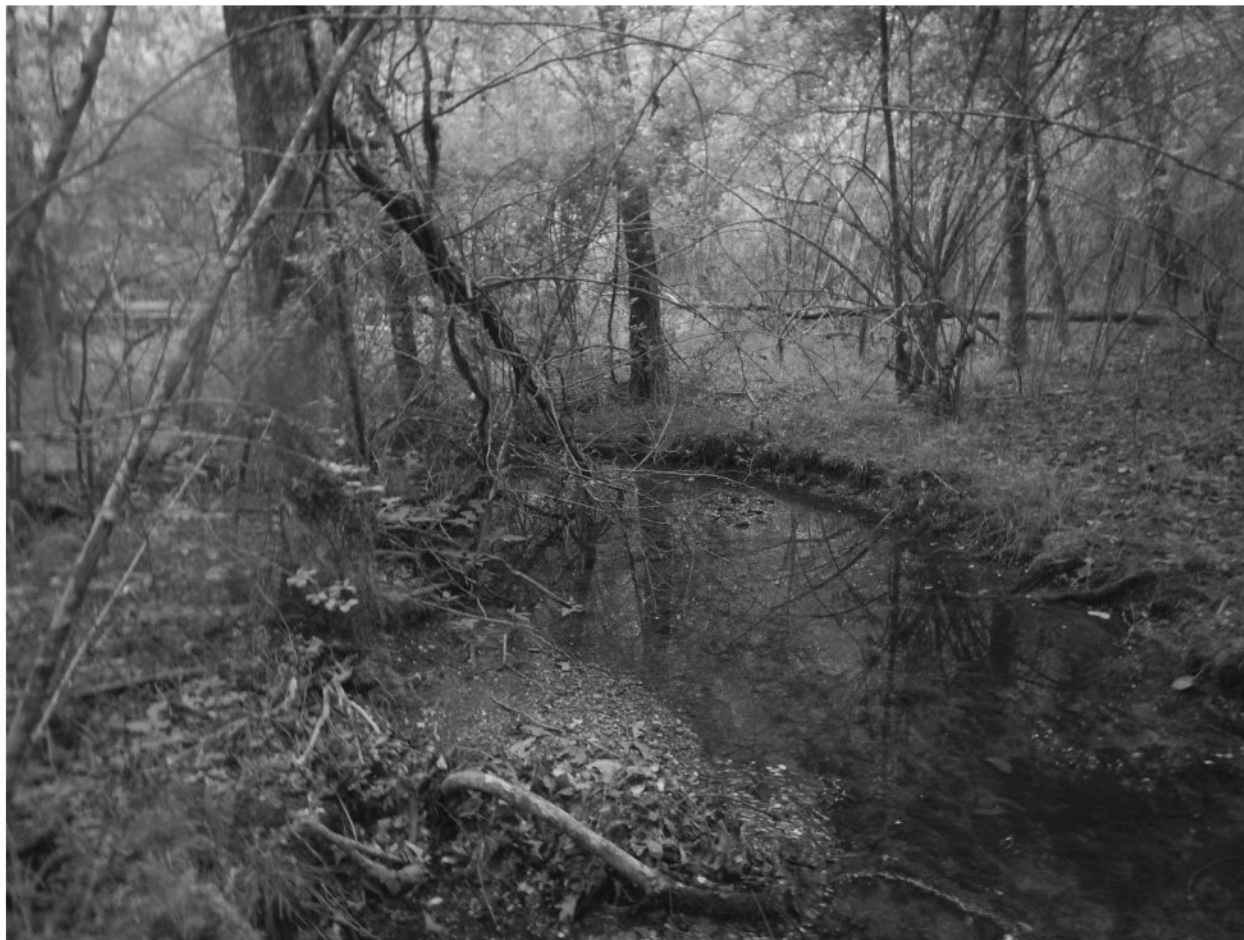
Photo No. 22

| Photo File Name | Date and Time of Photo | Photographer | Description |
|---|---|---|---|
| DSCN6435 | 05/01/2024, 12:18 PM | Chelsey Sherwood | Showing undisturbed stream channel (S-7). Picture taken facing upstream, north. |

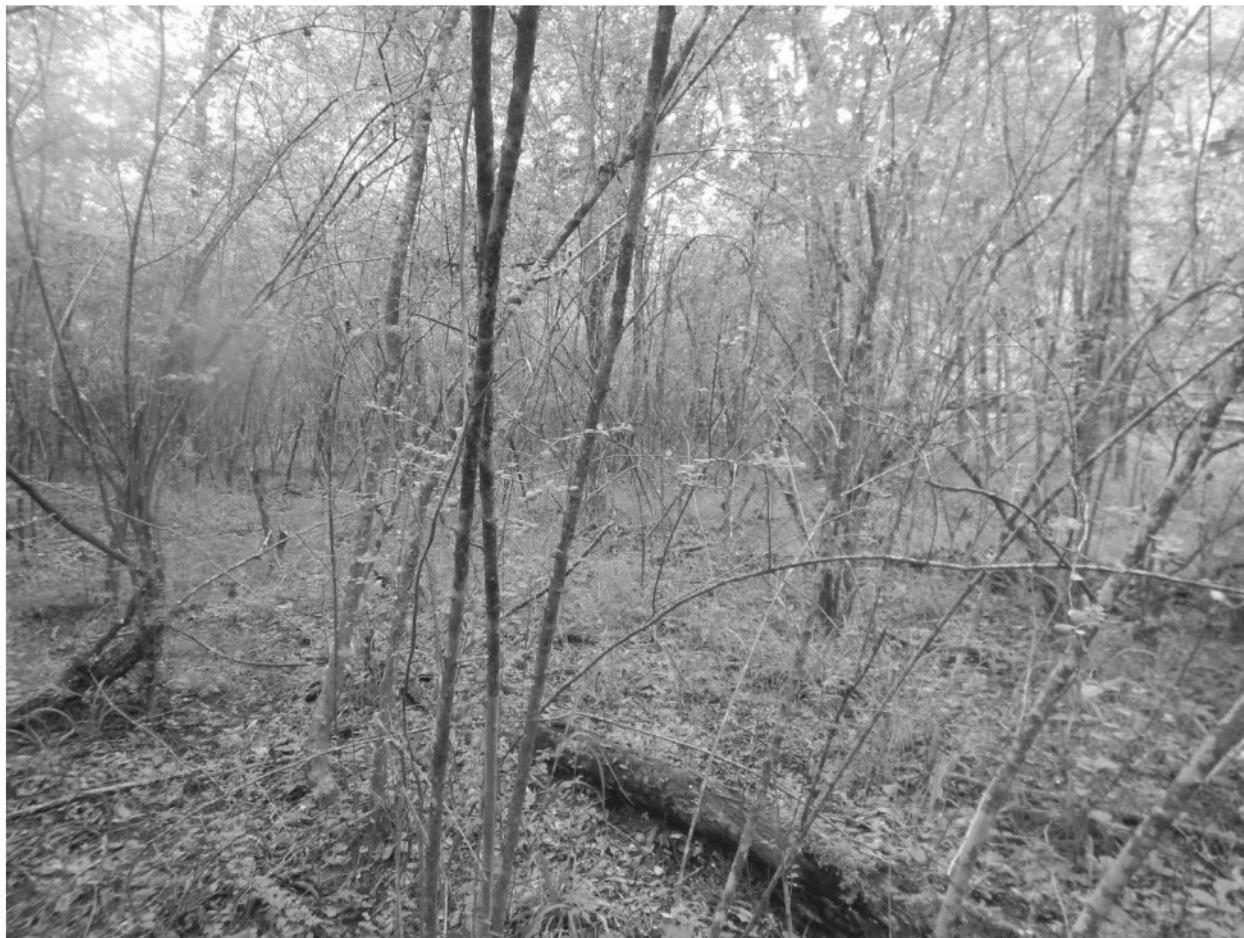
Photo No. 23

| Photo File Name | Date and Time of Photo | Photographer | Description |
|---|---|---|---|
| DSCN6436 | 05/01/2024, 12:18 PM | Chelsey Sherwood | Showing wetland (W-4) adjacent to stream from photo 22. Picture taken facing west. |

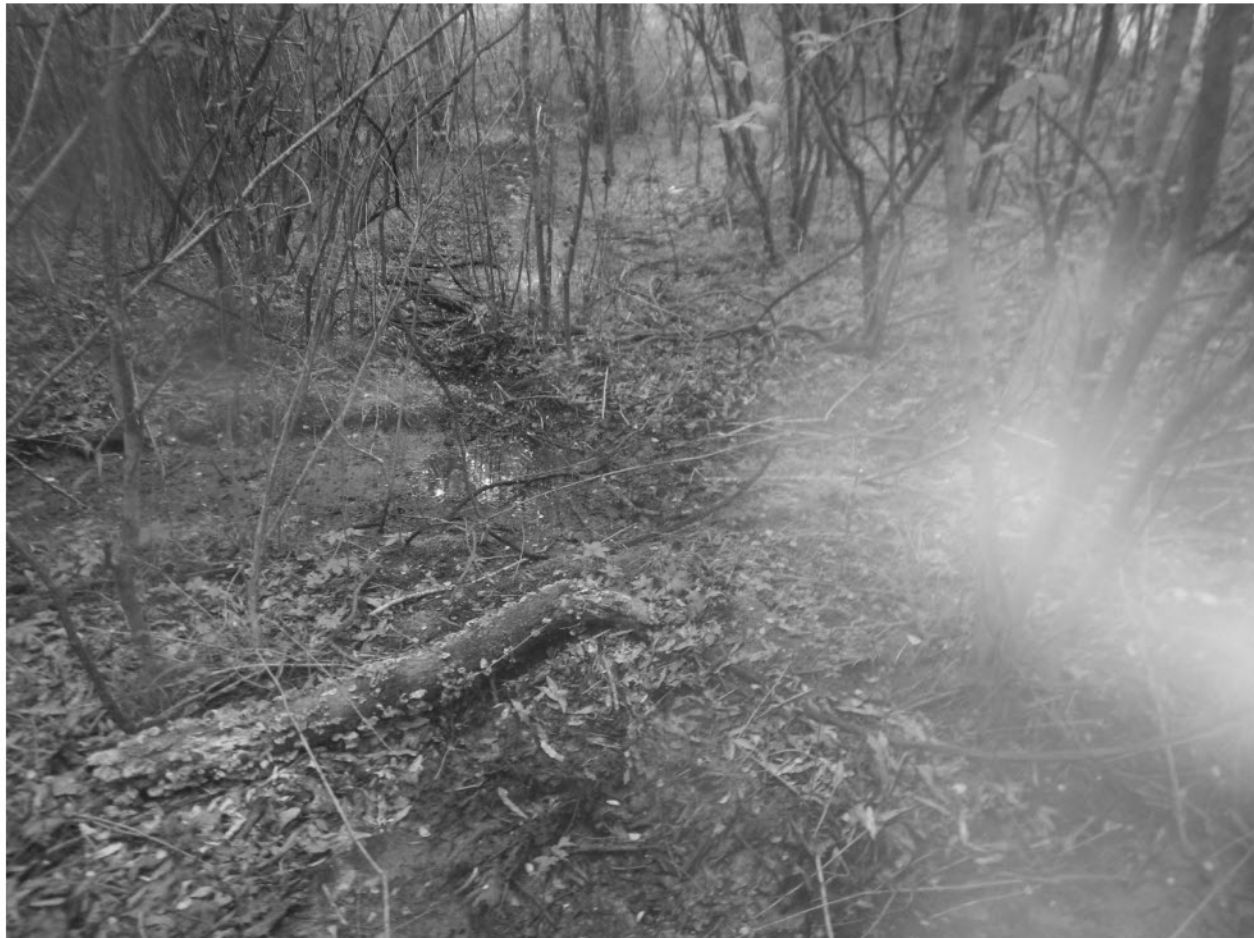
Photo No. 24

| Photo File Name | Date and Time of Photo | Photographer | Description |
|---|---|---|---|
| DSCN6437 | 05/01/2024, 12:24 PM | Chelsey Sherwood | Showing swale that connects wetland (W-1) to stream (S-7). Picture taken facing downstream, southeast. |

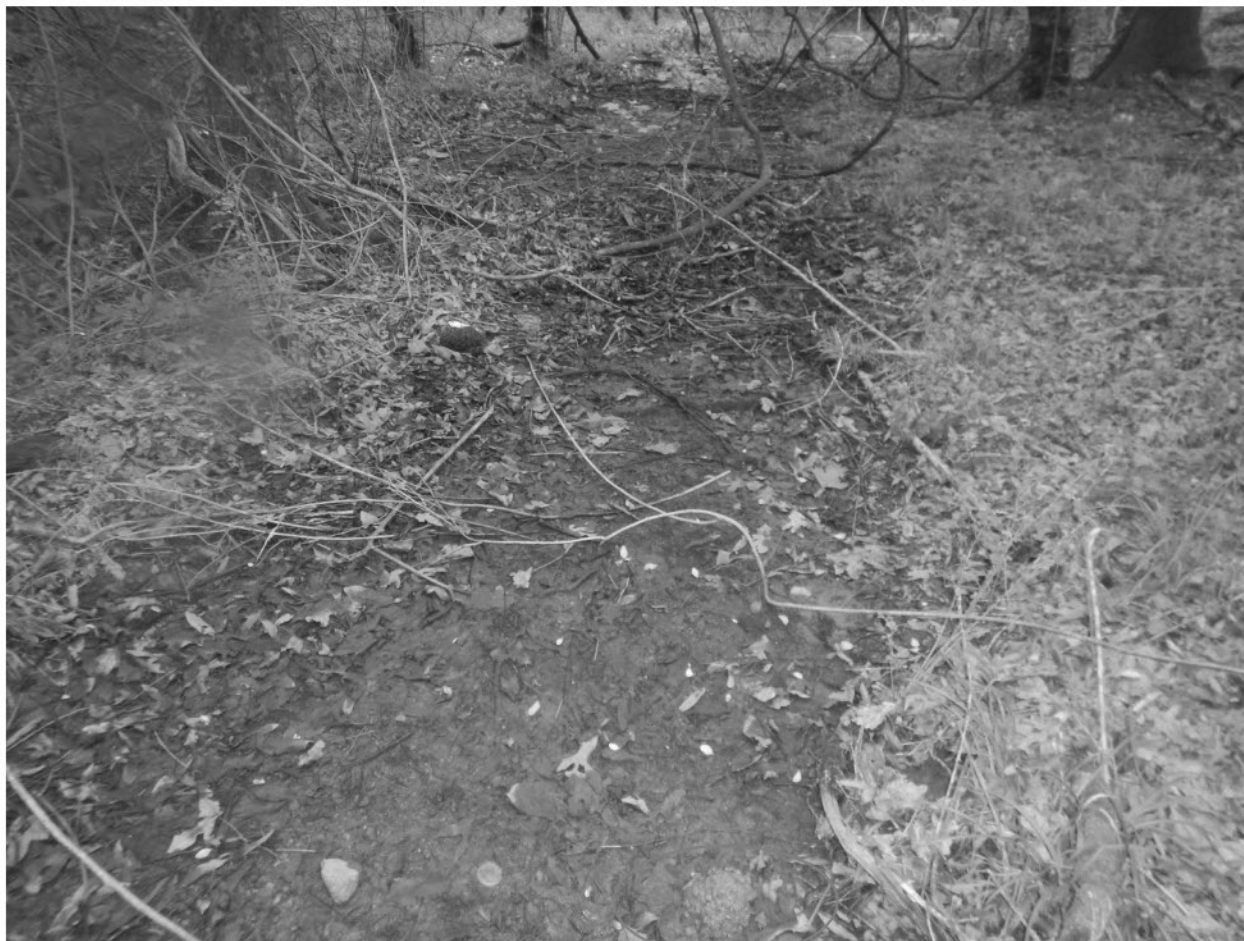
Photo No. 25

| Photo File Name | Date and Time of Photo | Photographer | Description |
|---|---|---|---|
| DSCN6438 | 05/01/2024, 12:26 PM | Chelsey Sherwood | Showing swale that connects wetland (W-1) to stream (S-7). Note crayfish burrow circled in red. Picture taken facing downstream, southeast. |

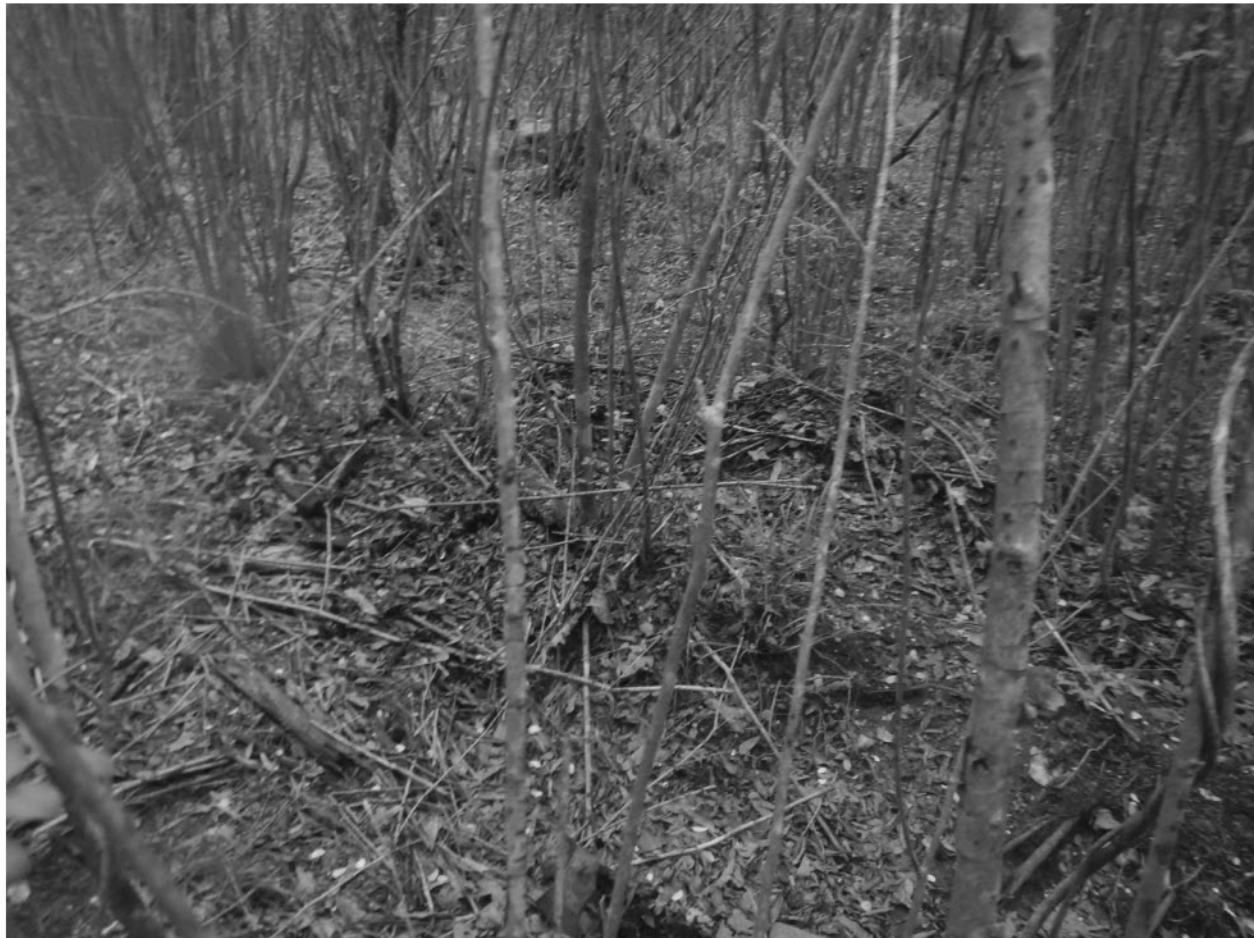
Photo No. 26

| Photo File Name | Date and Time of Photo | Photographer | Description |
|---|---|---|---|
| DSCN6439 | 05/01/2024, 12:28 PM | Chelsey Sherwood | Showing swale that connects wetland (W-1) to stream (S-7). Note wrack lines of debris. Picture taken facing downstream, southeast. |

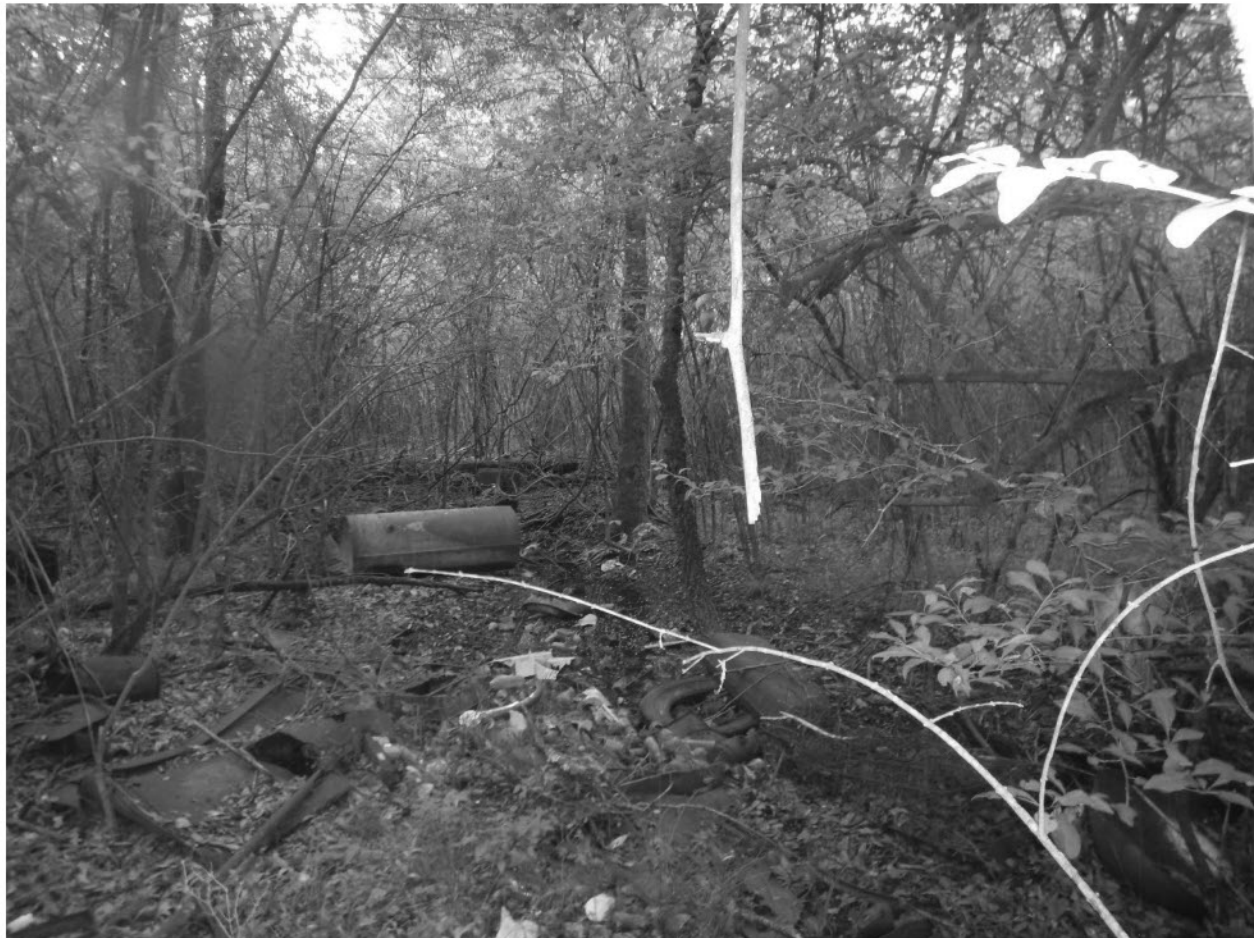
Photo No. 27

| Photo File Name | Date and Time of Photo | Photographer | Description |
|---|---|---|---|
| DSCN6440 | 05/01/2024, 12:30 PM | Chelsey Sherwood | Showing swale that connects wetland (W-1) to stream (S-7). Picture taken facing downstream, southeast. |

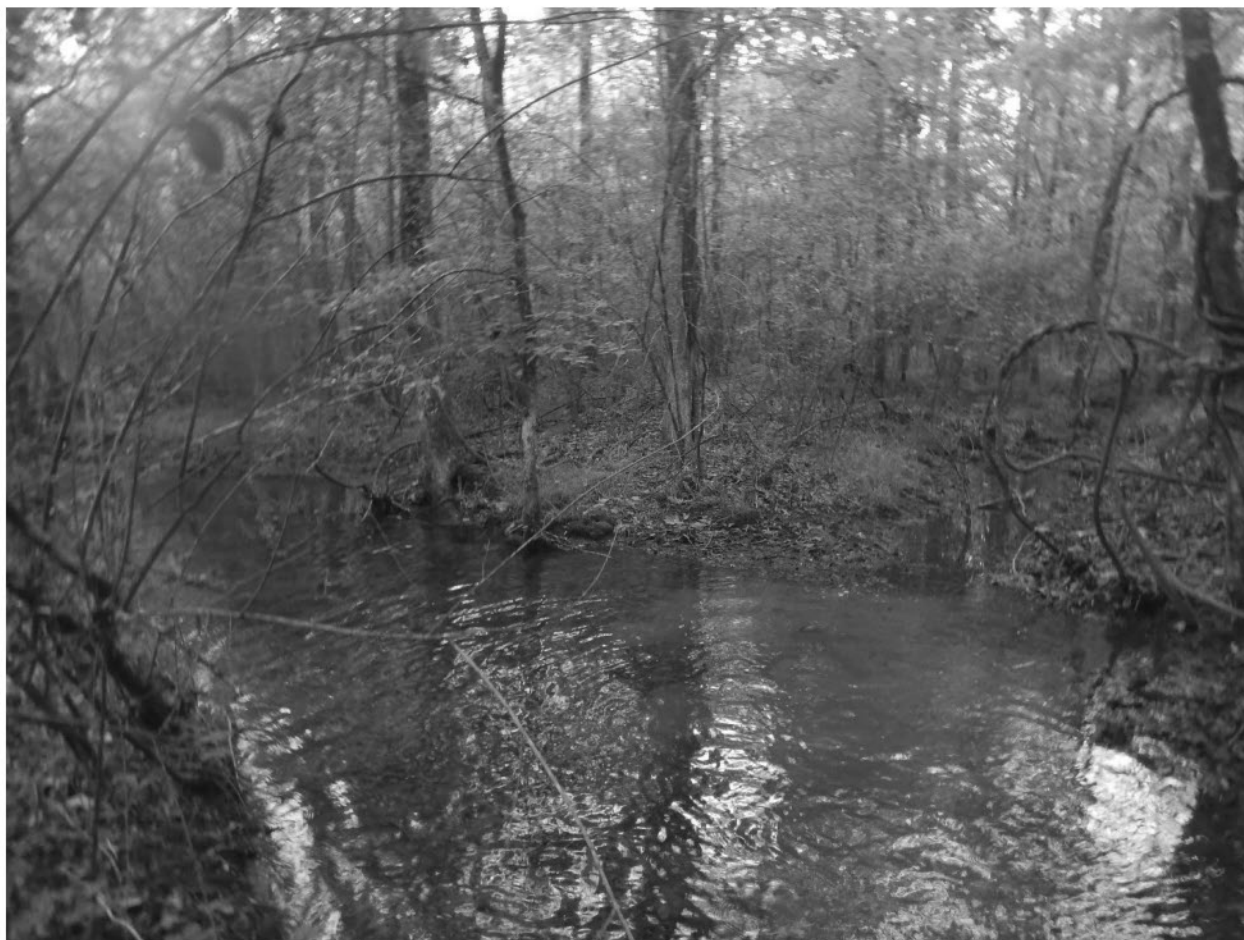
Photo No. 28

| Photo File Name | Date and Time of Photo | Photographer | Description |
|---|---|---|---|
| DSCN6441 | 05/01/2024, 12:38 PM | Chelsey Sherwood | Showing confluence of unmapped stream on right with stream (S-7). Picture taken facing upstream, northwest. |

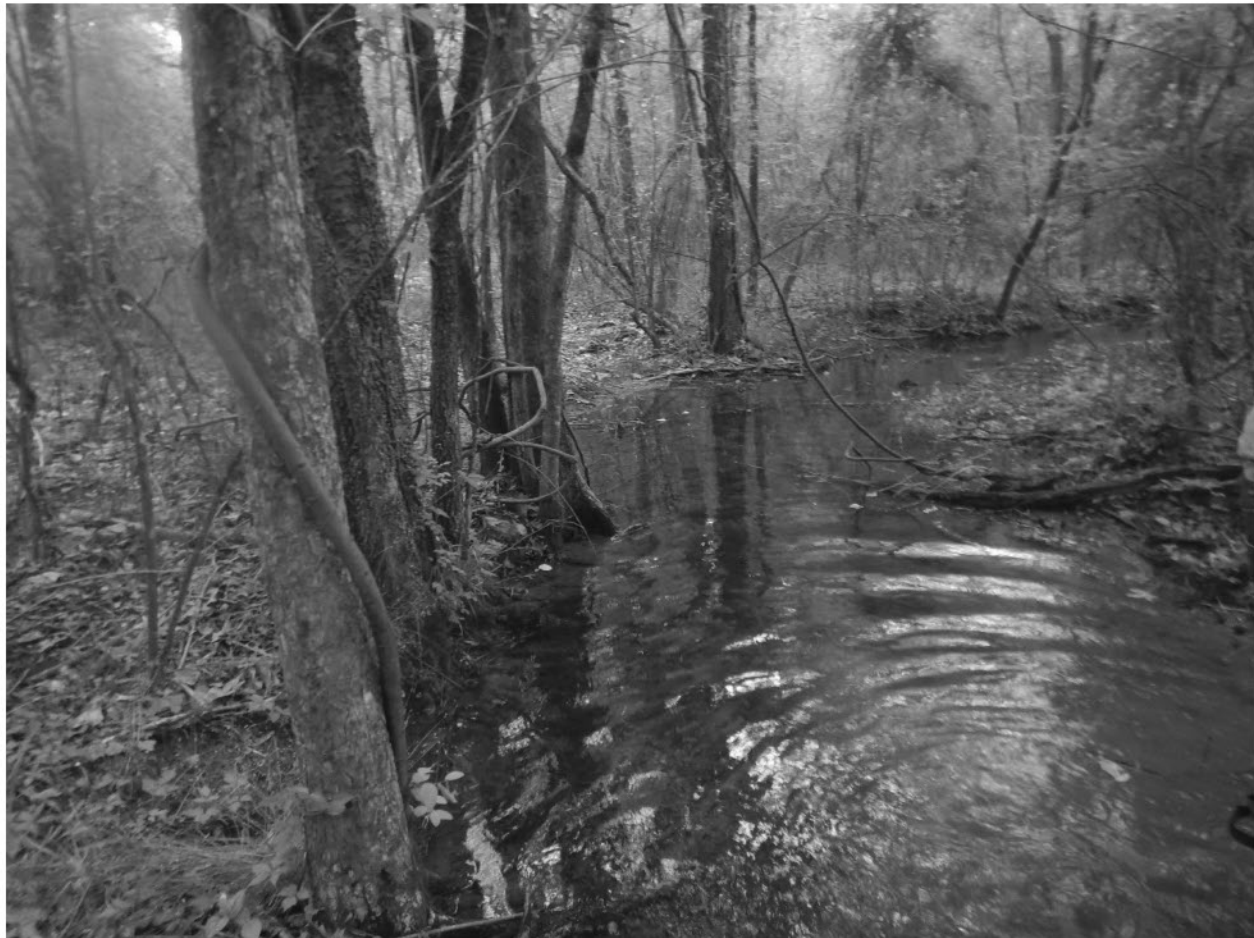
Photo No. 29

| Photo File Name | Date and Time of Photo | Photographer | Description |
|---|---|---|---|
| DSCN6442 | 05/01/2024, 12:38 PM | Chelsey Sherwood | Showing stream (S-7) downstream of confluence of unmapped stream in photo 28. Picture taken facing downstream, southeast. |

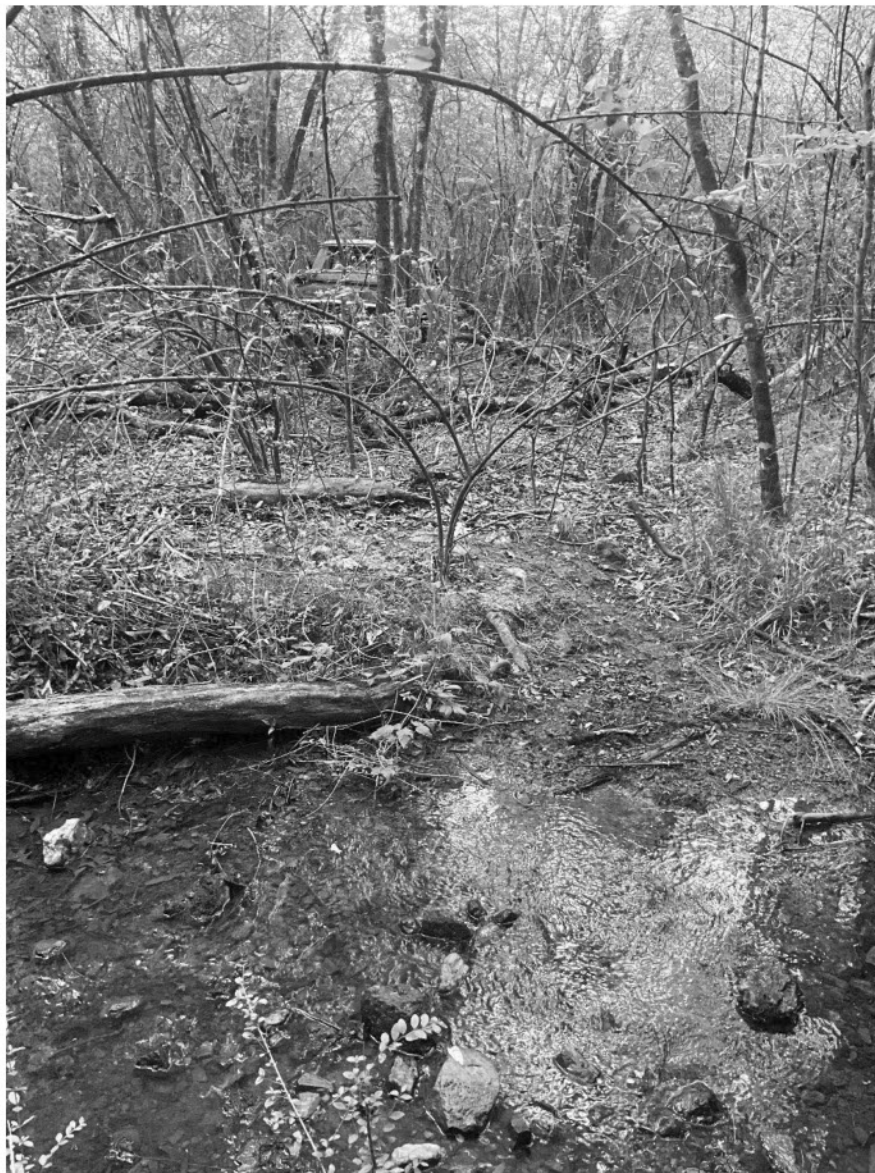
Photo No. 30

| Photo File Name | Date and Time of Photo | Photographer | Description |
|---|---|---|---|
| DSCN6443 | 05/01/2024, 12:41 PM | Chelsey Sherwood | Showing where swale connects to stream (S-7). Picture taken facing northwest to right bank. |

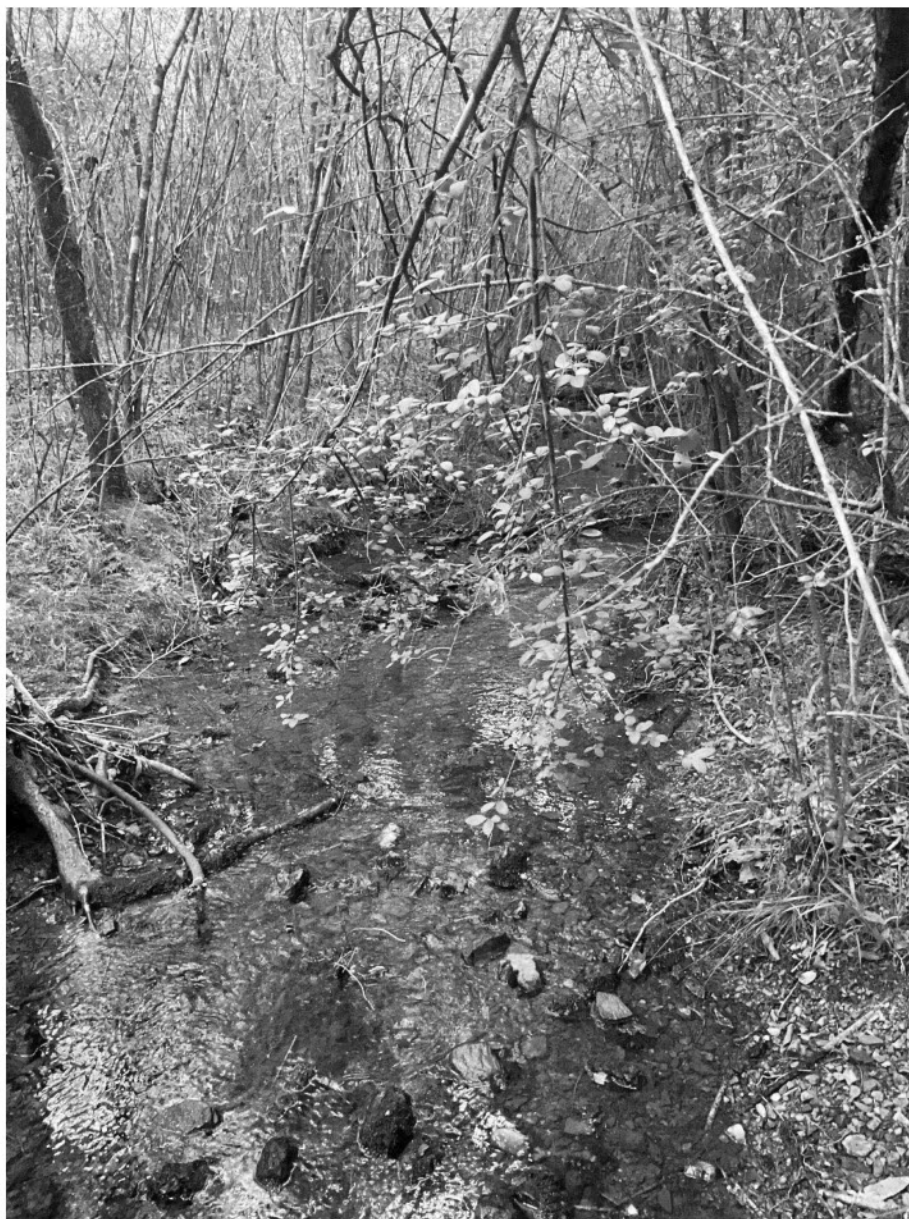
Photo No. 31

| Photo File Name | Date and Time of Photo | Photographer | Description |
|---|---|---|---|
| DSCN6444 | 05/01/2024, 12:42 PM | Chelsey Sherwood | Showing downstream of where swale connects to stream (S-7). Picture taken facing southeast. |

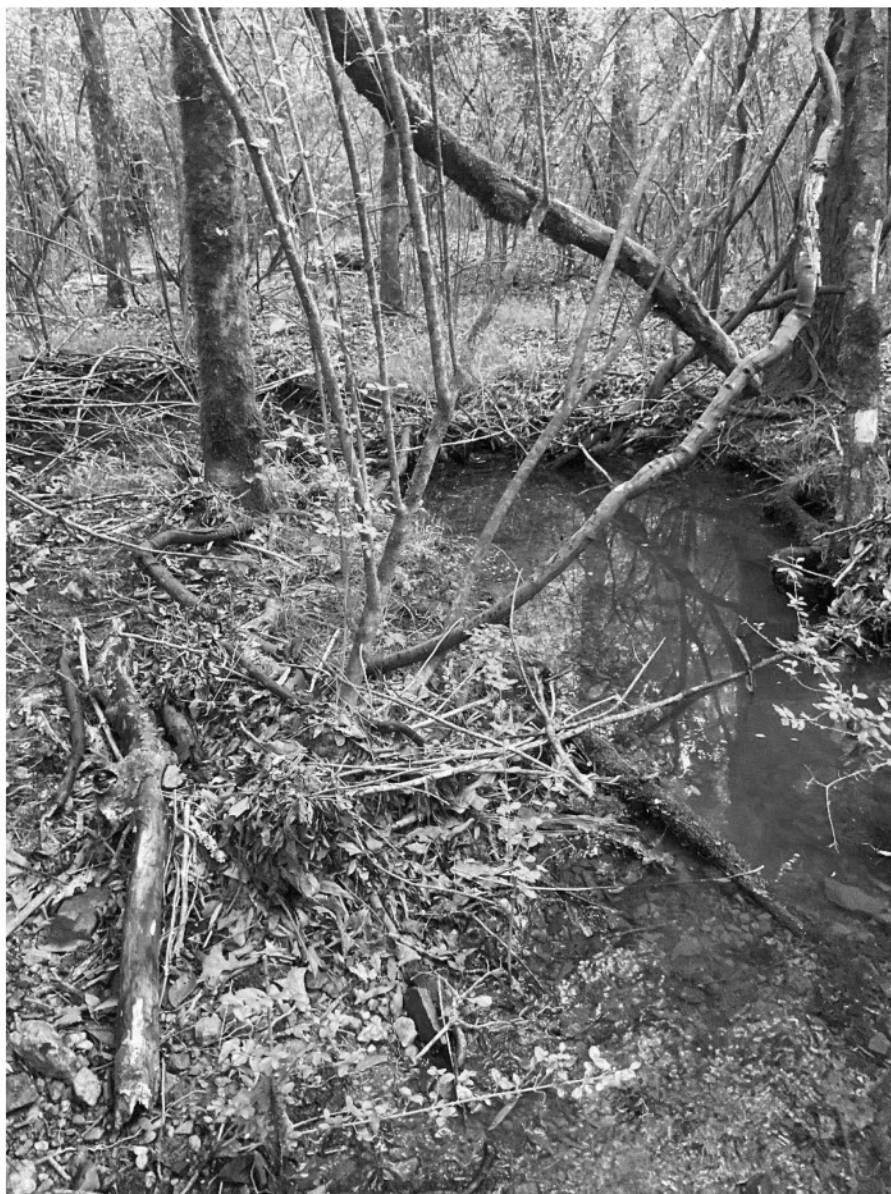
Photo No. 32

| Photo File Name | Date and Time of Photo | Photographer | Description |
|---|---|---|---|
| DSCN6445 | 05/01/2024, 12:42 PM | Chelsey Sherwood | Showing upstream of where swale connects to stream (S-7). Note wrack lines of debris. Picture taken facing northwest. |

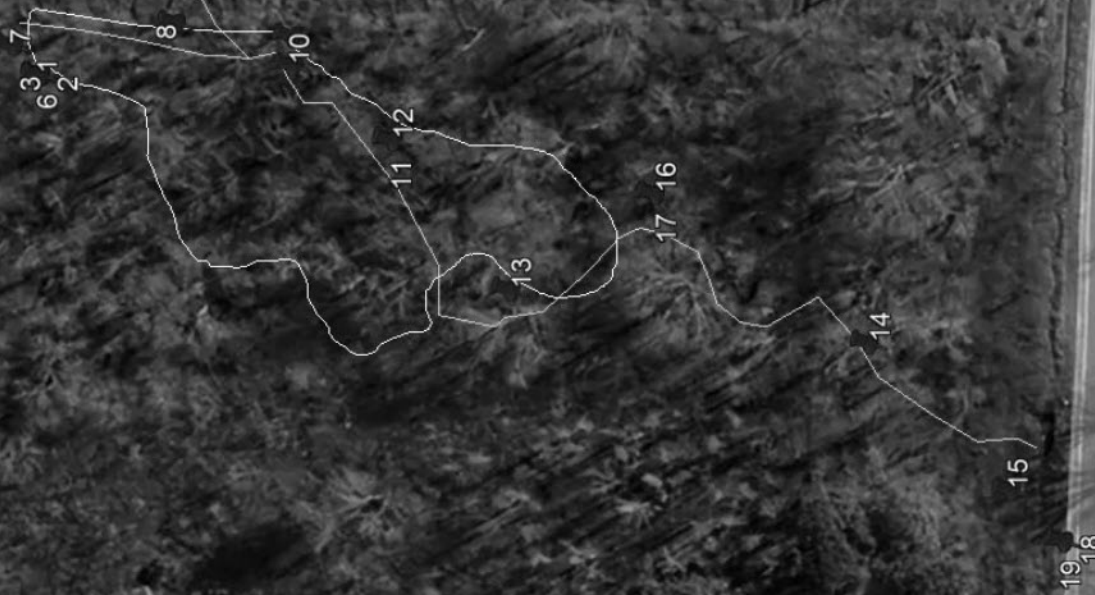
# Crystal Valley, LLC Photo Locations

| Appendix 1. Note that on the Photo Locations map Photo numbers 4,5,9 are not listed on map, but photos 1-6 are in the same location and photo 9 is beside 10. | | | |

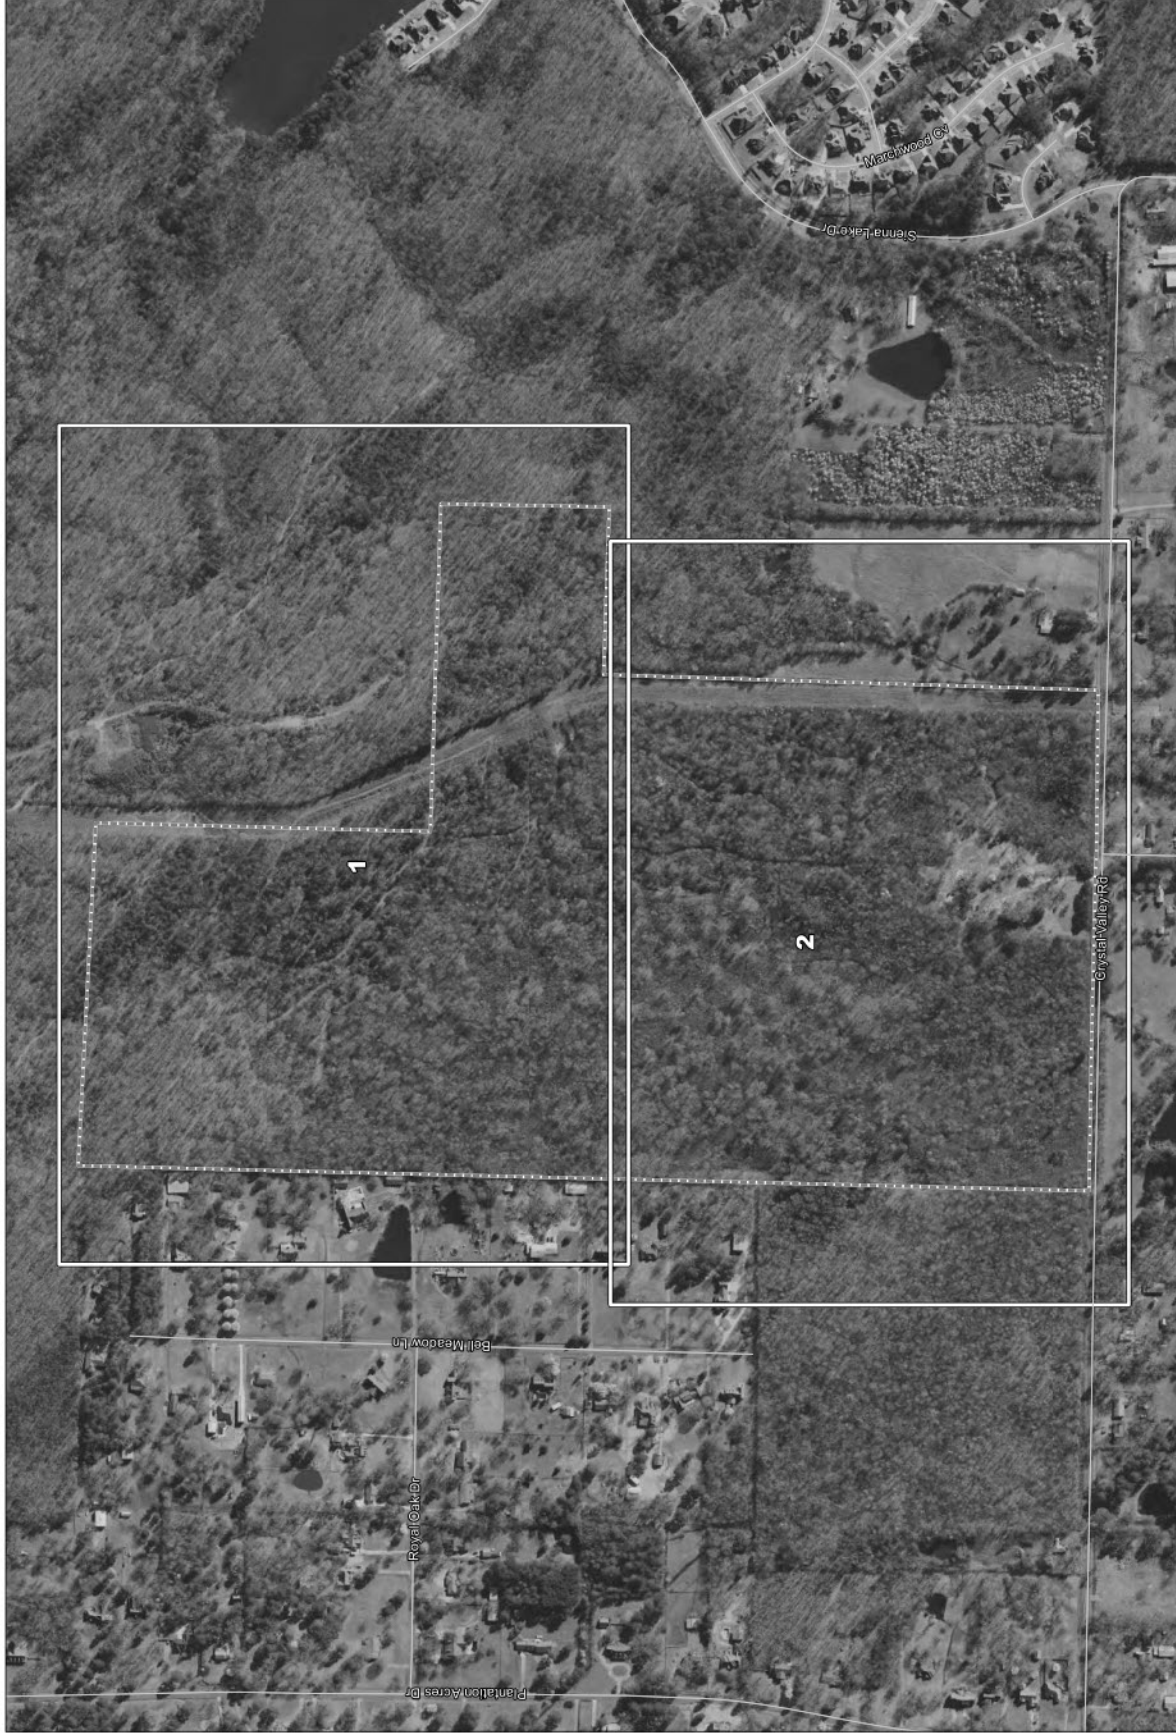
| | | | | | | AERIAL OVERALL MAP | | | | AQUATIC RESOURCES DELINEATION | | | | | |

| Wetlands | |
| Name | Area (acres) |
| W-1 | 1.3 |
| W-2 | 0.47 |

| Streams | |
