## Region 6 - Enforcement & Compliance Assurance Division

### INSPECTION REPORT

| Company Name: | <b>Williford Petroleum, LLC</b> | |
| Facility Name: | <b>A. E. Denny B</b> | |

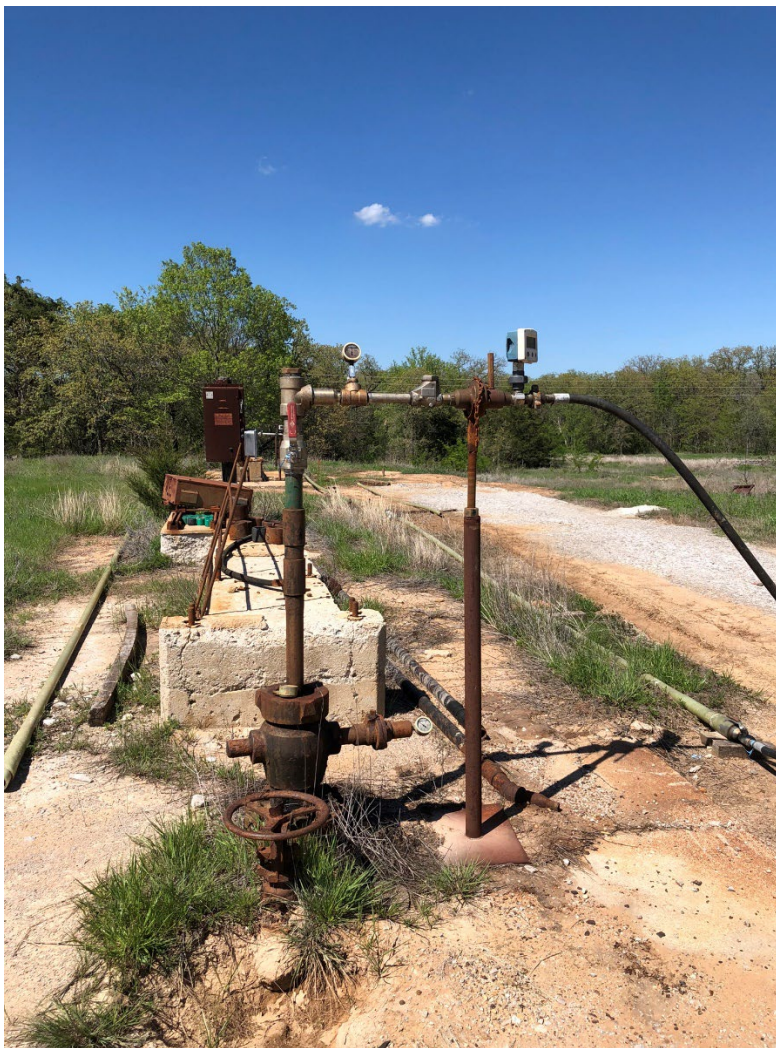
Photo No. 1

**Description:** This was one of two active injection wells located on the A.E. Denney Lease B (#16 and #12).

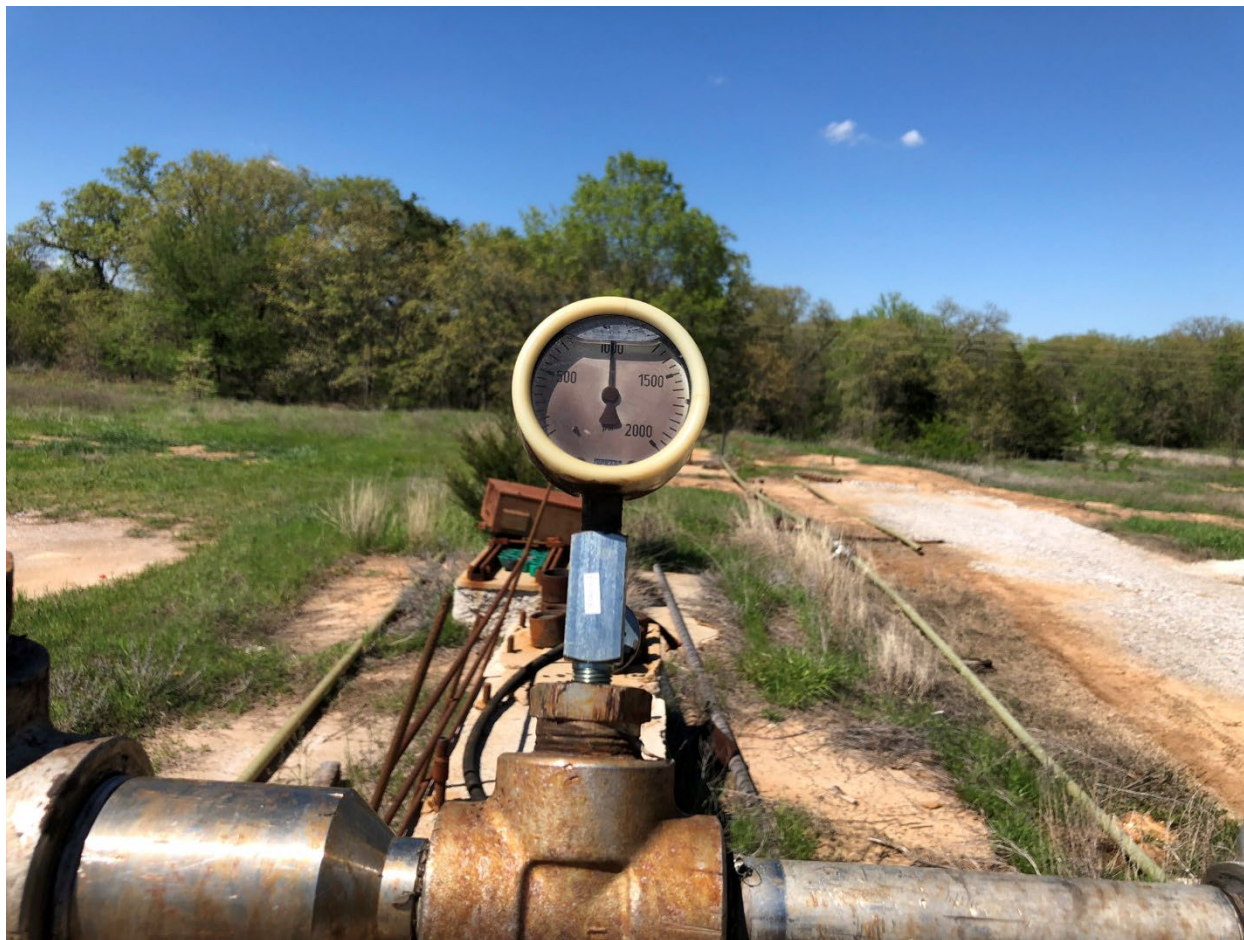
Photo No. 2

**Description:** This was one of two active injection wells located on the A.E. Denney Lease B (#16 and #12). This well's tubing gauge (company gauge) showed approximately 1000 psig during the inspection.

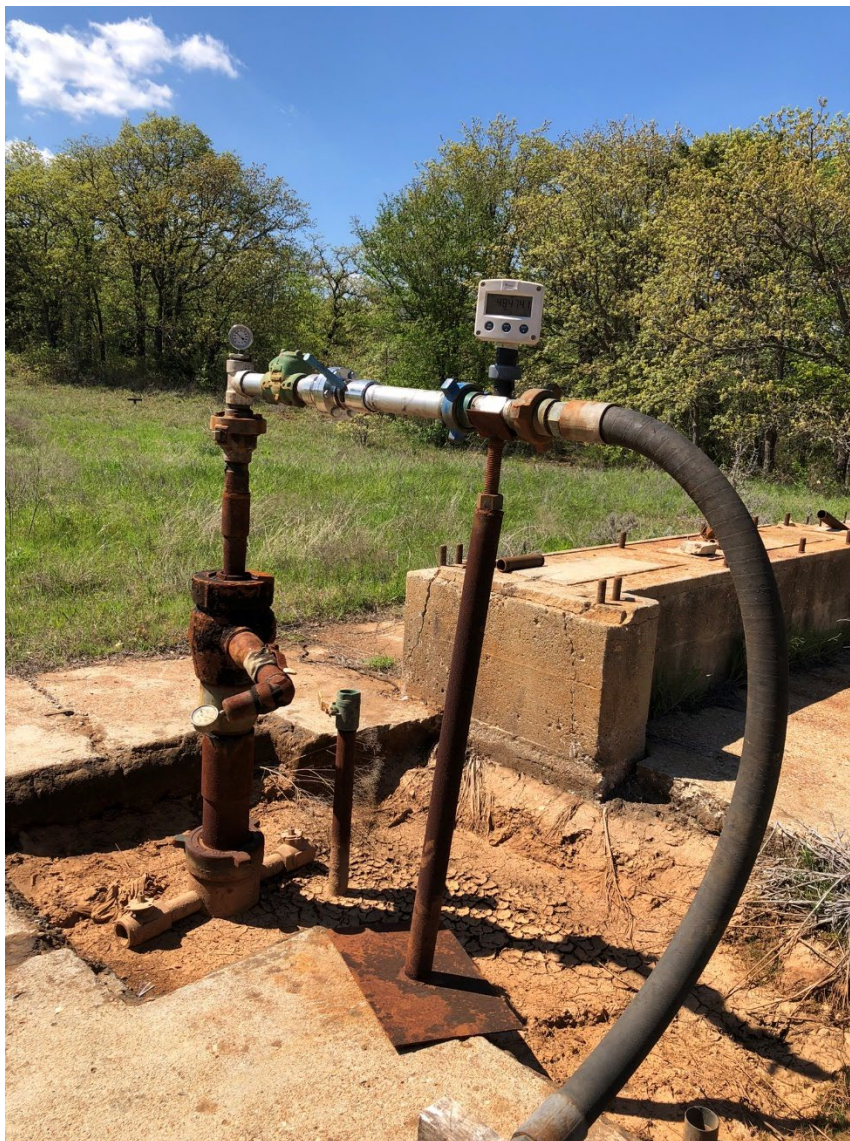
Photo No. 3

**Description:** This was second of two active injection wells located on the A.E. Denney Lease B (#16 and #12).

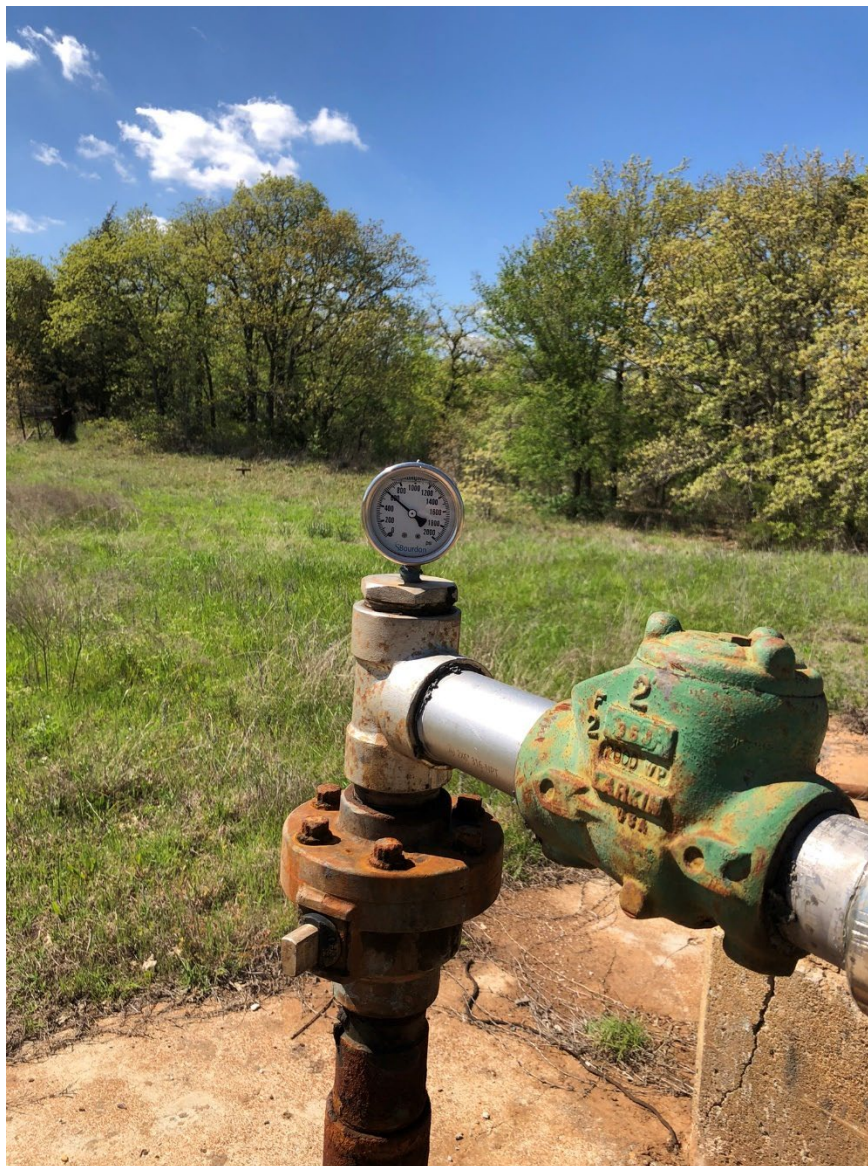
Photo No. 4

**Description:** This was second of two active injection wells located on the A.E. Denney Lease B (#16 and #12). This well's tubing gauge (company gauge) showed approximately 600 psig during the inspection.

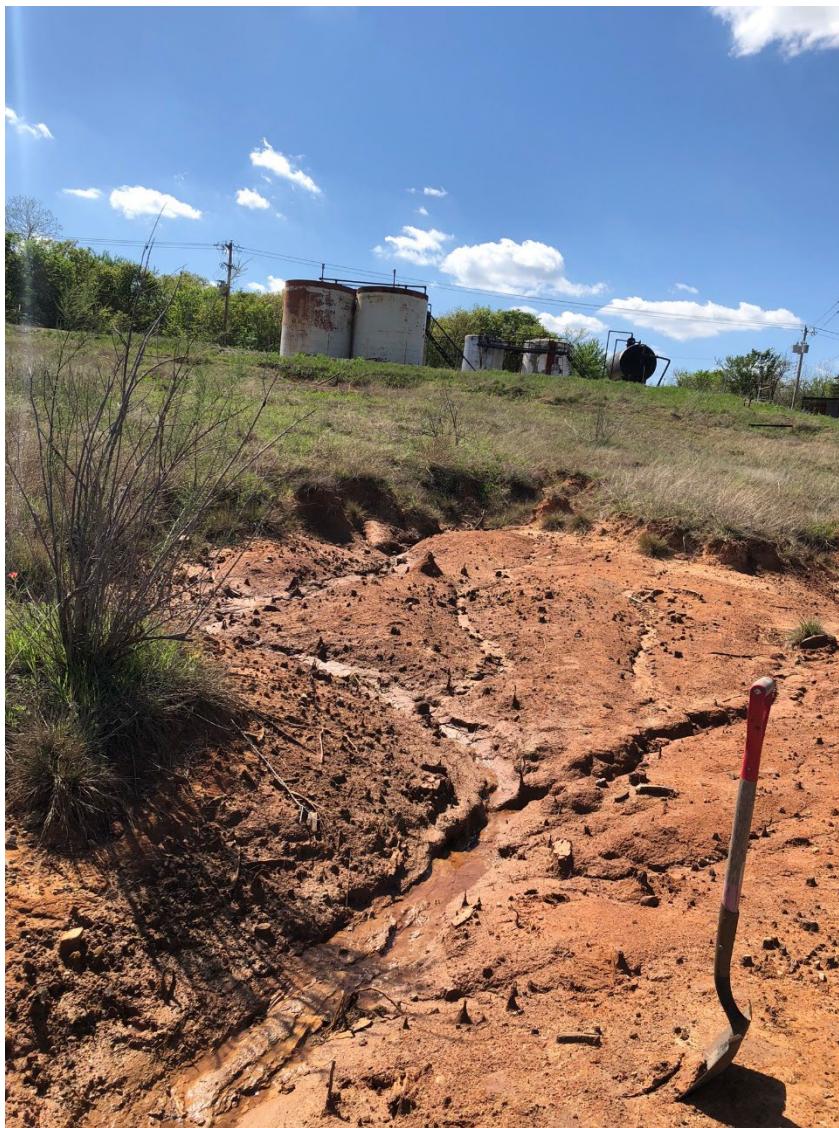
Photo No. 5

**Description:** This shows some surface eroded and potentially contaminated area on the A.E. Denny B Lease located downhill from the nearby tank battery and directly south of the injection wells on the lease. This had some small pooling of fluids during the inspection.

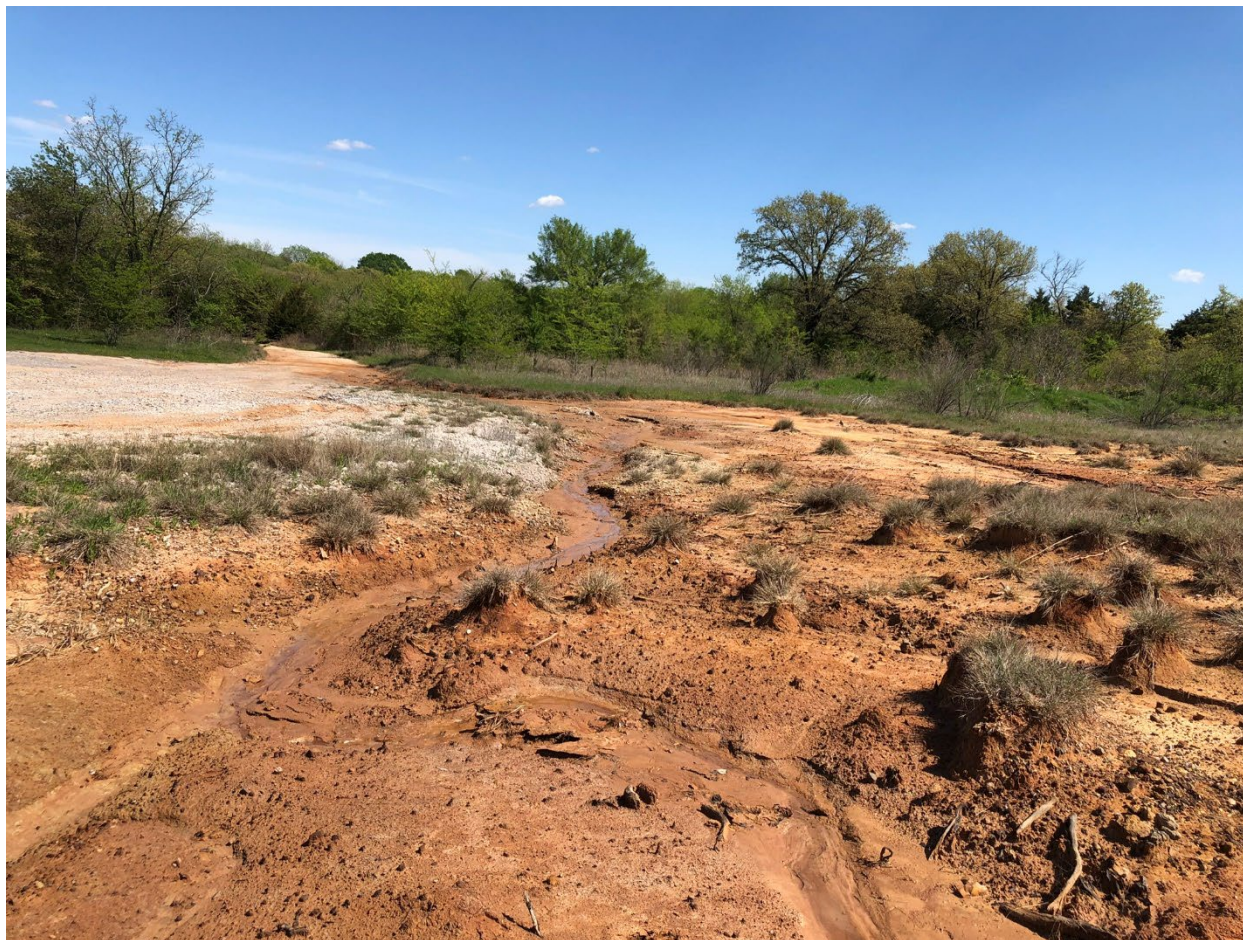
Photo No. 6

**Description:** This shows some surface eroded and potentially contaminated area on the A.E. Denny B Lease located downhill from the nearby tank battery and directly south of the injection wells on the lease. This had some small pooling of fluids during the inspection.

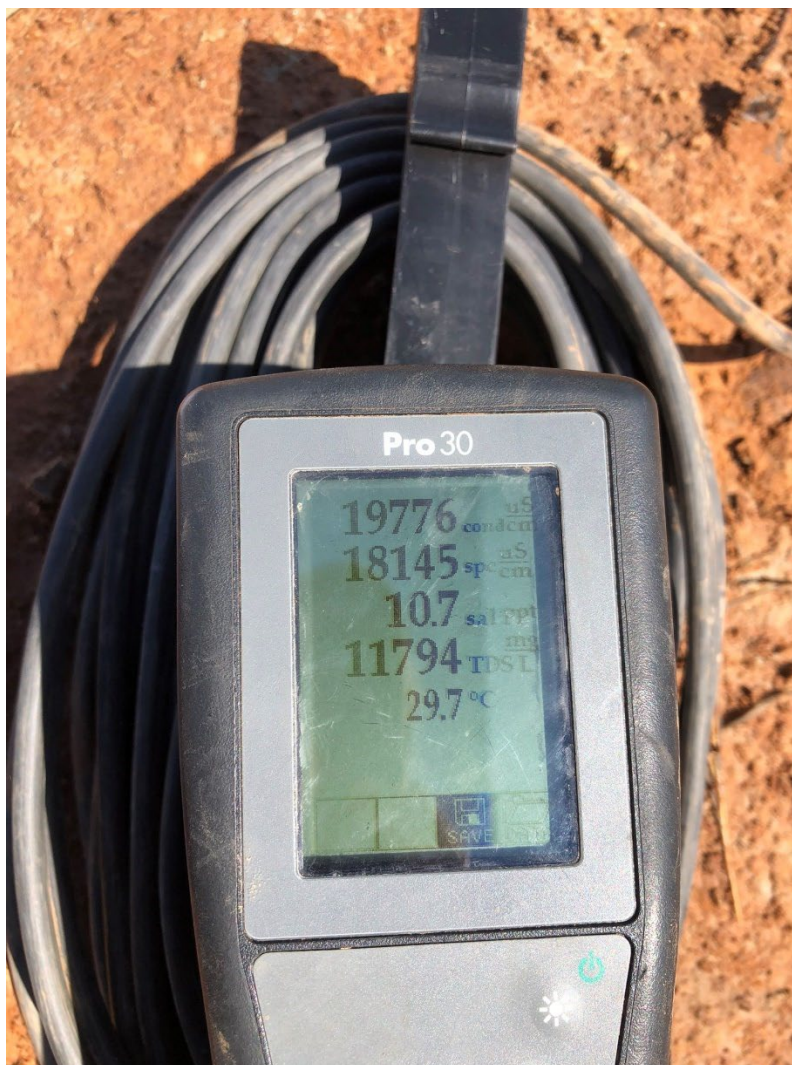
Photo No. 7

I assessed the surface water quality in the area with a properly calibrated YSI Pro 30 Conductivity Meter. The assessment can be seen in the **Appendix A** Photo Log, Photo Nos. 5 – 17. GPS location information for each observation is recorded with each photo in the photo log. I assessed two tributaries and Walnut Creek in this area. Specifically, for the A.E. Denny B Lease, there was only some surface contamination at site observed, the elevated TDS reading (Photo No. 7) did not flow off site during the inspection.

**Description:** This photo shows that a Total Dissolved Solids (TDS) reading was taken with a properly calibrated YSI Pro 30 Conductivity Meter during the inspection of the fluids observed near the injection wells on the A.E. Denny B Lease (located downhill from the nearby tank battery and directly south of the injection wells on the lease). An elevated TDS reading of 11,794 milligrams per liter (mg/L) was observed during the inspection.

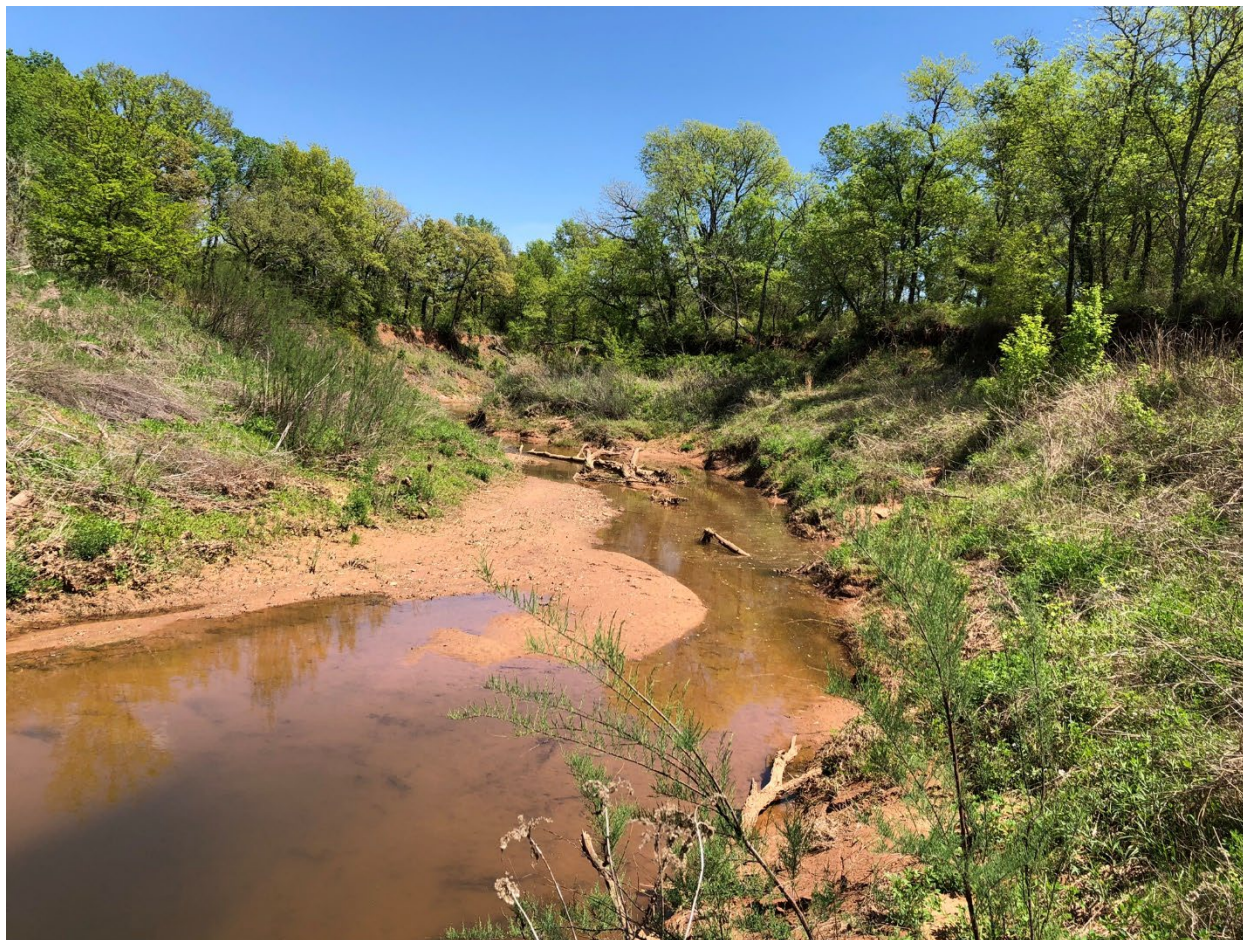
Photo No. 9

**Description:** This photo shows a downstream view of Walnut Creek during the inspection, downstream from multiple inspection points including the A.E. Denney B Lease and the Bayou Unit area. Walnut Creek had ordinary high water mark, bed features, bank features, and riparian vegetation at this location.

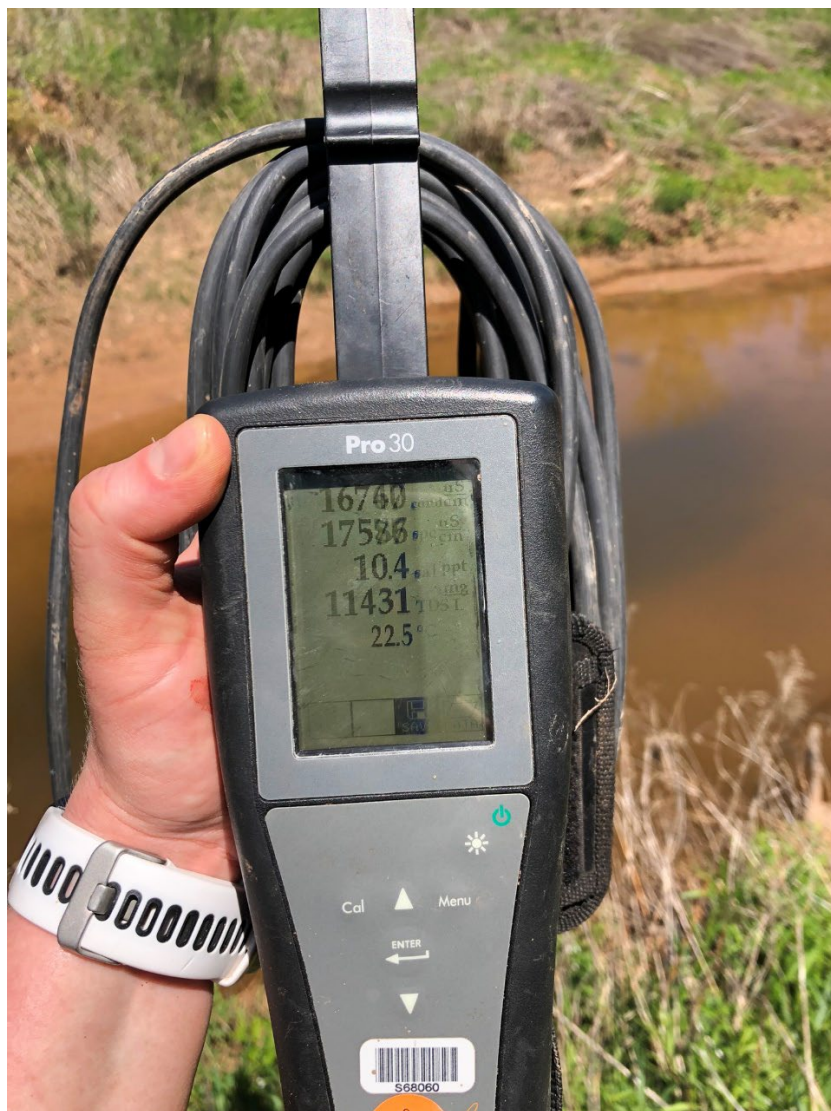
Photo No. 11

With the conductivity meter, I took Total Dissolved Solids (TDS) readings throughout the creek surveys. At the confluence of a downstream (from the A.E. Denny B Lease) tributary and Walnut Creek a TDS reading of 11,431 mg/L (Photo No. 11) was taken in Walnut Creek. Ordinary high water mark, flow, debris, bed features, bank features, riparian vegetation, and black discoloration in Walnut Creek were observed here during the inspection. See **Appendix A**, Photo Nos. 8 – 14.

**Description:** This photo shows a view of Walnut Creek during the inspection, downstream from multiple inspection points including the A.E. Denney B Lease and the Bayou Unit area. An elevated TDS reading of 11,431 mg/L was taken at this location during the inspection.

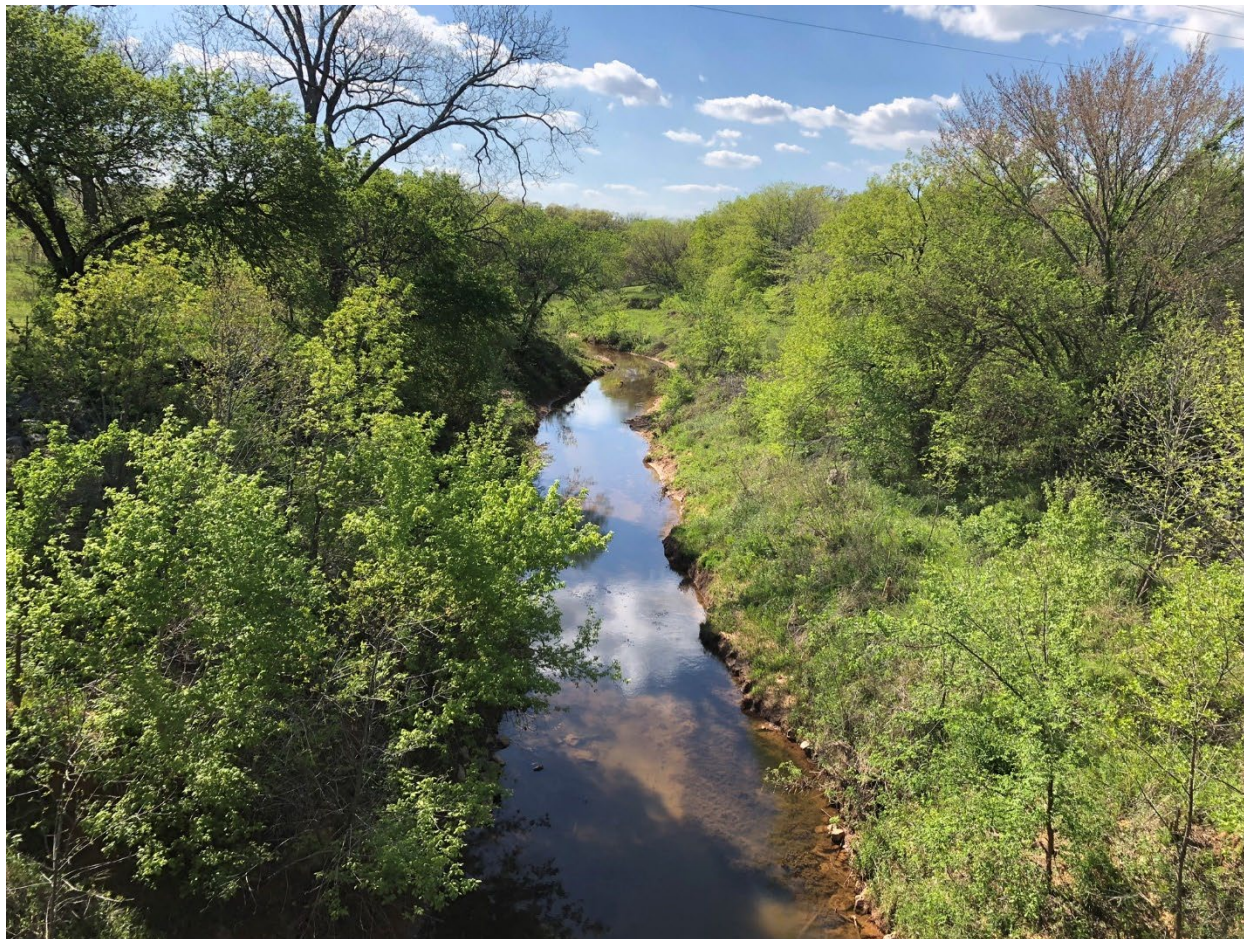
Photo No. 12

**Description:** This photo shows an upstream view of Walnut Creek. This location is downstream from the Bayou Unit and documented TDS readings along Walnut Creek. Bed, bank, and riparian vegetation were observed in this location of the creek. We were standing on a large bridge along Texaco Road over the creek at this location.

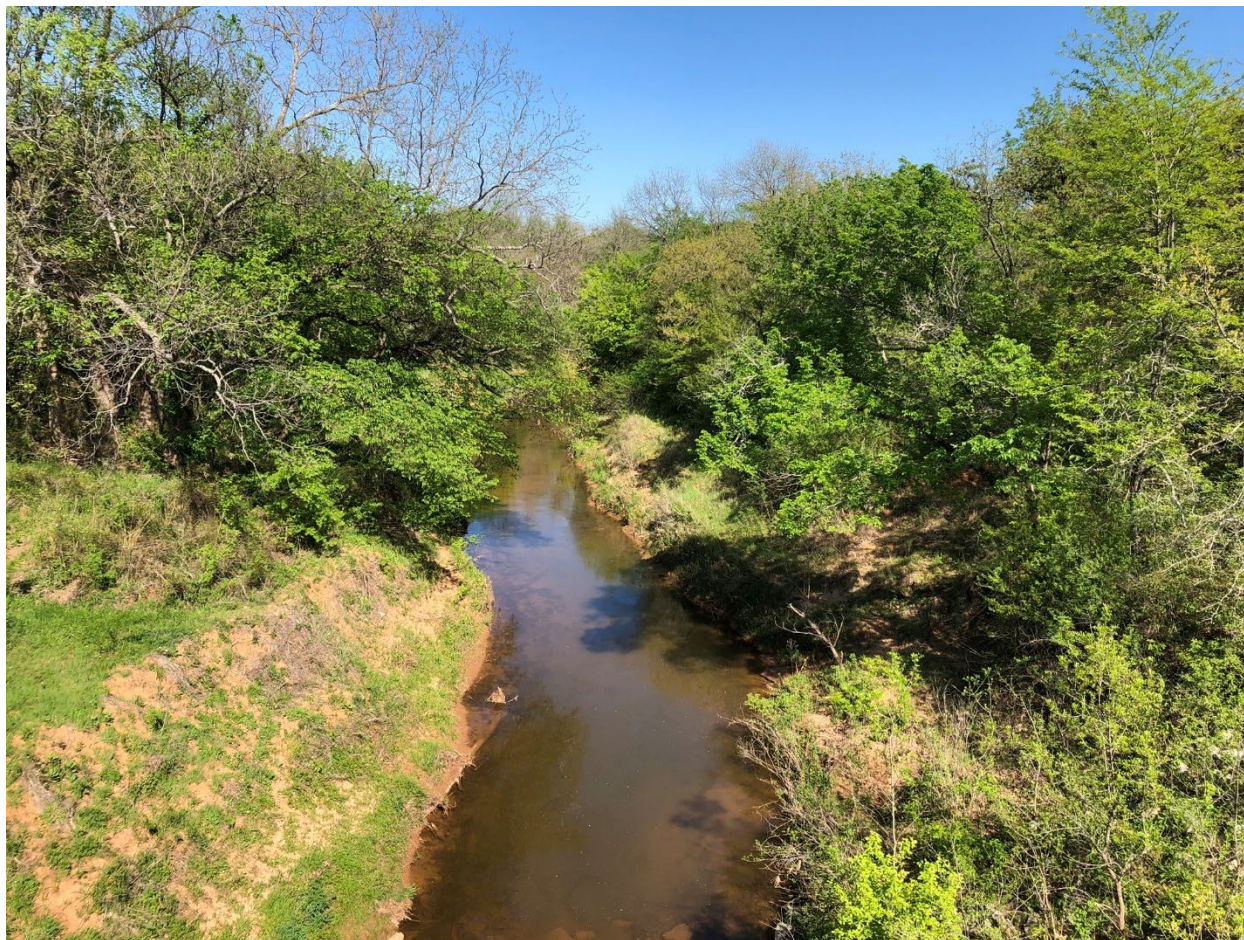
Photo No. 13

**Description:** This photo shows a downstream view of Walnut Creek. This location is downstream from the Bayou Unit and documented TDS readings along Walnut Creek. Bed, bank, and riparian vegetation were observed in this location of the creek. We were standing on a large bridge along Texaco Road over the creek at this location.

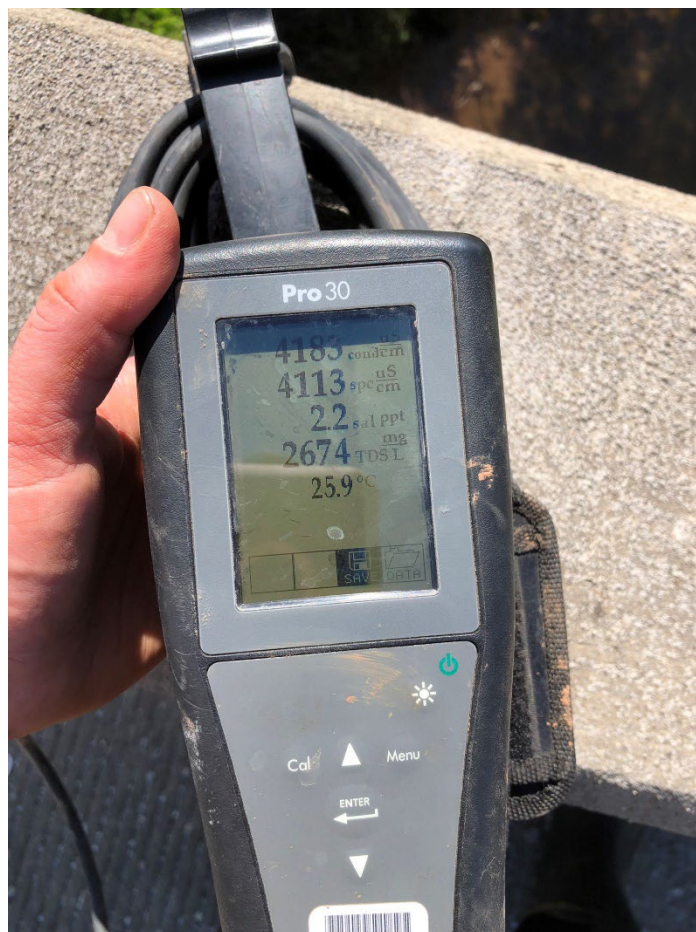
Photo No. 14

**Description:** This photo shows a TDS reading of 2,674 mg/L in Walnut Creek at this location. This location is downstream from the Bayou Unit and documented TDS readings along Walnut Creek. Bed, bank, and riparian vegetation were observed in this location of the creek. We were standing on a large bridge along Texaco Road over the creek at this location.

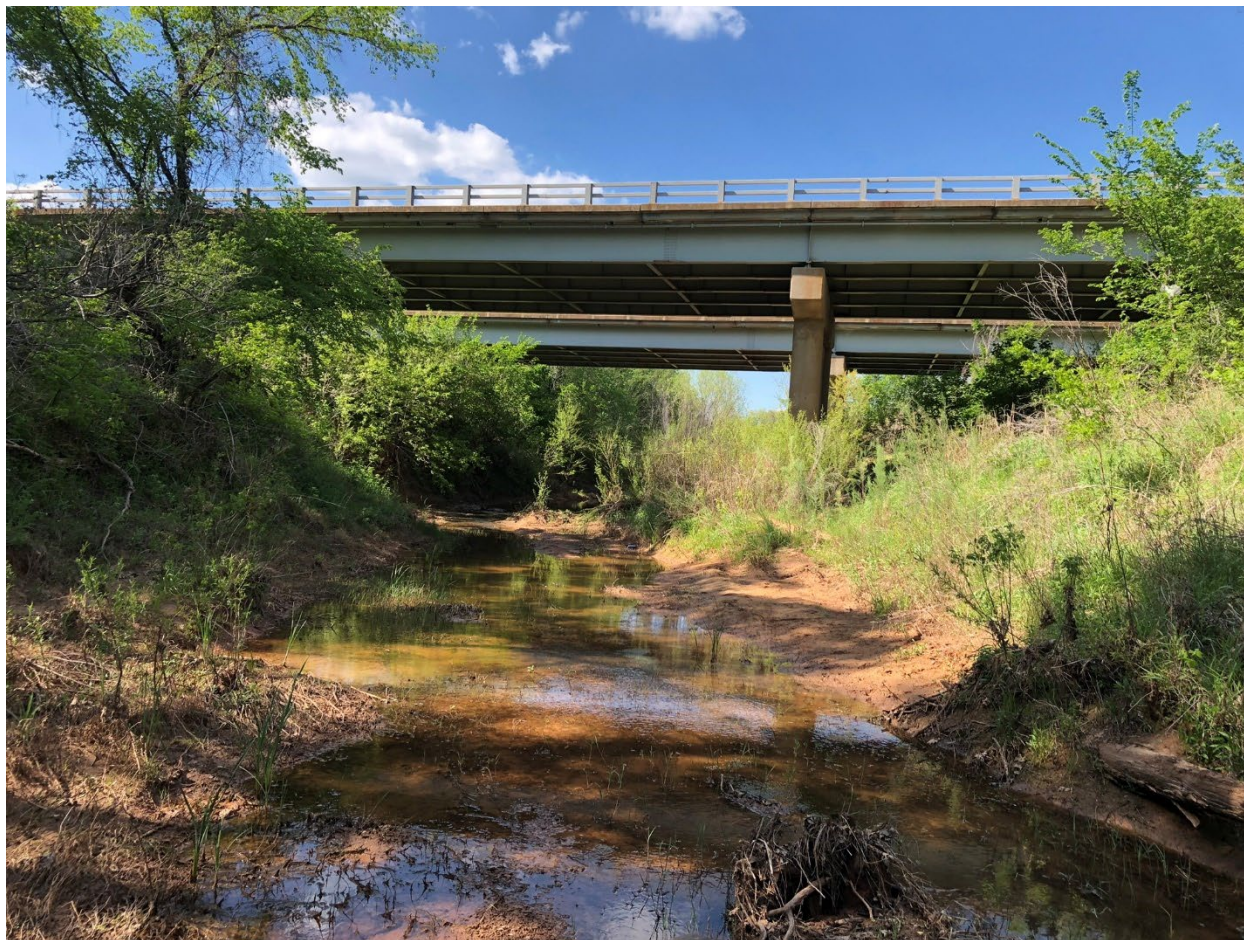
Photo No. 15

I also assessed Walnut Creek upstream from the Bayou Unit along Walnut Creek and Hwy 70. This was assessed as a “background” reading during the inspection and observations are seen in **Appendix A**, Photo Nos. 15 – 17. Bed, bank, and riparian vegetation were observed in this location of the creek. A TDS reading of 1,713 mg/L was taken.

**Description:** This photo shows an upstream view of Walnut Creek at this location, which is background of Walnut Creek. This location is upstream from the Bayou Unit and documented TDS readings along Walnut Creek. Bed, bank, and riparian vegetation were observed in this location of the creek. We were under a large bridge along Hwy. 70 at this location.

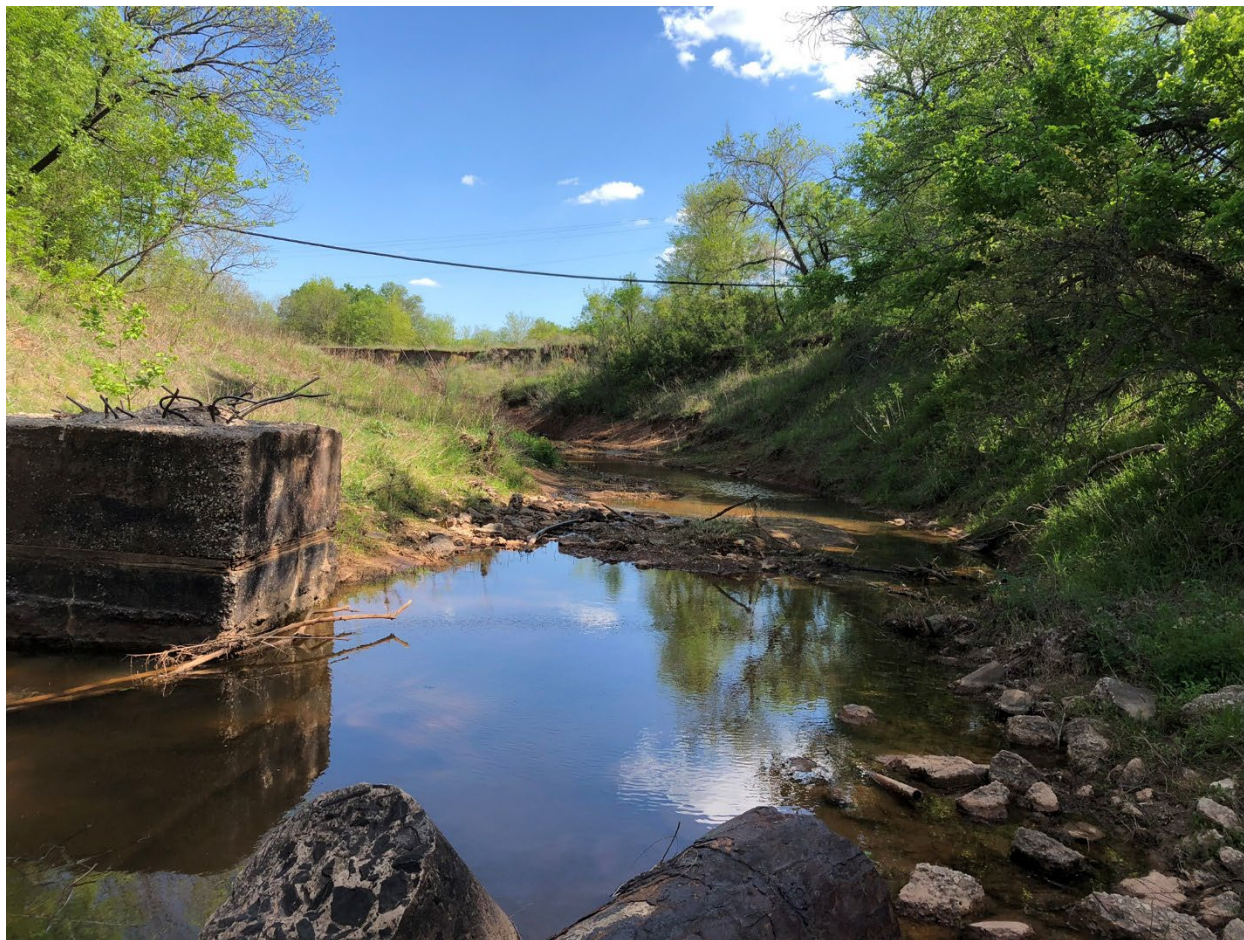
Photo No. 16

**Description:** This photo shows a downstream view of Walnut Creek at this location, which is background of Walnut Creek. This location is upstream from the Bayou Unit and documented TDS readings along Walnut Creek. Bed, bank, and riparian vegetation were observed in this location of the creek. We were under a large bridge along Hwy. 70 at this location.
