## RCRA COMPLIANCE EVALUATION INSPECTION REPORT

W.R. Meadows of Georgia  
100 Riverside Drive  
Cartersville, Georgia 30120  
EPA ID: GAR000030486

Primary NAICS Code: 325510 Paint and Coating Manufacturing

December 9, 2021

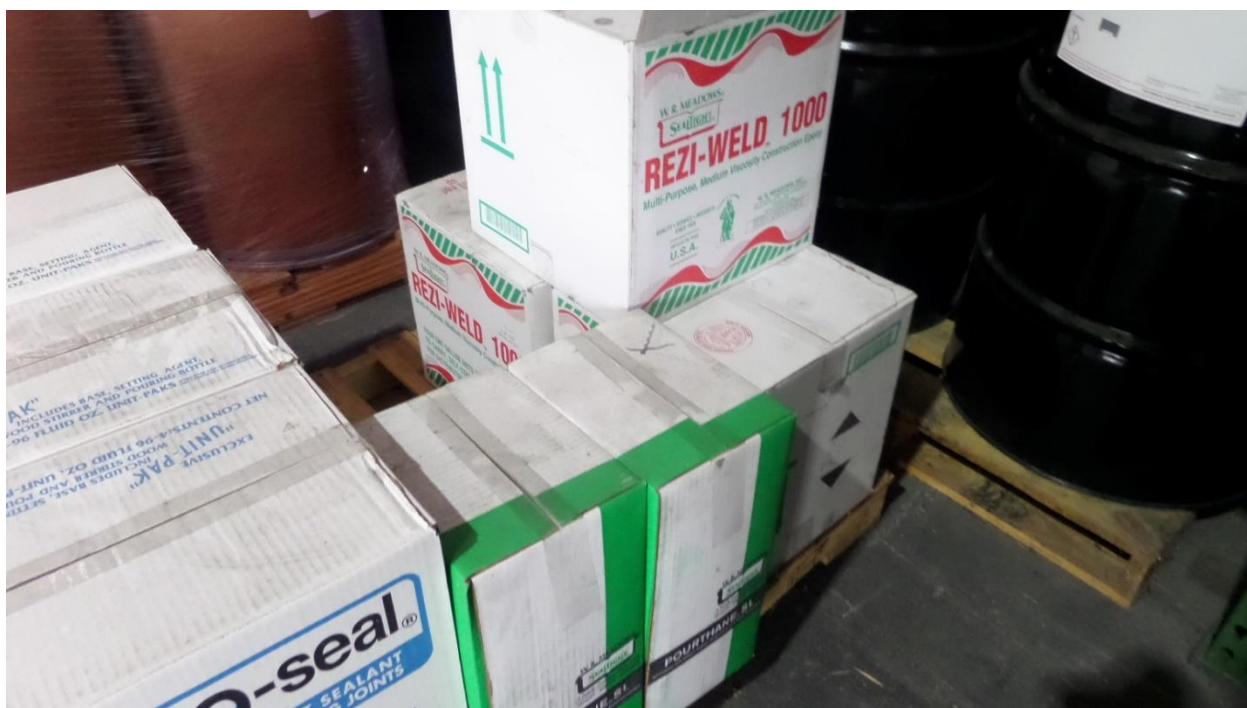
Upon entering the building, a few feet from the door, the inspectors observed two pallets with DECK-O-SEAL® (concrete pool deck sealant), one pallet with MEL-PRIME® (a solvent-based adhesive) and one pallet with REZI WELD 1000® (concrete restoration products). The inspectors noted the DECK-O-SEAL® and REZI WELD 1000® boxes were marked with an "X" (Photographs 1 and 2). Numerous MEL-PRIME® containers show evidence of releases (Photograph 3).

The inspectors discussed the operations within this area and the containers on the two pallets with Mr. Randy Scott Nichols, Cure Plant Operator. Mr. Nichols stated that the REZI WELD 1000® on the pallets were received the week before the inspection and would be discarded as hazardous waste because of expired shelf life and/or leaking containers. The inspectors noted nine 5-gallon containers of REZI WELD 1000®, totaling 45-gallons of hazardous waste. After the discussion, it appeared that the hazardous waste was under control of the operator, and therefore, appeared to be a Satellite Accumulation Area (SAA). The inspectors observed the containers of MEL-PRIME® included the hazard content (flammable) but were not marked or labeled with the words "Hazardous Waste".

Photograph 1: View of material customer returned material in the Cure Building. Material was intended to be managed as hazardous waste at the time of the inspection.

**Pursuant to Ga. Comp. R. and Regs. 391-3-11-.08(1) [40 C.F.R. § 262.15(a)(5)(i)], which is a condition of the SAA Permit Exemption, a generator must mark or label its container with the words "Hazardous Waste."**

**Pursuant to Ga. Comp. R. and Regs. 391-3-11-.08(1) [40 C.F.R. § 262.15(a)(1)], which is a condition of the SAA Permit Exemption, if a container holding hazardous waste is not in good condition, or if it begins to leak, the generator must immediately transfer the hazardous waste from this container to a container that is in good condition and does not leak, or immediately transfer and manage the waste in a central accumulation area operated in compliance with § 262.16(b) or § 262.17(a).**

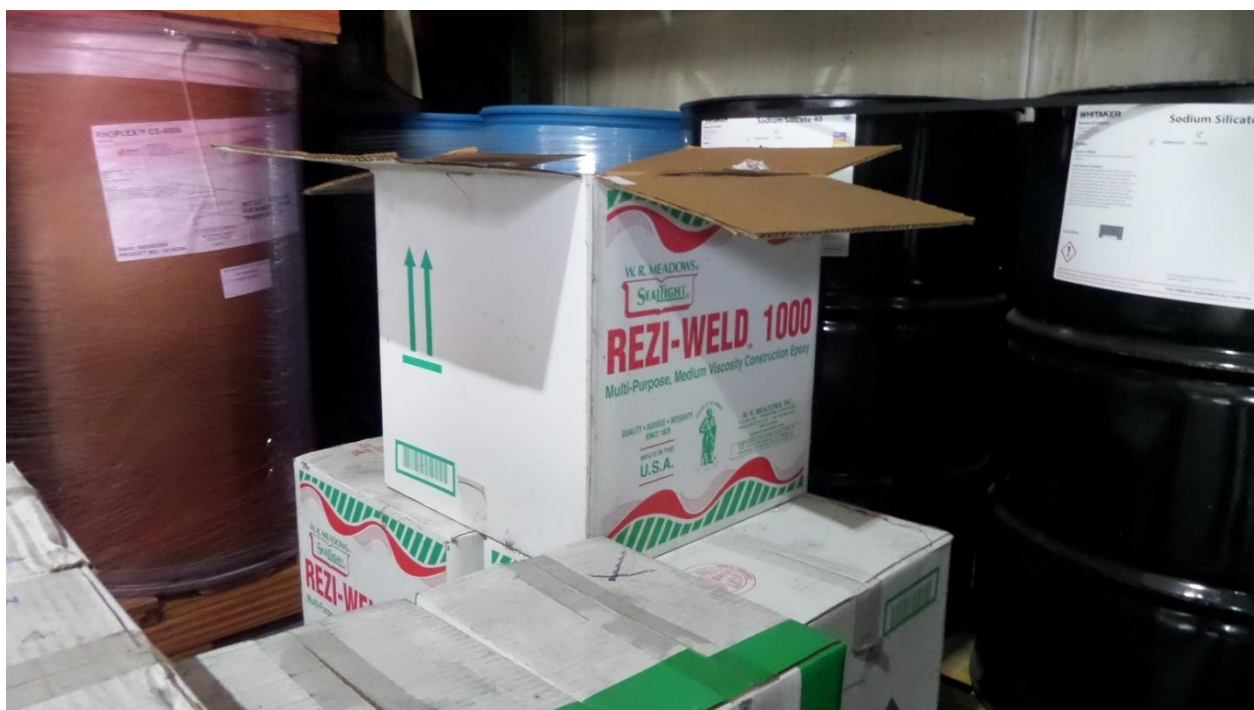
Photograph 2: View of material customer returned material in the Cure Building. Material was intended to be managed as hazardous waste at the time of the inspection.

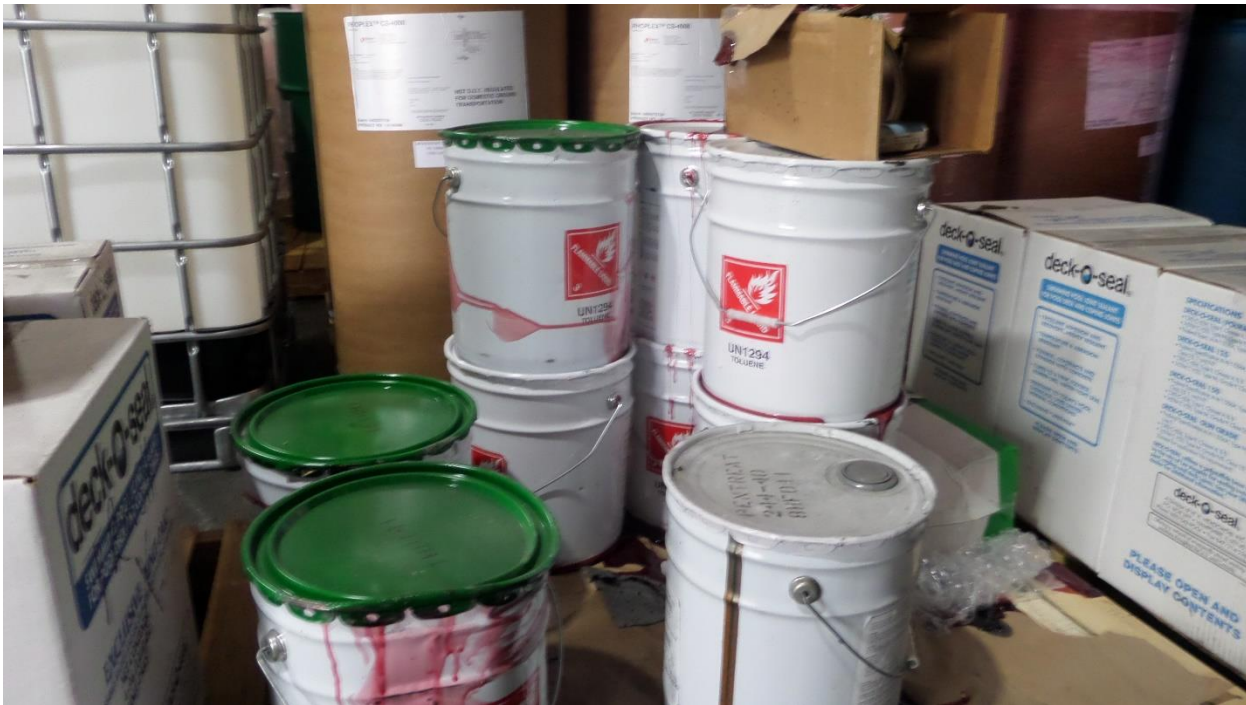
Photograph 3: View of material customer returned material in the Cure Building. Material was intended to be managed as hazardous waste at the time of the inspection.

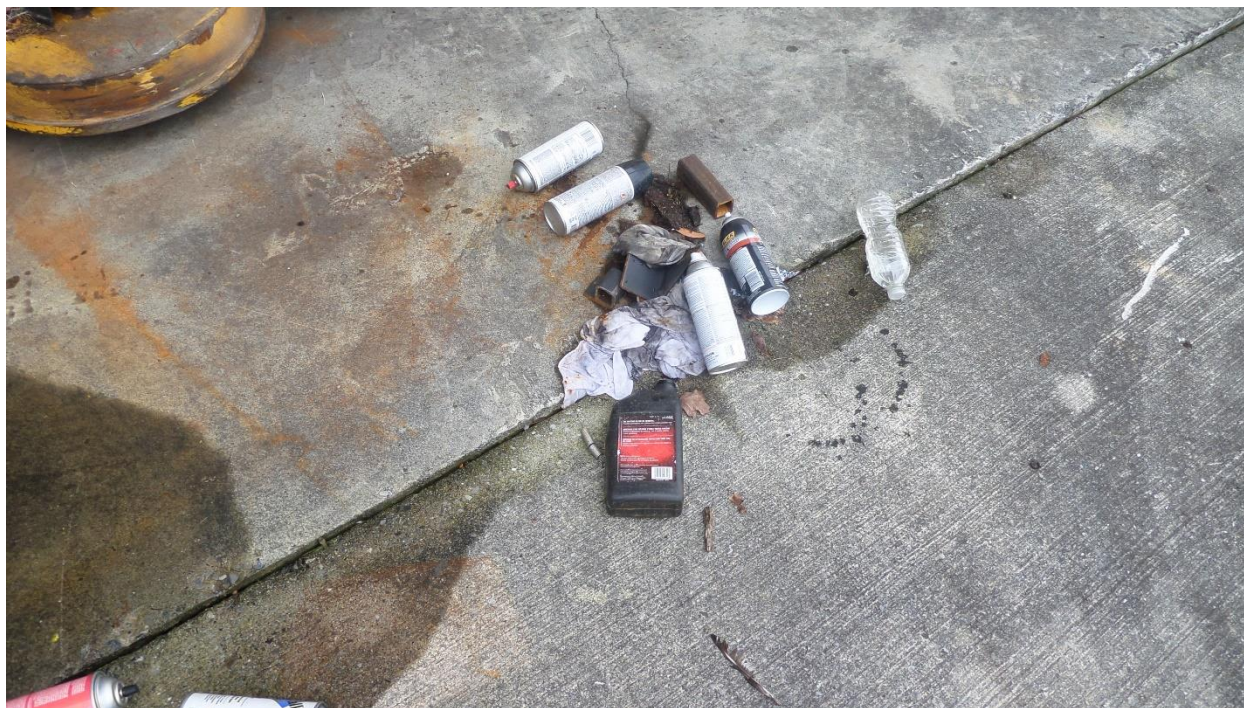
Once the inspectors walked outside the LMP Building and toward the maintenance shop, used aerosol cans were found in unlabeled pales and on the ground (Photographs 5 and 6). The inspectors informed Mr. Bentley that the aerosol cans must follow the applicable requirements, including make a determination of whether WR Meadows would manage the aerosol cans as hazardous waste or universal waste. In response, Mr. Carey submitted a photograph on December 15, 2021, documenting that the aerosol cans had been removed from the area.

*Photograph 6: View of discarded aerosol cans located on the concrete outside and adjacent to the Maintenance Shop.*

**Pursuant to Ga. Comp. R. and Regs. 391-3-11-.08(1) [40 C.F.R. § 262.11], a person who generates a solid waste, as defined in Ga. Comp. R. and Regs. 391-3-11-.07(1) [40 C.F.R. § 261.2], must make an accurate determination as to whether that waste is a hazardous waste in order to ensure wastes are properly managed according to applicable RCRA regulations articulated in Ga. Comp. R. and Regs. 391-3-11-.08(1) [40 C.F.R. § 262.11].**

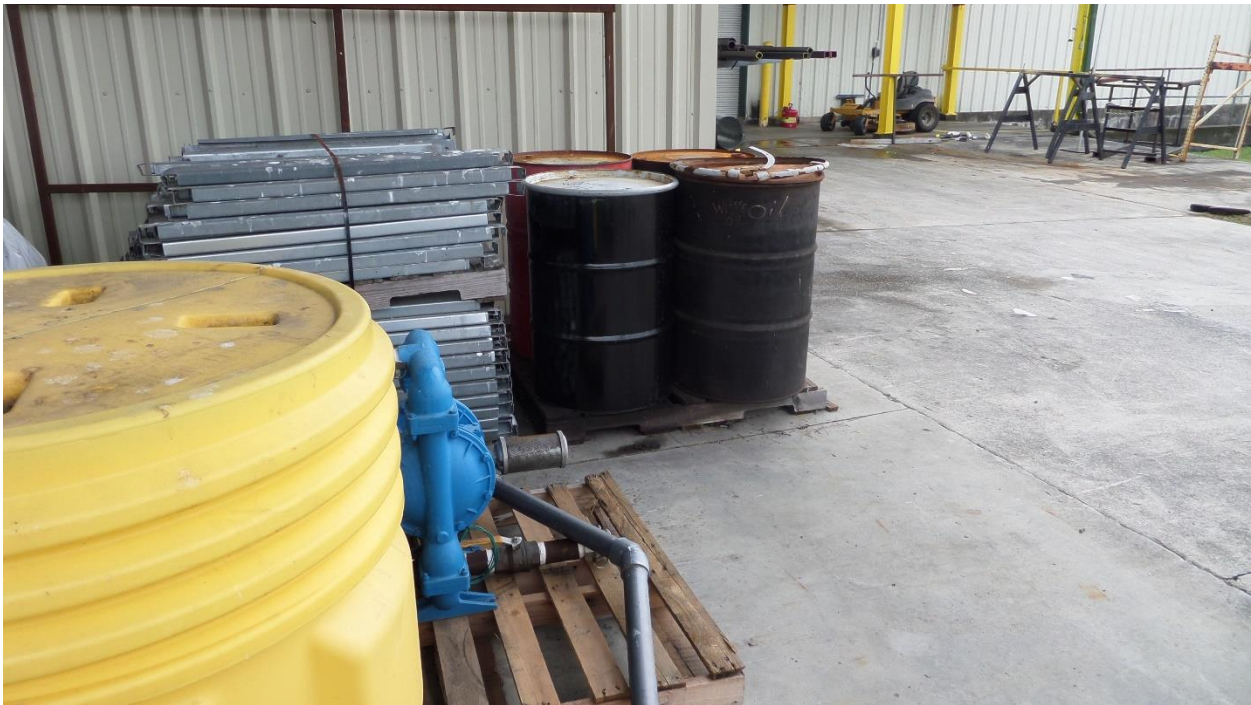
One central accumulation area (CAA) was observed behind the Maintenance Shop, which was used to store a total of ten containers, including eight 55-gallon containers (Photographs 7 and 8) and two 275-gallon containers. One 275-gallon container was labeled as “Used Oil”. The other nine containers were not labeled. The inspectors asked whether a waste determination had been made on the materials in the containers. Mr. Bentley stated they had not made a waste determination but would discuss the issue with the CAA operator. After conferring with the CAA operator, Mr. Bentley informed the inspectors that one 55-gallon container (Photographs 9 and 10) held hazardous waste and one 275-gallon container held used oil (Photograph 11). The contents of hazardous waste were observed to be several 1-quart containers of P/G Primer. Mr. Bentley stated that the P/G Primer had been returned and were no longer usable. Facility representatives placed a hazardous waste label on the container while the inspectors were on-site (Photograph 10).

Photograph 7: View of nonhazardous waste located in the central accumulation storage area adjacent to the Maintenance Shop Containers. The containers were unlabeled at the time of the inspection.

**Pursuant to Ga. Comp. R. and Regs. 391-3-11-.08(1) [40 C.F.R. § 262.11], a person who generates a solid waste, as defined in Ga. Comp. R. and Regs. 391-3-11-.07(1) [40 C.F.R. § 261.2], must make an accurate determination as to whether that waste is a hazardous waste in order to ensure wastes are properly managed according to applicable RCRA regulations articulated in Ga. Comp. R. and Regs. 391-3-11-.08(1) [40 C.F.R. § 262.11].**

**Pursuant to Ga. Comp. R. and Regs. 391-3-11-.17(1) [40 C.F.R. § 279.22(c)(1)], containers used to store used oil at generator facilities must be labeled or marked clearly with the words “Used Oil.”**

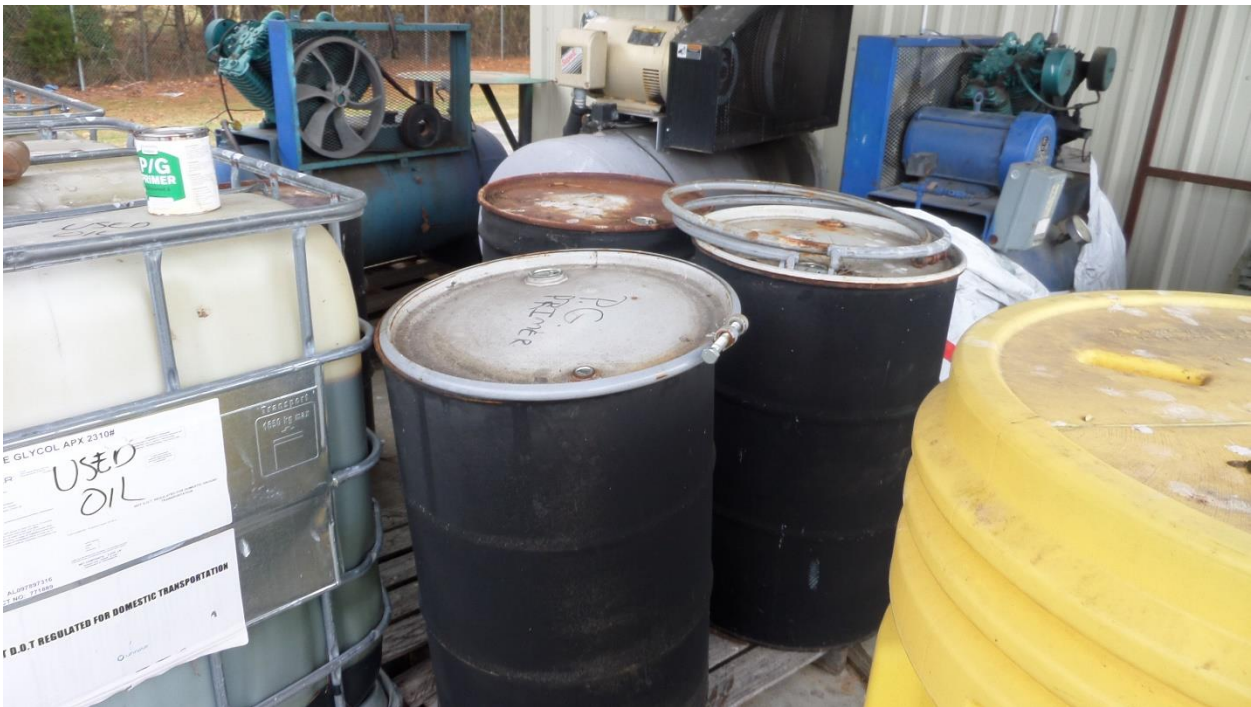
Photograph 8: View of nonhazardous and hazardous waste located in the CAA adjacent to the Maintenance Shop Containers. The containers were unlabeled at the time of the inspection.

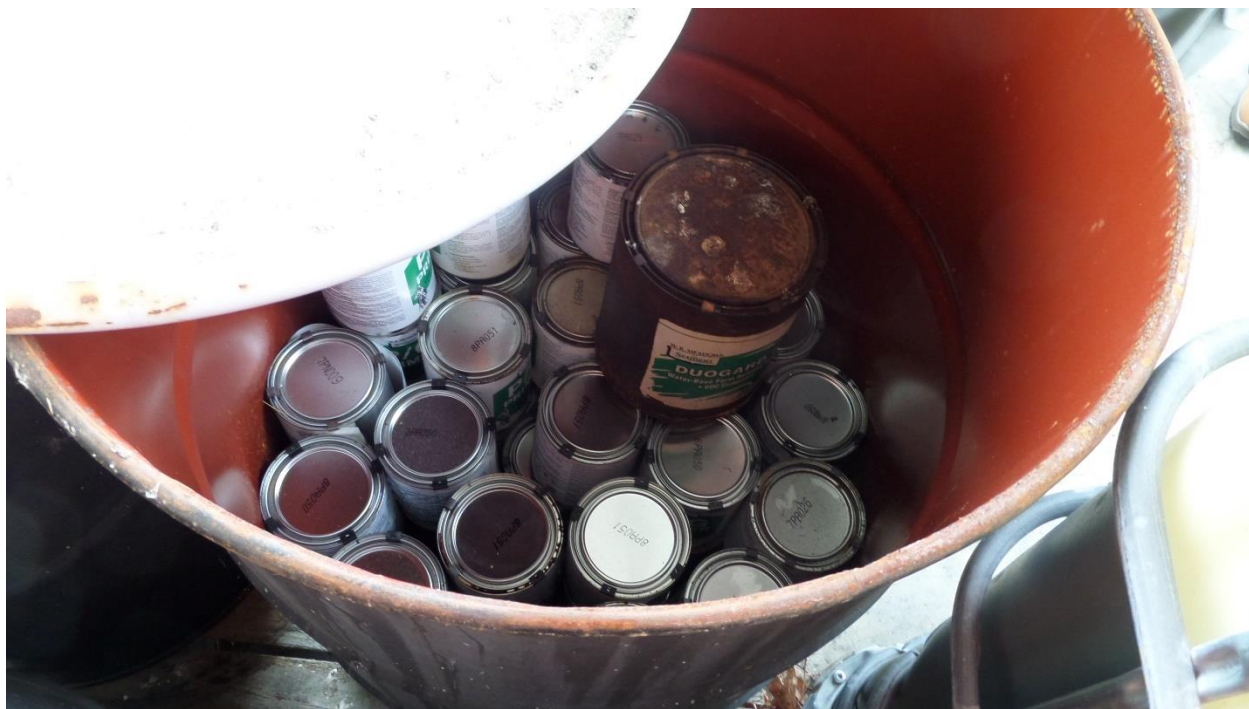
Photograph 9: View of hazardous waste, PG Primer, located in the central accumulation storage area adjacent to the Maintenance Shop Containers. The containers were unlabeled at the time of the inspection.

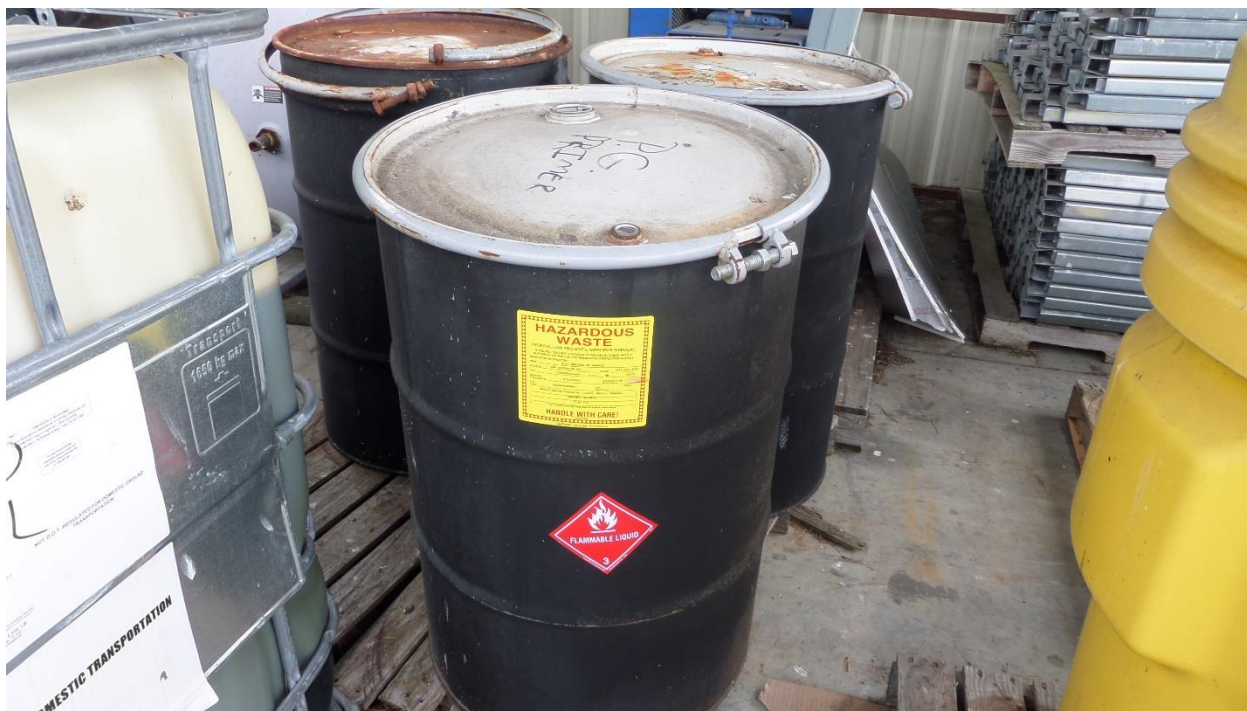
Photograph 10: View of PG Primer hazardous waste container located in the CAA adjacent to the Maintenance Shop Container. Containers were labeled during the inspection.

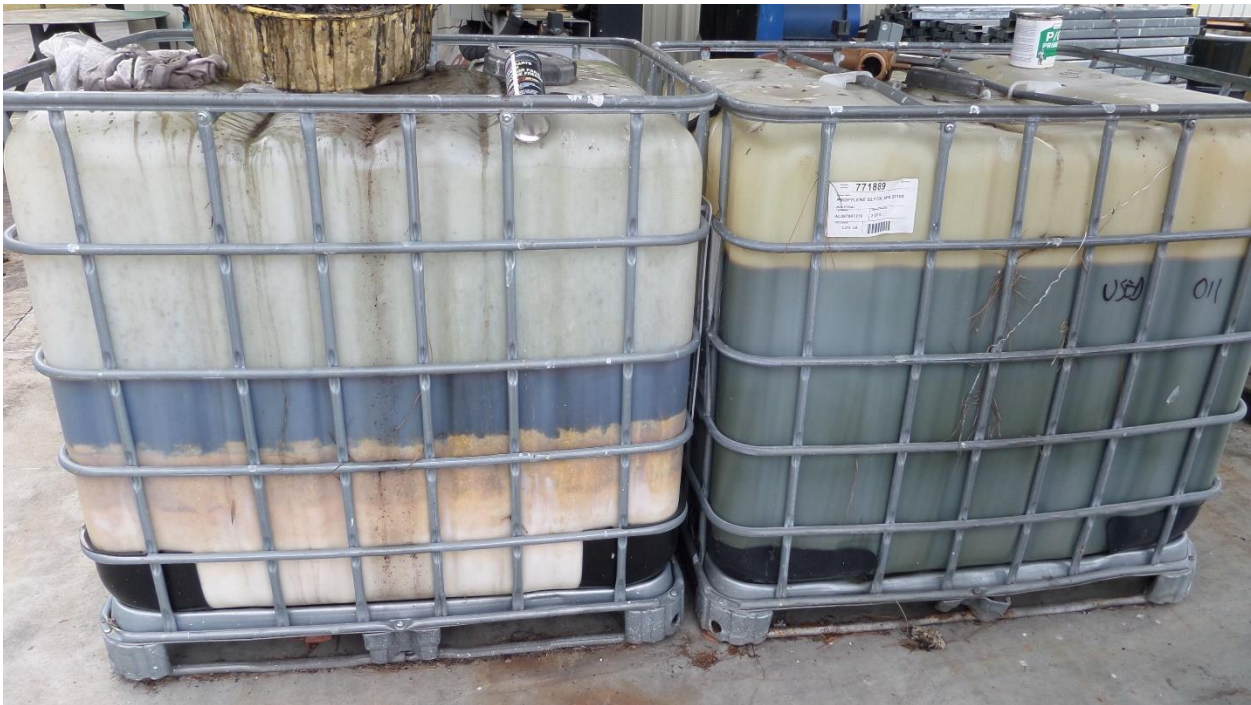
Photograph 11: View of nonhazardous waste located in the CAA adjacent to the Maintenance Shop Containers.

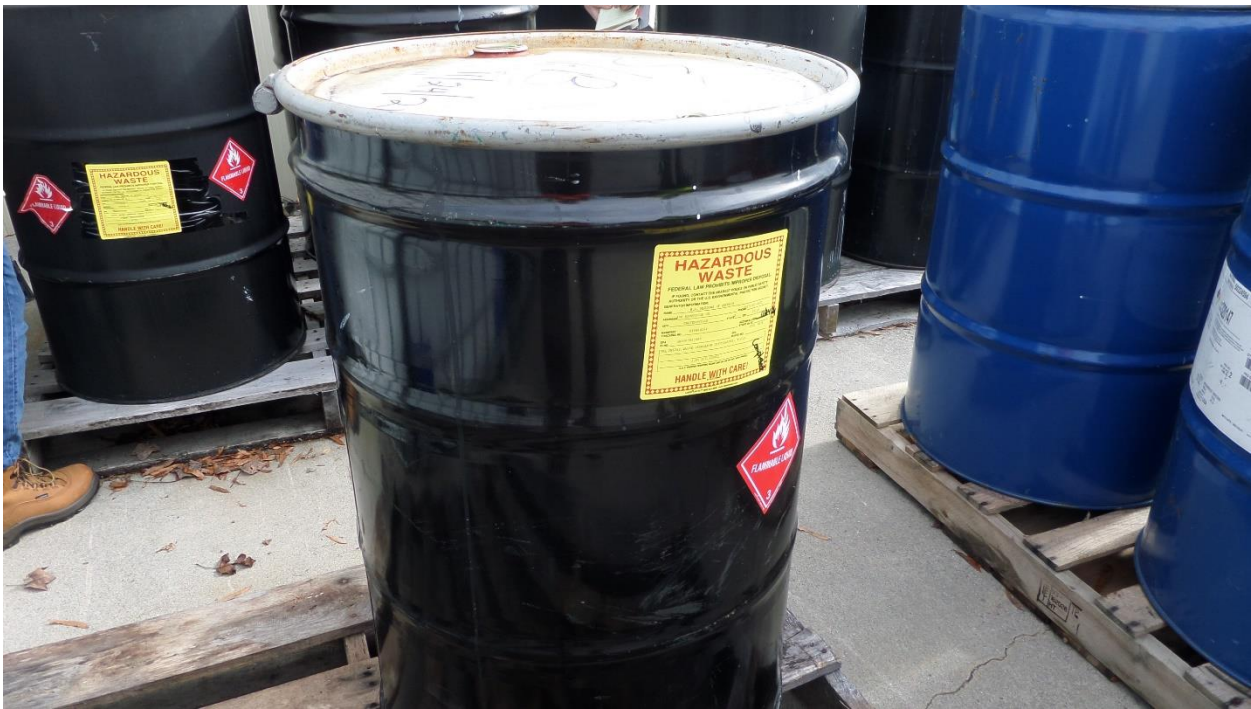
The inspectors observed five hazardous waste 55-gallon containers located adjacent to the Cure Plant. The containers were labeled as follows: one flammable waste container dated 10/27/2021, one petroleum distillate waste container dated 10/22/2021, one corrosive waste container dated 10/8/2021, one petroleum distillate waste container dated 11/3/2021, and one petroleum distillate container dated 11/24/21. The five 55-gallon containers were labeled with the words “Hazardous Waste” as well as the hazard contents. All containers were dated and closed (Photographs 12 through 15).

The inspectors discussed management of the five 55-gallon hazardous waste containers with Mr. Bentley and informed him that placement of the containers adjacent to the Cure Plant did not appear to be a suitable location for a CAA due to the lack of spill/fire control equipment, as well as the heavy vehicle traffic passing through the area. During the exit conference Mr. Carey stated the area was not intended for CAA storage adjacent to the Cure Plant, but rather should be kept in the CAA located adjacent to the Maintenance Area. On December 15, 2021, Mr. Carey emailed photographs showing that the hazardous waste containers had been moved away from the Cure Plant and into to the CAA adjacent to the Maintenance Building.

Photograph 12: View of hazardous waste container located in the CAA adjacent to the Cure Building.

**Pursuant to Ga. Comp. R. and Regs. 391-3-11-.08(1) [40 C.F.R. § 262.15(a)], a generator may accumulate as much as 55 gallons of non-acute hazardous waste in containers at or near the point of generation where wastes initially accumulate, which is under the control of the operator of the process generating the waste, without a permit or without having interim status, as required by Section 12-8-66 of the GHWMA, Ga. Code Ann. § 12-8-66 [Section 3005 of RCRA, 42 U.S.C. § 6925], and without complying with Ga. Comp. R. and Regs. 391-3-11-.08(1) [40 C.F.R. § 262.16(b) or §262.16(b)], except as required in Ga. Comp. R. and Regs. 391-3-11-.08(1) [40 C.F.R. § 262.15(a)(7)], provided that the generator complies with the SAA Permit Exemption.**

**Pursuant to Ga. Comp. R. and Regs. 391-3-11-.08(1) [40 C.F.R. § 262.15(a)(6)(ii)], which is a condition of the SAA Permit Exemption, a generator who accumulates non-acute hazardous waste**

**in excess of the 55 gallons at or near any point of generation must remove the excess from the satellite accumulation area within three consecutive calendar days.**

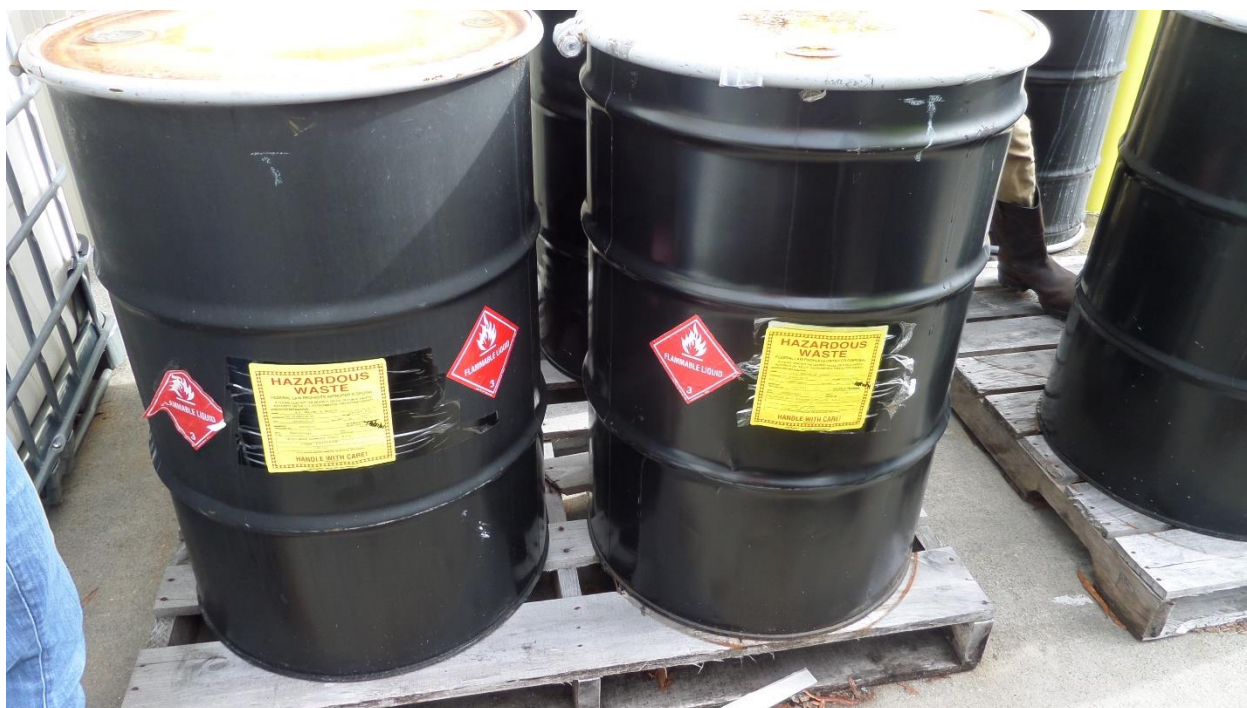
Photograph 13: View of hazardous waste container located in the CAA adjacent to the Cure Building.

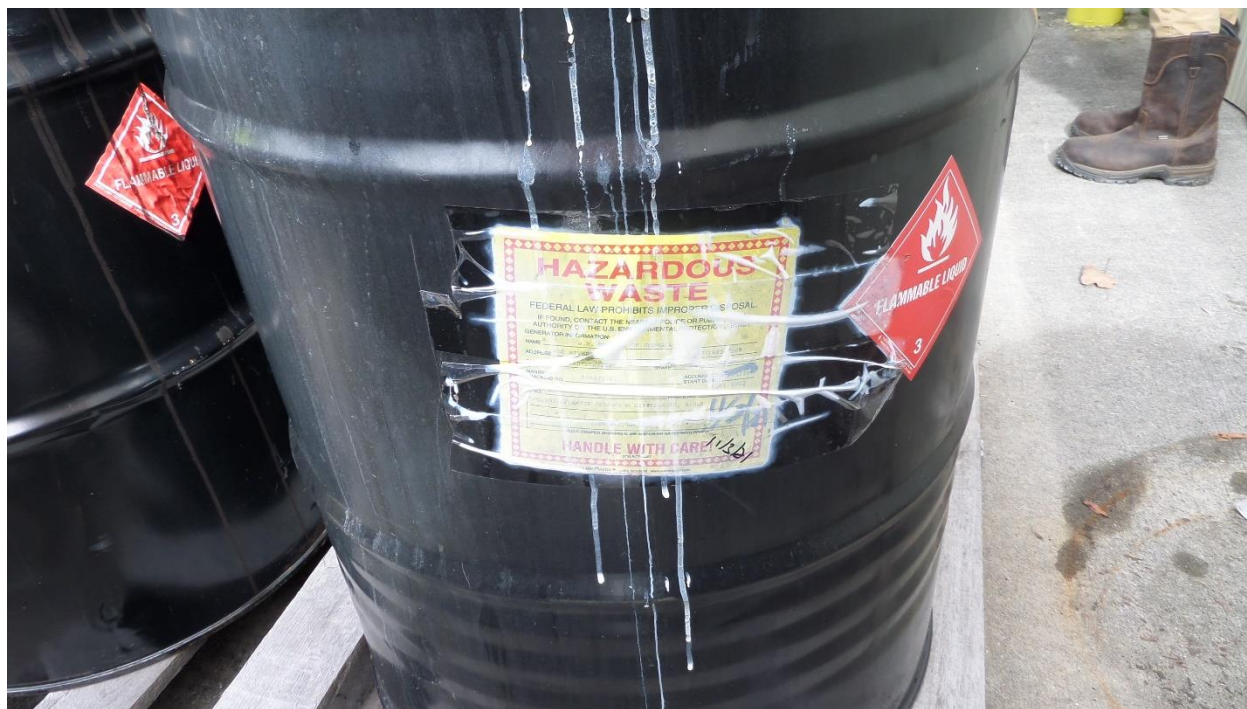
Photograph 14: View of hazardous waste container located in the CAA adjacent to the Cure Building.
