*Skilful* UPKEEP OF  
**PROPULSION TURBINES**

# SKILFUL UPKEEP OF PROPULSION TURBINES

*By Harold J. Chase*

# PROPULSION TURBINES AND GEARS

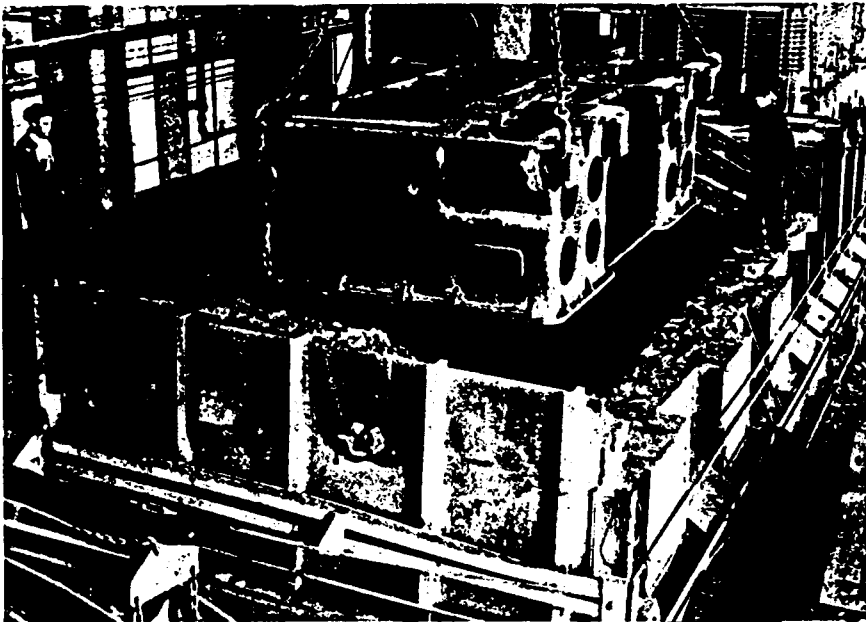
Fig. 8 - ...this center section of a double-reduction gear casing — being lowered into an annealing furnace after welding.

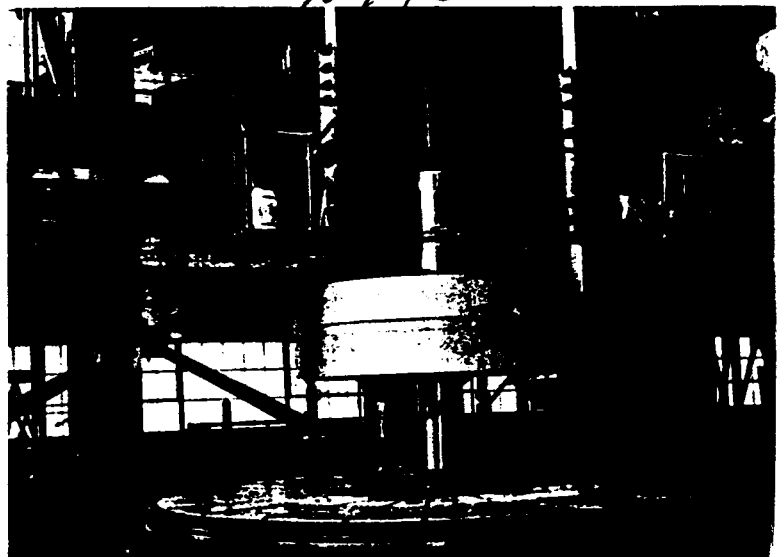
Fig. 10 - Machining a low-speed gear on a 20-ft vertical boring mill at Lynn. This giant and a 14-ft unit have been installed for boring low-speed gear hubs and for turning gear webs and tires.

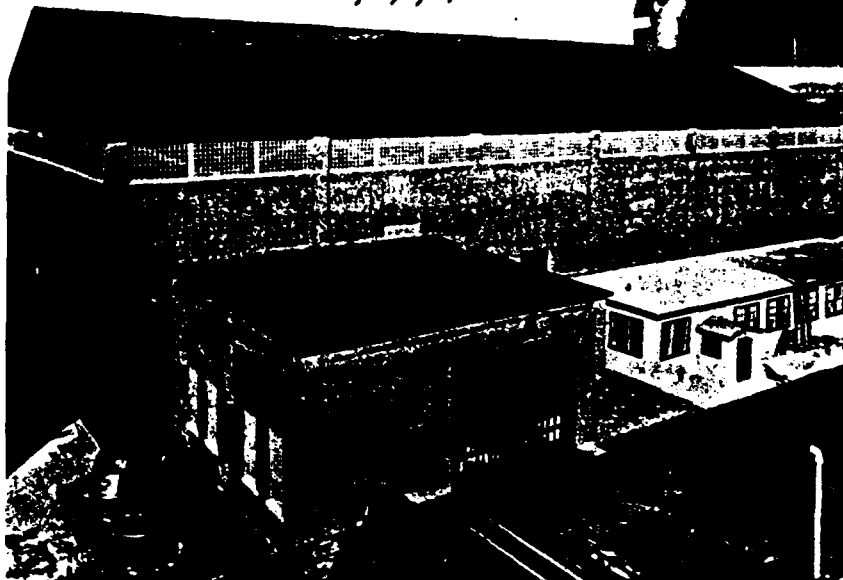
Fig. 12 - Quality and accuracy, for quiet operation, are built into G-E gears in this modern temperature-controlled building which houses such equipment as...

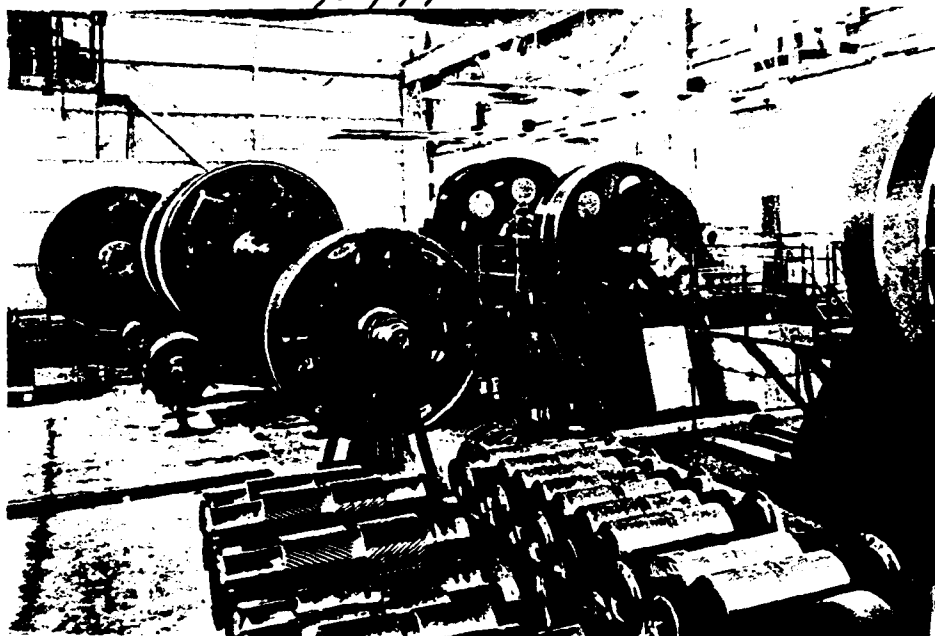
Fig. 15 - Gears and pinions in various stages of manufacture at Lynn.
