## REGION 10 Enforcement Division

### INSPECTION REPORT

| <b>Company Name:</b> | State of Alaska Department of Transportation and Public Facilities (Alaska DOT & PF) | | |
| <b>Facility or Site Name:</b> | ALASKA DOT & PF PEGER ROAD | | |

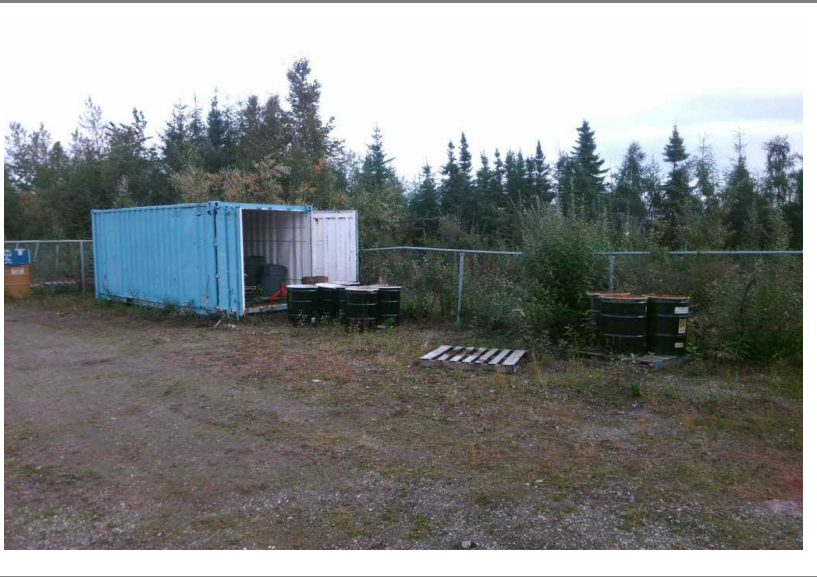
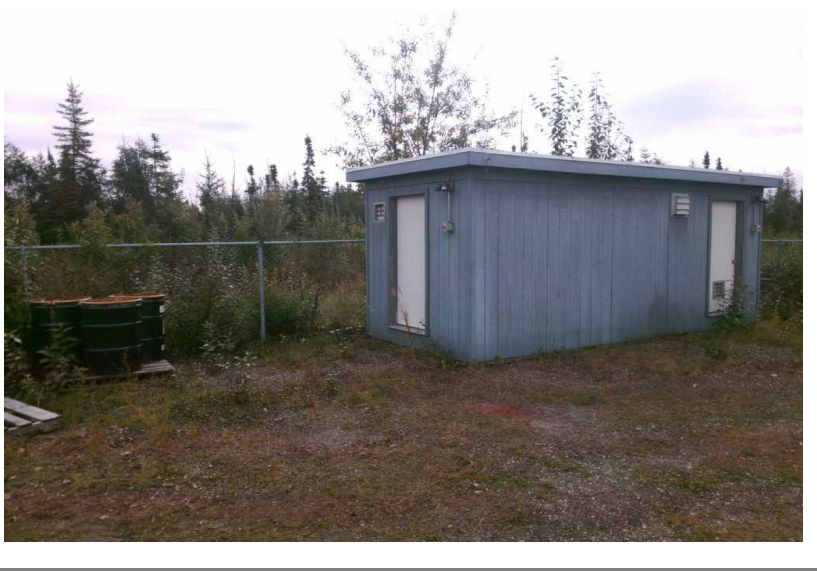
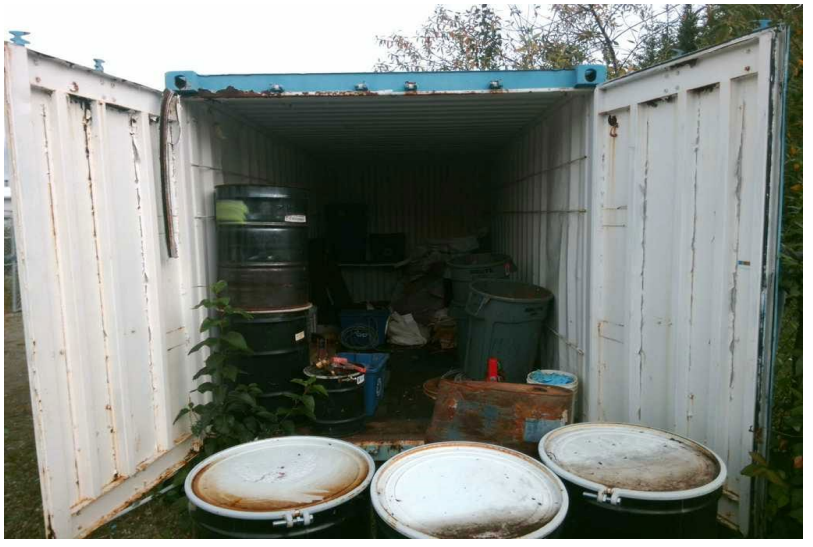
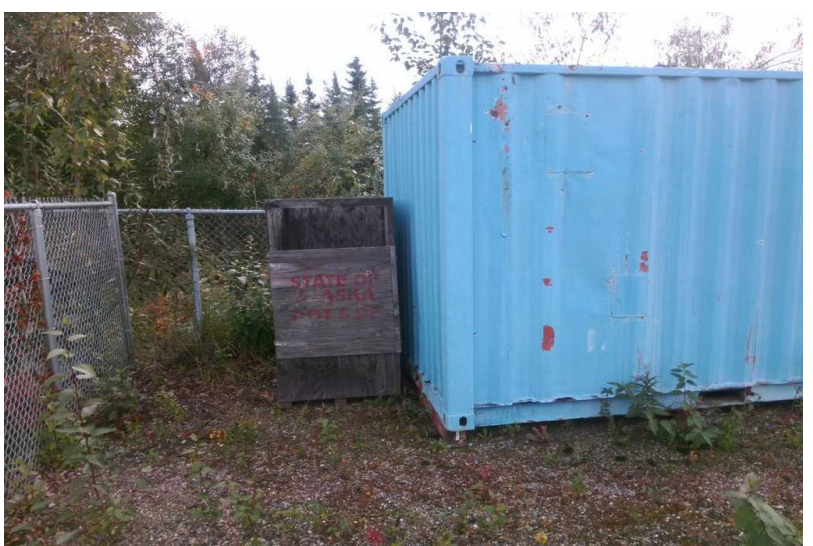
| While inspecting the Drum Storage Area, Mr. Myers said he keeps a 55-gallon container just outside the gate entrance to the CAA for the accumulation of aerosol cans which are managed as universal waste. Mr. Myers said that it hardly ever gets used. At the time of the inspection, the container was empty. | |

| <div>[Title]</div> <div>08/26/2021 11:11 AM (AKT)</div> <div>Jon Jones</div> <div>Drum Storage Area (CAA)</div> <div>No CBI</div> <div>No PII</div> <div>View of the area around the blue Connex.</div> | |
| <div>[Title]</div> <div>08/26/2021 11:11 AM (AKT)</div> <div>Jon Jones</div> <div>Drum Storage Area (CAA)</div> <div>No CBI</div> <div>No PII</div> <div>Another view of the CAA.</div> | |

| <p>[Title]</p> <p>08/26/2021 11:12 AM (AKT)</p> <p>Jon Jones</p> <p>Drum Storage Area (CAA)</p> <p>No CBI</p> <p>No PII</p> <p>A view of the Connex in the CAA.</p> | |
| <p>[Title]</p> <p>08/26/2021 11:12 AM (AKT)</p> <p>Jon Jones</p> <p>Drum Storage Area (CAA)</p> <p>No CBI</p> <p>No PII</p> <p>View of the area around the entrance to the CAA.</p> | |

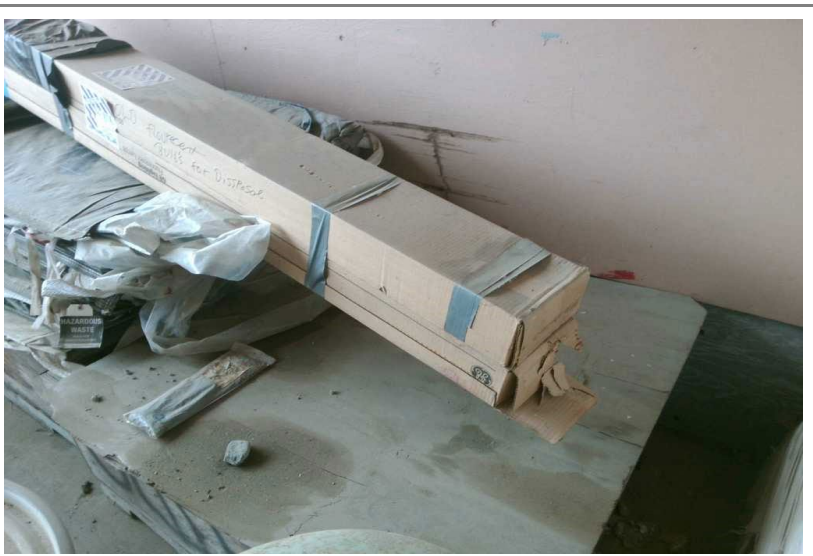
| <p>[Title]</p> <p>08/26/2021 01:25 PM (AKT)</p> <p>Jon Jones</p> <p>Hazmat Recycling Area</p> <p>No CBI</p> <p>No PII</p> <p>View of two cardboard boxes that contain eight-foot waste fluorescent lamps.</p> <p>The top box has a plastic bag covering one end that was taped together and the bottom box was open on both ends.</p> | |

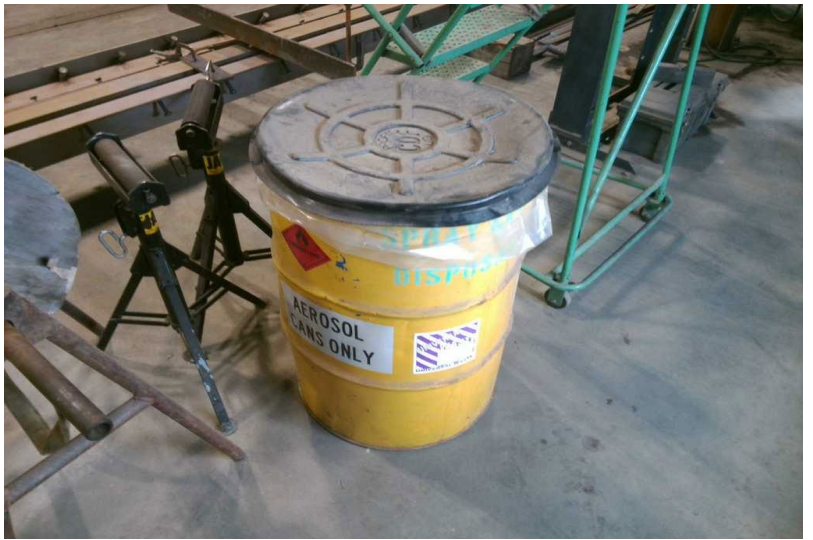
| At the time of the inspection, the facility was utilizing a 55-gallon container for accumulating aerosol cans which the facility manages as universal waste. During the inspection, the container was labeled, closed and empty. | |

| <div>[Title]</div> <div>08/26/2021 10:49 AM (AKT)</div> <div>Jon Jones</div> <div>Bridge and Drilling Shop/UWAA</div> <div>No CBI</div> <div>No PII</div> <div>View of 55-gallon container for accumulating waste aerosol cans which the facility manages as universal waste.</div> | |

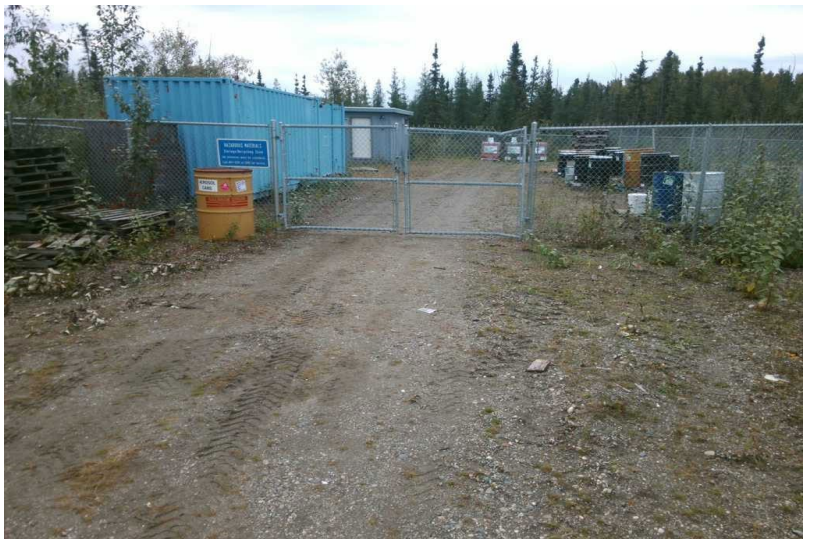
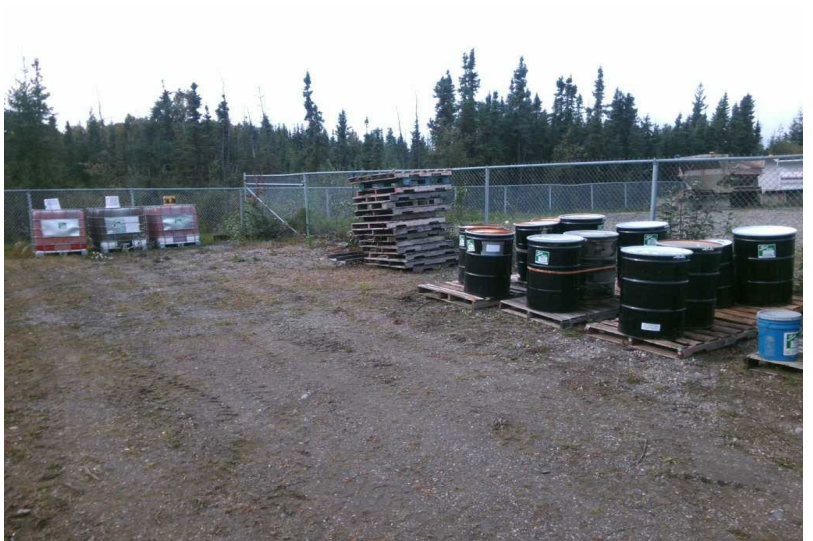
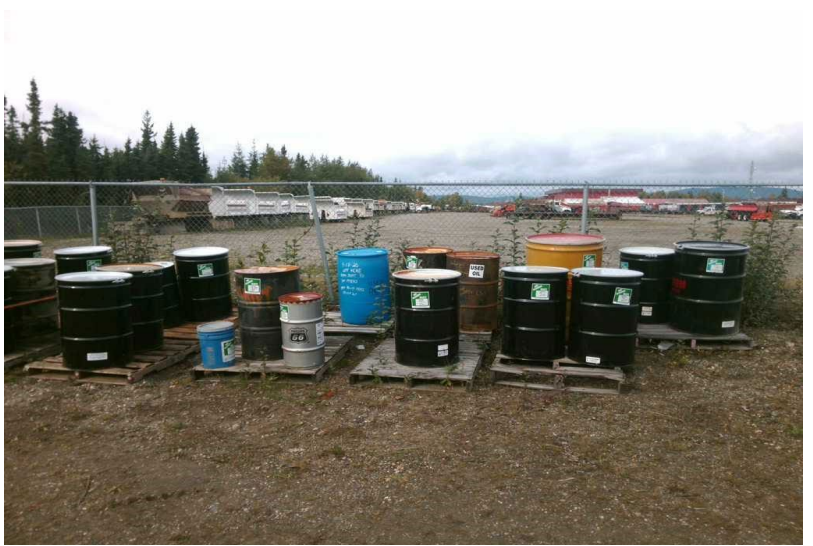
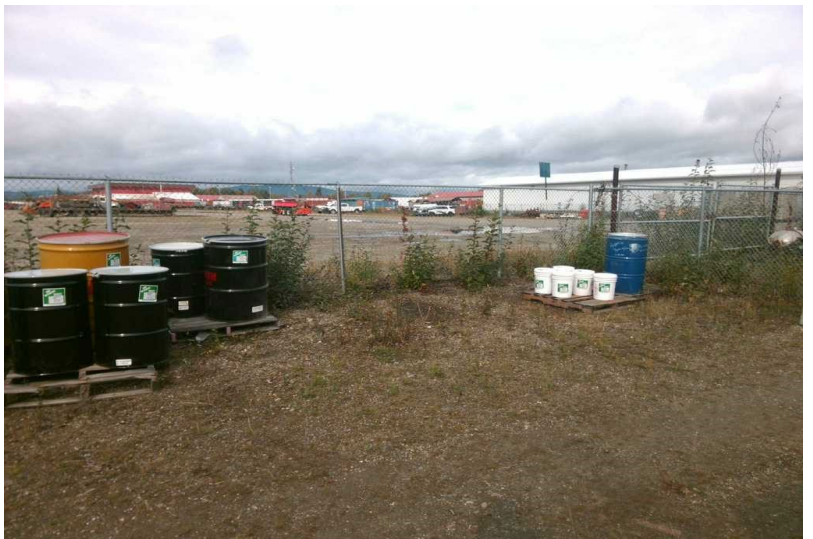
| At the time of the inspection, the only wastes in accumulation were non-hazardous wastes consisting of oily water, POL contaminated soil, mixed glycols, and used urea (also known as Diesel Exhaust Fluid or “DEF”). | |

| <div>[Title]</div> <div>08/26/2021 10:54 AM (AKT)</div> <div>Jon Jones</div> <div>Drum Storage Area (CAA)</div> <div>No CBI</div> <div>No PII</div> <div>View of the entrance to the Drum Storage Area.</div> | |
| <div>[Title]</div> <div>08/26/2021 11:10 AM (AKT)</div> <div>Jon Jones</div> <div>Drum Storage Area (CAA)</div> <div>No CBI</div> <div>No PII</div> <div>View of the waste in the CAA. Wastes in accumulation were non-hazardous wastes consisting of oily water, POL soil, mixed glycols, used urea (DEF).</div> | |

| <p>[Title]</p> <p>08/26/2021 11:10 AM (AKT)</p> <p>Jon Jones</p> <p>Drum Storage Area (CAA)</p> <p>No CBI</p> <p>No PII</p> <p>Another view of the waste in the CAA. Wastes in accumulation were non-hazardous wastes consisting of oily water, POL soil, mixed glycols, used urea (DEF).</p> | |
| <p>[Title]</p> <p>08/26/2021 11:10 AM (AKT)</p> <p>Jon Jones</p> <p>Drum Storage Area (CAA)</p> <p>No CBI</p> <p>No PII</p> <p>Another view of the waste in the CAA. Wastes in accumulation were non-hazardous wastes consisting of oily water, POL soil, mixed glycols, used urea (DEF).</p> | |

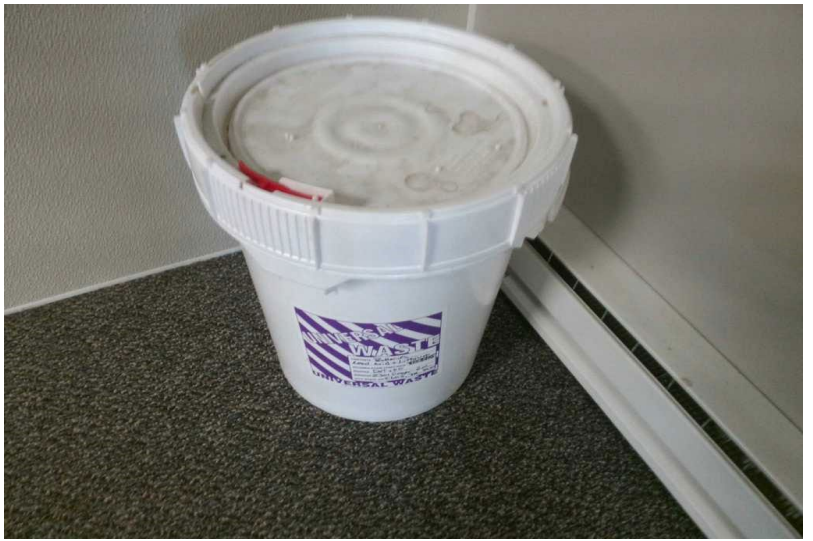
| <p>During the inspection, there was an accumulation container for batteries outside of Mr. Myers's office. At the time of the inspection the 5-gallon container held one lead-acid battery. The facility manages batteries as universal waste.</p> | |

| <p>[Title]</p> <p>08/26/2021 02:02 PM (AKT)</p> <p>Jon Jones</p> <p>Environmental Office</p> <p>No CBI</p> <p>No PII</p> <p>View of a universal waste battery container located just outside of Mr. Myers's office.</p> | |

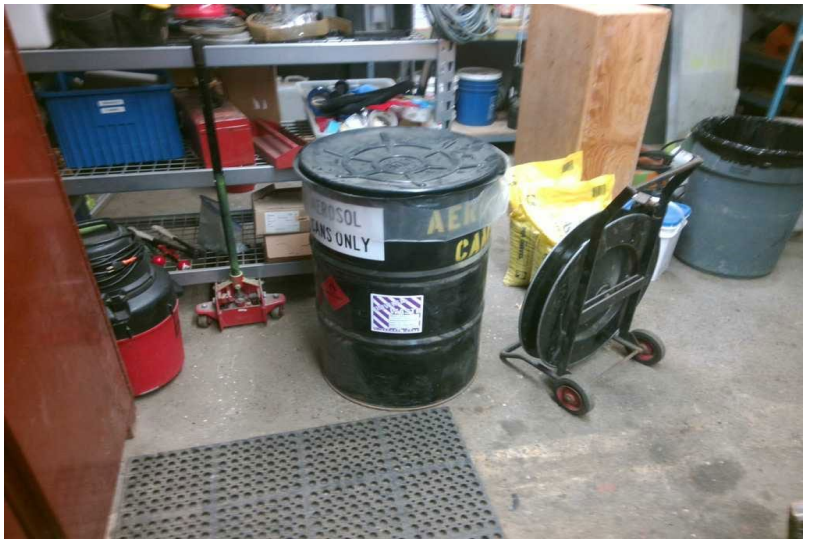
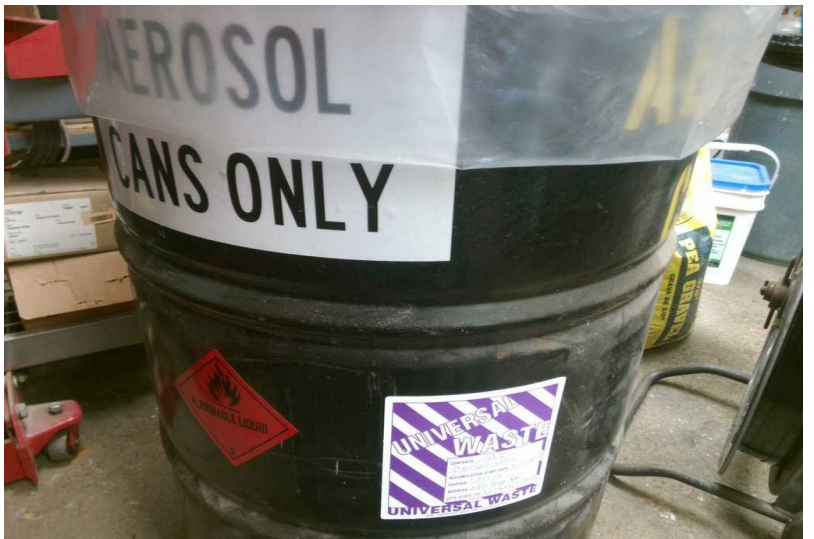
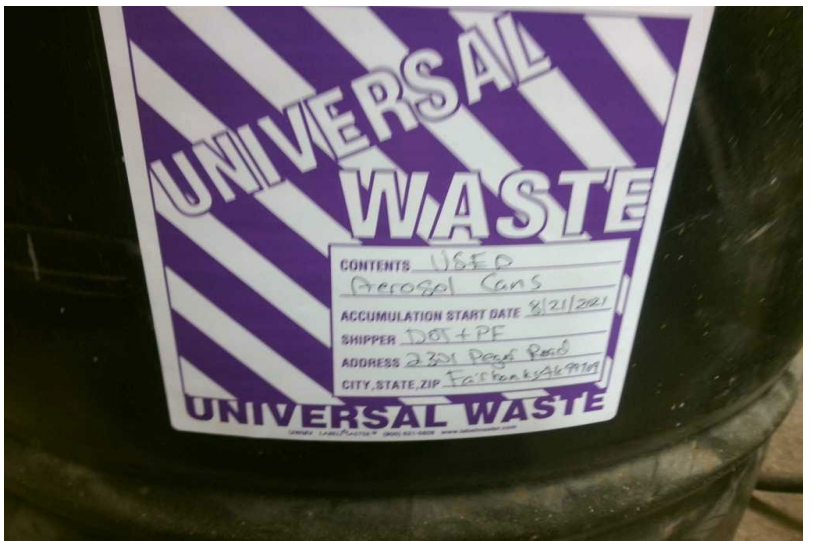
| <p>At the time of the inspection there was a 55-gallon container that was being used to accumulate universal waste aerosol cans. At the time of the inspection the container was labeled with a universal waste label and was empty.</p> | |

| <div>[Title]</div> <div>08/26/2021 09:26 AM (AKT)</div> <div>Jon Jones</div> <div>Facility Services/Shop</div> <div>No CBI</div> <div>No PII</div> <div>View of a 55-gallon container being used to accumulate universal waste aerosol cans.</div> | |
| <div>[Title]</div> <div>08/26/2021 09:26 AM (AKT)</div> <div>Jon Jones</div> <div>Facility Services/Shop</div> <div>No CBI</div> <div>No PII</div> <div>Close-up view of the labeling on the container.</div> | |
| <div>[Title]</div> <div>08/26/2021 09:27 AM (AKT)</div> <div>Jon Jones</div> <div>Facility Services/Shop</div> <div>No CBI</div> <div>No PII</div> <div>Close-up view of the universal waste label.</div> | |

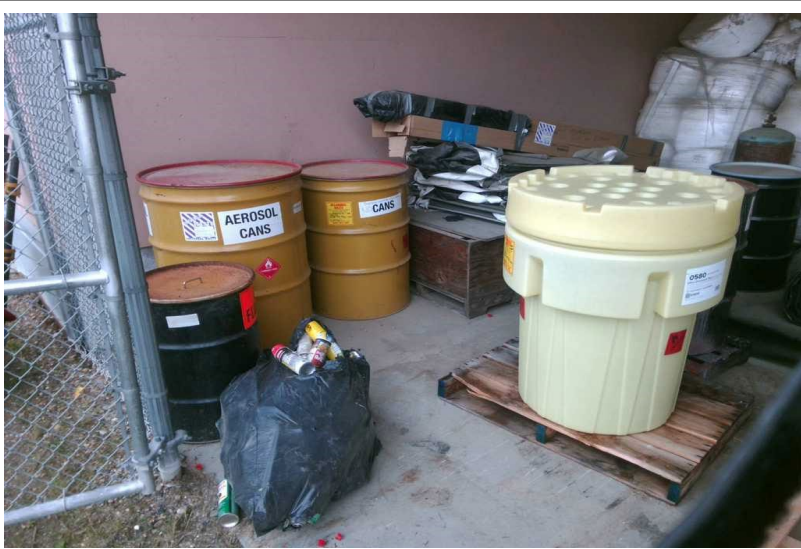
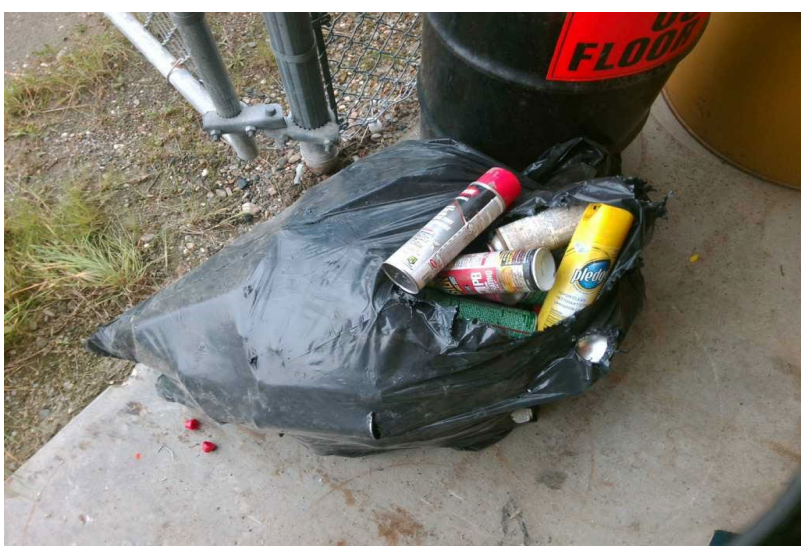
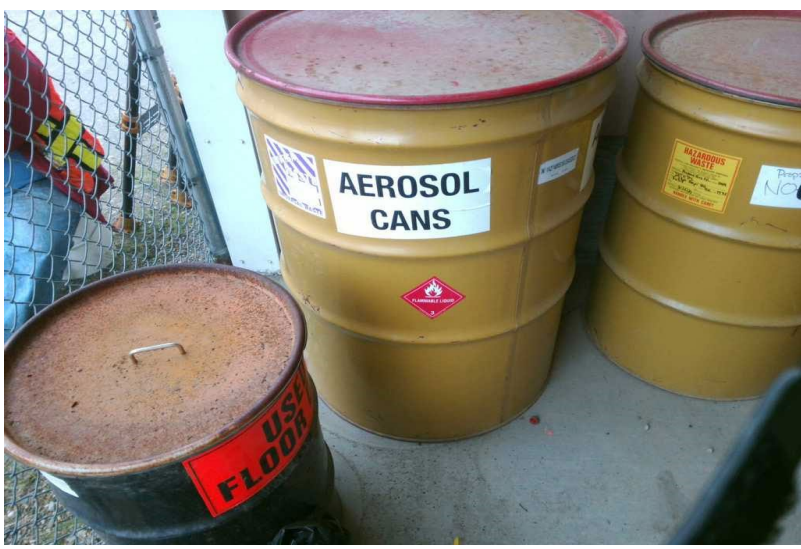
| <p>When I arrived at the Hazmat Recycling Area (HRA), I saw a large, open plastic garbage containing waste aerosol cans that was laying in front of an 85-gallon overpack container that was being utilized to accumulate aerosol cans which the facility manages as universal waste. The plastic bag that contained the waste aerosol cans was not labeled as universal waste. According to Mr. Myers, someone, somewhere must have been accumulating them and then brought them out to the caged area. At the time of the inspection, the 85-gallon overpack container the facility was using to accumulate universal waste aerosols was empty.</p> <p>I also saw a 55-gallon container that was the same color as the 85-gallon overpack. It was labeled as hazardous waste and contained 35 waste propane cylinders. The container was labeled and was marked with a hazard indicator but was not closed. There was no drum ring on the container and the lid was not making a complete seal with the container.</p> | |

| <p>[Title]</p> <p>08/26/2021 11:23 AM (AKT)</p> <p>Jon Jones</p> <p>Hazmat Recycling Area</p> <p>No CBI</p> <p>No PII</p> <p>View of the garbage bag that contains waste aerosol cans.</p> | |
| <p>[Title]</p> <p>08/26/2021 11:24 AM (AKT)</p> <p>Jon Jones</p> <p>Hazmat Recycling Area</p> <p>No CBI</p> <p>No PII</p> <p>Close-up view of the garbage bag containing waste aerosol cans.</p> | |
| <p>[Title]</p> <p>08/26/2021 11:24 AM (AKT)</p> <p>Jon Jones</p> <p>Hazmat Recycling Area</p> <p>No CBI</p> <p>No PII</p> <p>View of an 85-gallon overpack container for the accumulation of waste aerosols. During the inspection, this container was empty.</p> | |

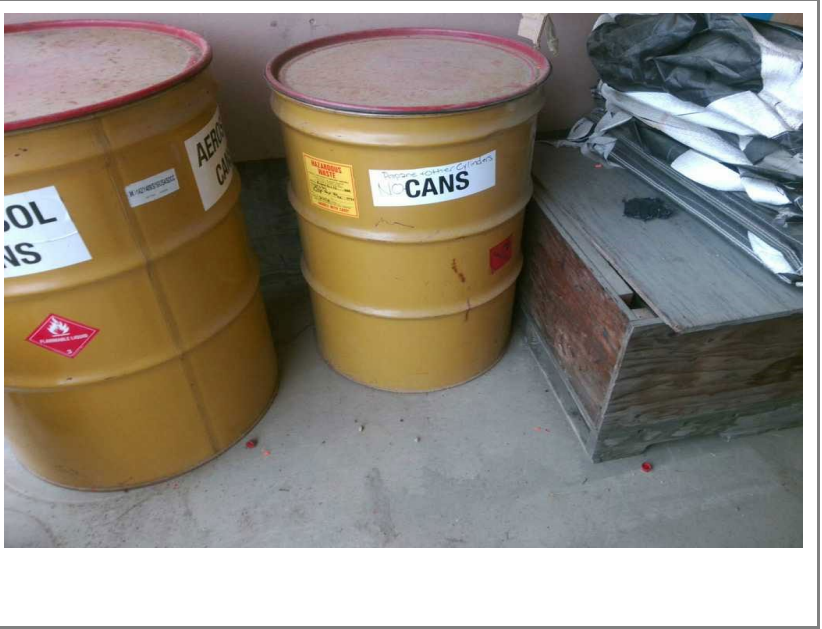
| View of a 55-gallon container that was labeled as hazardous waste and contained 35 waste propane cylinders. The container was labeled and was marked with a hazard indicator but was not closed. There was no drum ring on the container and the lid was not making a complete seal with the container. | |

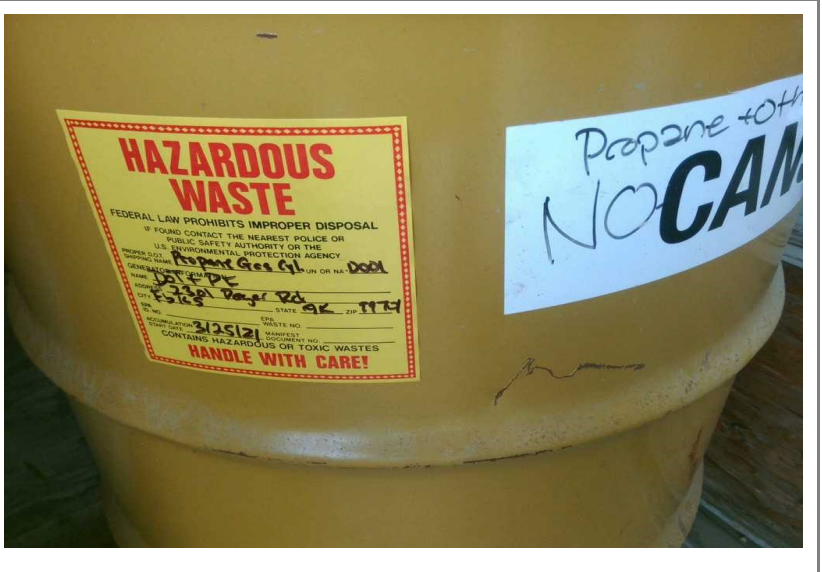
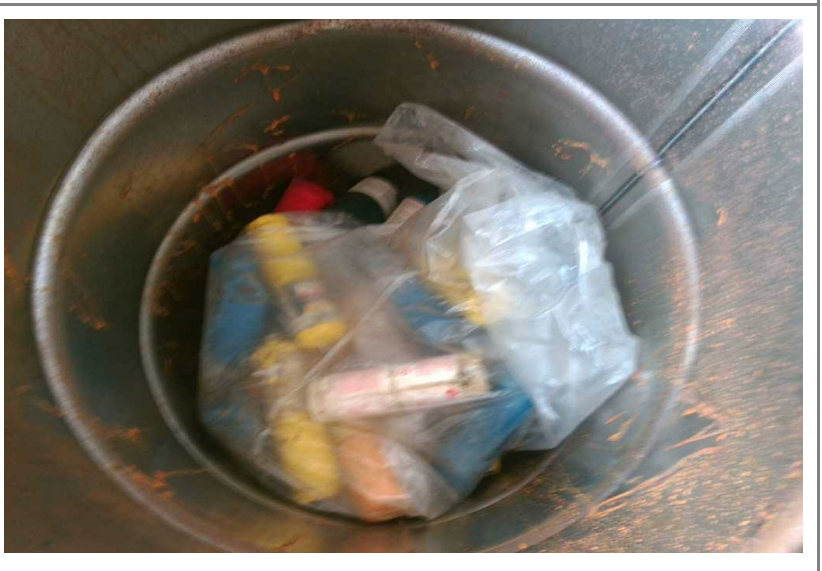
| Close-up view of the container label. | |
| View of the waste propane cylinders in the container. | |

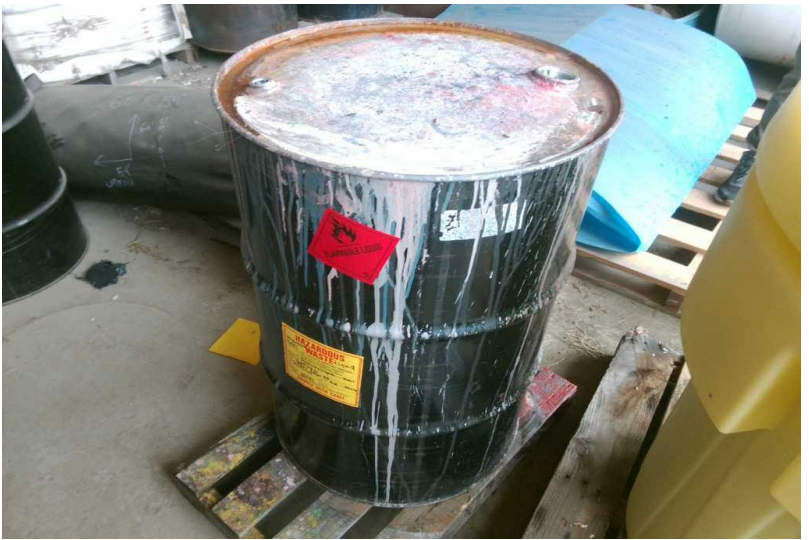
| <p>While in the HRA, I saw a 55-gallon satellite container of waste aerosol can residue/liquid that had been collected from punctured aerosol cans. I tapped on the container to determine the level of waste in the container and determined that it was approximately 1/3 full. Mr. Myers confirmed that it was 1/3 full. The container was closed, labeled as hazardous waste, and was marked with a hazard indicator. Mr. Myers stated that ADOT&amp;PF had been accumulating the hazardous waste in this satellite container since 2019.</p> | |

| <p>[Title]</p> <p>08/26/2021 01:13 PM (AKT)</p> <p>Jon Jones</p> <p>Hazmat Recycling Area</p> <p>No CBI</p> <p>No PII</p> <p>View of a 55-gallon container in use for accumulation of waste aerosol can residue/liquid.</p> | |

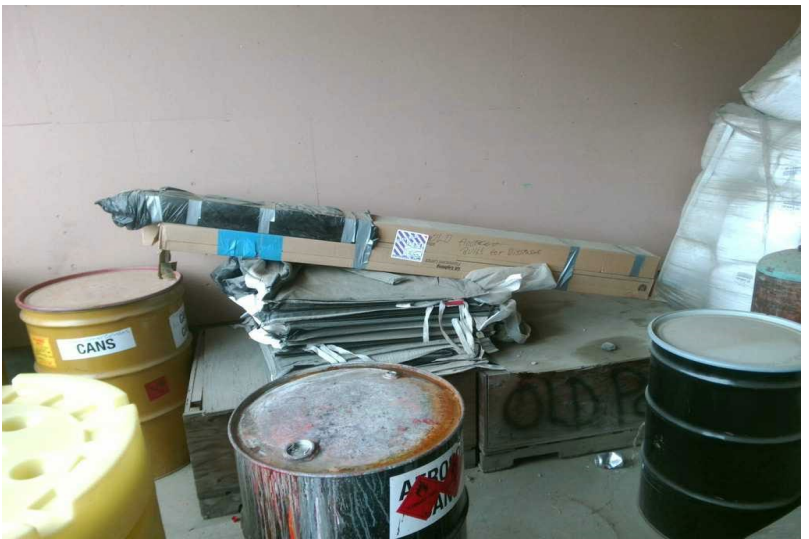
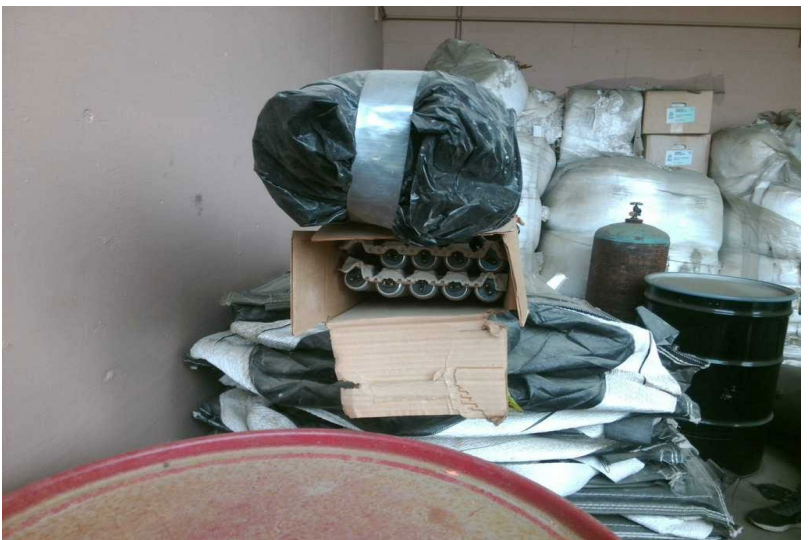
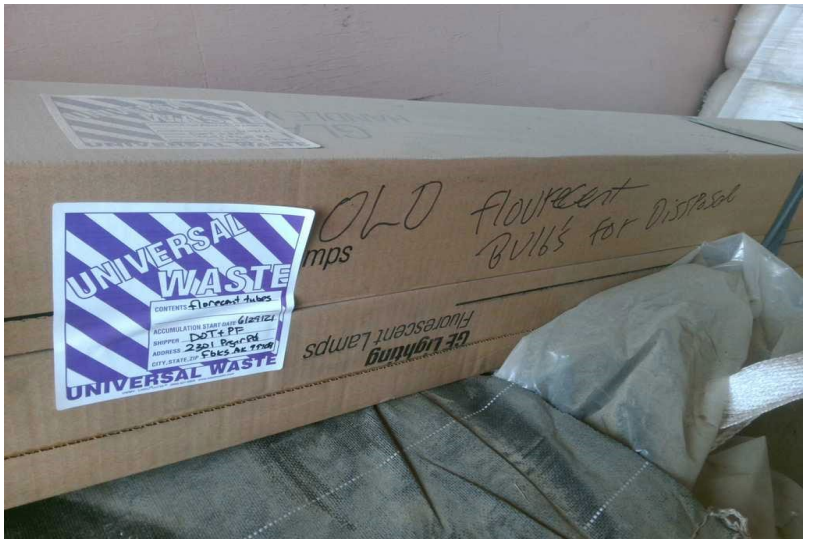
| <p>[Title]</p> <p>08/26/2021 01:24 PM (AKT)</p> <p>Jon Jones</p> <p>Hazmat Recycling Area</p> <p>No CBI</p> <p>No PII</p> <p>View of two cardboard boxes that contain eight-foot waste fluorescent lamps.</p> <p>The top box has a plastic bag covering one end that was taped together and the bottom box was open on both ends.</p> | |
| <p>[Title]</p> <p>08/26/2021 01:24 PM (AKT)</p> <p>Jon Jones</p> <p>Hazmat Recycling Area</p> <p>No CBI</p> <p>No PII</p> <p>Another view of two cardboard boxes that contain eight-foot waste fluorescent lamps.</p> <p>The top box has a plastic bag covering one end that was taped together and the bottom box was open on both ends.</p> | |

| <p>[Title]</p> <p>08/26/2021 01:25 PM (AKT)</p> <p>Jon Jones</p> <p>Hazmat Recycling Area</p> <p>No CBI</p> <p>No PII</p> <p>Close-up view of the label on the two cardboard boxes that contain eight-foot waste fluorescent lamps.</p> | |

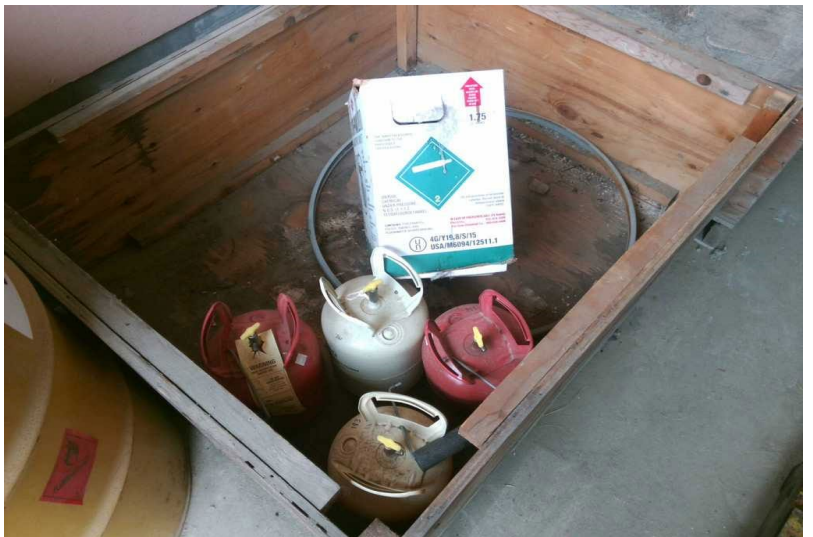
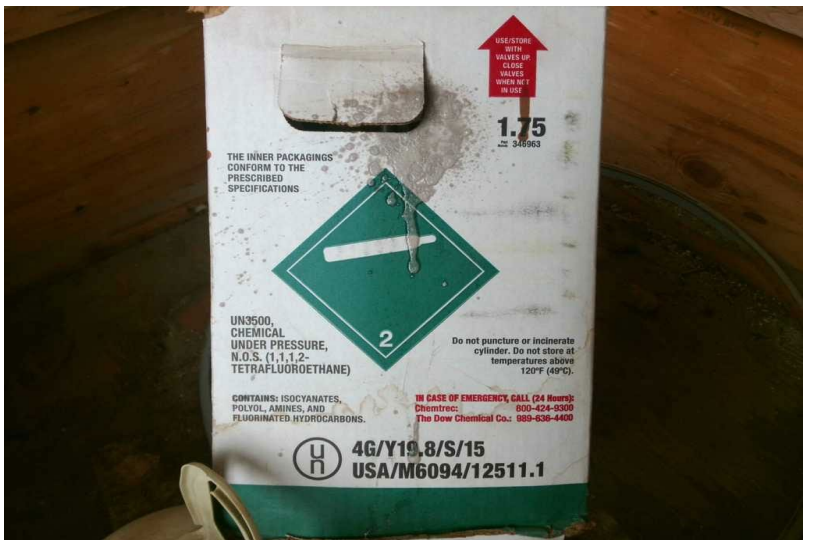
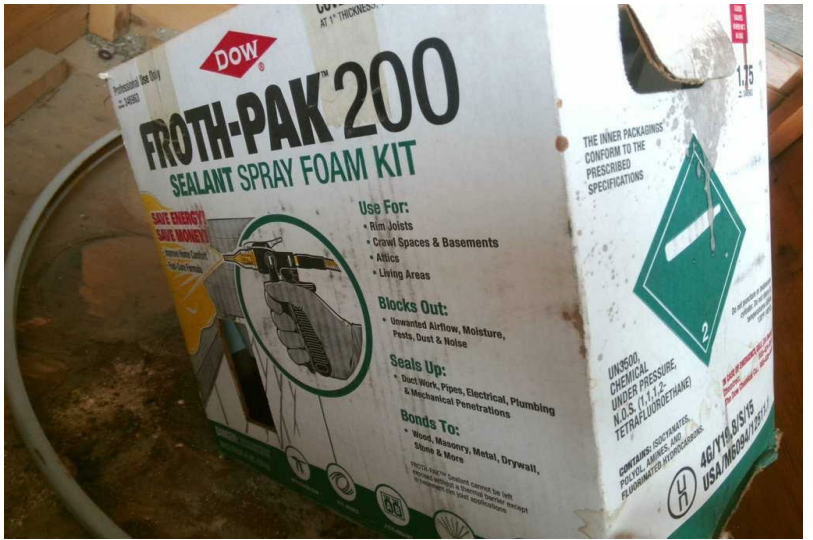
| <p>[Title]</p> <p>08/26/2021 01:38 PM (AKT)</p> <p>Jon Jones</p> <p>Hazmat Recycling Area</p> <p>No CBI</p> <p>No PII</p> <p>View of six (four loose cylinders, two in box), waste spray foam cylinders. Mr. Myers told me they froze over the winter and need to be disposed. Mr. Myers said he needed to make a waste determination and would research the SDS for guidance on disposal.</p> | |
| <p>[Title]</p> <p>08/26/2021 01:39 PM (AKT)</p> <p>Jon Jones</p> <p>Hazmat Recycling Area</p> <p>No CBI</p> <p>No PII</p> <p>Close-up view of the labeling on the box of spray foam cylinders.</p> | |

| <div>[Title]</div> <div>08/26/2021 01:39 PM (AKT)</div> <div>Jon Jones</div> <div>Hazmat Recycling Area</div> <div>No CBI</div> <div>No PII</div> <div>Another close-up view of the labeling on the box of spray foam cylinders.</div> | |

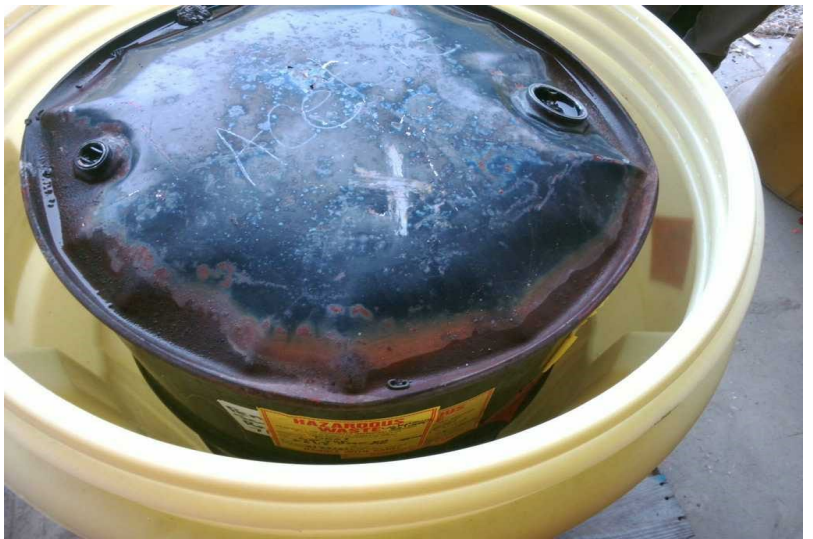
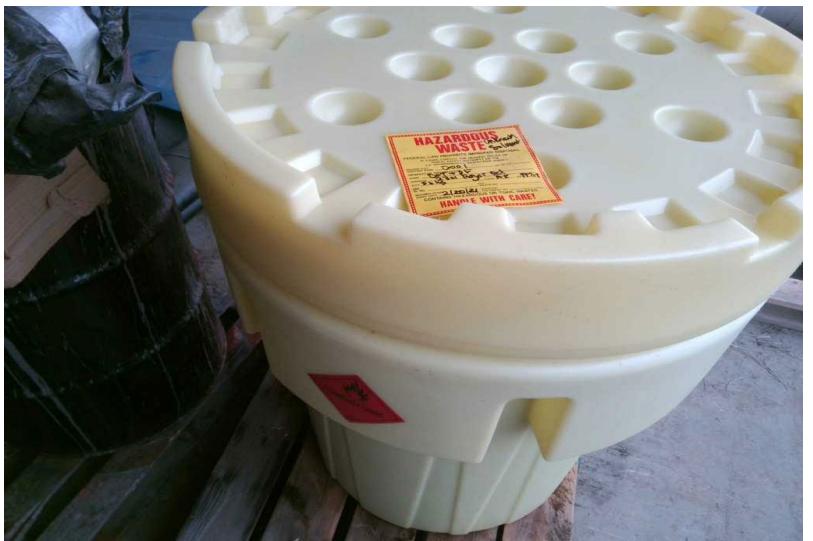
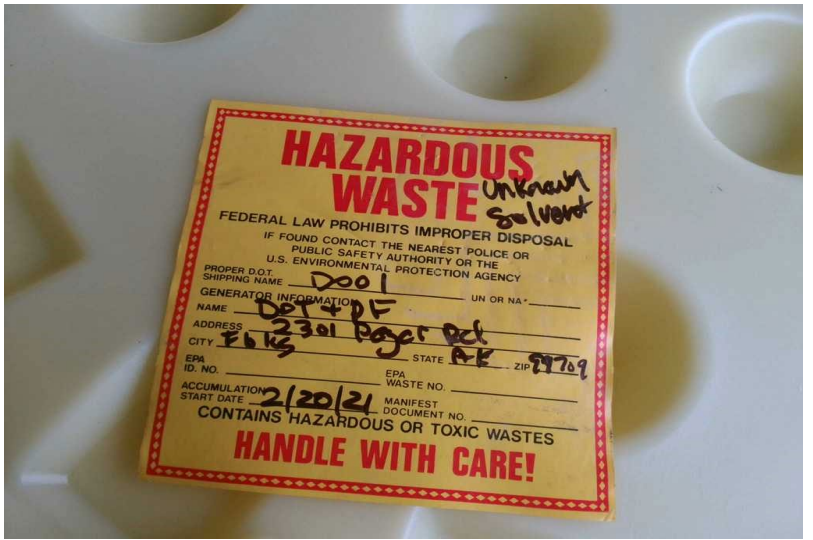
| <p>While still in the HRA, I saw an 85-gallon poly overpack container that held a 55-gallon container of an unknown solvent. According to Mr. Myers, someone thought it was acetone and marked the container as such. The container was labeled with the words "Hazardous Waste" and an ASD of 2/20/21. The container was also marked with a hazard indicator. According to Mr. Myers the container is full. Mr. Myers said he had analytical data for the solvent and he provided me with a copy which is included with this report (See records review JJ1-RR-001).</p> | |

| <div>[Title]</div> <div>08/26/2021 01:52 PM (AKT)</div> <div>Jon Jones</div> <div>Hazmat Recycling Area</div> <div>No CBI</div> <div>No PII</div> <div>View of 85-gallon poly overpack container that's holding a 55-gallon container of an unknown solvent.</div> | |
| <div>[Title]</div> <div>08/26/2021 01:52 PM (AKT)</div> <div>Jon Jones</div> <div>Hazmat Recycling Area</div> <div>No CBI</div> <div>No PII</div> <div>Another view of 85-gallon poly overpack container that's holding a 55-gallon container of an unknown solvent.</div> | |

| <p>[Title]</p> <p>08/26/2021 01:53 PM (AKT)</p> <p>Jon Jones</p> <p>Hazmat Recycling Area</p> <p>No CBI</p> <p>No PII</p> <p>Close-up view of the label on 85-gallon poly overpack container that's holding a 55-gallon container of an unknown solvent.</p> | |

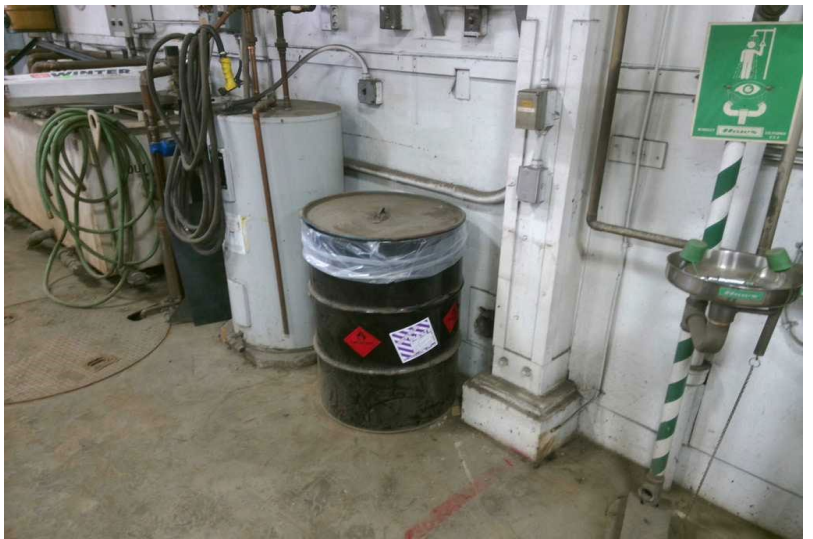
| <p>[Title]</p> <p>08/26/2021 10:09 AM (AKT)</p> <p>Jon Jones</p> <p>Heavy Equipment / Warm Storage/Welding Shop</p> <p>No CBI</p> <p>No PII</p> <p>View of a 55-gallon container for the accumulation of waste aerosol cans. There was one aerosol in the container and the container was closed and labeled as universal waste.</p> | |

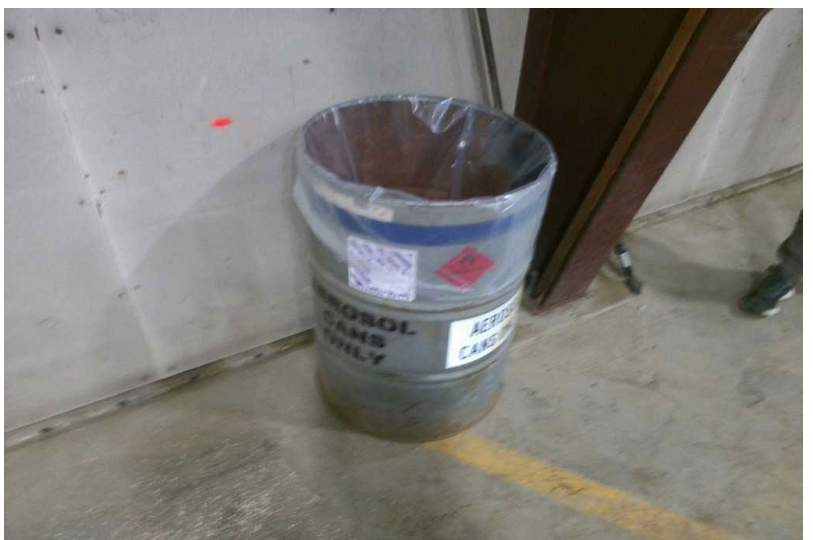
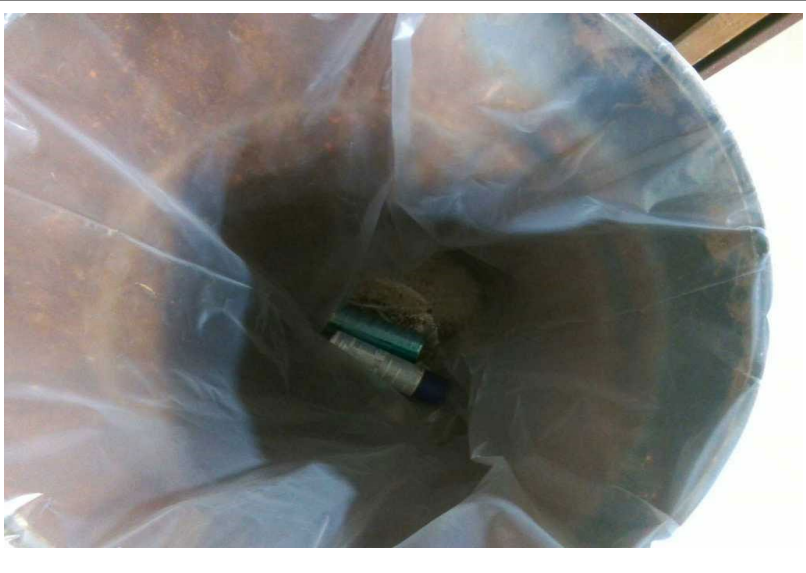
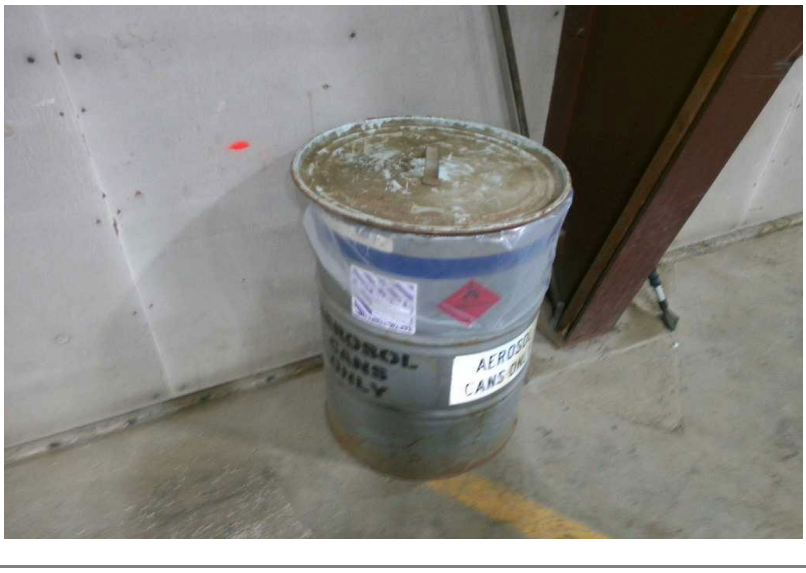
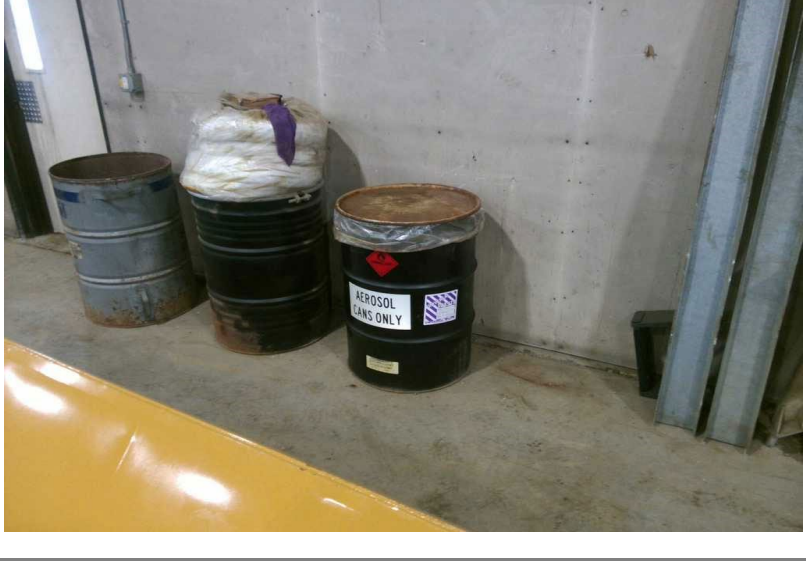
| <p>[Title]</p> <p>08/26/2021 09:40 AM (AKT)</p> <p>Jon Jones</p> <p>Large Warm Storage</p> <p>No CBI</p> <p>No PII</p> <p>View of a 55-gallon container that was being utilized as an accumulation container for waste aerosol cans.</p> | |

| <p>[Title]</p> <p>08/26/2021 09:40 AM (AKT)</p> <p>Jon Jones</p> <p>Large Warm Storage</p> <p>No CBI</p> <p>No PII</p> <p>View of two aerosol cans inside the container.</p> | |
| <p>[Title]</p> <p>08/26/2021 09:42 AM (AKT)</p> <p>Jon Jones</p> <p>Large Warm Storage</p> <p>No CBI</p> <p>No PII</p> <p>Another view of the same container, seen in the previous photo, with the lid placed on the container.</p> | |
| <p>[Title]</p> <p>08/26/2021 09:46 AM (AKT)</p> <p>Jon Jones</p> <p>Large Warm Storage</p> <p>No CBI</p> <p>No PII</p> <p>View of an additional 55-gallon container in the same area that was also being utilized as an accumulation container for waste aerosol cans.</p> | |

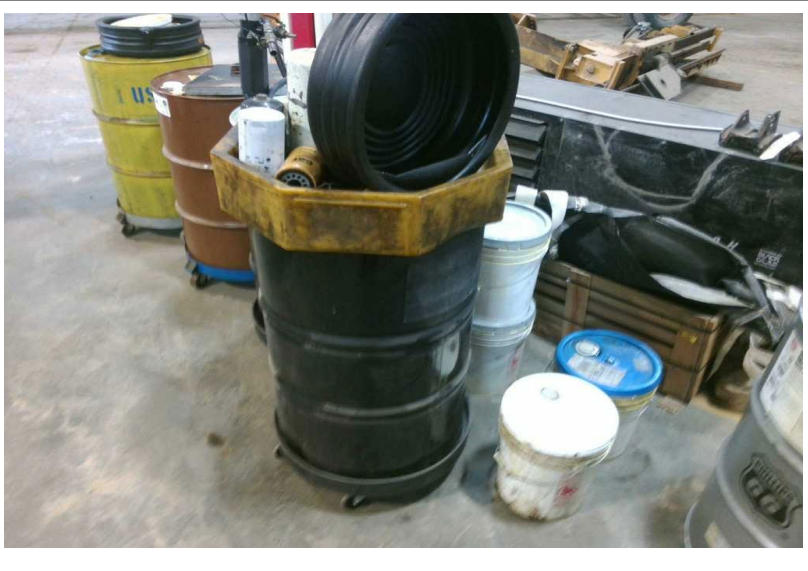
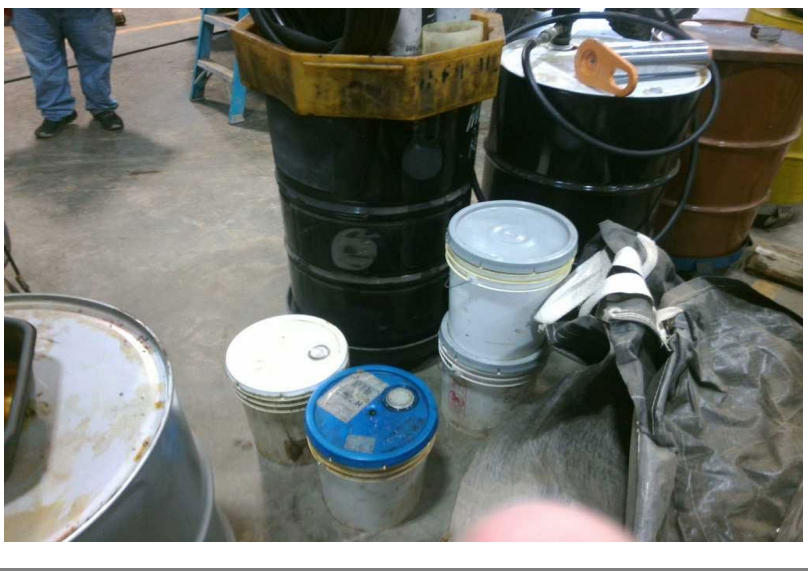
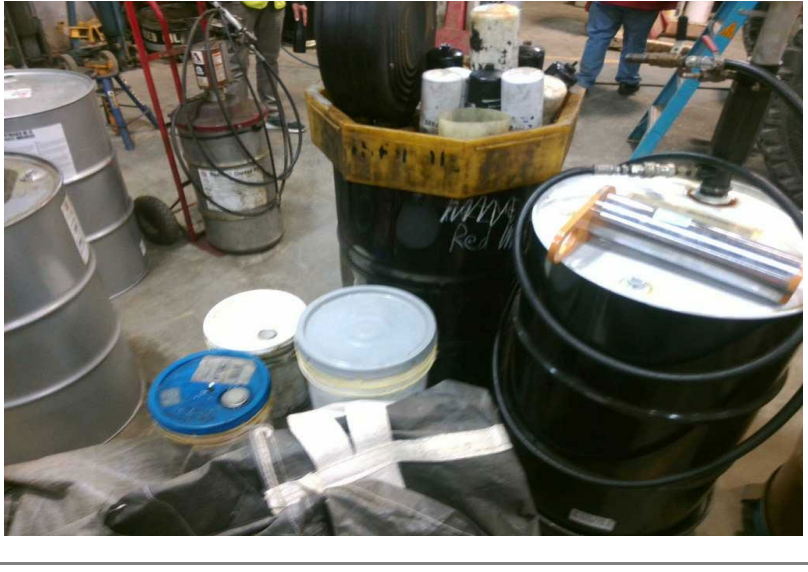
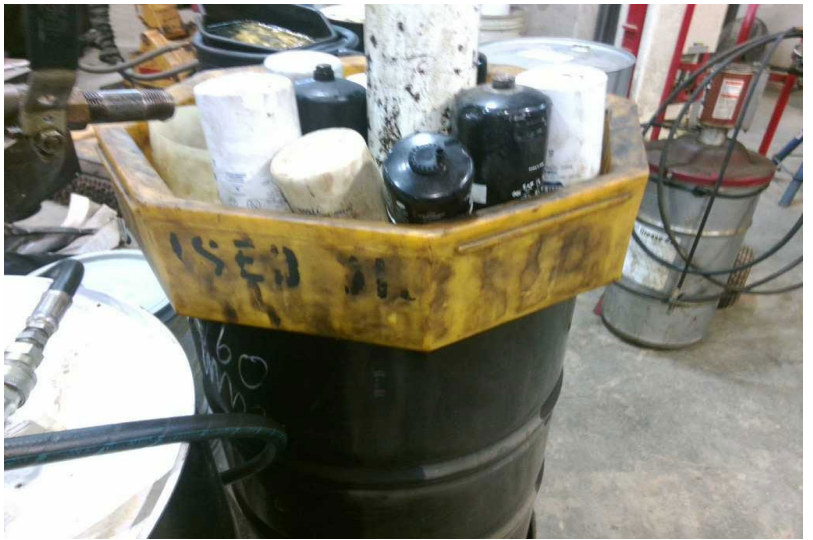
| <div data-bbox="70 165 708 219">[Title]</div> <div data-bbox="70 219 708 277">08/26/2021 09:54 AM (AKT)</div> <div data-bbox="70 277 708 336">Jon Jones</div> <div data-bbox="70 336 708 394">Large Warm Storage</div> <div data-bbox="70 394 708 452">No CBI</div> <div data-bbox="70 452 708 510">No PII</div> <div data-bbox="70 510 708 734">View of the five containers that were not labeled with the words "Used Oil."</div> | |
| <div data-bbox="70 745 708 799">[Title]</div> <div data-bbox="70 799 708 857">08/26/2021 09:54 AM (AKT)</div> <div data-bbox="70 857 708 916">Jon Jones</div> <div data-bbox="70 916 708 974">Large Warm Storage</div> <div data-bbox="70 974 708 1032">No CBI</div> <div data-bbox="70 1032 708 1090">No PII</div> <div data-bbox="70 1090 708 1314">Another view of the five containers that were not labeled with the words "Used Oil."</div> | |
| <div data-bbox="70 1326 708 1379">[Title]</div> <div data-bbox="70 1379 708 1438">08/26/2021 09:55 AM (AKT)</div> <div data-bbox="70 1438 708 1496">Jon Jones</div> <div data-bbox="70 1496 708 1554">Large Warm Storage</div> <div data-bbox="70 1554 708 1612">No CBI</div> <div data-bbox="70 1612 708 1671">No PII</div> <div data-bbox="70 1671 708 1895">Another view of the five containers that were not labeled with the words "Used Oil."</div> | |

| <p>[Title]</p> <p>08/26/2021 09:59 AM (AKT)</p> <p>Jon Jones</p> <p>Large Warm Storage</p> <p>No CBI</p> <p>No PII</p> <p>View of the funnel on top of the 55-gallon container.</p> | |

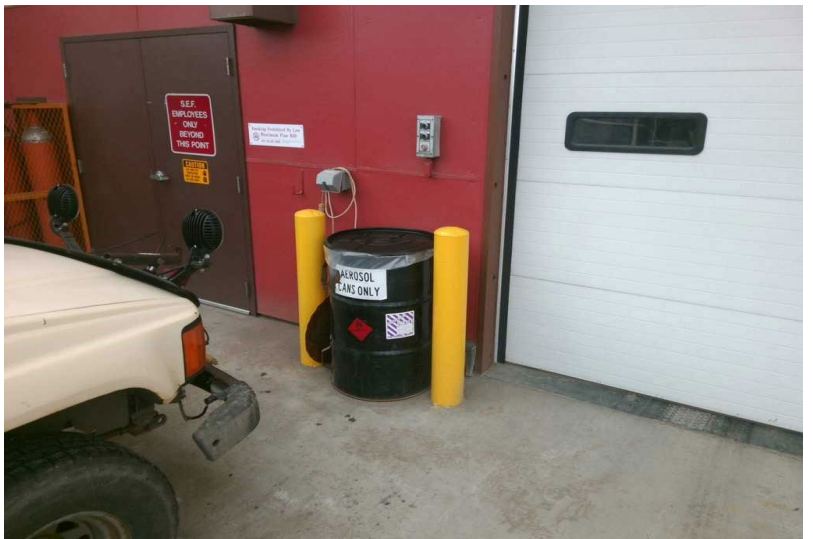
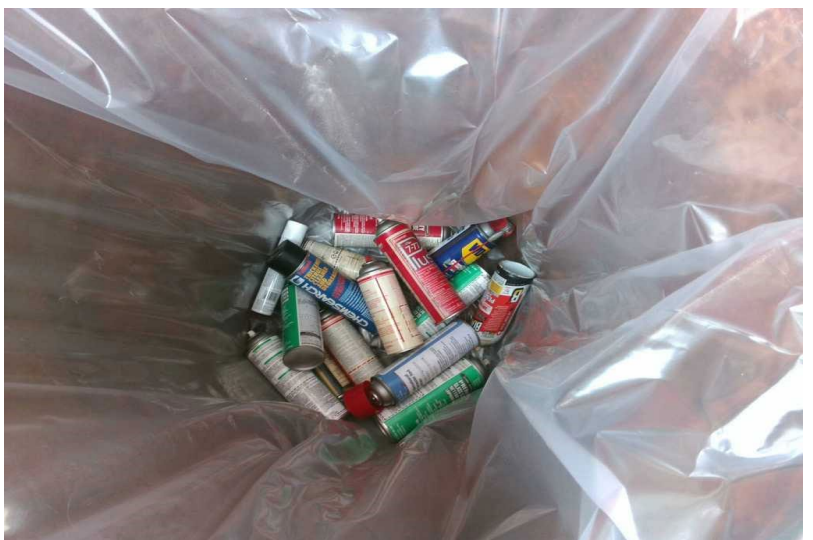
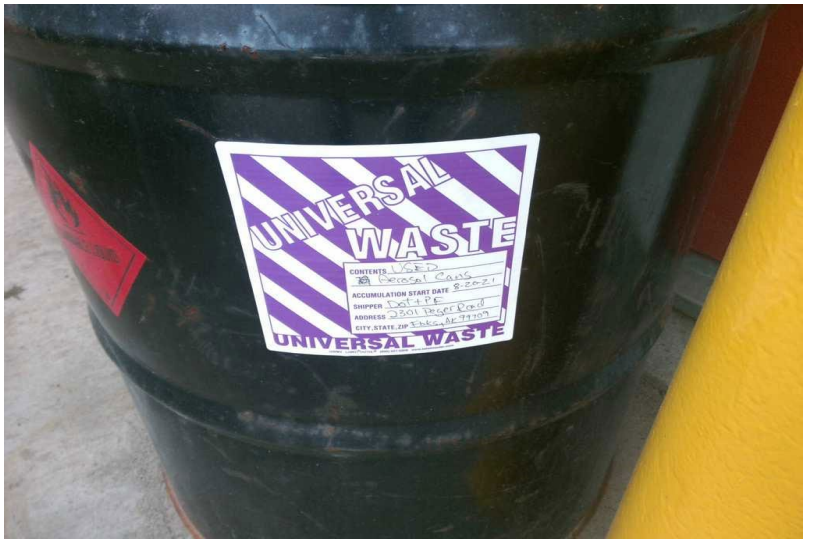
| <p>[Title]</p> <p>08/26/2021 10:38 AM (AKT)</p> <p>Jon Jones</p> <p>Light Duty Shop/Outside the building, on the north side</p> <p>No CBI</p> <p>No PII</p> <p>View of a 55-gallon container used to accumulate waste aerosol cans. The container was labeled, closed, and contained approximately 16 aerosol cans.</p> | |
| <p>[Title]</p> <p>08/26/2021 10:39 AM (AKT)</p> <p>Jon Jones</p> <p>Light Duty Shop/Outside the building, on the north side</p> <p>No CBI</p> <p>No PII</p> <p>View of the waste aerosols inside the container.</p> | |

| <p>[Title]</p> <p>08/26/2021 10:39 AM (AKT)</p> <p>Jon Jones</p> <p>Light Duty Shop/Outside the building, on the north side</p> <p>No CBI</p> <p>No PII</p> <p>Close-up view of the container label.</p> | |
