## REGION 10 Enforcement Division

### INSPECTION REPORT

| <b>Company Name:</b> | State of Alaska Department of Transportation and Public Facilities (Alaska DOT & PF) | | |
| <b>Facility or Site Name:</b> | ALASKA DOT & PF PEGER ROAD | | |

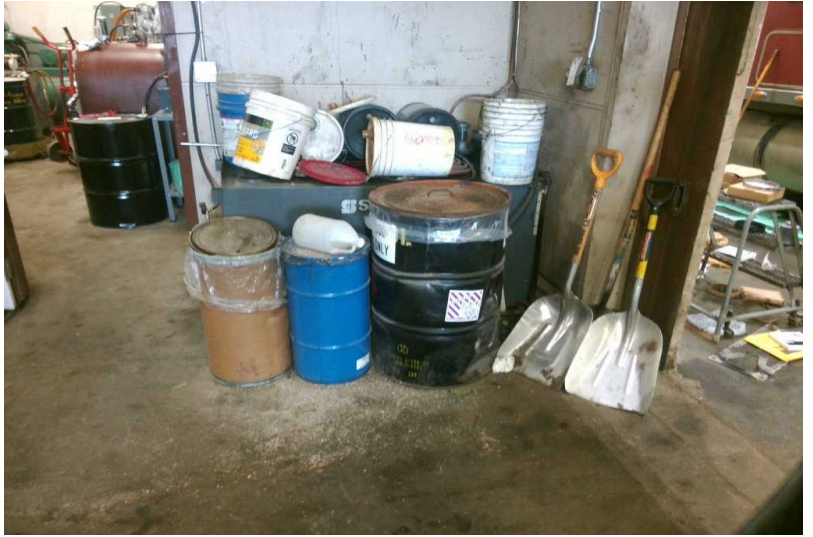
| <p>[Title]</p> <p>08/26/2021 10:21 AM (AKT)</p> <p>Jon Jones</p> <p>State Equipment Fleet (SEF) Maintenance Shop/Heavy Equipment side</p> <p>No CBI</p> <p>No PII</p> <p>View of a 55-gallon container prepared for use to accumulate waste aerosols. The container is seen here with a universal waste label.</p> | |

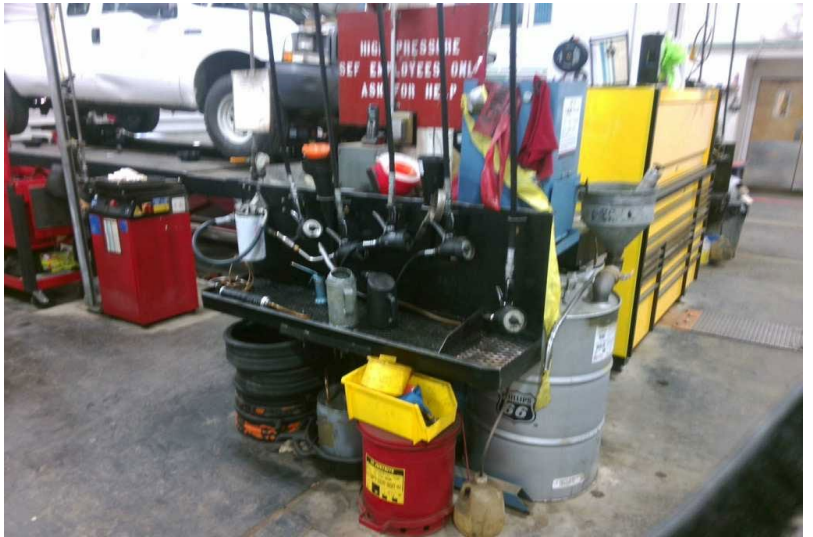
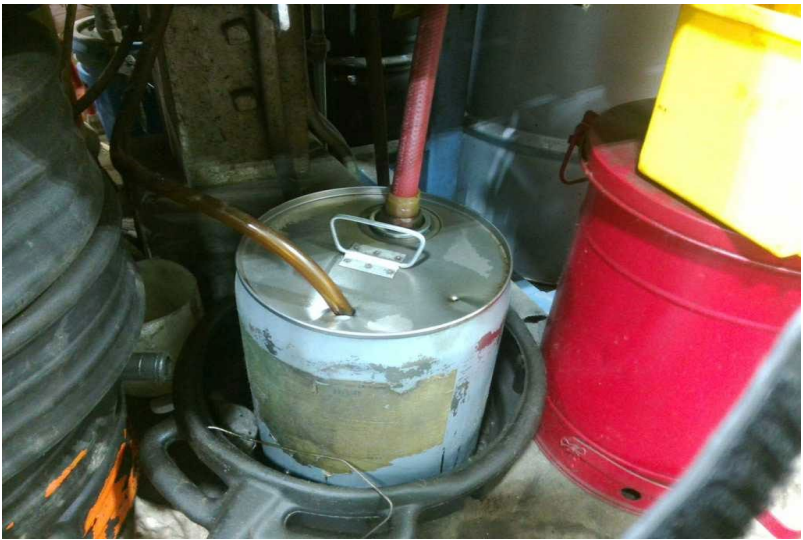
| <p>[Title]</p> <p>08/26/2021 10:28 AM (AKT)</p> <p>Jon Jones</p> <p>State Equipment Fleet (SEF) Maintenance Shop/Light Duty Shop</p> <p>No CBI</p> <p>No PII</p> <p>View of the oil filter crusher.</p> | |

| View of a 5-gallon container that was connected to and accumulating used oil from a used oil filter crusher. The 5-gallon container of used oil is not labeled with the words, "Used Oil." | |
