## Region 6 - Enforcement & Compliance Assurance Division

### INSPECTION REPORT

| Company Name: | <b>Eubanks, James and Mike (J&amp;M)</b> | |
| Facility Name: | <b>Patterson 2 and 3 SWD Tank Battery</b> | |

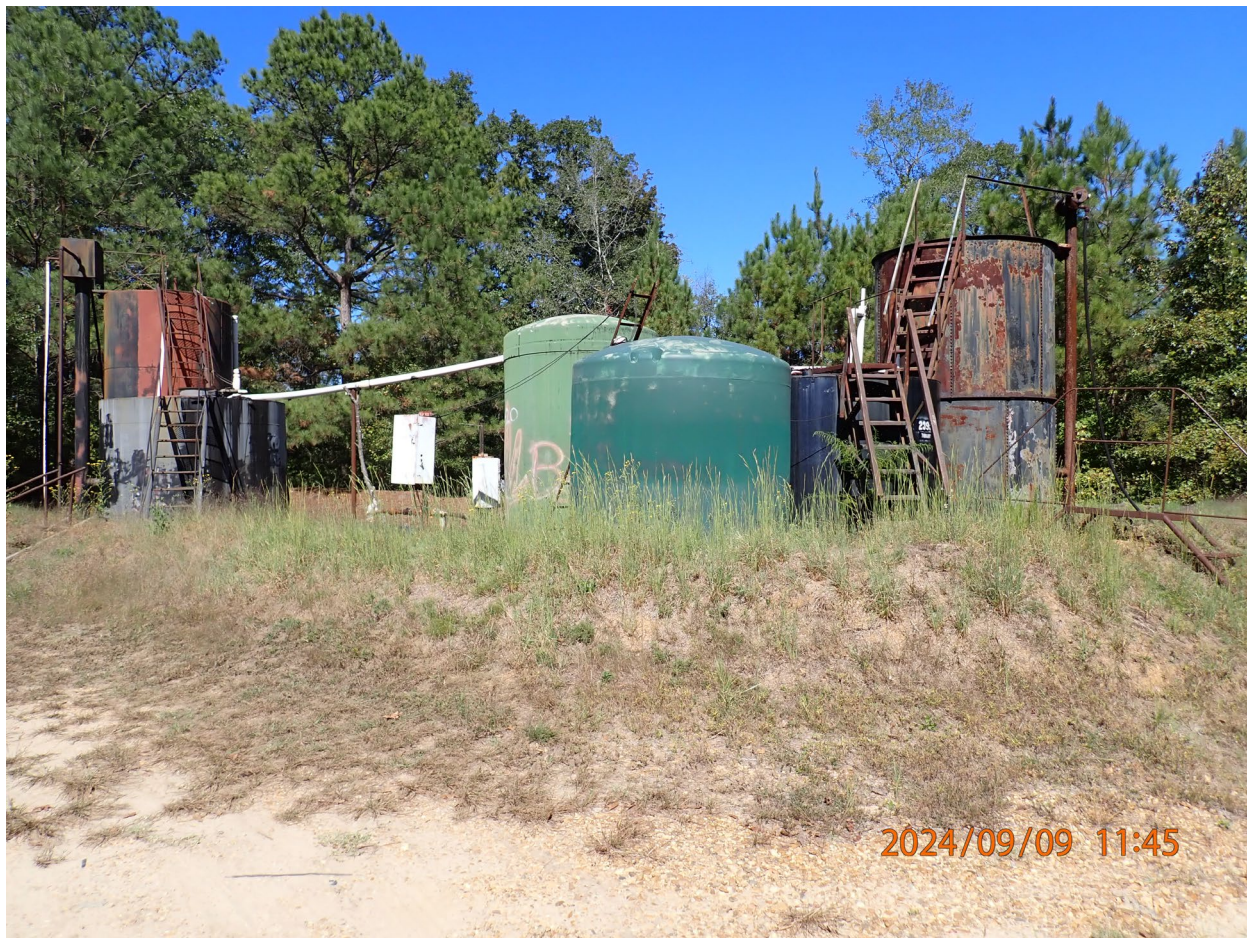
Photo No. 1

I observed the Eubanks, James and Mike (J&M) / Patterson 2 and 3 SWD Tank Battery and associated secondary containment, storage tanks, and saltwater disposal (SWD) wells; see Appendix 1 (Photographs Log), see Photo No. 1. For additional GPS location and photo metadata, see Appendix 1.

**Description:** Looking N, this photo shows an overview of the Patterson 2 and 3 SWD Tank Battery; no signage onsite.

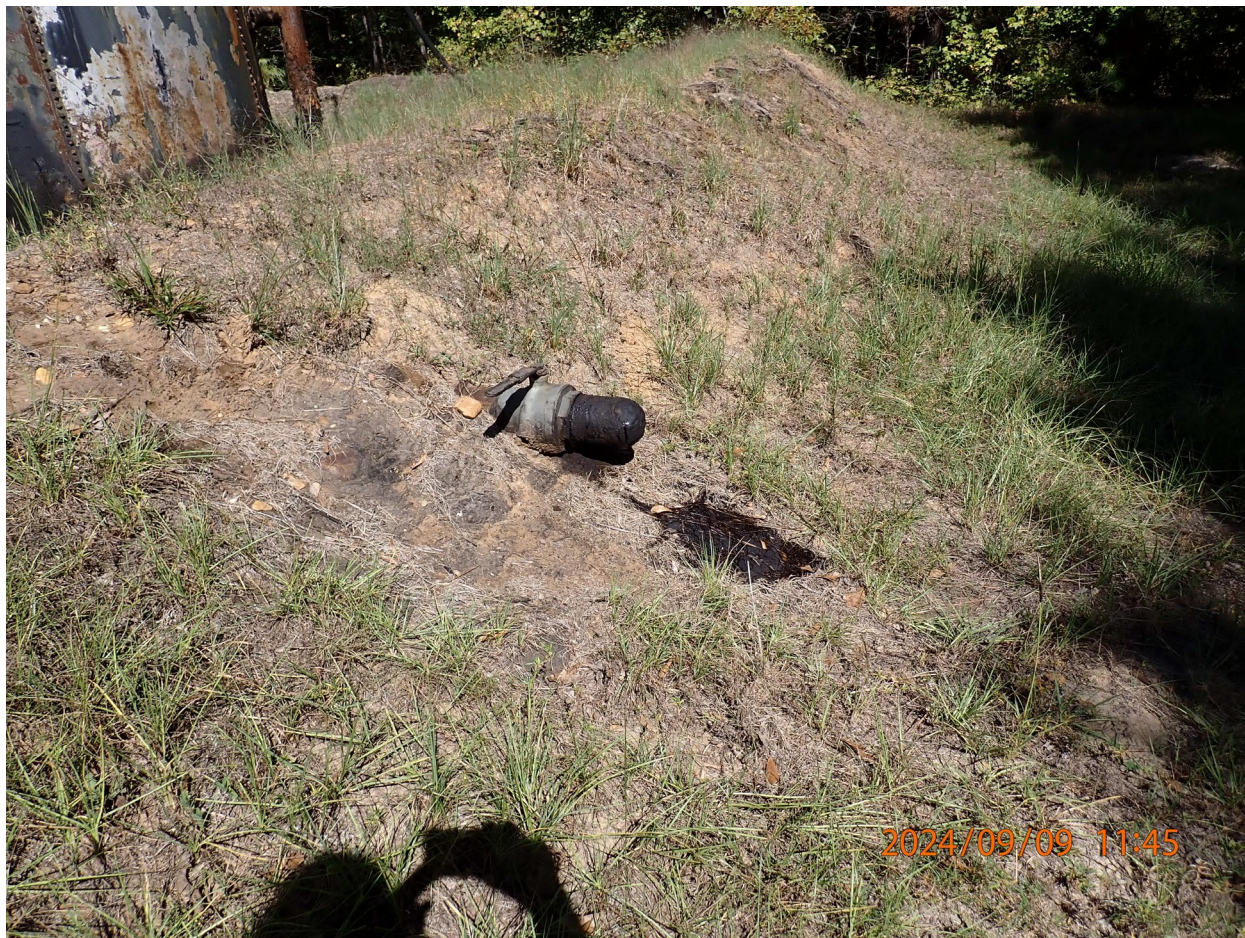
I observed production/transfer lines outside secondary containment without catchment buckets, see Photo No. 2 and No. 3.

**Description:** Looking NW, this photo shows a production/transfer pipe without a catch bucket.

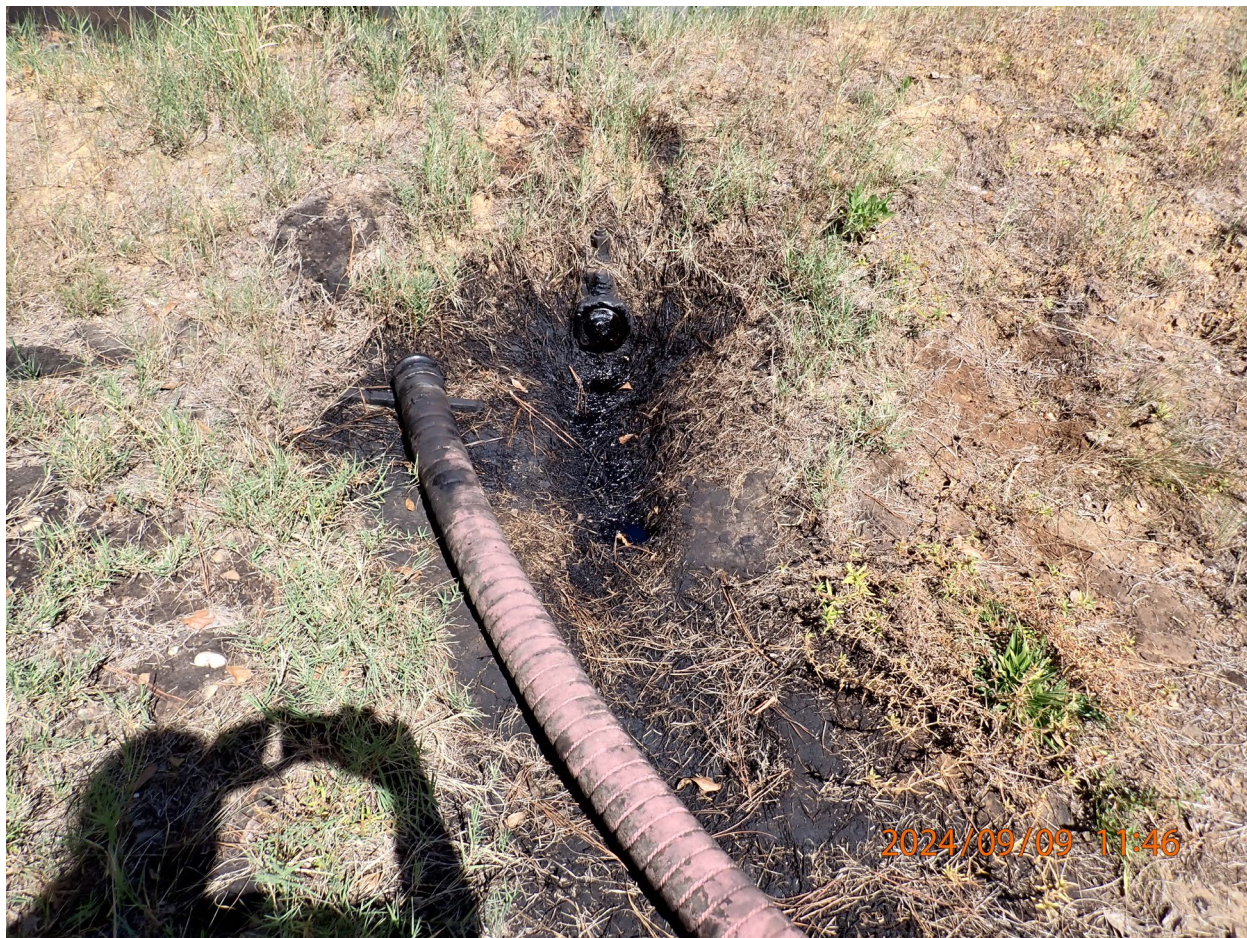
Photo No. 3

**Description:** Looking NW, this photo shows a second production/transfer pipe without a catch bucket and loose oil outside of secondary containment.

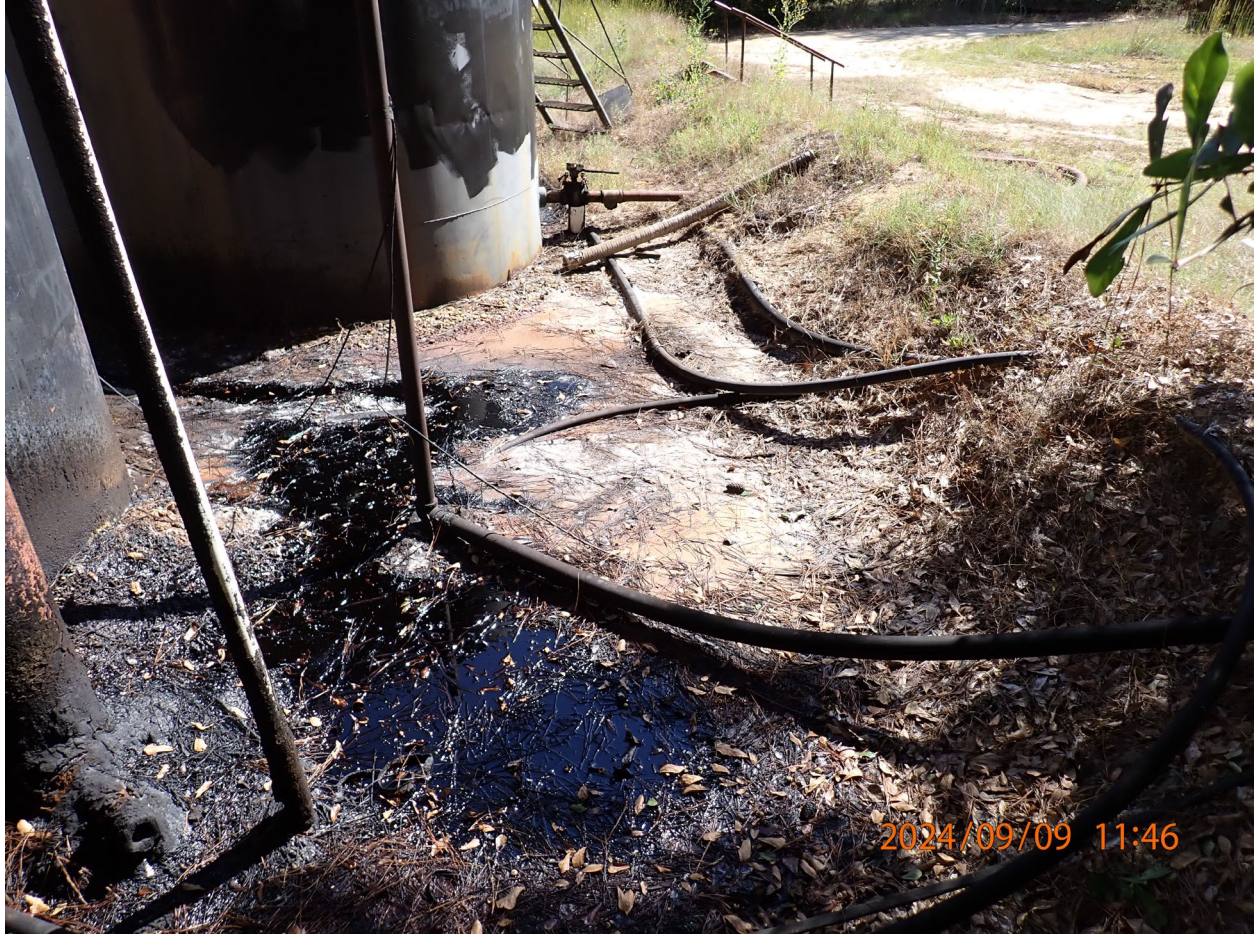
Photo No. 4

I observed loose oil around tanks and active leaks of crude oil from tanks/valves inside secondary containment, see Photo No. 4, No. 11, No. 12, and No. 19.

**Description:** Looking NW, this photo shows loose oil inside the secondary containment.

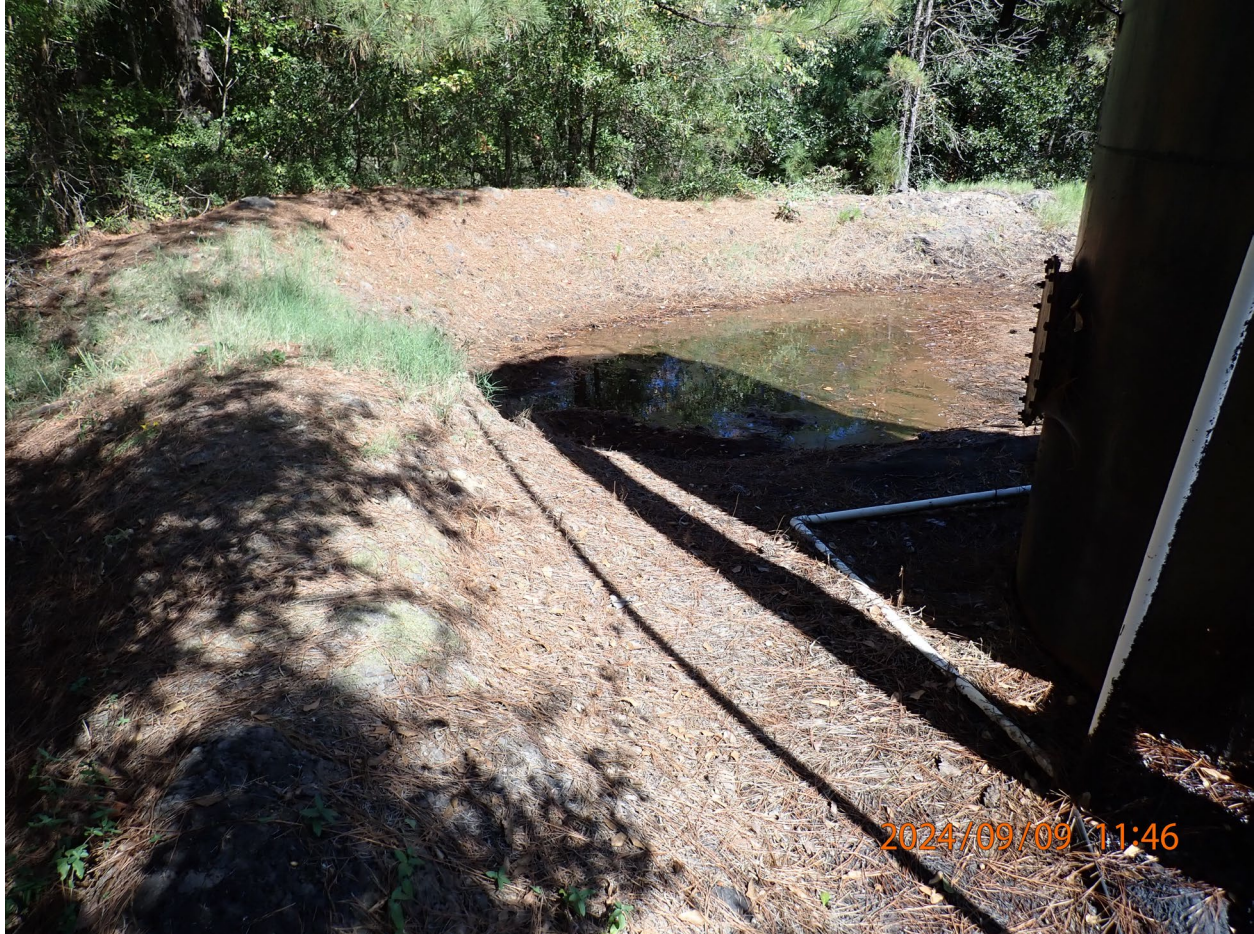
I observed the drainpipe, cap, and flowpath from the secondary containment; see Photo No. 5 through No. 9.

**Description:** Looking NW, this photo shows produced water inside the secondary containment.

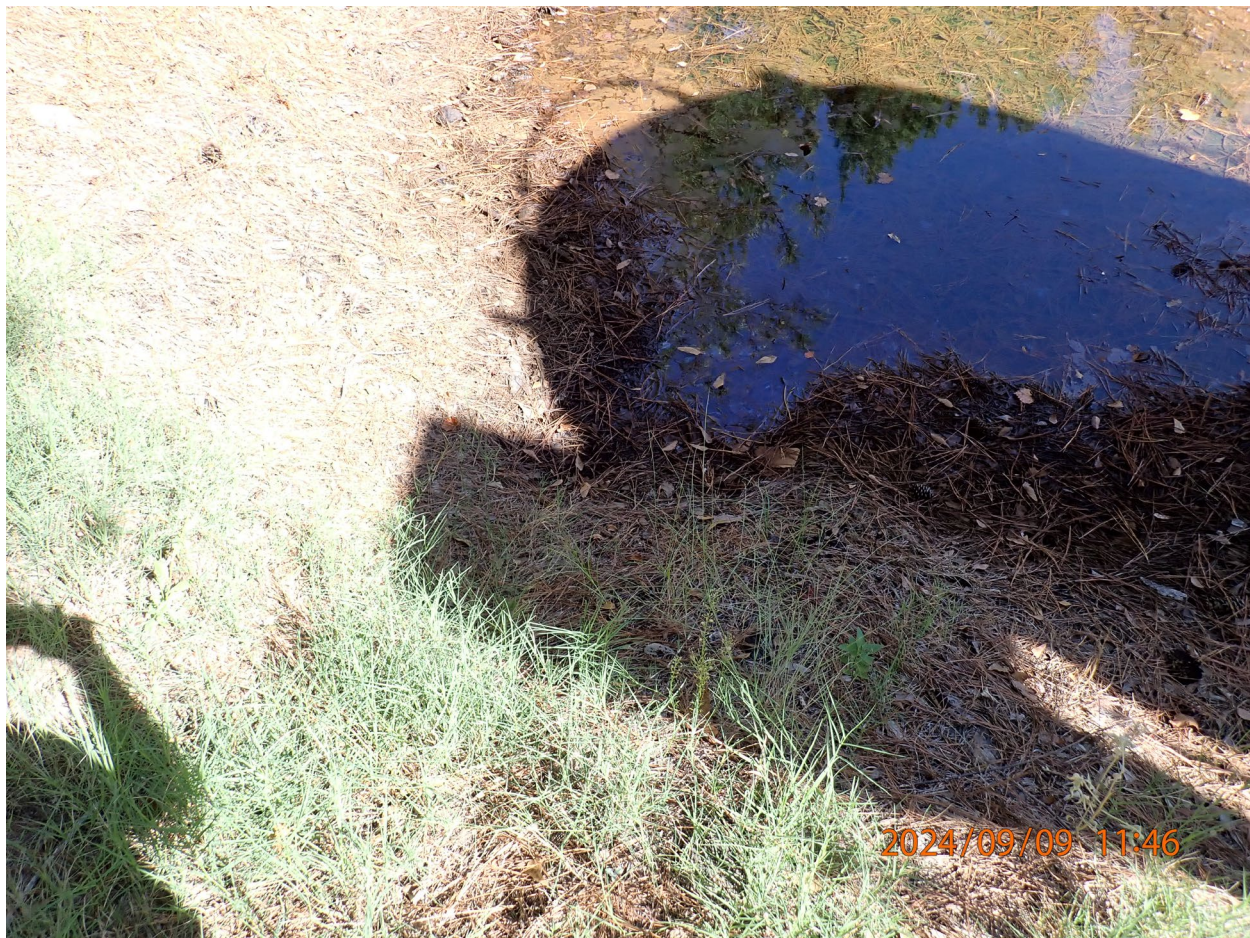
Photo No. 6

**Description:** Looking NW, this photo shows produced water collected at the drainpipe for secondary containment.

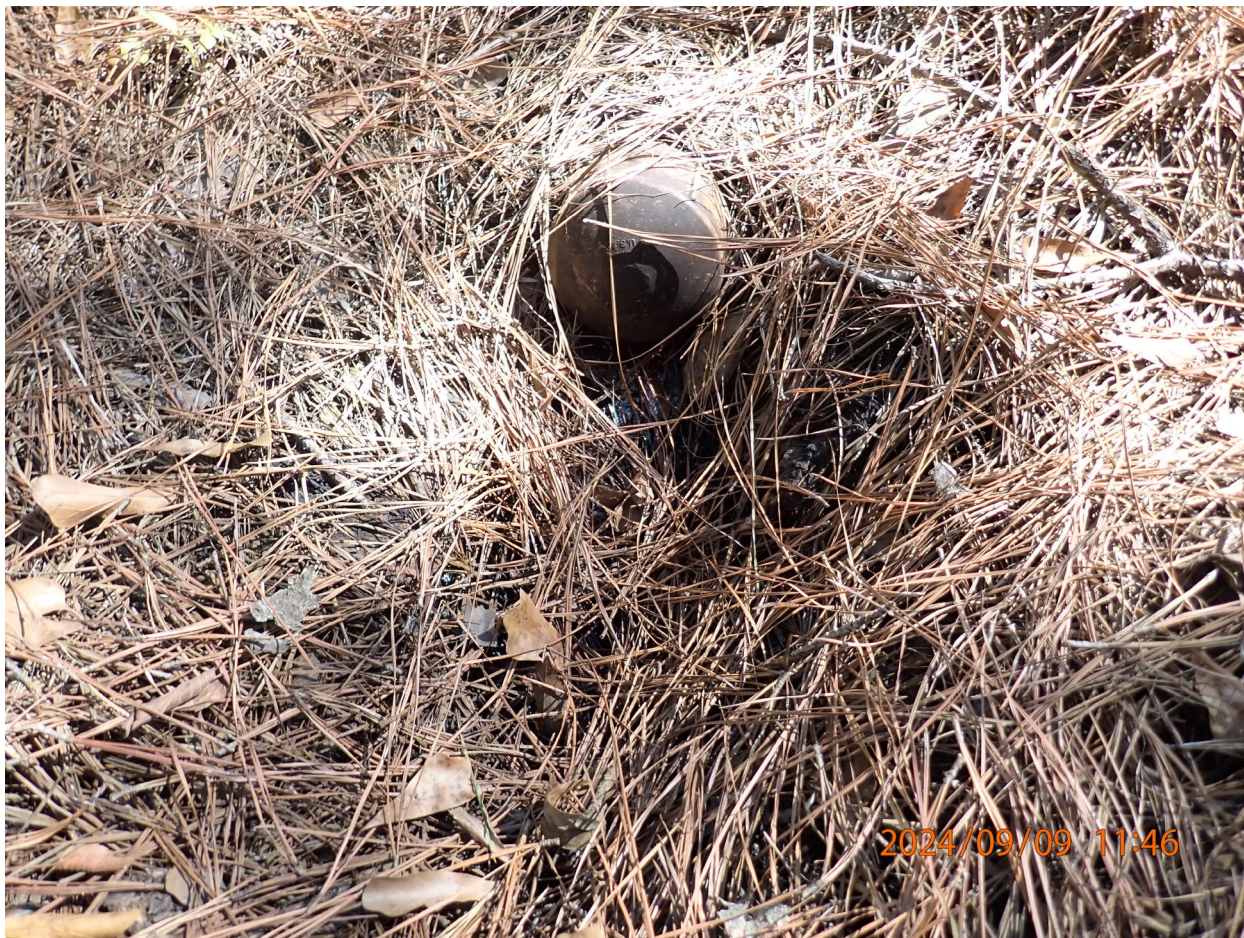
Photo No. 7

**Description:** Looking W, this photo shows the cap on the drainpipe for secondary containment; minor leak of crude oil was noted at the drainpipe.

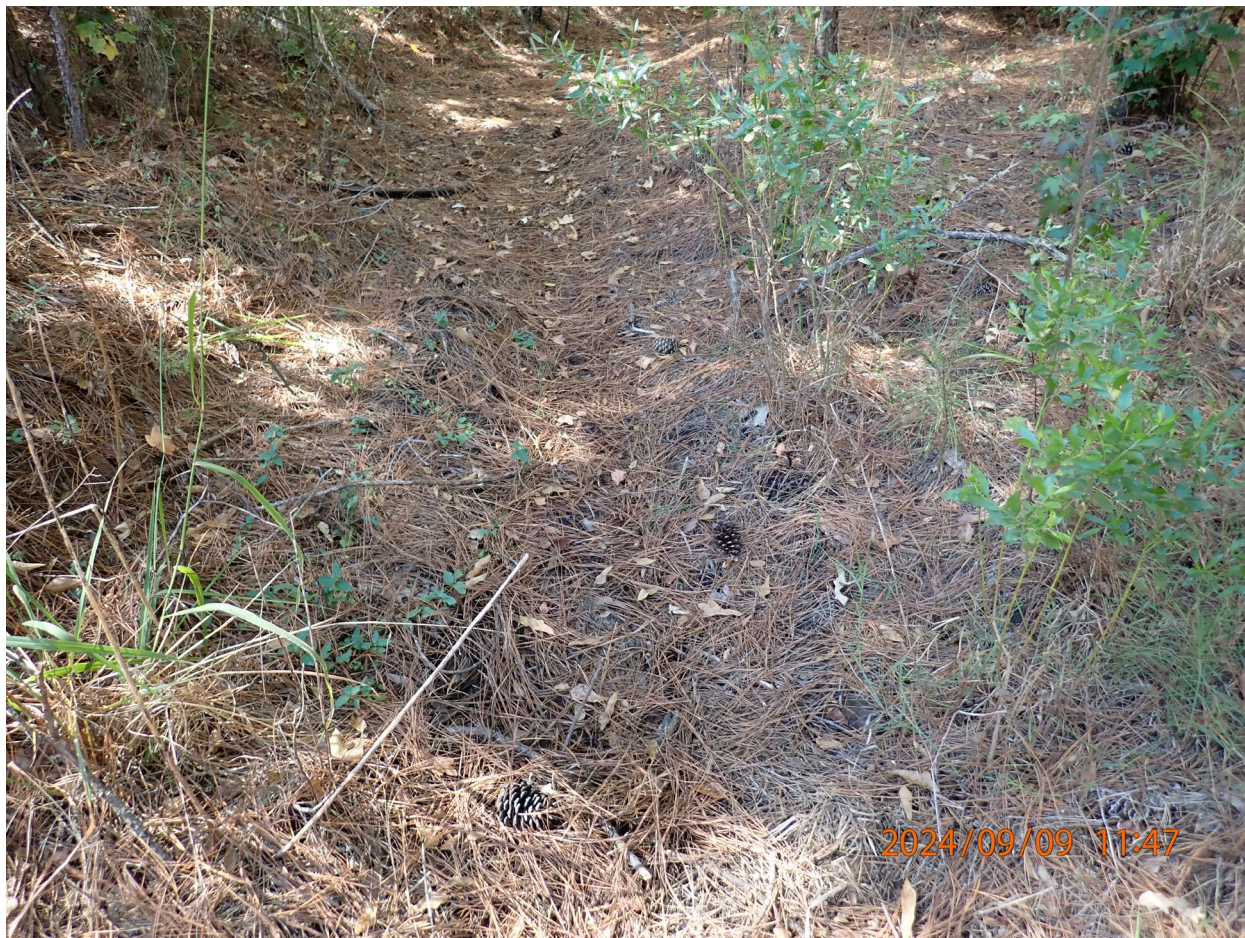
Photo No. 8

**Description:** Looking SE, this photo shows the flowpath from the drainpipe for secondary containment leading to Holmes Creek.

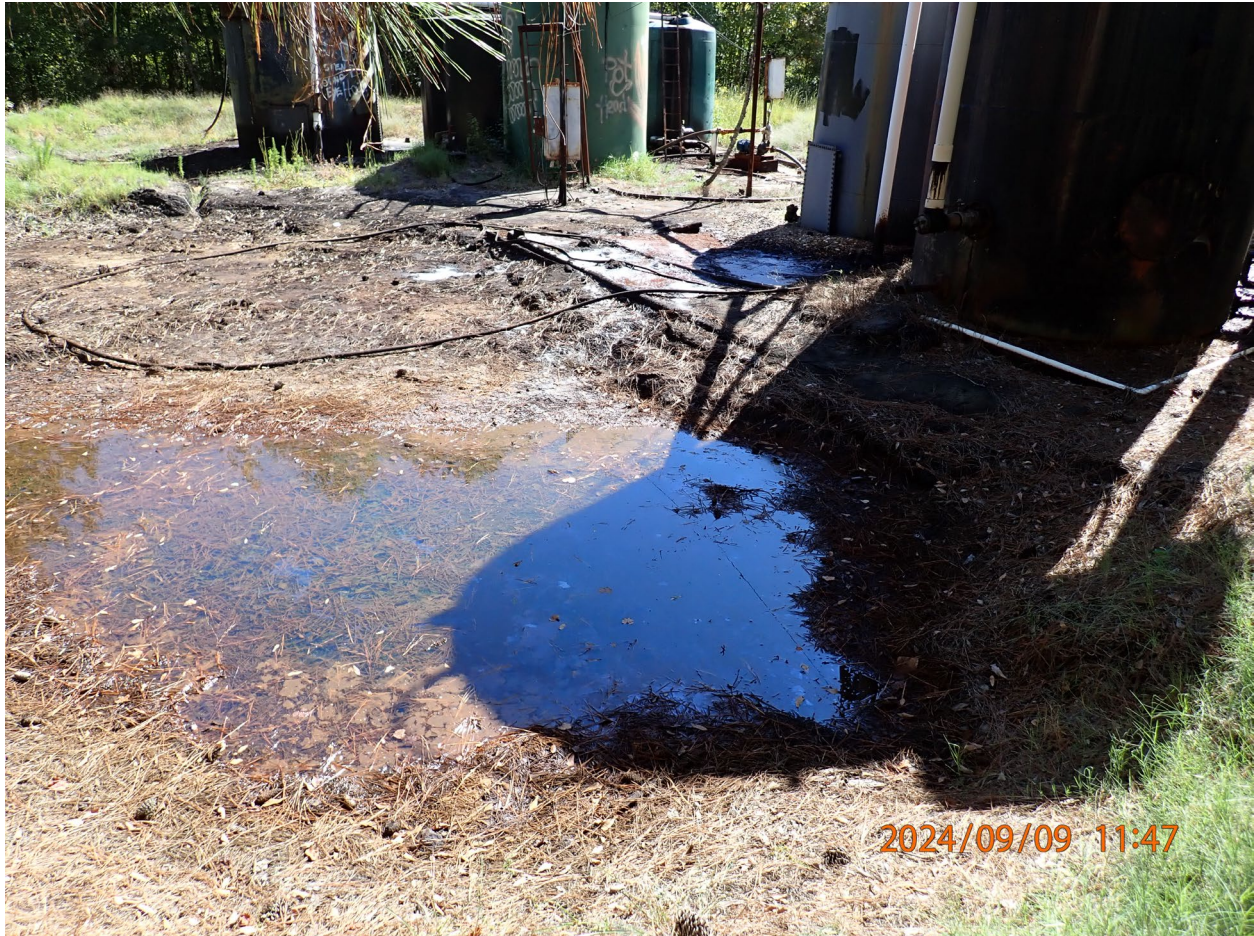
Photo No. 9

**Description:** Looking SW, this photo shows additional view of the produced water inside secondary containment.

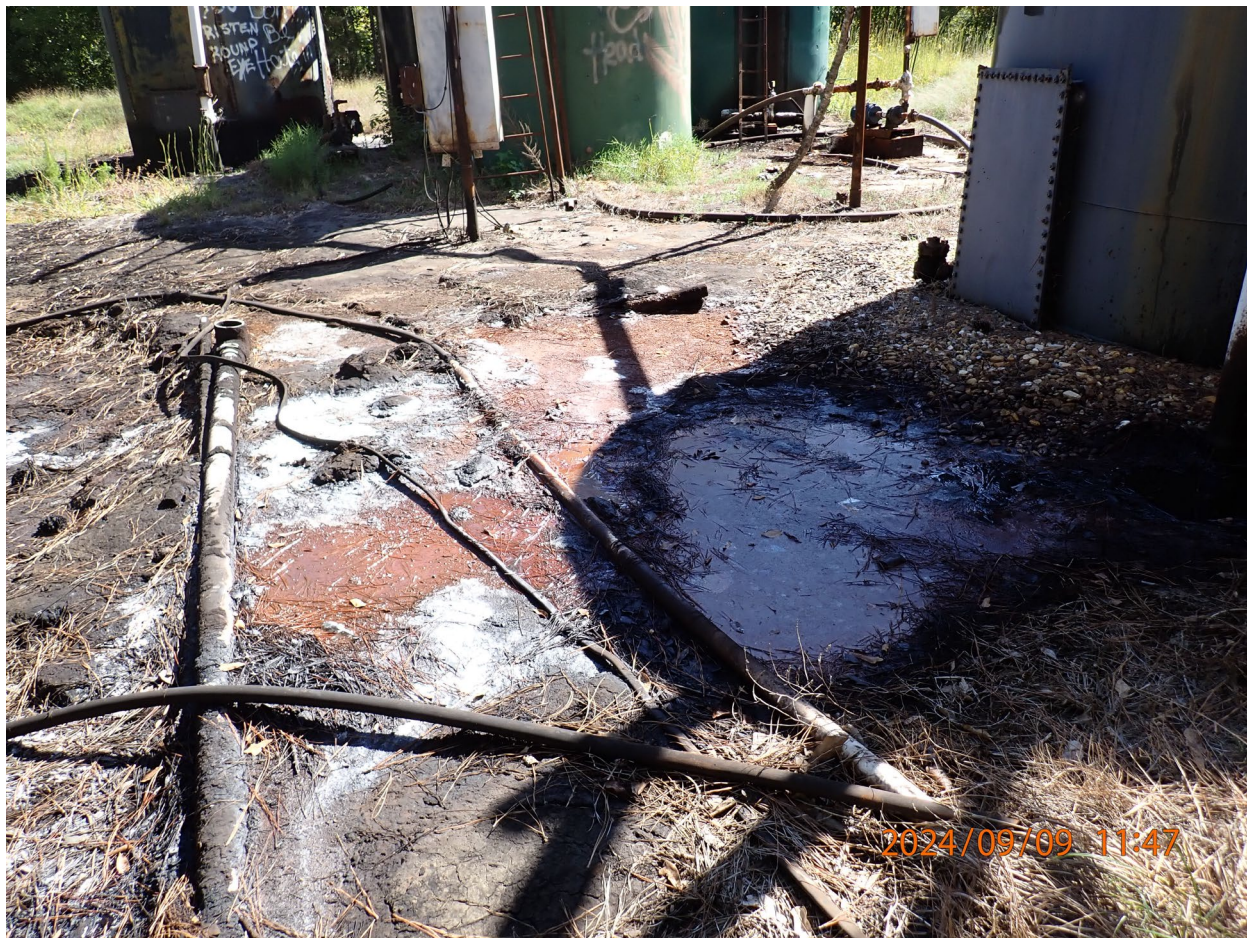
Photo No. 10

I observed active leaks of saltwater, saltwater staining, salt crystals, and saltwater corrosion of a storage tank inside secondary containment; see Photo No. 10, and No. 13 through No. 18.

**Description:** Looking W-SW, this photo shows saltwater and salt crystals inside secondary containment.

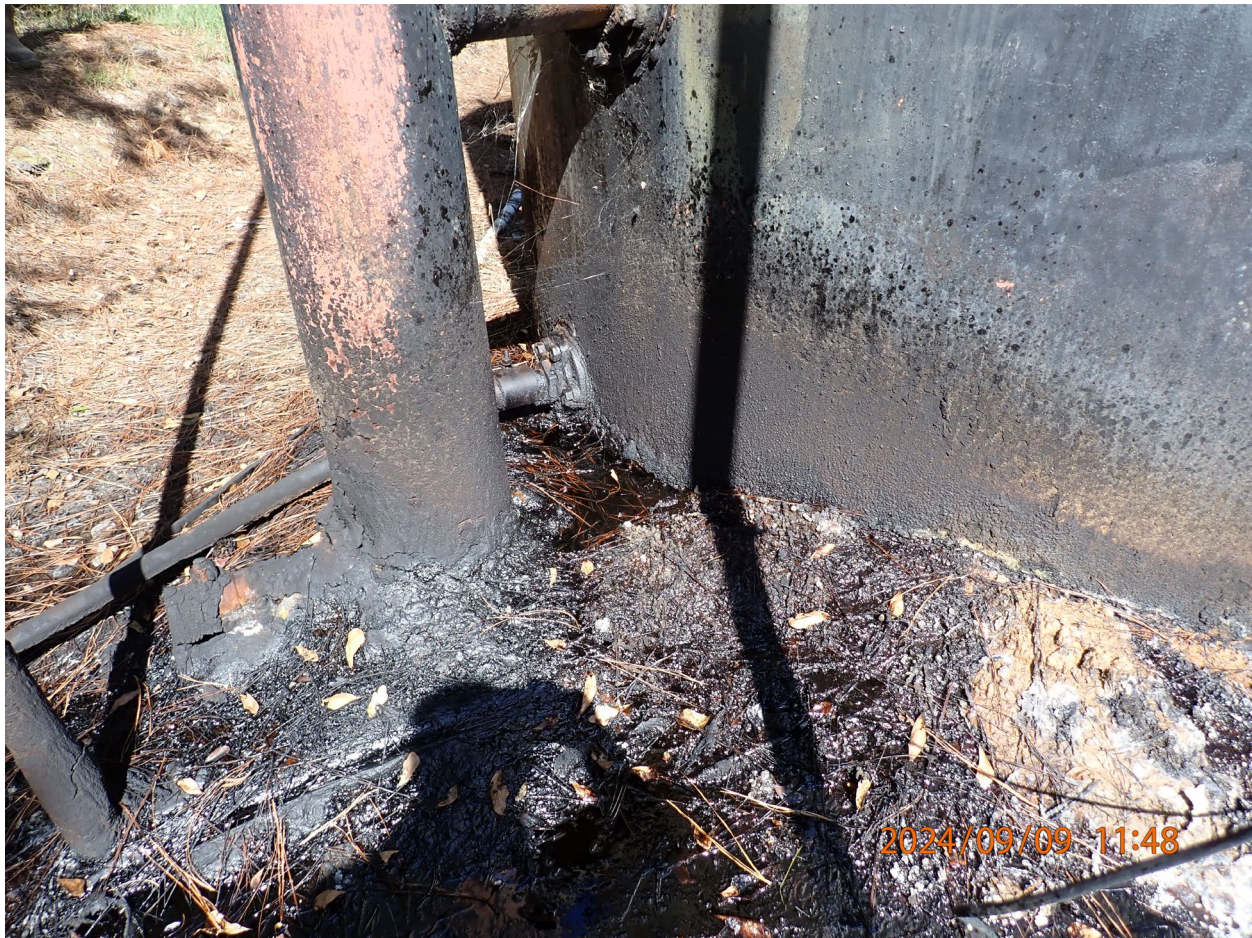
Photo No. 11

**Description:** Looking NW, this photo shows a crude oil leak and loose oil inside secondary containment.

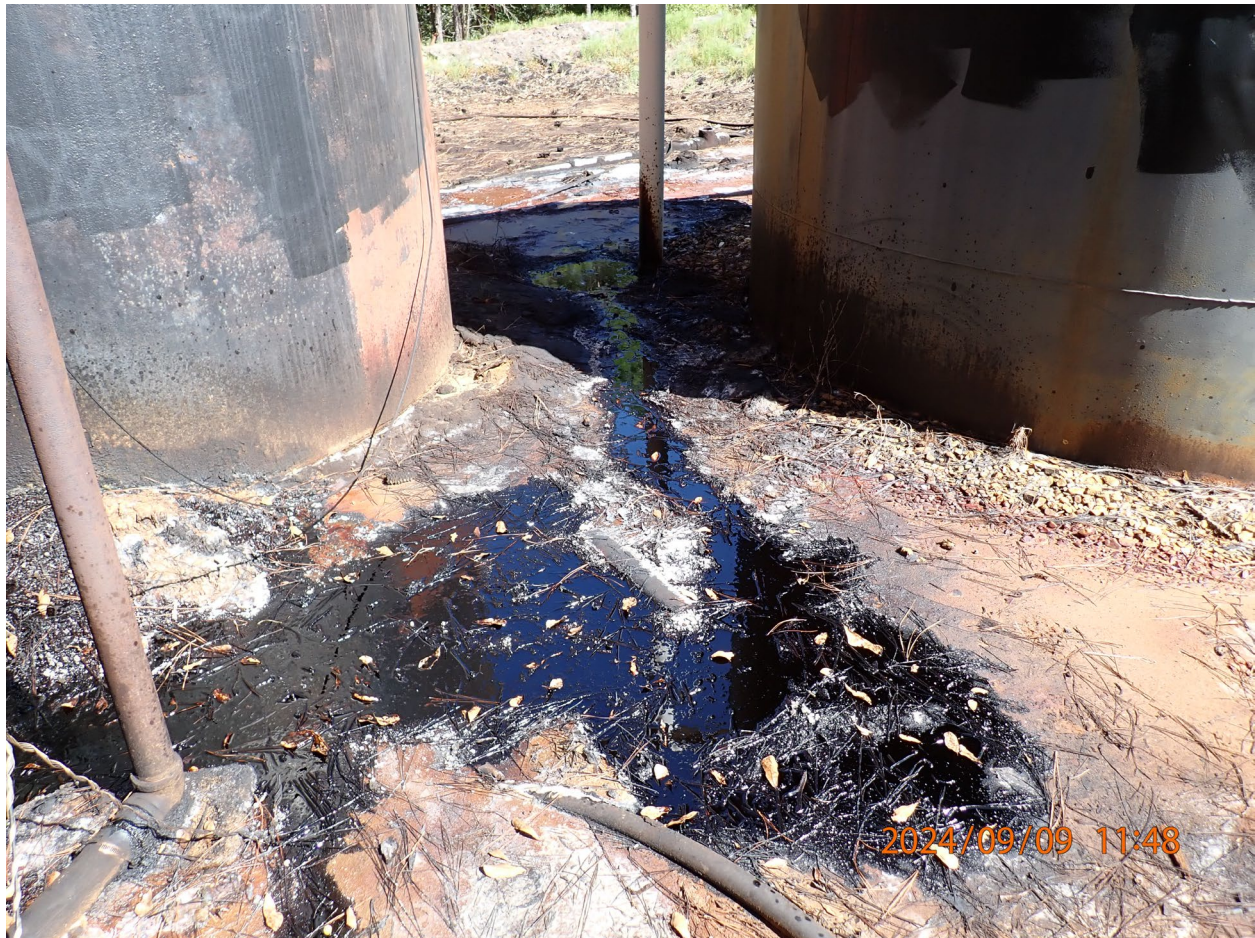
Photo No. 12

**Description:** Looking NW, this photo shows the flowpath of crude oil from a storage tank inside secondary containment.

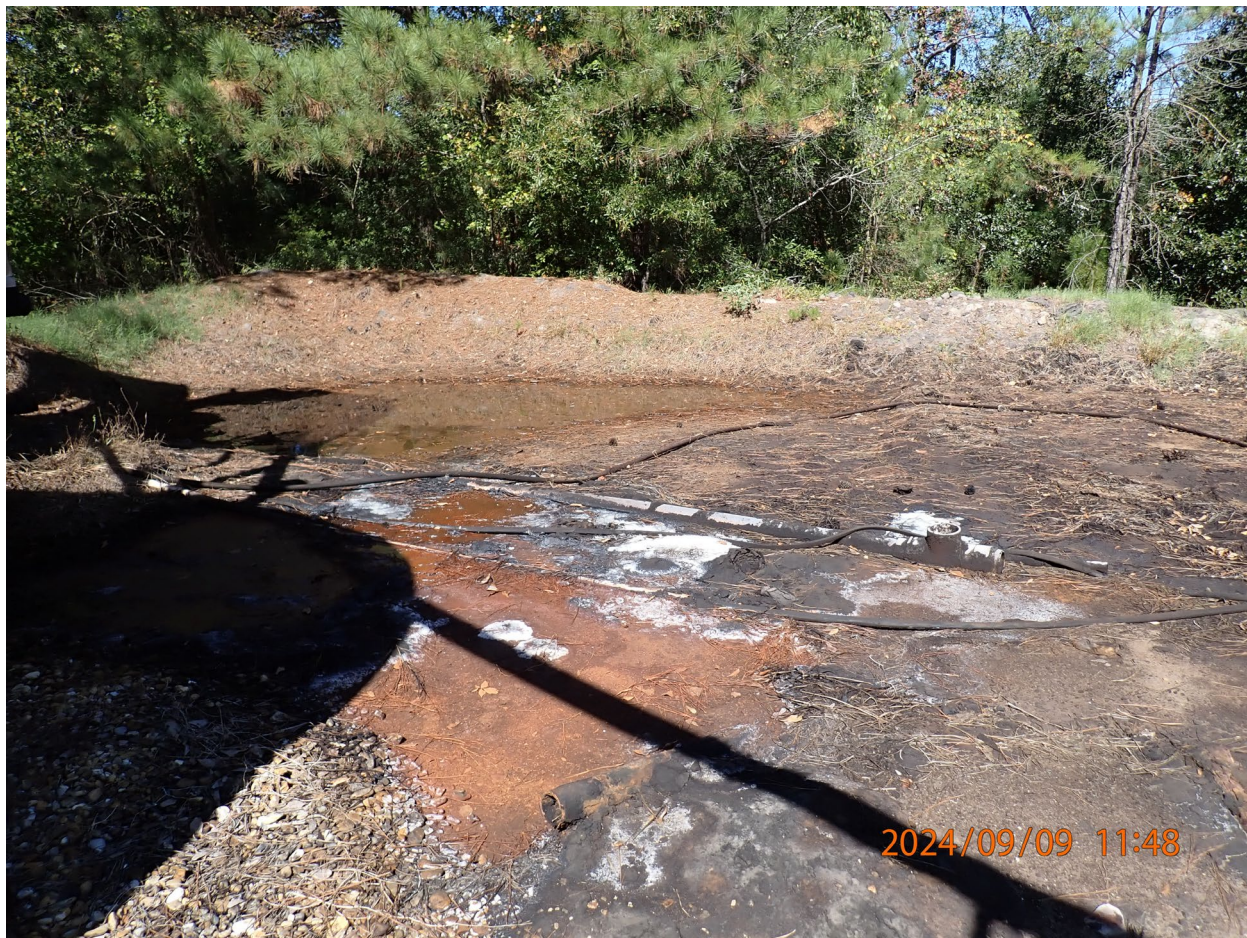
Photo No. 13

**Description:** Looking NE, this photo shows an additional view of saltwater and salt crystals inside secondary containment.

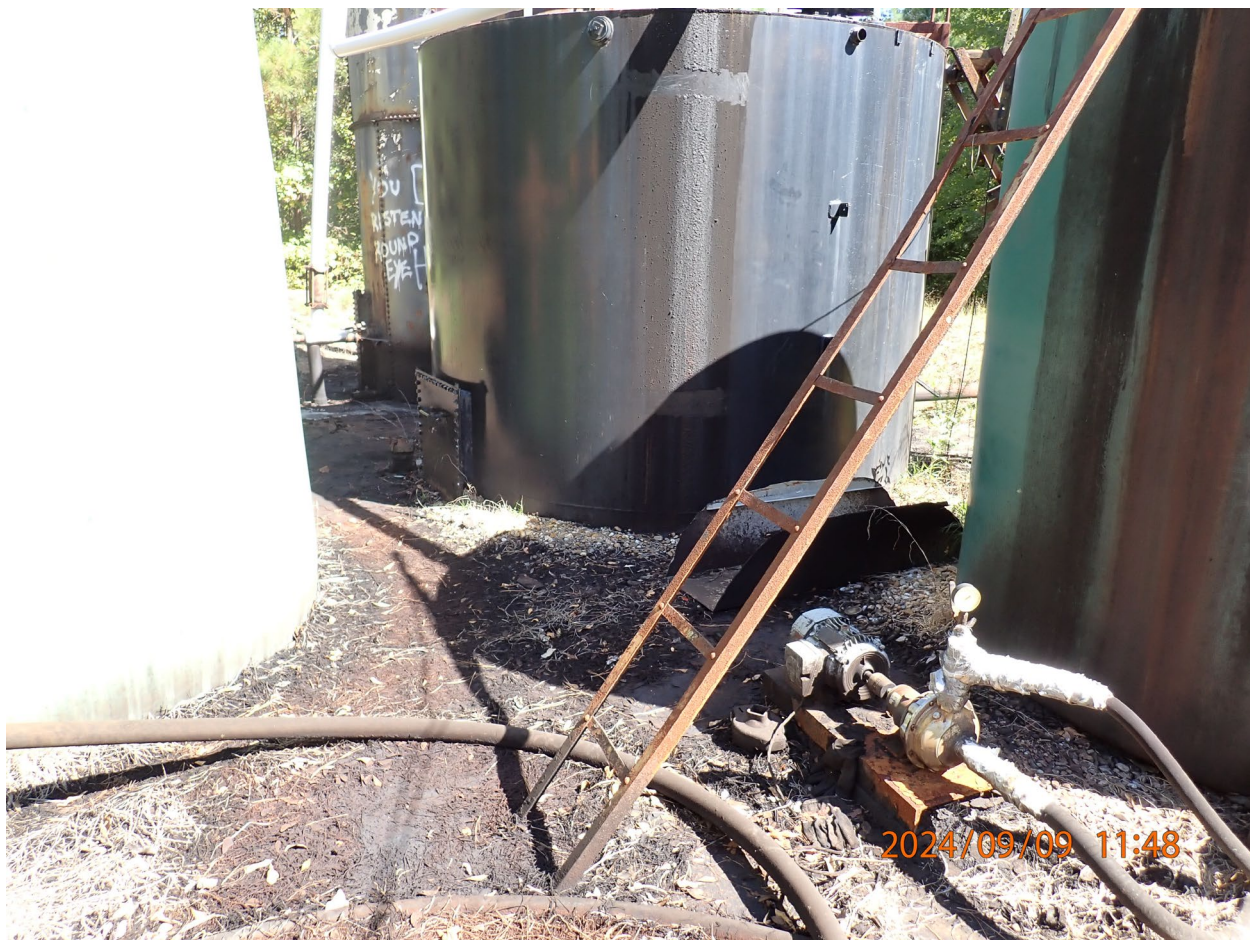
Photo No. 14

**Description:** Looking NW, this photo shows an overview of the storage tanks inside secondary containment.

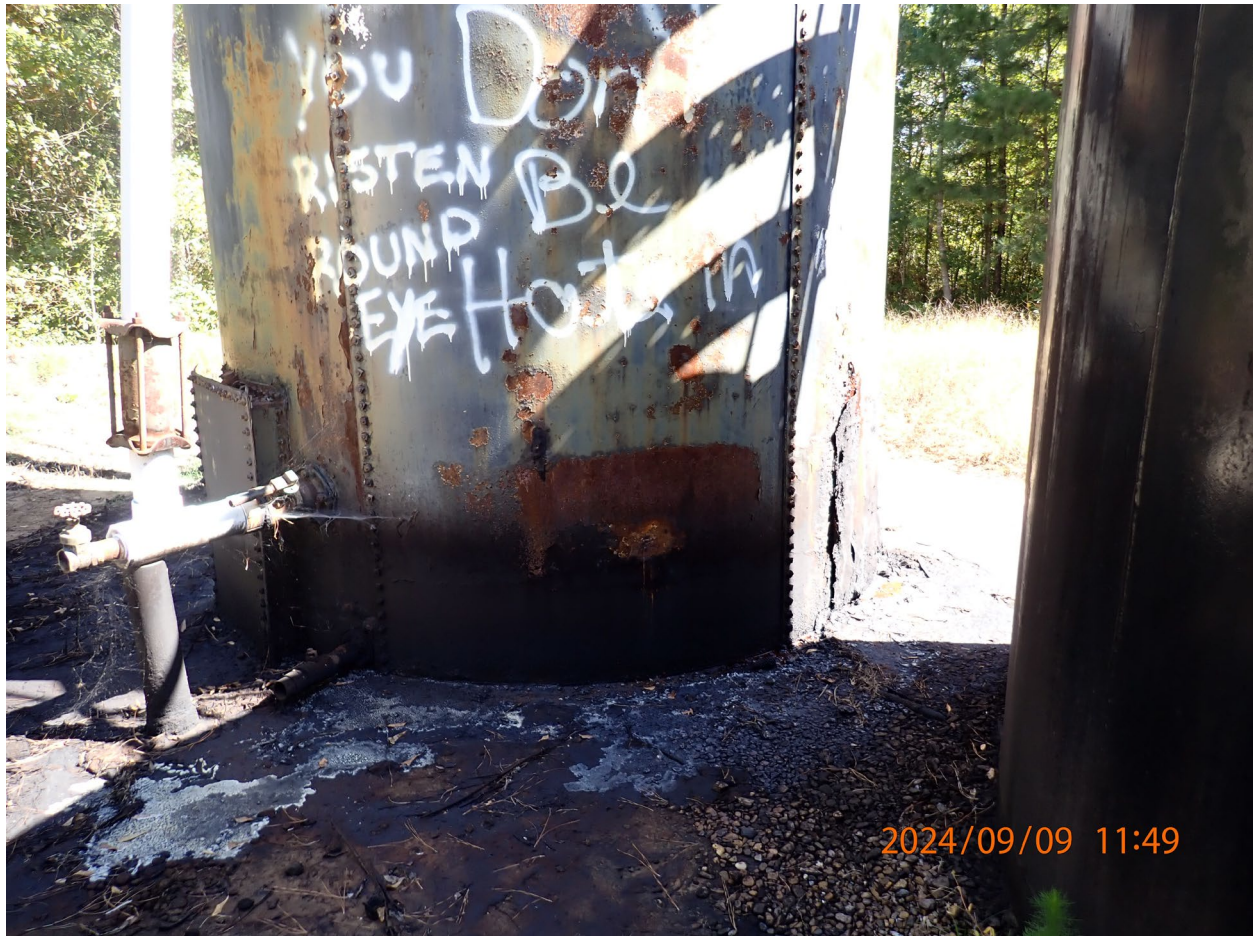
Photo No. 15

**Description:** Looking NW, this photo shows a corroded tank with loose oil and salt crystals.

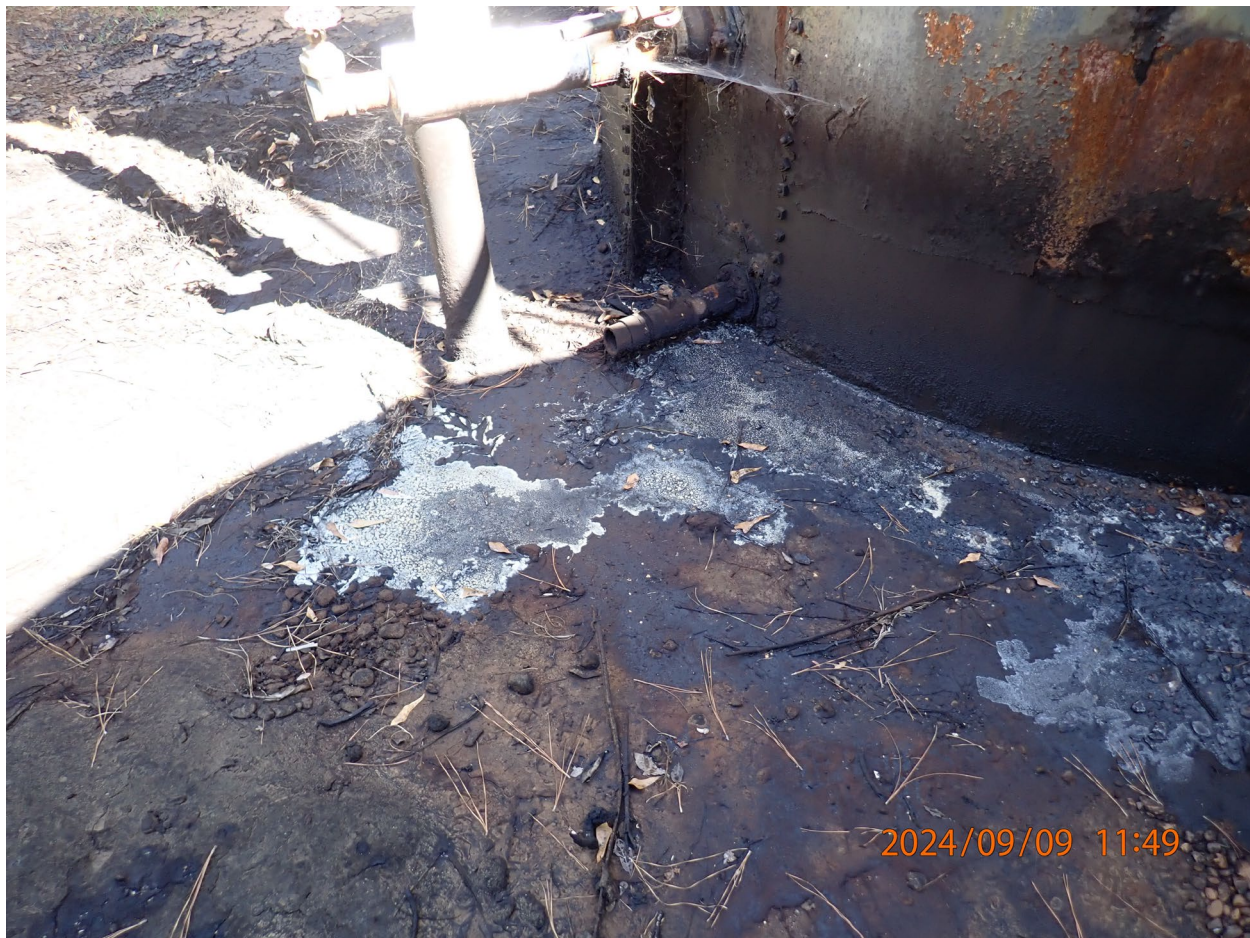
Photo No. 16

**Description:** Looking NW, this photo shows an additional view of the loose oil and salt crystals from Photo No. 15.

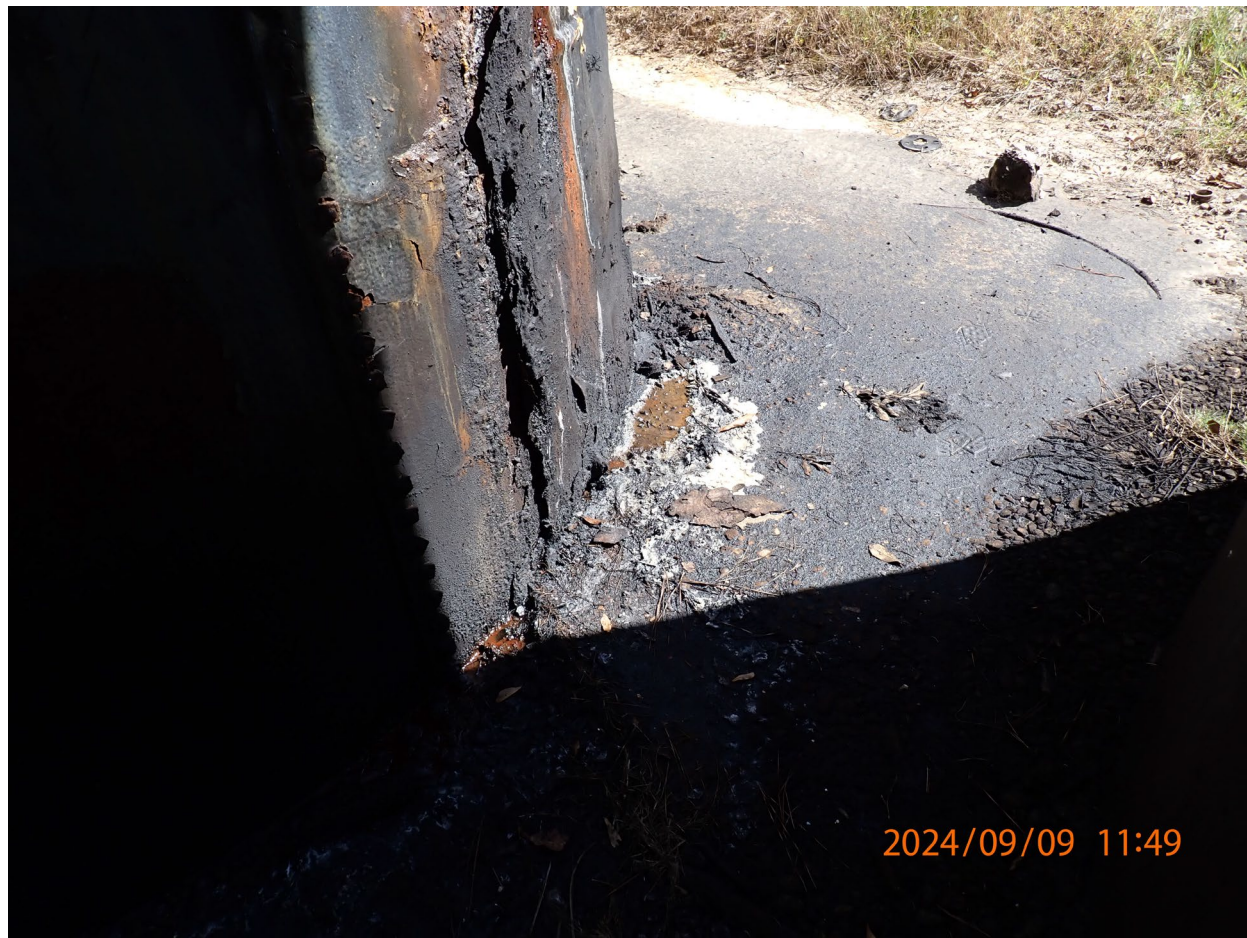
Photo No. 17

**Description:** Looking W-NW, this photo shows a closeup of the corroded tank inside secondary containment from Photo No. 15 and 16.

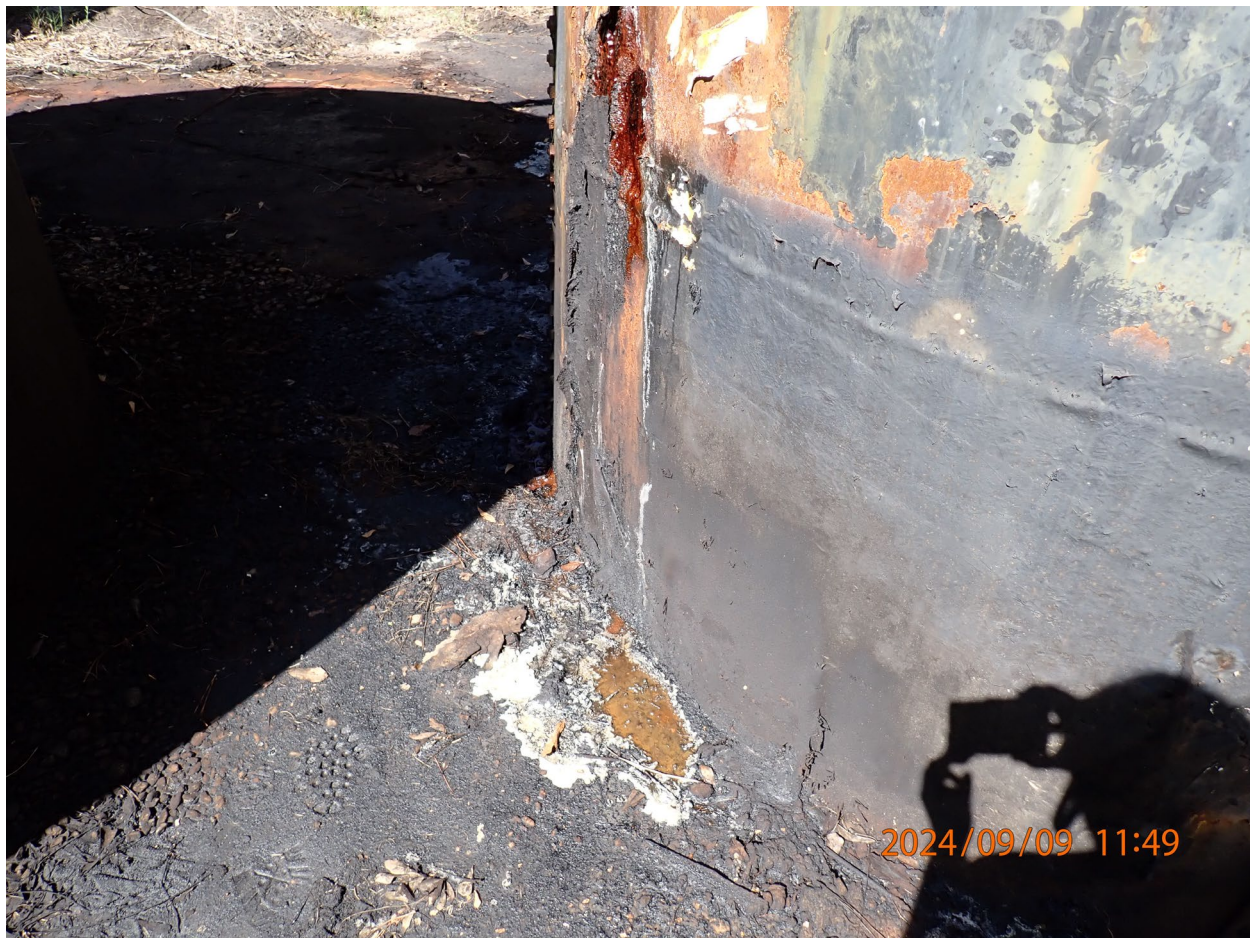
Photo No. 18

**Description:** Looking NE, this photo shows an active leak in the corroded storage tank from Photo No. 15 through 17.

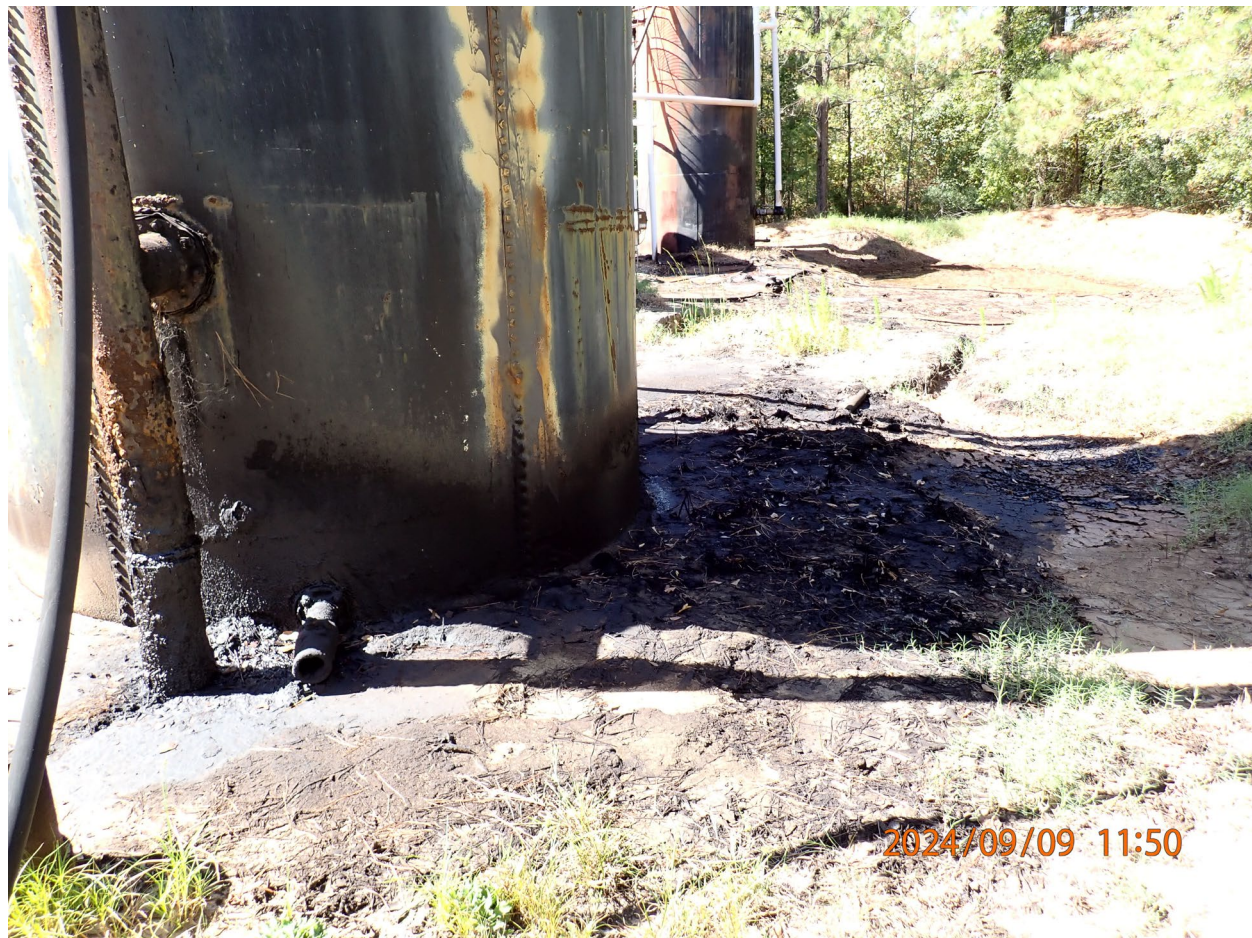
Photo No. 19

**Description:** Looking W-NW, this photo shows an overview from the backside of the secondary containment.
