## Region 6 - Enforcement & Compliance Assurance Division

### INSPECTION REPORT

| Company Name: | <b>Eubanks, James and Mike (J&amp;M)</b> | |
| Facility Name: | <b>Patterson 2 and 3 SWD Tank Battery</b> | |

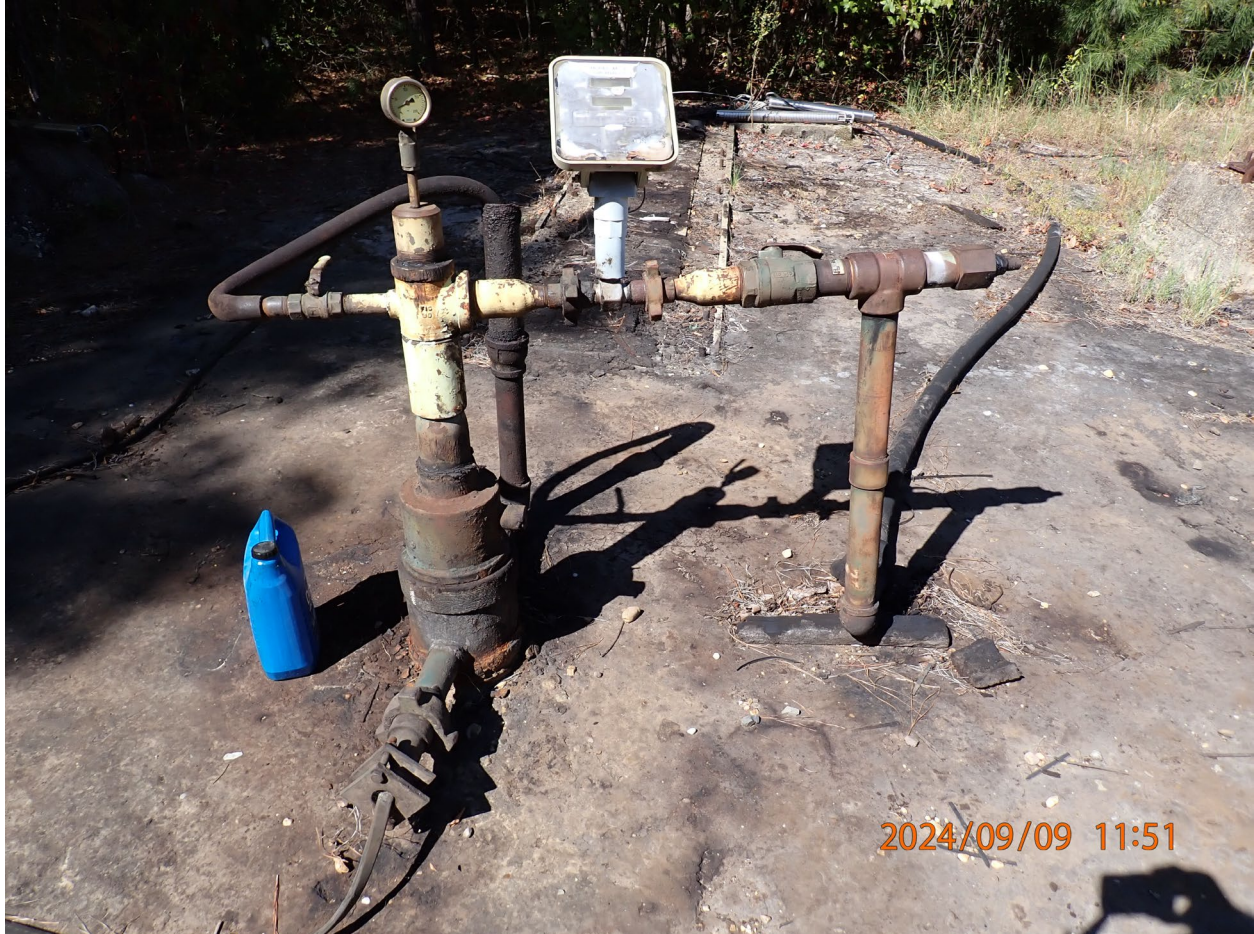
Photo No. 20

I observed one of two SWD wells located in the area, see Photo No. 20.

**Description:** Looking N-NE, this photo shows one of two Saltwater Disposal (SWD) wells located in the area.
