*Resource Conservation and Recovery Act (RCRA)*  
 Compliance Evaluation Inspection

Facility Name:	Dana Transport		
EPA ID Number:	PRR000018259		
Date of Inspection:	January 23, 2025		
Generator Status in Record:	LQG		
Generator Status at the time of inspection:	LQG		
RCRA Permitted:	No		
Basis for Inspection:	Core Program		
Corrective Action:	No		
Project ID	CEPD-RCRA-09-0141		
Facility Physical Location: (Municipality, PR, zip code)	{10203 Industry Drive}		
Geographical Coordinates:	18.417629, -66.1401		
Facility Owner:	Ronald Dana	732-750-9100	
	rondana@danacompanies.com		
	Mailing address: 210 Essex Ave. East, Avenel, NJ. 07001		
Facility Operator:	Alberto Grau	787-642-8968	
	agrau@danacompanies.com		
	Mailing address: 195 Industrial Luchetti, carretera 5 Industrial Luchetti , PR 00961-7420		
NAICS:	562998	SIC:	
Area:			
Number Employees:	30		
Personnel participating in inspection:			
<b>Inspector's Name</b>	<b>Affiliation</b>	<b>Title</b>	<b>{phone/email}</b>
Khrystian M Vazquez	EPA Region 2-CEPD	RCRA Inspector	787-977-5860

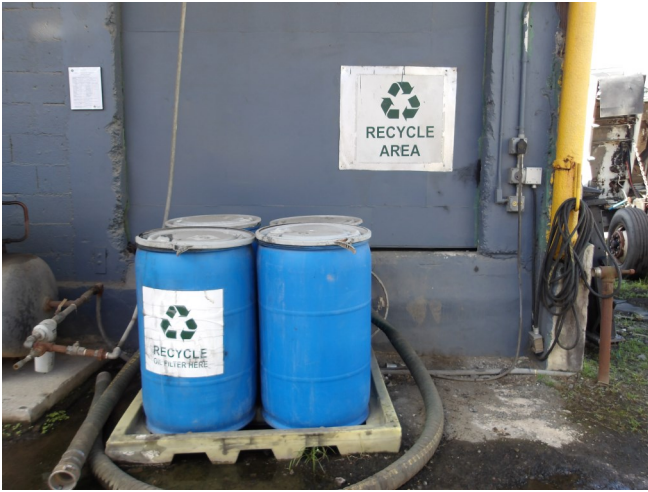
Picture 100-001  
Used Oil Recycled Area

The area is located outside the Tools and Parts area and is identified as Recycle Area. Four (4) 55gallon blue plastic containers were on top of a wood pallet. The first two containers had pads impregnated with oil. The third container had one empty bottle of SW-30 motor oil, and the last (fourth) container had one empty spray of Harris Engine Enamel.

**These containers had a recycle label, but none of them had a Used Oil or Universal Waste Label.**

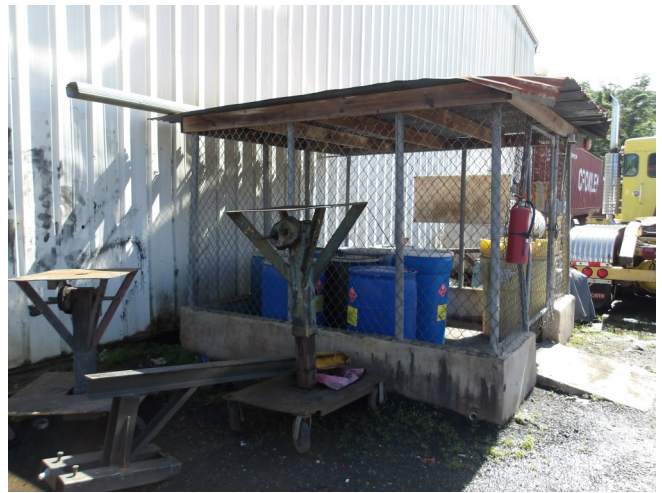
Picture 100-022  
Side view of HWSA

The HWSA is a pad locked cyclone fenced square, built over a small dike with a ramp in the front and a poorly<sup>1</sup> constructed aluminum roof. Outside and on the left side of the HWSA there is a fire extinguisher with its certification up to date, but there was no **“NO SMOKE”** sign observed (*Reference: General (40 CFR § 262 Subpart A)*). The fence gate had a sign that read **“CAUTION HAZARDOUS WASTE STORAGE AREA”**. On the top left corner was the fire alarm. **In addition, the HWSA did not have a water system at adequate volume and pressure to supply water hose stream, or foam in an emergency event** (*Reference: 40 CFR § 262 SUBPART M*). The right side of the HWSA had a sign, without a **dated emergency name and locations** of the Fire Department, Police, Hospitals, National Response Center and EQB (now Department of Environmental and Natural Resources).

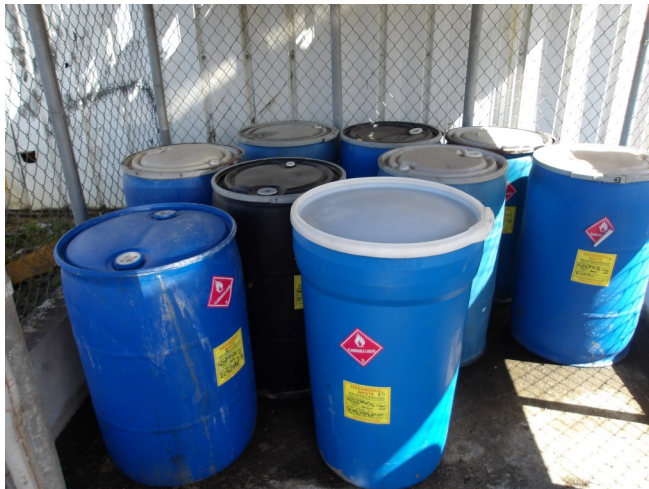
Picture 100-037  
Containers inside the HWSA

**During the observation of this area, I told Mr. Hernandez that aisle space was not observed and the importance of such practice.**

**During the observation of the HWSA, aisle space was not observed in between containers.**

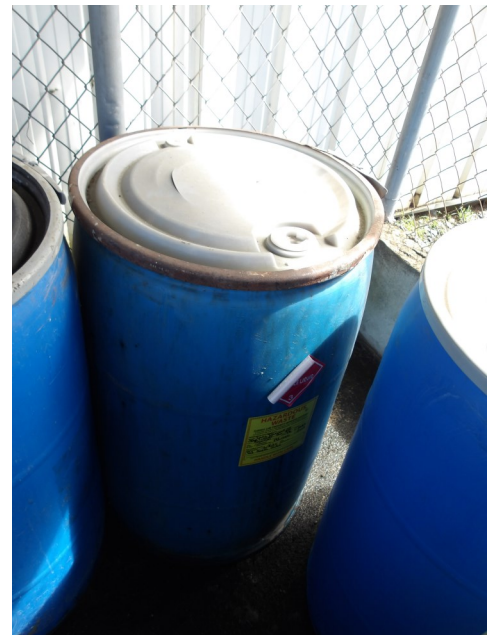
Picture 100-047  
Container with top lid crack

- Six-55 gallon blue plastic container with caustic sludge all dated 12/06/24 with the appropriate label and pictogram. **The lid from this container was cracked.**

**At the time of the inspection the lid from one of the HWSA containers was observed cracked.**

If a container holding hazardous waste is not in good condition, or if it begins to leak, the large quantity generator must immediately transfer the hazardous waste from this container to a container that is in good condition, or immediately manage the waste in some other way that complies with the conditions for exemption of this section.

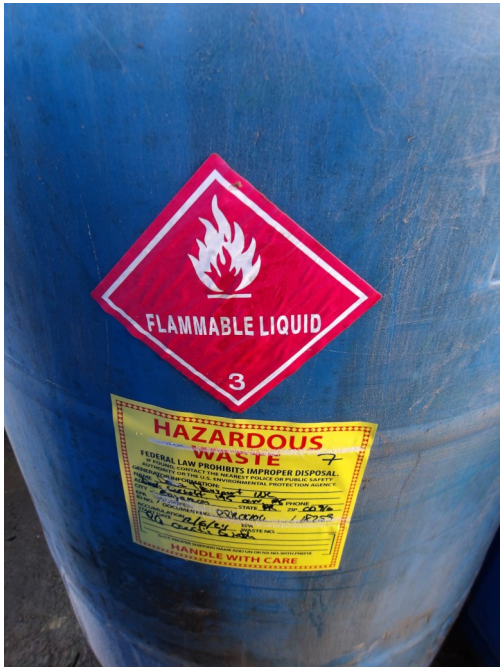
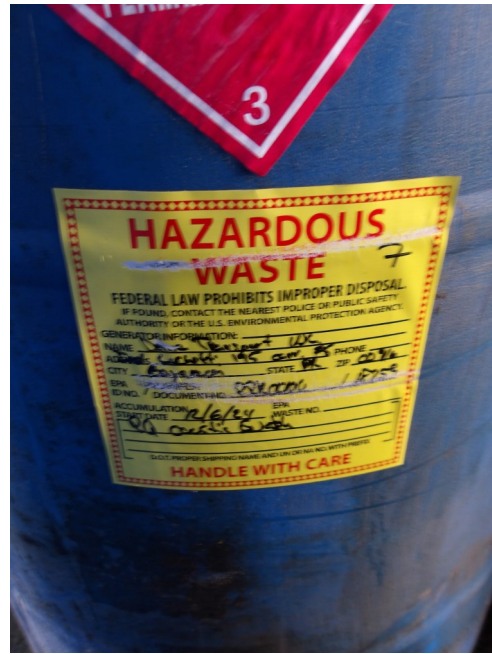
Picture 100-048  
Information of Hazardous waste inside container with cracked lid

Picture 100-049  
Information of Hazardous waste inside container with cracked lid

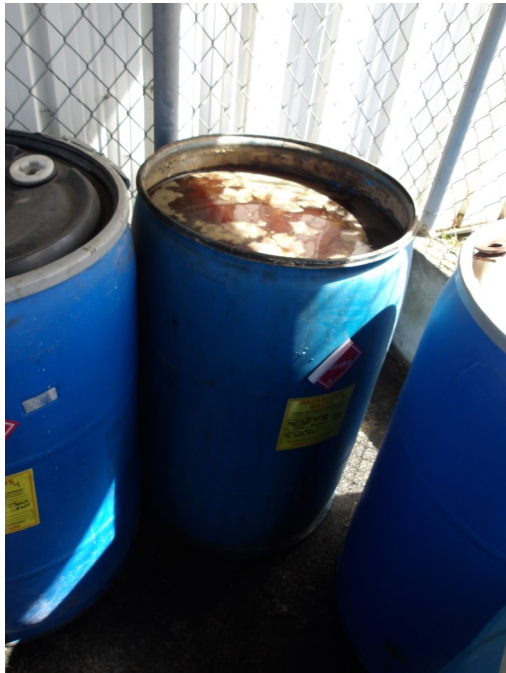
Picture 100-050  
Inside view of container with cracked lid

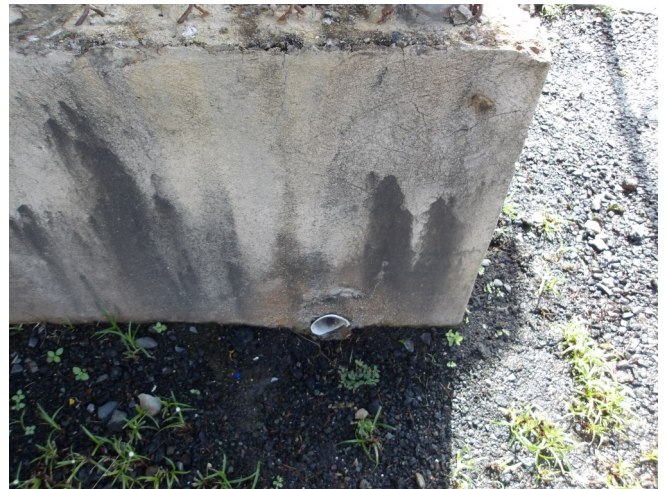
**At the time of the inspection the control valve that regulates spills to the outside at the dike around the HWSA was found to be broken.**

**At the time of the inspection the valve that controls spill to the outside of the dike surrounding the HWSA was found to be broken.**

Picture 100-056  
HWSA controlled valve missing

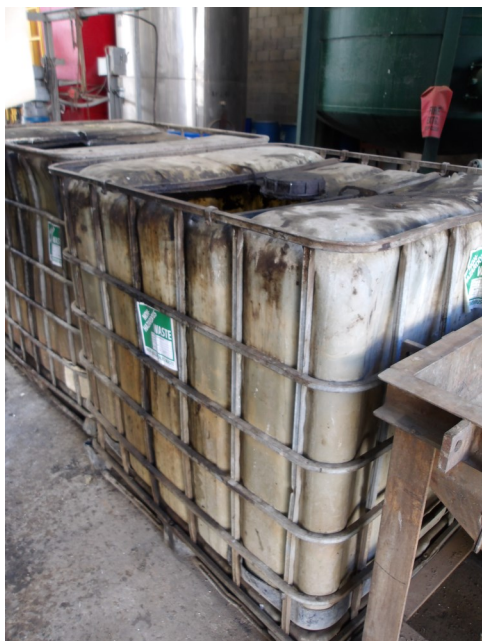
Picture 100-065  
Non-Hazardous waste container

Next to the WWTP I observed two Steel Pallets IBC tanks with a Non-Hazardous waste label. **The two tanks had effluent residues inside, but one of the tanks had a top broken opening space uncovered.** None of the tanks were in use at the time of the inspection. I asked Mr. Hernandez why there was no cover on the tanks and according to him is not mandatory to have the opening covered when not in used.

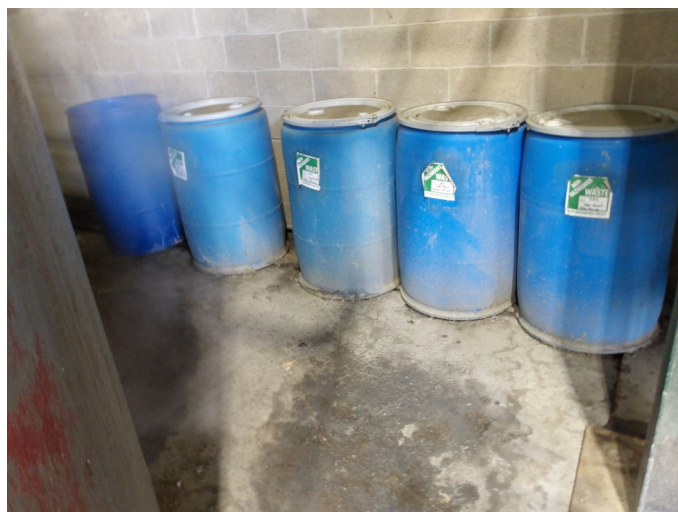
Picture 100-078  
Container use for raw material

On the side wall I also observed: Five (5) 55-gallon blue containers labeled non-hazardous waste caustic sodium. According to Mr. Hernandez, the labels were to identify the content but not waste, it was material to be use. I explained Mr. Hernandez that wrongfully labeling container can cause misunderstanding and mismanagement in an emergency. Mr. Hernandez immediately proceeded to take away the labels of all five containers.

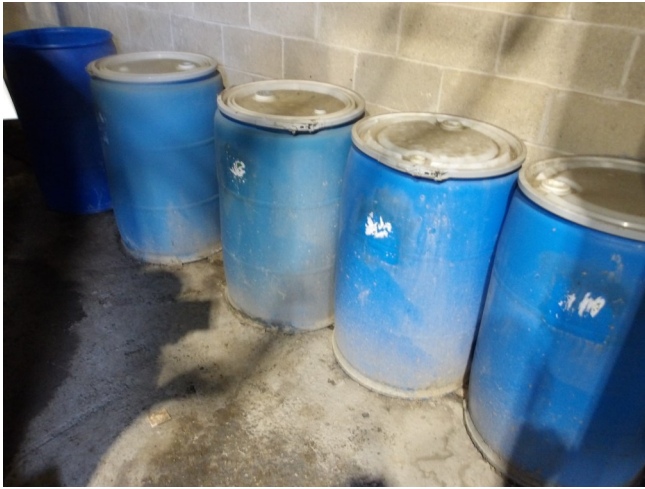
Picture 100-081  
Labels were removed from containers use for raw material

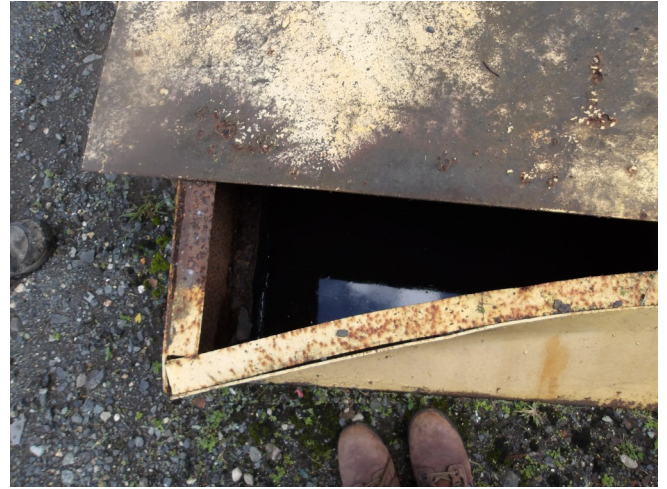
I also observed an oil tramp where the top lid did not cover the entire opening leaving it partially open.

Picture 100-107  
Oil tramp lid, does not fit the tramp
