**UNITED STATES ENVIRONMENTAL PROTECTION AGENCY  
REGION 8  
RESOURCE CONSERVATION AND RECOVERY ACT**

**Facility Name:** RNI Seep Ridge COWDF

**Type and Purpose of Inspection:** Compliance Evaluation Inspection (CEI) and Compliance Schedule Evaluation (CSE)

**Facility Type:** Commercial Oilfield Waste Disposal Facility

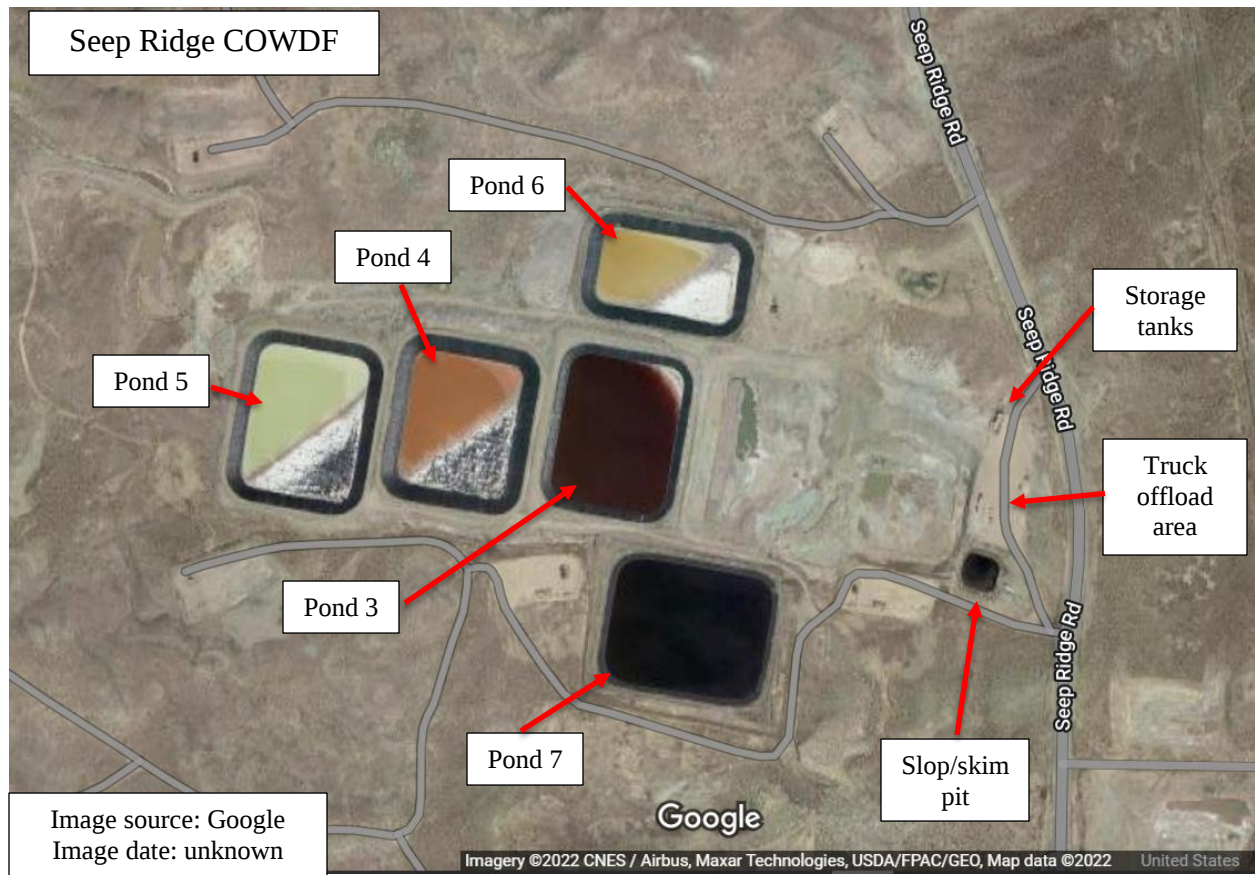
**ATTACHMENT 1: SITE MAP**

**General Facility and Process Description:** The RNI Seep Ridge facility (Seep Ridge) is a commercial oilfield waste disposal facility (COWDF) that receives RCRA Subtitle C-exempt E&P oilfield waste for storage, treatment and/or disposal. The site includes five evaporation ponds, one slop/skim pond, and one slop/skim vault with concrete cover. The facility was not in operation at the time of the inspection. During typical operations, incoming truck loads are offloaded into a vault located near the northeast corner of the facility, then routed to the skim pond and evaporation ponds.

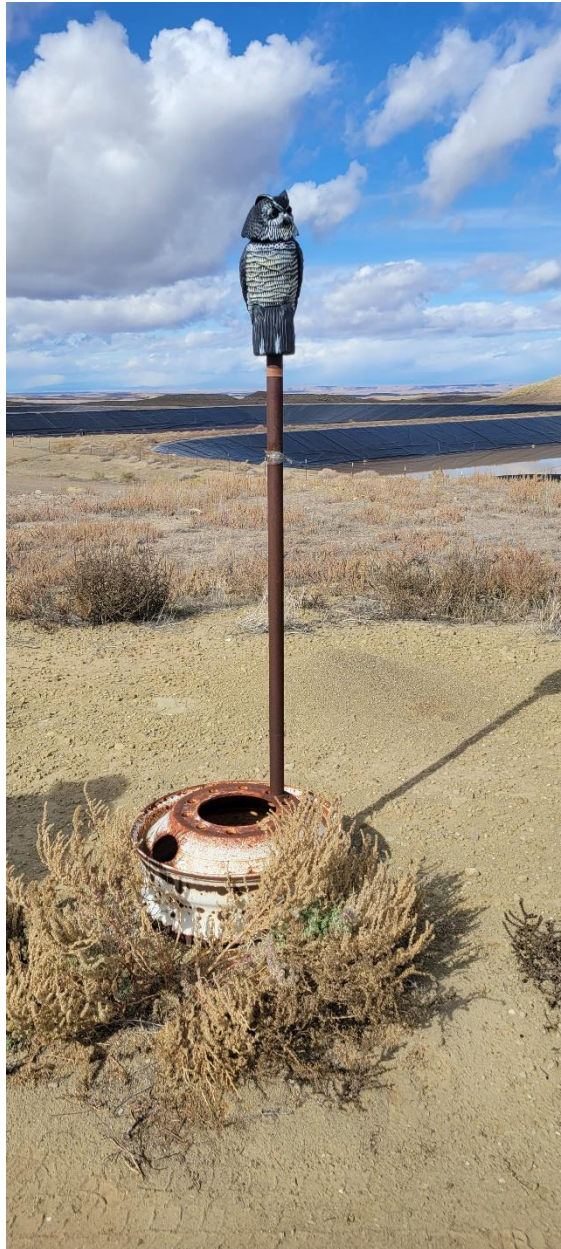
At evaporation Pond 7 located in the southeast portion of the facility, I observed that bird deterrent owl decoys had been placed in multiple locations around the pond. Partial installations

Photo 1, 20221026\_124214.jpg 10/26/2022 12:42 p.m., photo of bird deterrent owl decoy set up at Pond 7. Pond 4 is visible to right in the background.

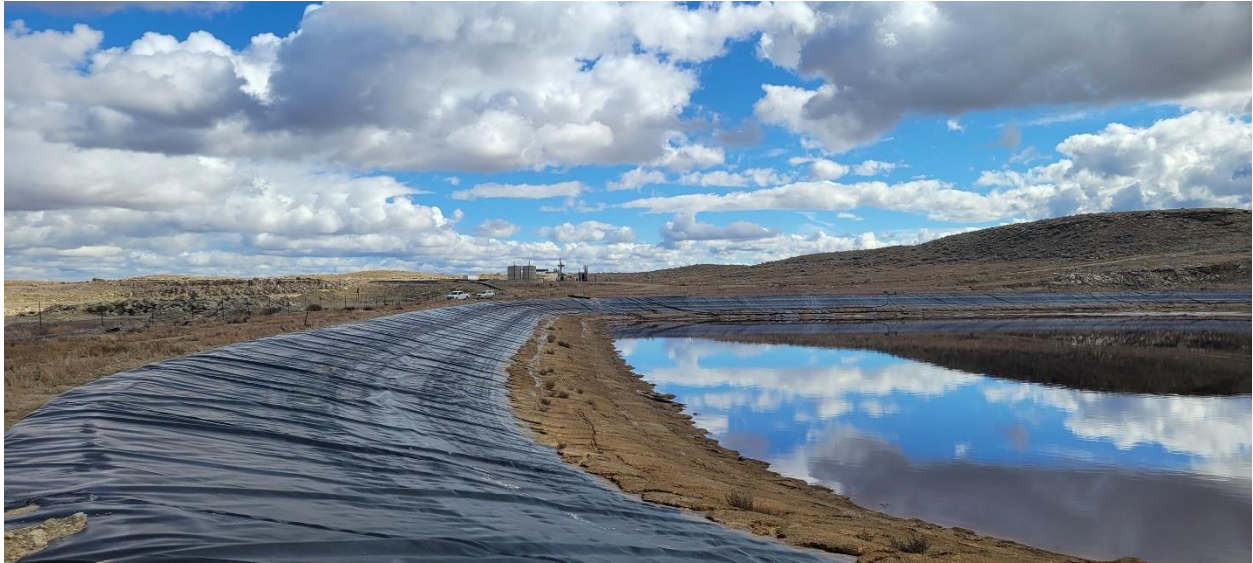
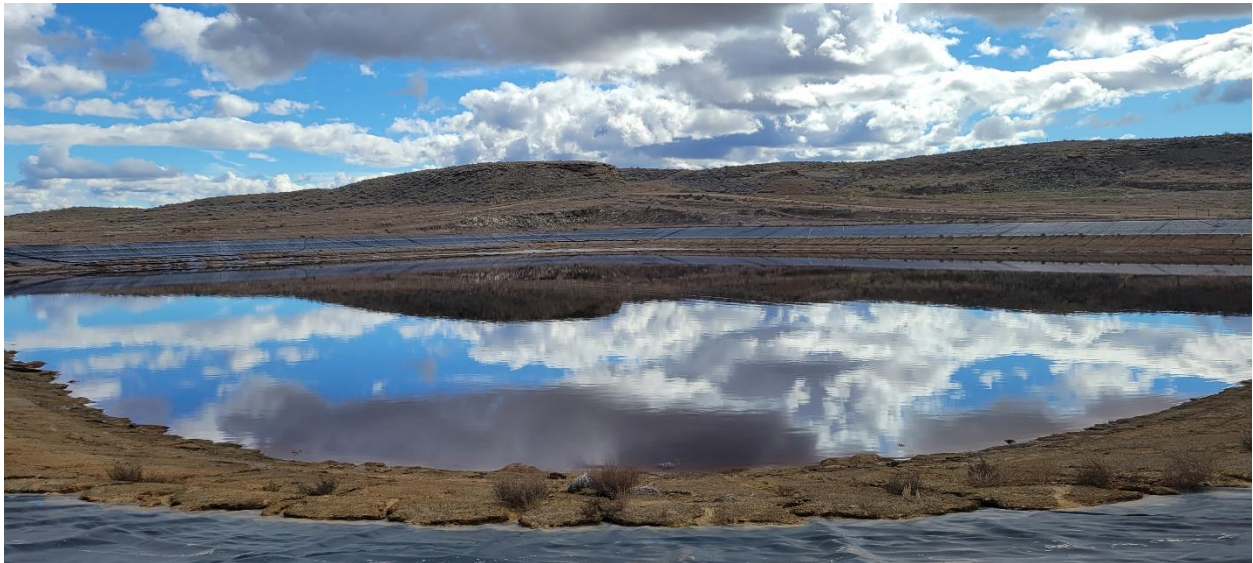
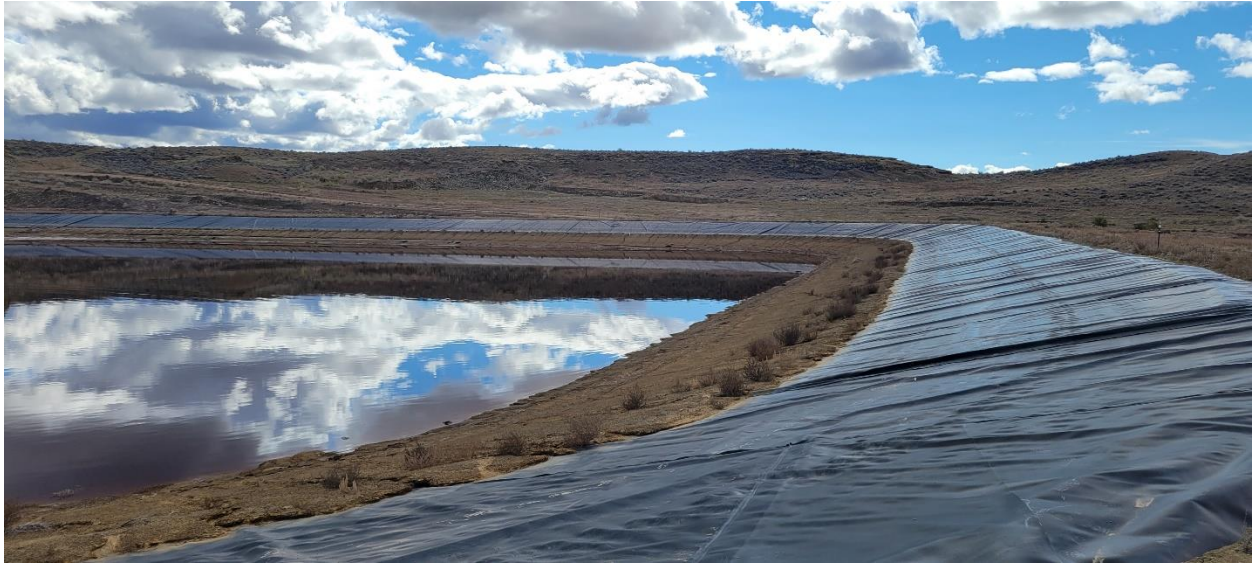
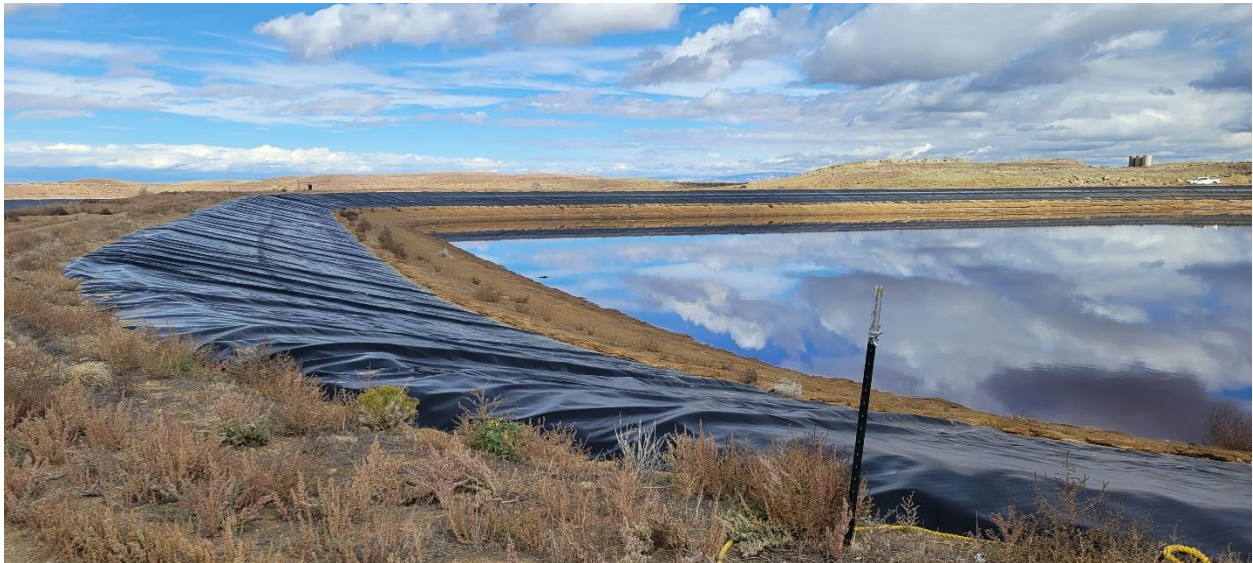
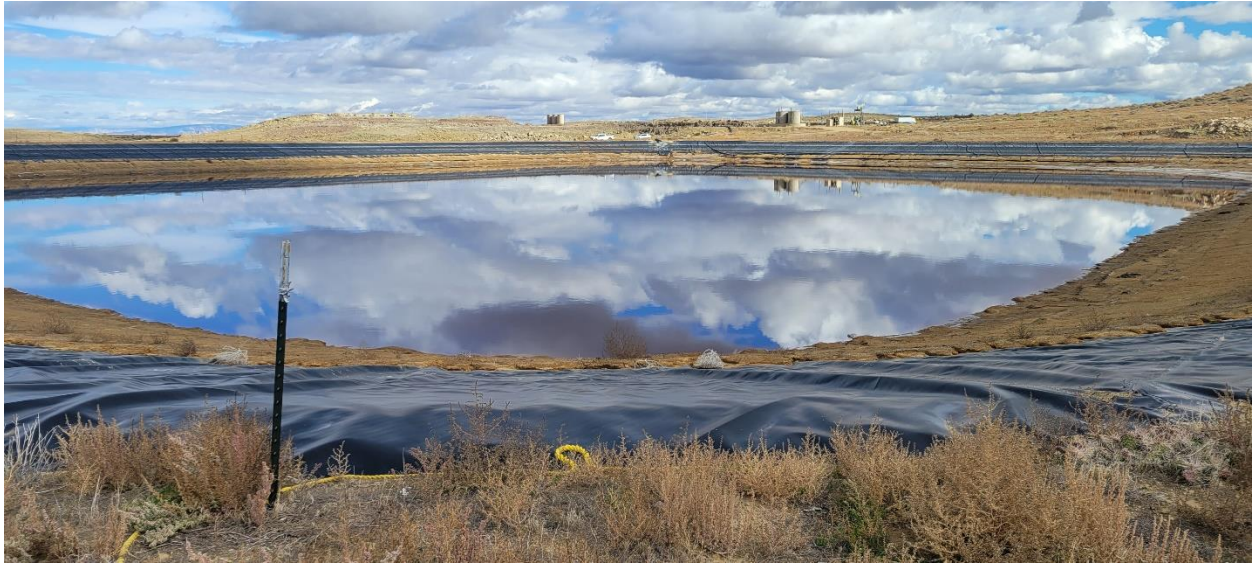
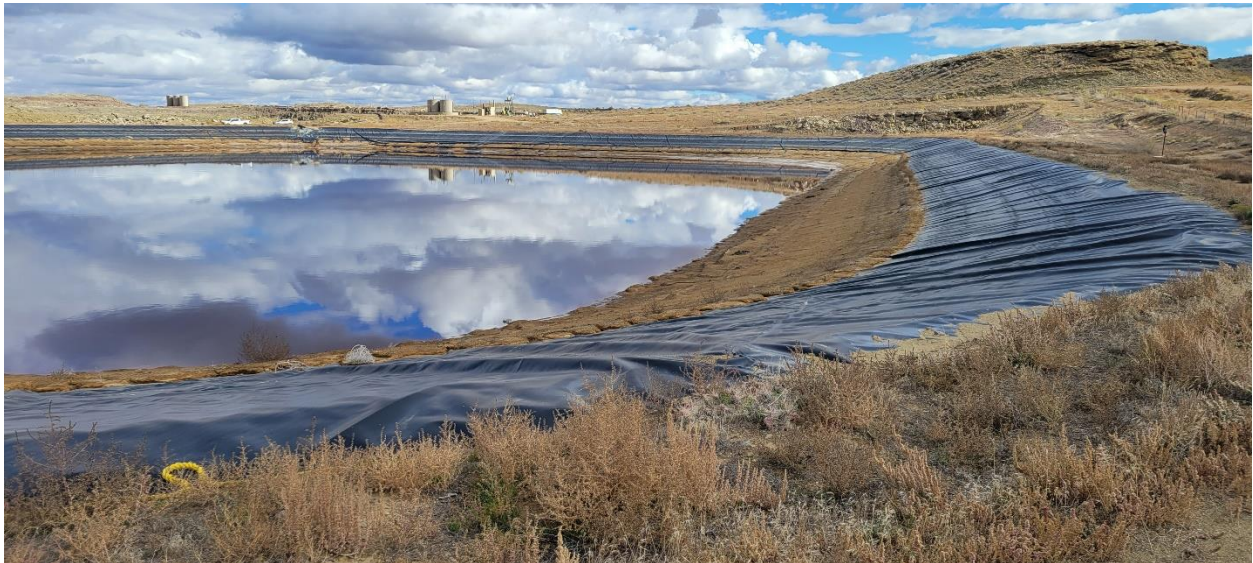
of previous bird deterrent systems (tape and reflectors) were also present at Pond 7. The pond was low, and no water was being added from the slop/skim pit at the time of the inspection. I did not observe evidence of wildlife presence, injury or mortality at the time of the inspection, and did not observe oil or sheen on the surface of the pond. See photos 1-9.

Photo 2, 20221026\_124404.jpg 10/26/2022 12:44 p.m., photo of Pond 7, taken from northwest corner of the pond facing east.

Photo 3, 20221026\_124407.jpg 10/26/2022 12:44 p.m., photo of Pond 7, panned right from photo 2.

Photo 4, 20221026\_124410.jpg 10/26/2022 12:44 p.m., photo of Pond 7, panned right from photo 3.

Photo 5, 20221026\_124706.jpg 10/26/2022 12:47 p.m., photo of Pond 7, taken from southwest corner of Pond 7 facing north.

Photo 6, 20221026\_124709.jpg 10/26/2022 12:47 p.m., photo of Pond 7, panned right from photo 5.

Photo 7, 20221026\_124711.jpg 10/26/2022 12:47 p.m., photo of Pond 7, panned right from photo 6.

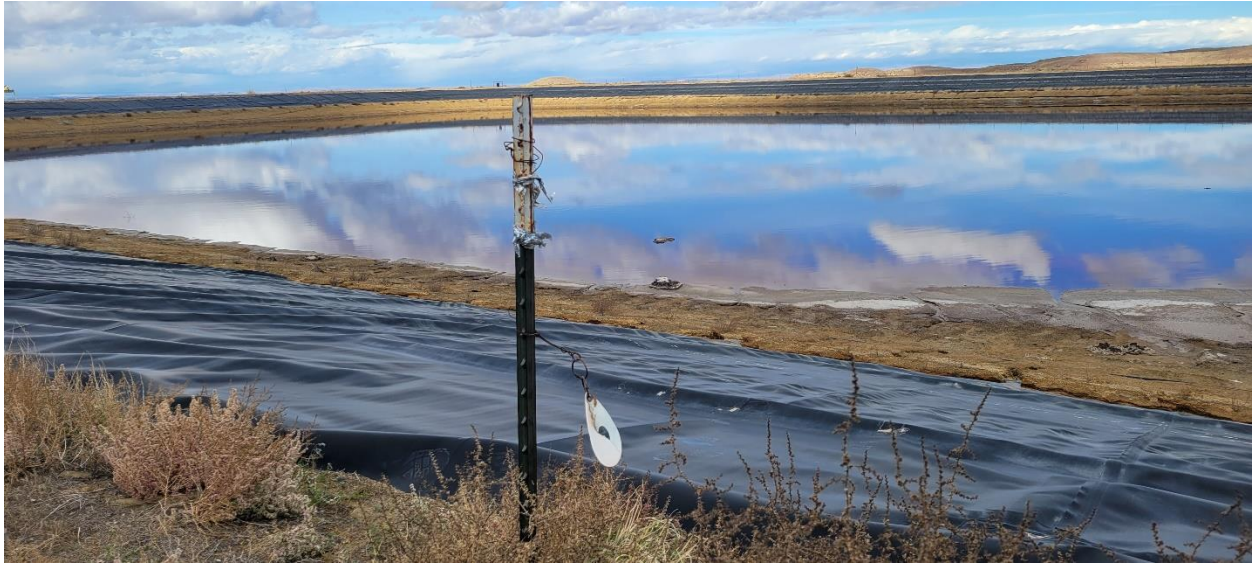
Photo 8, 20221026\_125115.jpg 10/26/2022 12:51 p.m., photo of previously attempted bird deterrents including remnants of reflective tape/ribbon and reflective disc.

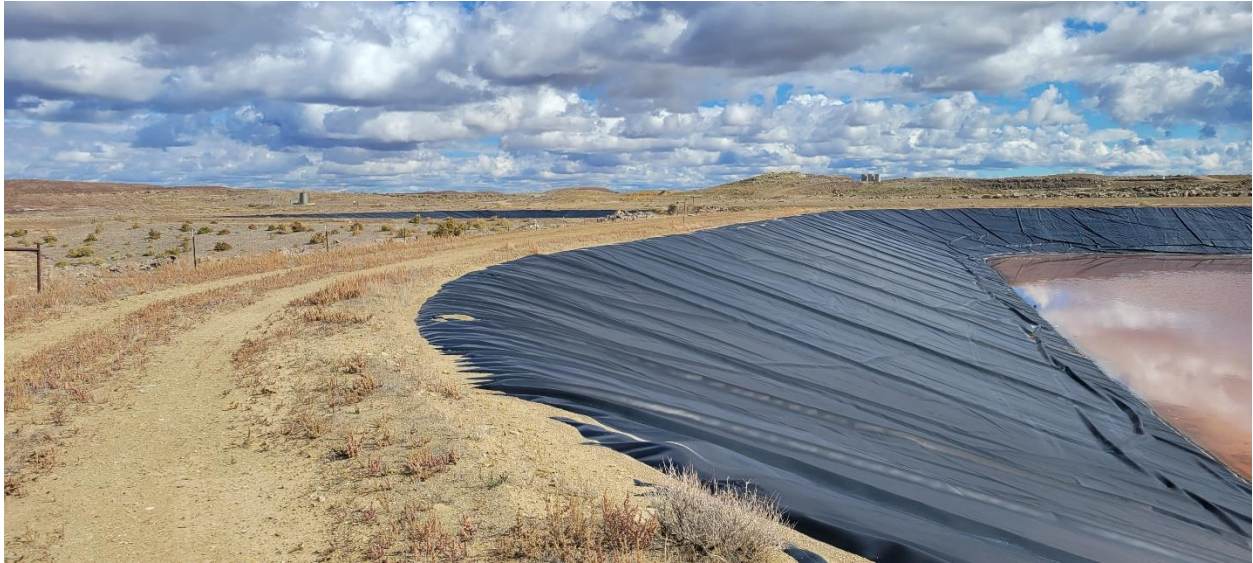
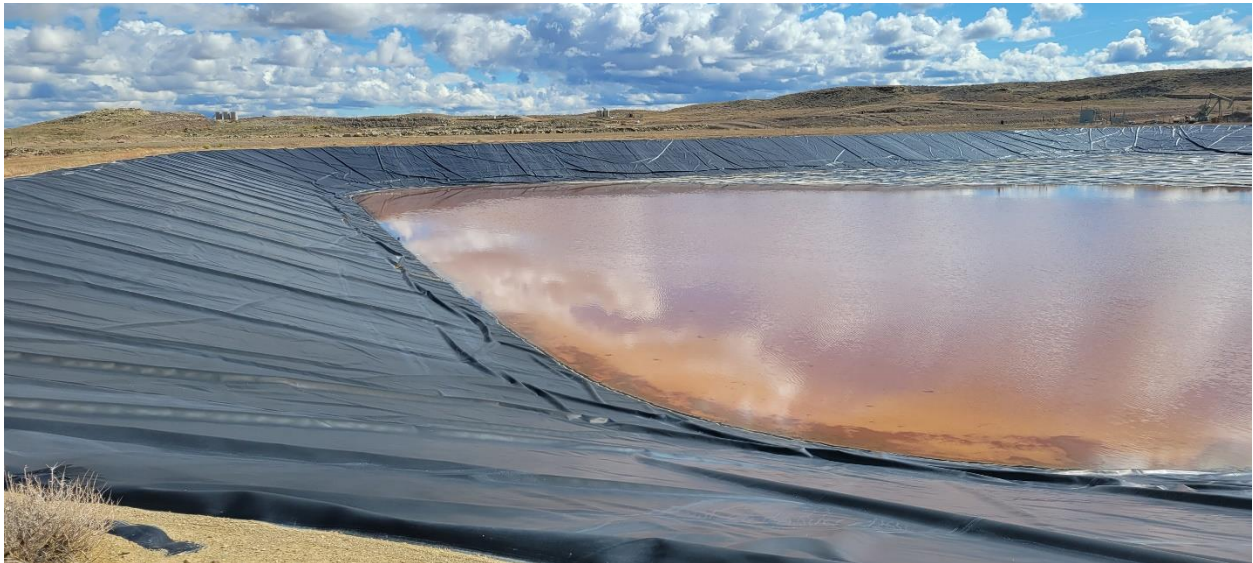
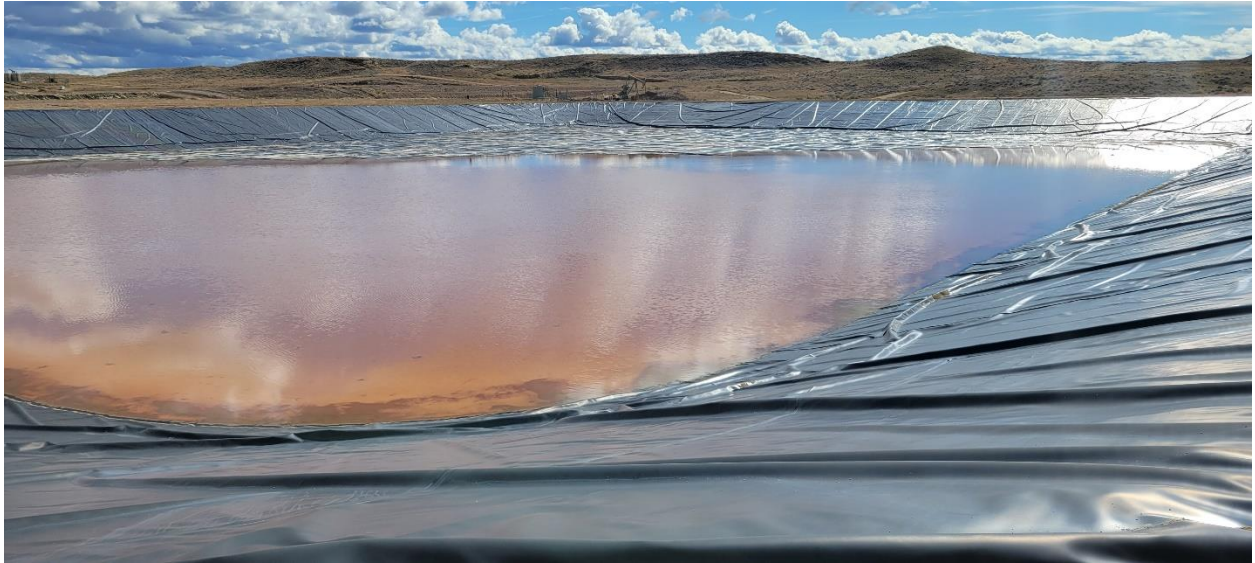
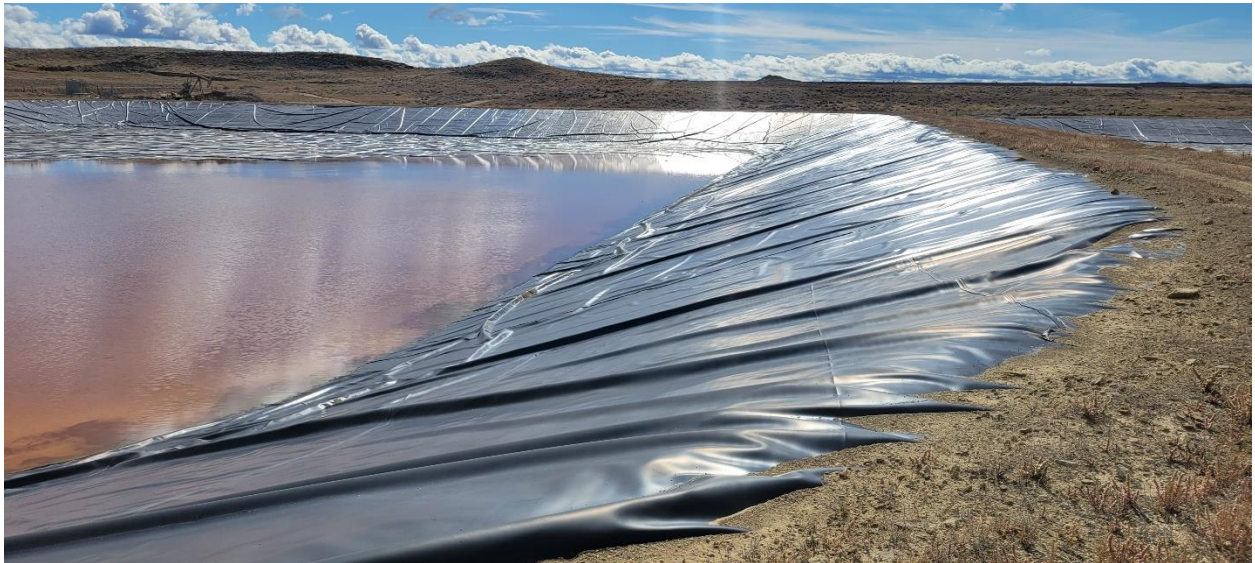
We then proceeded to the remaining ponds. I observed Pond 3 (no photos taken), Pond 4, Pond 5 and Pond 6. See photos 10-20.

Photo 10, 20221026\_130347.jpg 10/26/2022 1:03 p.m., photo of Pond 4 taken from northwest corner of the pond.

Photo 11, 20221026\_130350.jpg 10/26/2022 1:03 p.m., photo of Pond 4, panned right from photo 10.

Photo 12, 20221026\_130353.jpg 10/26/2022 1:03 p.m., photo of Pond 4, panned right from photo 11.

Photo 13, 20221026\_130355.jpg 10/26/2022 1:03 p.m., photo of Pond 4, panned right from photo 12.

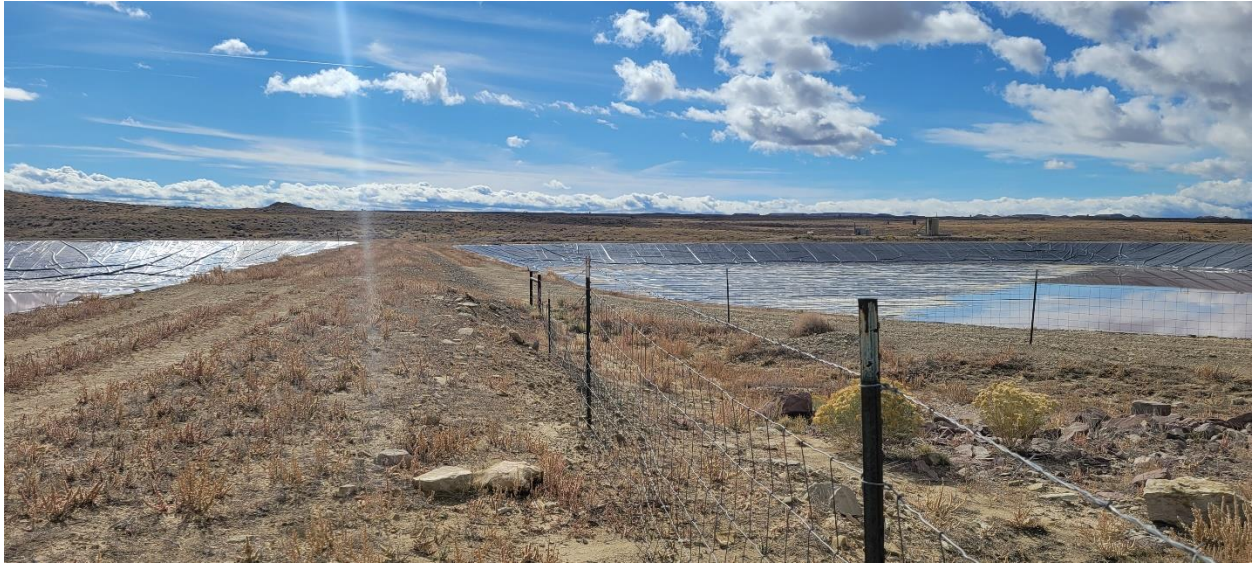
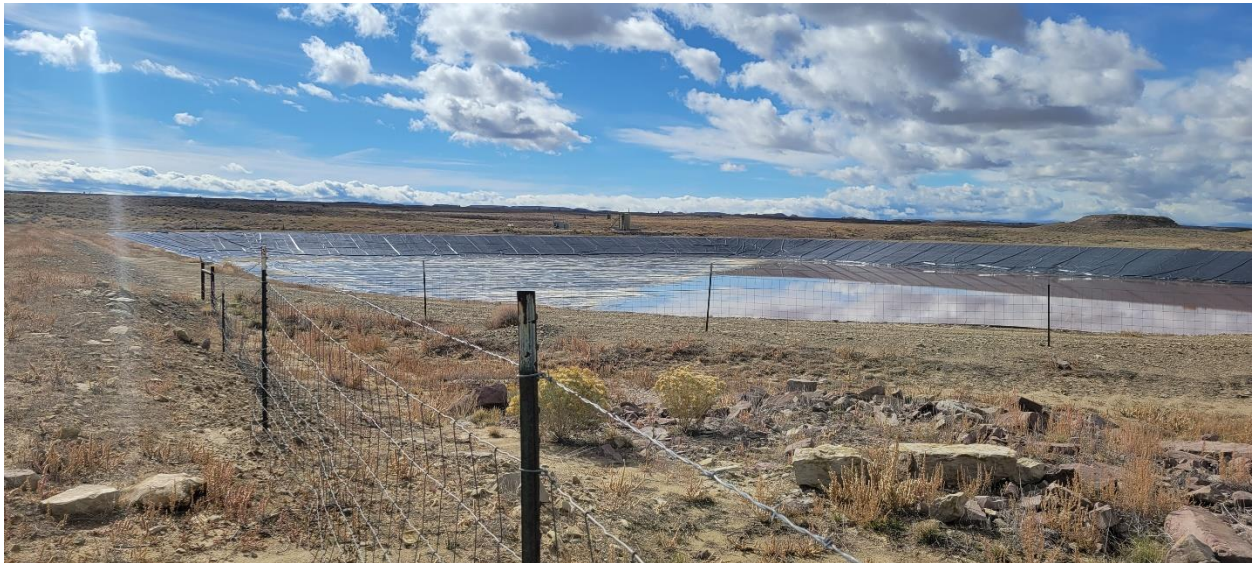
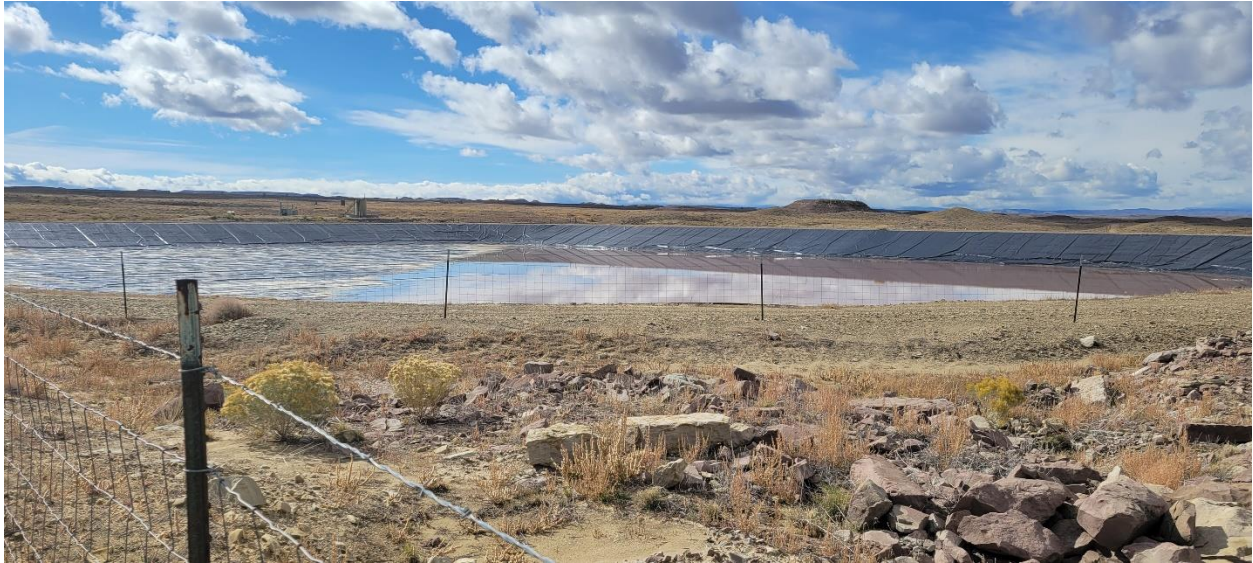
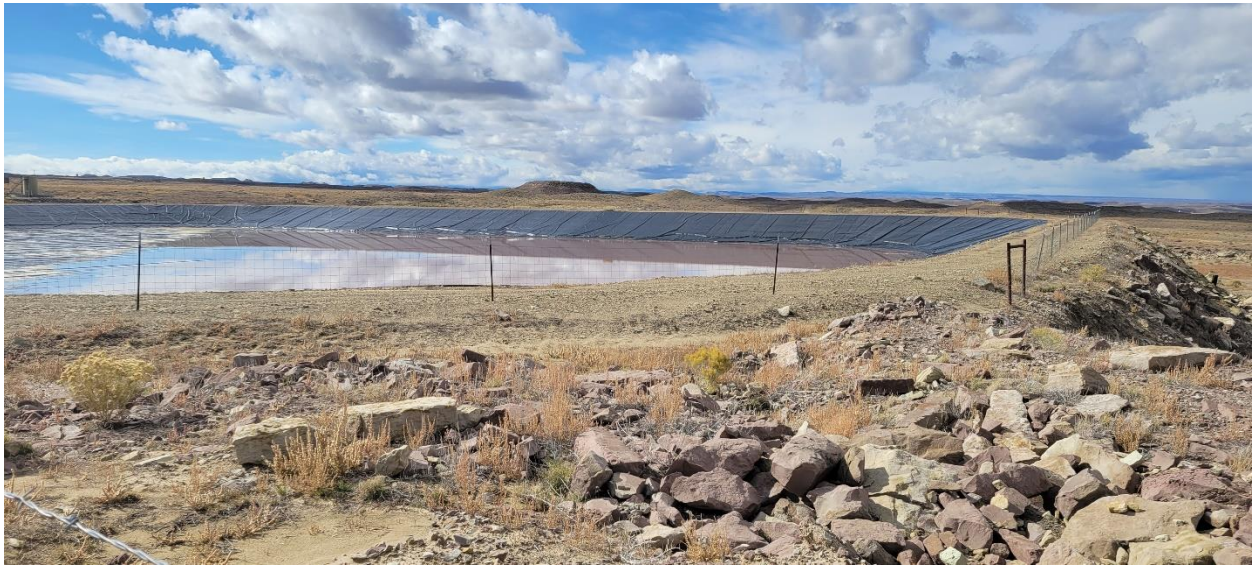
Photo 14, 20221026\_130440.jpg 10/26/2022 1:04 p.m., photo of Pond 5 (to right, with Pond 4 visible to left) near northeast corner, facing south.

Photo 15, 20221026\_130442.jpg 10/26/2022 1:04 p.m., photo of Pond 5, panned right from photo 14.

Photo 16, 20221026\_130444.jpg 10/26/2022 1:04 p.m., photo of Pond 5, panned right from photo 15.

Photo 17, 20221026\_130446.jpg 10/26/2022 1:04 p.m., photo of Pond 5, panned right from photo 16.

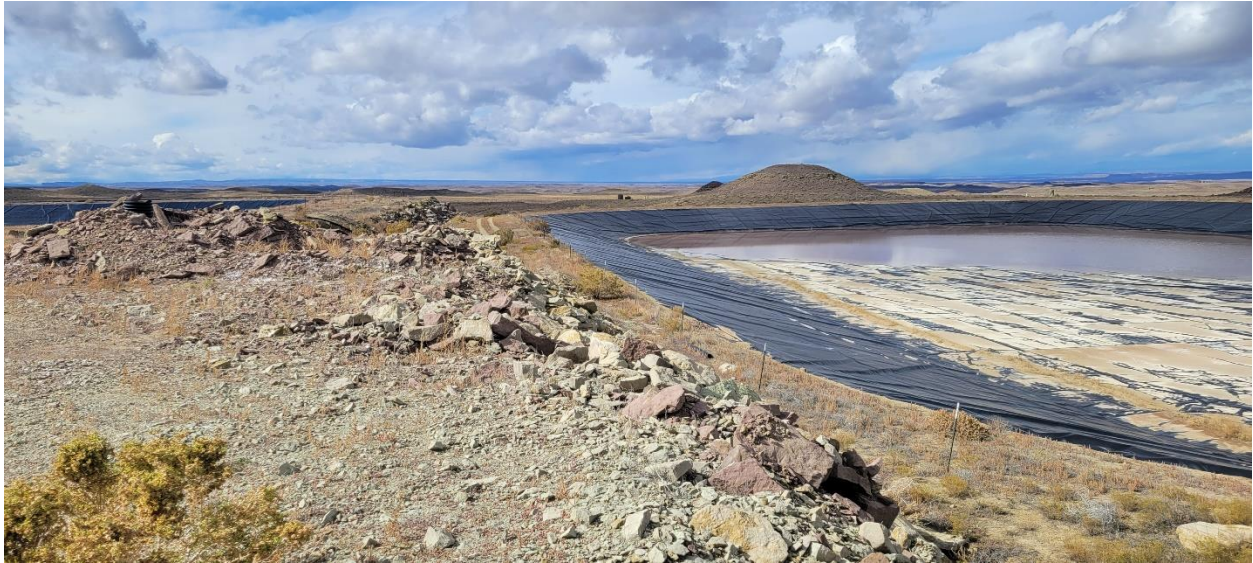
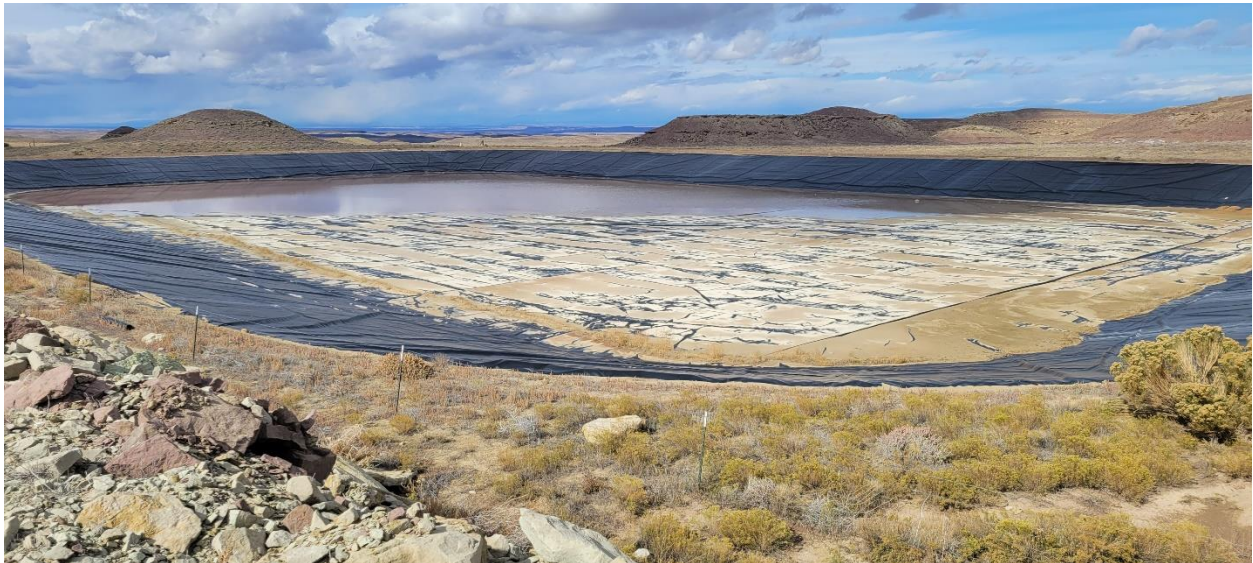
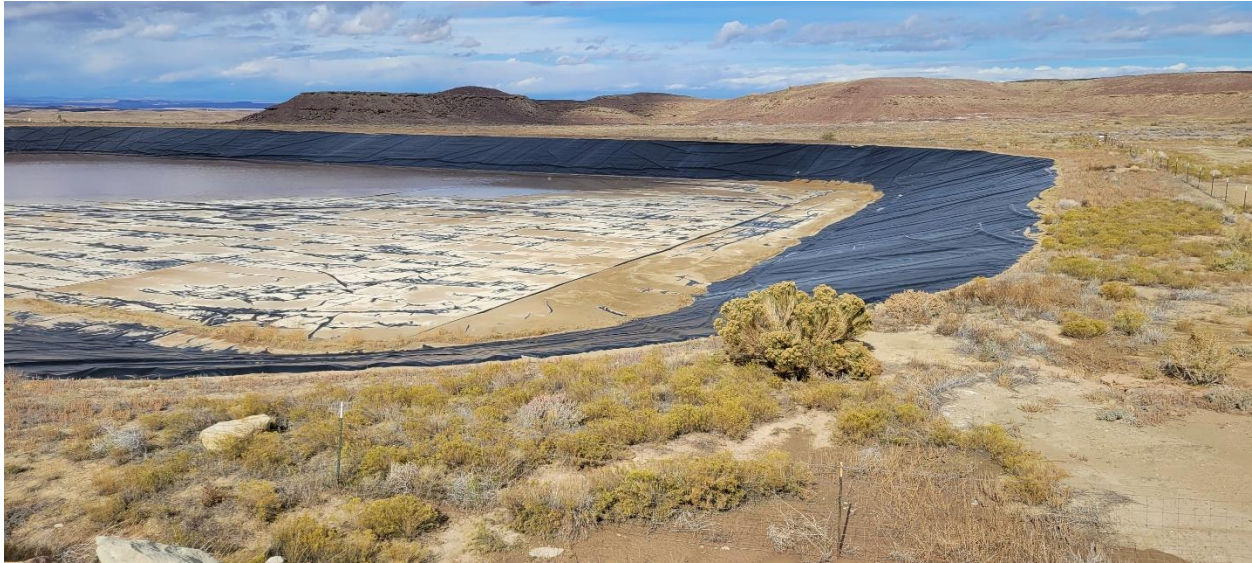
Photo 18, 20221026\_131333.jpg 10/26/2022 1:13 p.m., photo of Pond 6 taken near southeast corner facing west. Black leak detection point pipe is visible to left.

Photo 19, 20221026\_131335.jpg, 10/26/2022 1:13 p.m., photo of Pond 6, panned right from photo 18.

Photo 20, 20221026\_131337.jpg, 10/26/2022 1:13 p.m., photo of Pond 6, panned right from photo 19.

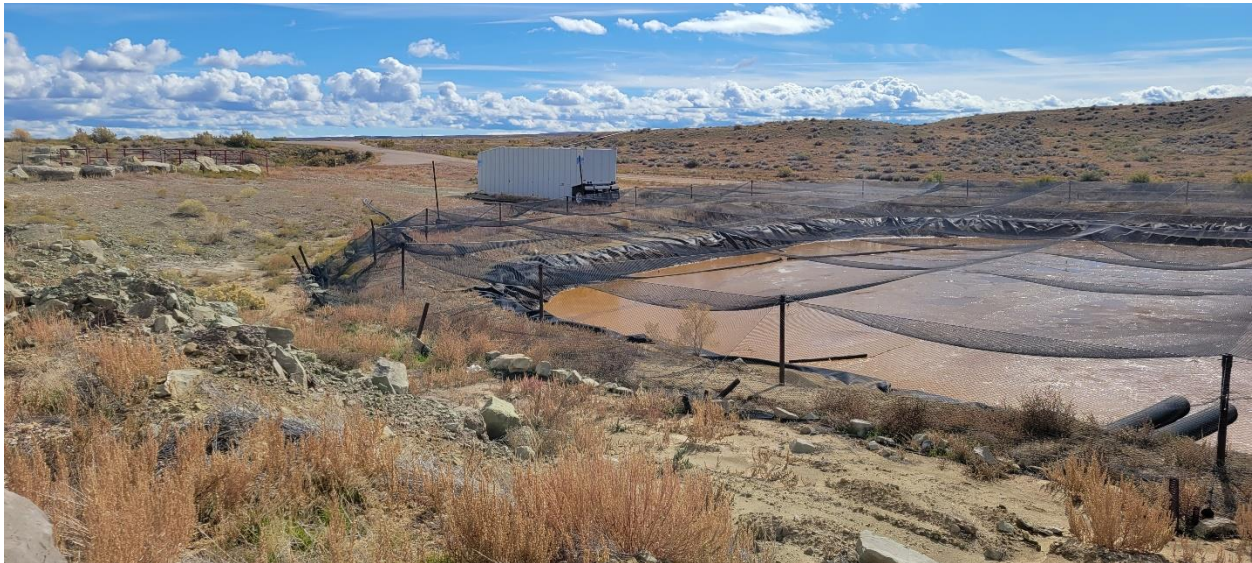
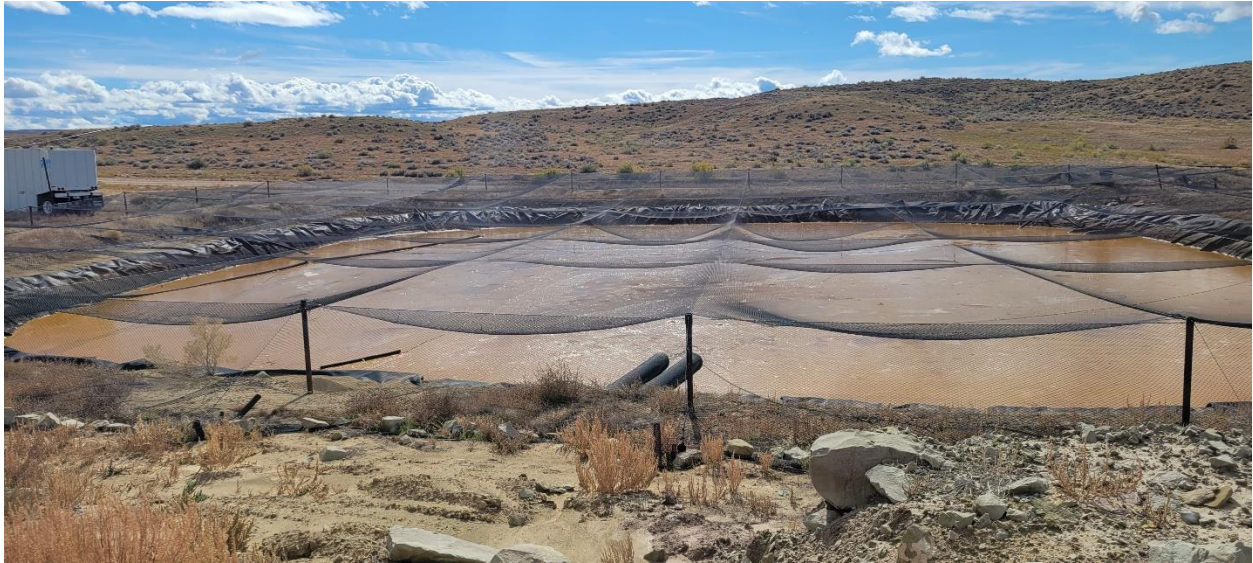
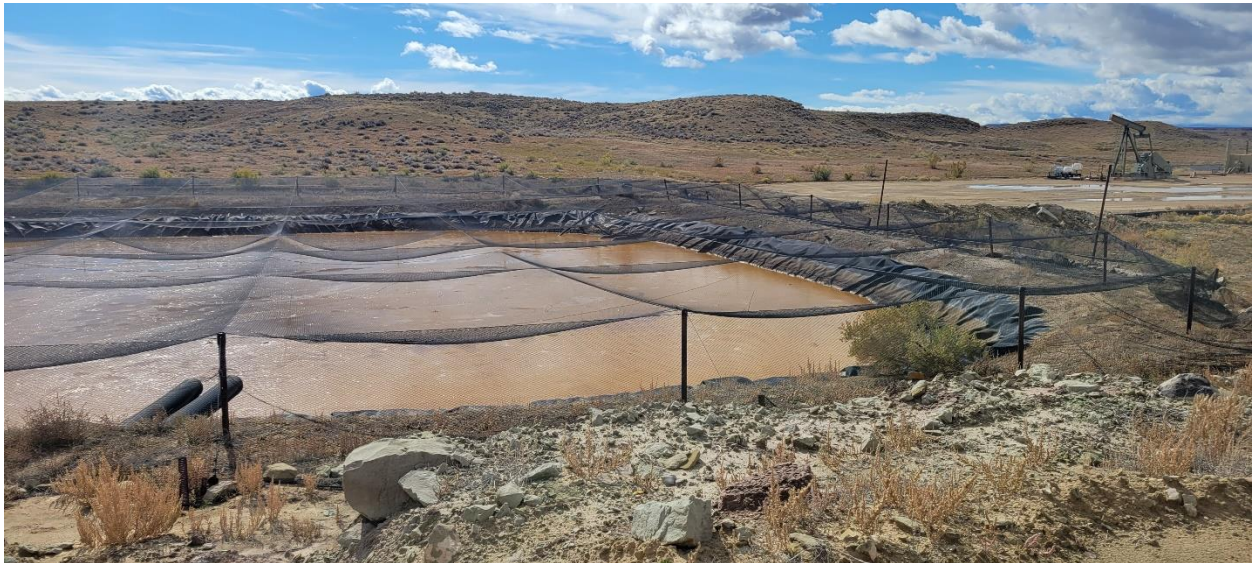
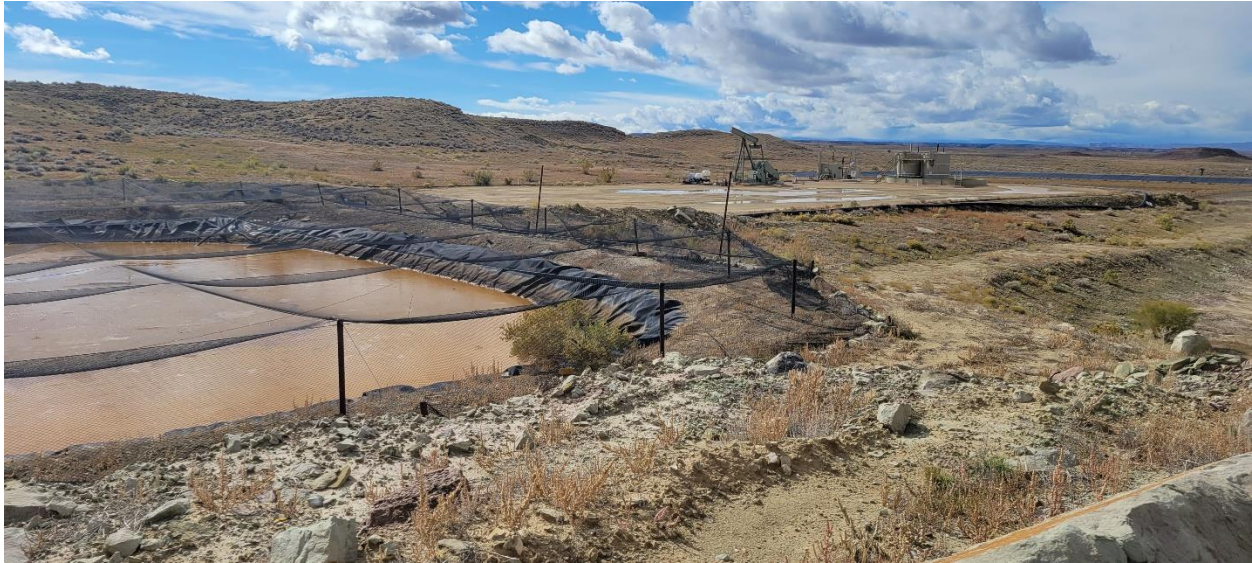
During the inspection, I did not observe ground-level gapping or holes in the netting over the slop/skim pit. See photos 21-24. The color of the material in the pit was a lighter brown color than is usually encountered, possibly because of weathering due to inactivity at the site. The netting appeared to be in good condition.

Photo 21, 20221026\_132146.jpg, 10/26/2022 1:21 p.m., photo of slop/skim pit taken from north side facing south. Netting appeared to be in good condition.

Photo 22, 20221026\_132148.jpg, 10/26/2022 1:21 p.m., photo of slop/skim pit, panned right from photo 21.

Photo 23, 20221026\_132150.jpg, 10/26/2022 1:21 p.m., photo of slop/skim pit, panned right from photo 22.

Photo 24, 20221026\_132153.jpg, 10/26/2022 1:21 p.m., photo of slop/skim pit, panned right from photo 23.

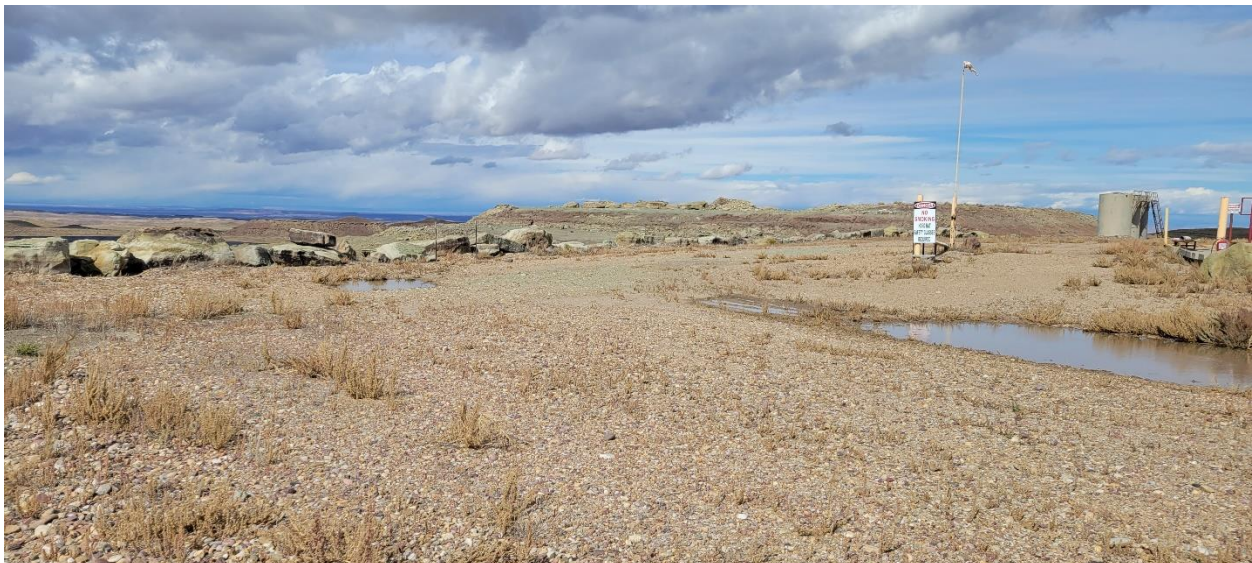
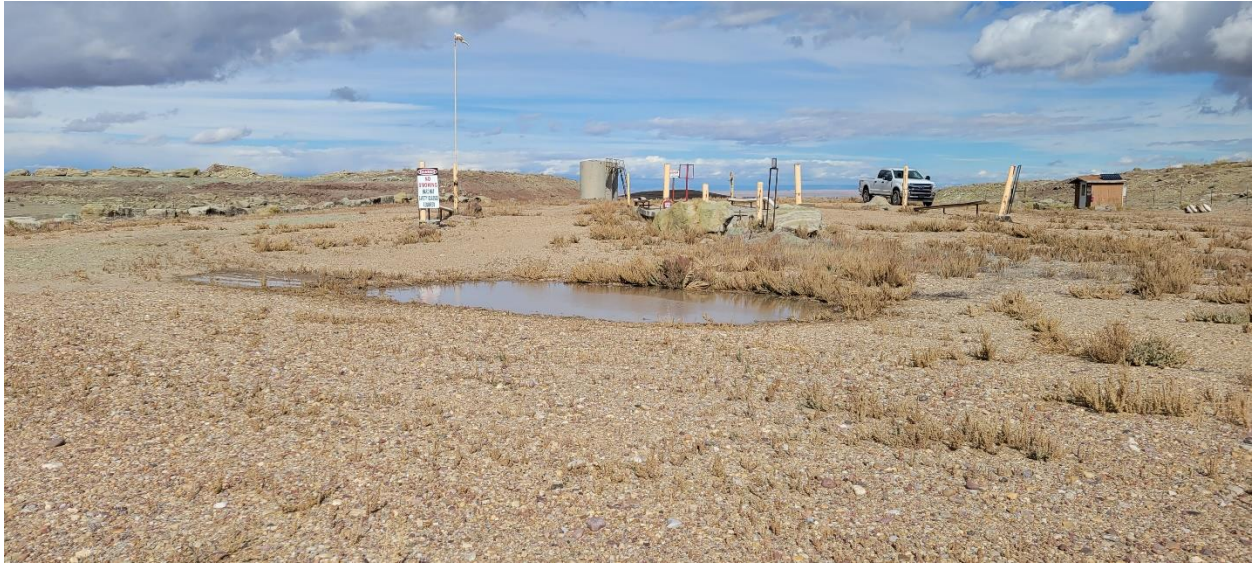
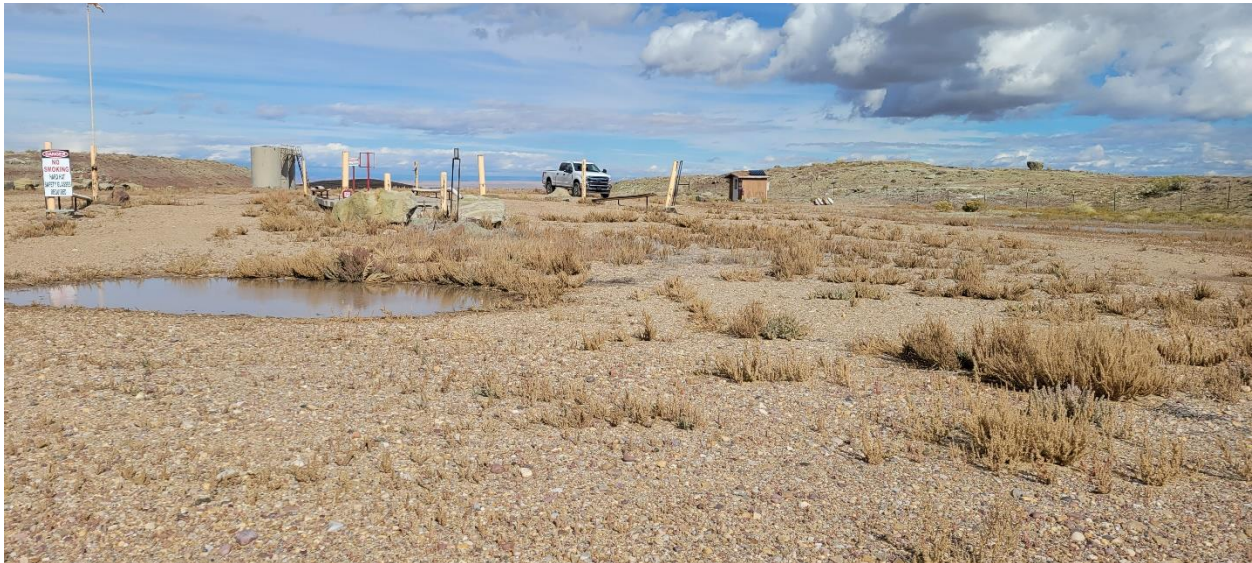
At the truck offload area, which includes the vault and three tanks, I observed that no recent tire marks were evident on the ground surface and that vegetation was growing in the area, indicating that no recent truck traffic had occurred. See photos 26-29. Mr. Hacking stated that the offload log setup for drivers to provide offload information had been taken to the Wonsit facility for use there.

Photo 25, 20221026\_132240.jpg, 10/26/2022 1:22 p.m., photo of truck unload/vault area taken from south end of area (north of slop/skim pit) facing northwest. The offload area did not appear to have been recently trafficked, with no apparent tire marks and with weeds growing indicating no recent incoming trucks. Ponding in this area appeared to be due to recent precipitation.

Photo 26, 20221026\_132242.jpg, 10/26/2022 1:22 p.m., photo of truck offload/vault area, panned right from photo 25.

Photo 27, 20221026\_132245.jpg, 10/26/2022 1:22 p.m., photo of truck offload/vault area, panned right from photo 26.

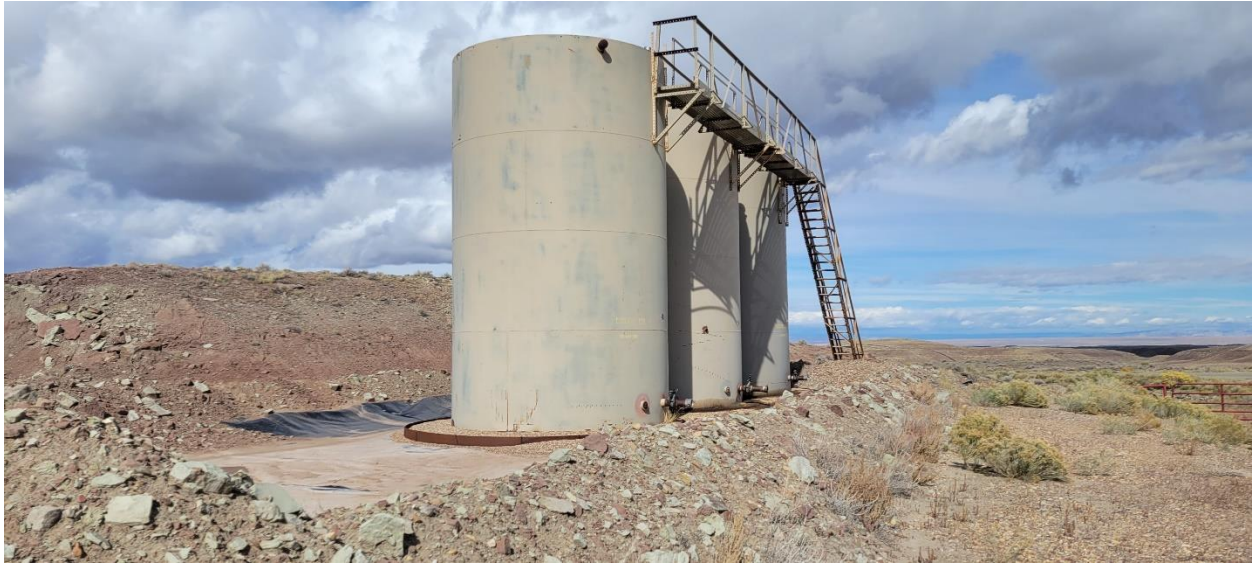
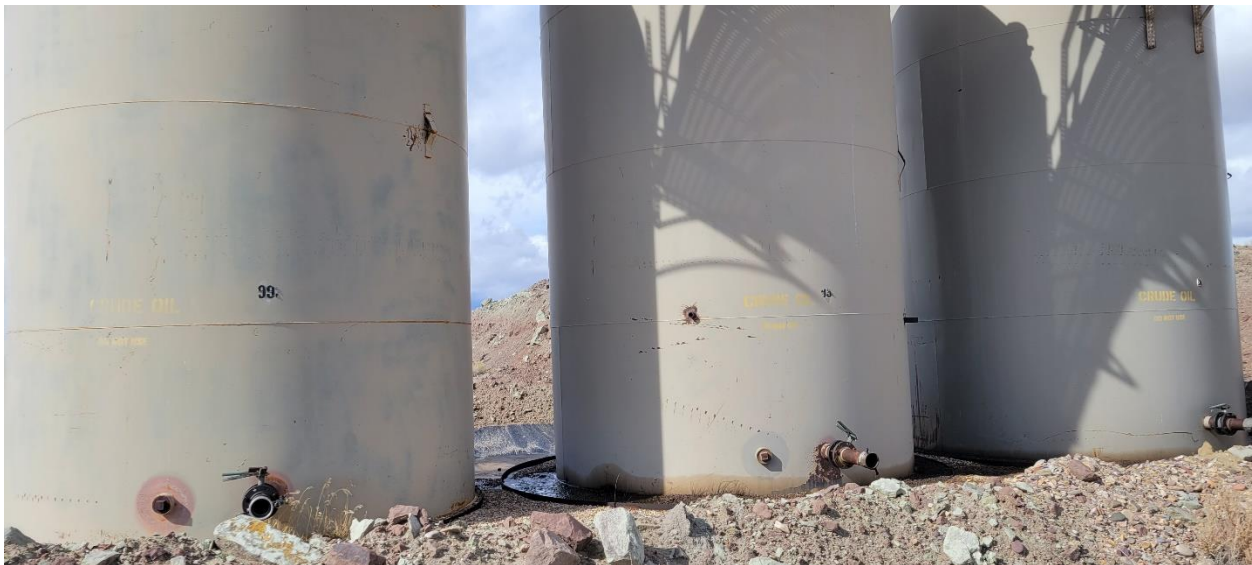
Photo 28, 20221026\_132749.jpg, 10/26/2022 1:27 p.m., photo of tanks located near truck offload area.

Photo 29, 20221026\_132809.jpg, 10/26/2022 1:28 p.m., photo of the same tanks shown in photo 28, with markings “do not use” painted on each tank.
