### INSPECTION REPORT

| Inspection Date(s): | 02/08/2018 | | |
| Company Name: | <b>Village of Fort Sumner</b> | | |
| Facility Name: | <b>Fort Sumner Wastewater Treatment Plant</b> | | |

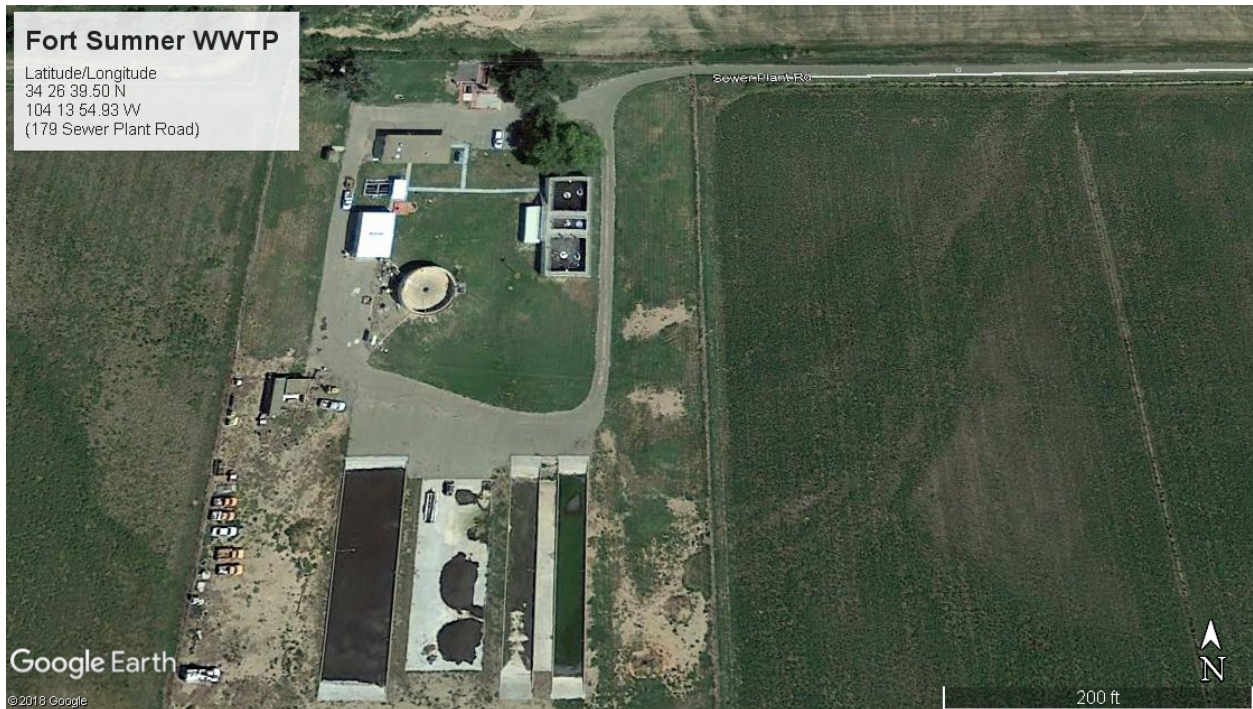
**Aerial #1:** Overall view of the Village of Fort Sumner Wastewater Treatment Plant. Aerial from Google Earth maps.

The WWTP a minor discharger with a design flow of 0.21 million gallons per day (MGD), is located at 179 Sewer Plant Road or approximately 2.0-miles southeast of the Fort Sumner Village Hall, De Baca County, New Mexico (depicted in Aerial #1 below). The WWTP facility serves a population of approximately 900 (2016 US Census) residents. The WWTP is operated by staff within the Public Works Department and consists of 2 full-time equivalent (FTE) positions and one (1) temporary position, on a Monday through Friday 8-hour per day basis. On-call staff is available on an as needed basis.
