## INSPECTION REPORT

| <b>Type of Inspection</b> | Compliance Evaluation Inspection | | |
| <b>Facility or Site Name</b> | Makah Wastewater Treatment Facility | | |
| <b>Permit Number</b> | WA0023213 | | |

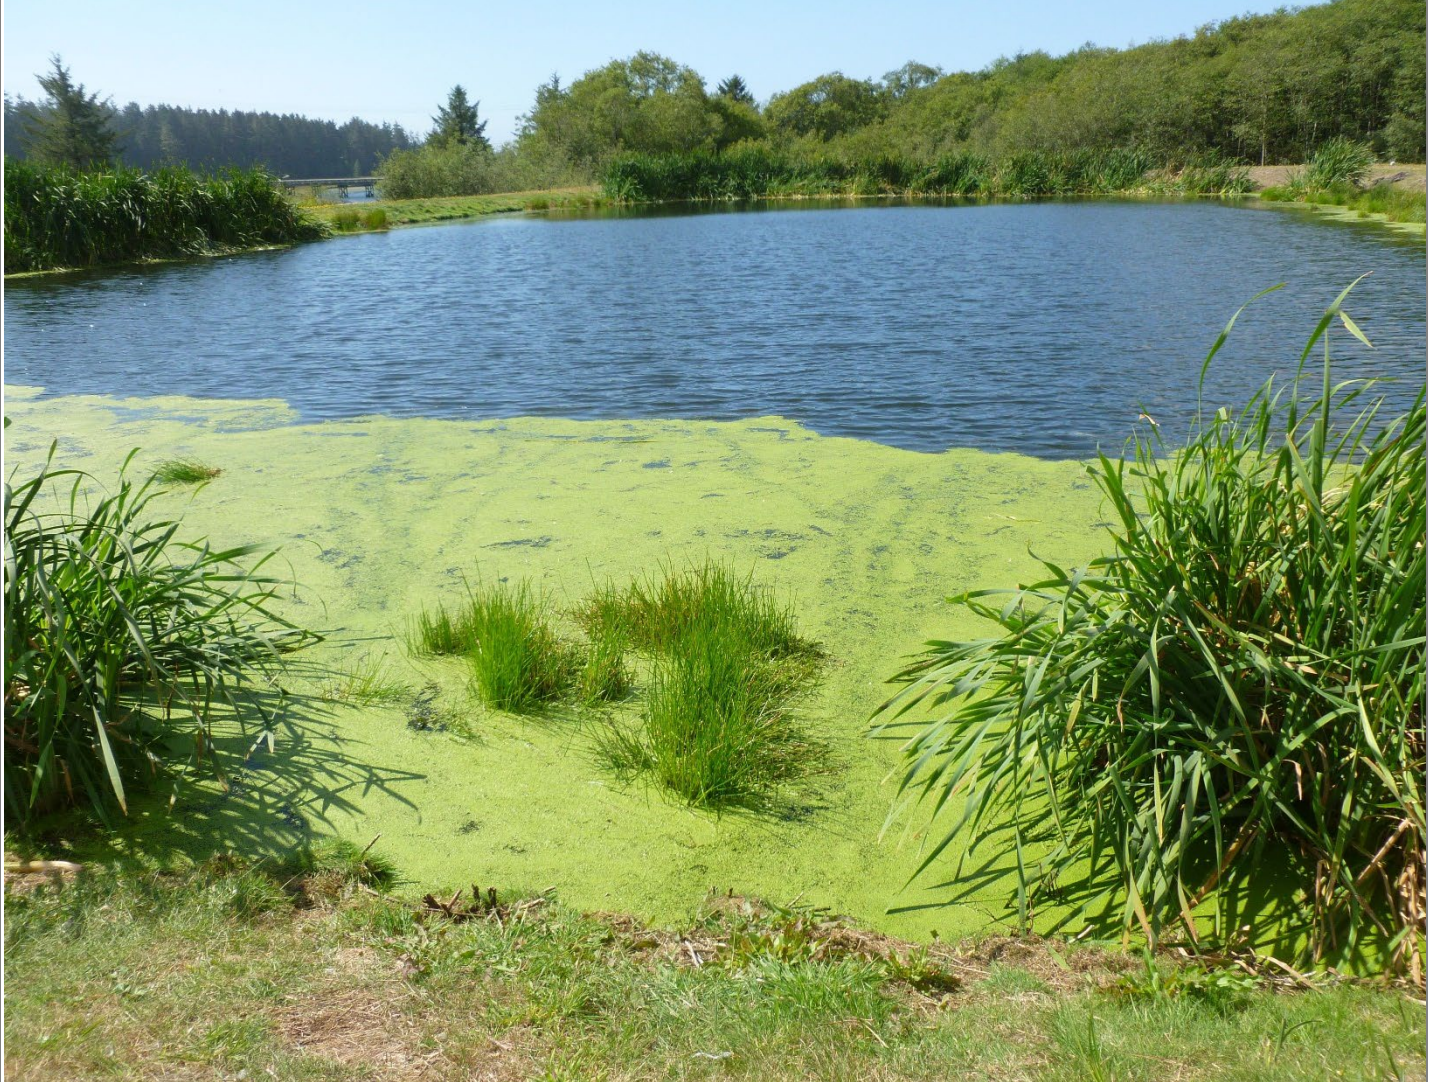
I observed accumulated duckweed on the eastern end of Lagoon 4, pictured in **Photo 1**. Mr. Herschleb said he has tried various herbicidal treatments to keep the duckweed under control. He also said he has used manual removal as a control measure. Manual removal appears to be the most effective control method.

**Photo 1/P1010842 – Lagoon 4 with duckweed**
