**Region 6 Compliance Assurance and Enforcement Division  
INSPECTION REPORT**

| Facility Name: | <b>Cargill, Incorporated – Westwego Grain Elevator</b> | | |
| Identification/Permit Number: | LA0046485 | | |

## NPDES Inspection Photo Log

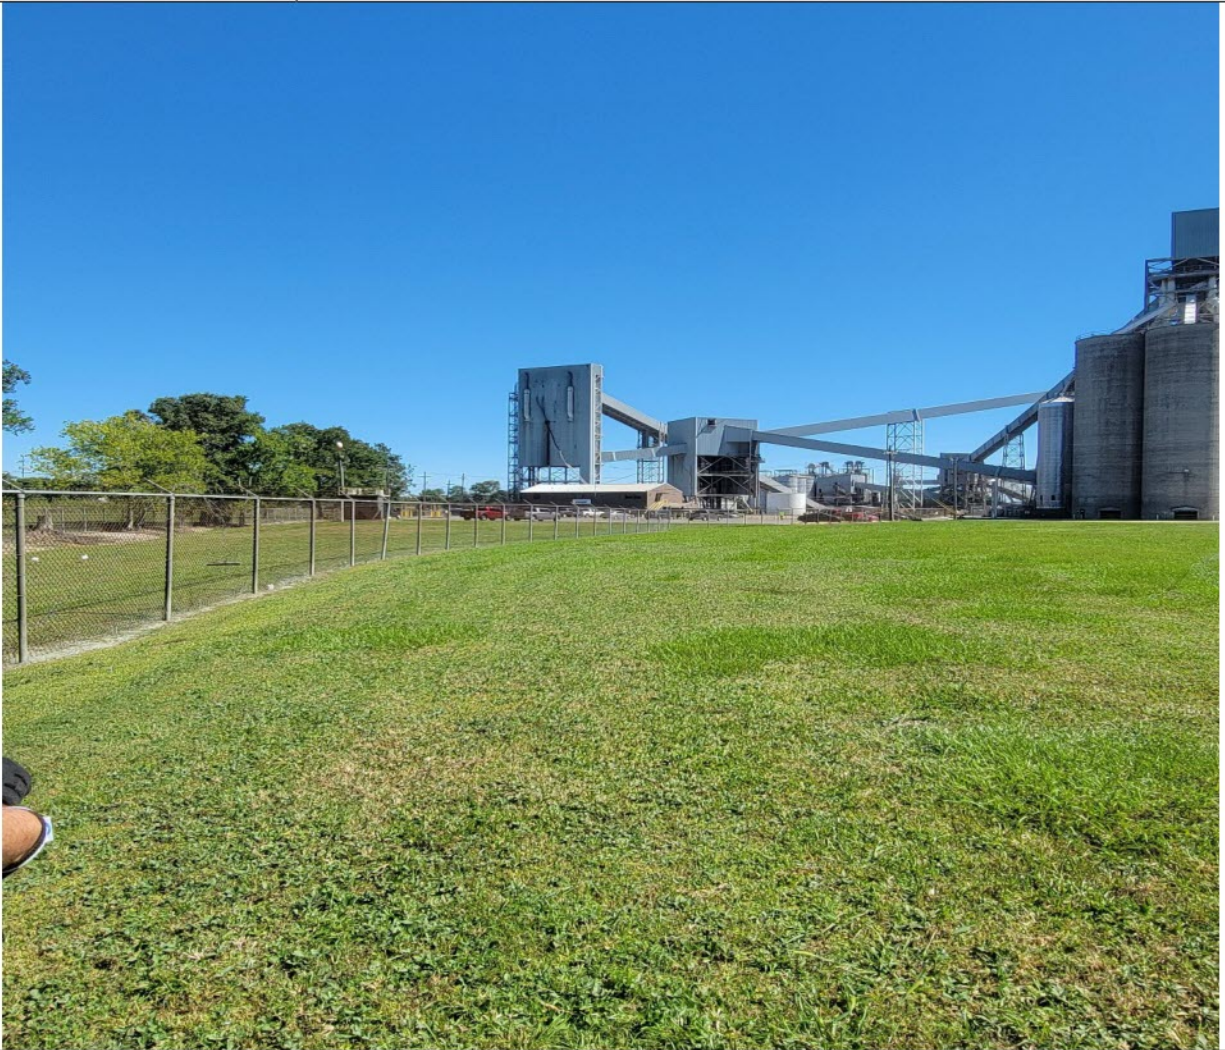
| Photo# | 1 | Date: | 9/27/2022 | Time: | 11:49 am |

| Description | Grain Elevators | | | | |

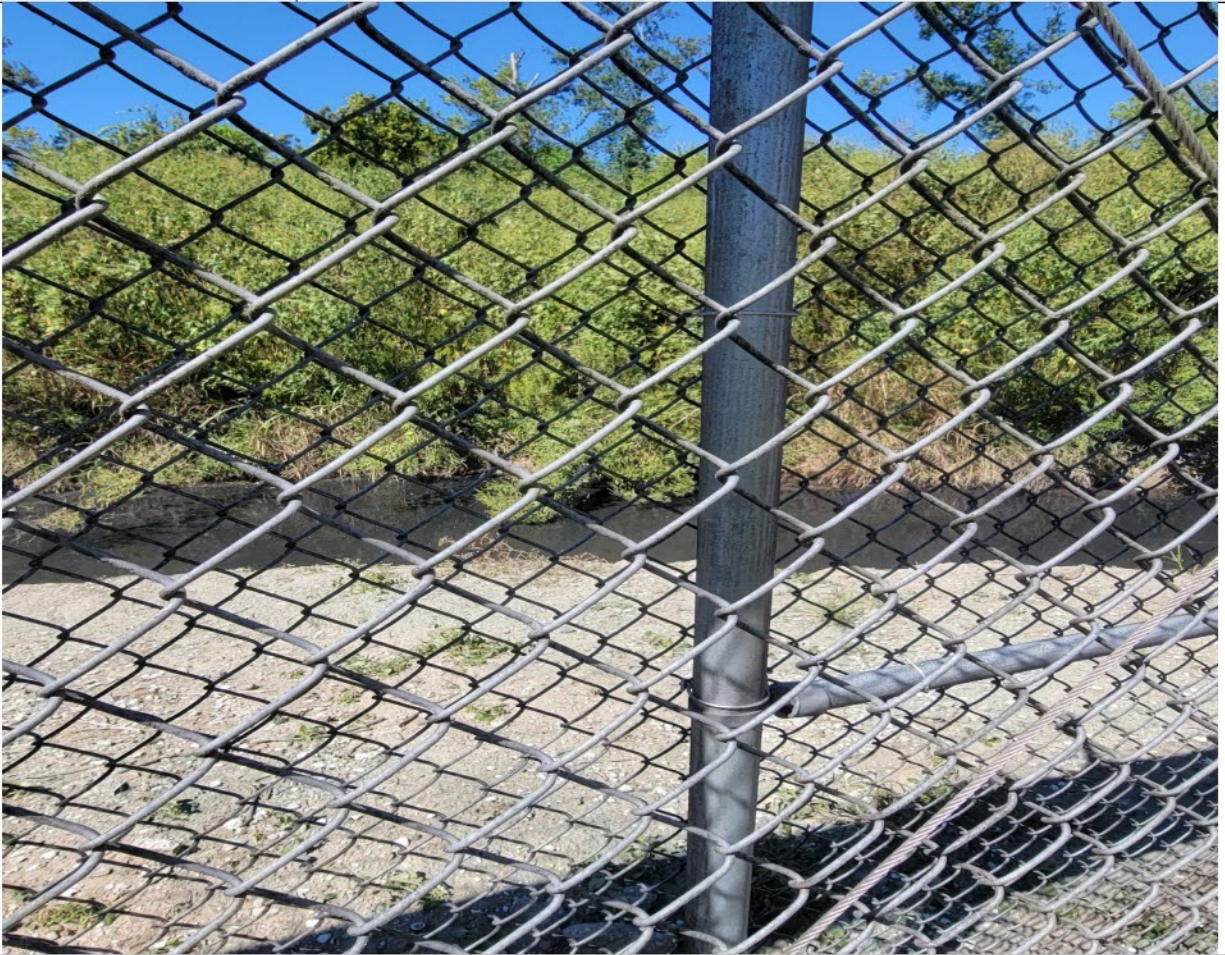
| NPDES Inspection Photo Log | | | | | |
|---|---|---|---|---|---|
| Photo# | 2 | Date: | 8/4/2022 | Time: | 10:48 am |

Cargill, Incorporated grain elevator and storage process contributes to the product being on the ground and getting into the stormwater. The various grains or particles of the grains can become airborne and settle on the ground or grains are spilled in transit. This contributes to the grains getting into the stormwater during wet weather events. The current design of the facility does not provide adequate segregation or settling prior to discharging from Outfall 004.

| NPDES Inspection Photo Log | | | | | |
|---|---|---|---|---|---|
| Description | | Storm canal flowing to outfall 004 (Septic conditions on day of inspection due to organics present and no flow) | | | |

- Cargill, Incorporated is in the process of doing some corrective actions. They have hired Curtis Environmental. Curtis Environmental collected geotechnical data last fall and is currently completing the design of a stormwater retention pond that will collect all the stormwater from the site. The plan is for the pond to have one discrete outfall so the stormwater sampling will more accurately represent the impact of stormwater runoff at the site. After the plans have been finalized Curtis Environmental will start the re-permitting process.

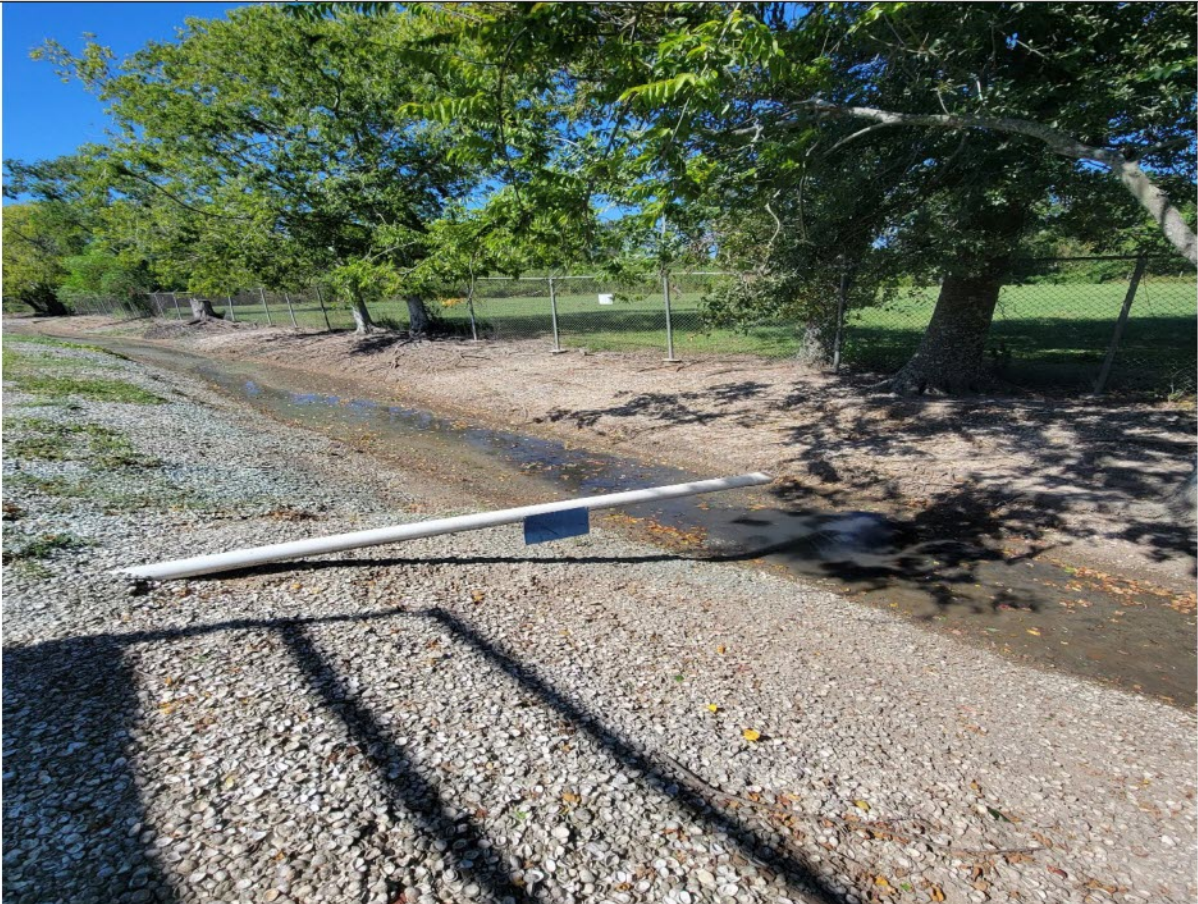
| Photo# | 3 | Date: | 9/27/2022 | Time: | 11:43 am |

Stormwater runoff is also collected from the yard and commingles with previous discharge from Outfall 003 prior to discharging to Outfall 004.

| Description | Outfall 003 flowing to canal that commingles with Outfall 004 | | | | |

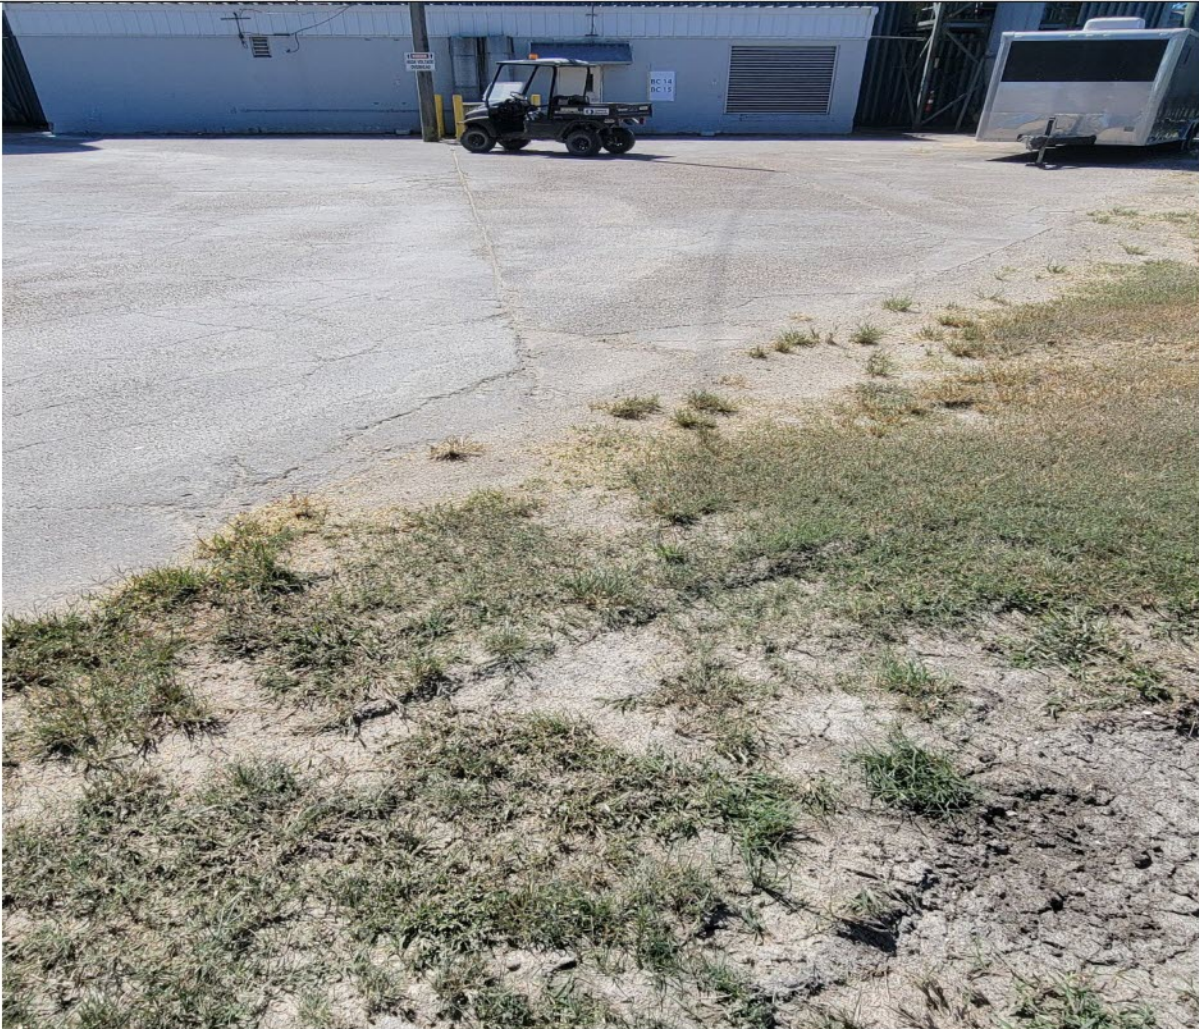
| Photo# | 4 | Date: | 9/27/2022 | Time: | 10:51 am |

| Description | Grain that is on the ground | | | | |

- Cargill, Incorporated has multiple permit exceedance of TOC. The facility has completed various projects to reduce grain dust but still has a problem meeting permit limits for TOC. The site has routine housekeeping that includes inspections of storm drains and a full-time housekeeping crew that addresses daily spills. Without adequate controls that segregate, settle, or filter the grains from the discharge, Cargill will continue to exceed TOC limits.

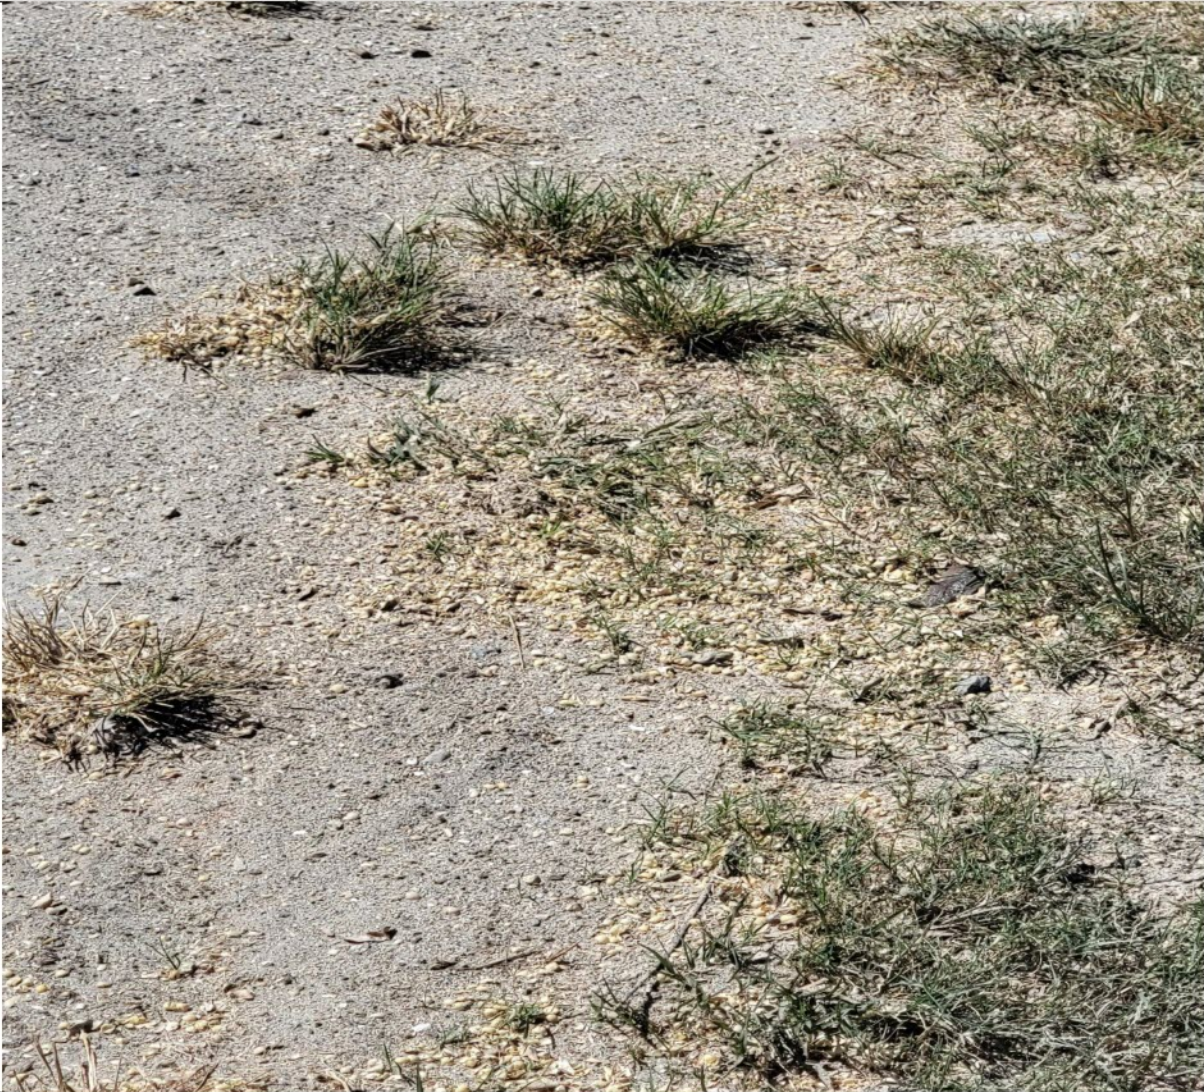
| NPDES Inspection Photo Log | | | | | |
|---|---|---|---|---|---|
| Photo# | 5 | Date: | 9/27/2022 | Time: | 11:51 am |

| NPDES Inspection Photo Log | | | | | |
|---|---|---|---|---|---|
| Description | | Close up view of grain on the ground | | | |
