## **RCRA Inspection Report**

Glasforms Inc. BLDGS #1-4  
3943 Valley East Industrial Dr.  
Birmingham, Alabama 35217  
EPA ID No: ALR000013128

November 02, 2021

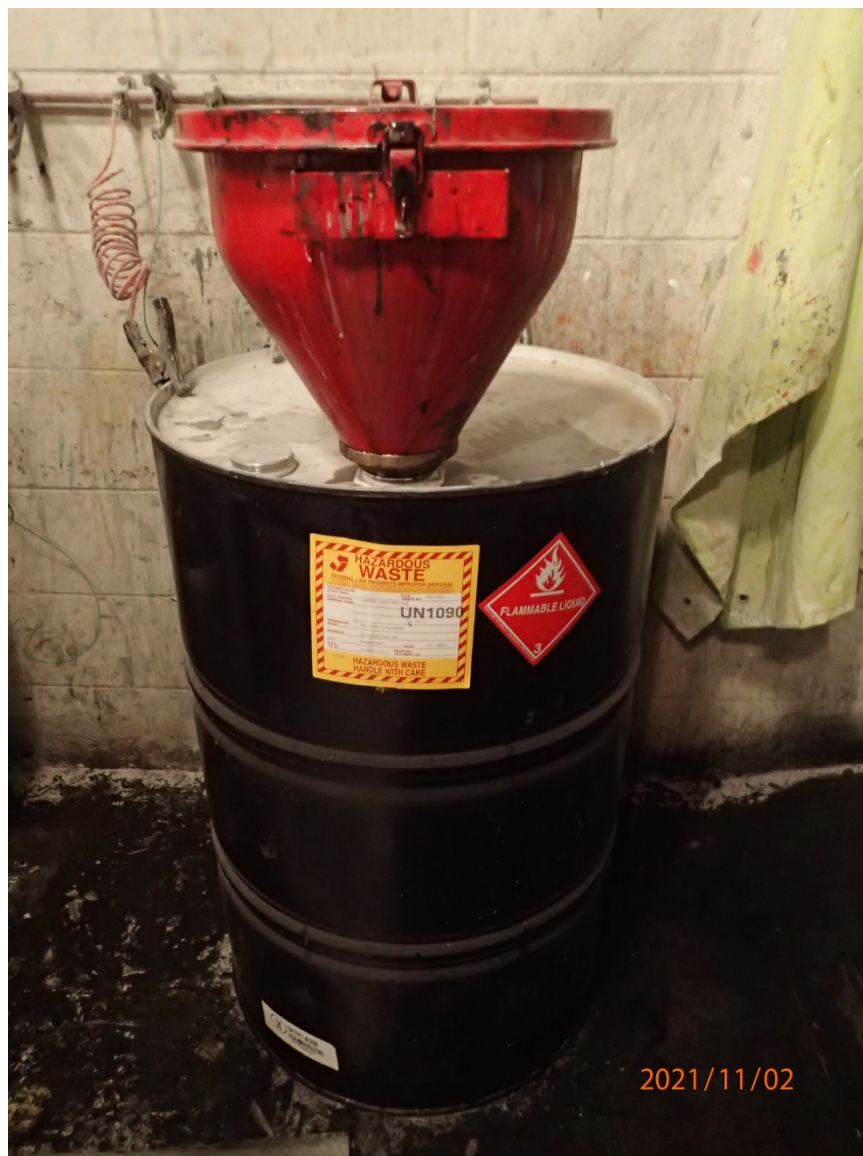
- One (1) 55-gallon SAA hazardous waste drum containing waste acetone sludge. The container was closed and labeled with the words "Hazardous Waste"; however, the container was not marked with an indication of hazard. This was corrected immediately onsite (Photo #1).

**Photo 1:** One (1) 55-gallon SAA hazardous waste drum containing waste acetone sludge. The container was closed and labeled with the words “Hazardous Waste”; however, the container was not marked with an indication of hazard. This was corrected immediately onsite.

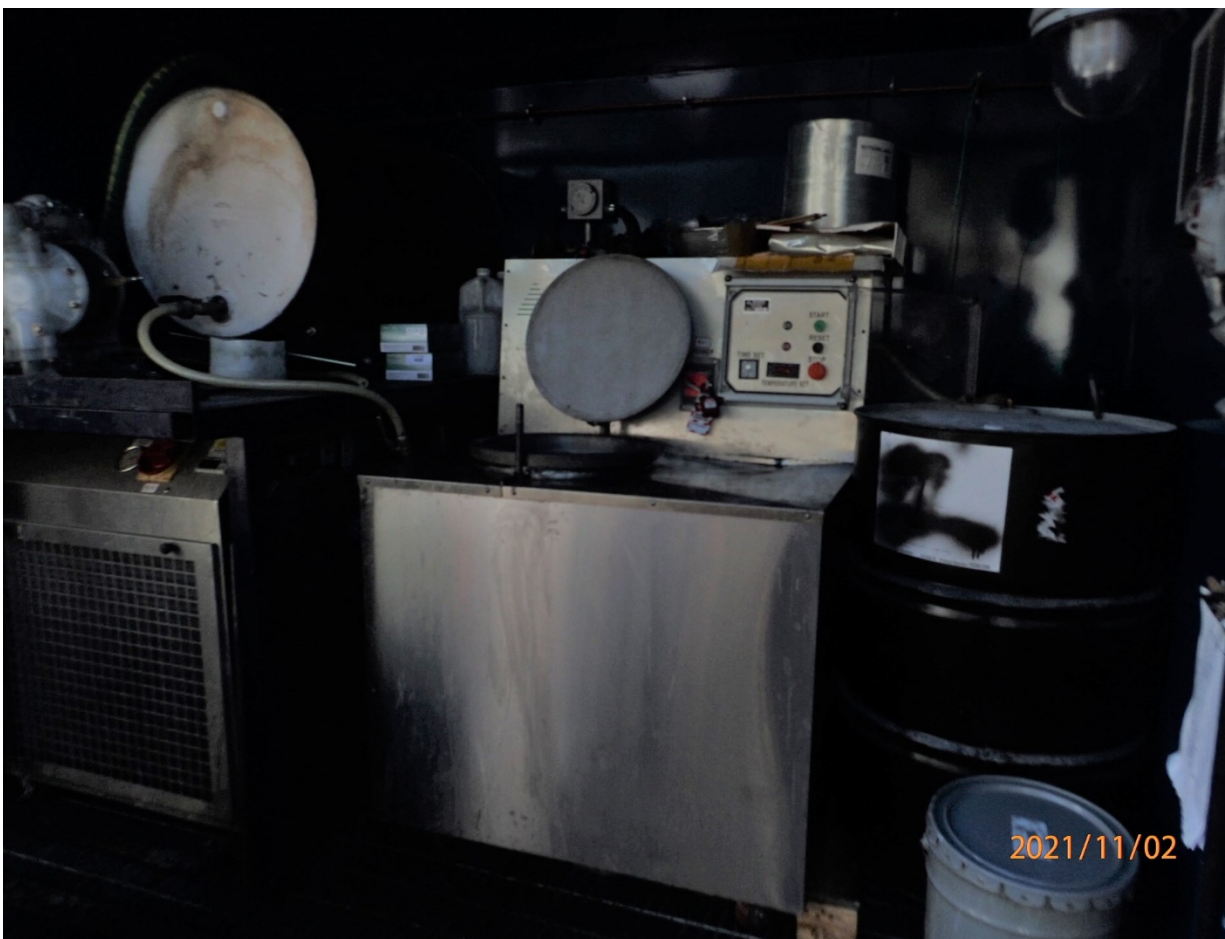
Next to the facility's 90-day hazardous waste central accumulation area (CAA) is the acetone recovery unit (located just behind Building #4) (Photo #2). Spent acetone is processed into reusable product. A 55-gallon drum labeled hazardous waste was observed on the pavement next to the reclamation area but was empty. No hazardous waste was observed in this area.

**Photo 2:** Acetone Recovery Unit. Not currently operating.

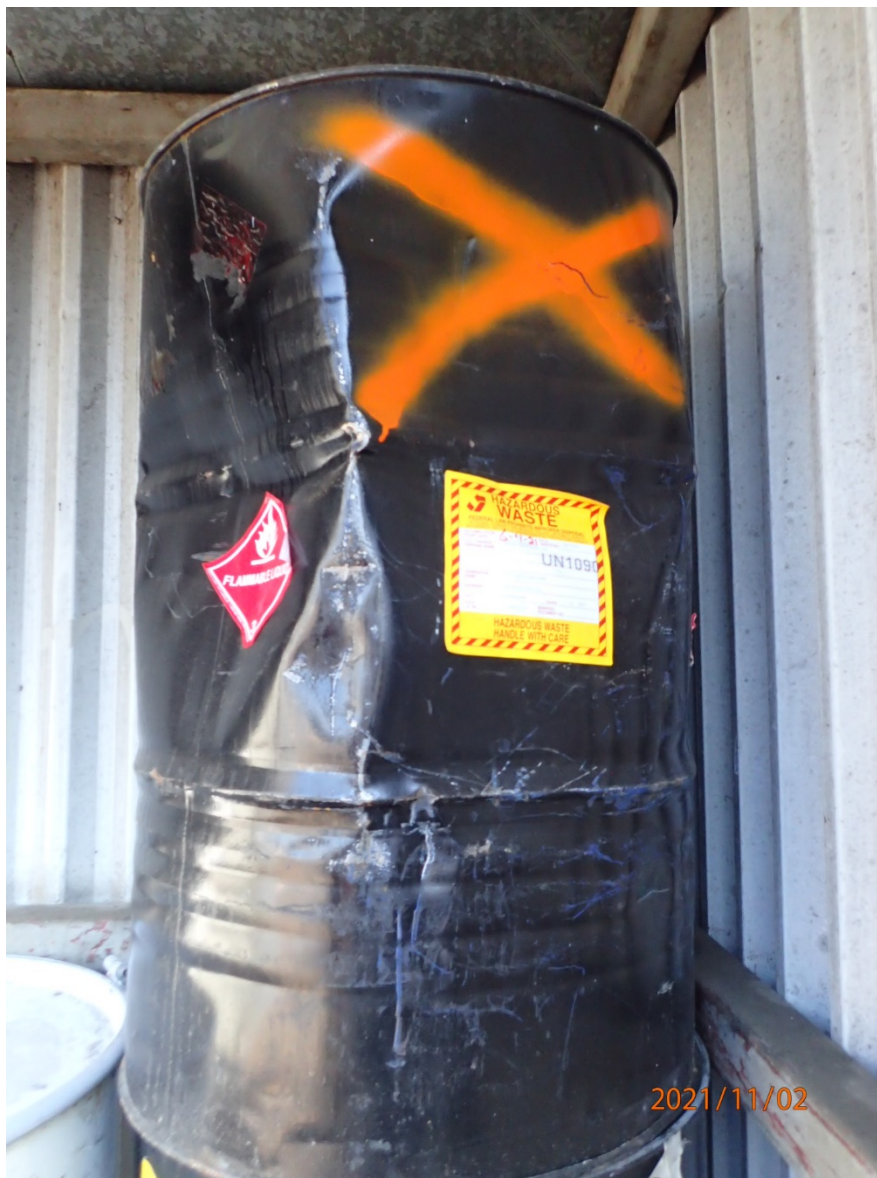
**Pursuant to ADEM Admin. Code r. 335-14-3-.01(7)(b) [40 CFR 262.17(b)], a large quantity generator who accumulates hazardous waste for more than 90 days is subject to the requirements of 40 CFR parts 124, 264 through 268, and part 270 of this chapter, and the notification requirements of section 3010 of RCRA, unless it has been granted an extension to the 90-day period. Such extension may be granted by EPA if hazardous wastes must remain on site for longer than 90 days due to unforeseen, temporary, and uncontrollable circumstances. An extension of up to 30 days may be granted at the discretion of the Regional Administrator on a case-by-case basis.**

**Photo 4:** One (1) 55-gallon drum of waste acetone. The container was closed and labeled with the words “Hazardous Waste” and marked with an indication of hazard. The drum was dated 6/4/2021, which was over the 90-day accumulation storage limit.

UPDATE: Mr. Shaver submitted photos on 11/03/2021 of both 55-gallon drums in overpack drums. Disposal of these drums was scheduled for 11/24/2021. (Photo #7)

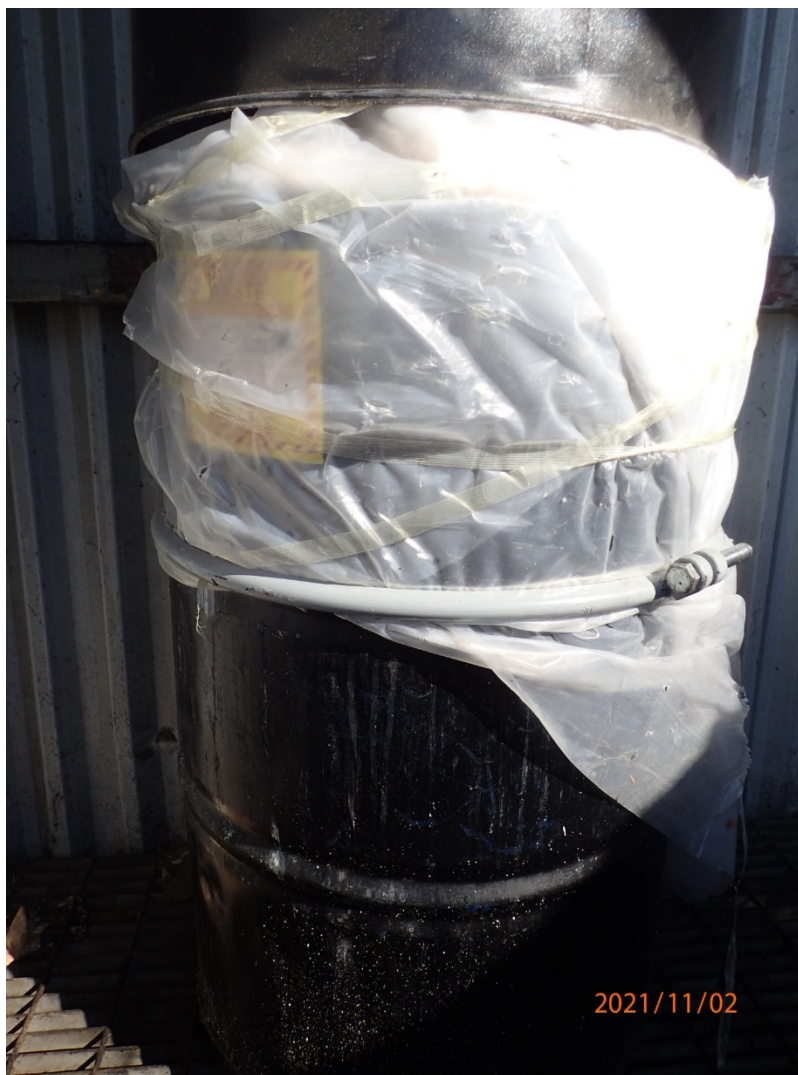
**Pursuant to ADEM Admin. Code r. 335-14-3-.01 (7)(a)1.(ii) [40 CFR 262.17(a)(1)(ii)], if a container holding hazardous waste is not in good condition, or if it begins to leak, the large quantity generator must immediately transfer the hazardous waste from this container to a container that is in good condition, or immediately manage the waste in some other way that complies with the conditions for exemption of this section.**

**Photo 5:** One (1) 55-gallon drum of waste acetone. The container was closed and labeled with the words “Hazardous Waste” and marked with an indication of hazard. The drum appeared to be bulging and the date was not clearly legible but appeared to be written as 05/ 2021. Mr. Shaver indicated the start accumulation date was over 90-days as well.

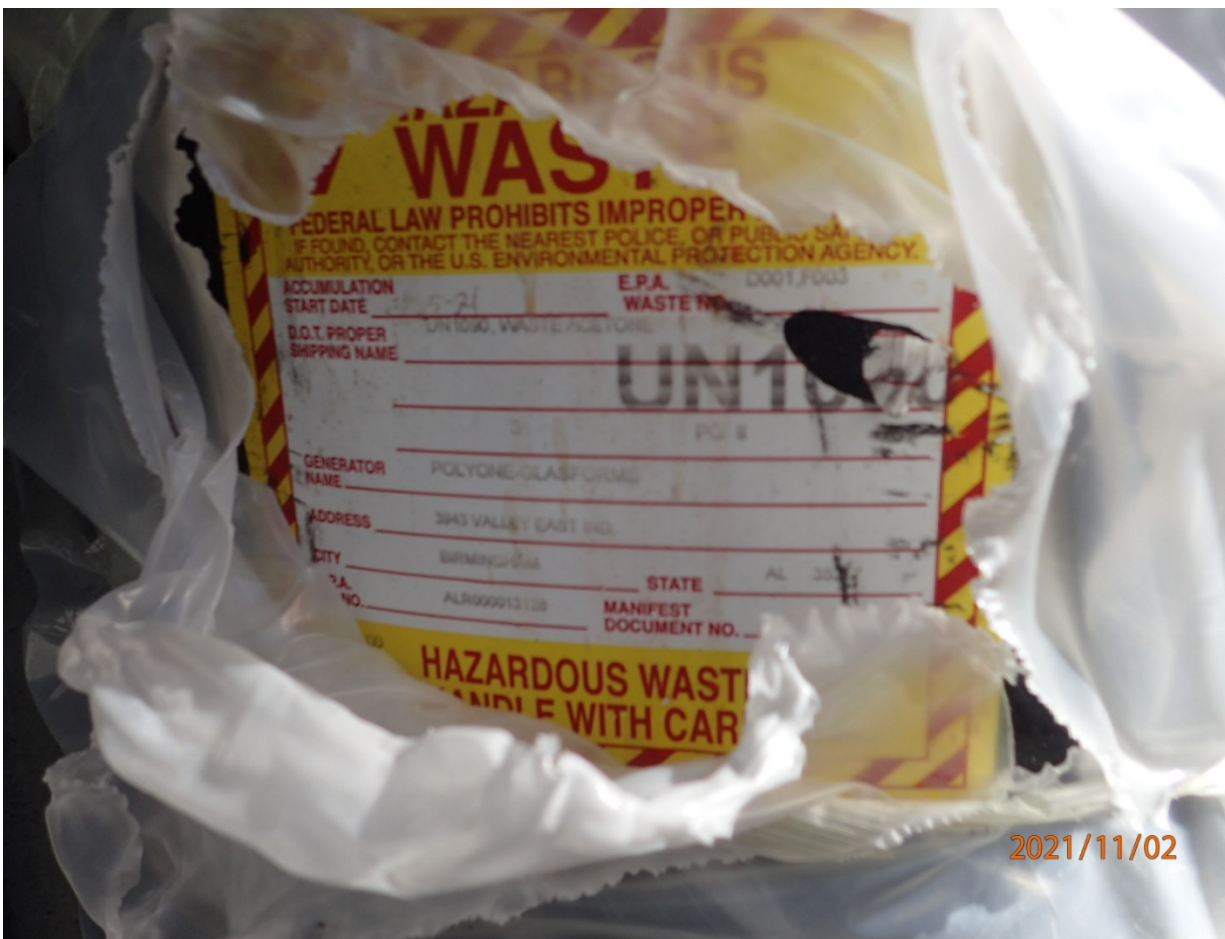
**Photo 6:** Close-up of drum with partial date of 5/21.

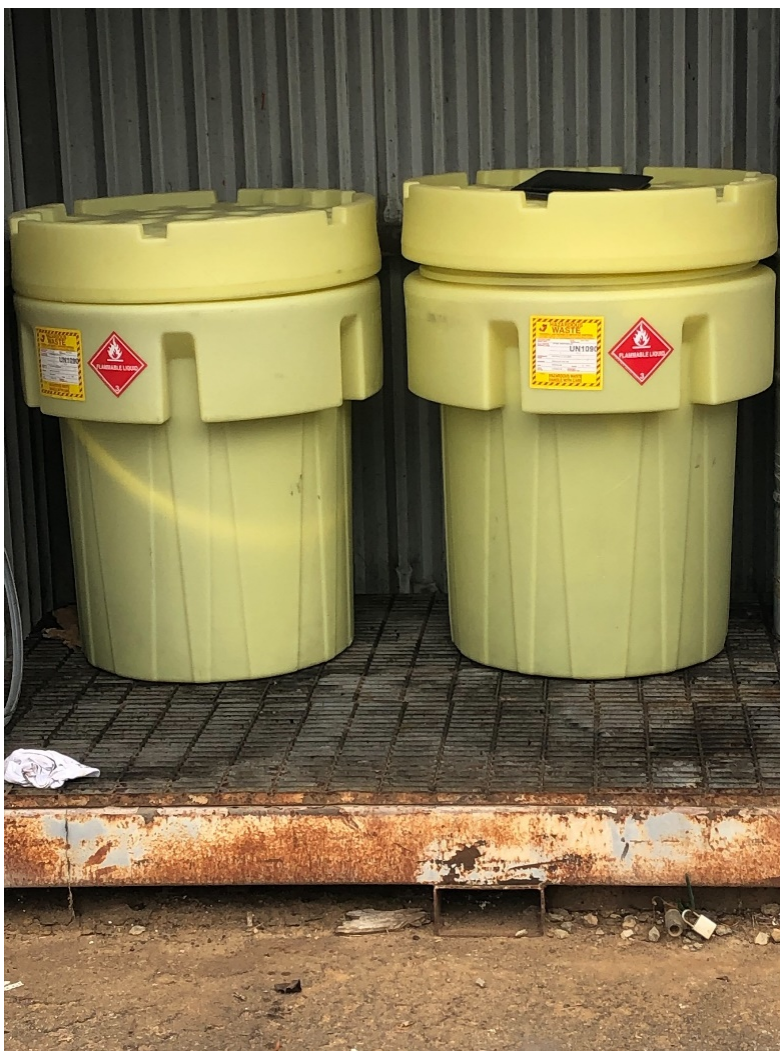
**Photo 7:** Both 55-gallon drums over 90-days containerized in overpack drums, awaiting disposal on 11/24/21.

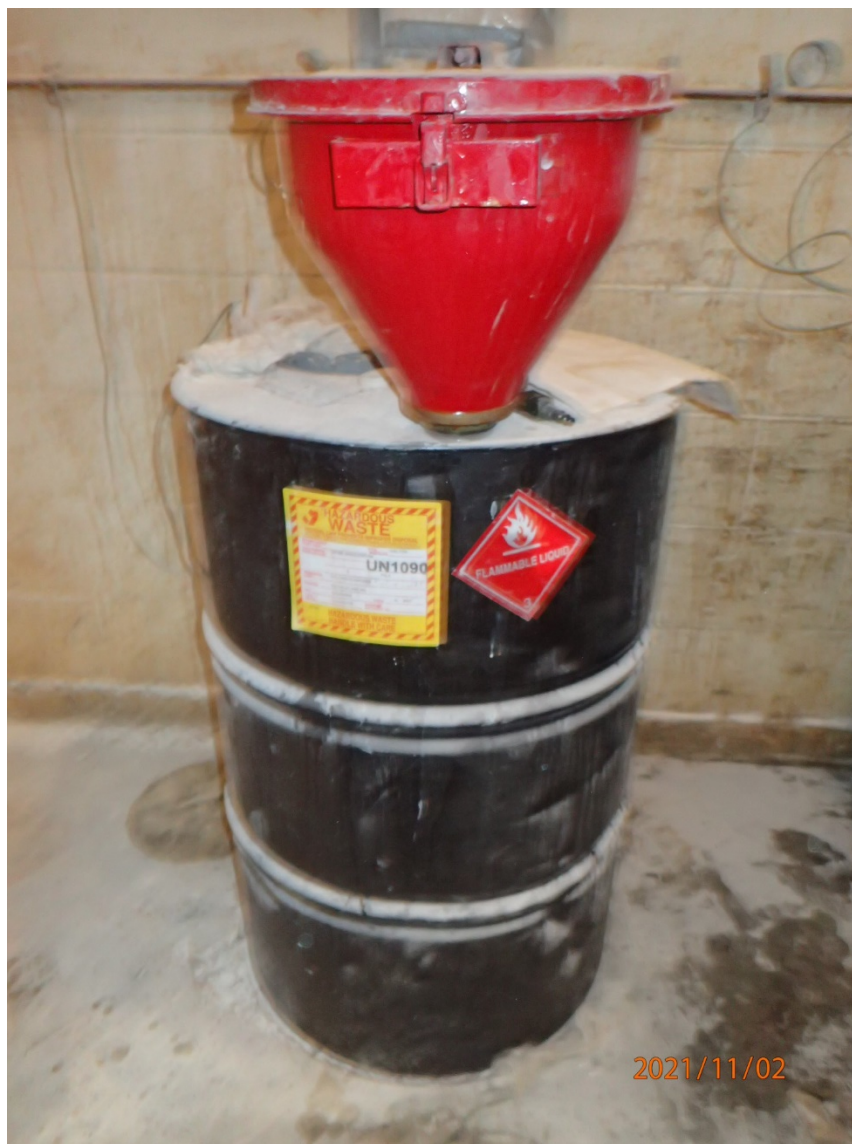
- One (1) 55-gallon drum of waste acetone. The container was closed and labeled with the words “Hazardous Waste”. The drum was not marked with the indication of hazard. This was corrected immediately onsite (Photo #8).

**Photo 8:** One (1) 55-gallon drum of waste acetone. The container was closed and labeled with the words "Hazardous Waste". The drum was not marked with the indication of hazard. This was corrected immediately onsite.

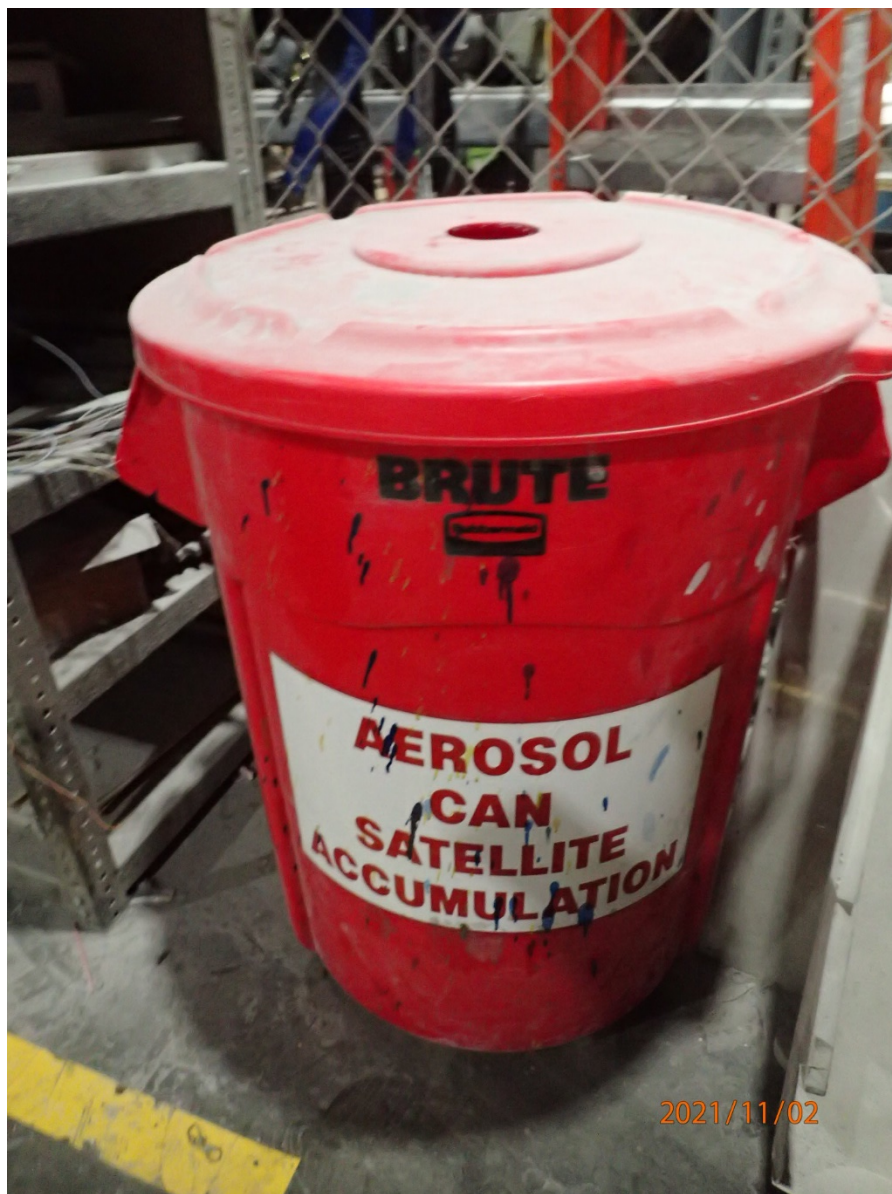
There was another SAA inside Building #2 for spent aerosol cans. Spent aerosol cans were stored in a container which did not have a hazardous waste label or marked with an indication of hazard. (Photo #9)

**Pursuant to ADEM Admin. Code r. 335-14-3-.01(6)(b)6.(i) [40 CFR 262.15(a)(5)], a generator must mark or label its container with the following: (i) The words “Hazardous Waste” (ii) An indication of the hazards of the contents (examples include, but are not limited to, the applicable hazardous waste characteristic(s) (i.e., ignitable, corrosive, reactive, toxic); hazard communication consistent with the Department of Transportation requirements at 49 CFR part 172 subpart E (labeling) or subpart F (placarding); a hazard statement or pictogram consistent with the Occupational Safety and Health Administration Hazard Communication Standard at 29 CFR 1910.1200; or a chemical hazard label consistent with the National Fire Protection Association code 704).**

**Photo 9:** Spent aerosol cans were stored in a container which did not have a hazardous waste label or marked with an indication of hazard.

UPDATE: Mr. Shaver submitted photos of universal waste fluorescent bulbs contained in closed boxes which were all labeled and dated. Photos of both containers of spent aerosol cans were submitted showing the containers labeled “Hazardous Waste”. (Photo #13 and #14)

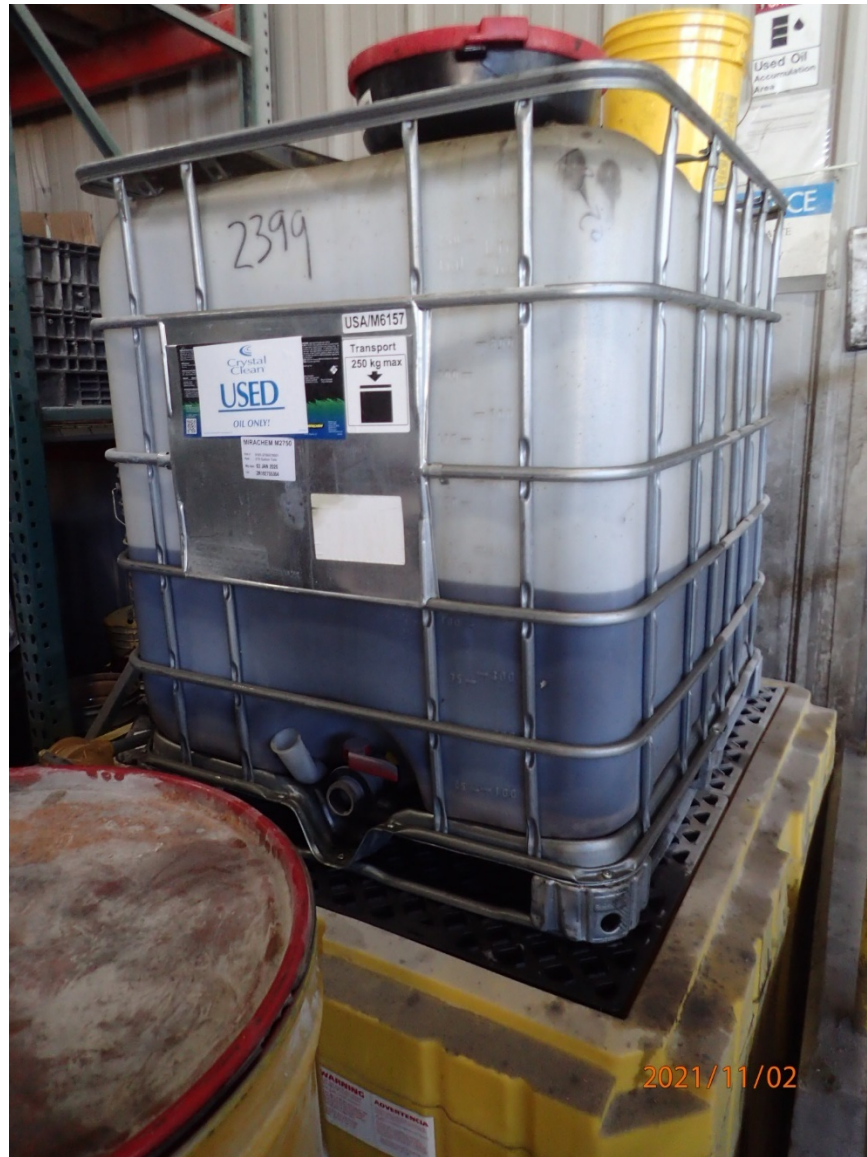
**Photo 10:** 250-gallon used oil tote.

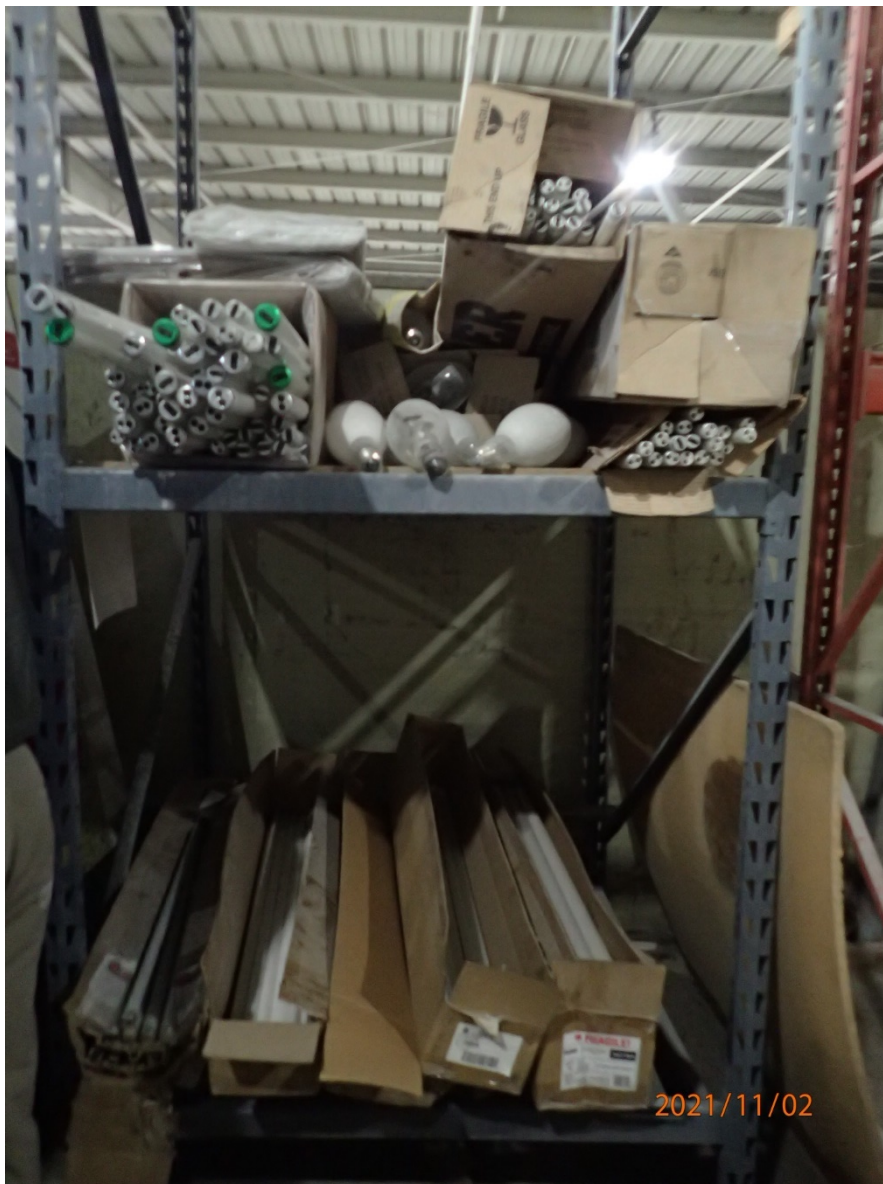
**Pursuant to ADEM Admin. Code r. 335-14-11-.02(4)(d) [40 CFR 273.13(d)], a small quantity handler of universal waste must manage lamps in a way that prevents releases of any universal waste or component of a universal waste to the environment, as follows: (1) A small quantity handler of universal waste must contain any lamp in containers or packages that are structurally sound, adequate to prevent breakage, and compatible with the contents of the lamps. Such containers and packages must remain closed and must lack evidence of leakage, spillage or damage that could cause leakage under reasonably foreseeable conditions. (2) A small quantity handler of universal waste must immediately clean up and place in a container any lamp that is broken and must place in a container any lamp that shows evidence of breakage, leakage, or damage that could cause the release of mercury or other hazardous constituents to the environment. Containers must be closed, structurally sound, compatible with the contents of the lamps and must lack evidence of**

Pursuant to ADEM Admin. Code r. 335-14-11-.02(5)(e) [40 CFR 273.14(e)], each lamp or a container or package in which such lamps are contained must be labeled or marked clearly with one of the following phrases: “Universal Waste - Lamp(s),” or “Waste Lamp(s),” or “Used Lamp(s)”.

Pursuant to ADEM Admin. Code r. 335-14-11-.02(6)(c) [40 CFR 273.15(c)], a small quantity handler of universal waste who accumulates universal waste must be able to demonstrate the length of time that the universal waste has been accumulated from the date it becomes a waste or is received. The handler may make this demonstration by:

**Photo 11:** Eleven (11) boxes of Universal Waste (UW) fluorescent lamps. The boxes of UW were open, not labeled, and not dated.

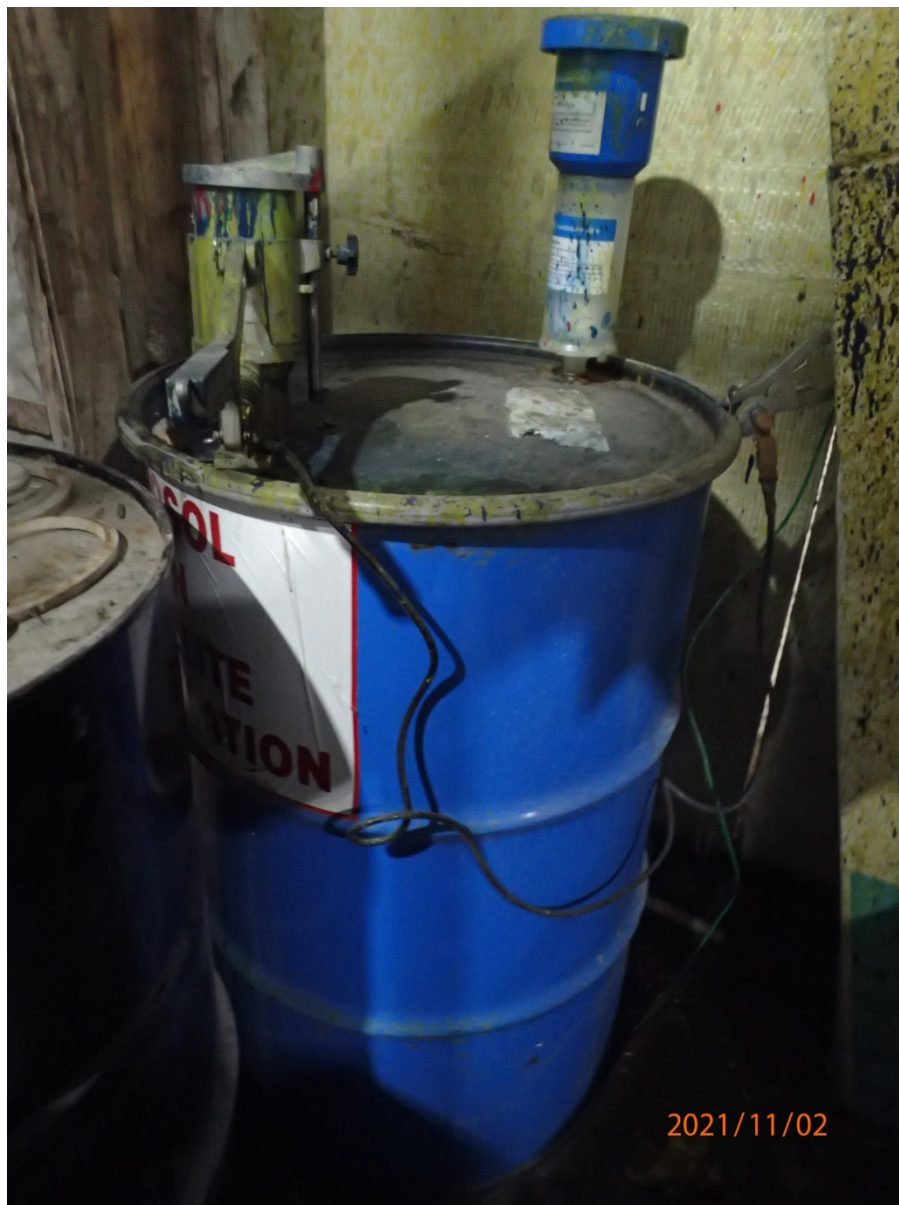
Pursuant to ADEM Admin. Code r. 335-14-3-.01(6)(b)6.(i) [40 CFR 262.15(a)(5)], a generator must mark or label its container with the following: (i) The words “Hazardous Waste” (ii) An indication of the hazards of the contents (examples include, but are not limited to, the applicable hazardous waste characteristic(s) (i.e., ignitable, corrosive, reactive, toxic); hazard communication consistent with the Department of Transportation requirements at 49 CFR part 172 subpart E (labeling) or subpart F (placarding); a hazard statement or pictogram consistent with the Occupational Safety and Health Administration Hazard Communication Standard at 29 CFR 1910.1200; or a chemical hazard label consistent with the National Fire Protection Association code 704).

**Photo 12:** One (1) aerosol can puncture device attached to a waste container. The container was not labeled with the words hazardous waste or marked with an indication of hazard.

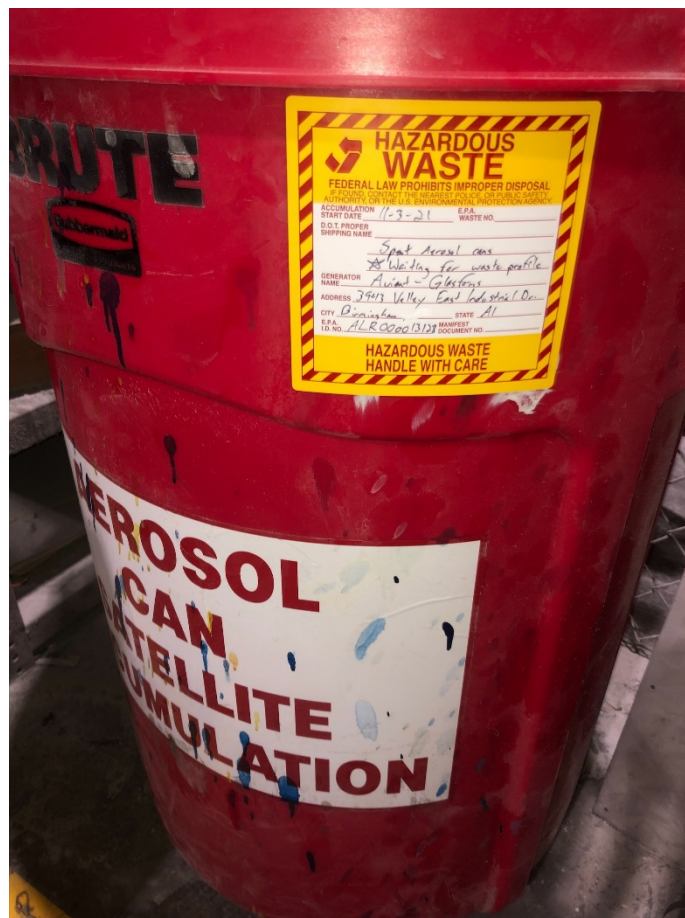
**Photo 14:** Photos of both containers of spent aerosol cans were submitted showing the containers labeled "Hazardous Waste".

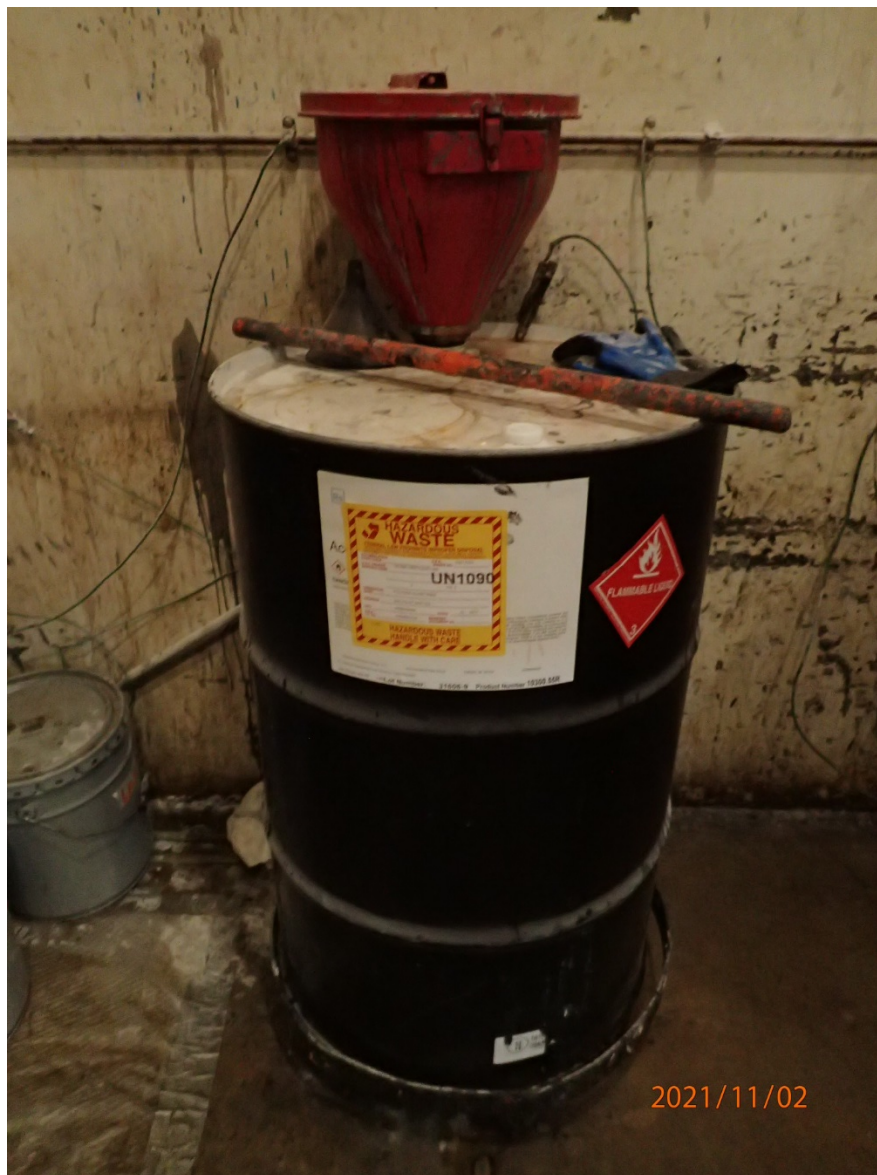
- One (1) 55-gallon drum of spent solvents. The container was closed but was missing a hazardous waste label. This was corrected immediately onsite (Photo #15). The container was marked with an indication of hazard.

**Photo 15:** One (1) 55-gallon drum of spent solvents. The container was closed but was missing a hazardous waste label. This was corrected immediately onsite (Photo #15). The container was marked with an indication of hazard.
