# **RCRA Compliance Evaluation Inspection Report**

Patrick Air Force Base  
1224 Jupiter Street 45 CES/CEIE  
Patrick Air Force Base (AFB), Florida 32925-3343  
County: Brevard  
EPA ID Number: FL2570024404

RCRA CEI Photographs for  
Patrick Air Force Base  
1224 Jupiter Street 45 CES/CEIE  
Patrick Air Force Base (AFB), Florida 32925-3343  
EPA ID Number: FL2570024404

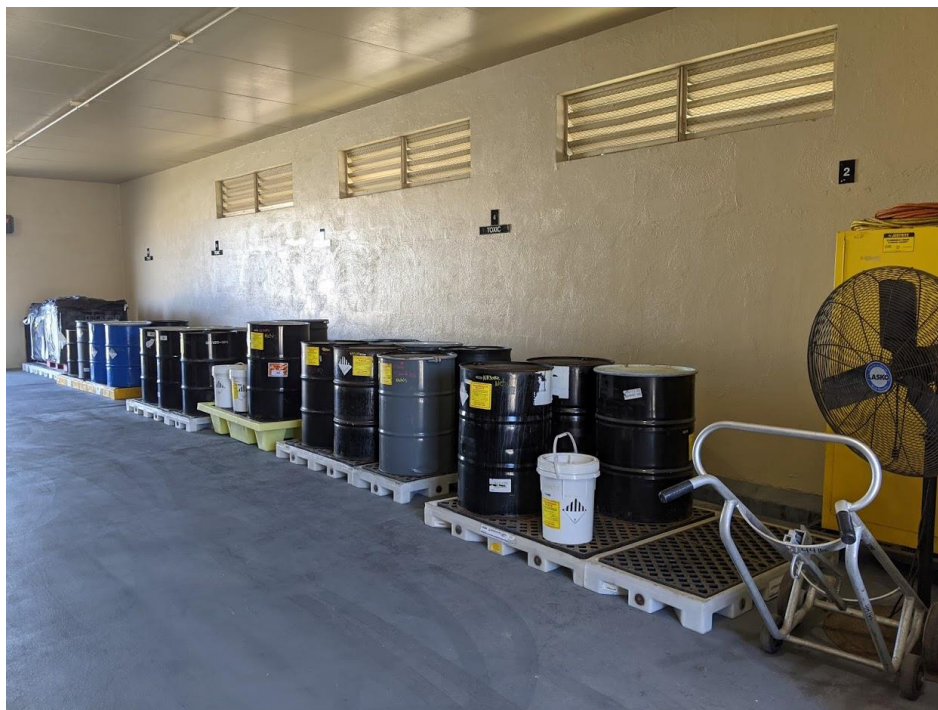
At the time of the inspection, the AFB was storing hazardous waste inside Building 947. There was a landline phone located on the wall outside the building, a fire extinguisher on each end of the building and one inside. A hazardous waste and no smoking sign were posted, as well as, the emergency contact information. Eyewash station, spill kit, as well as other pertinent personal protective equipment (PPE) were available in Bay 1. Bay's 2-10 were designated for waste storage. Waste is separated according to its characteristic type and stationed on top of secondary containment. The bays with different waste characteristics were separated by a wall. At the time of the inspection there were approximately 34 containers. All waste containers were closed, labeled, and dated. No containers were dated beyond one year from the time of the inspection. One 250-gallon tote of non-regulated aqueous film-forming foam (AFFF) wastewater that is used to clean fire suppression foam was also stored in this building. EPA Hazardous Waste Codes identified on containers at the time of the inspection consisted of: D001, D005, D006, D007, D008, D018, D035, D039, F003, F005 and primarily consisted of waste from aerosols, the gun range, and paint-related waste generation from aircraft maintenance (Photographs 1, 2 of 4).

Photograph 1 of 4: Central Accumulation Area

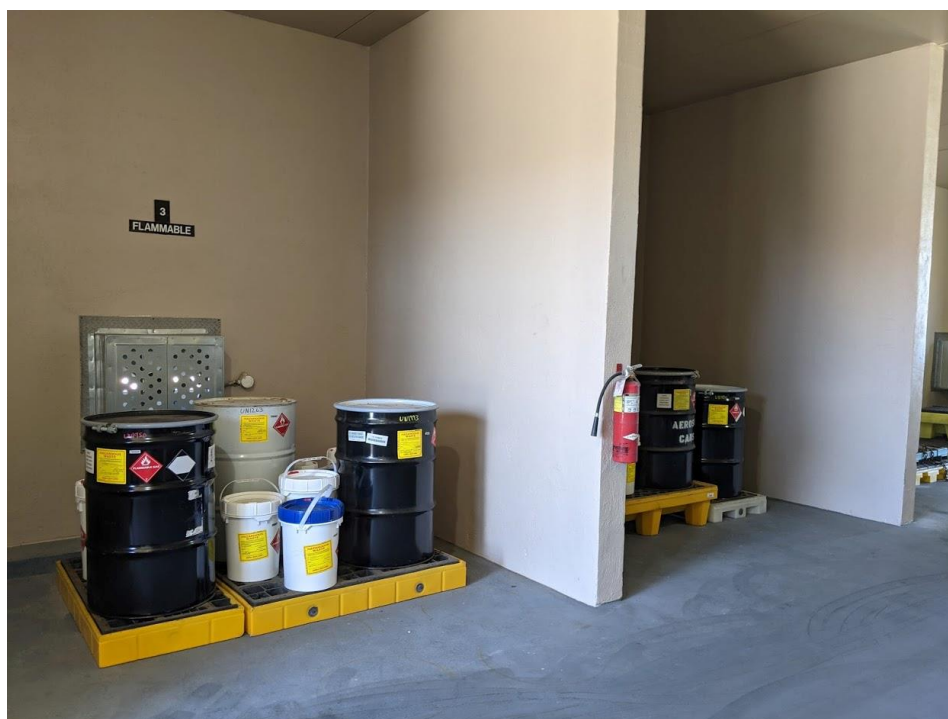
Photograph 2 of 4: Central Accumulation Area

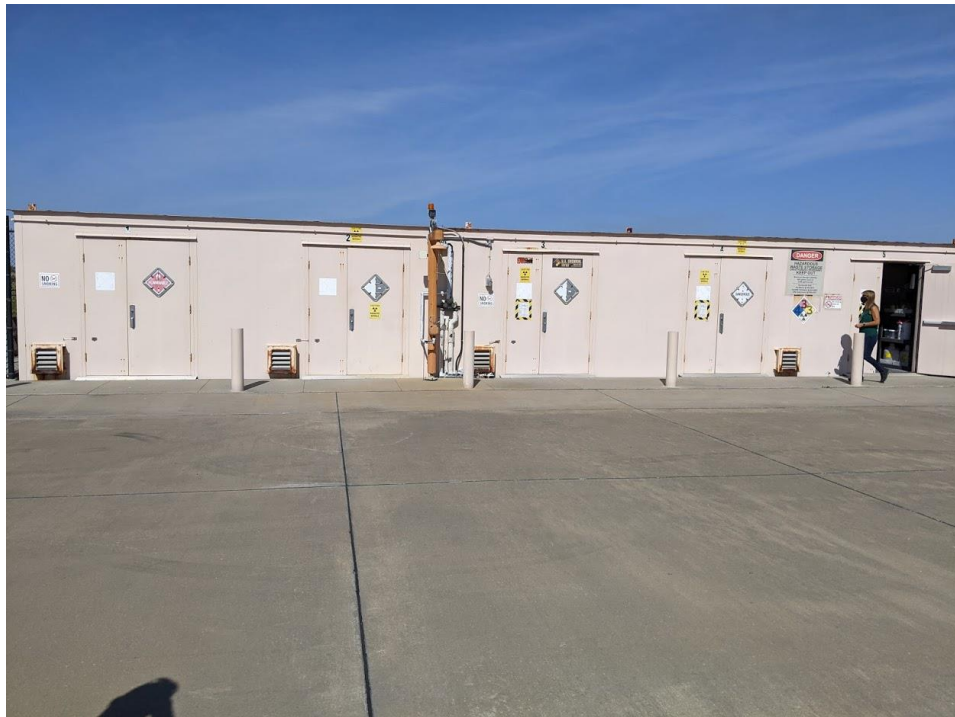
Stationed outside, the AF TAC consisted of 5 lockers separated based on hazard compatibility. Locker numbers 1 and 2 were designated for non-RCRA radioactive waste, locker numbers 3 and 5 were designated for hazardous waste, and locker number 4 was designated for mixed hazardous waste. At the time of the inspection, there were approximately 70-plus containers of varying sizes organized on shelves within the lockers. All containers were labeled, dated, and closed. Waste in this area is generated from lab samples collected from various military operation missions. EPA Waste Codes identified on containers in this area at the time of the inspection consisted of D001, D003, D002, D005, D006, D007, D008, D010, and D011. Oily rags and non-regulated material from resin cartridges were also stored at this location at the time of the inspection (Photographs 3, 4 of 4).

Photograph 3 of 4: Locker Storage

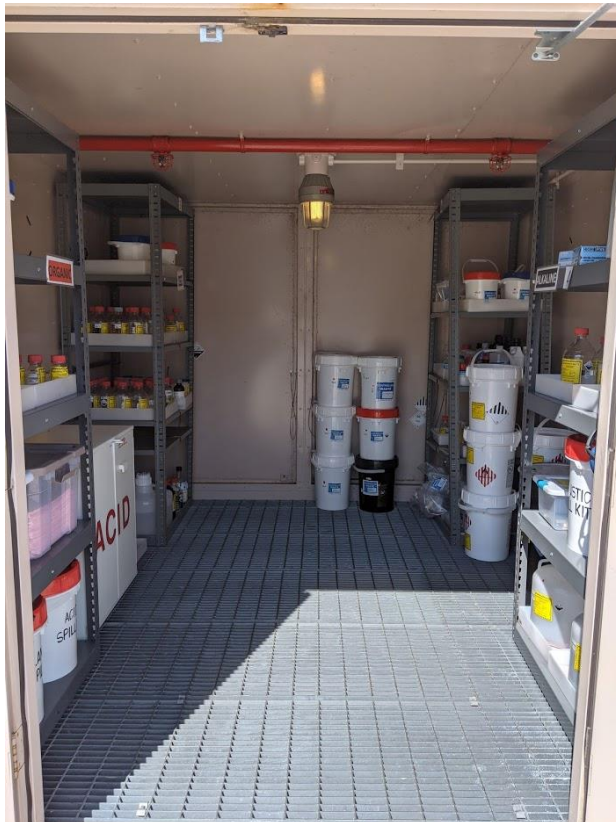
Photograph 4 of 4: Locker Storage
