**Region 6 - Enforcement & Compliance Assurance Division**  
**INSPECTION REPORT**

| Inspection Date(s): | August 24, 2023 | |
| Company Name: | <b>Stolt Tankers USA, Inc</b> | |
| Facility Name: | <b>Stolt Barging Services</b> | |

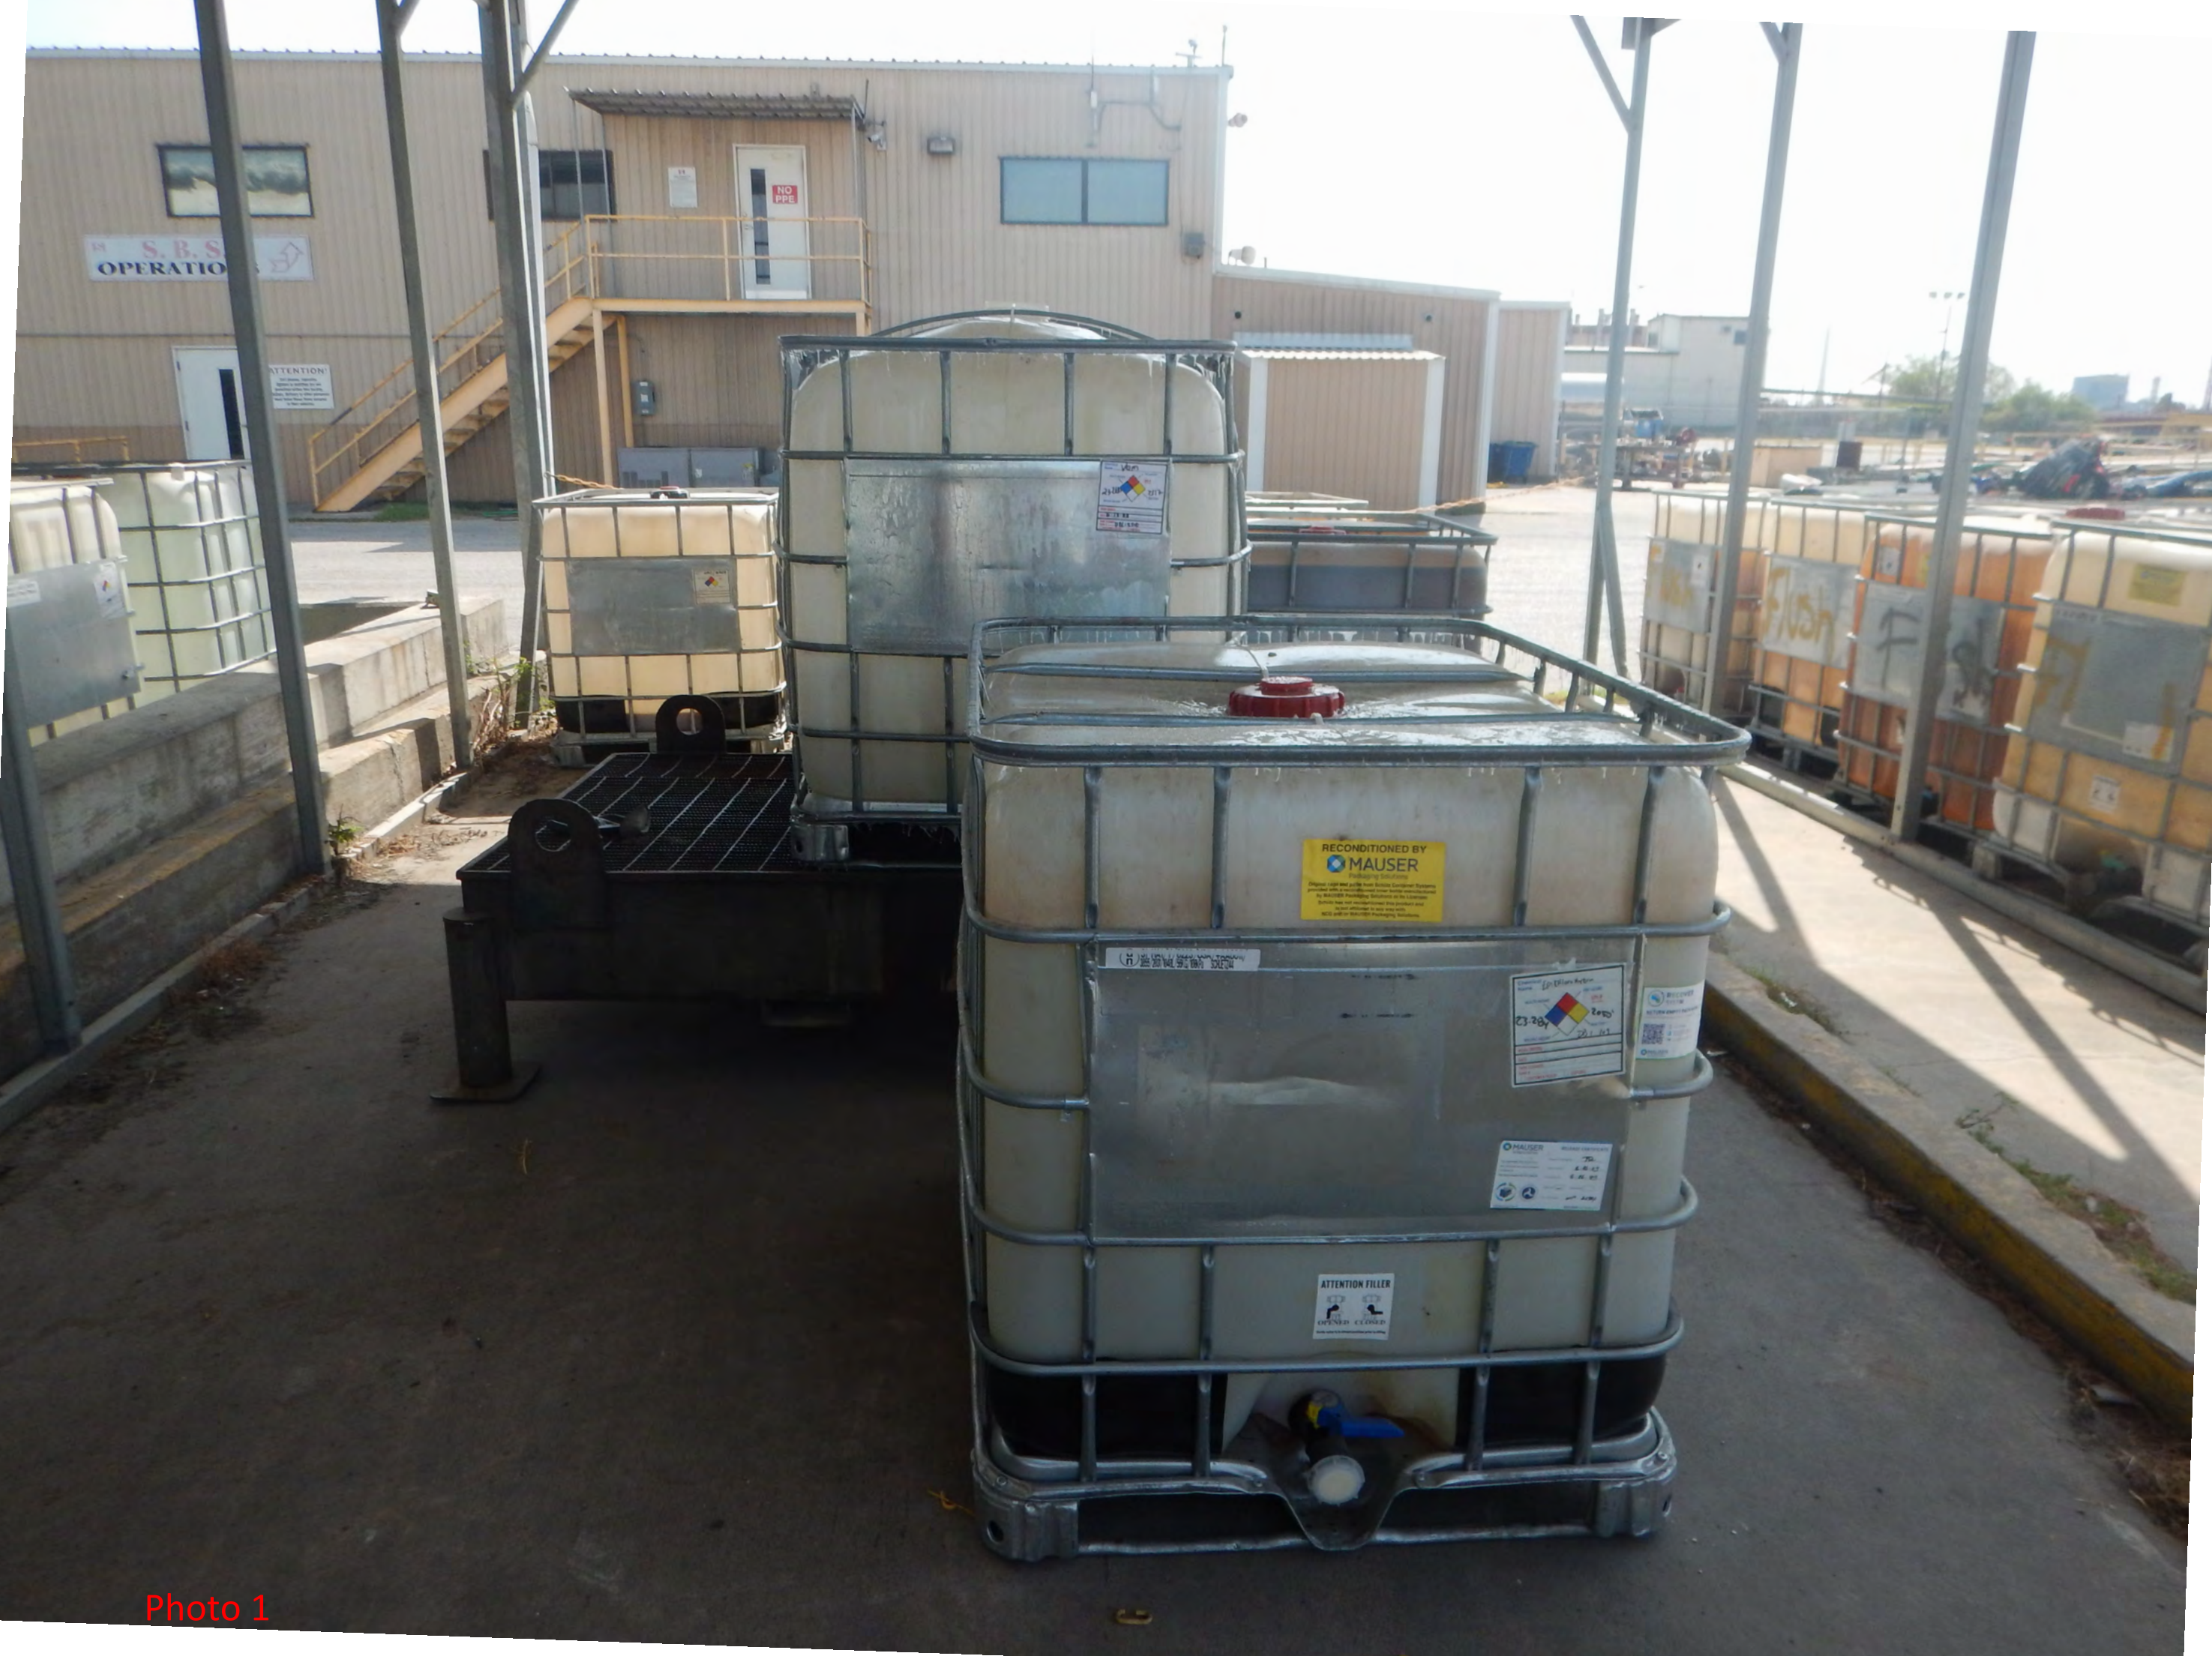
Photo 1

The container management standards for large quantity generators require containers accumulating hazardous waste to be kept closed unless waste is actively being added or removed. During this inspection we observed 3 containers which were in hazardous waste service and open when unattended and not being filled or emptied. Two ISO containers used for the accumulation of corrosive waste were open at the time of inspection. See photos 17, 18, 21, and 22 in Appendix 1. One container labeled as containing "VAM" in the <90-day container central accumulation area was open at the time of inspection. See photos 1, 3, 9, 10 in Appendix 1.

| Photo Number | File Name | | Date | Time | Photographer | Description |
|---|---|---|---|---|---|---|
| 1 | DSCN1150 | .JPG | 24-Aug-23 | 1050 | John Penland | <90-day Container Central Accumulation Area (CAA) |

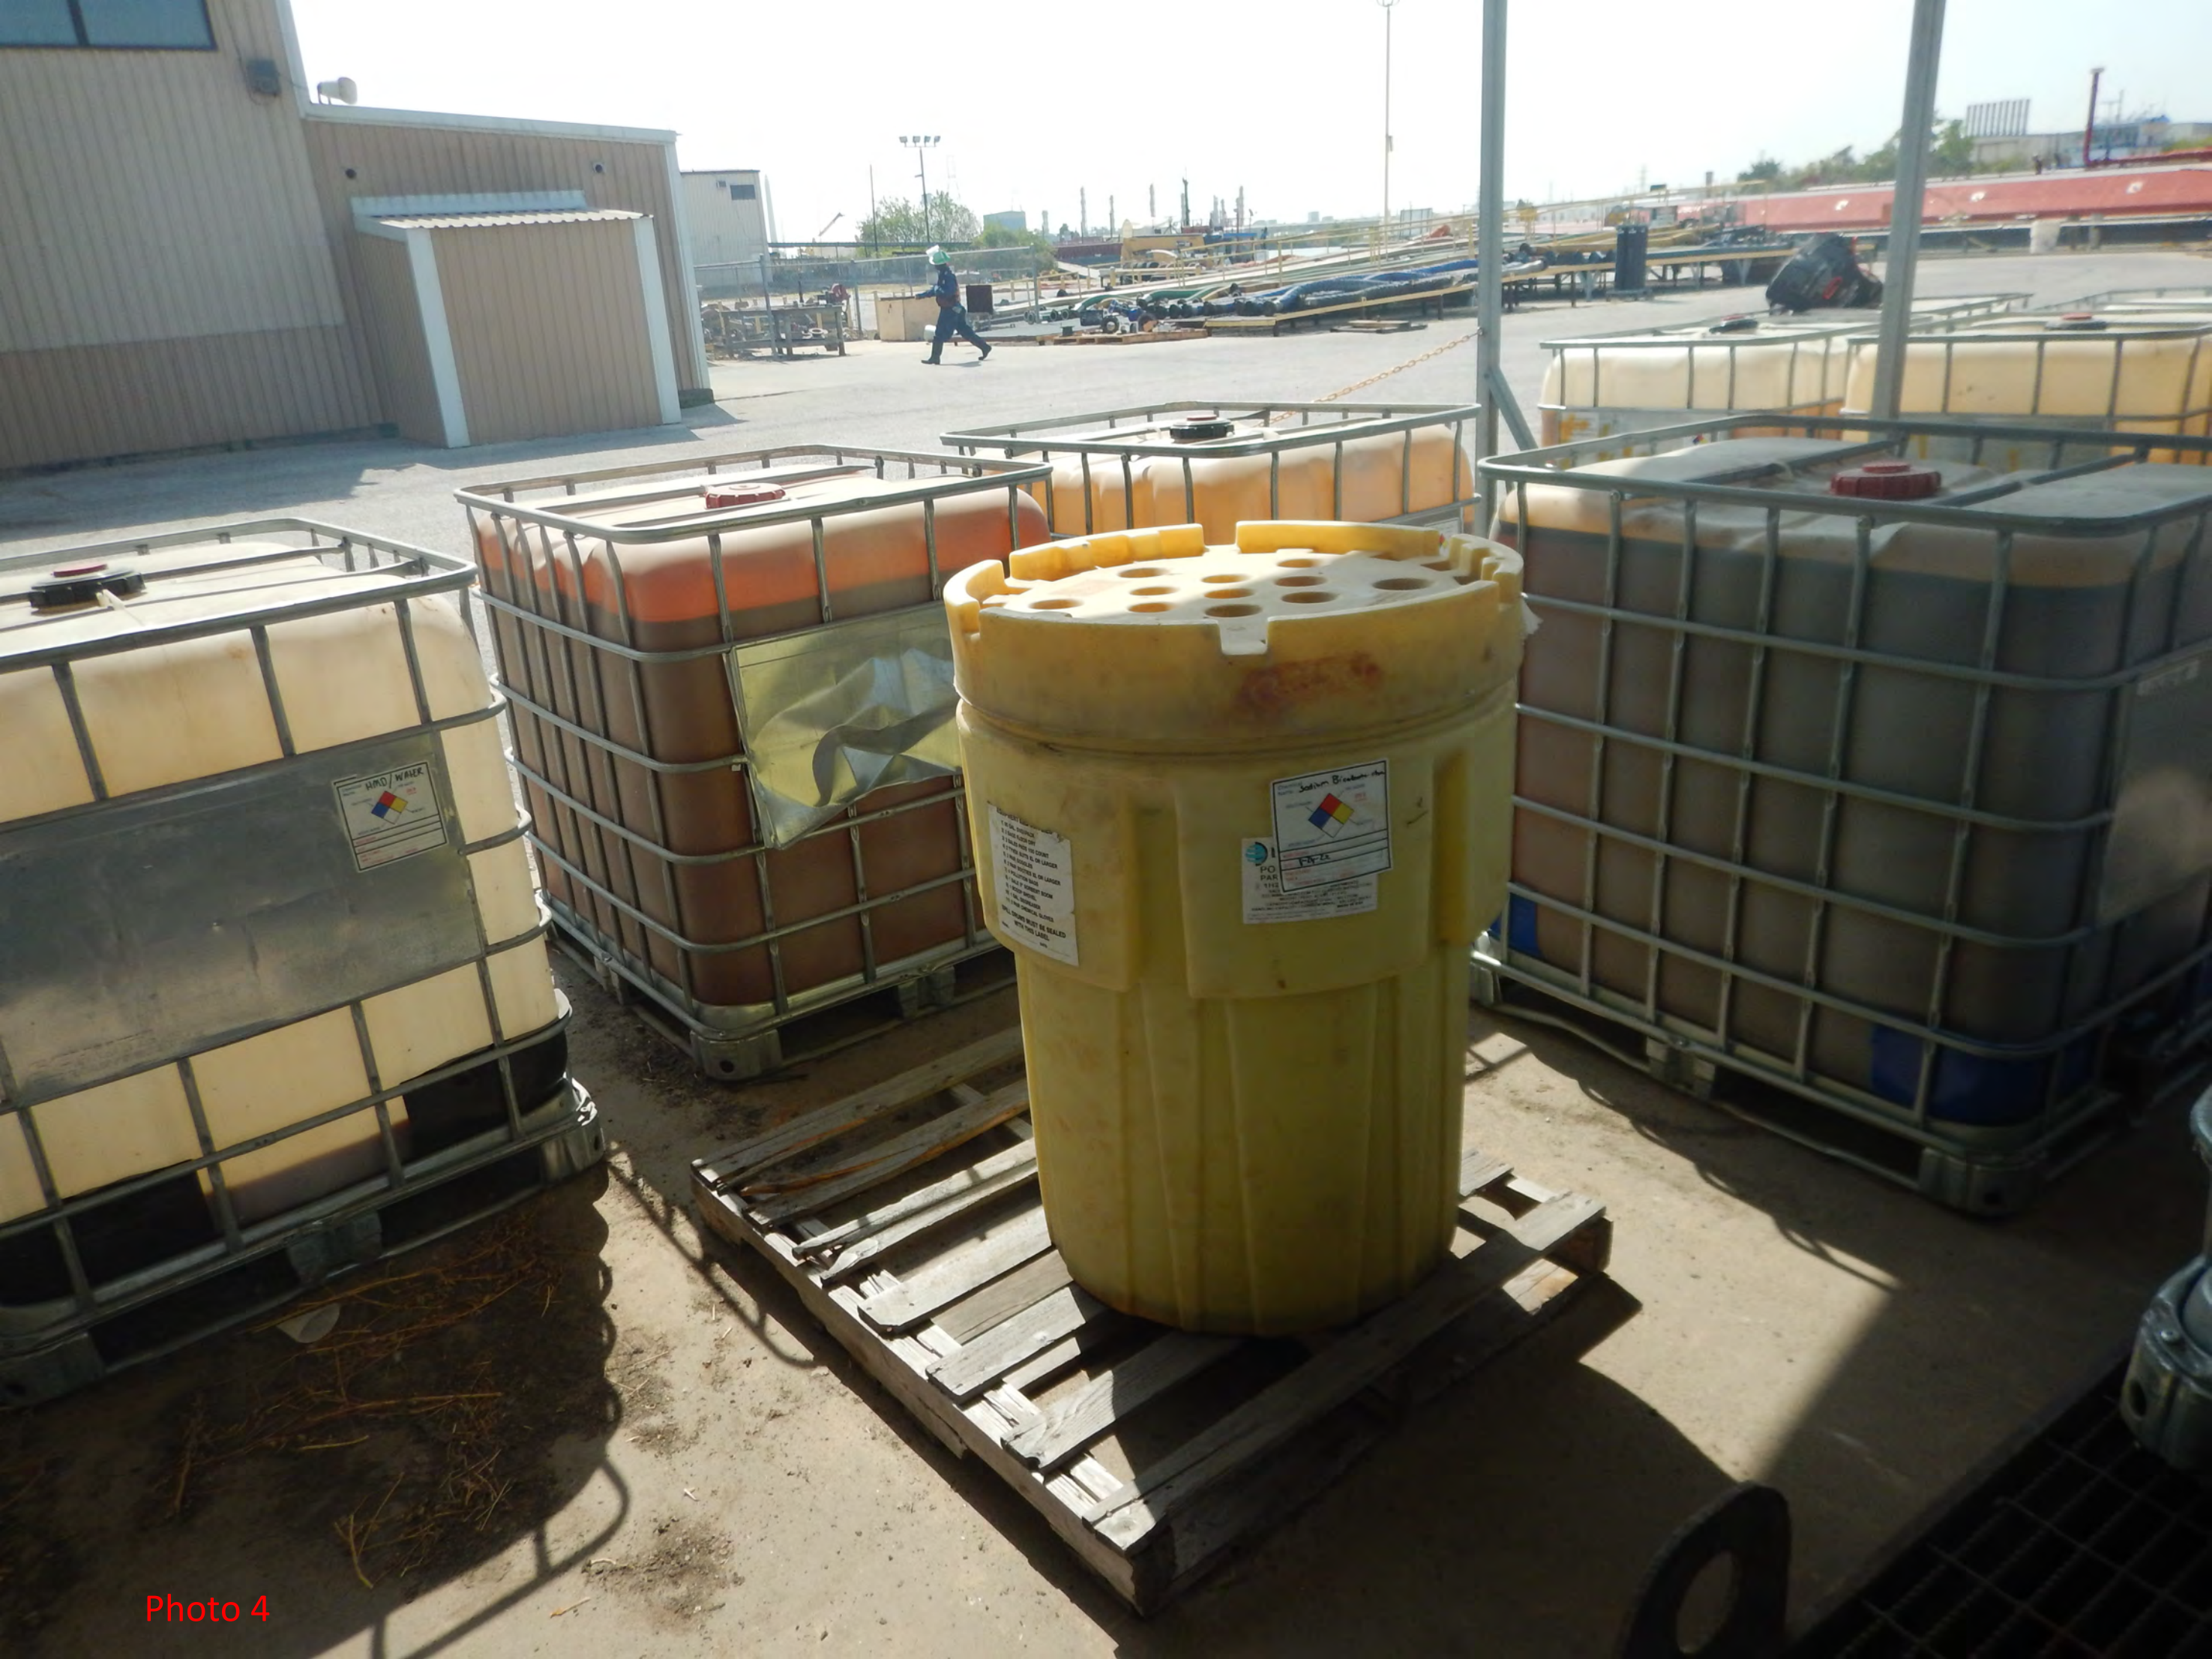
Photo 4

| Photo Number | File Name | | Date | Time | Photographer | Description |
|---|---|---|---|---|---|---|
| 4 | DSCN1153 | .JPG | 24-Aug-23 | 1050 | John Penland | <90-day Container Central Accumulation Area (CAA) |

- Container Storage:
    - Central Container Accumulation Area
      - 7 containers located in the hazardous waste container central accumulation area were not labeled as hazardous waste.

- 4 containers located in the hazardous waste container central accumulation area were not labeled with an accumulation start date.
      - 1 container located in the hazardous waste container central accumulation area was open at the time of inspection.

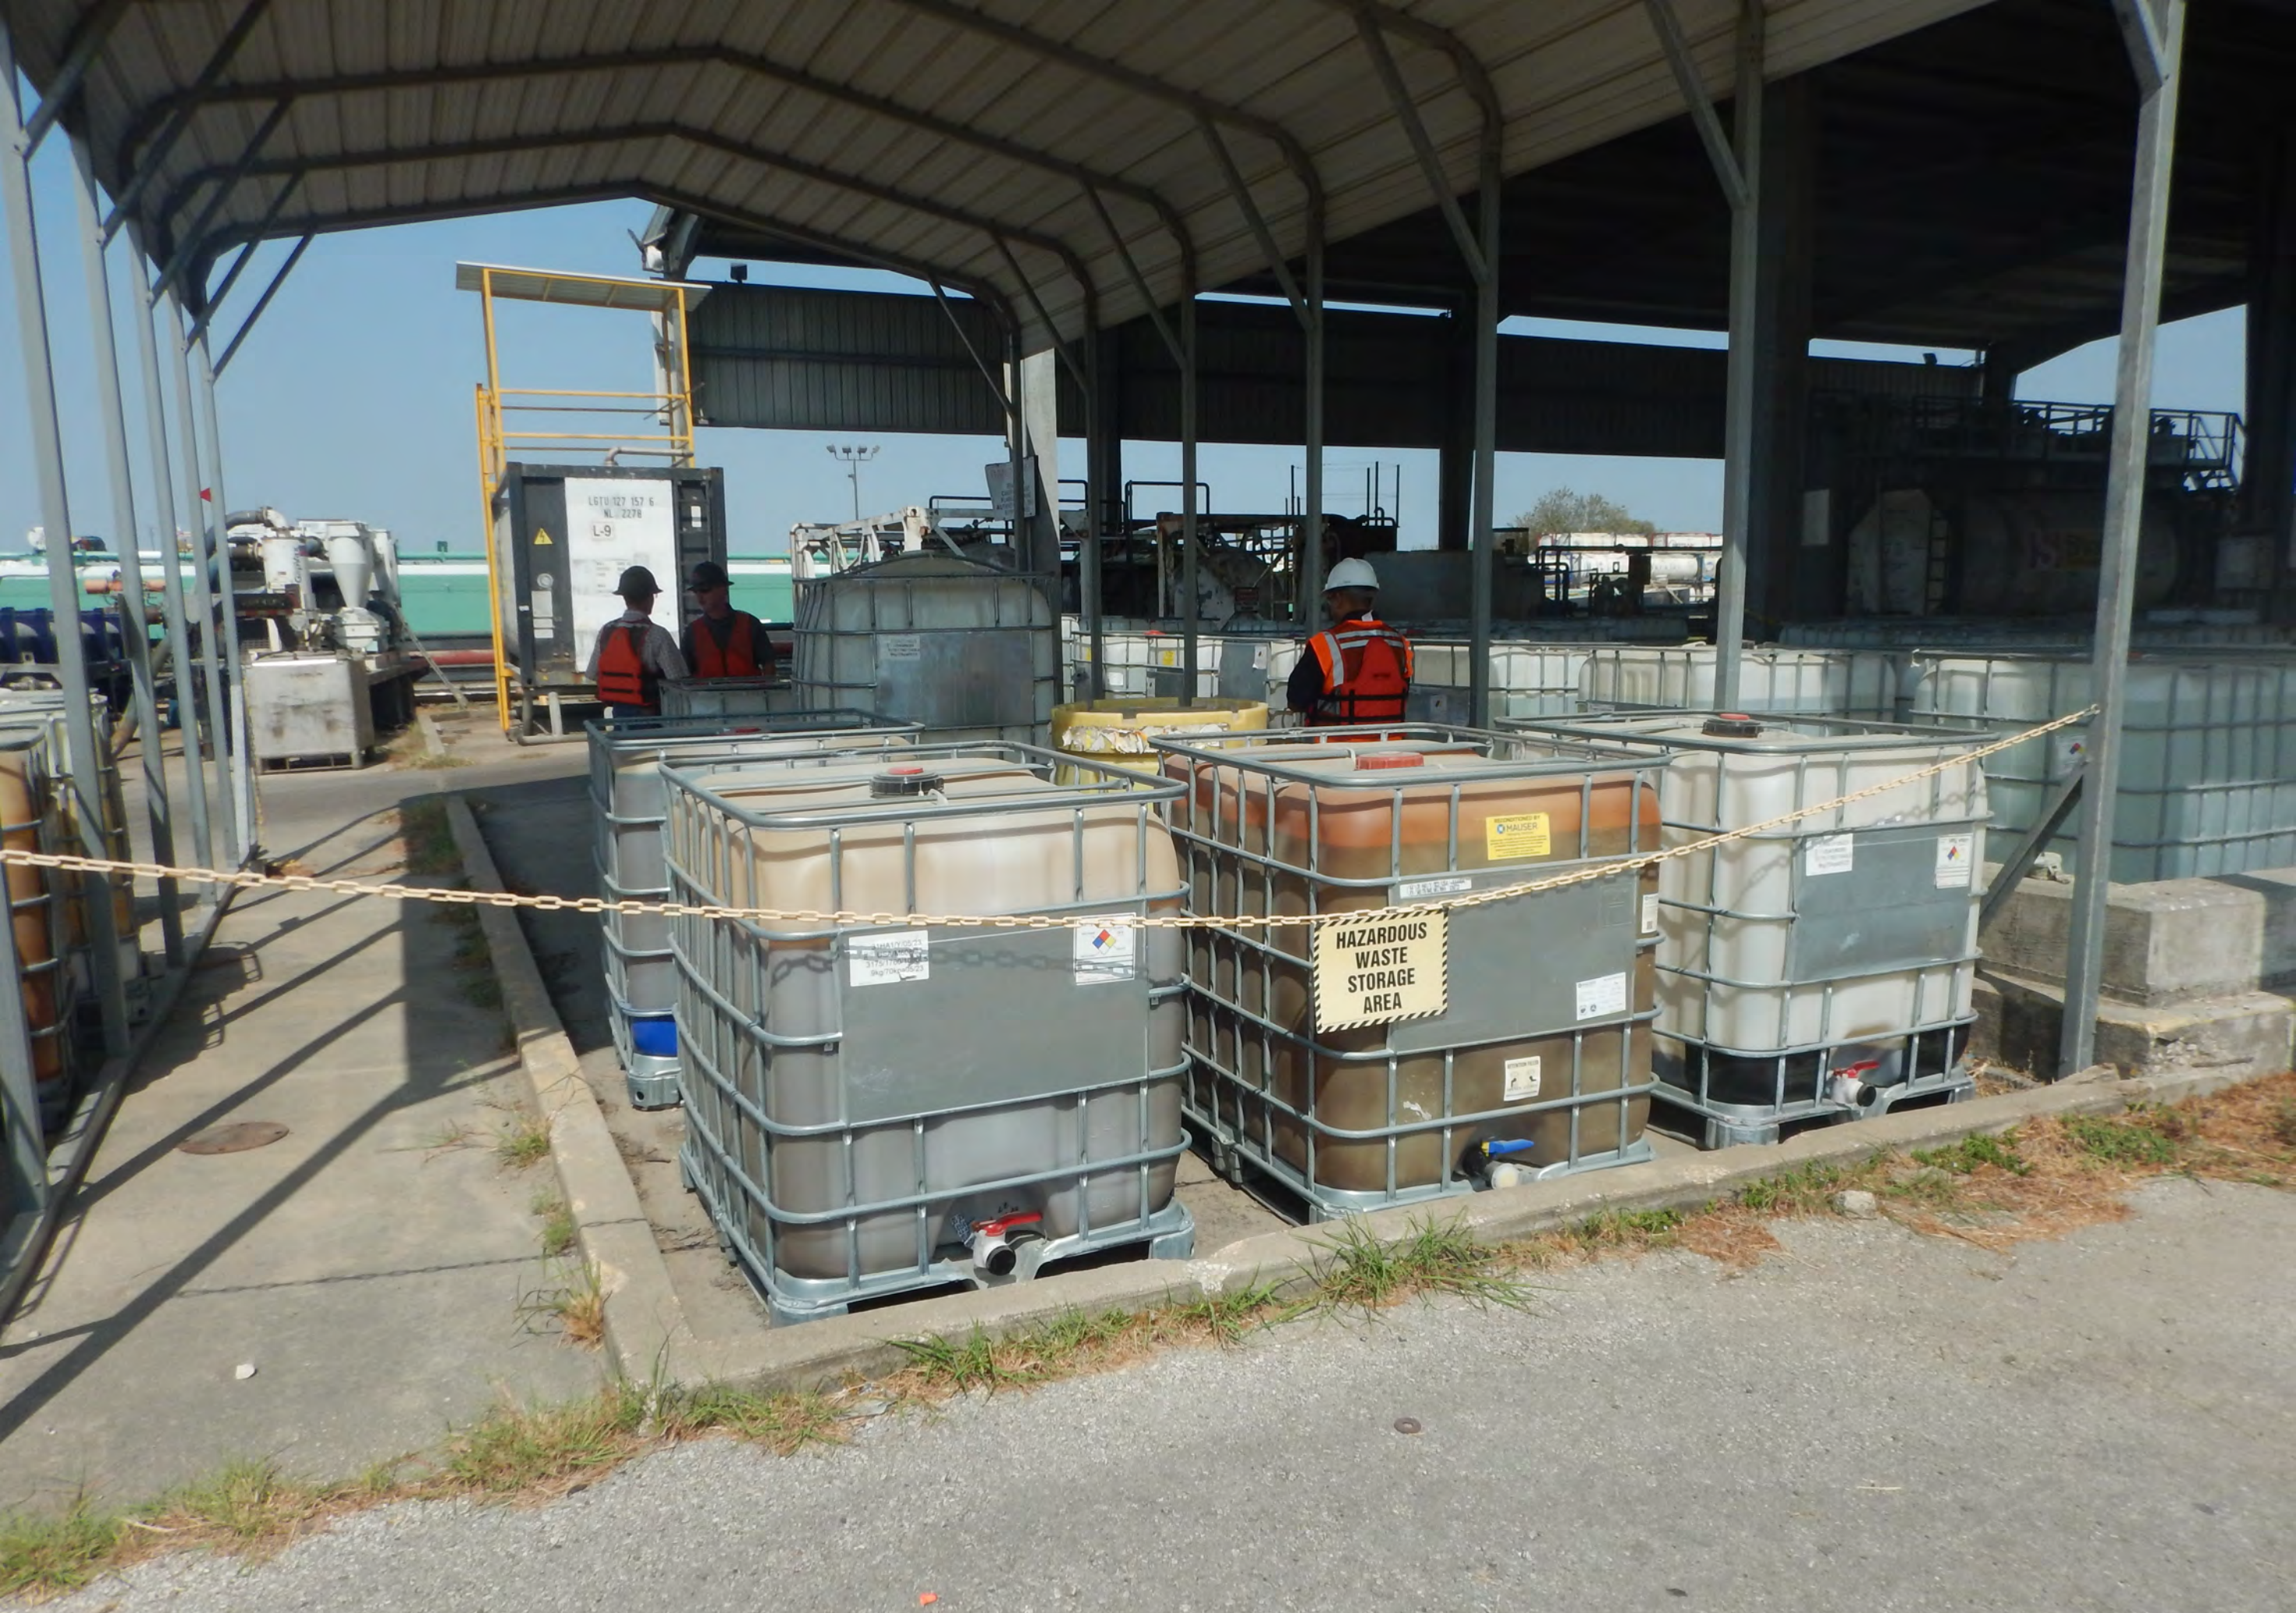
Photo 9

| Photo Number | File Name | | Date | Time | Photographer | Description |
|---|---|---|---|---|---|---|
| 9 | DSCN1158 | .JPG | 24-Aug-23 | 1051 | John Penland | <90-day Container Central Accumulation Area (CAA) |

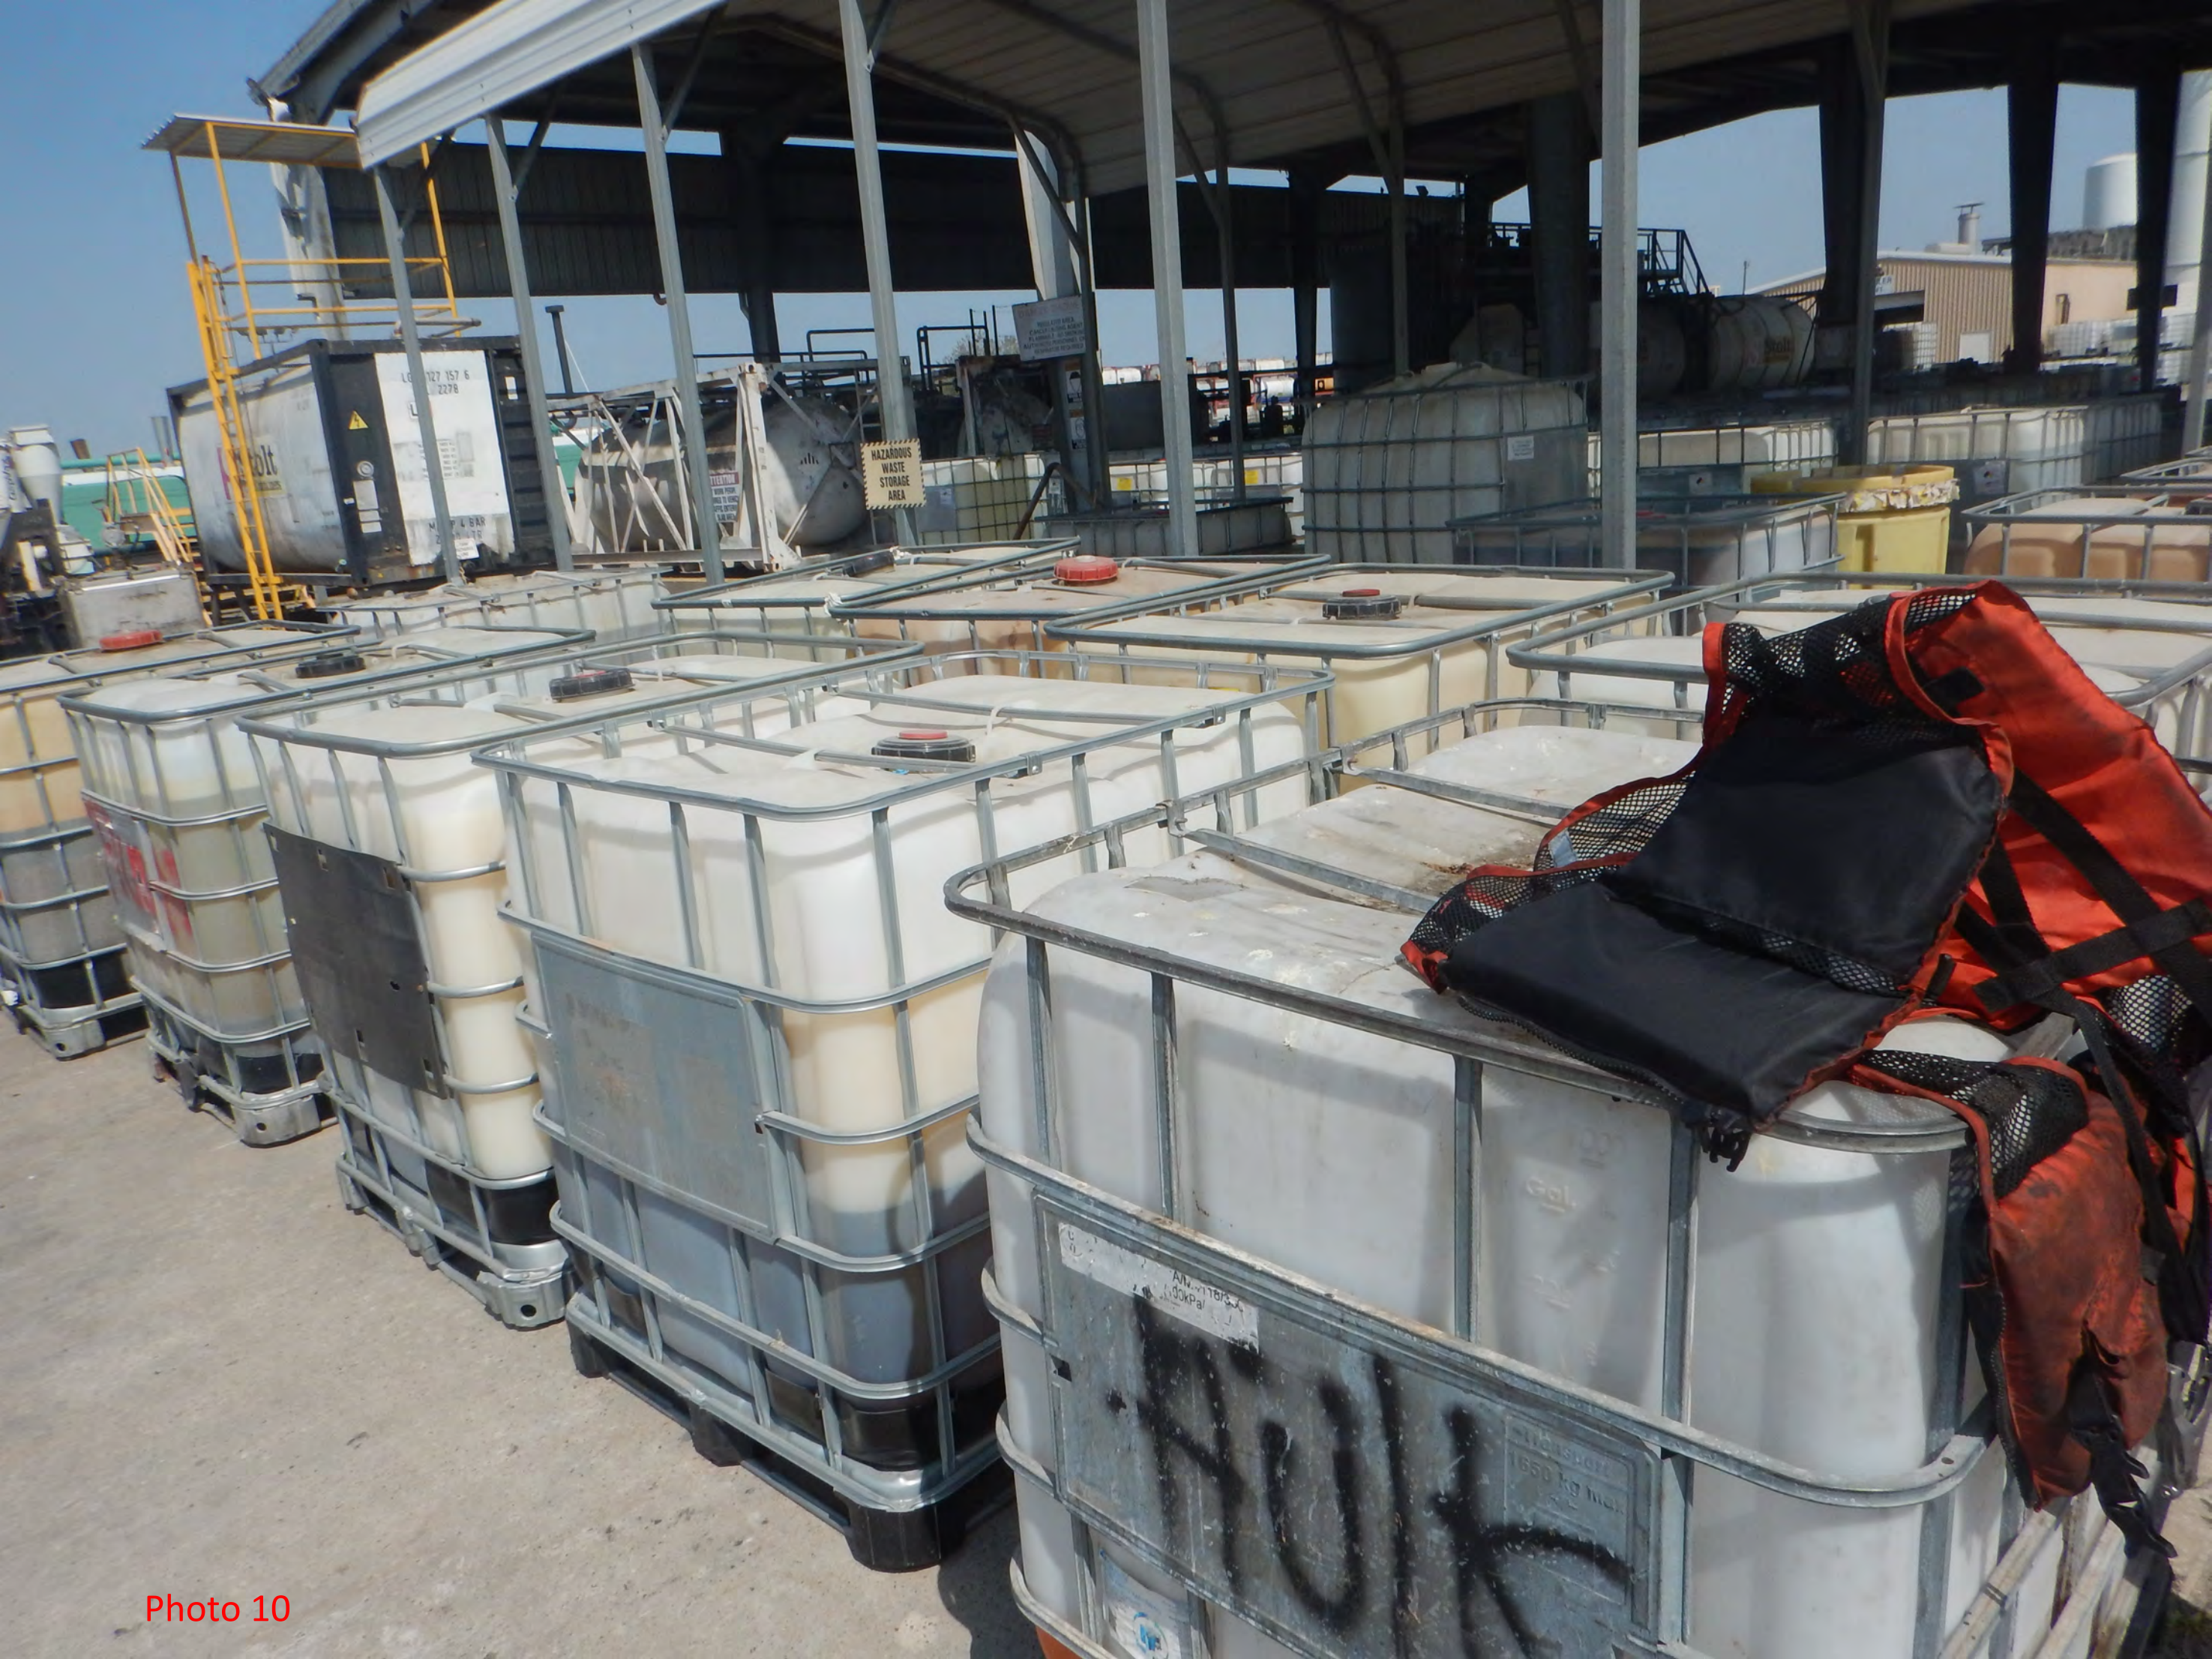
Photo 10

| Photo Number | File Name | | Date | Time | Photographer | Description |
|---|---|---|---|---|---|---|
| 10 | DSCN1159 | .JPG | 24-Aug-23 | 1055 | John Penland | Flush water containers located next CAA |

- 10 Totes were staged near the Central Accumulation Area. According to Corrie Henry these were flush water from the cleaning of contaminated equipment and would be pumped to the frac tank.

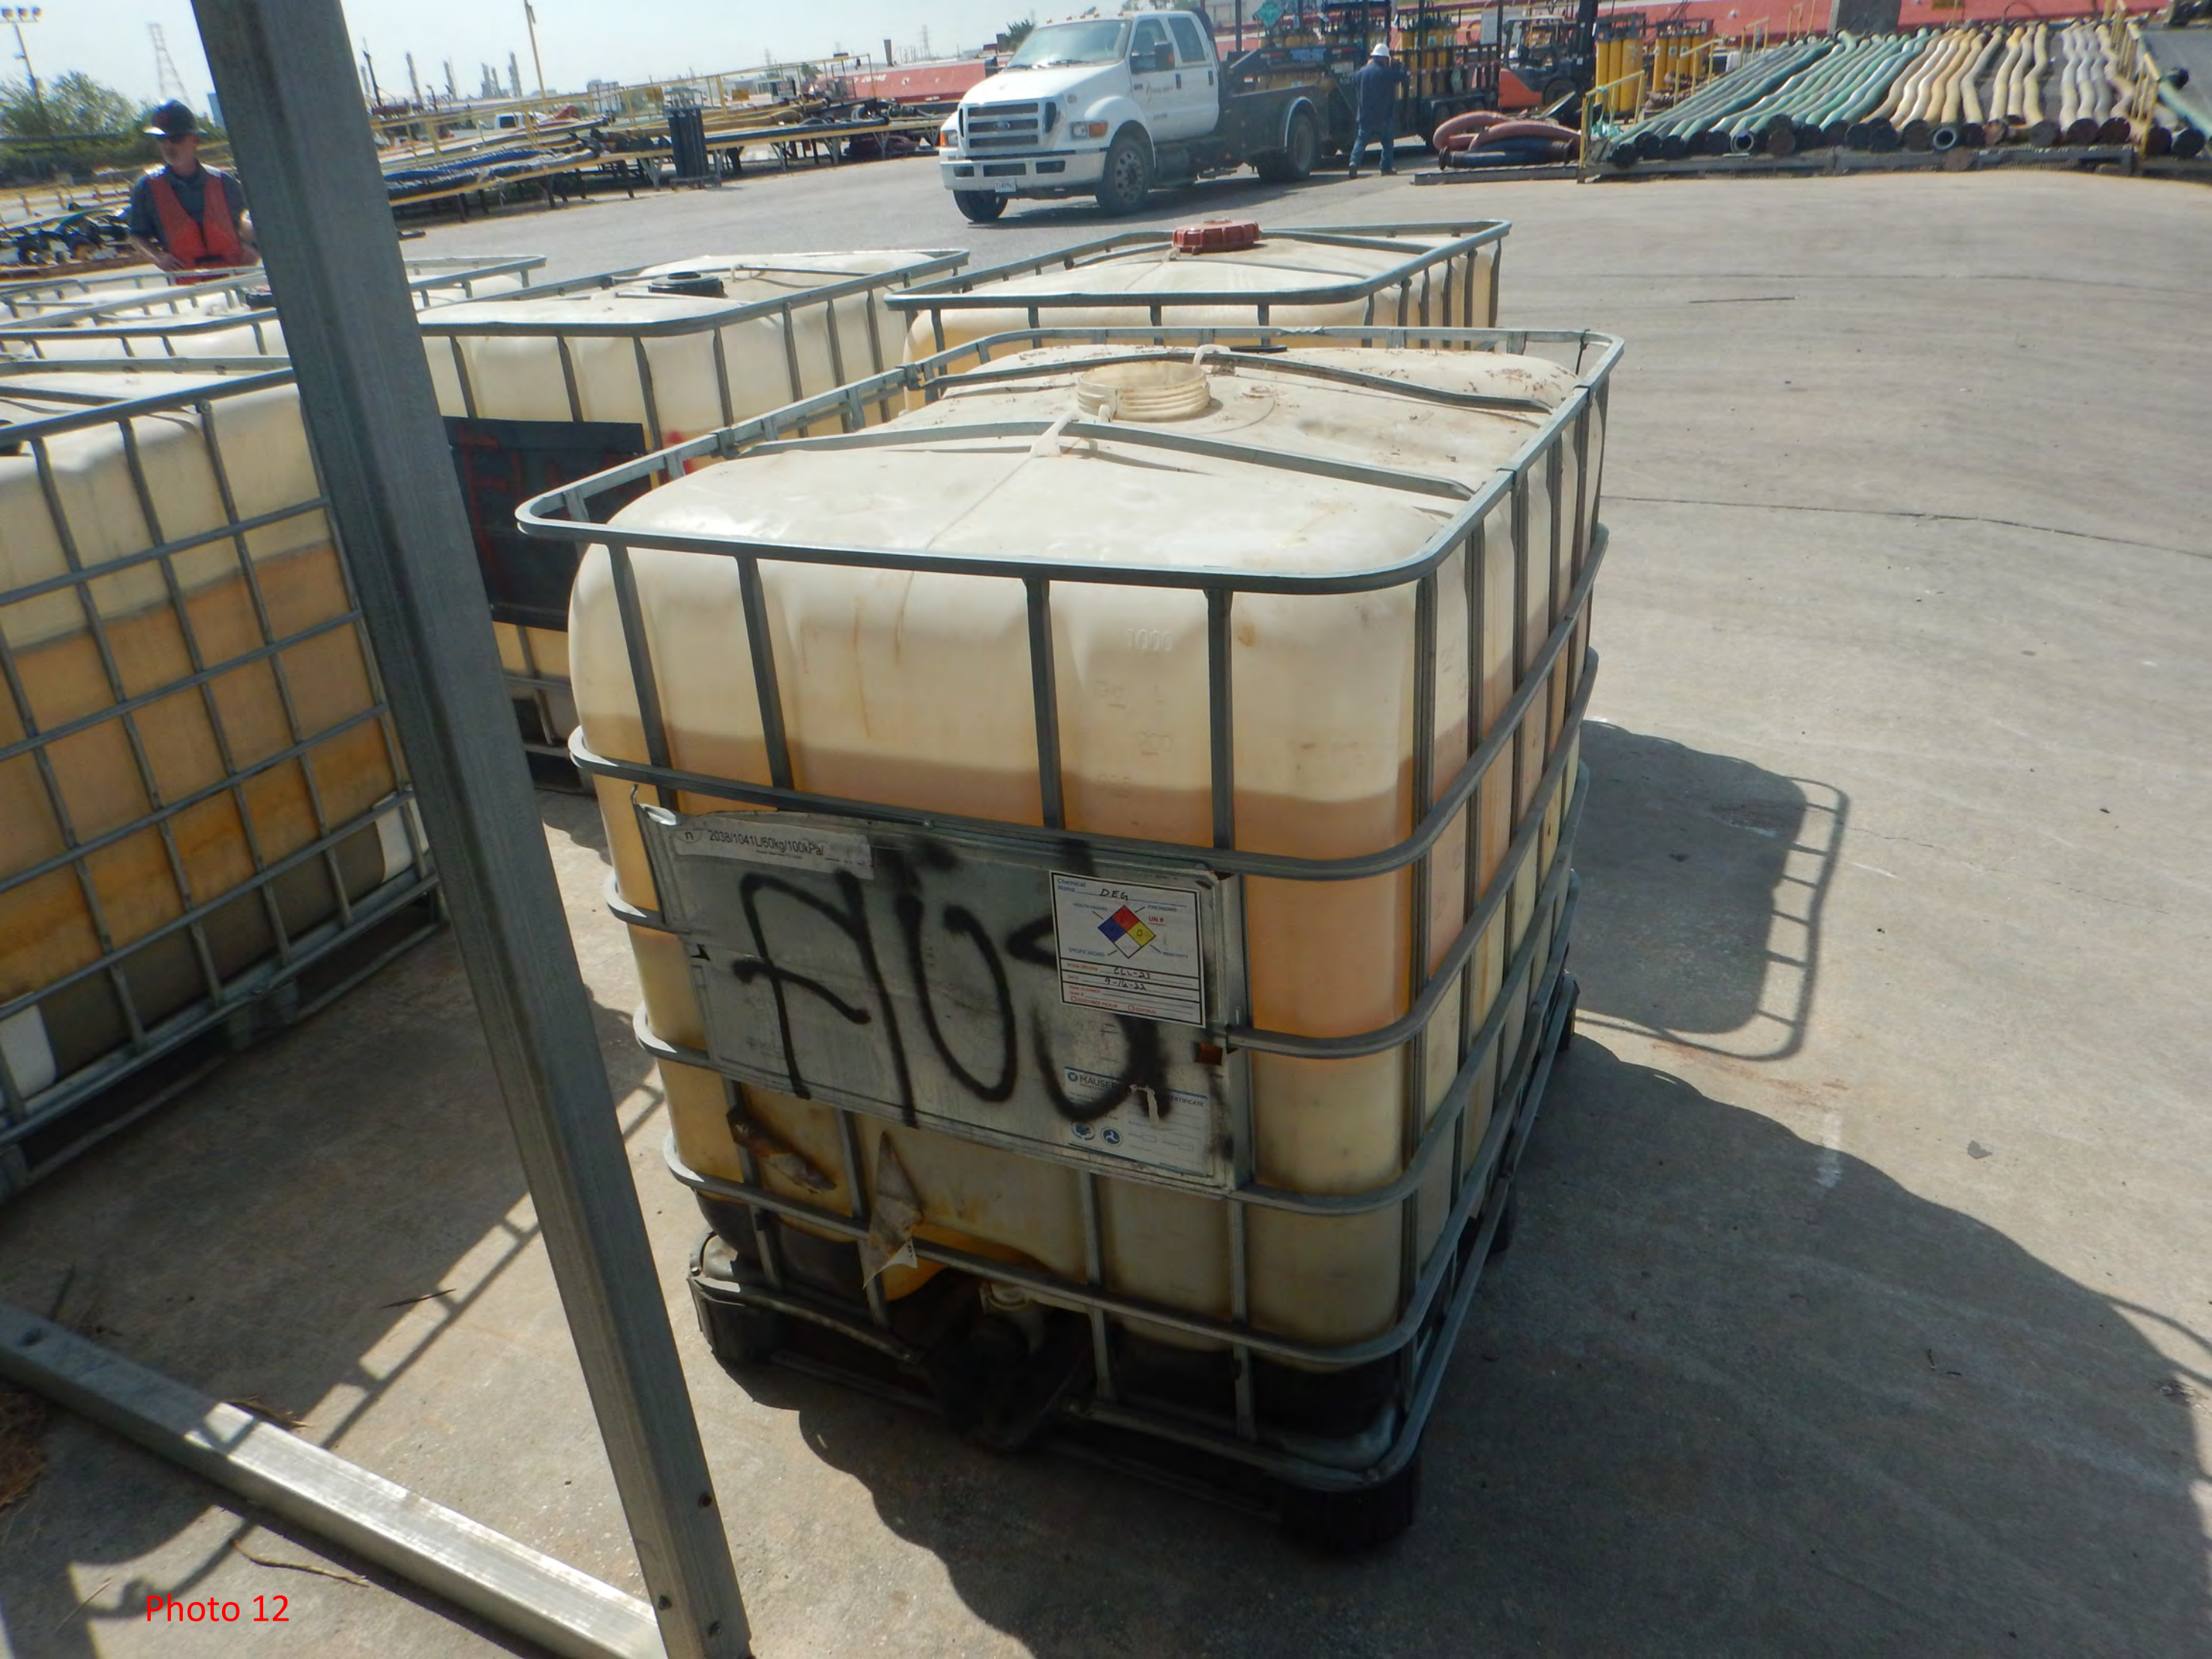
Photo 12

| Photo Number | File Name | | Date | Time | Photographer | Description |
|---|---|---|---|---|---|---|
| 12 | DSCN1161 | .JPG | 24-Aug-23 | 1056 | John Penland | Flush water containers located next CAA |

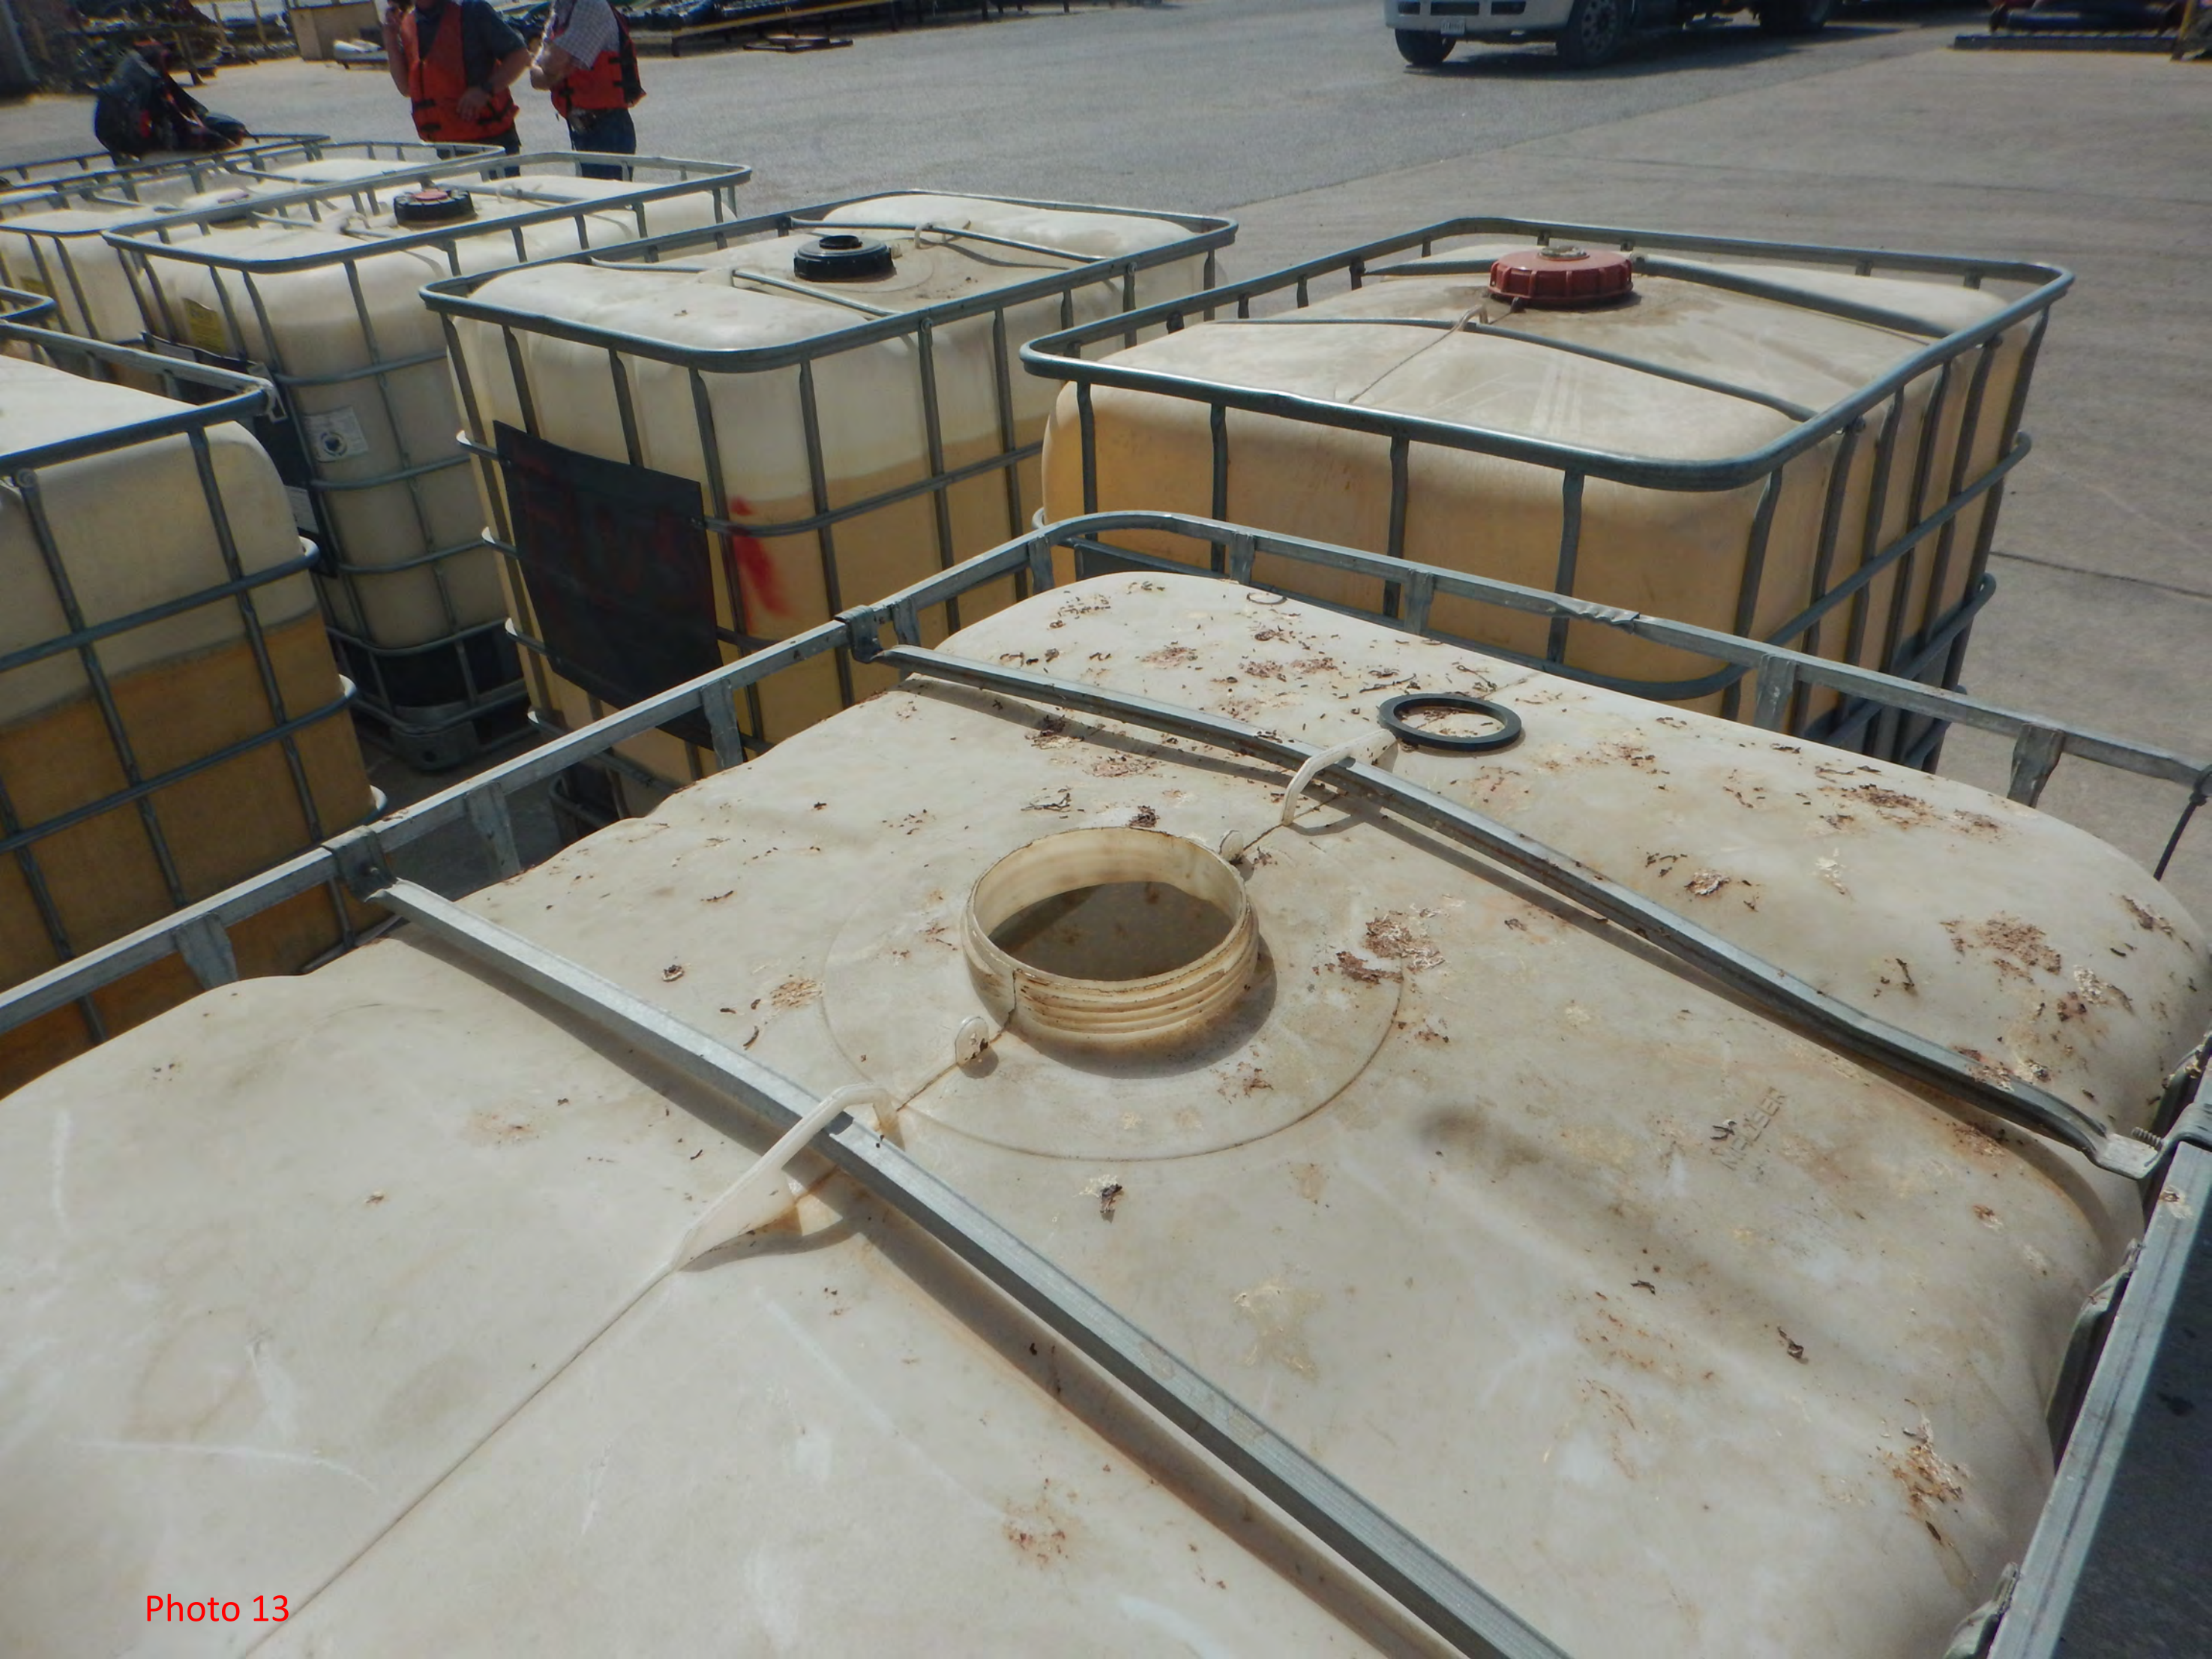
Photo 13

| Photo Number | File Name | | Date | Time | Photographer | Description |
|---|---|---|---|---|---|---|
| 13 | DSCN1162 | .JPG | 24-Aug-23 | 1056 | John Penland | Flush water containers located next CAA |
