**Region 6 - Enforcement & Compliance Assurance Division**  
**INSPECTION REPORT**

| Inspection Date(s): | August 24, 2023 | |
| Company Name: | <b>Stolt Tankers USA, Inc</b> | |
| Facility Name: | <b>Stolt Barging Services</b> | |

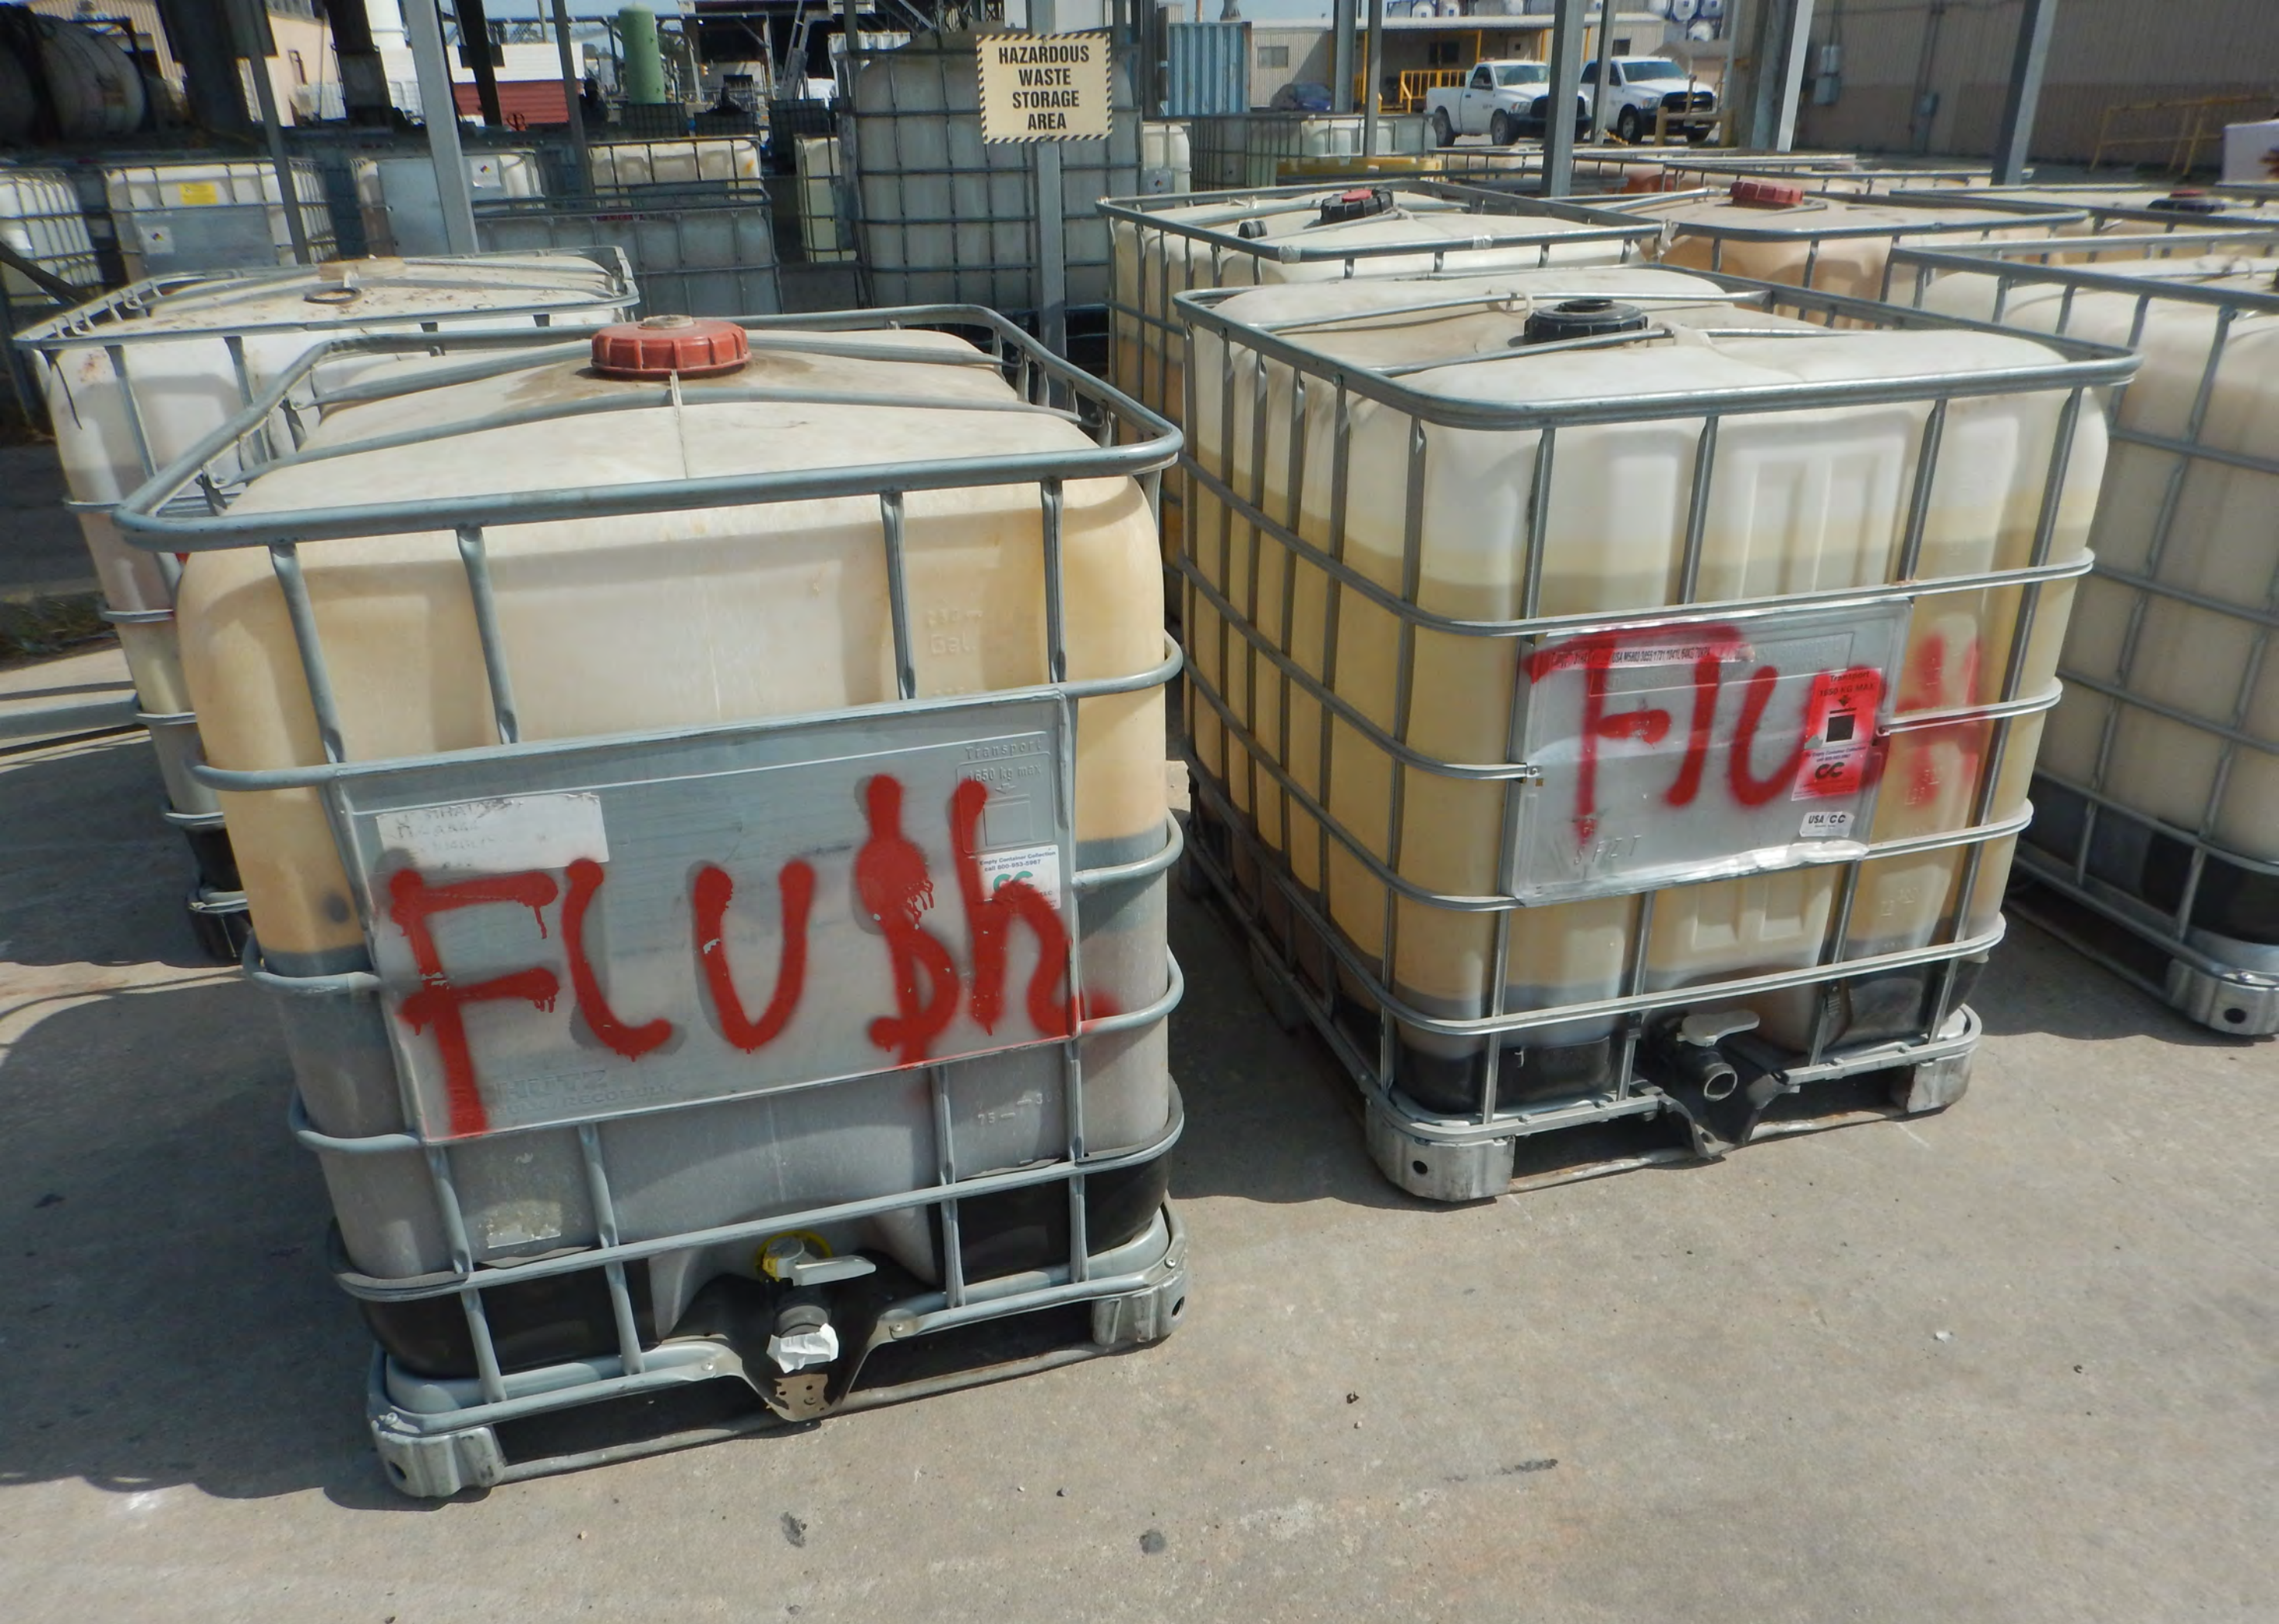
Photo 14

| Photo Number | File Name | | Date | Time | Photographer | Description |
|---|---|---|---|---|---|---|
| 14 | DSCN1163 | .JPG | 24-Aug-23 | 1056 | John Penland | Flush water containers located next CAA |

- 10 Totes were staged near the Central Accumulation Area. According to Corrie Henry these were flush water from the cleaning of contaminated equipment and would be pumped to the frac tank.

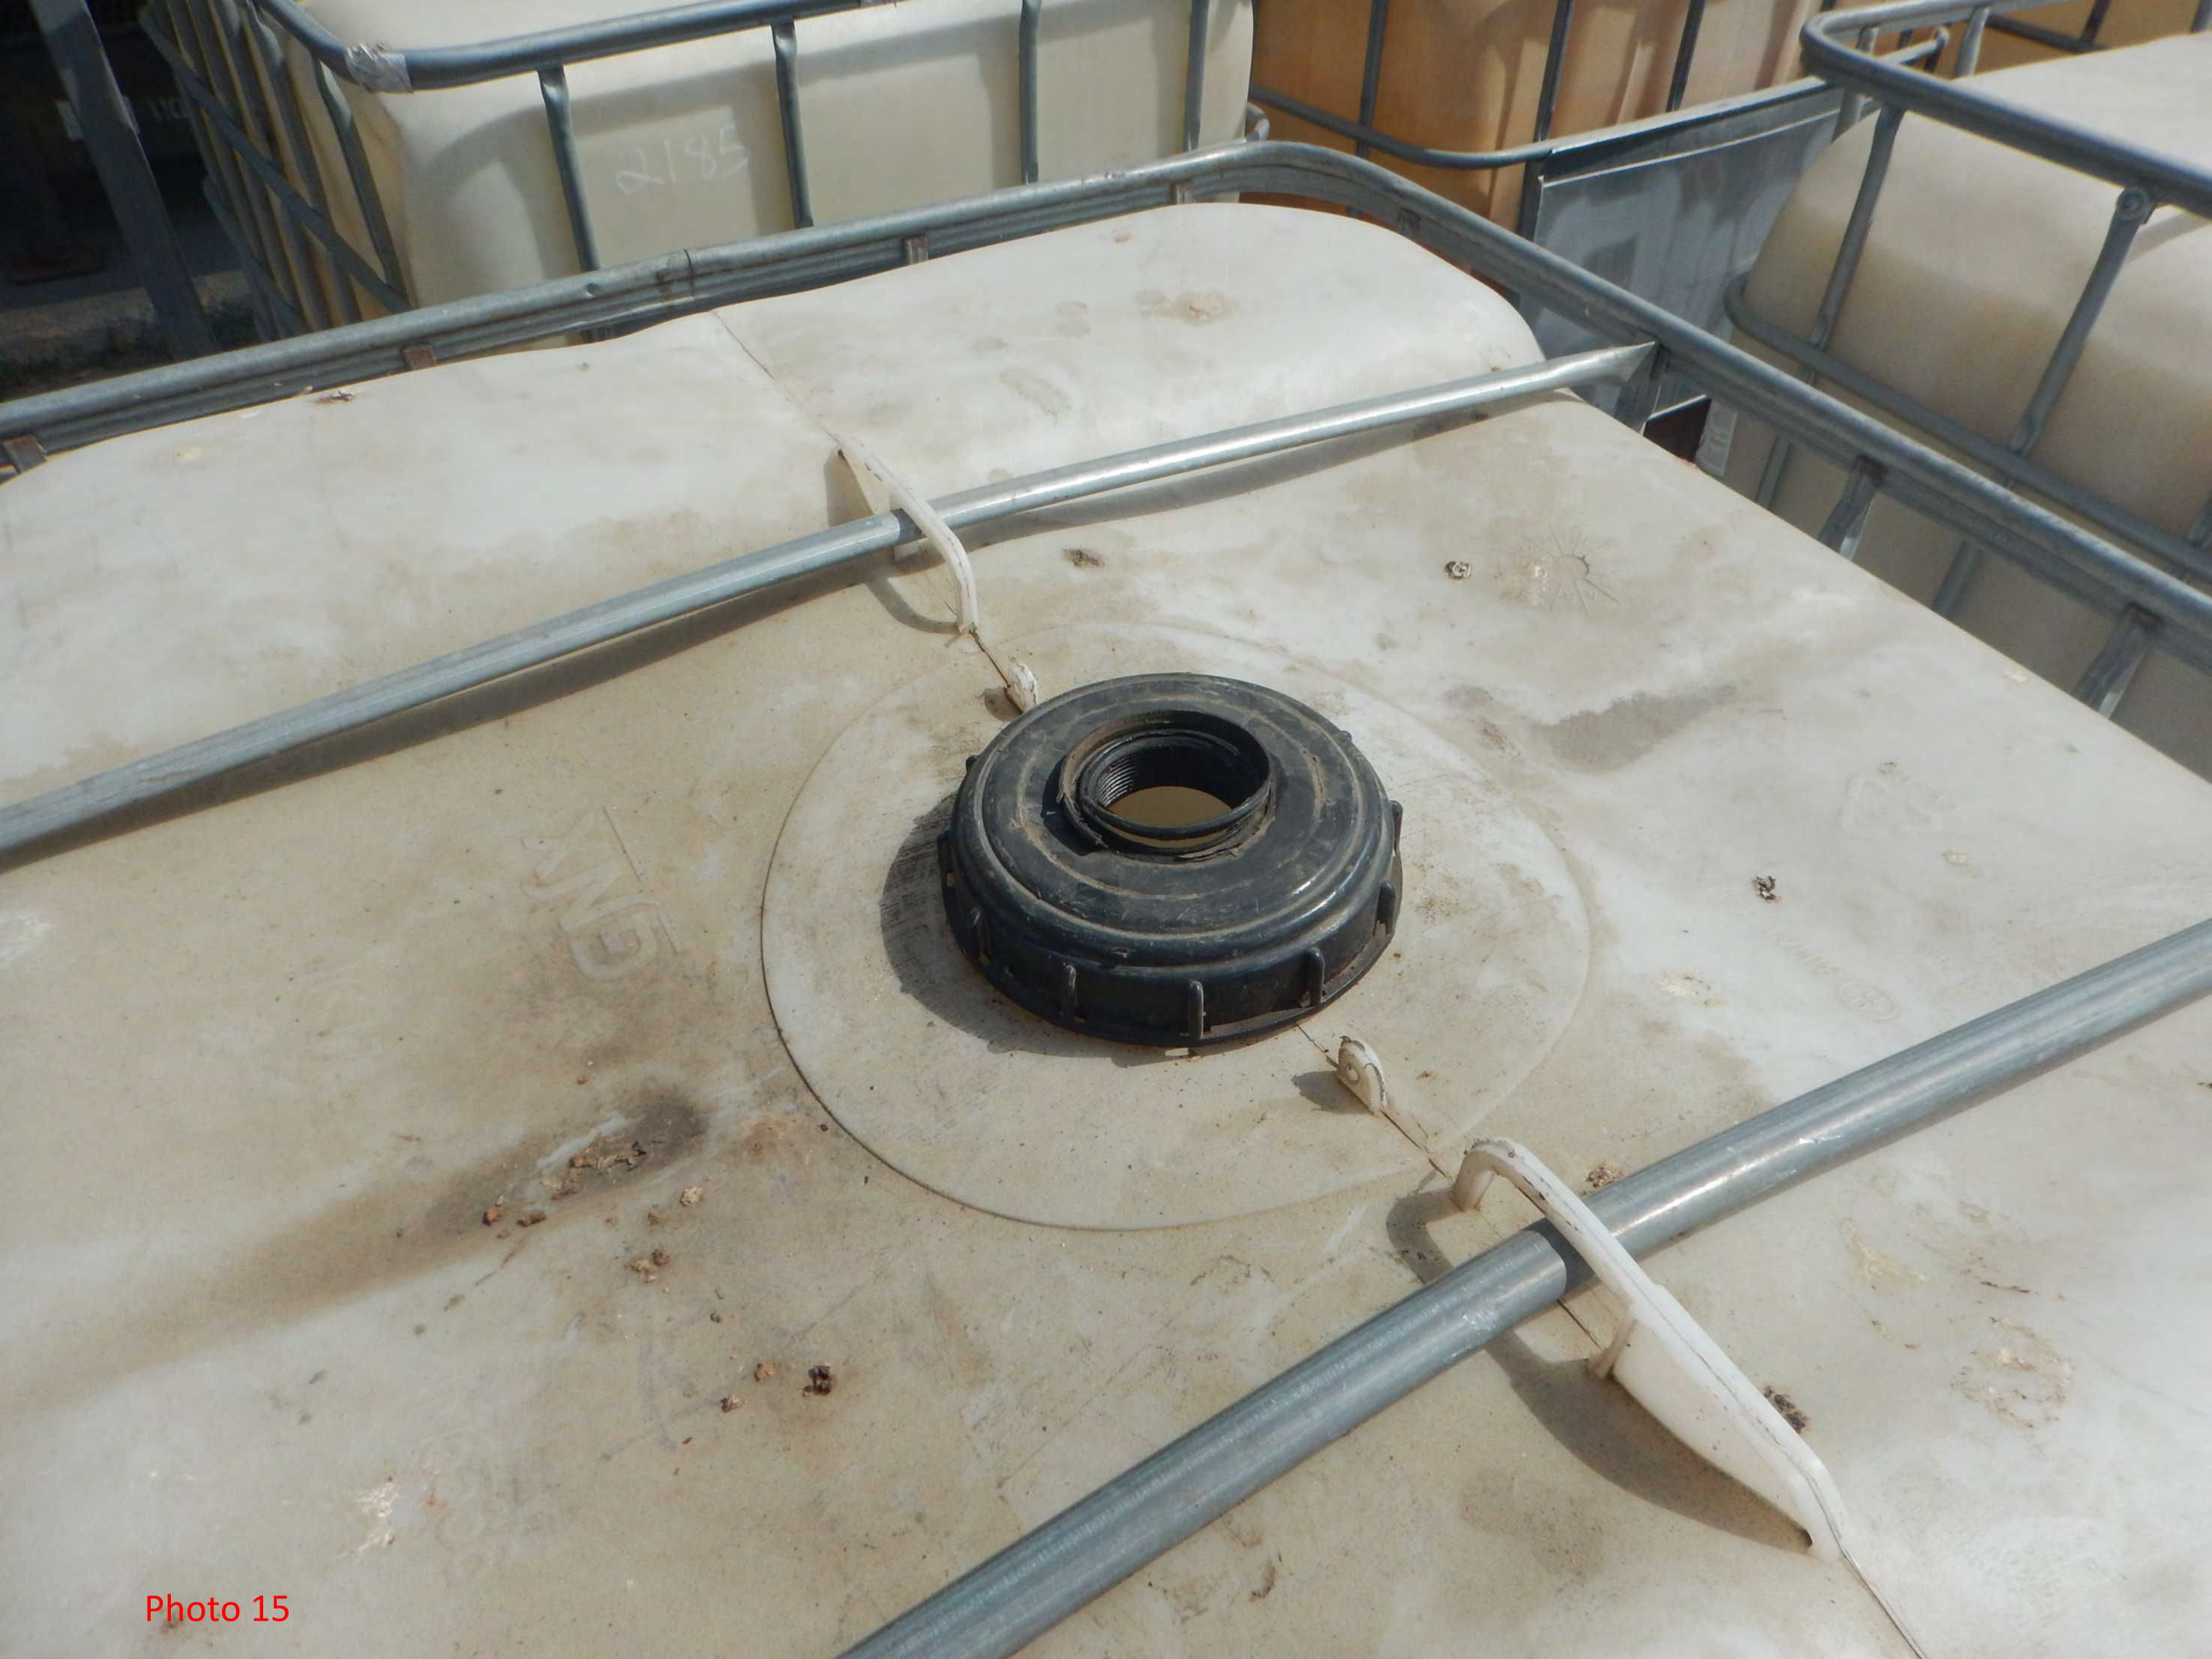
Photo 15

| Photo Number | File Name | | Date | Time | Photographer | Description |
|---|---|---|---|---|---|---|
| 15 | DSCN1164 | .JPG | 24-Aug-23 | 1056 | John Penland | Flush water containers located next CAA |

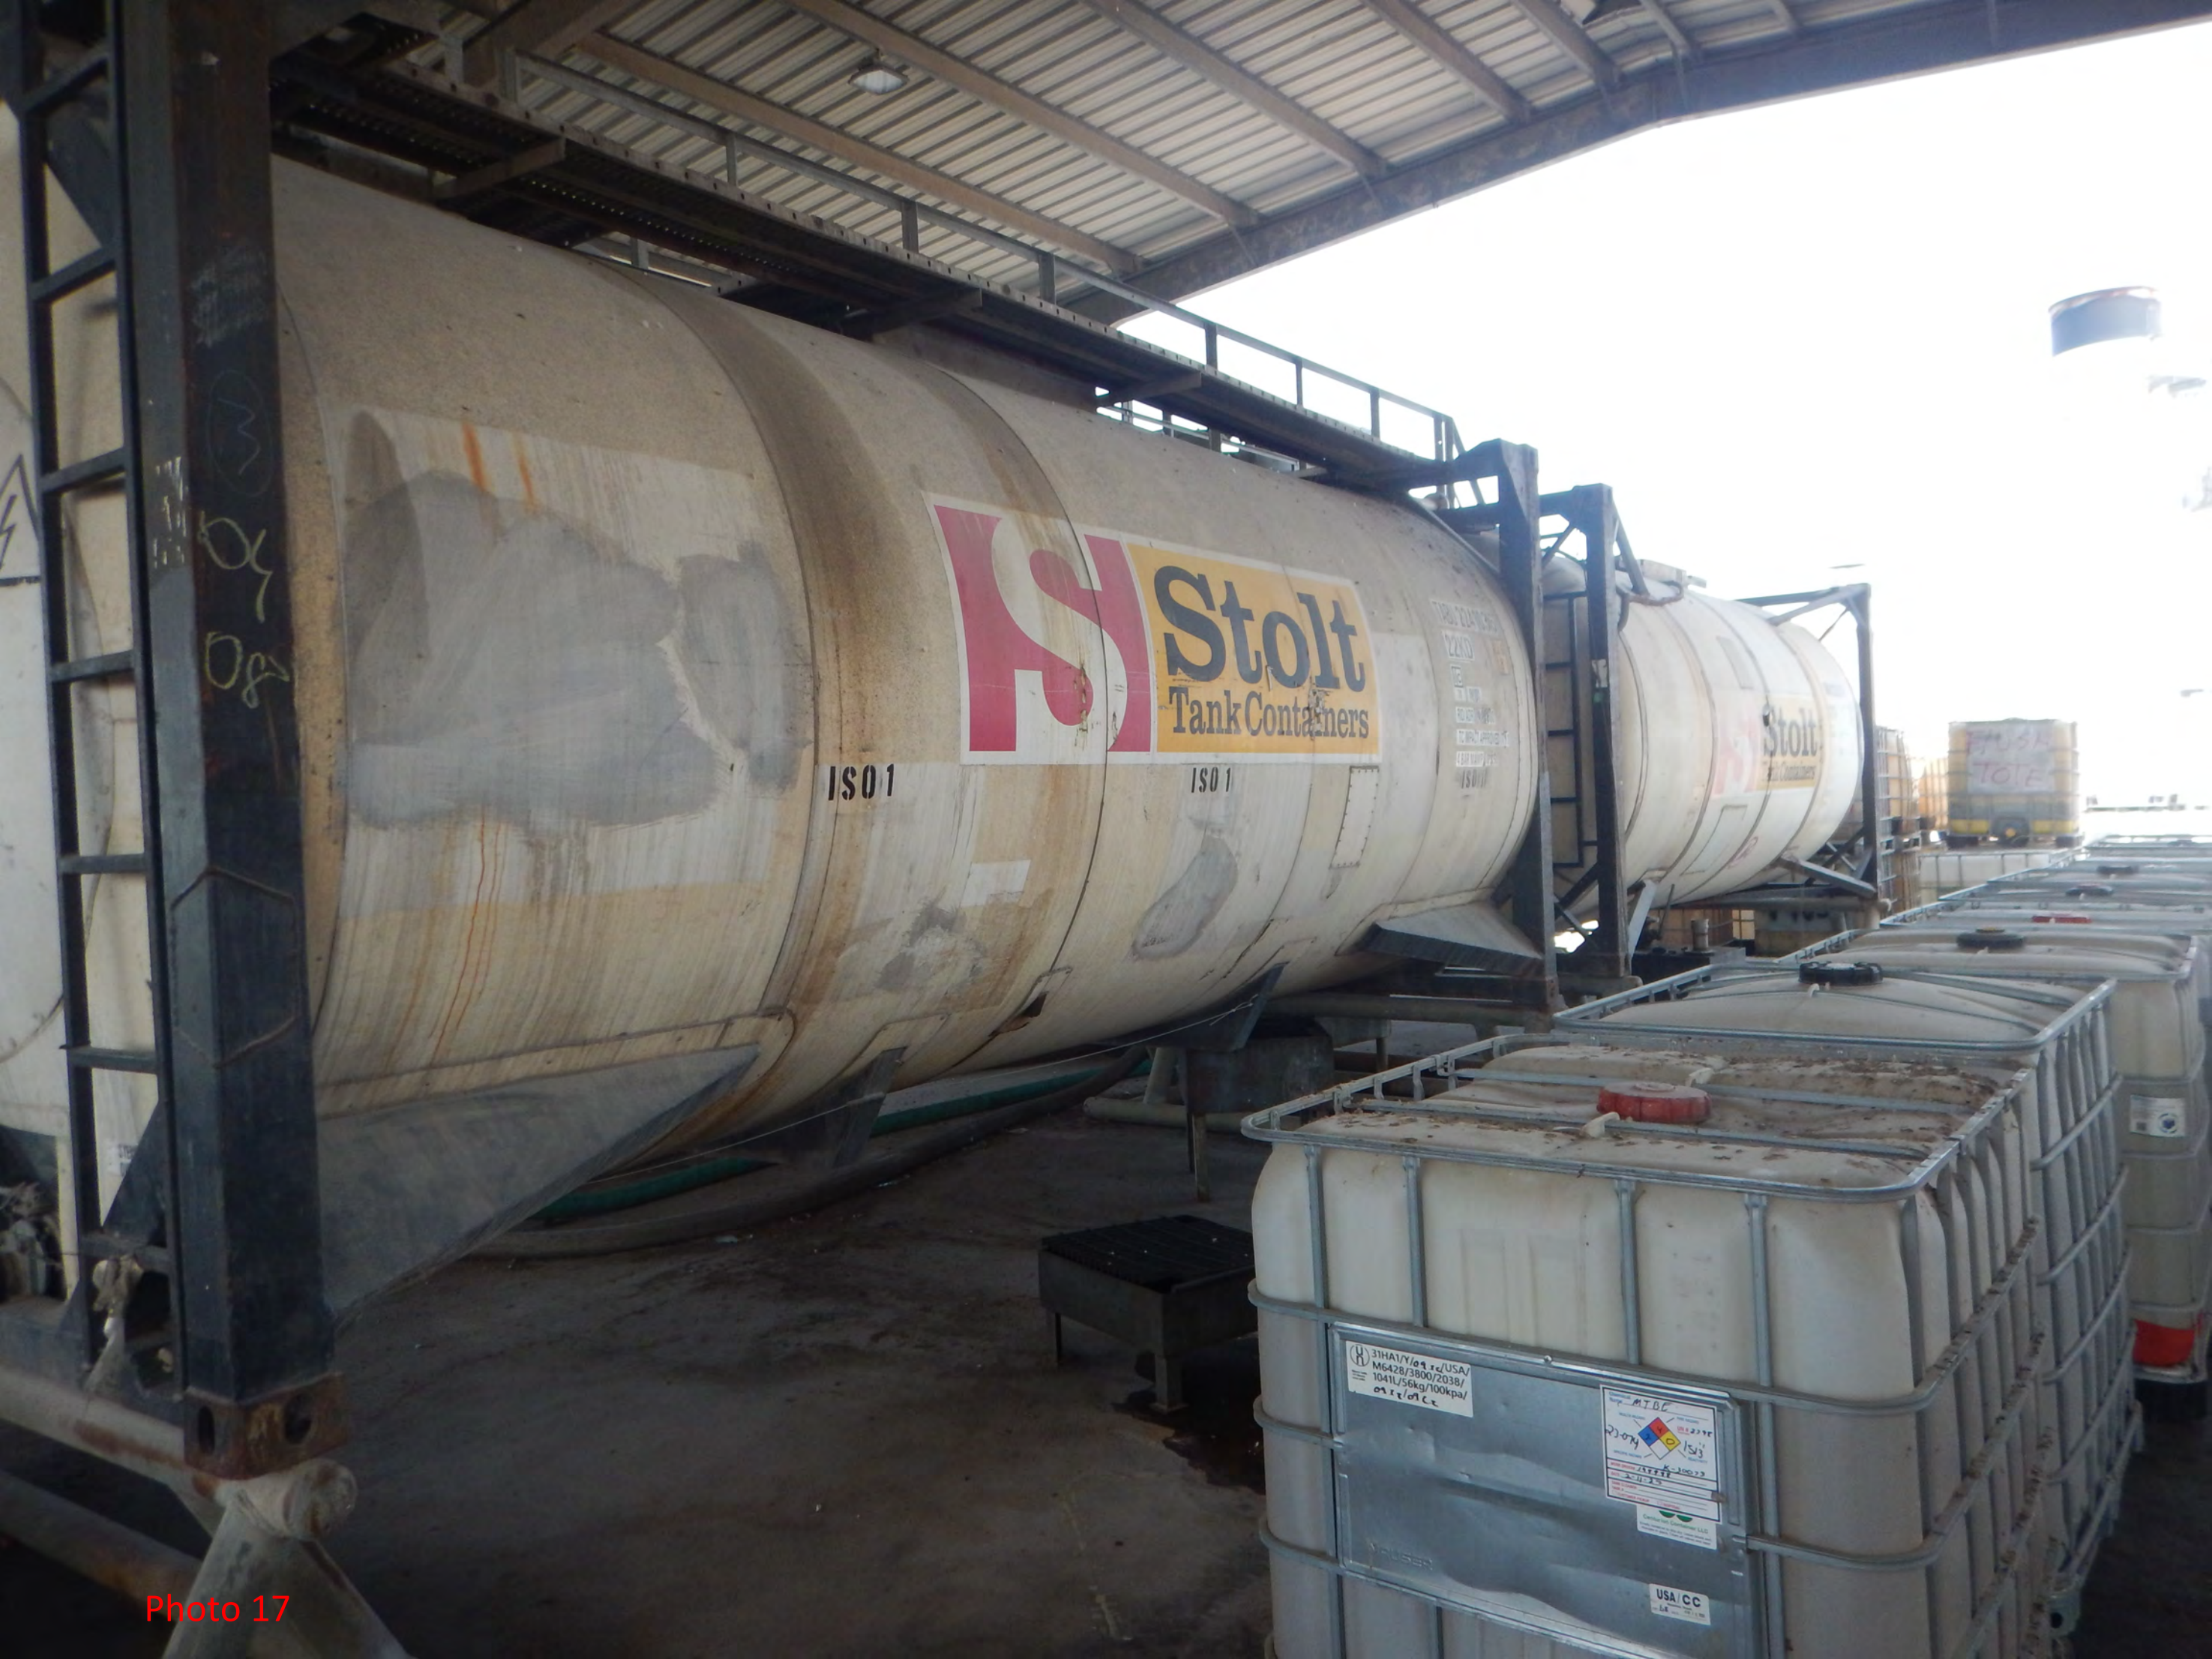
Photo 17

| Photo Number | File Name | | Date | Time | Photographer | Description |
|---|---|---|---|---|---|---|
| 17 | DSCN1166 | .JPG | 24-Aug-23 | 1107 | John Penland | ISO Containers used for the accumulation of Corrosive (D002) hazardous wastes |

- ISO Containers
      - These containers were open and unlabeled at the time of inspection.
    - Frac Tank
      - This tank was open and unlabeled at the time of inspection.

- 40 CFR 262.17 (a)(5)(iv) Failure to close containers of hazardous waste
    - 2 ISO containers used for the accumulation of corrosive waste were open at the time of inspection.

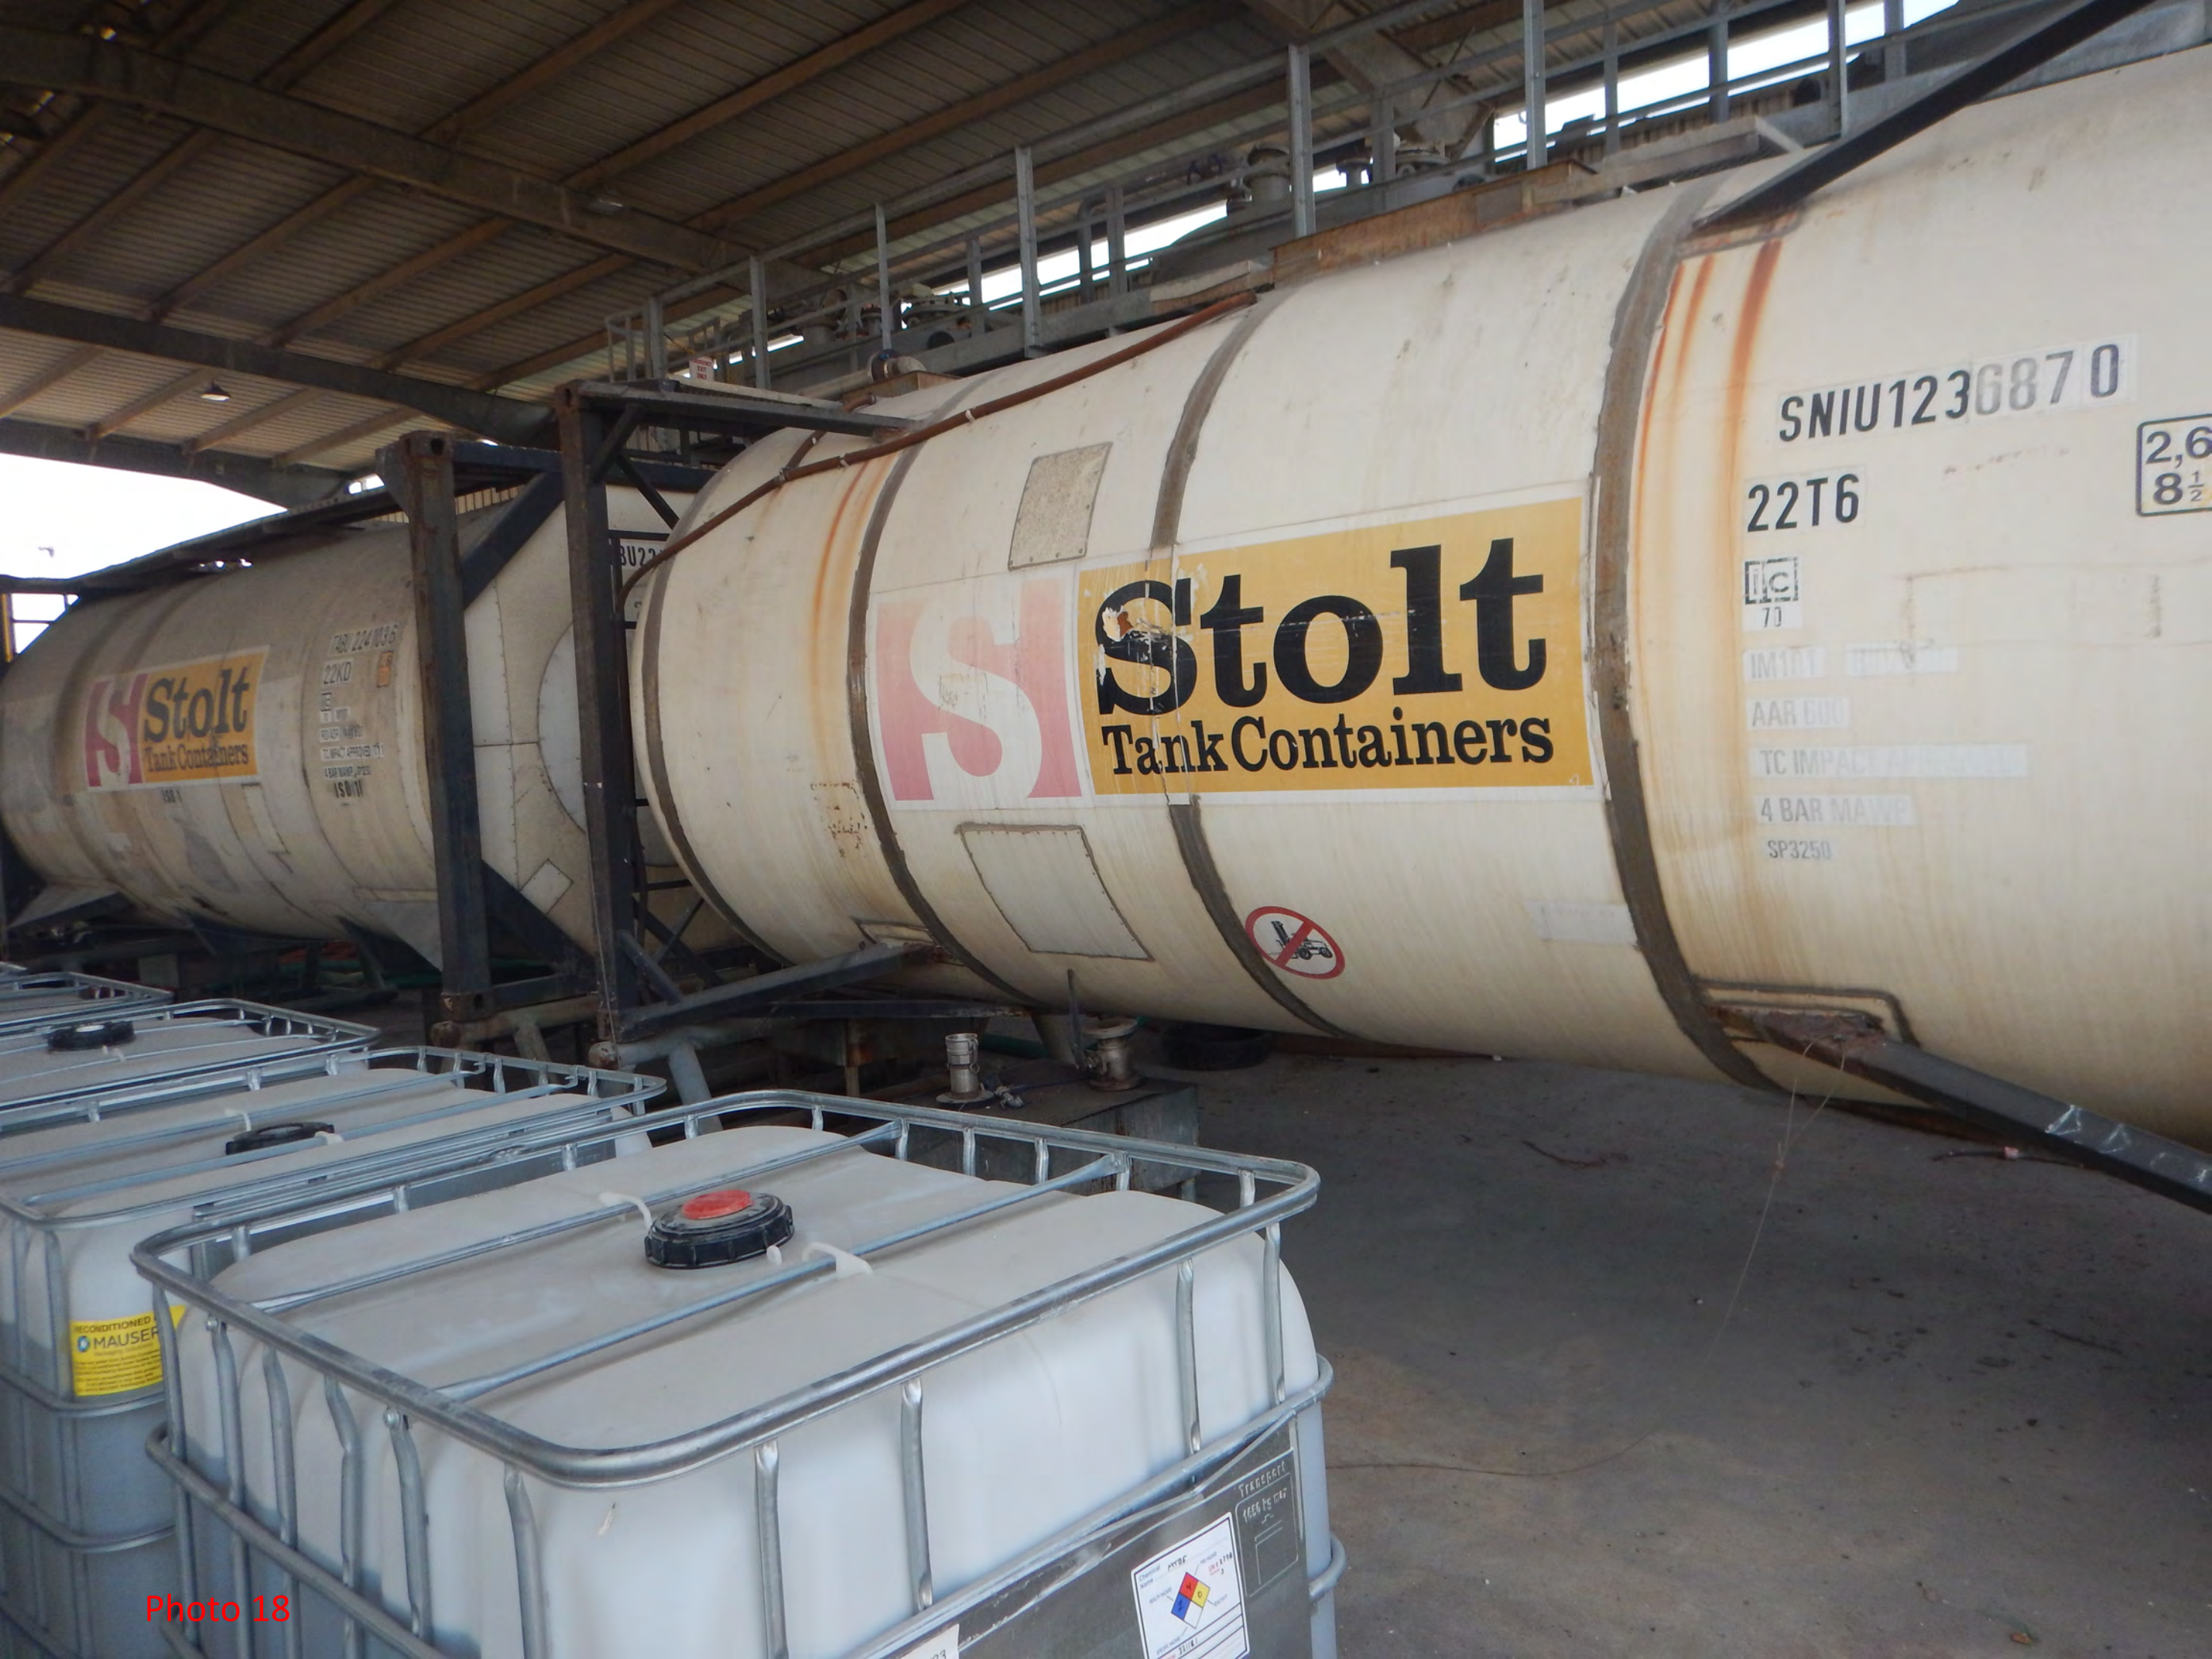
Photo 18

| Photo Number | File Name | | Date | Time | Photographer | Description |
|---|---|---|---|---|---|---|
| 18 | DSCN1167 | .JPG | 24-Aug-23 | 1107 | John Penland | ISO Containers used for the accumulation of Corrosive (D002) hazardous wastes |

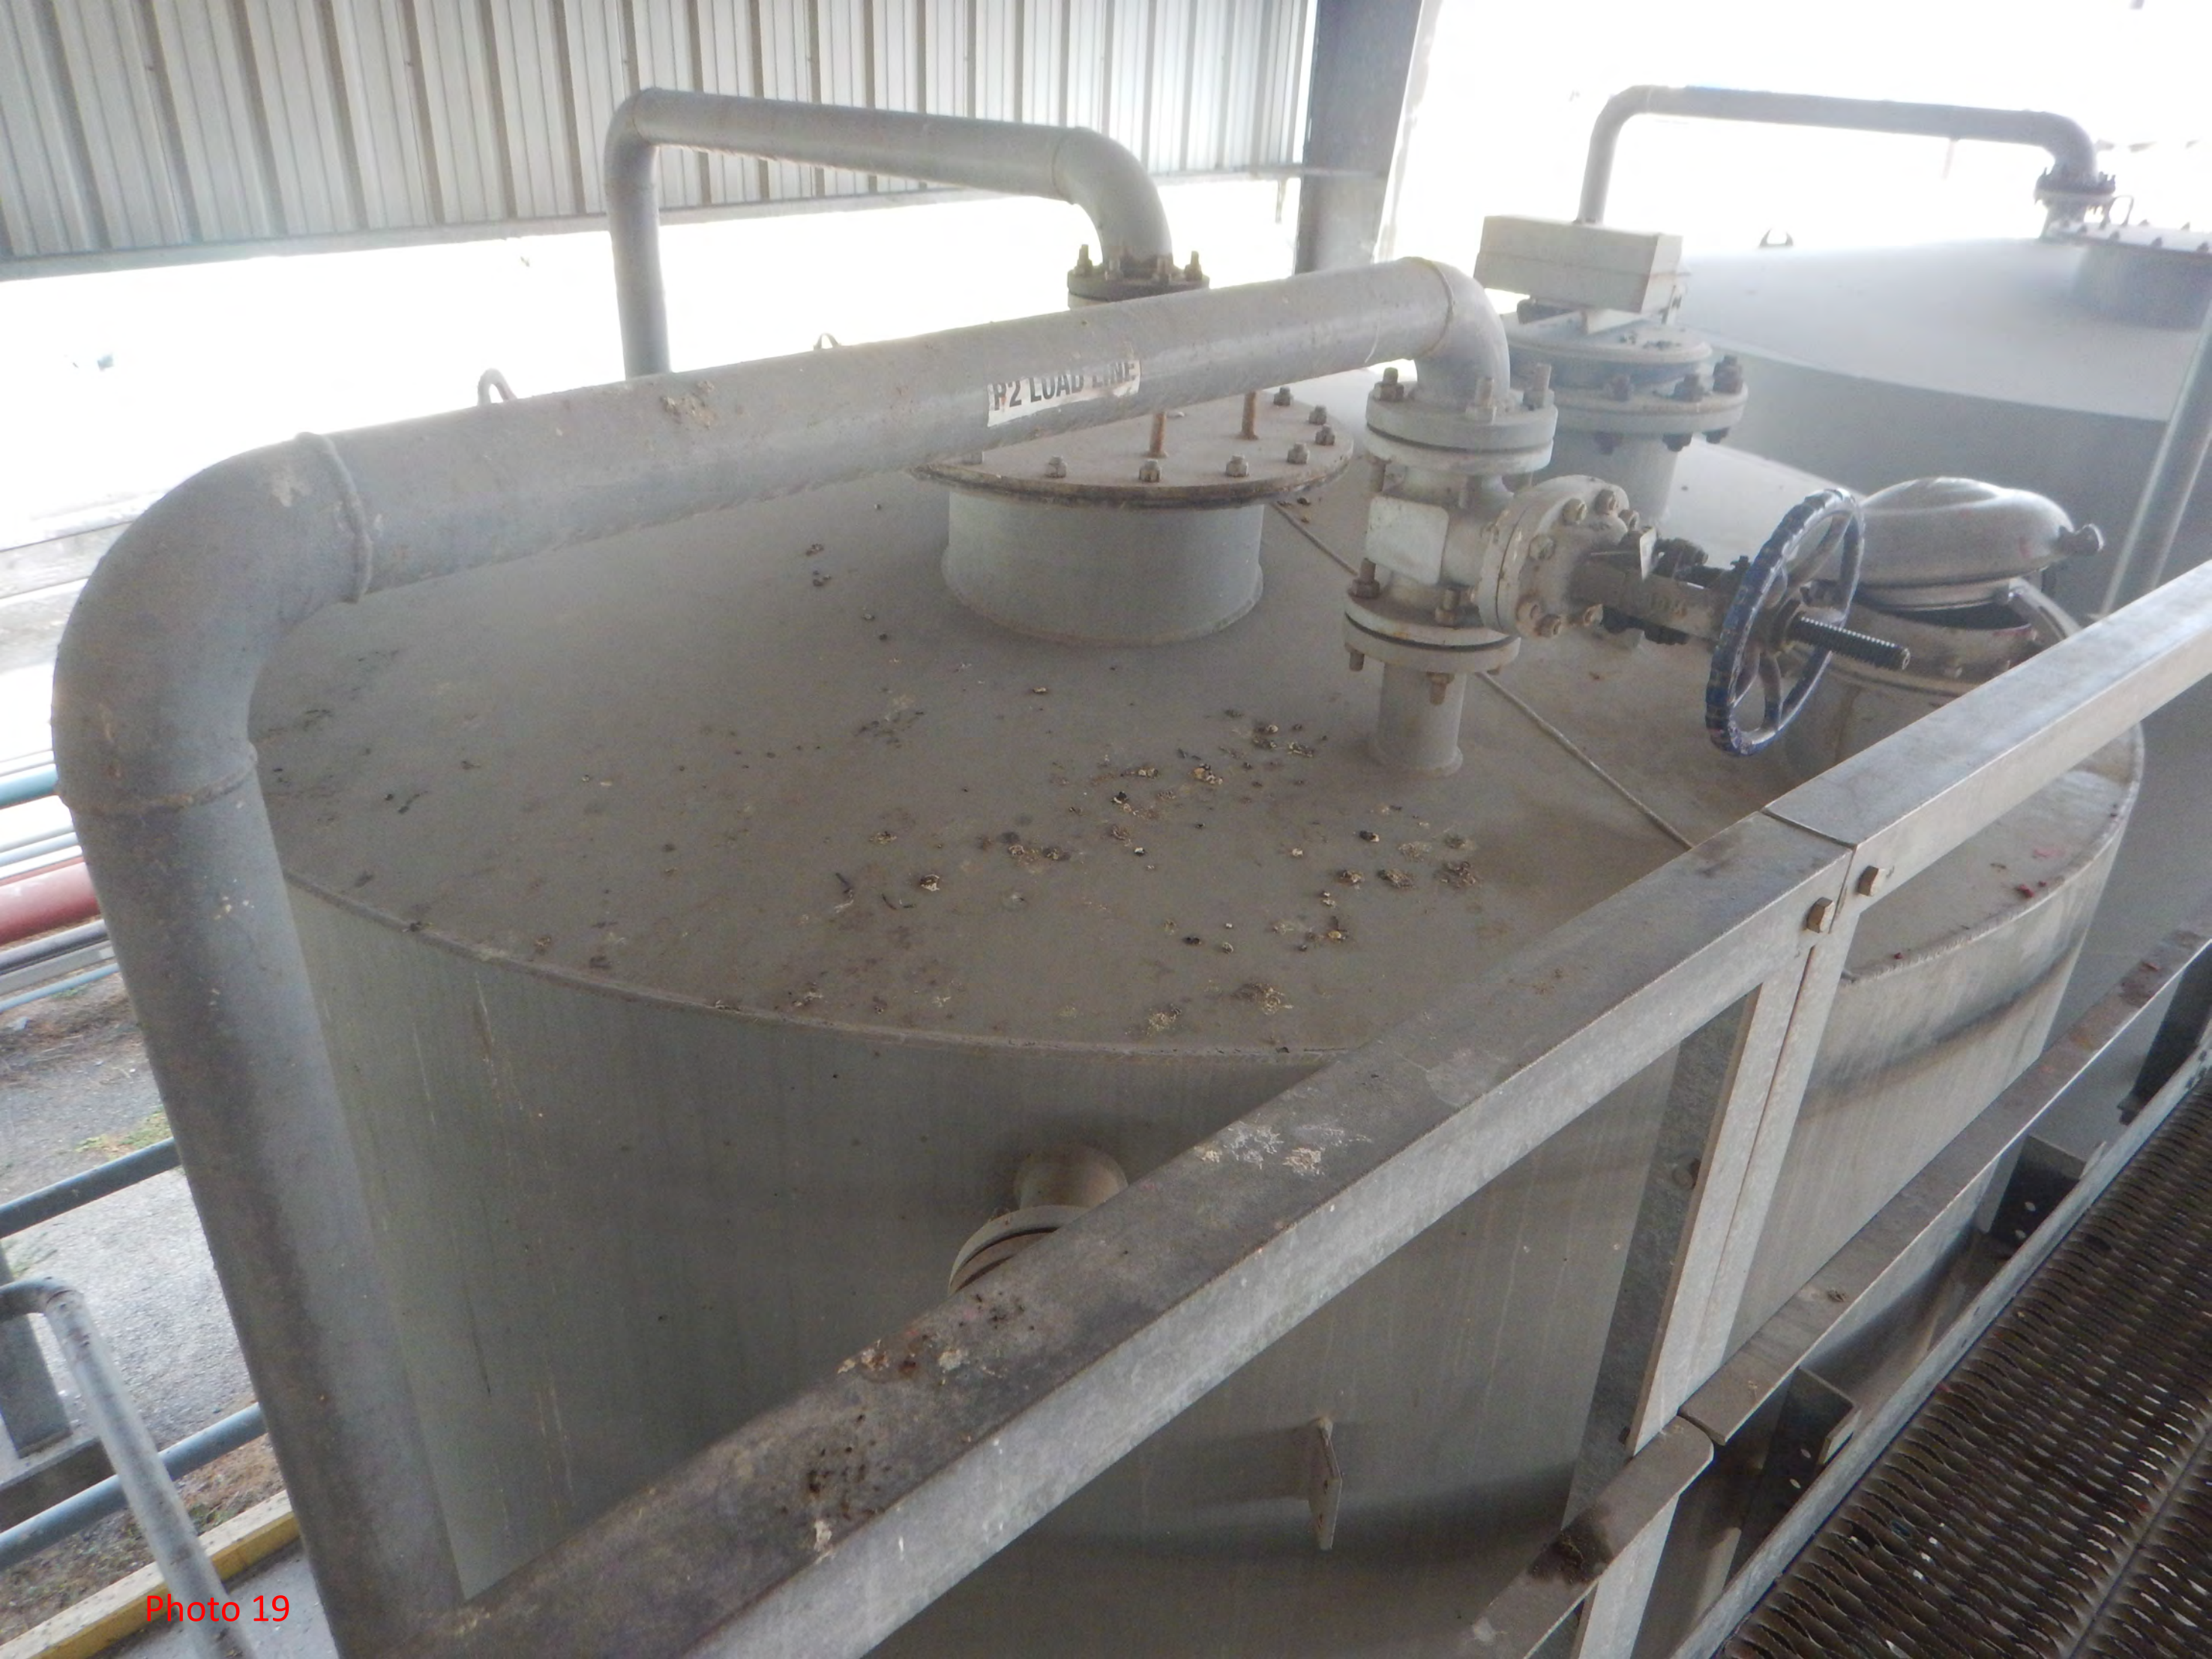
Photo 19

| Photo Number | File Name | | Date | Time | Photographer | Description |
|---|---|---|---|---|---|---|
| 19 | DSCN1168 | .JPG | 24-Aug-23 | 1109 | John Penland | Product Storage tank. Open hatch |

- 1 container in the container central accumulation area was open at the time of inspection.
  - Closure of tanks and containers
    - All three of the product storage tanks were open at the time of inspection.

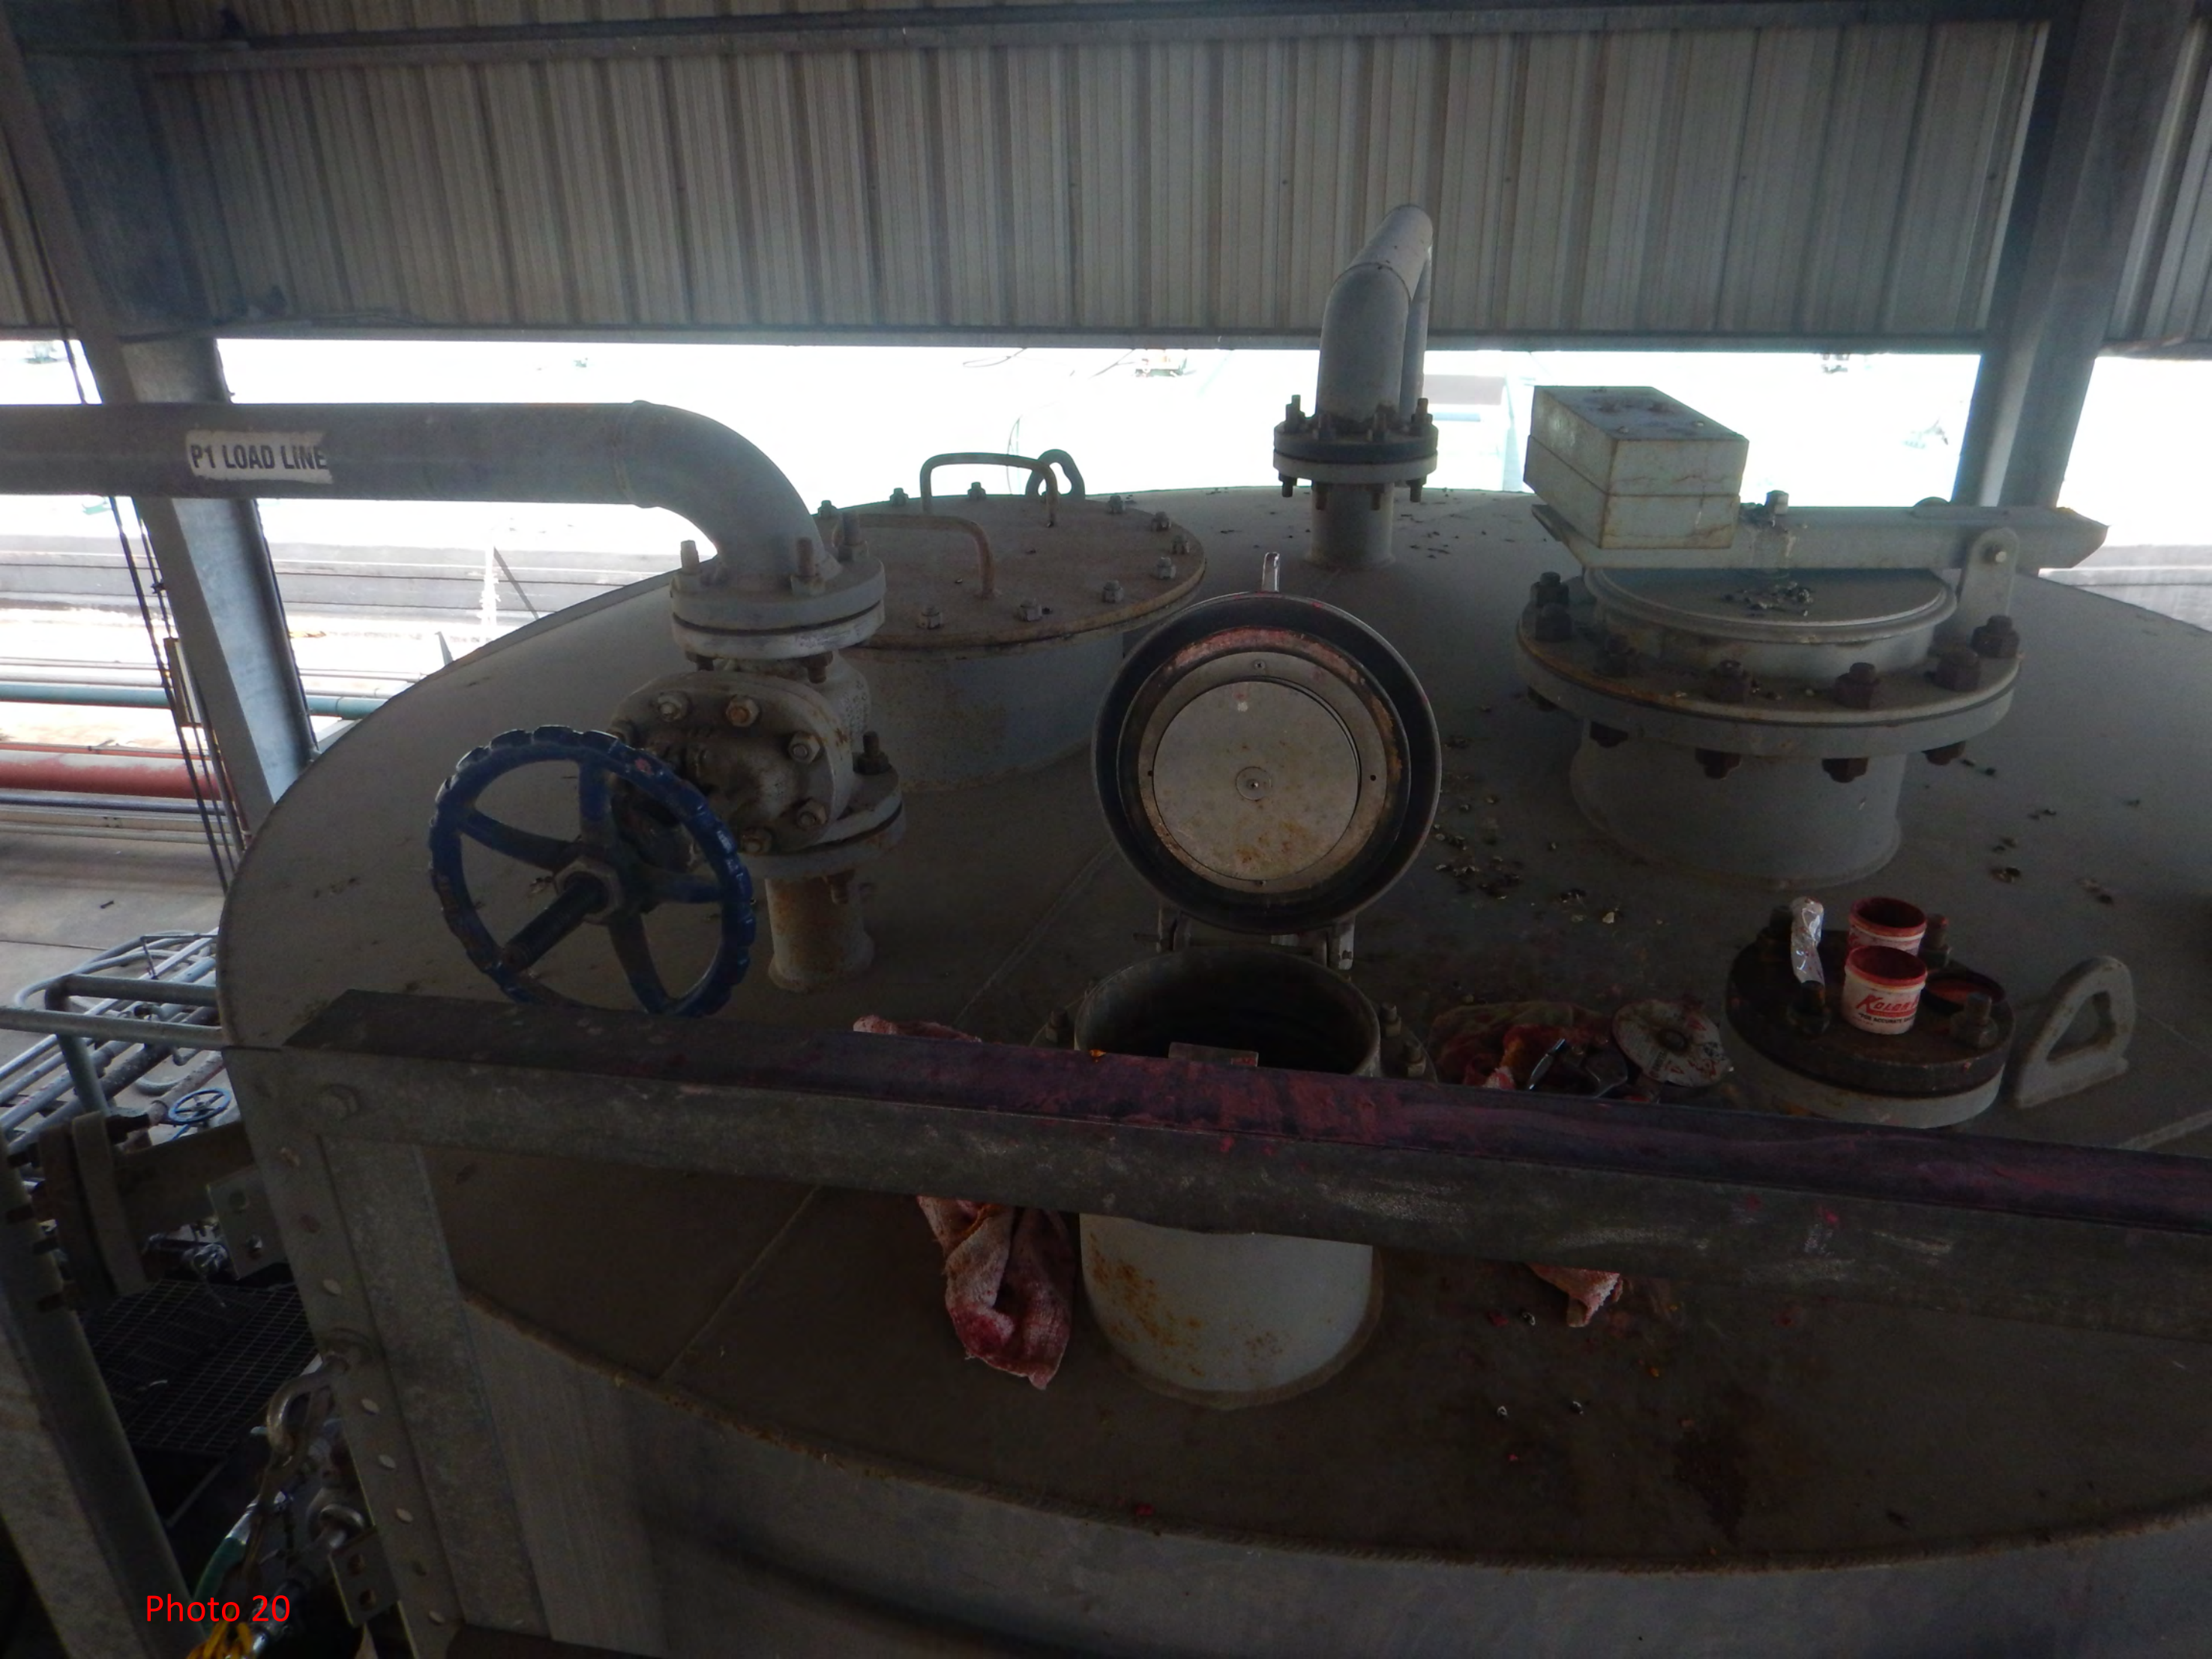
Photo 20

| Photo Number | File Name | | Date | Time | Photographer | Description |
|---|---|---|---|---|---|---|
| 20 | DSCN1169 | .JPG | 24-Aug-23 | 1110 | John Penland | Product Storage tank. Open hatch |
