**Region 6 - Enforcement & Compliance Assurance Division**  
**INSPECTION REPORT**

| Inspection Date(s): | August 24, 2023 | |
| Company Name: | <b>Stolt Tankers USA, Inc</b> | |
| Facility Name: | <b>Stolt Barging Services</b> | |

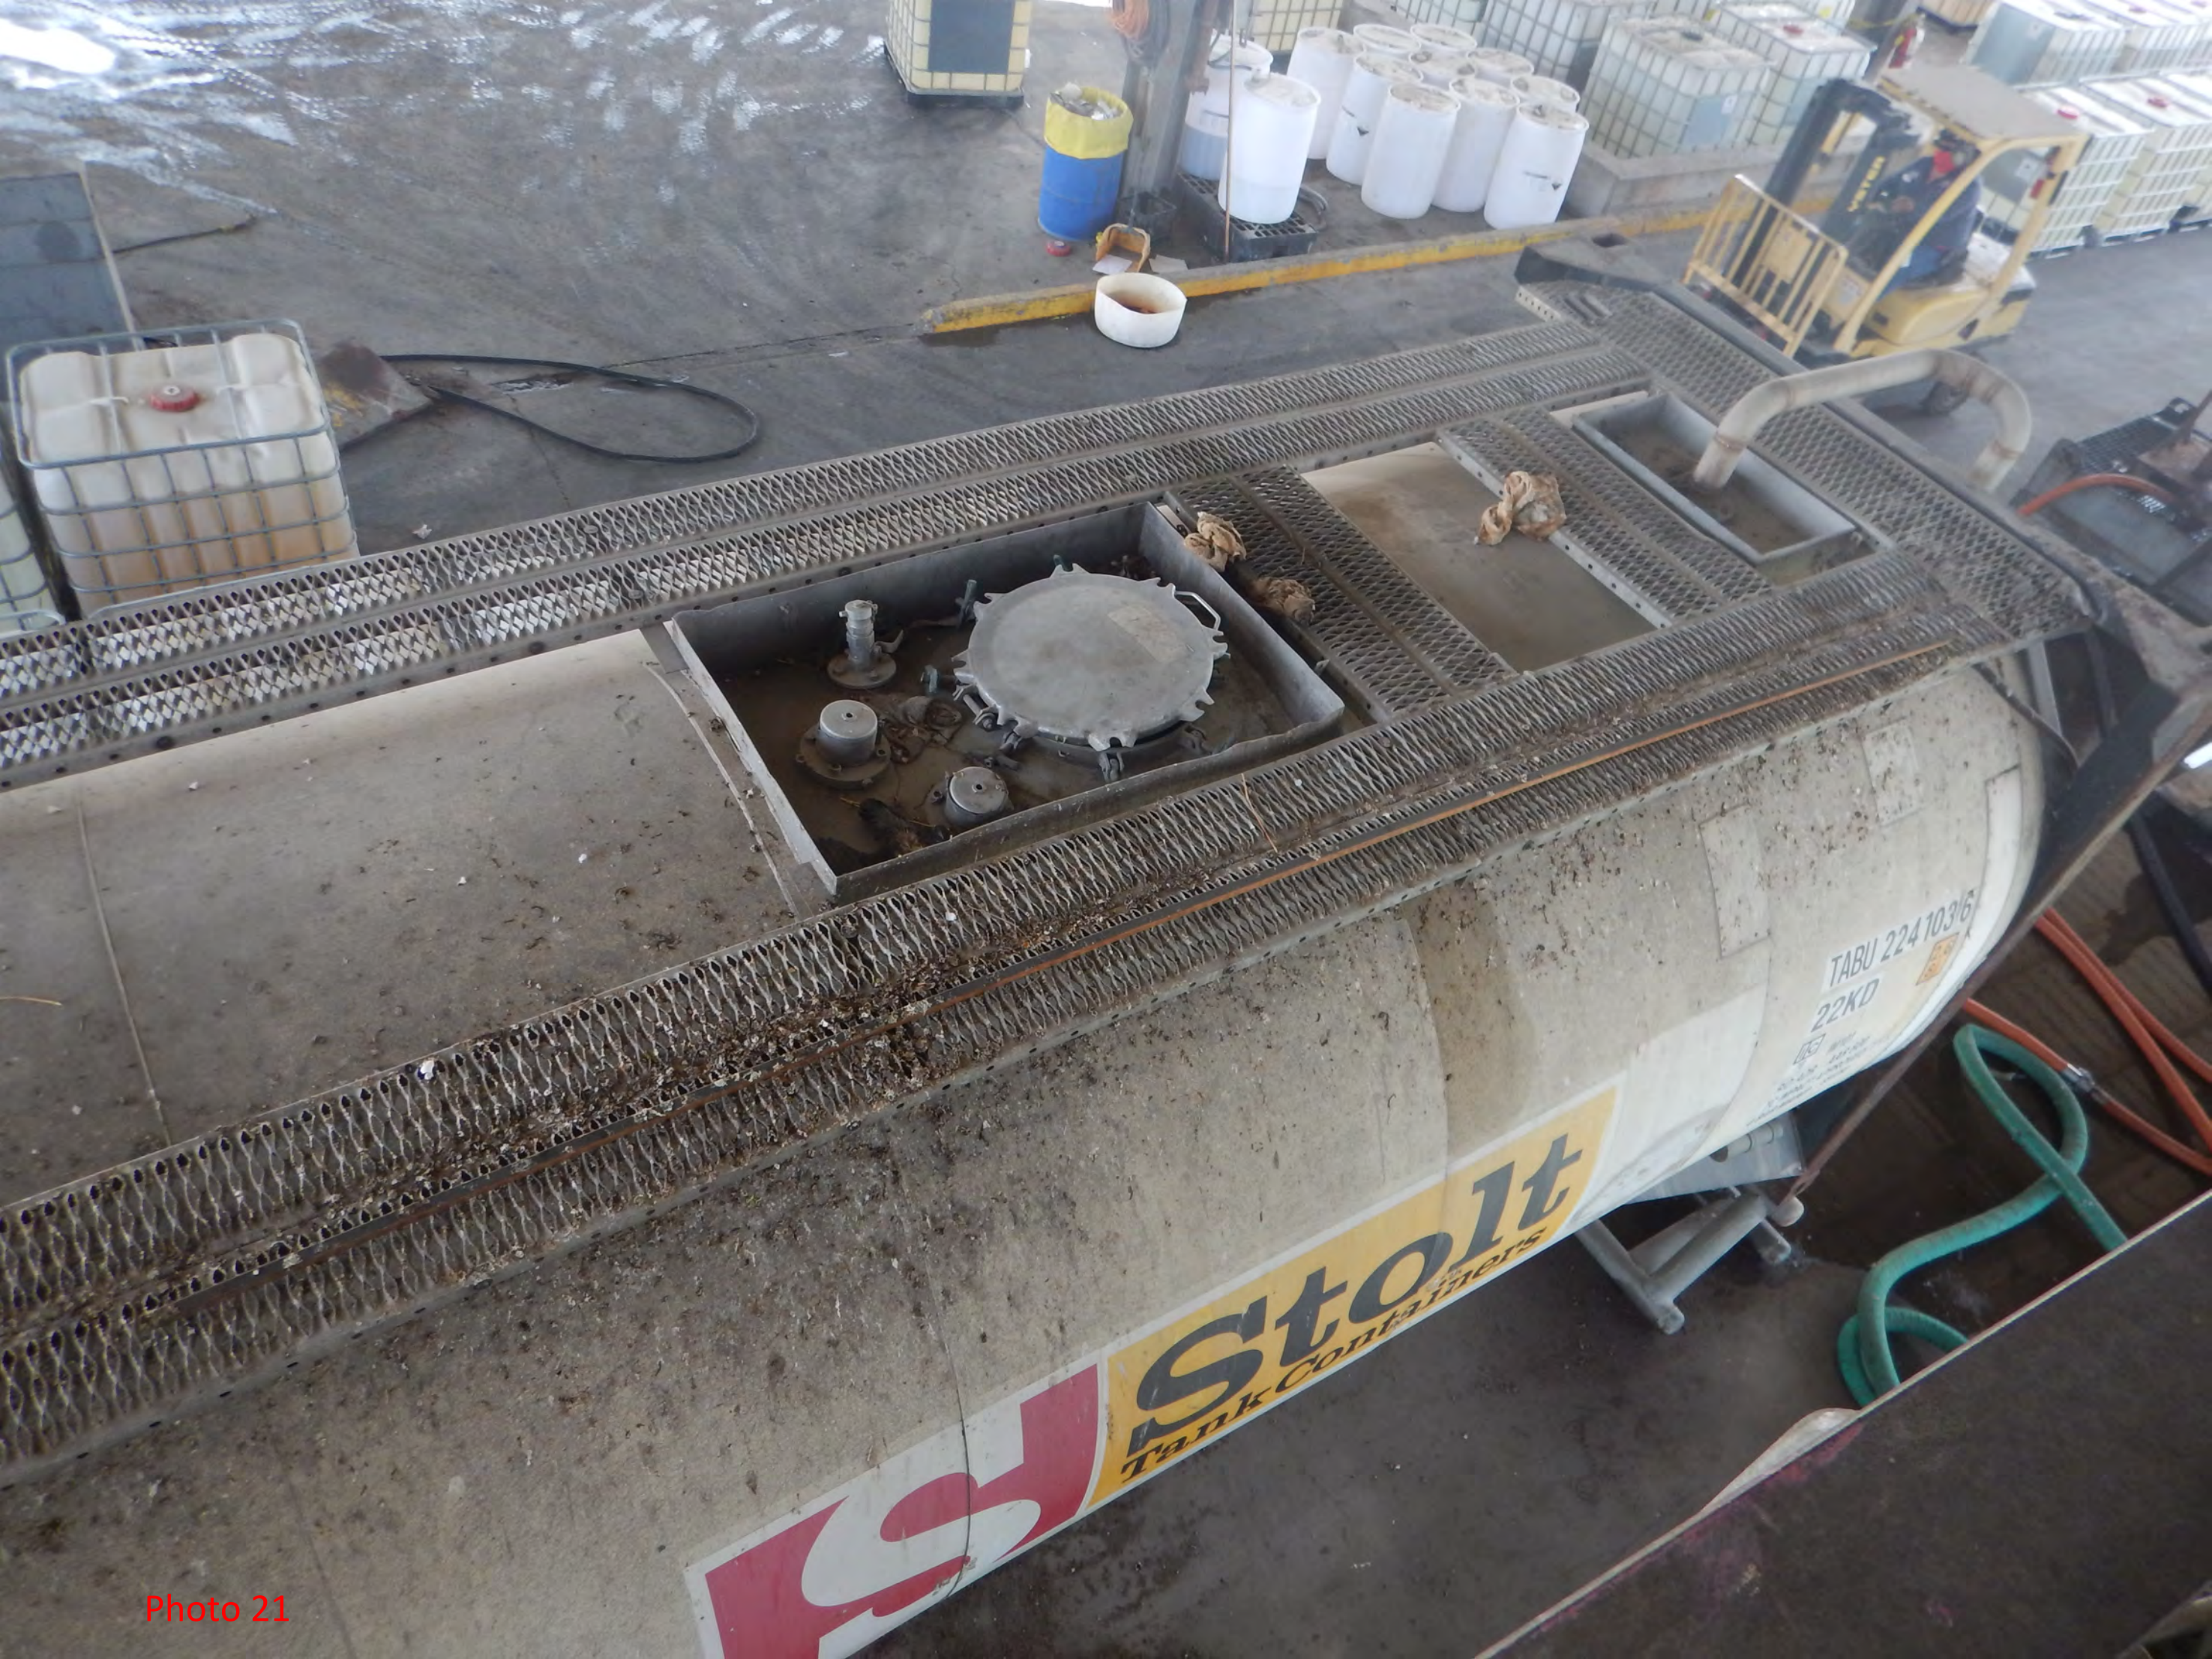
Photo 21

| Photo Number | File Name | | Date | Time | Photographer | Description |
|---|---|---|---|---|---|---|
| 21 | DSCN1170 | .JPG | 24-Aug-23 | 1110 | John Penland | ISO Containers used for the accumulation of Corrosive (D002) hazardous wastes |

- ISO Containers
      - These containers were open and unlabeled at the time of inspection.
    - Frac Tank
      - This tank was open and unlabeled at the time of inspection.

- 40 CFR 262.17 (a)(5)(iv) Failure to close containers of hazardous waste
    - 2 ISO containers used for the accumulation of corrosive waste were open at the time of inspection.

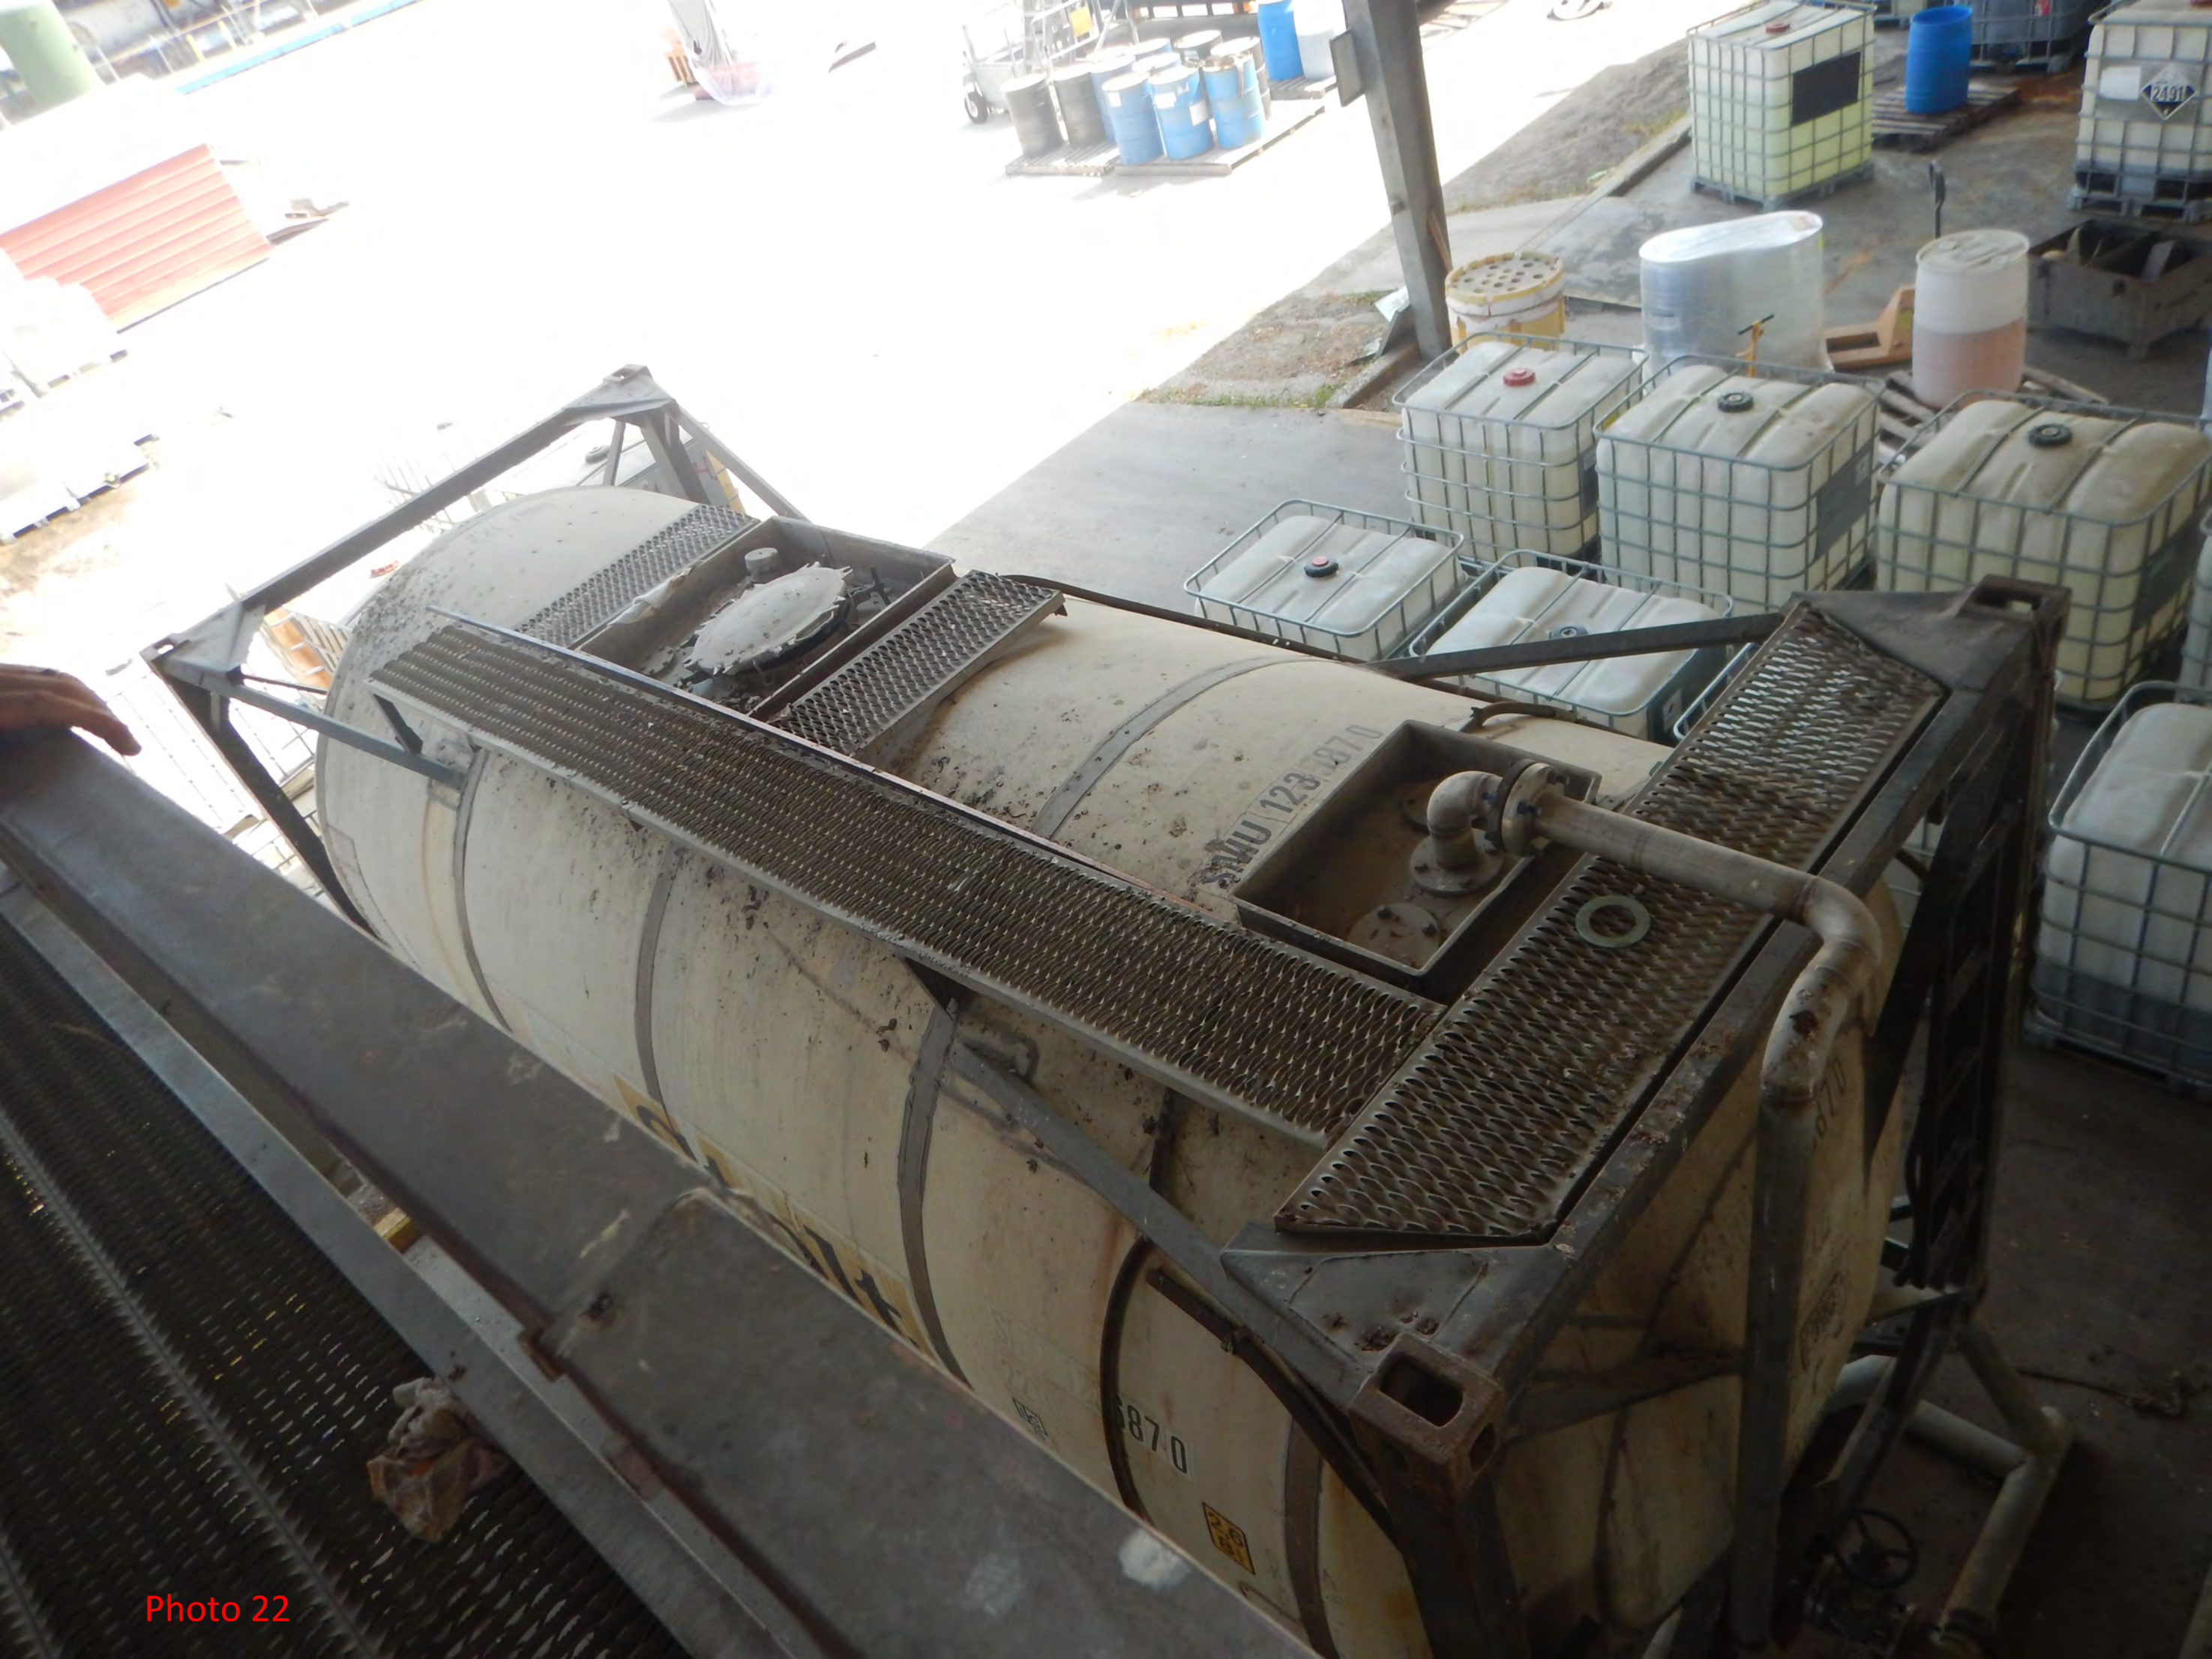
Photo 22

| Photo Number | File Name | | Date | Time | Photographer | Description |
|---|---|---|---|---|---|---|
| 22 | DSCN1171 | .JPG | 24-Aug-23 | 1110 | John Penland | ISO Containers used for the accumulation of Corrosive (D002) hazardous wastes |

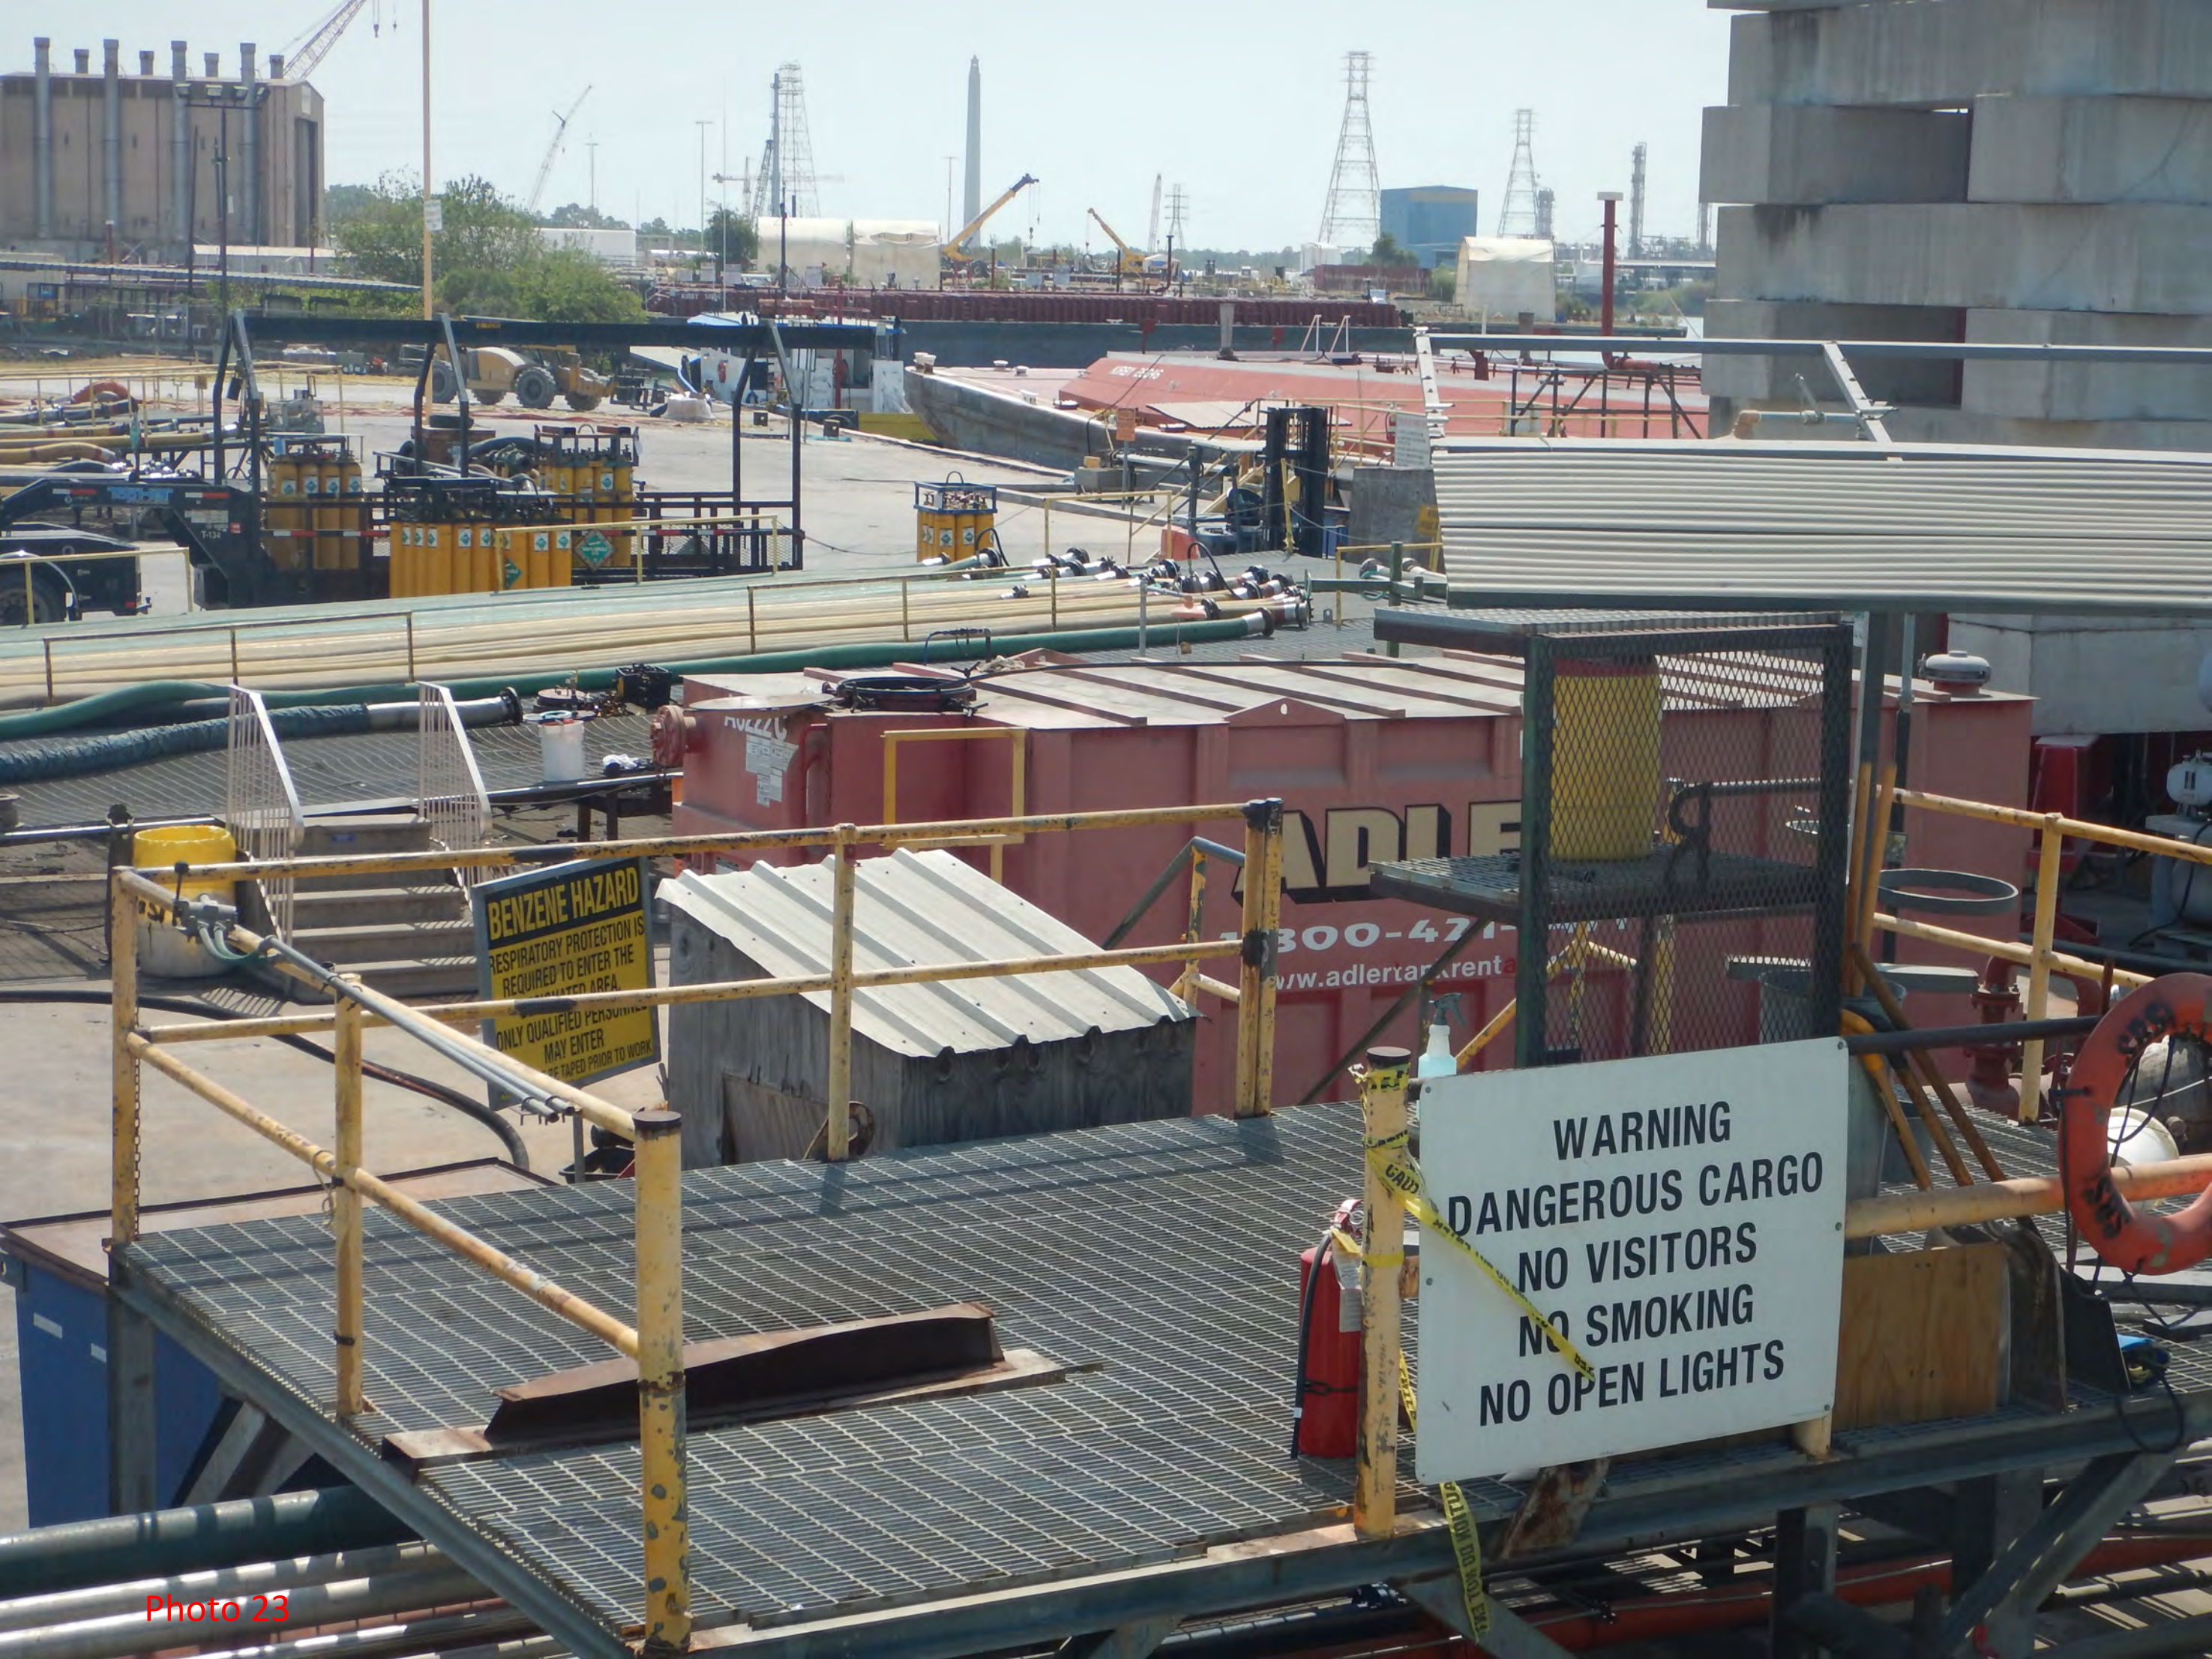
| Photo Number | File Name | | Date | Time | Photographer | Description |
|---|---|---|---|---|---|---|
| 23 | DSCN1172 | .JPG | 24-Aug-23 | 1128 | John Penland | Frac tank used for the accumulation of organic waste waters. Sent as recyclable to Intergulf |

- The oily water frac tank was open at the time of inspection.
    - The vac box used for the separation of rust and scale from wash waters was left open after the pump was shut off.

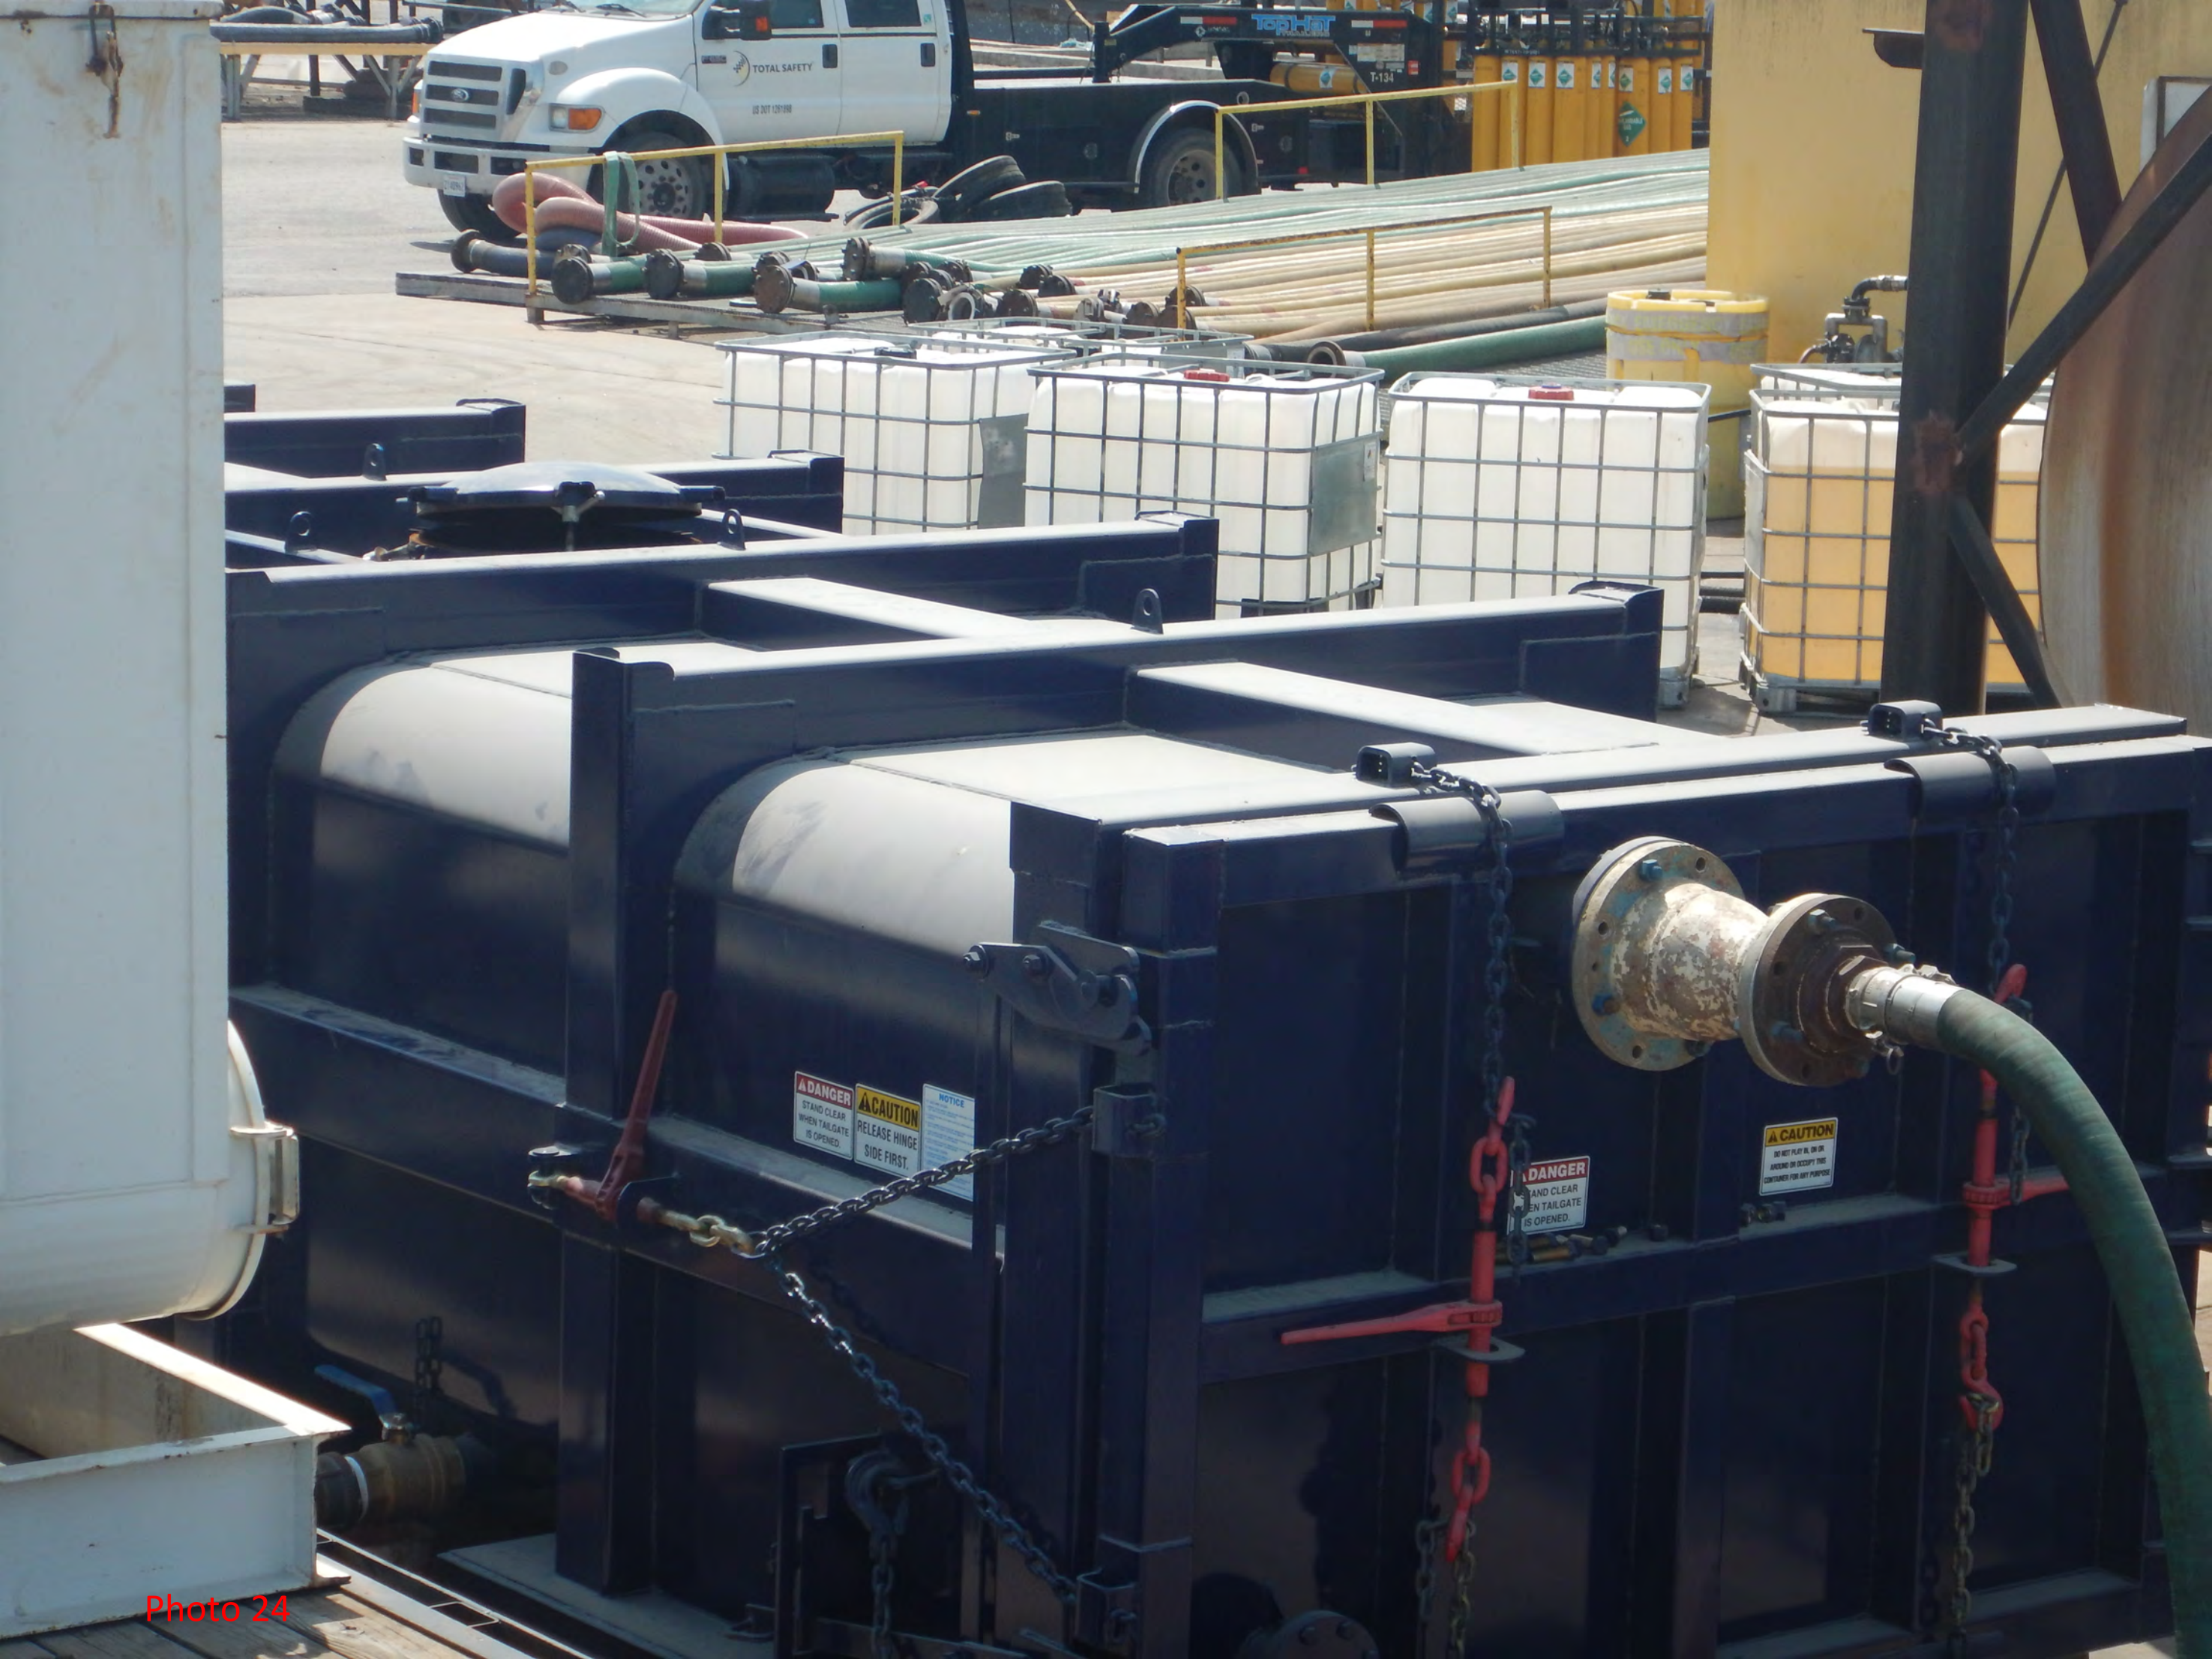
Photo 24

| Photo Number | File Name | | Date | Time | Photographer | Description |
|---|---|---|---|---|---|---|
| 24 | DSCN1173 | .JPG | 24-Aug-23 | 1131 | John Penland | Container used for solids removal from barge washwater. |
