## RCRA Inspection Report

Mercedes-Benz Vans LLC  
8501 Palmetto Commerce Parkway  
Ladson, South Carolina 29456  
Ladson County

April 10, 2024, at 9:35 a.m. EDT

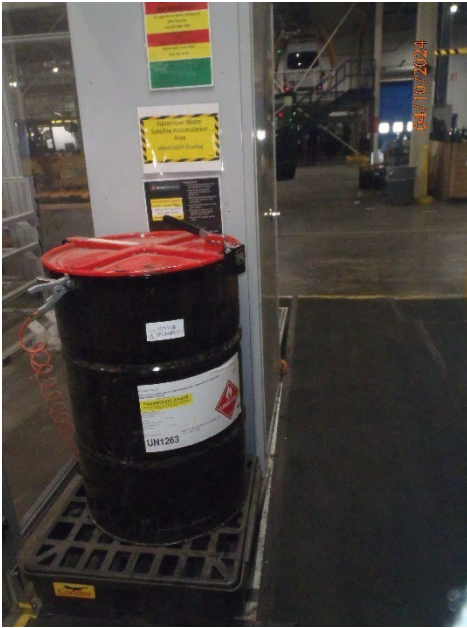
Picture 1 – Assembly Window Glazing SAA

Assembly supplies the trim line parts for the van interiors. This building only has one production line. The inspectors observed a black 55-gallon container of Solvent Paint Contaminated personal protective equipment (PPE), Absorbent Debris and Contaminated Residue, D001, F003, F005 (Picture 1) in the Window Glazing satellite accumulation area (SAA). The container had a red flap lid and sat on secondary containment. The container was closed and labeled, and the secondary containment was clean. No issues were observed in the area.

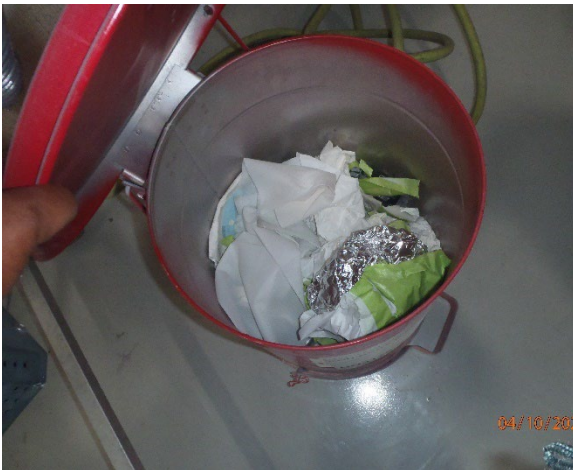
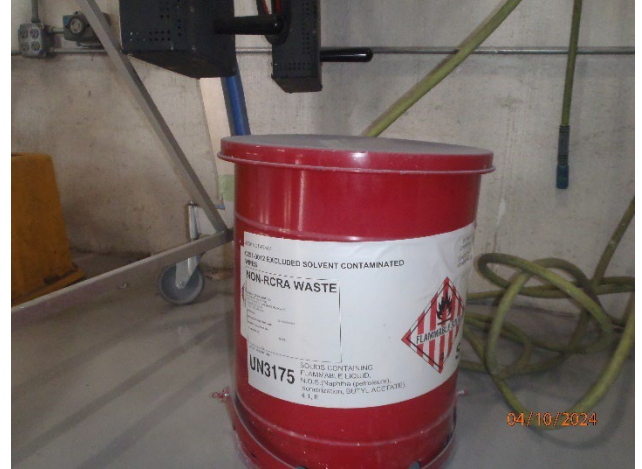
Picture 2 – Rework Area SAA

The inspectors observed a 5-gallon step container labeled Excluded Solvent Contaminated Wipes, C251-0012 Non-Hazardous, Flammable (Pictures 2-3) in the Rework Area. However, the inspectors observed paint contaminated PPE inside the container, which the facility representative confirm was hazardous waste debris. Mr. Revell explained that the hazardous waste contents should have been placed in a SAA.

At the time of the inspection, the inspectors observed hazardous waste debris inside the excluded solvent wipe container. MBV employees did not accurately identify the debris as

hazardous waste rather than excluded solvent wipes. The inspectors explained that the solvent contaminated wipes exclusion no longer applied to the container or its contents because hazardous waste was added to the container. Instead, the container was subject to the conditions of the SAA Permit Exemption. The container did not have hazardous label with hazard indication.

**Pursuant to S.C. Code Ann. Regs. 61-79.262.11 [40 C.F.R. § 262.11], a person who generates a solid waste, as defined in S.C. Code Ann. Regs. 61-79.261.2 [40 C.F.R. § 261.2], must make an accurate determination as to whether that waste is a hazardous waste in order to ensure wastes are properly managed according to applicable RCRA regulations articulated in S.C. Code Ann. Regs. 61-79.262.11 [40 C.F.R. § 262.11].**

| Task No. | Description | Assigned To | Correction Date |
|---|---|---|---|
| Task 1 | Excluded Solvent Wipe Red Can - contained foreign debris (Assembly Spot Paint Repair) | Paint Shop | 4/11/2024 |

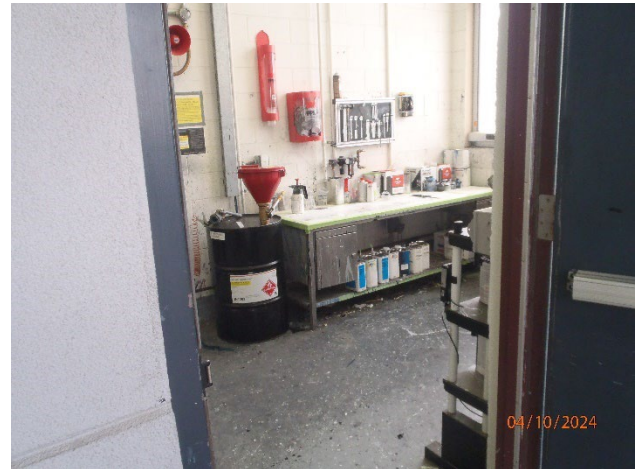
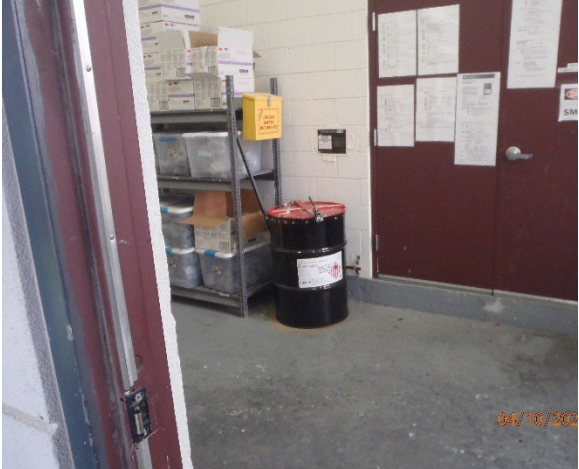
Picture 4 – Touch up Paint Mix Room SAA

Outside the Rework Area, was the Touch up Paint Mix Room. Due to the flammable nature of the paint mixing process, cameras and cellphones were not allowed inside this room. Therefore, photos were taken from the doorway. MBV manages two SAAs and an accumulation area for excluded solvent wipes inside. The inspectors observed one 55-gallon container of Paint Waste D001, D035, F003, F005 in the first SAA; one 55-gallon container of Solvent Paint Contaminated PPE, Absorbent Debris and Contaminated Residue, D001, F003, F005 in the second SAA; one 55-gallon container of Excluded Solvent Wipes Non-Hazardous; and a spill kit and an eyewash (Pictures 4-6) in the Touch up Paint Mix Room.

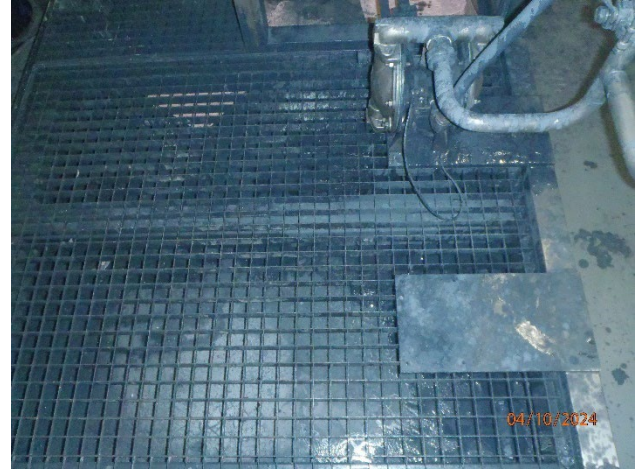
Picture 9 – Primer Purge Recovery System secondary containment for pump

At the time of the inspection, a grated secondary containment underneath a pump contained a release of primer paint (Picture 9). Mr. Mark Beckwith, Paint Shop Manager, explained that a recent maintenance repair had occurred, and the staff had yet to clean out the secondary containment. Mr. Beckwith went on to say that the release had happened the day before and they were waiting for it to fully dry before cleaning it up, in an attempt to prevent further mess and release. Drying is considered a form of treatment. Spill response and facility maintenance should be performed promptly.

**Pursuant to S.C. Code Ann. Regs. 61-79.262.90 states: A generator must clean up any hazardous waste discharge that occurs during generation or processing or storage and take such other action as may be required or approved by Federal, State, or local officials so that the hazardous waste discharge no longer presents a hazard to human health or the environment.**

**Pursuant to S.C. Code Ann. Regs. 61-79.262.17(a)(6)], [40 C.F.R. § 262.17(a)(6)], which incorporates S.C. Code Ann. Regs. 61-79.262.251 [40 C.F.R. § 262.251], and is a condition of**

**the LQG Permit Exemption, a generator is required to maintain and operate its facility to minimize the possibility of a fire, explosion, or any unplanned sudden or non-sudden release of hazardous waste or hazardous waste constituents to air, soil, or surface water which could threaten human health or the environment.**

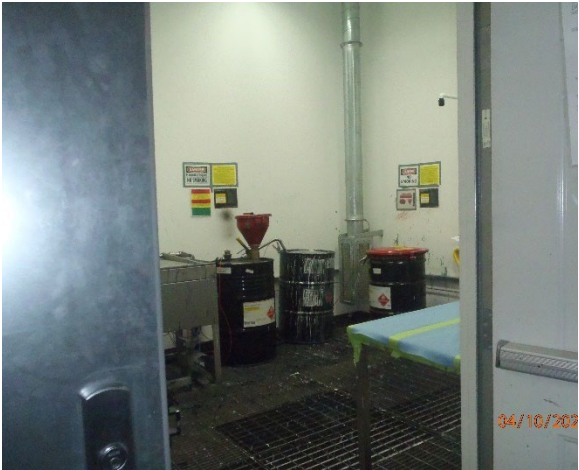
Picture 7 – Paint Shop Paint Mix Room SAA

Due to the flammable nature of the paint mixing process, cameras and cellphones were not allowed inside this room. The Paint Mix Room had an eyewash and two SAAs. The inspectors observed one 55-gallon container of Hazardous Waste Paint D001, D035, F003, F005 in the first SAA, and one 55-gallon container of Solvent Waste Paint Solids and Debris D001, F003, F005 in the second SAA (Picture 7).

The inspectors observed that a paint gun inside the bunghole of a 55-gallon container located between the two containers in the SAAs. When asked, the inspectors were told that the paint gun hose was connected to the solvent wash. Clean solvent is placed into the container and pumped using paint gun into the solvent wash tank for cleaning equipment.

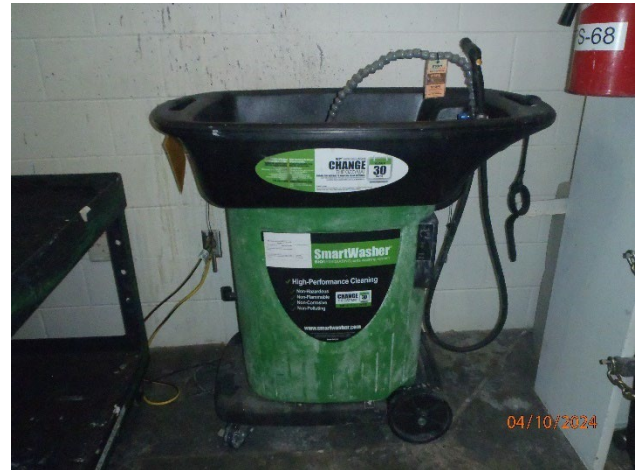
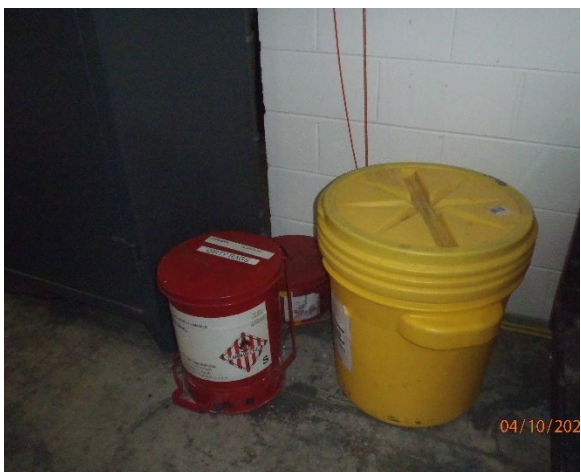
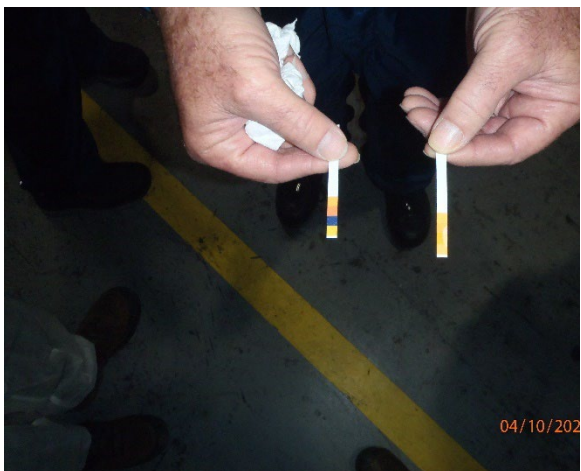
Picture 10 – Paint Shop Maintenance Ozzy Juice Smart Washer

The Paint Shop Maintenance is an enclosed storage area. The inspectors observed a green SmartWasher® with OzzyJuice®, a red one-gallon container of spent OzzyJuice®, and a red 5-gallon flip can with Excluded Wipes, Flammable Solid (Pictures 10-12). The OzzyJuice® inside the SmartWasher®, is an aqueous-based solution which contains a mixture of pH-neutral emulsifiers and surfactants. This solution is used for parts cleaning. The inspectors noted that the OzzyJuice® had a soapy smell. However, the red one-gallon container labeled “spent OzzyJuice®” observed behind the excluded wipes container (Picture 12) did not have a soapy smell, but a solvent smell, and contained at least one-inch of clear yellow liquid. When the inspectors asked Mr. Beckwith and his staff, no one could identify the contents of the container. Mr. Richmond and Mr. Donohue tested each the OzzyJuice® from the SmartWasher® and the unknown contents of the red container with pH indicator strips. The OzzyJuice® test strip was clear, and the unknown contents test strip was purple which indicates a pH of 12 (basic) (Picture 13). The inspectors stated a hazardous waste determination was needed on the unknown contents of the red one-gallon container.

**Pursuant to S.C. Code Ann. Regs. 61-79.262.11 [40 C.F.R. § 262.11], a person who generates a solid waste, as defined in S.C. Code Ann. Regs. 61-79.261.2 [40 C.F.R. § 261.2], must make an accurate determination as to whether that waste is a hazardous waste in order to ensure wastes are properly managed according to applicable RCRA regulations articulated in S.C. Code Ann. Regs. 61-79.262.11 [40 C.F.R. § 262.11].**

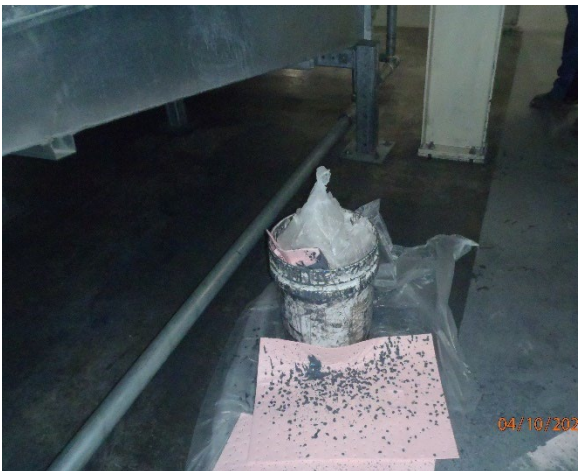
Picture 8 – Primer Purge Recovery System clean up debris

In addition, a release of primer on the floor was in the process of being cleaned up. A 5-gallon container with hazardous waste paint debris was observed sitting on plastic and surrounded by absorbent pads (Picture 8). When observed by the inspectors, there was no one actively cleaning up the release and the container was not closed or labeled as hazardous waste.

**Pursuant to S.C. Code Ann. Regs. 61-79.262.15(a)(5) [40 C.F.R. § 262.15(a)(5)], which is a condition of the SAA Permit Exemption, a generator is required to mark or label its containers (i) with the words “Hazardous Waste” and (ii) with an indication of the hazards of the contents.**

**Pursuant to S.C. Code Ann. Regs. 61-79.262.15(a)(4) [40 C.F.R. § 262.15(a)(4)], which is a condition of the SAA Permit Exemption, a generator is required to keep containers of hazardous waste closed at all times during accumulation, except when adding, removing, or consolidating waste; or when temporary venting of a container is necessary for the proper operation of equipment, or to prevent dangerous situations, such as build-up of extreme pressure.**

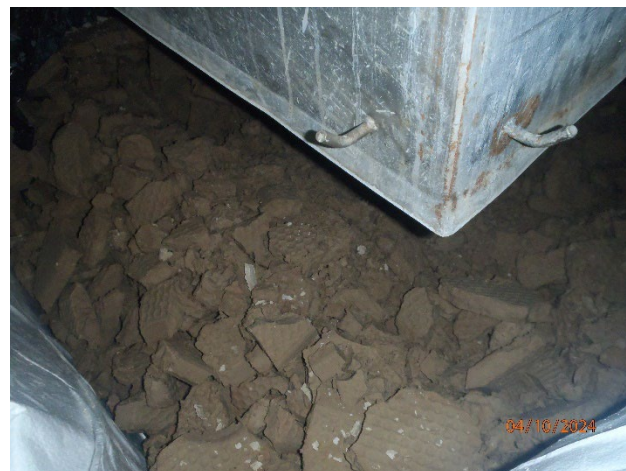
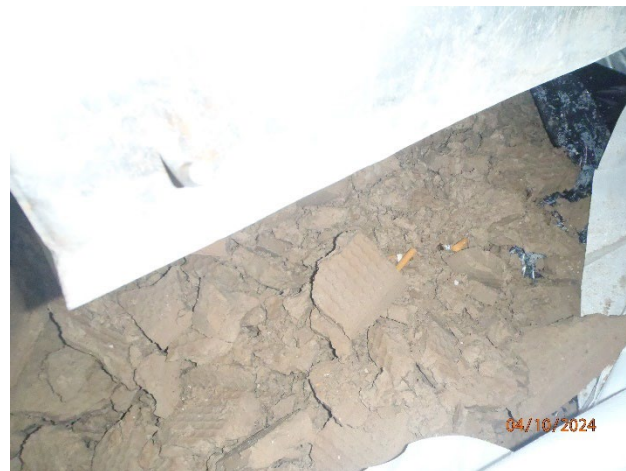
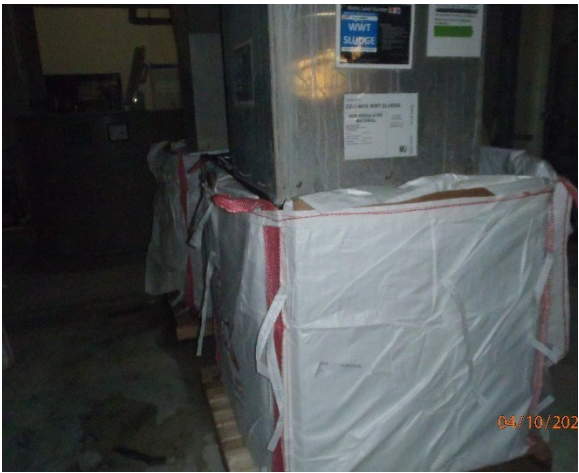
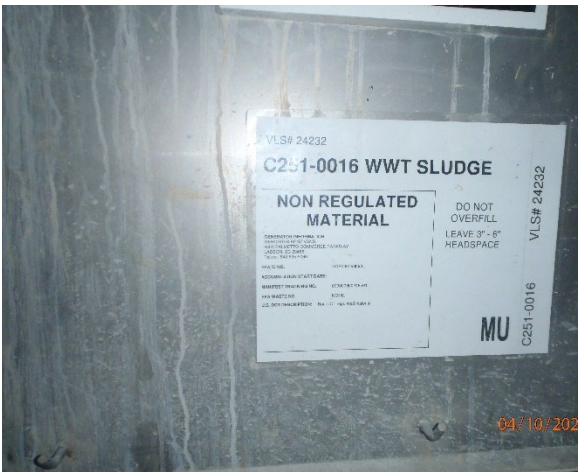
Picture 16 – WWTP sludge

The Wastewater Treatment Plant generated 25 cubic yard supersacks of Non-Regulated Wastewater Treatment Plant Sludge (C251-0016) (Pictures 16-19). The inspectors observed two supersacks, and discarded cigarette butts inside one of the supersacks. The inspectors made Mr. Beckwith aware of the housekeeping issue. No hazardous waste was observed in this area.

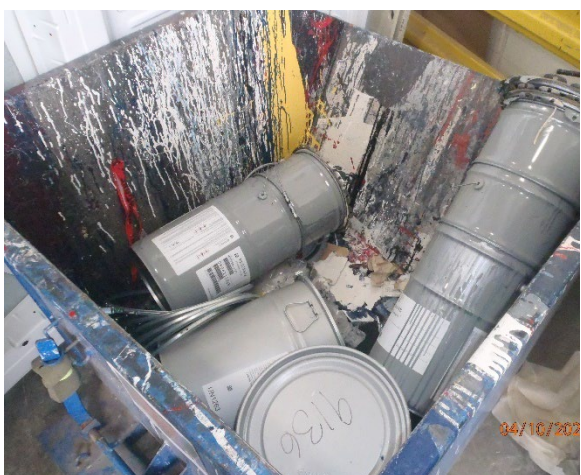
Picture 15 – Mix Room Storage scrap metal bin w/discarded HW paint cans

Outside Mix Room Storage was a loading area with a scrap metal bin that contained discarded paint cans that were not RCRA empty (Pictures 14-15). This container was labeled “Scrap Metal Bin” by Mercedes-Benz Vans LLC and contained paint contaminated PPE and many non-RCRA empty paint containers, some of which had drained into the bottom of the container. The inspectors observed waste paint residue released inside the scrap metal bin. According to the waste profile records, MBV has identified waste paint as D001, D035, F003, F005 hazardous waste. Therefore, the inspectors stated that the released hazardous waste paint needed to be cleaned up and the paint residue and non-empty containers needed to be managed as hazardous waste.

**Pursuant to S.C. Code Ann. Regs. 61-79.262.11 [40 C.F.R. § 262.11], a person who generates a solid waste, as defined in S.C. Code Ann. Regs. 61-79.261.2 [40 C.F.R. § 261.2], must make an accurate determination as to whether that waste is a hazardous waste in order to ensure wastes are properly managed according to applicable RCRA regulations articulated in S.C. Code Ann. Regs. 61-79.262.11 [40 C.F.R. § 262.11].**

**Pursuant to S.C. Code Ann. Regs. 61-79.262.90 states: A generator must clean up any hazardous waste discharge that occurs during generation or processing or storage and take such other action as may be required or approved by Federal, State, or local officials so that the hazardous waste discharge no longer presents a hazard to human health or the environment.**

**Pursuant to S.C. Code Ann. Regs. 61-79.262.17(a)(6)], [40 C.F.R. § 262.17(a)(6)], which incorporates S.C. Code Ann. Regs. 61-79.262.251 [40 C.F.R. § 262.251], and is a condition of the LQG Permit Exemption, a generator is required to maintain and operate its facility to minimize the possibility of a fire, explosion, or any unplanned sudden or non-sudden release of hazardous waste or hazardous waste constituents to air, soil, or surface water which could threaten human health or the environment.**

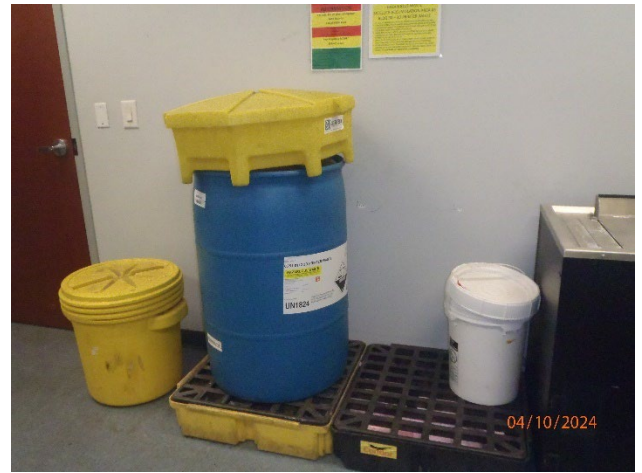
Picture 21 – Building 90 SAA

Building 90 is the Charleston Excellence Center where MBV manages a SAA in the 3-D Printing Room. The inspectors observed a 55-gallon container of 3-D Printer Waste, Corrosive, D002 with a yellow funnel and sitting on a secondary containment pallet in this SAA (Picture 21). A yellow spill kit and a 5-gallon container used as transfer bucket was also in this area. No issues were observed.

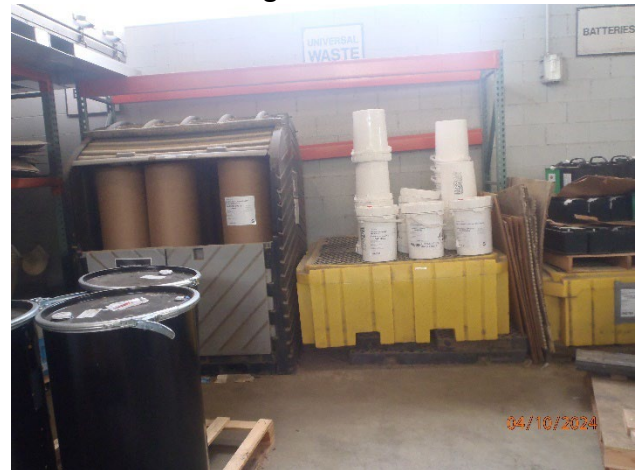
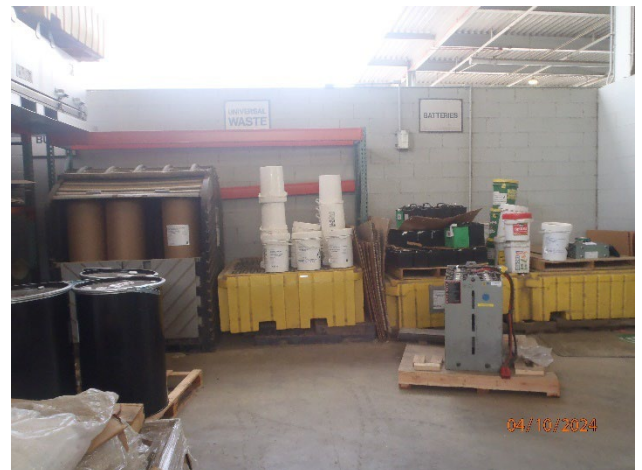
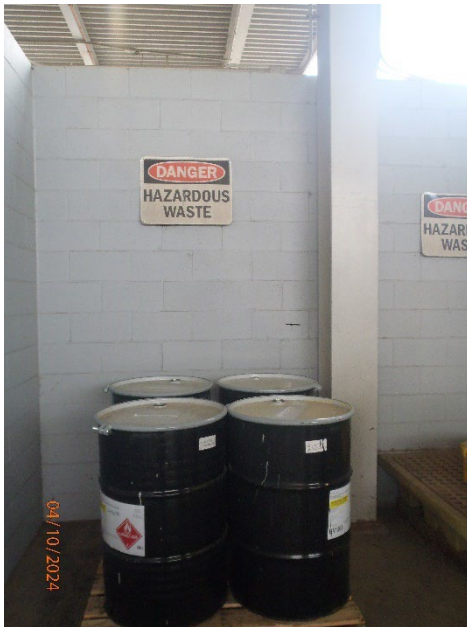
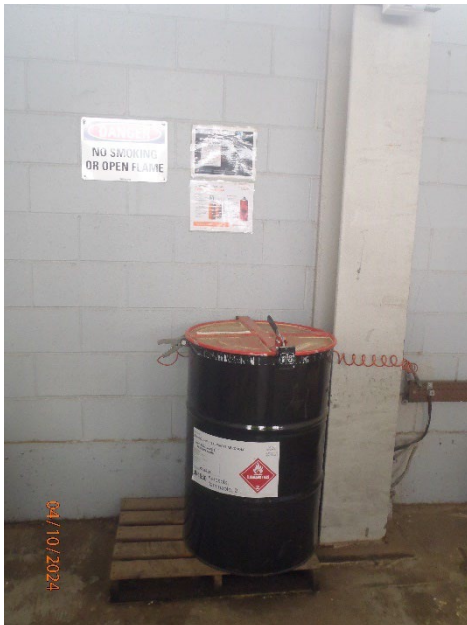
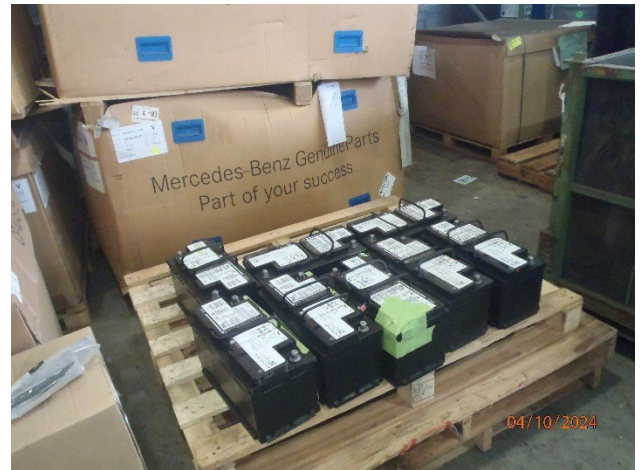
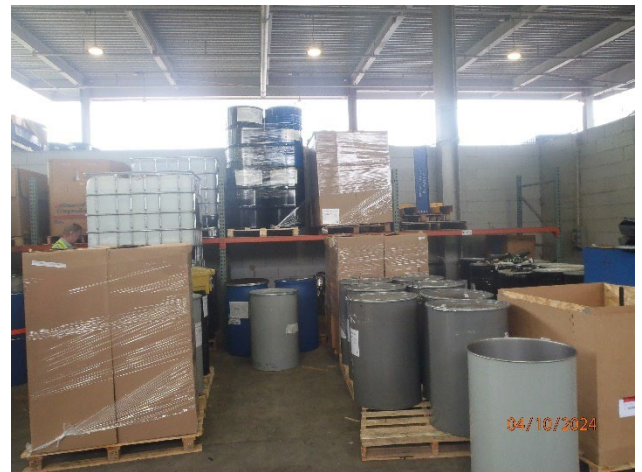
The less than 90-day central accumulation area (CAA) is a separate building on campus. The inspectors observed the following (Pictures 22-33):

- A spill cart;
- One fiberboard carton of universal waste lamps, closed, labeled, and dated April 9, 2024;
- One 5-gallon container of universal waste lithium batteries closed, labeled, and

- dated December 6, 2023;
- One 5-gallon container of universal waste nickel-cadmium batteries closed, labeled, and dated January 19, 2024;
- 36 spent lead acid batteries dated January 7, 2024;
- Four 55-gallon containers of hazardous waste, closed, labeled, and the oldest dated April 3, 2024, and the remainder dated April 5, 2024;
- One 55-gallon container of universal waste aerosol containers closed, labeled, and dated April 2, 2024;
- A pallet of dead batteries waiting to be moved to the universal waste area, dated April 9, 2024;
- cartons of C251-0054 Welding Dust Filters;
- Eight totes of C251-0048 Oily Water;
- One 55-gallon container of oily solids; and
- Twelve 55-gallon containers of airbag seatbelt pretensioners, marked as non-hazardous waste, Reactive, to be sent for reclamation.

No issues were observed inside the CAA.

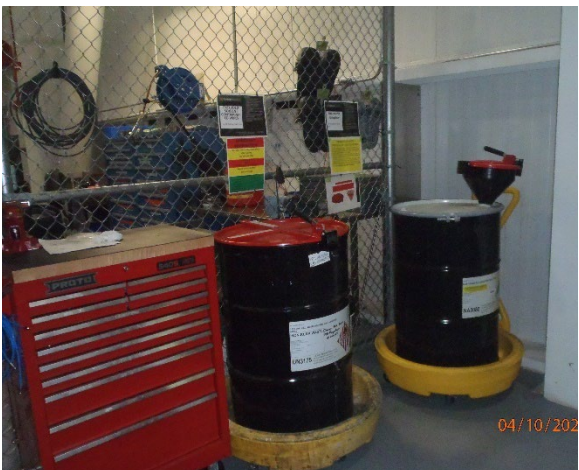
Picture 20 – Ultrasonic Waste SAAs

Mr. Beckwith toured the inspectors upstairs to observe a SAA for managing hazardous waste ACCRA Strip Solution and an area for managing solvent contaminated wipes. The inspectors observed one 55-gallon container, labeled ACCRA Strip Solution, Toxic, D010, in the SAA; one 55-gallon container, labeled Excluded Solvent Contaminated Wipes, C251-0012 Non-Hazardous, Flammable, in the contaminated wipes accumulation area; and a spill kit (Picture 20). Both containers were sitting on secondary containment pallets, closed, and labeled. No issues were observed.
