## **RCRA Inspection Report**

University of Florida  
3076 Longleaf Road Gainesville, Florida  
32611

EPA ID#: FLD000823393  
NAICS #: 611310 - Colleges, Universities, and  
Professional Schools

9:15 AM March 5, 2025, and 9:00 AM March 6, 2025

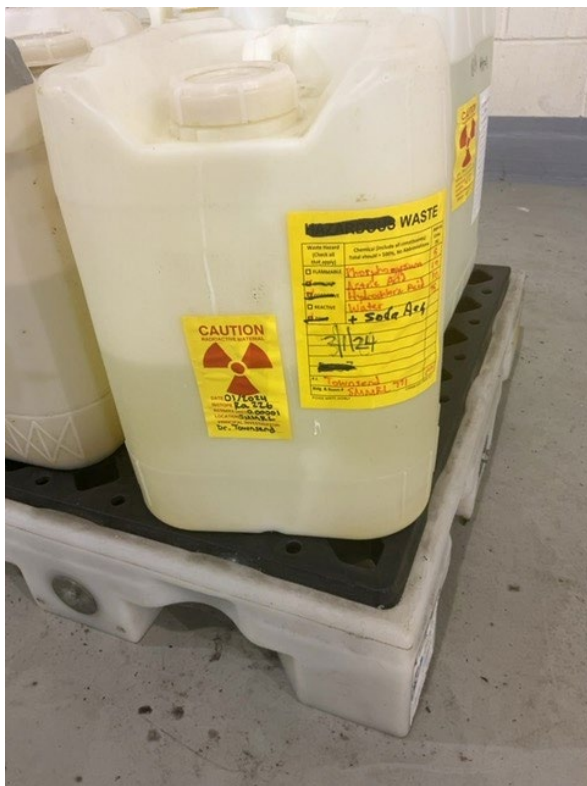
Photo 1 –  
Mixed waste  
label in Phase II  
permitted  
storage area.

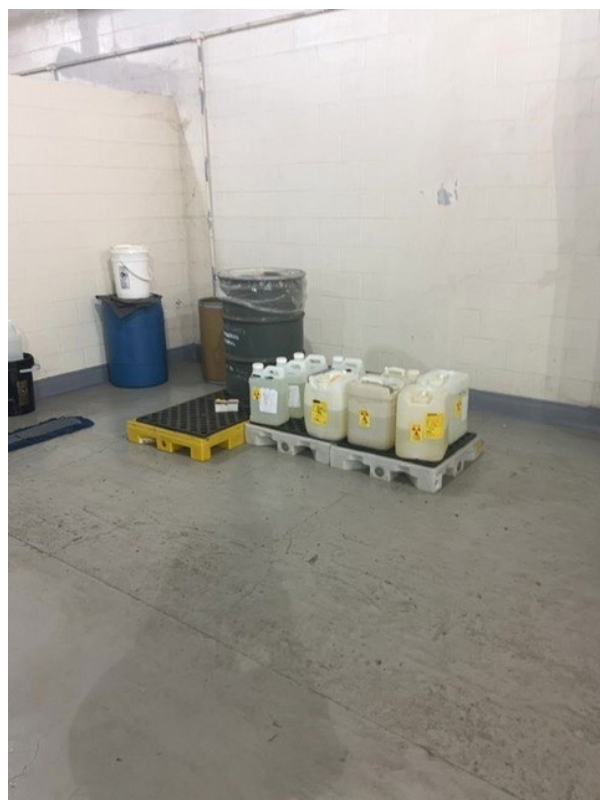
At the time of the inspection, inspectors observed the following containers in Area 8. Facility representatives informed inspectors that some of the corrosive mixed waste is neutralized before storage in Phase II so it remains only radioactive. All radioactive containers were marked with a tri-fold radiation warning symbol (Photo 1). Unless otherwise noted, these containers were closed, labeled with the words "Hazardous Waste, D022 and D002," marked with corrosive and toxic DOT labels, and an accumulation date (Photo 2):

Photo 2 –  
Corrosive  
mixed waste  
containers in  
Phase II  
permitted  
storage area  
for radioactive  
waste.

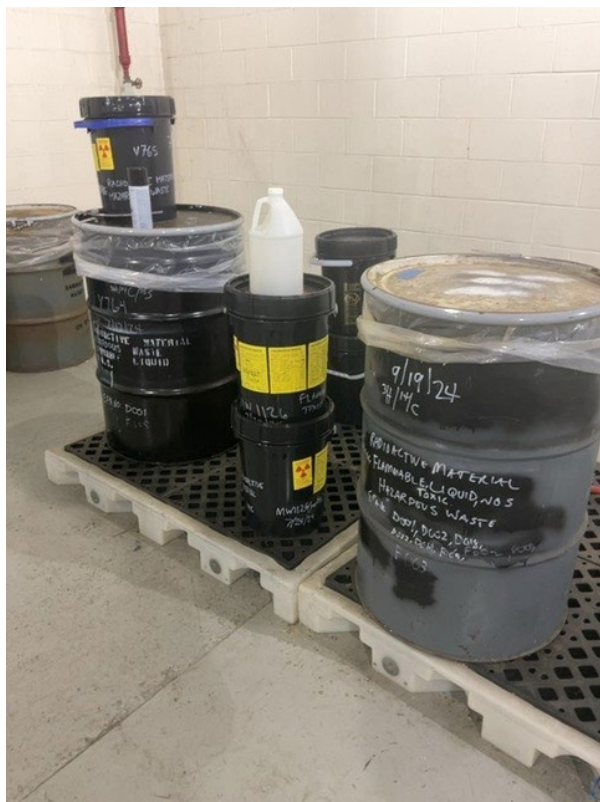
At the time of the inspection, inspectors observed the following containers in Area 9 (Photo 3). Unless otherwise noted, these containers were closed, labeled with the words “Hazardous Waste, D001,” marked with flammable DOT labels, and an accumulation date:

Photo 3 –  
Flammable  
mixed waste  
containers in  
Phase II  
permitted  
storage area  
for radioactive  
waste.

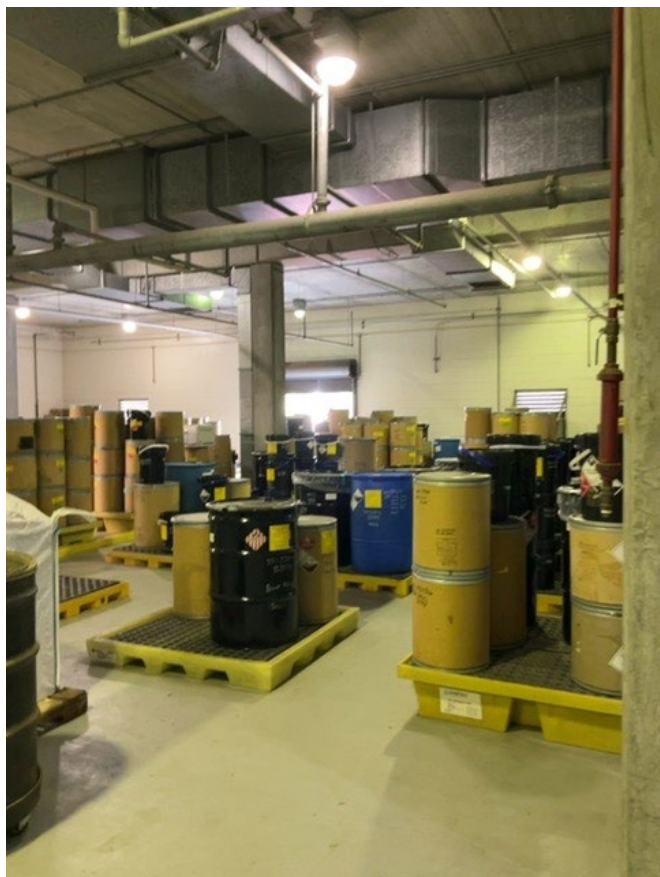
Phase I of the permitted storage warehouse is located in a section separate from Phase II (Photo 4.) Phase I is in the north side of the building and is segregated by a concrete wall and a narrow hallway. Phase I consists of the designated 90-day accumulation area for hazardous waste generated on site, as well as five separate sections permitted for one year storage of hazardous waste. This unit is permitted to store D001 through D043, F001 through F005, F019, F022, F027 and numerous U and P listed hazardous wastes. Some permitted waste is stored in separate rooms in the Phase I area, as well as the middle of the main Phase I area between four columns in the area’s center. The columns are lined with a concrete berm around 3 sides. Waste stored in the main Phase I area outside of these columns is designated as 90-day CAA waste. Inspectors recommended designating a clear barrier or signage to clearly distinguish the areas different with accumulation time limits.

Photo 4 –  
Phase I of the  
permitted  
storage area.  
This area is  
permitted for  
nonhazardous  
and  
nonradioactive  
hazardous  
waste storage.

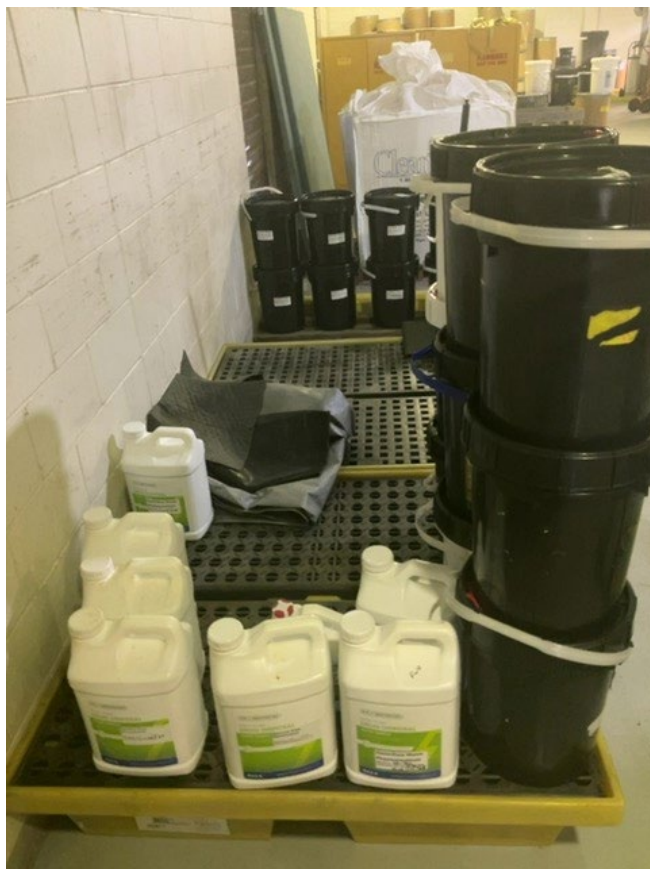
Inspectors observed hazardous waste pharmaceuticals stored on a secondary containment pallet in permitted storage Area 1B near the entrance of the Phase I storage area (Photo 5). All containers in this area were labeled with the words “Hazardous Waste Pharmaceuticals” and dated less than a year from the date of the inspection (Photo 6). At the time of the inspection, inspectors observed seven 2.5-gallon Rx destroyer containers, one 1-gallon container and eighteen 5-gallon black buckets holding hazardous waste in Area 1B. The oldest container in this area was dated May 1, 2024.

Photo 5 –  
Permitted  
storage area 1B  
on Phase I.

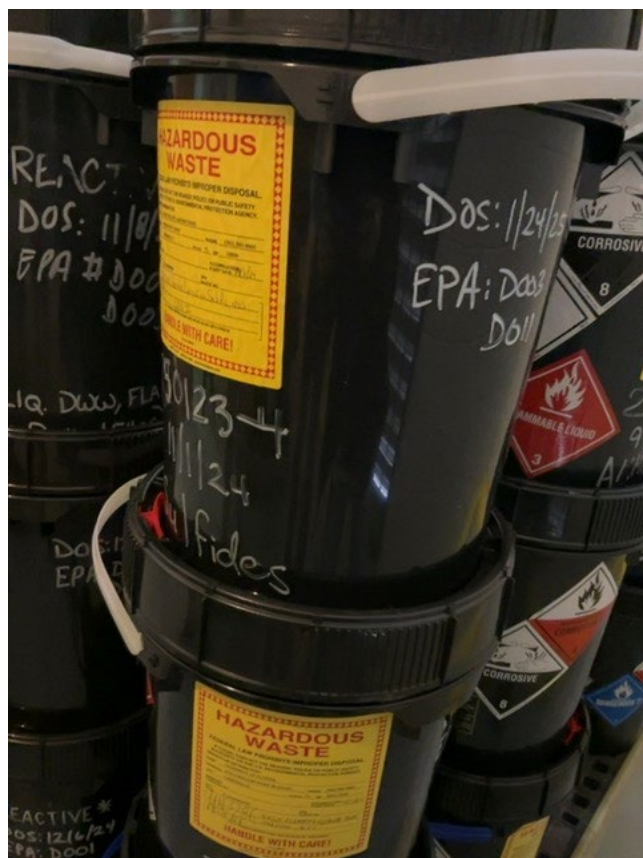
Of the above containers, four 5-gallon, one 12-gallon, and two 15-gallon containers did not include an indication of all the hazards of the contents on the label (Photos 7-8). These were corrected on site.

**Pursuant to Permit number 17756-007-HO, Permit Condition I.24.c [40 C.F.R. § 268.50(a)(2)(i)], the following conditions apply to land disposal (placement) of hazardous wastes: The storage of hazardous wastes restricted from land disposal in 40 CFR Part 268 is prohibited unless the requirements of 40 CFR Part 268 Subpart E are met.**

Photo 7 – Reactive hazardous waste container in Area 1B that was labeled EPA waste code D003 but not marked with an indication of the hazard of reactivity.

Photo 8 - Reactive hazardous waste container in Area 1B that was labeled EPA waste code D003 but not marked with an indication of the hazard of reactivity.

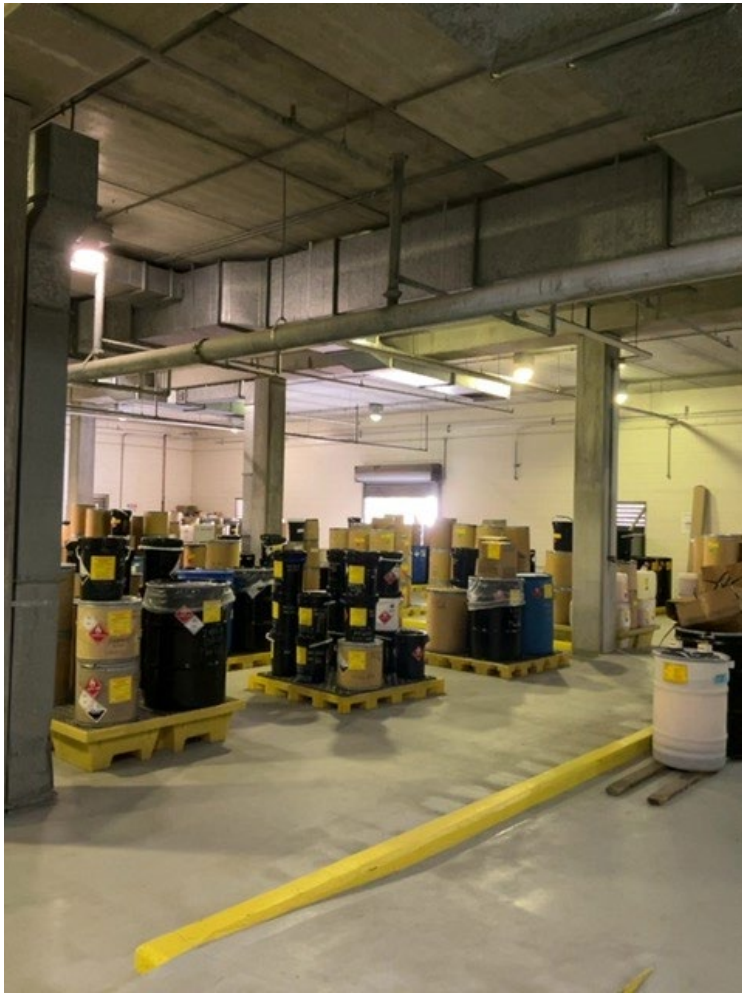
Area 2B was located in between the four columns in the center of the Phase I side of the waste storage warehouse and is designated as part of the one-year permitted waste storage unit (Photo 9). Containers in this area are stored on secondary containment pallets and dated with an accumulation date as well as the date the container was brought to the permitted storage area. All containers were marked as moved to permitted storage less than one year from the date of the inspection. Unless otherwise noted, all containers in Area 2B were labeled as hazardous waste with an indication of the contents’ hazards. Inspectors observed the following containers in three rows within this area at the time of the inspection:

Photo 9 –  
Permitted  
hazardous  
waste storage  
area 2 B.

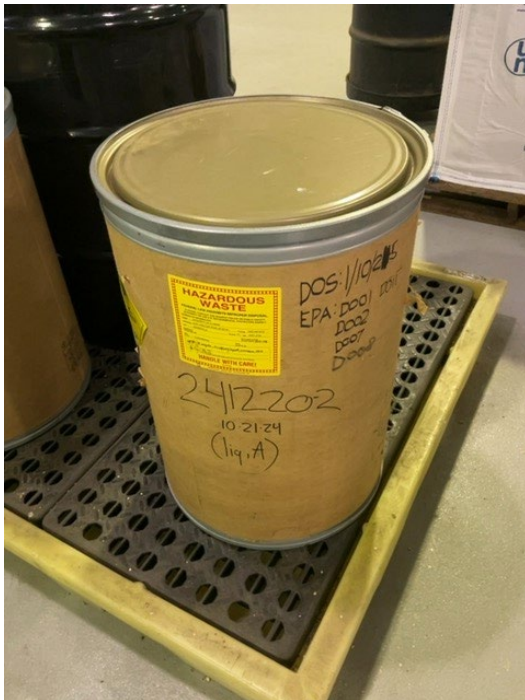
Of the containers listed above, one 55-gallon, one 30-gallon, one 15-gallon, and two 5-gallon containers were not properly marked with an indication of their contents' hazards (Photo 10). These labels were corrected on site.

**Pursuant to Permit number 17756-007-HO, Permit Condition I.24.c [40 C.F.R. § 268.50(a)(2)(i)], the following conditions apply to land disposal (placement) of hazardous wastes: (c) The storage of hazardous wastes restricted from land disposal in 40 CFR Part 268 is prohibited unless the requirements of 40 CFR Part 268 Subpart E are met.**

Photo 10 –  
Container in  
permitted  
storage Area 2B  
that was  
marked with  
toxic EPA waste  
codes and not  
marked with an  
indication of  
the hazard of  
toxicity.

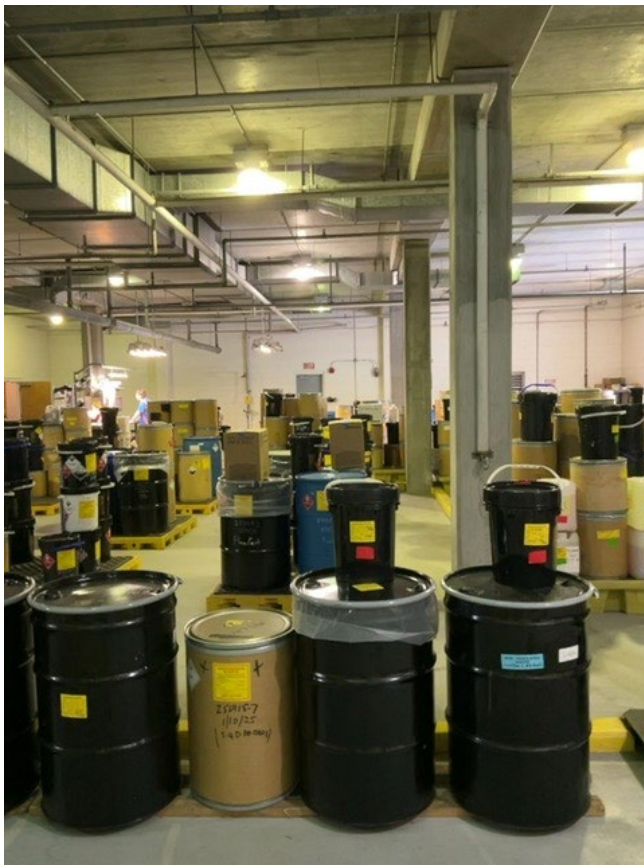
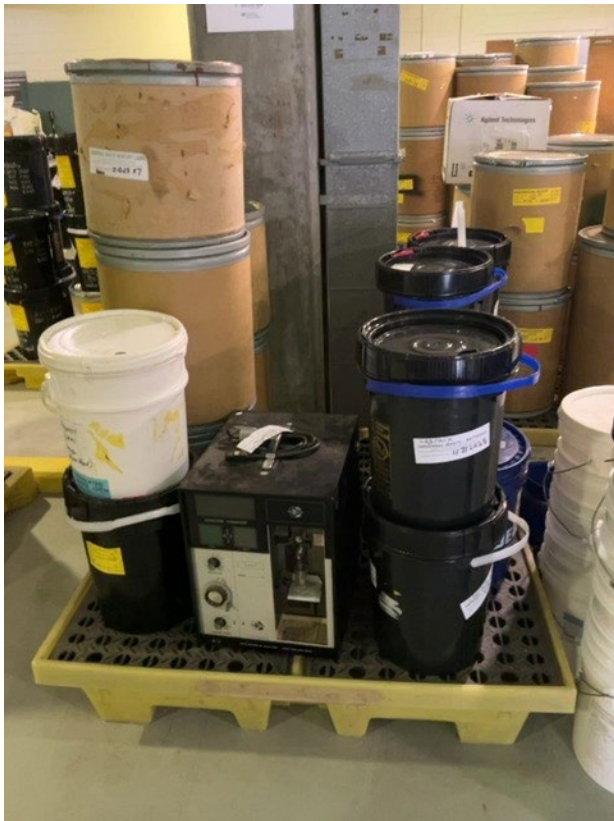
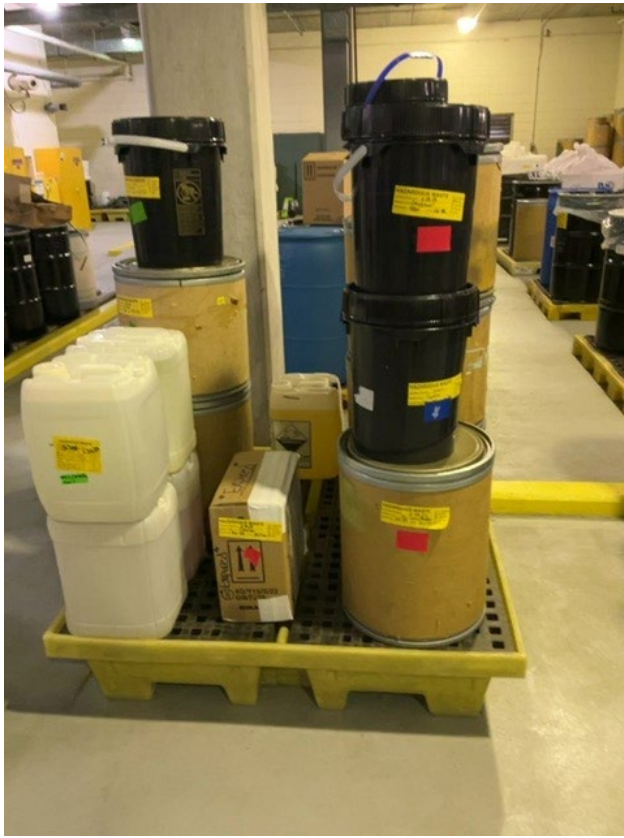
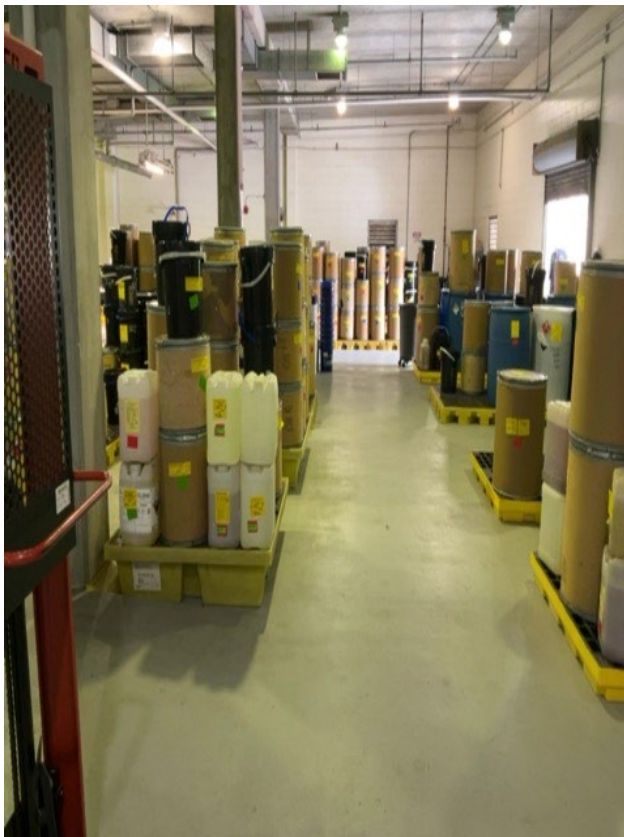
The facility stores 90- day central accumulation area waste in Building 831 (Photos 11-14). This waste is stored in areas outside the areas permitted for one year storage. Unless otherwise noted, the containers in the 90-Day CAA were marked with the words "Hazardous Waste," an indication of the contents' hazards was check marked on the label or was written out in marker, and the container was dated less than 90-days from the date of the inspection.

Photo 11 – 90-day central accumulation area containers in Building 831.

Photo 12 - 90-day central accumulation area containers in Building 831.

Photo 13 - 90-day central accumulation area containers in Building 831.

Photo 14 - 90-day central accumulation area containers in Building 831.

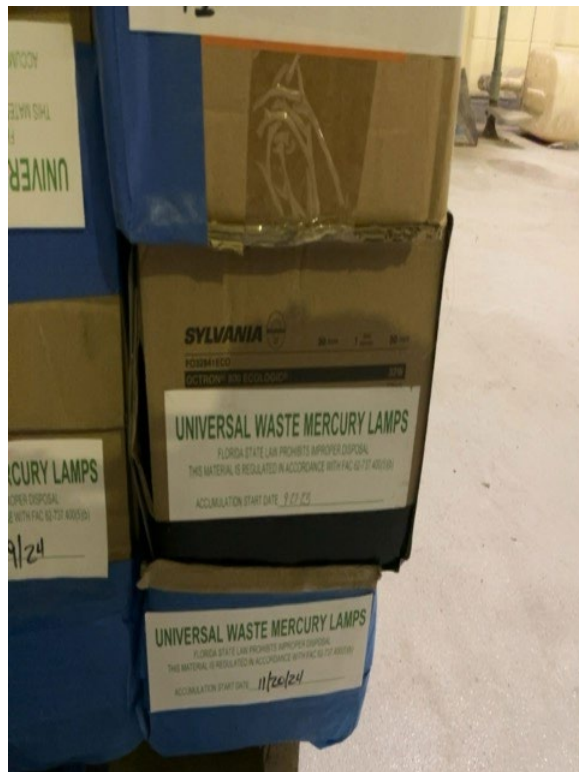
Photo 15 – Box of Universal Waste lamps that was marked with an accumulation date greater than one year from the date of the inspection.

Photo 16 - Box of Universal Waste lamps that was marked with an accumulation date greater than one year from the date of the inspection.

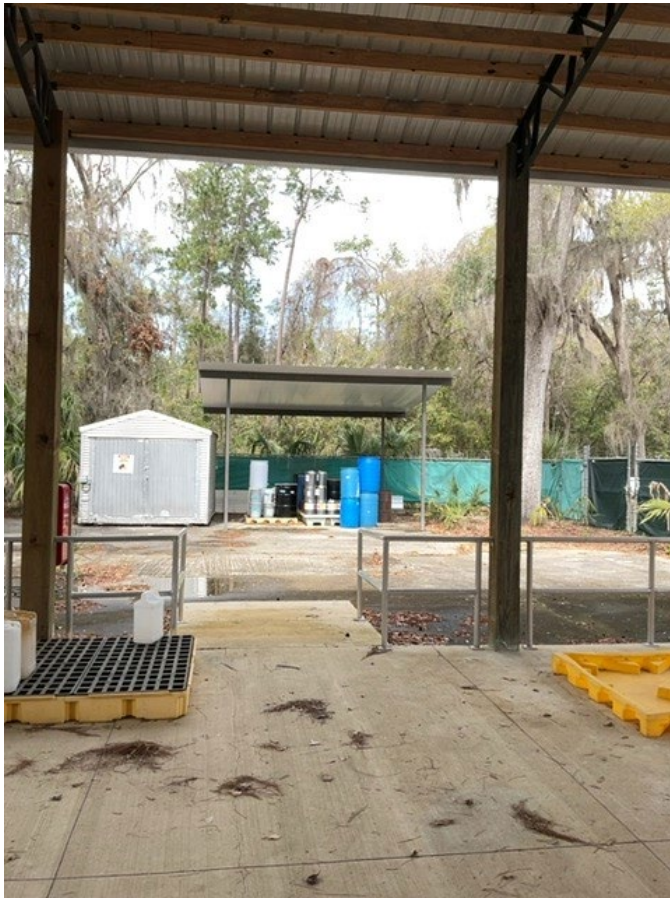
The facility's compound area was located across the parking lot from the permitted storage building (Photo 19). This area consisted of flammable cabinets and storage sheds surrounded by a chain link fence. Personnel also perform elementary neutralization on corrosive material in this area using sodium carbonate. Inspectors observed a shower and eye wash station in this area.

Photo 19 – Compound area used for elementary neutralization and used oil storage.

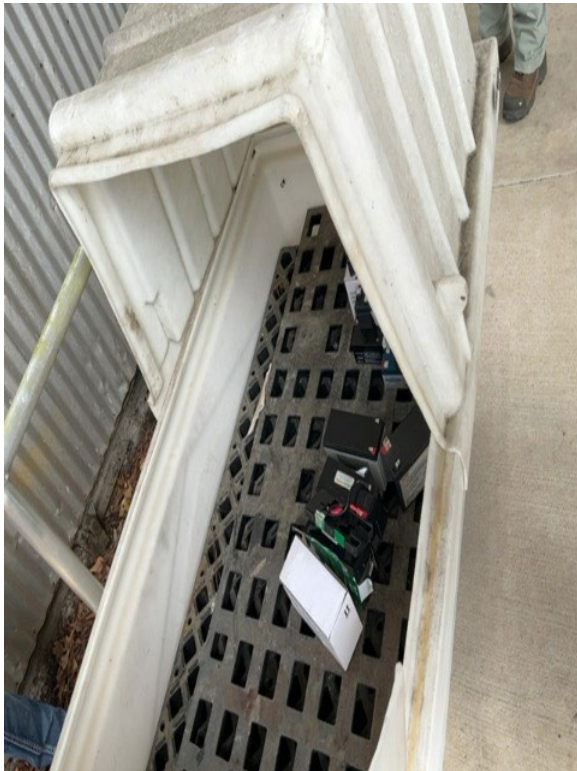
Photo 20 – Clamshell storage unit in the compound area storing a waste lead acid battery.

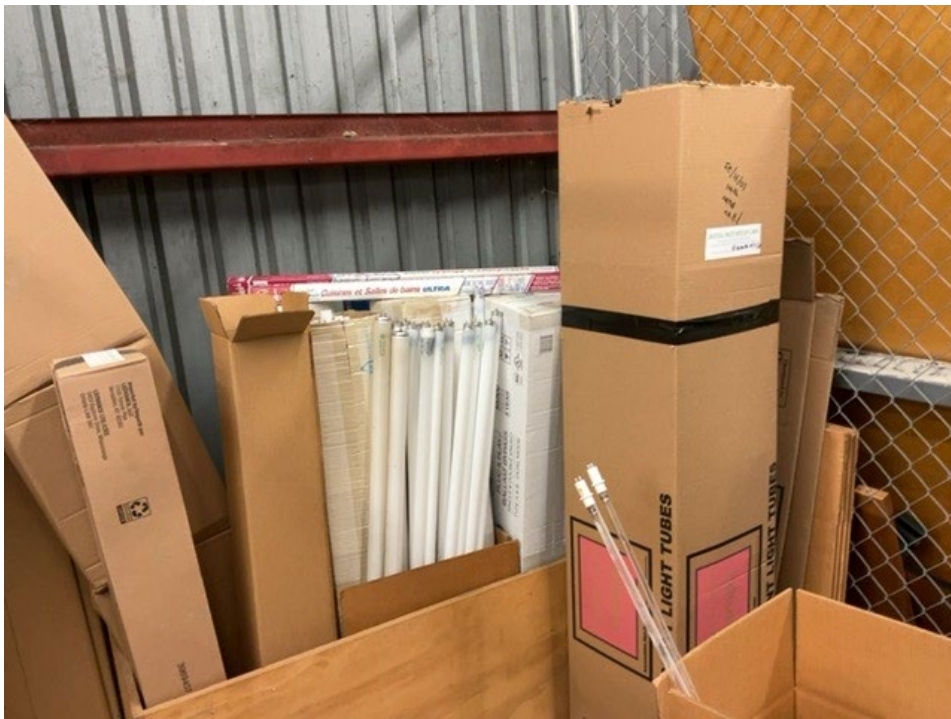
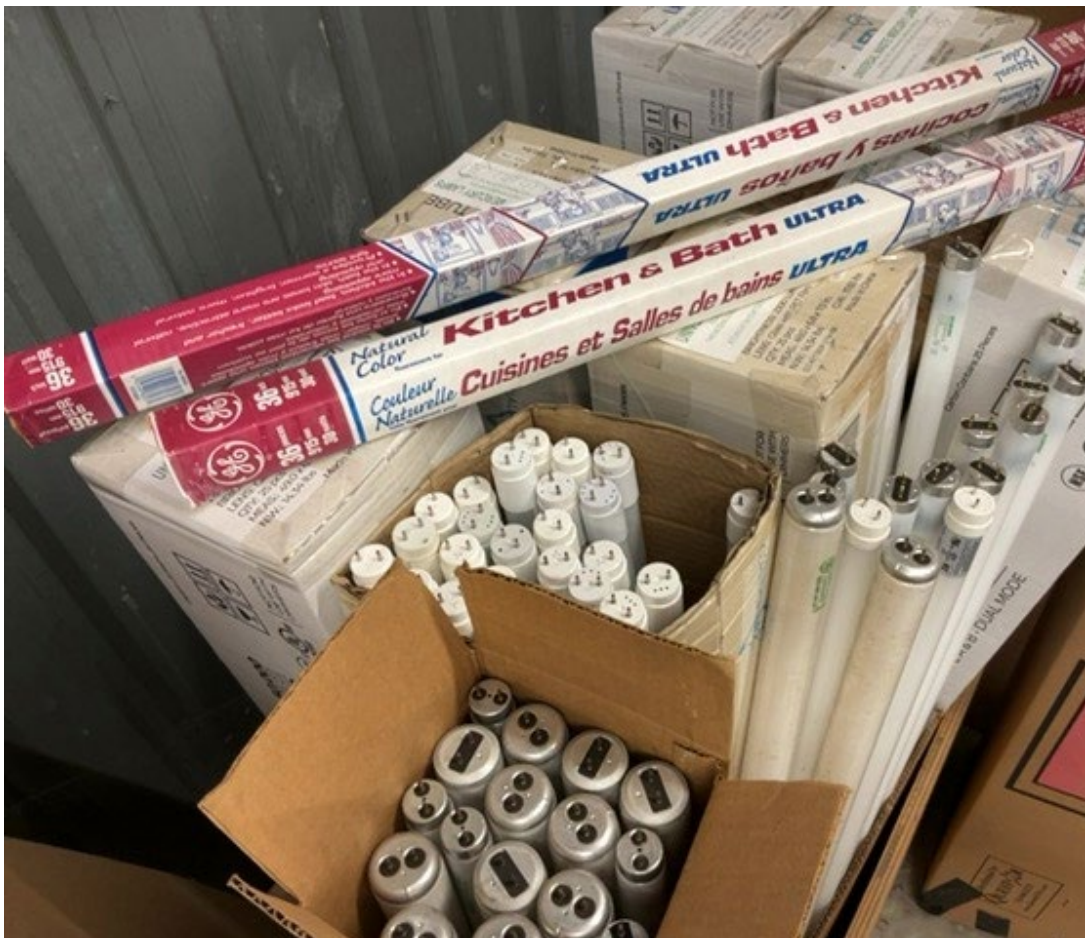
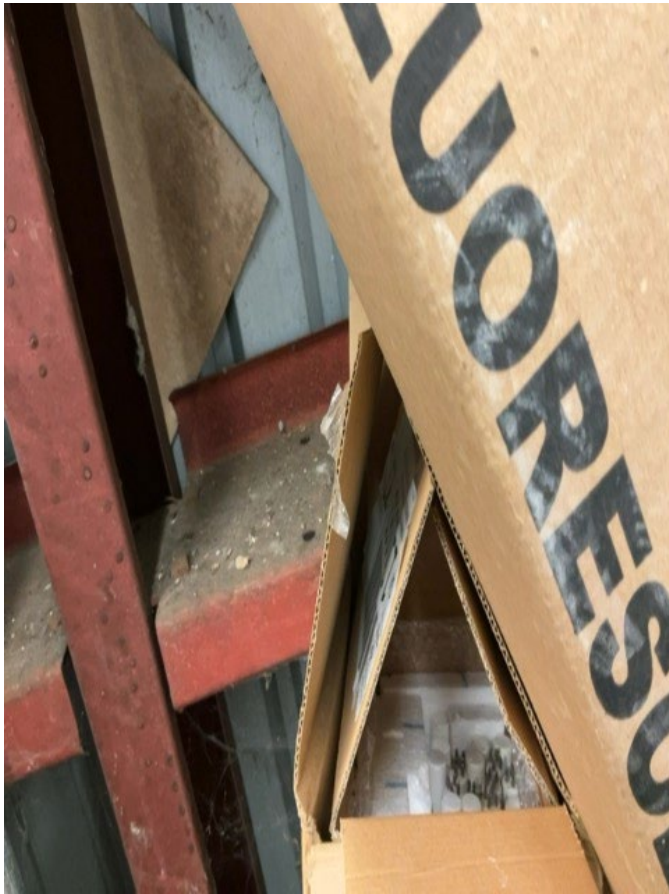
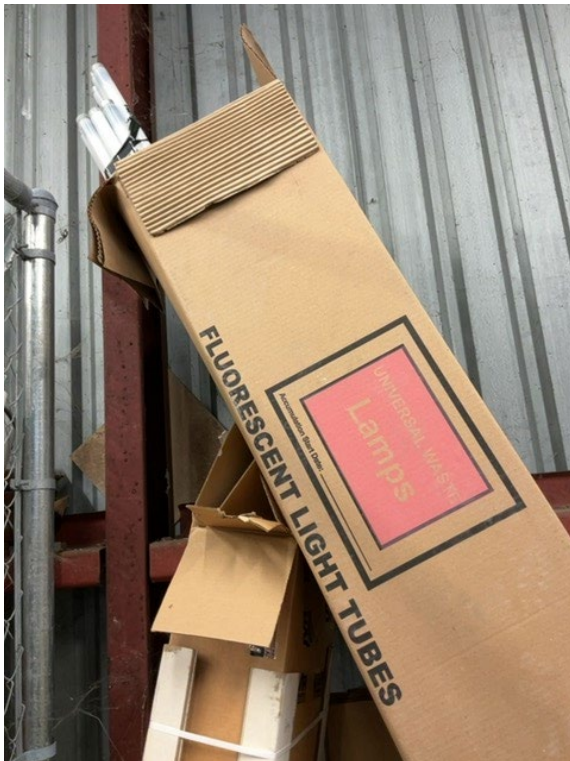
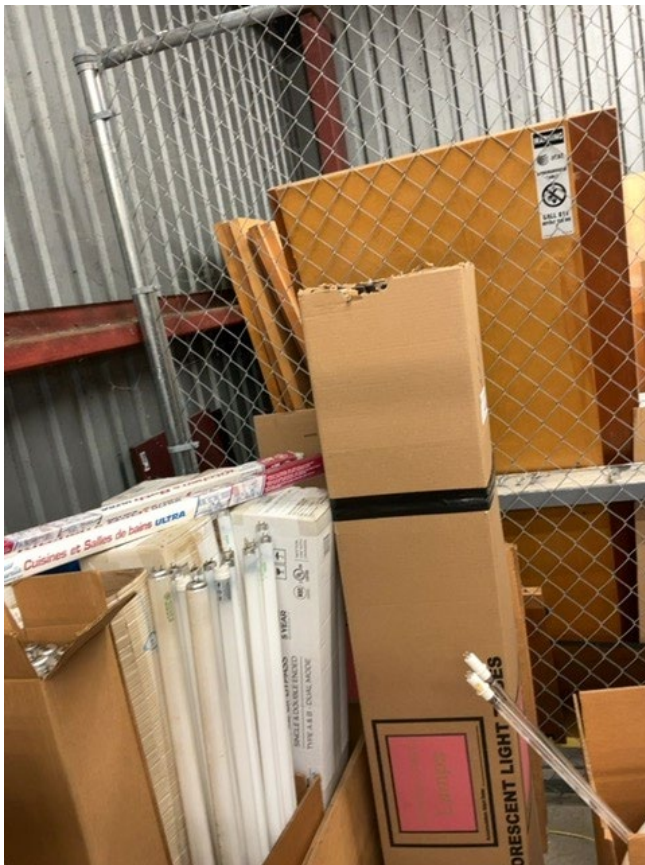
**Pursuant to Fla. Admin. Code Ann. r. 62-730.185(1) [40 C.F.R. § 273.13(d)(1)], a SQHUW must manage lamps in a way that prevents releases of any universal waste or component of a universal waste to the environment, as follows: A small quantity handler of universal waste must contain any lamp in containers or packages that are structurally sound, adequate to prevent breakage, and compatible with the contents of the lamps. Such containers and packages must remain closed and must lack evidence of leakage, spillage or damage that could cause leakage under reasonably foreseeable conditions.**

Photo 21 –  
Nine open  
universal waste  
lamp boxes in  
the IFAS  
Warehouse,  
Building 665.

Photo 22 –  
Nine open  
universal waste  
lamp boxes in  
the IFAS  
Warehouse,  
Building 665.

Photo 23 -  
Open universal  
waste lamp  
boxes in the  
IFAS  
Warehouse,  
Building 665.

Photo 24 -  
Open universal  
waste lamp  
boxes in the  
IFAS  
Warehouse,  
Building 665.

Photo 25 -  
Open universal  
waste lamp  
boxes in the  
IFAS  
Warehouse,  
Building 665

All of the universal waste observed in this area properly containerized, labeled, and shipped for disposal the following day during the CEI.

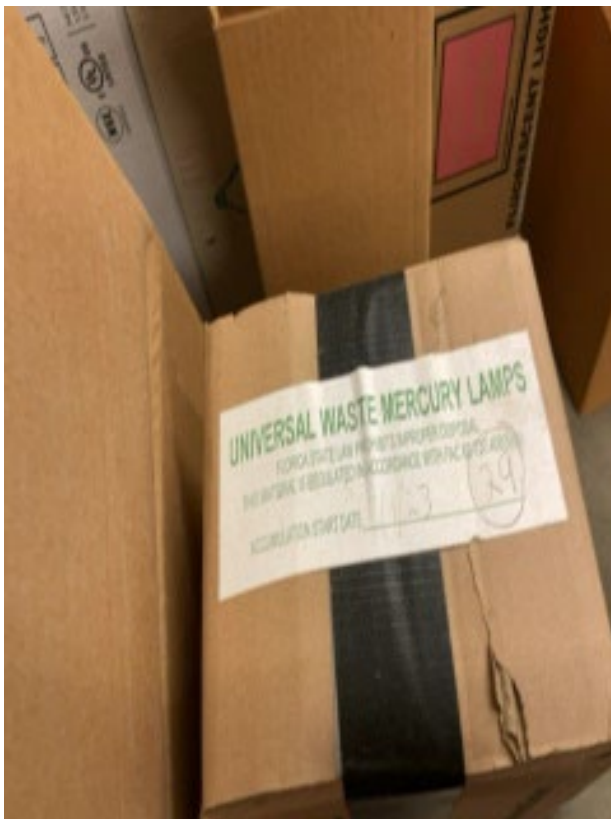
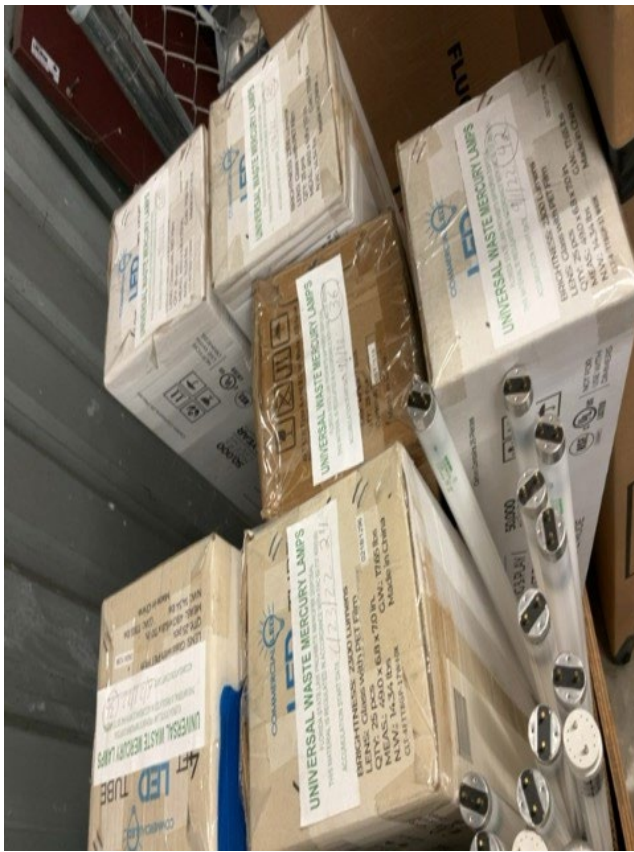
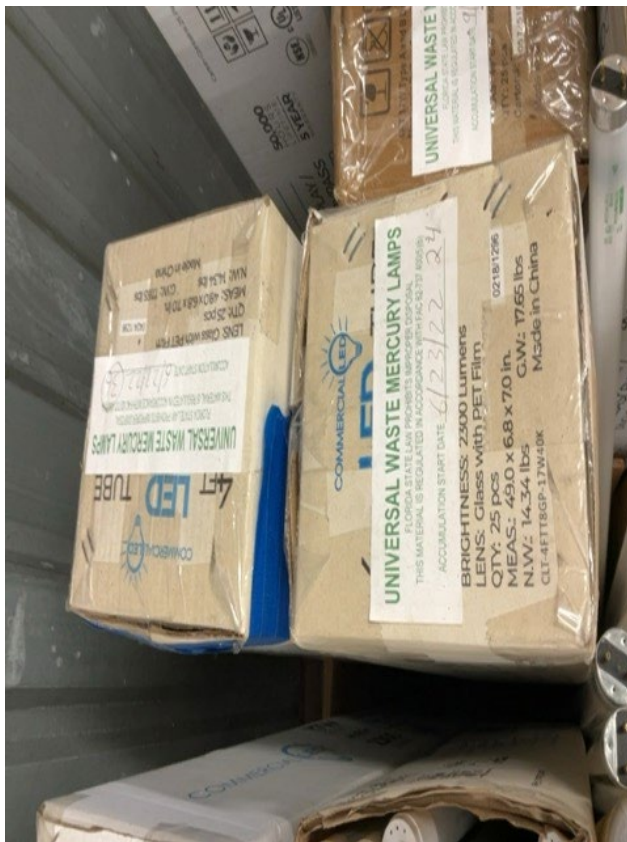
Photo 26 -  
Universal waste  
lamp box in the  
IFAS  
Warehouse  
Building 665  
marked with an  
accumulation  
date greater  
than one year  
from the date  
of the CEI.

Photo 27 - Universal waste lamp boxes in the IFAS Warehouse Building 665 marked with an accumulation date greater than one year from the date of the CEI

Photo 28 - Universal waste lamp boxes in the IFAS Warehouse, Building 665 marked with an accumulation date greater than one year from the date of the CEI.

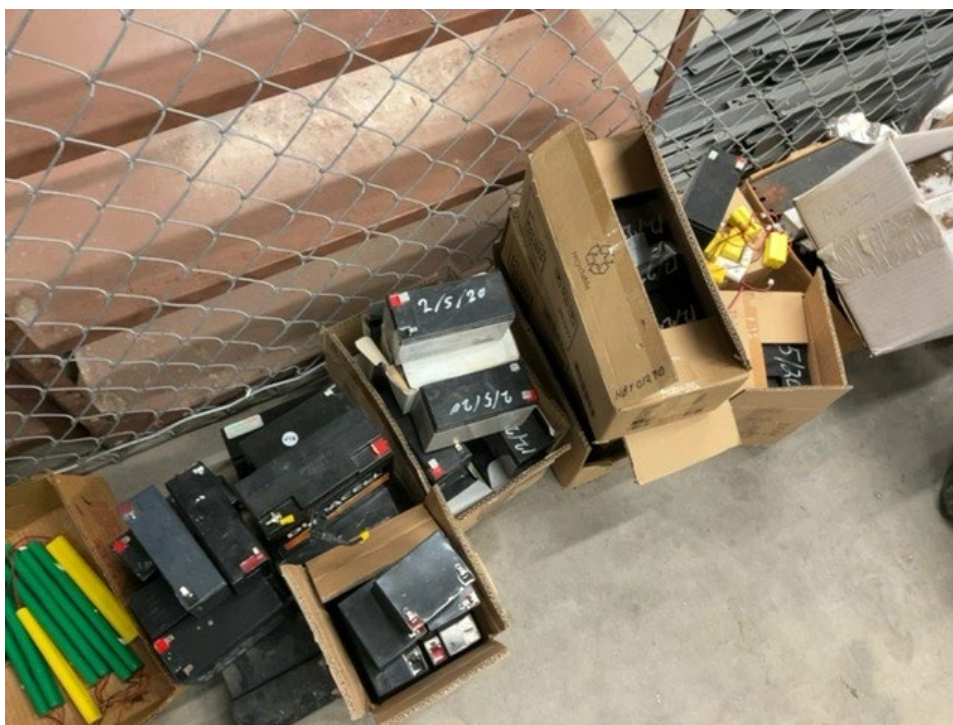
Only one of the boxes was properly marked with the words “universal waste batteries,” and the other 12 were not labeled. All 13 boxes of batteries were missing an accumulation date.

Photo 30 – 13 boxes of universal waste batteries not properly labeled or marked with an accumulation date.

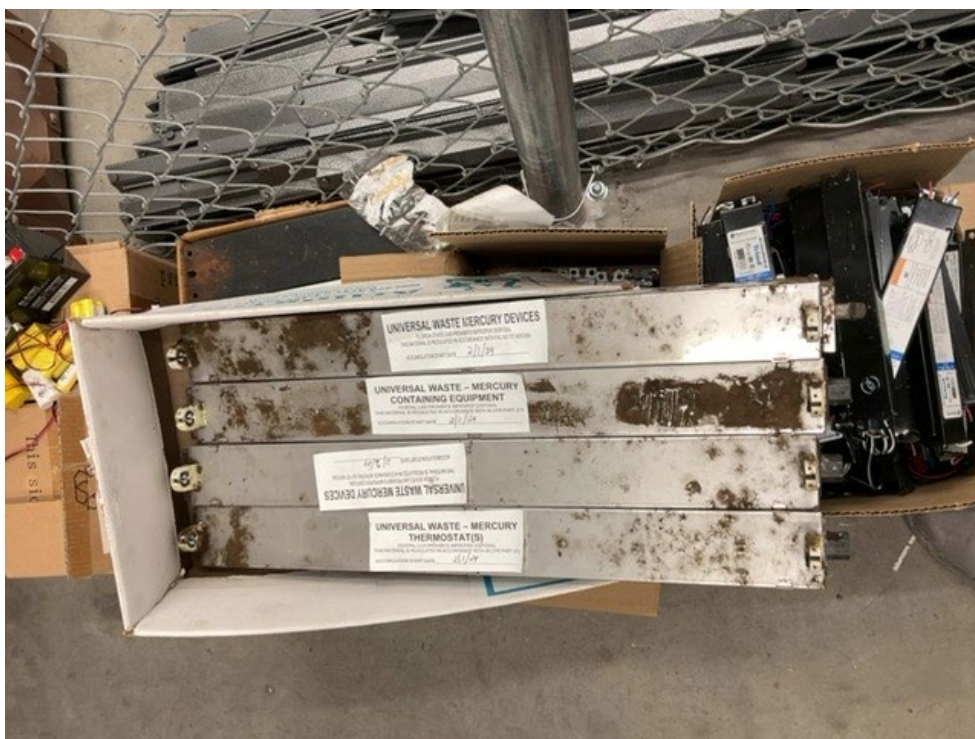
**Pursuant to Fla. Admin. Code Ann. r. 62-730.185(1) [40 CFR 273.13(c)(1)] A small quantity handler of universal waste must place in a container any universal waste mercury-containing equipment with non-contained elemental mercury or that shows evidence of leakage, spillage, or damage that could cause leakage under reasonably foreseeable conditions. The container must be closed, structurally sound, compatible with the contents of the device, must lack evidence of leakage, spillage, or damage that could cause leakage under reasonably foreseeable conditions, and must be reasonably designed to prevent the escape of mercury into the environment by volatilization or any other means.**

Photo 31 – Mercury equipment observed in the IFAS warehouse stored in open, unlabeled container.

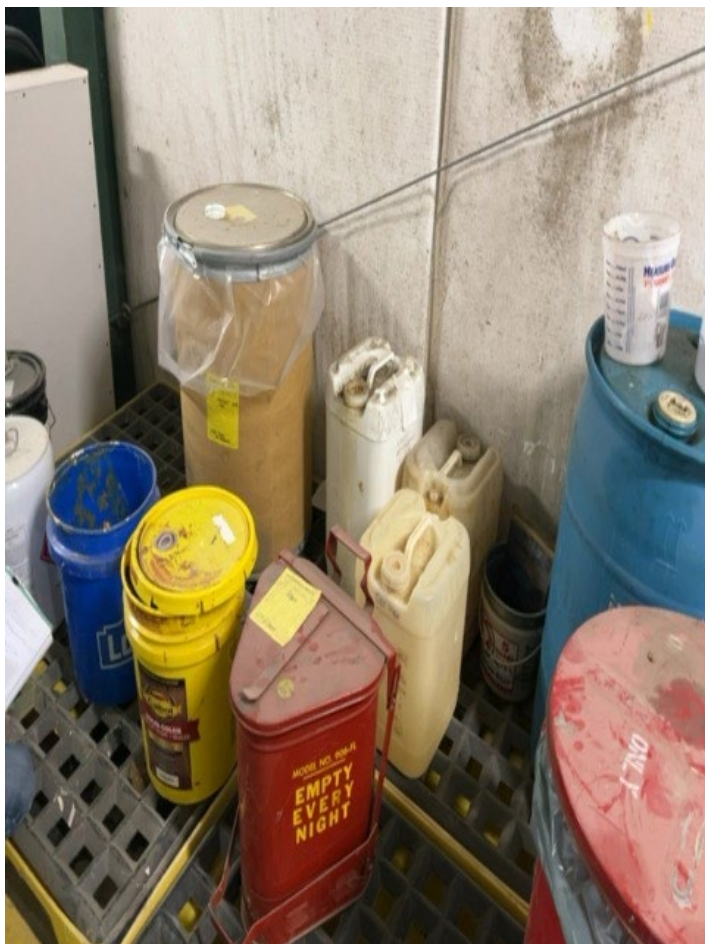
IFAS maintains a SAA in the IFAS paint shop (Photo 32.) Inspectors observed containers stored on wood pallets in the corner of the paint shop storage area. At the time of the inspection, the following containers were observed in this area:

Photo 32 – SAA in IFAS paint shop.

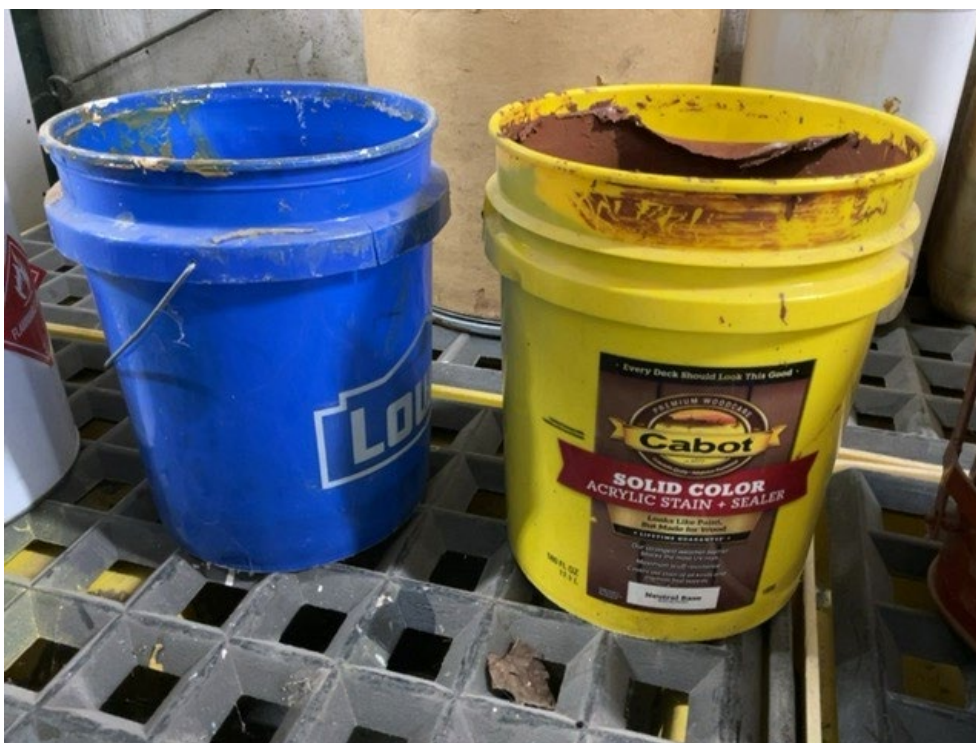
Photo 33 – Open RCRA-empty containers in the IFAS paint shop SAA.

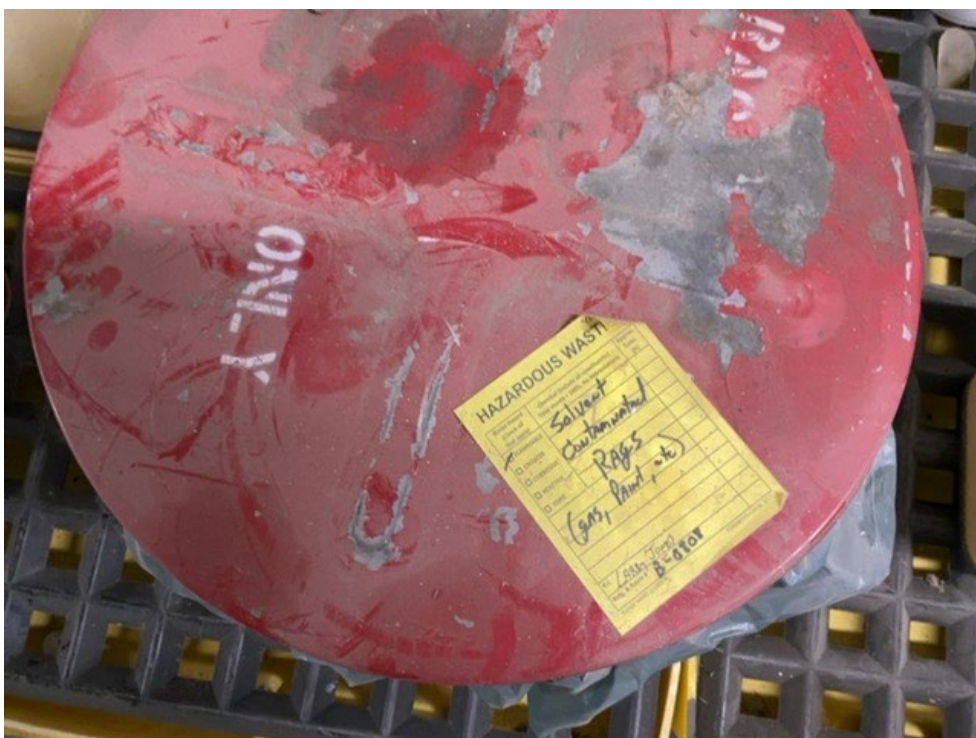
- One 7-gallon empty container labeled as contaminated solvent rags
- One open 1-gallon RCRA empty paint can. Inspectors reminded facility representatives that although the paint can was RCRA empty at the time of the inspection, a nonempty paint container should not be left open to dry out and evaporate.
- Two empty 5-gallon containers of flammable product cleaner.
- One 30-gallon SAA container storing HW aerosols. At the time of the inspection, this container held two aerosol cans and was labeled with the words “Hazardous Waste Flammable.” This container was missing a toxic indication of hazard.

**Pursuant to Fla. Admin. Code Ann. r. 62-730.160(1) [40 C.F.R. § 262.15(a)(5)(ii)], which is a condition of the SAA Permit Exemption, a generator is required to mark or label its containers (ii) with an indication of the hazards of the contents.**

Photo 34 – Container of solvent contaminated rags missing the toxic indication of hazards.

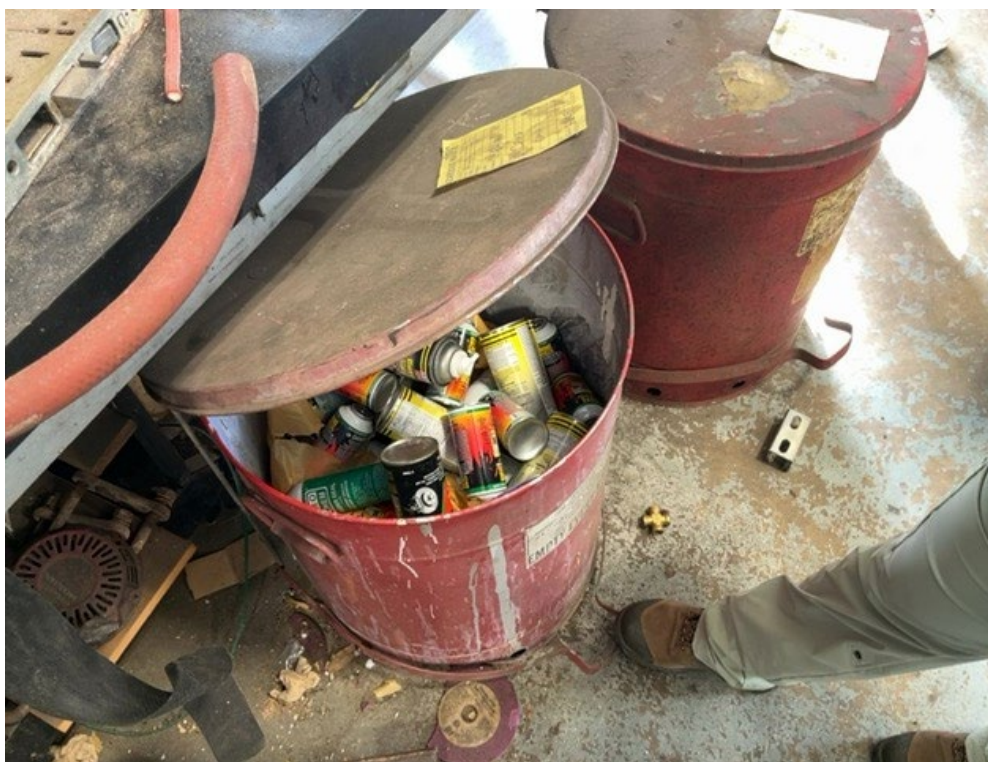
Inspectors observed a 20-gallon SAA container accumulating hazardous waste aerosol cans along the outside of the maintenance shop (Photo 36). At the time of the inspection, this container was labeled with the words “hazardous waste, flammable” but was not marked with a toxic indication of hazards.

**Pursuant to Fla. Admin. Code Ann. r. 62-730.160(1) [40 C.F.R. § 262.15(a)(5)(ii)], which is a condition of the SAA Permit Exemption, a generator is required to mark or label its containers (ii) with an indication of the hazards of the contents.**

Photo 36 – Aerosol waste container observed outside of the IFAS maintenance shop. This container was missing a toxic indication of hazard.

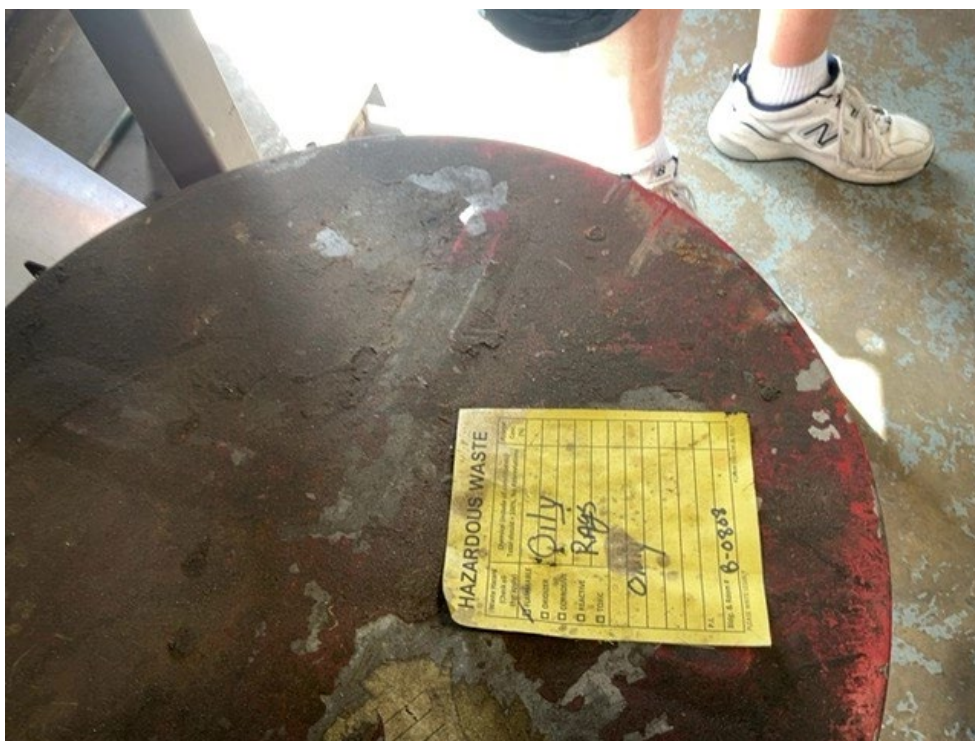
Inspectors also observed a satellite accumulation container for oily rags in the maintenance shop (Photo 37). Mac’s 4800 Break Cleaner and GRO contact cleaner is used with rags in this area. The oily rags container was marked with a flammable hazardous waste label. Inspectors requested an SDS of the contact cleaner and brake cleaner in the records review which demonstrated that Rags used with Mac’s 4800 Brake Cleaner generate an F005 hazardous waste when disposed of. The container of rags was missing a toxic indication of hazard at the time of the inspection.

**Pursuant to Fla. Admin. Code Ann. r. 62-730.160(1) [40 C.F.R. § 262.15(a)(5)(ii)], which is a condition of the SAA Permit Exemption, a generator is required to mark or label its containers (ii) with an indication of the hazards of the contents.**

Photo 37 – Oily rags container observed in the IFAS maintenance shop missing a toxic indication of hazard.

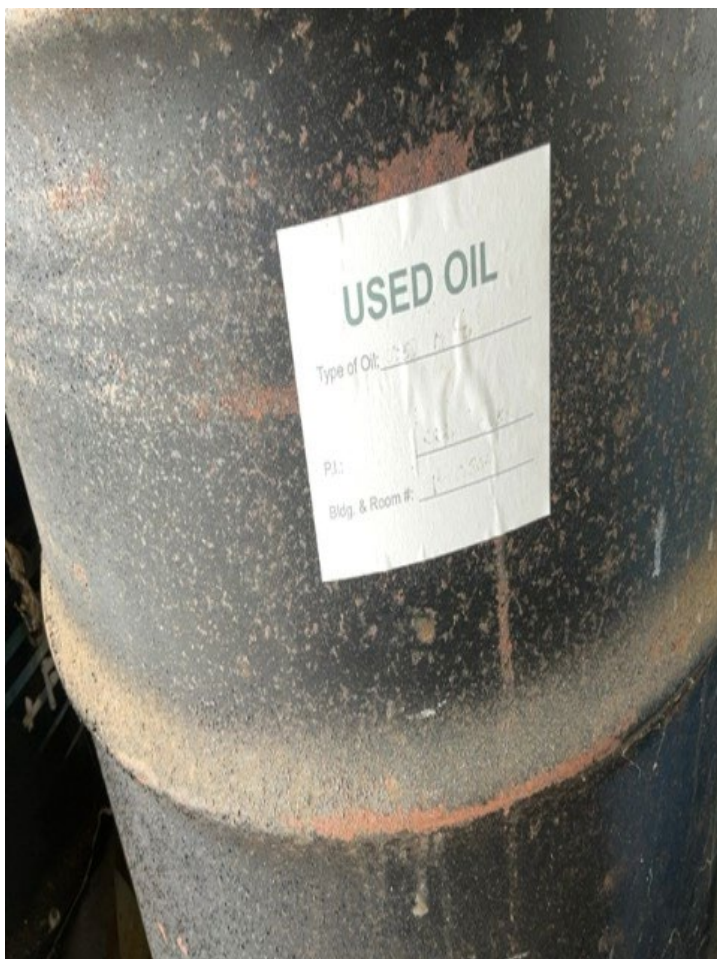
Photo 38 – Faded used oil filter label on container in the IFAS maintenance shop.

Photo 39 –  
Corrected used  
oil filter label  
on container in  
the IFAS  
maintenance  
shop.

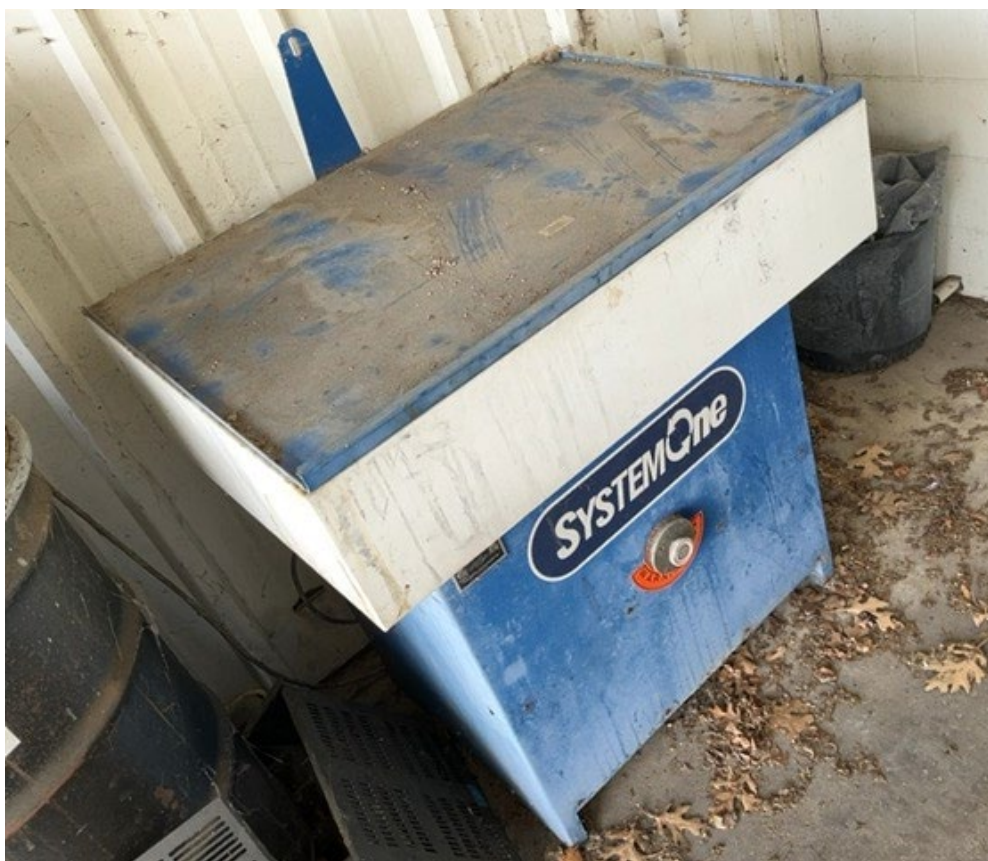
Photo 40 –  
unused Parts  
Washer in  
maintenance  
shop that  
contained  
liquid sat the  
time of the  
inspection.
