## **RCRA Inspection Report**

University of Florida  
3076 Longleaf Road Gainesville, Florida  
32611

EPA ID#: FLD000823393  
NAICS #: 611310 - Colleges, Universities, and  
Professional Schools

9:15 AM March 5, 2025, and 9:00 AM March 6, 2025

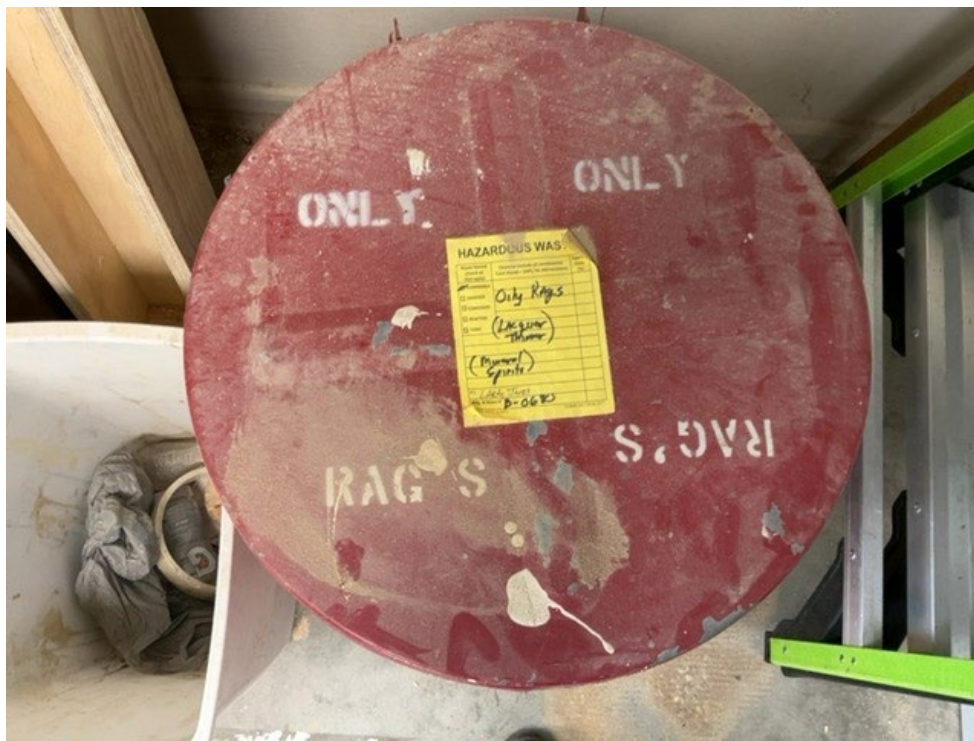
container accumulating oily rags in the carpentry shop was marked with as flammable but was missing a toxic hazard indication.

Photo 41 – Oily rags container observed in IFAS carpentry shop. This container was missing a toxic indication of hazard.

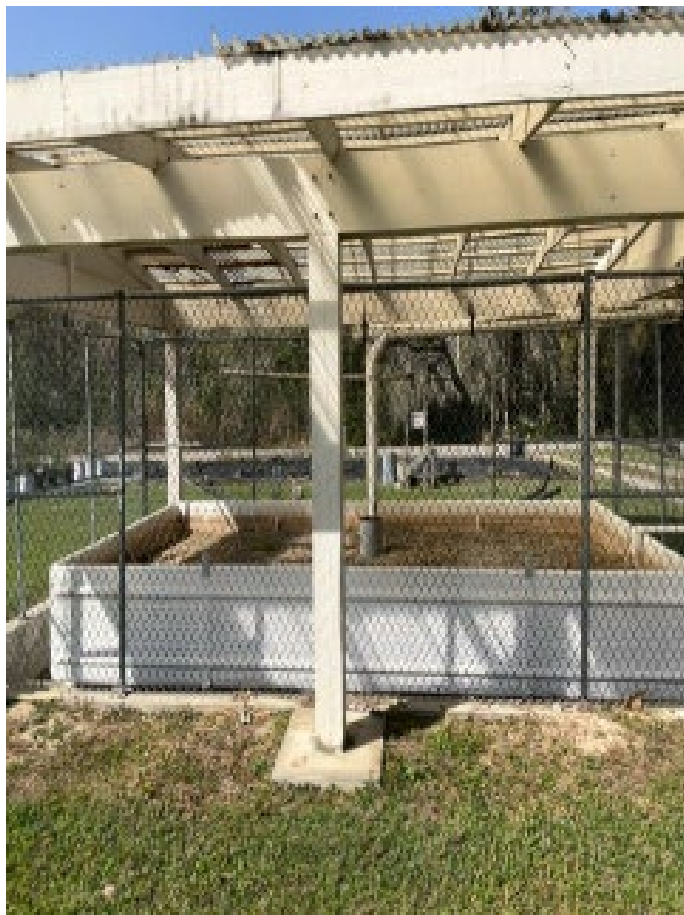
Photo 42 – IFAS Pesticide degradation pit

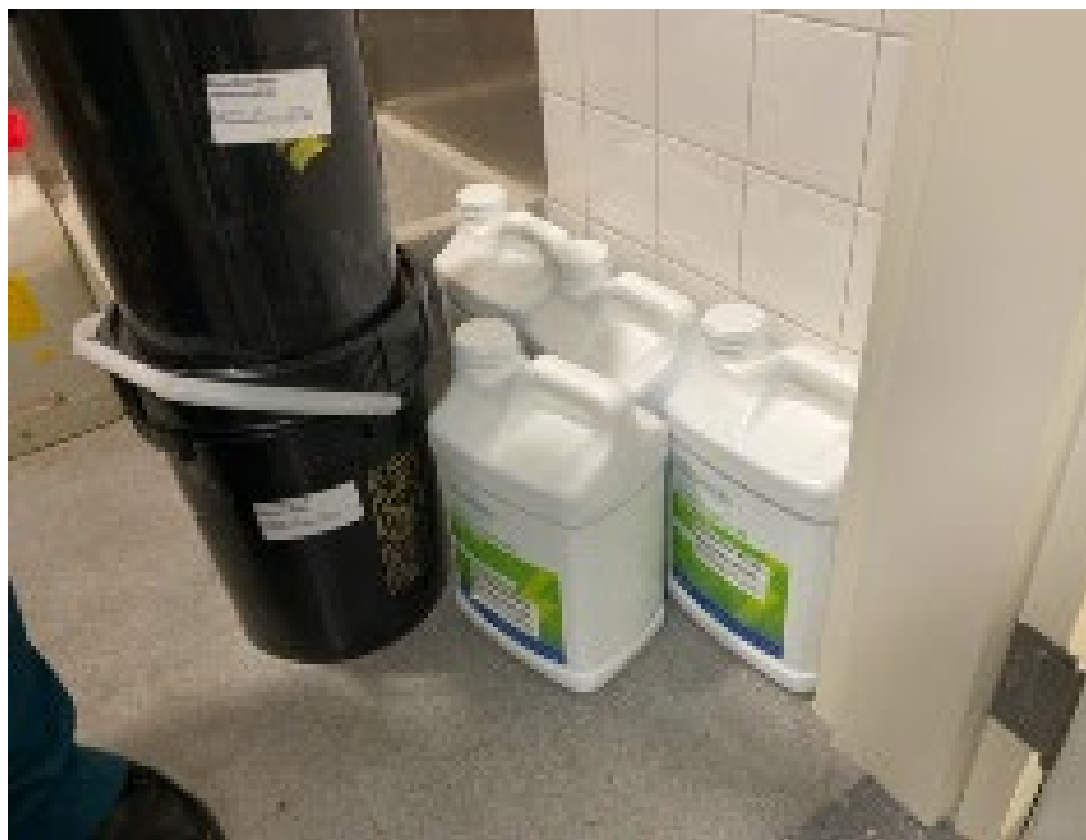
Photo 44 – Hazardous waste containers observed in the Vet Sciences Pharmacy

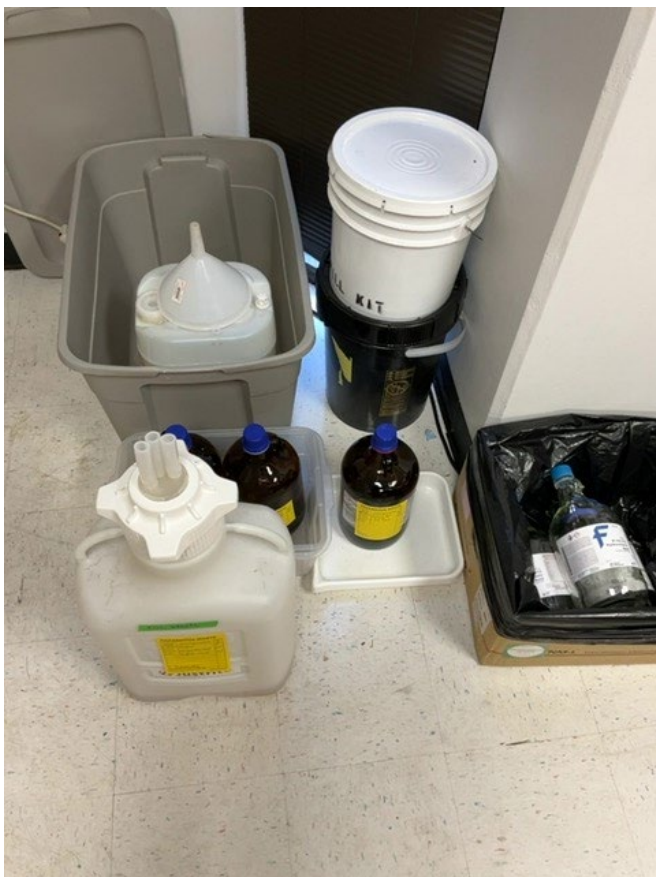
Photo 51 –  
Biology  
building, Carr  
Hall Room 518  
Lab SAA

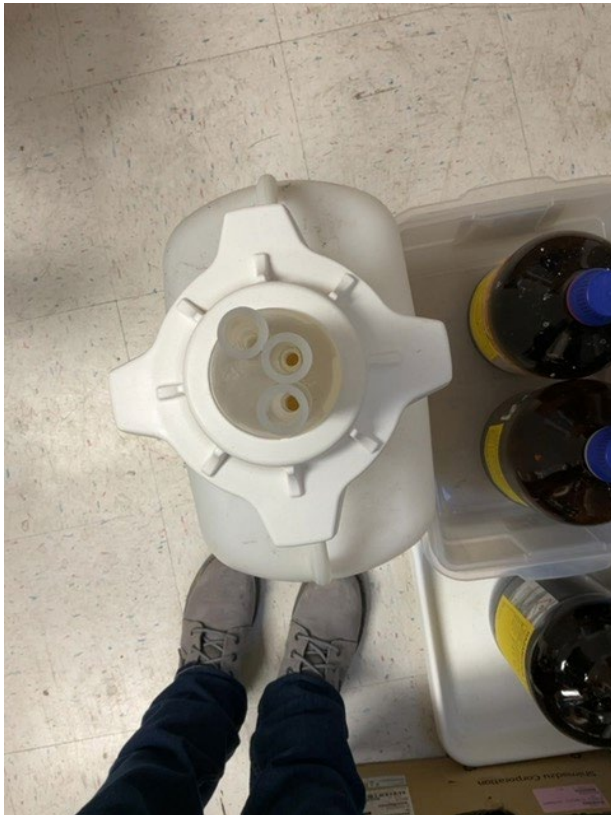
Photo 52 –  
Open  
container in  
biology lab SAA

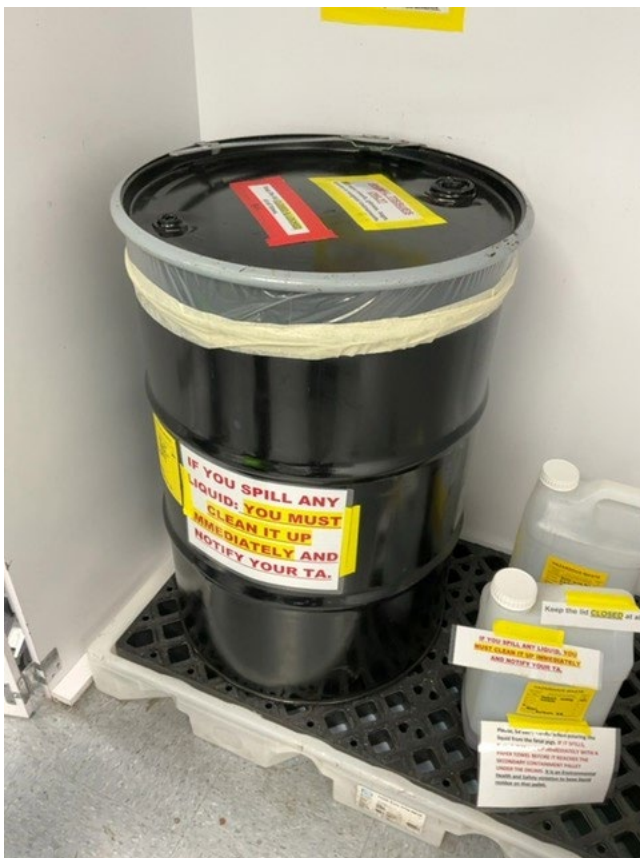
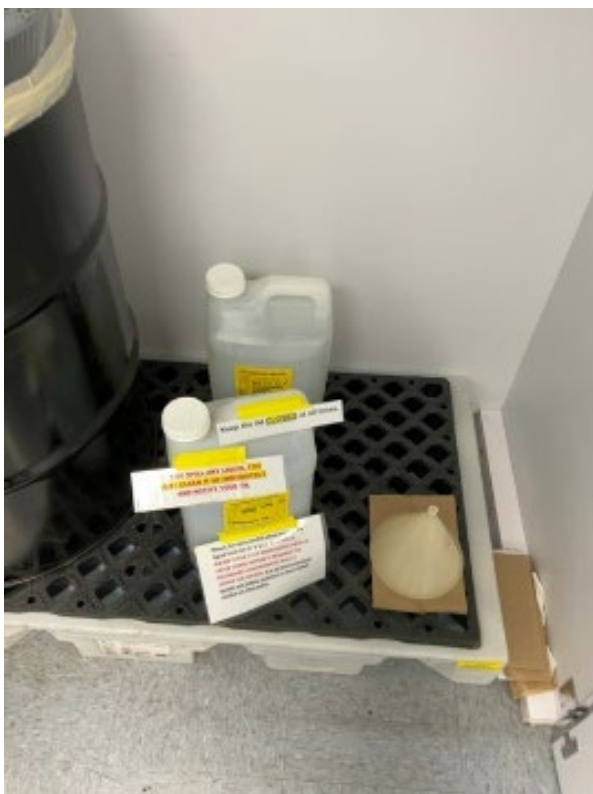
Photo 55 – SAA  
in Teaching Lab  
– Room 011.

Photo 56 - SAA  
in Teaching Lab  
– Room 011.
