## **RCRA Inspection Report**

Invincible Boat Company  
4705 N.W. 132<sup>nd</sup> Street  
Opa Locka, Florida 33054

February 6, 2025, at 9:45 A.M.

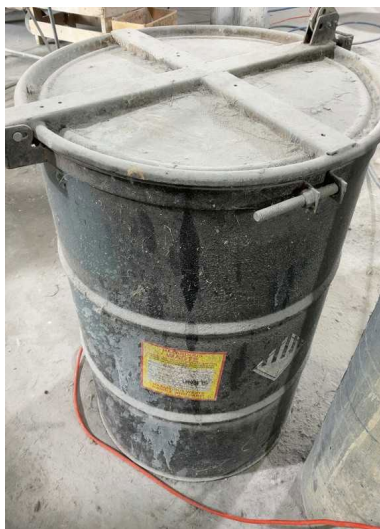
| Photo 01 | | | IMG-2025020611131713173920585.jpg |

- One 55-gallon container of used solvent-contaminated wipes in a designated satellite accumulation area (SAA). The container was closed and labeled as "Hazardous Waste", missing an indication of the hazard, and marked with a Class 9 DOT placard. Because the Class 9 DOT placard does not indicate any specific hazard associated with the waste, the EPA has determined that it is not appropriate to meet the RCRA indication of hazards labeling standard ([Frequent Questions About Implementing the Hazardous Waste Generator Improvements Final Rule | US EPA](#)).

| 55-gallon container of used solvent-contaminated wipes in a designated satellite accumulation area (SAA). The container was closed and labeled as "Hazardous Waste", missing an indication of the hazard, and marked with a Class 9 DOT placard. | | | |

**Pursuant to Fla. Admin. Code Ann. r. 62-730.160(1) [40 C.F.R. § 262.15(a)(5)(ii)], a generator must mark or label its container with the following: (ii) An indication of the hazards of the contents (examples include, but are not limited to, the applicable hazardous waste characteristic(s) (i.e., ignitable, corrosive, reactive, toxic); hazard communication consistent with the Department of Transportation requirements at 49 CFR part 172 subpart E (labeling) or subpart F (placarding); a hazard statement or pictogram consistent with the Occupational Safety and Health Administration Hazard Communication Standard at 29 CFR 1910.1200; or a chemical hazard label consistent with the National Fire Protection Association code 704).**

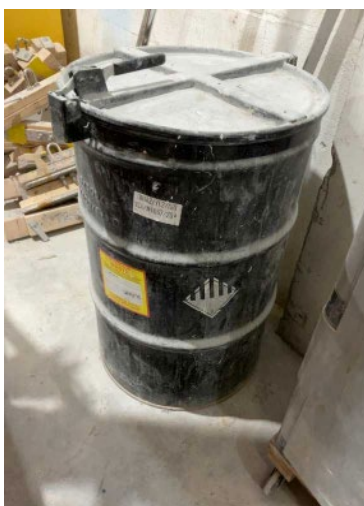
| Photo 02 | | | IMG-2025020611303630362112975.jpg |

- Two 55-gallon containers of used solvent-contaminated wipes in separate designated SAAs. The containers were closed and labeled as "Hazardous Waste", missing an indication of the hazard, and marked with a Class 9 DOT placard. Because the Class 9 DOT placard does not indicate any specific hazard associated with the waste, the EPA

has determined that it is not appropriate to meet the RCRA indication of hazards labeling standard ([Frequent Questions About Implementing the Hazardous Waste Generator Improvements Final Rule | US EPA](#)).

| One of two 55-gallon containers of used solvent-contaminated wipes in separate designated SAAs. The containers were closed and labeled as "Hazardous Waste", missing an indication of the hazard, and marked with a Class 9 DOT placard. | | | |

**Pursuant to Fla. Admin. Code Ann. r. 62-730.160(1) [40 C.F.R. § 262.15(a)(5)(i)(ii)], a generator must mark or label its container with the following: (i) The words “Hazardous Waste” and (ii) An indication of the hazards of the contents (examples include, but are not limited to, the applicable hazardous waste characteristic(s) (i.e., ignitable, corrosive, reactive, toxic); hazard communication consistent with the Department of Transportation requirements at 49 CFR part 172 subpart E (labeling) or subpart F (placarding); a hazard statement or pictogram consistent with the Occupational Safety and Health Administration Hazard Communication Standard at 29 CFR 1910.1200; or a chemical hazard label consistent with the National Fire Protection Association code 704).**

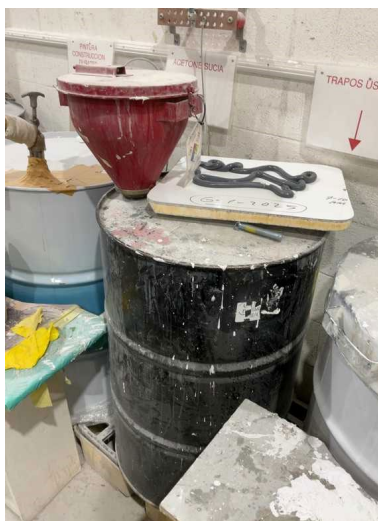
| Photo 03 | | | IMG-2025020611352835282620089.jpg |

- One 55-gallon container of waste acetone in a designated SAA. The container was closed, marked with an indication of the hazard of the contents, but missing a hazardous waste label.
- One 55-gallon container of used solvent-contaminated wipes in a designated SAA. The container was closed, marked with an indication of the hazard of the contents, but did not have a hazardous waste label.

| 55-gallon container of used acetone in a designated SAA. The container was closed, marked with an indication of the hazard of the contents, but missing a hazardous waste label. | | | |

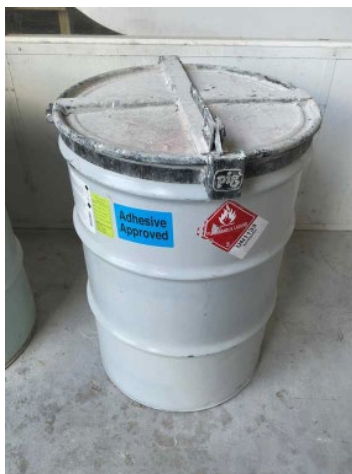
| Photo 04 | | | IMG-2025020611413741372433106.jpg |

| 55-gallon container of used solvent-contaminated wipes in a designated SAA. The container was closed, marked with an indication of the hazard of the contents, but did not have a hazardous waste label. | | | |

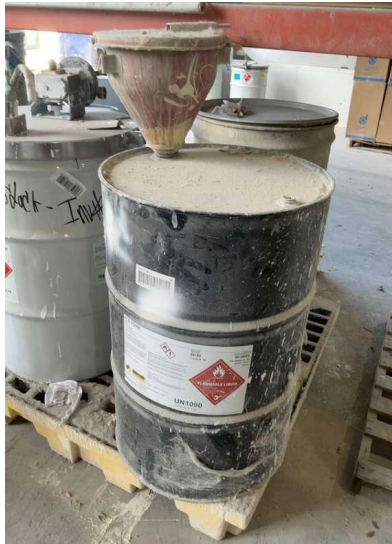
| Photo 05 | | | IMG-202502061140014012794633.jpg |

- One 55-gallon container of waste acetone. The container was closed and was marked with an indication of the hazard of the contents, but did not have a hazardous waste label or a start accumulation date.

| 55-gallon container of used acetone. The container was closed and was marked with an indication of the hazard of the contents, but did not have a hazardous waste label or a start accumulation date. | | | |

**Pursuant to Fla. Admin. Code Ann. r. 62-730.160(1) [40 C.F.R. § 262.17(a)(5)(i)(A)(C)], A large quantity generator must mark or label its containers with the following: (A) The words “Hazardous Waste”; (C) The date upon which each period of accumulation begins clearly visible for inspection on each container.**

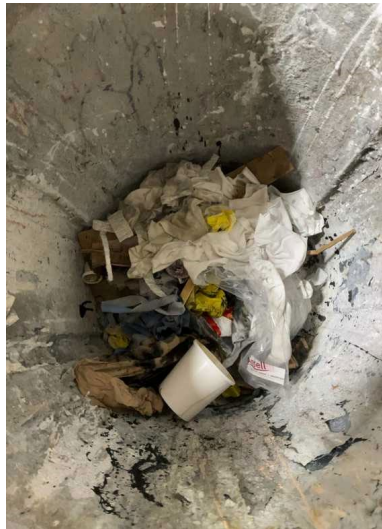
| Photo 06 | | | IMG-202502061207577572346441.jpg |

- One 33-gallon waste receptacle which had solid waste, and a red fiberglass paste material inside and another 33-gallon waste receptacle with solid waste and a blue liquid (Photos 06-07). At the time of the inspection, facility personnel could not identify what the wastes were or what process they were generated from; however, facility personnel stated they would investigate and hold these containers for a waste determination. The containers were also going to be re-labeled “Hazardous Waste—Pending Analysis”.
- Two 55-gallon containers of used solvent-contaminated wipes in a SAA. The containers were closed, and not marked with an indication of the hazard of the contents, and did not have a hazardous waste label (Photos 08 and 09).

| 33-gallon waste receptacle with solid waste and a blue substance. | | | |

**Pursuant to Fla. Admin. Code Ann. r. 62-730.160(1) [40 C.F.R. § 262.11], a person who generates a solid waste, as defined in 40 C.F.R. § 261.2, must make an accurate determination as to whether that waste is a hazardous waste in order to ensure wastes are properly managed according to applicable RCRA regulations.**

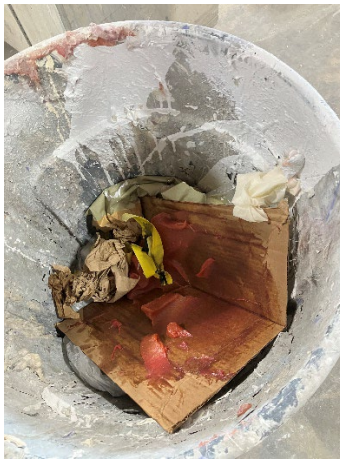
| Photo 07 - Building 05 | | | IMG_6510.jpg |

| 33-gallon waste receptacle with solid waste and a blue substance. | | | |

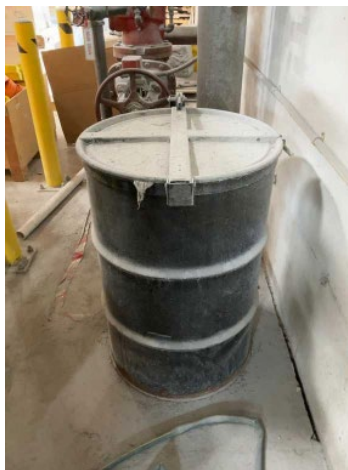
| Photo 08 | | | IMG-2025020612154515451907192.jpg |

| One of two 55-gallon containers of used solvent-contaminated wipes in a SAA. The containers were closed, and not marked with an indication of the hazard of the contents, and did not have a hazardous waste label | | | |

**Pursuant to Fla. Admin. Code Ann. r. 62-730.160(1) [40 C.F.R. § 262.15(a)(5)(i)(ii)], a generator must mark or label its container with the following: (i) The words “Hazardous Waste” and (ii) An indication of the hazards of the contents (examples include, but are not limited to, the applicable hazardous waste characteristic(s) (i.e., ignitable, corrosive, reactive, toxic); hazard communication consistent with the Department of Transportation requirements at 49 CFR part 172 subpart E (labeling) or subpart F (placarding); a hazard statement or pictogram consistent with the Occupational Safety and Health Administration Hazard Communication Standard at 29 CFR 1910.1200; or a chemical hazard label consistent with the National Fire Protection Association code 704).**

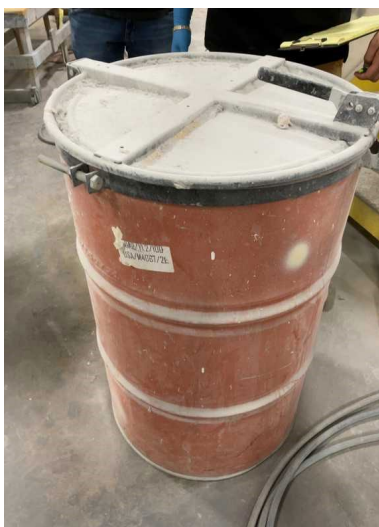
| Photo 09 | | | IMG-2025020612202920292003903.jpg |

| One of two 55-gallon containers of used solvent-contaminated wipes in a SAA. The containers were closed, and not marked with an indication of the hazard of the contents, and did not have a hazardous waste label | | | |
