## **RCRA Inspection Report**

Nouryon EPA ID# NCD0006223116  
485 Cedar Springs Road  
Salisbury, North Carolina 28147

March 4, 2021

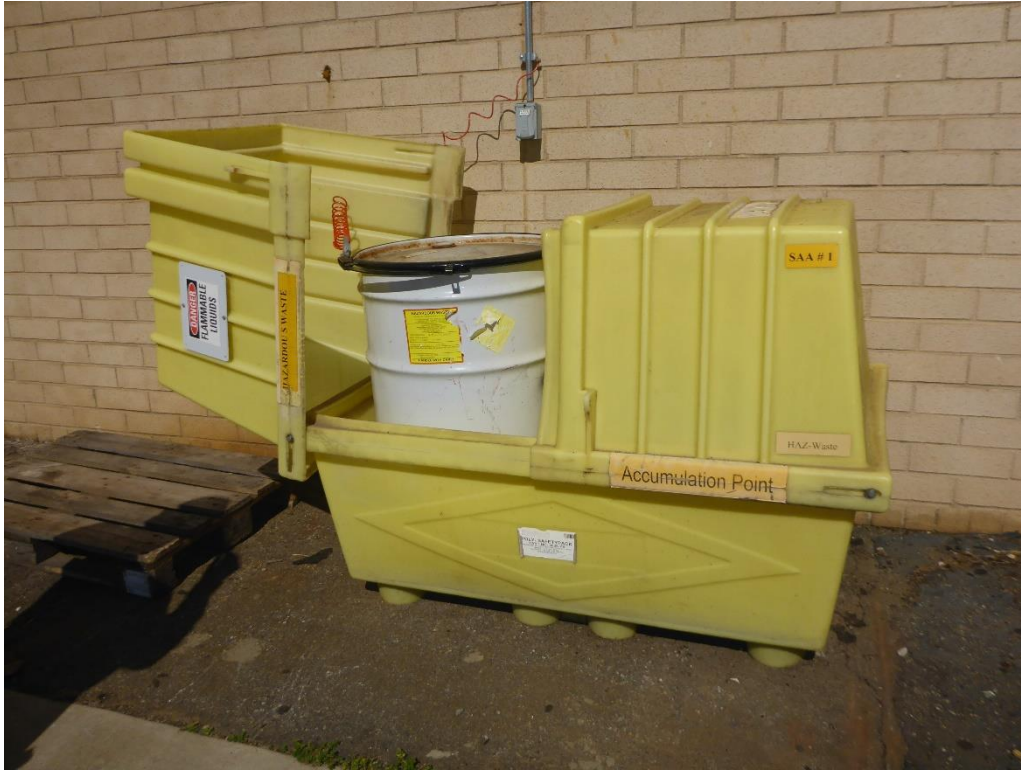
**SAA #1 - Paint Cans:** Nouryon manages a SAA just outside the Maintenance Area for managing waste paint cans that are generated in Areas 1 and 2, the Warehouse, and the Maintenance Area as D001 hazardous waste (Photo #1). The inspectors observed one 55-gallon drum inside a locked, plastic clam-shell secondary containment unit at this SAA. The clam-shell was identified as SAA #1, labeled "hazardous waste" and "danger flammable liquids." The drum was labeled hazardous waste paint cans and identified with a very faded flammable liquid DOT hazard placard. The drum lid was secured with a drum locking ring. Mr. Fleming verified that employees had replaced the faded sticker with a new flammable liquid DOT hazard placard before the end of the inspection.

**Photo 1:** One 55-gallon drum inside a locked, plastic clam-shell secondary containment unit at SAA #1, which is used to accumulate hazardous waste paint cans generated throughout the facility. The clam-shell was identified as SAA #1, labeled hazardous waste and “danger flammable liquids.” The drum was labeled hazardous waste paint cans and identified with a faded flammable liquid DOT hazard placard.

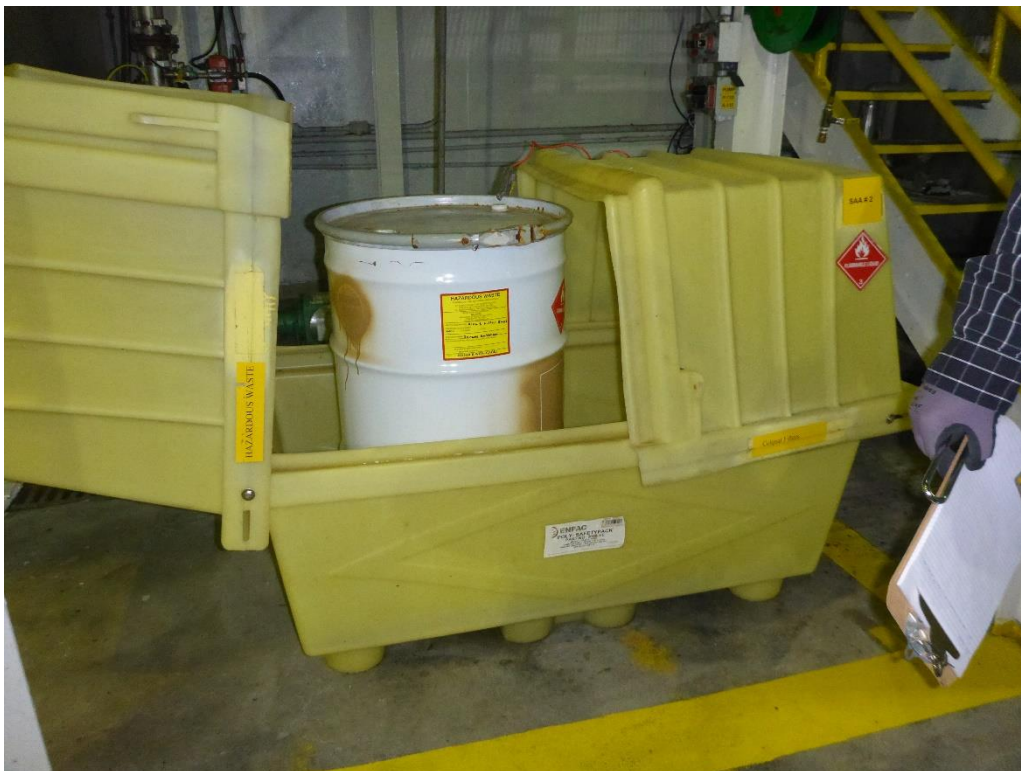
**SAA #2 – Celquat Bag Filters:** Nouryon manages a SAA in front of Tank R9 in the Area 1 Reactor Room for managing Celquat-bag filters used to collect solids from IPA solvent as D001 hazardous waste (Photo #2). The inspectors observed one 55-gallon drum inside a locked, plastic clam-shell secondary containment unit at this SAA. The clam-shell was identified as SAA #2, labeled "hazardous waste" and marked with a flammable liquid DOT hazard placard. The drum was labeled as hazardous waste flammable liquid and identified with a flammable liquid DOT hazard placard. The drum lid was secured with a drum locking ring.

**Photo 2:** One 55-gallon drum inside a locked, plastic clam-shell secondary containment unit at SAA #2, which is used to accumulate hazardous waste filters that are generated by the Celquat process. The clam-shell was identified as SAA #2, labeled hazardous waste and marked with a flammable liquid DOT hazard placard. The drum was labeled hazardous waste flammable liquid and identified with a flammable liquid DOT hazard placard.

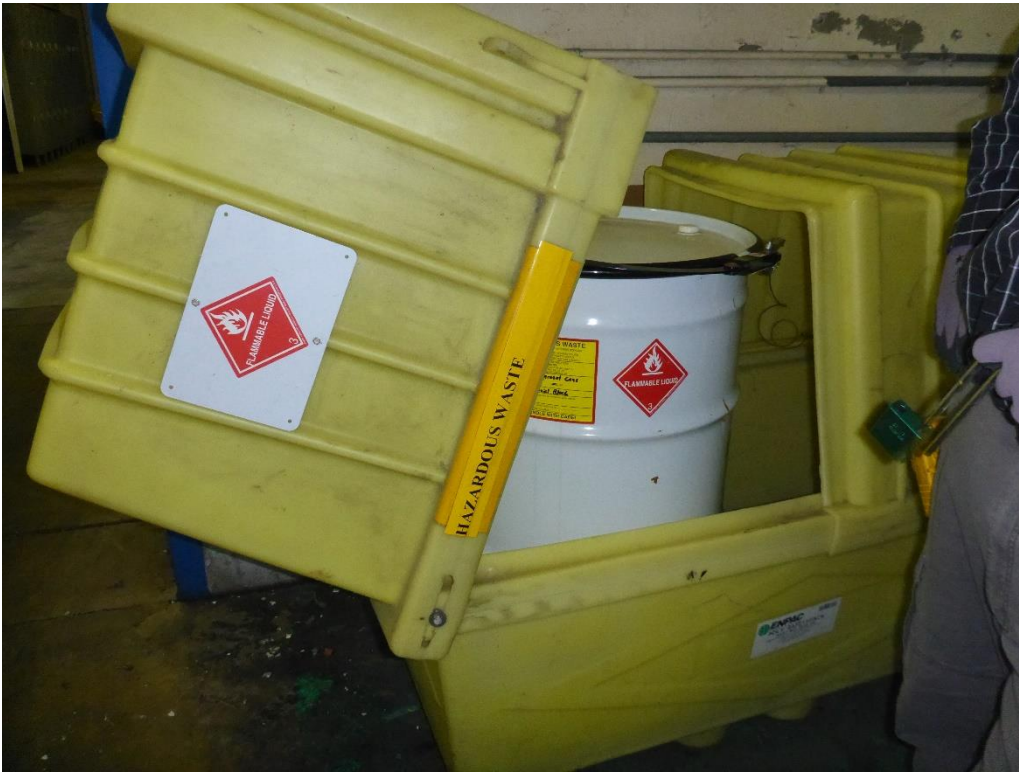
**SAA #3 – Aerosol Cans:** Nouryon manages a SAA just inside the Area 1 Tank Farm Room for managing waste aerosol cans that are generated in Areas 1 and 2, the Warehouse, and the Maintenance Area as D001 hazardous waste (Photo #3). The inspectors observed one 55-gallon drum inside a locked, plastic clam-shell secondary containment unit at this SAA. The clam-shell was identified as SAA #3, labeled "hazardous waste," and marked with a flammable liquid DOT hazard placard. The drum was labeled as hazardous waste flammable liquid and identified with a flammable liquid DOT hazard placard. The drum lid was secured with a drum locking ring.

**Photo 3:** One 55-gallon drum inside a locked, plastic clam-shell secondary containment unit at SAA #3, which is used to accumulate hazardous waste aerosol cans that are generated on this side of the facility. The clam-shell was identified as SAA #3, labeled as hazardous waste and marked with a flammable liquid DOT hazard placard. The drum was labeled hazardous waste flammable liquid and identified with a flammable liquid DOT hazard placard.

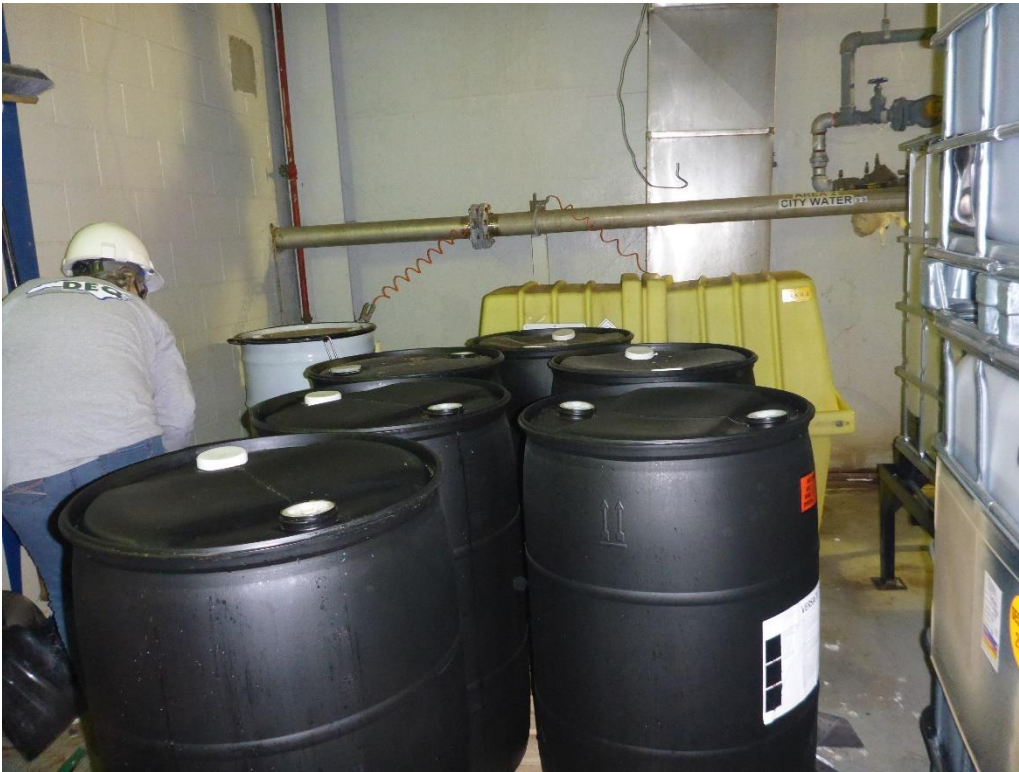
**SAA #4 and #5 - Sulfonating:** Nouryon manages two SAAs outside the OAA grinding room (inside the building near S10) (Photo #4). SAA #4 is used to manage samples from the Sulfonating process as D001 / D002 / D028 hazardous waste. The inspectors observed one 55-gallon drum and two one-gallon jugs inside a locked, plastic clam-shell secondary containment unit at this SAA (Photo #5 and #6). The clam-shell was identified as SAA #4, labeled "hazardous waste," and marked with flammable liquid, toxic and corrosive DOT hazard placards. The drum was labeled as hazardous SPS waste and identified with flammable liquid and corrosive DOT hazard placards, but it was not identified with a toxic DOT hazard placard. The two one-gallon

SAA #5 is used to manage waste filters from the IE column, S5, Storage Tank, D1, D2 and S8 in the Sulfonating Process Area as D001 / D028 hazardous waste. The inspectors observed one 55-gallon drum on a secondary containment unit at this SAA. The drum was labeled as hazardous waste SPS filter bags and products, and it was identified with flammable solid and toxic DOT hazard placards.

**Photo 4:** SAAs #4 and #5 located in the Sulfonating Production Area. The locked, plastic clam-shell secondary containment unit is SAA #4, and the secondary containment pallet next to the clam-shell is SAA #5. Nouryon accumulates hazardous waste sulfonating waste that is generated by sampling the sulfonating process in SAA #4, and accumulates hazardous waste sulfonating filters that are generated by the Sulfonating process in SAA #5. The clam-shell was identified as SAA #4, labeled hazardous waste and marked with flammable liquid, toxic and corrosive DOT hazard placards. The drum in SAA #5 was labeled hazardous waste SPS filter bags and products and identified with flammable solid and toxic DOT hazard placard.

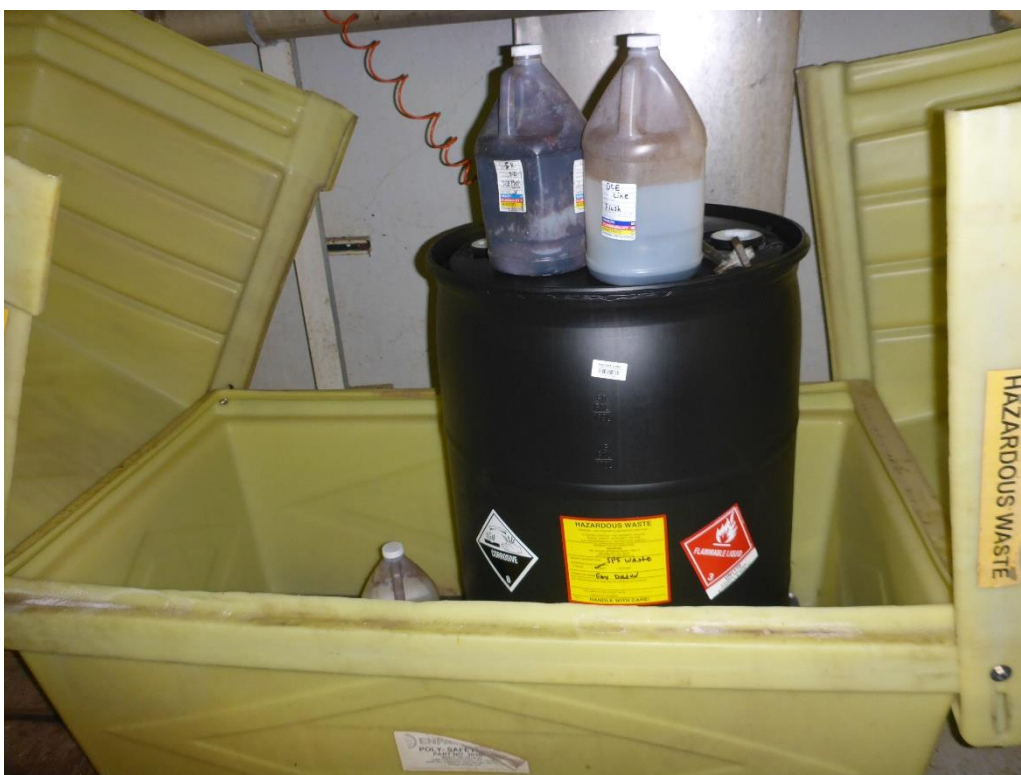
Mr. Mark S., an employee working in this area, joined the inspection participants in this area. He explained that the one-gallon jugs contained sample material from the sulfonating process. He poured liquid from the jugs into the 55-gallon drum in SAA #4. After pouring, the inspection participants observed a solidified mass of material approximately four inches thick inside one of the jugs. Mr. Fleming stated that the waste profile for SPS filter bags and waste managed in SAA #5 will be reviewed to confirm whether the solidified mass can be disposed of with that waste stream.

**Photo 5:** Two one-gallon jugs inside the locked, plastic clam-shell secondary containment unit at SAA #4. The jugs were each labeled DCE Line Flush and identified with a Hazcom label. One jug was dated 03/21/2019. The drum was labeled hazardous waste and identified with flammable liquid and corrosive DOT hazard placards, but it was not identified with a toxic DOT hazard placard.

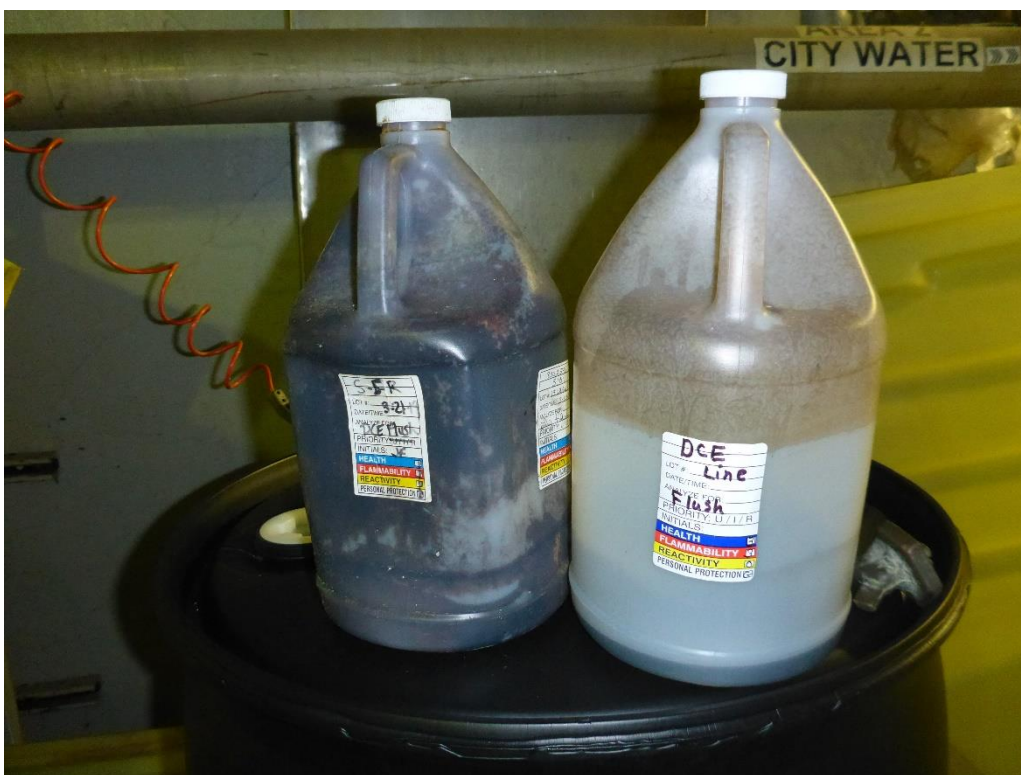
**Photo 6:** Two one-gallon jugs inside the locked, plastic clam-shell secondary containment unit at SAA #4. The jugs were each labeled DCE Line Flush and identified with a Hazcom label. One jug was dated 03/21/2019.

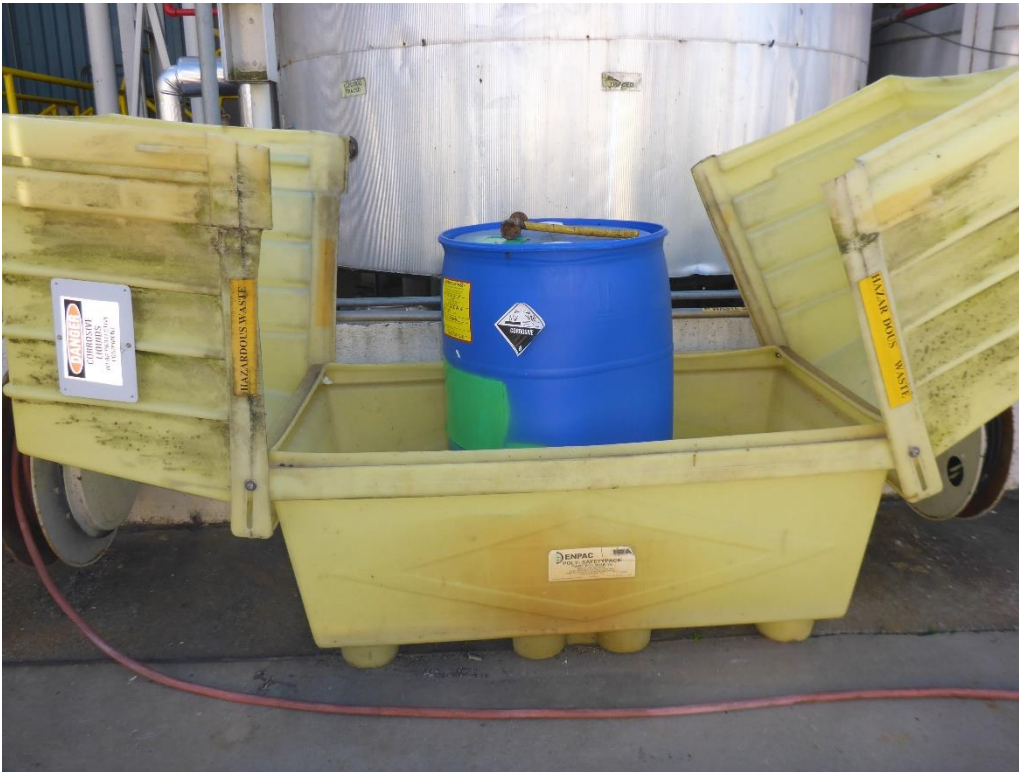
SAA #6 – Mono Ethanol Amines (MEA): Nouryon manages a SAA outside of the Area 2 Reactor Room across from the MEA storage tank for managing MEA sample waste generated in the ST 53 and MV 2 receiver areas as D002 hazardous waste (Photo #7). The inspectors observed one 55-gallon drum inside a locked, plastic clam-shell secondary containment unit at this SAA. The clam-shell was identified as SAA #6, and it was labeled “hazardous waste” and “danger corrosive liquids.” The drum was labeled as hazardous MEA waste and identified with a corrosive DOT hazard placard.

**Photo 7:** One 55-gallon drum inside a locked, plastic clam-shell secondary containment unit at SAA #6, which is used to accumulate hazardous waste MEA waste that is generated by sampling the MEA process. The clam-shell was labeled as SAA #6 and “danger corrosive liquids.” The drum was labeled hazardous waste MEA waste and identified with a corrosive DOT hazard placard.

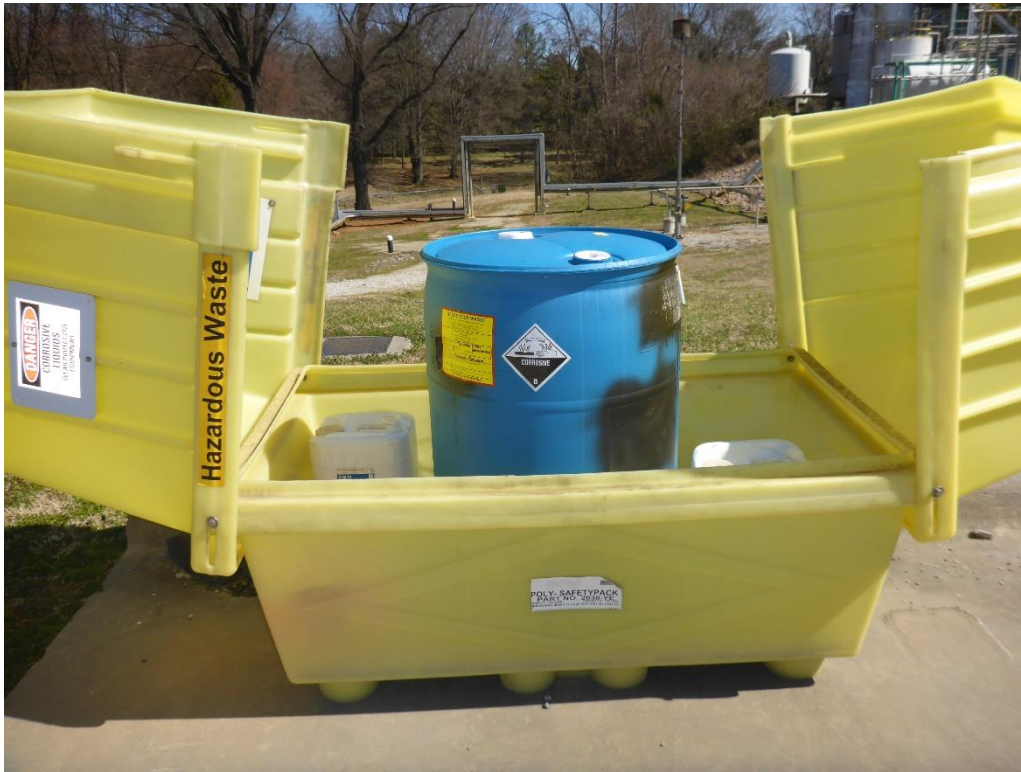
SAA #7 – MEA Flare: Nouryon manages a SAA on a concrete pad above the MEA flare for managing draining flare bottoms generated at the MEA flare as D002 hazardous waste (Photo #8). The inspectors observed one 55-gallon drum inside a locked, plastic clam-shell secondary containment unit at this SAA. The clam-shell was identified as SAA #7, and it was labeled “hazardous waste” and “danger corrosive liquids.” The drum was labeled as hazardous MEA

waste and identified with a corrosive DOT hazard placard.

**Photo 8:** One 55-gallon drum inside a locked, plastic clam-shell secondary containment unit at SAA #7, which is used to accumulate hazardous waste MEA waste that is generated by the MEA flare. The clam-shell was labeled as SAA #7 and “danger corrosive liquids.” The drum was labeled hazardous waste MEA waste and identified with a corrosive DOT hazard placard.

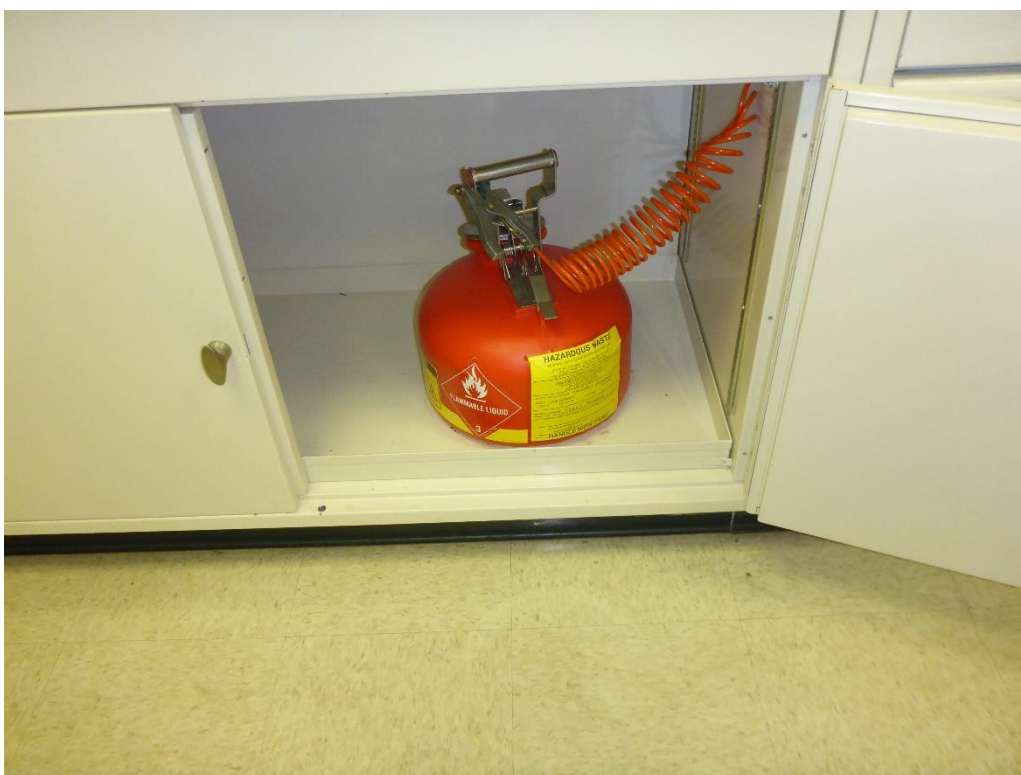
SAA #8 – Process Development (PD) Lab Waste: Nouryon manages a SAA at the PD Laboratory for managing waste from PD lab analysis and small trial batches as D001 hazardous waste (Photo #9). The inspectors observed one flammable can in this SAA. The can was located underneath a laboratory hood. It was labeled as hazardous waste and identified with a flammable liquid DOT hazard placard.

**Photo 9:** One one-gallon flammable can at SAA #8, which is used to accumulate hazardous waste flammable liquids that are generated in the PD laboratory. The can was labeled hazardous waste and identified with a flammable liquid DOT hazard placard.

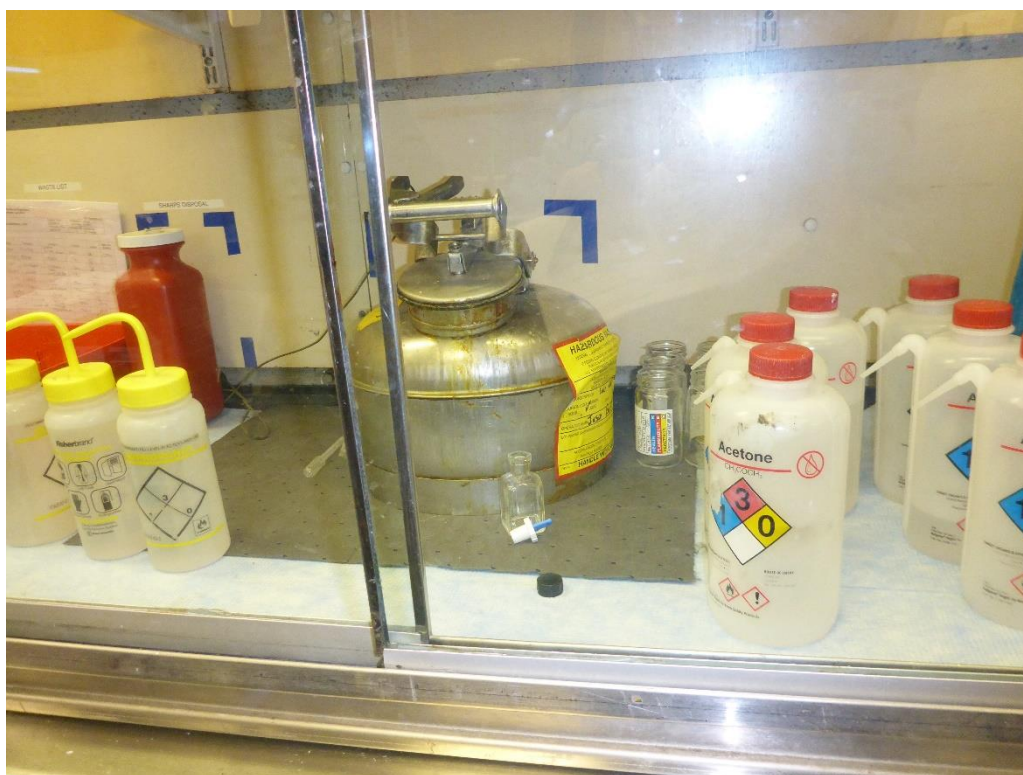
SAA #9, #10, #11 and #12 – Quality Control (QC) Lab Waste: At the time of the inspection, Nouryon was managing four SAAs in the QC Lab. SAA #9 was used to manage waste generated during laboratory analyses as D001 hazardous waste (Photo #10). The inspectors observed one two-gallon container in this SAA. The container was located under a laboratory hood. It was labeled hazardous waste lab waste and identified with a flammable liquid DOT hazard placard. SAA #10 and #11 were used to manage waste generated by each of the Karl Fisher analysis units as D001 hazardous waste (Photo #11 and #12). Each one-liter container was attached to a Karl Fisher unit, labeled hazardous waste, and identified with a flammable liquid DOT hazard placard. SAA #12 was used to manage waste laboratory samples and out of date materials as D001 hazardous waste (Photo #13). The five-gallon container was located inside a laboratory cabinet. The container was labeled hazardous waste QC lab pack and identified with a corrosive DOT hazard placard.

Laboratory personnel explained that, because the waste accumulation containers at the Karl Fisher units are made of glass, personnel pour the contents of these containers into the two-gallon container at SAA #9, which is then poured into the 55-gallon drum at the laboratory Central Accumulation Area (CAA). The inspectors noted that the regulations do not allow a generator to transfer hazardous waste from one SAA to another, and the inspection participants discussed various options for modifying the standard operating procedures at the laboratory to comply with the RCRA regulations. This discussion continued via email correspondence between the inspectors and Mr. Fleming from March 5 through March 11, 2021.

**Photo 10:** One two-gallon container at SAA #9, which is used to accumulate hazardous waste flammable liquids that are generated by sample analysis in the laboratory. The container was labeled as SAA #9 and hazardous waste and identified with a flammable liquid DOT hazard placard.

One proposed option for compliance is to designate a single SAA in the QC laboratory for accumulating QC laboratory testing. The two containers at the Karl Fisher (formerly SAA #10 and #11) units and the container under the laboratory hood (formerly SAA #9), could all be managed as containers within the same SAA. The total volume of waste in all containers within the SAA must remain below 55-gallons, and each container must meet the conditions of the SAA exemption (i.e. remain closed, be labeled “hazardous waste,” and be marked with an indication of the hazards). However, this management option would allow for hazardous waste to be transferred from the Karl Fisher containers into the laboratory hood container prior to transfer into the 55-gallon drum at the laboratory CAA.

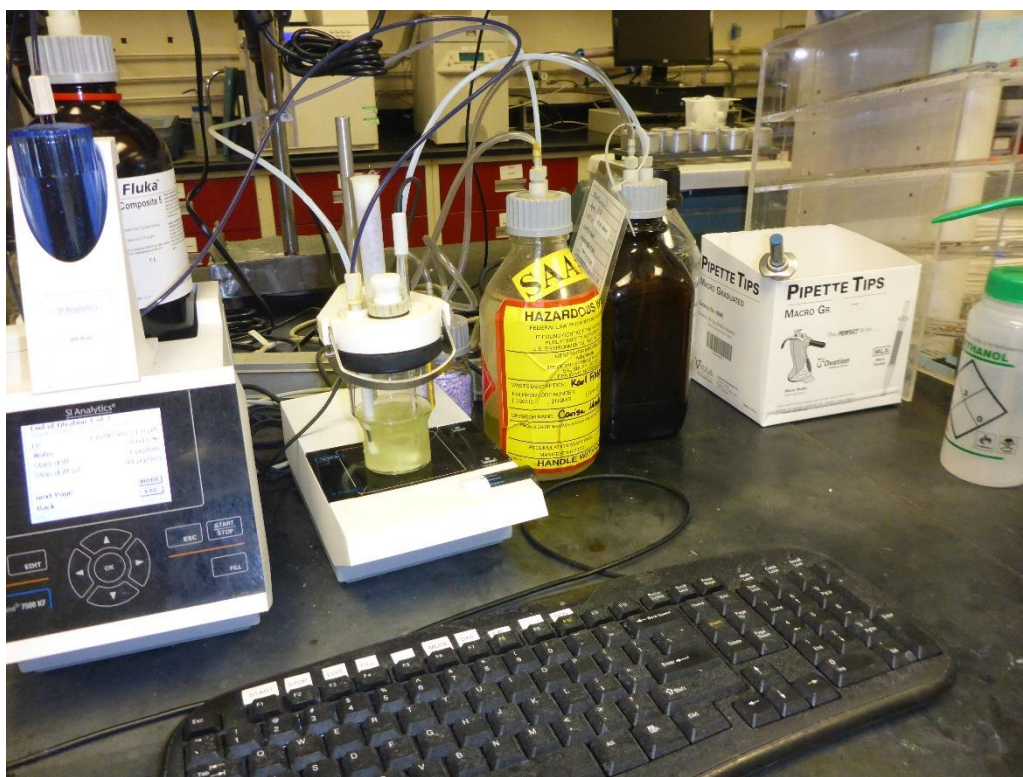
**Photo 11:** One one-liter jar at SAA #10, which is used to accumulate hazardous waste flammable liquids that are generated by the Karl Fisher unit. The jar was labeled as SAA #11 and hazardous waste and identified with a flammable liquid DOT hazard placard.

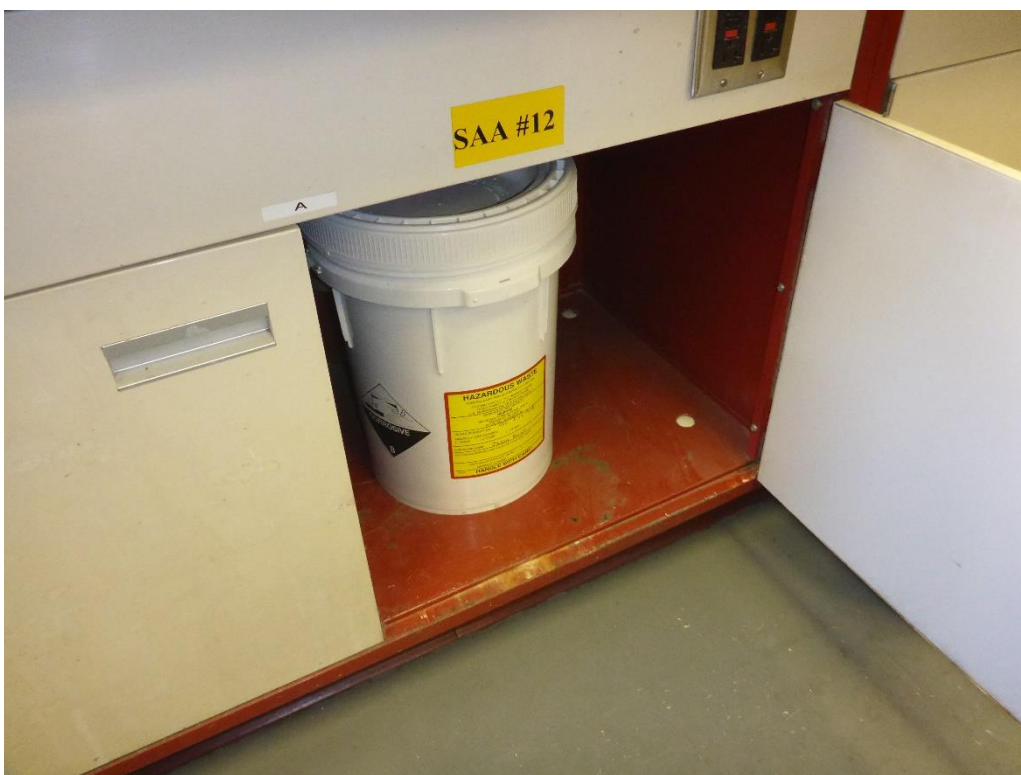
**Photo 13:** One 5-gallon bucket at SAA #12, which is used to accumulate hazardous waste laboratory chemicals that are generated in the laboratory. The bucket was labeled as SAA #12 and hazardous waste lab pack and identified with a corrosive DOT hazard placard.

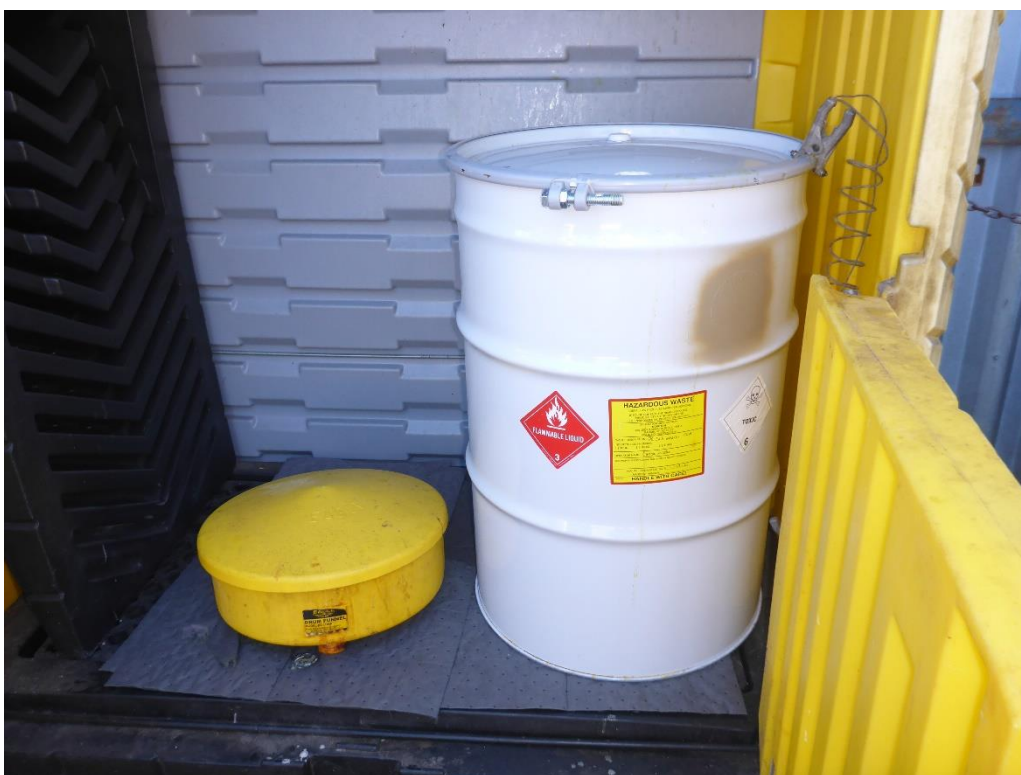
Laboratory Waste CAA: Nouryon manages a hazardous waste CAA between the QC and PD laboratories (Photo #14). This area is a plastic secondary containment shed located just outside the QC laboratory. The area was identified with a sign which read “hazardous waste storage.” Nouryon manages ignitable waste in this CAA, and the inspectors observed signs reading “danger, no smoking,” and “danger, flammable liquids” on the outside of the storage shed.

**Photo 14:** Laboratory CAA between the QC and PD laboratories. The area is a plastic secondary containment shed located just outside the QC laboratory. The area was identified with a sign which read “hazardous waste storage.” Nouryon manages ignitable waste in this CAA, and the shed was also identified with signs reading “danger, no smoking,” and “danger, flammable liquids.”

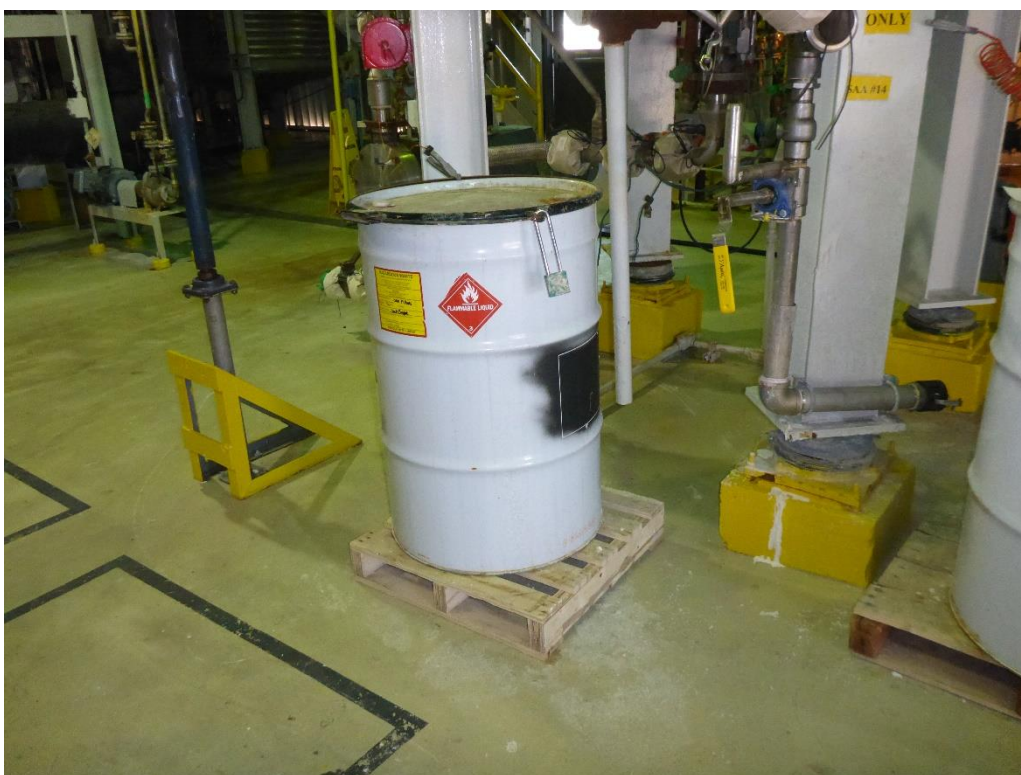
SAA #13 and #14 – Tank Storage Area: Nouryon manages two SAAs inside Area 3 in front of R01. SAA #13 is used to manage waste filter bags generated by filtering OAA while pumping to storage tanks as D001 hazardous waste (Photo #15). The inspectors observed one 55-gallon container in this SAA. The drum was located on a wooden pallet. It was labeled hazardous waste OAA filters and identified with a flammable liquid DOT hazard placard.

**Photo 15:** One 55-gallon drum at SAA #13, which is used to accumulate hazardous waste OAA filters that are generated by the OAA process. The drum was labeled hazardous waste OAA filters and identified with a flammable liquid DOT hazard placard.

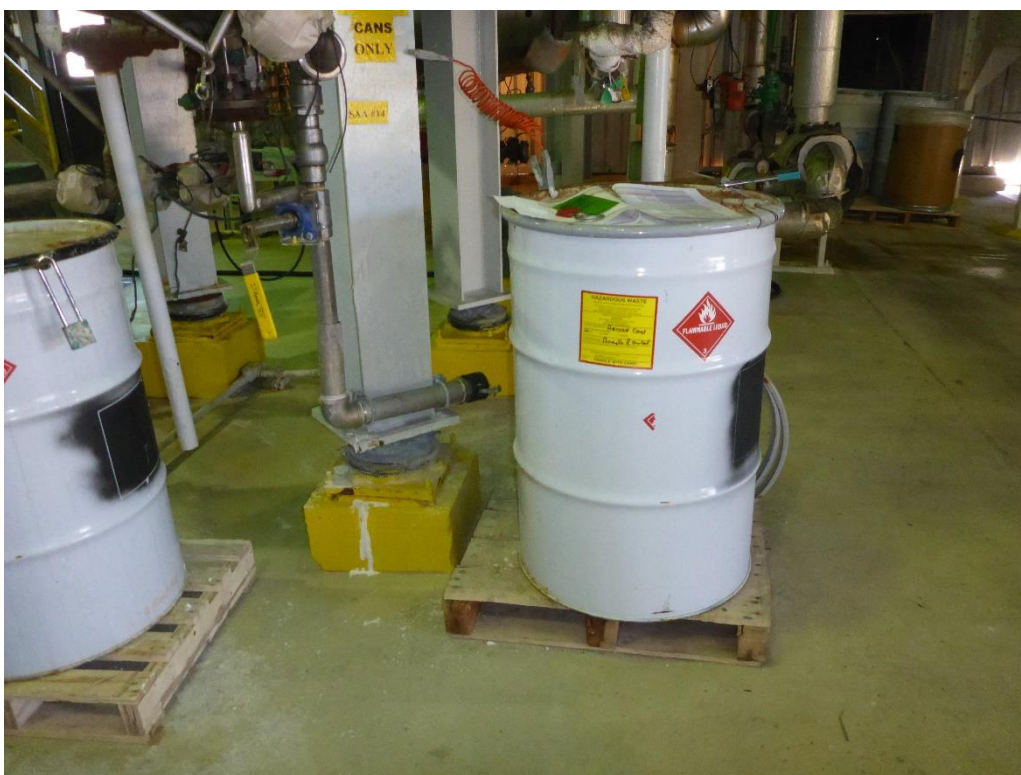
SAA #14 is used to manage waste aerosol cans generated in Areas 3 and 4, the Warehouse, and the Maintenance Area as D001 hazardous waste (Photo #16). The inspectors observed one 55-gallon container in this SAA. The drum was located on a wooden pallet. It was labeled hazardous waste aerosol cans and identified with a flammable liquid DOT hazard placard.

**Photo 16:** One 55-gallon drum at SAA #14, which is used to accumulate hazardous waste aerosol cans that are generated on this side of the facility. The drum was labeled hazardous waste aerosol cans and identified with a flammable liquid DOT hazard placard.

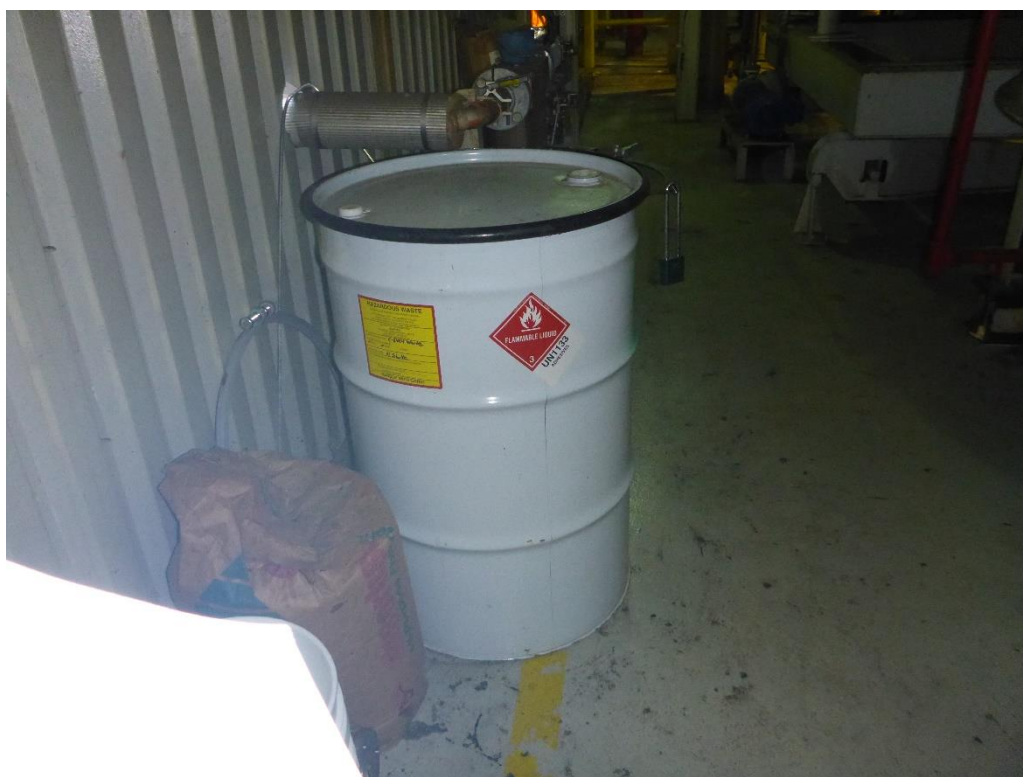
SAA #16 – C-6424 Sample Flushing / Filter Media: Nouryon manages a SAA behind Tank C41 in Area 2 for managing sampling and cleaning waste generated in Area 2 Tank C41 and Tank MV4 as D001 hazardous waste (Photo #18). The inspectors observed one 55-gallon drum at this SAA. The drum was labeled as hazardous waste C-6424 waste and identified with a flammable liquid DOT hazard placard.

**Photo 18:** One 55-gallon drum at SAA #16, which is used to accumulate hazardous waste flammable liquids that are generated by sampling and cleaning operations at the C-6424 process. The drum was labeled hazardous waste C-6424 waste and identified with a flammable liquid DOT hazard placard.

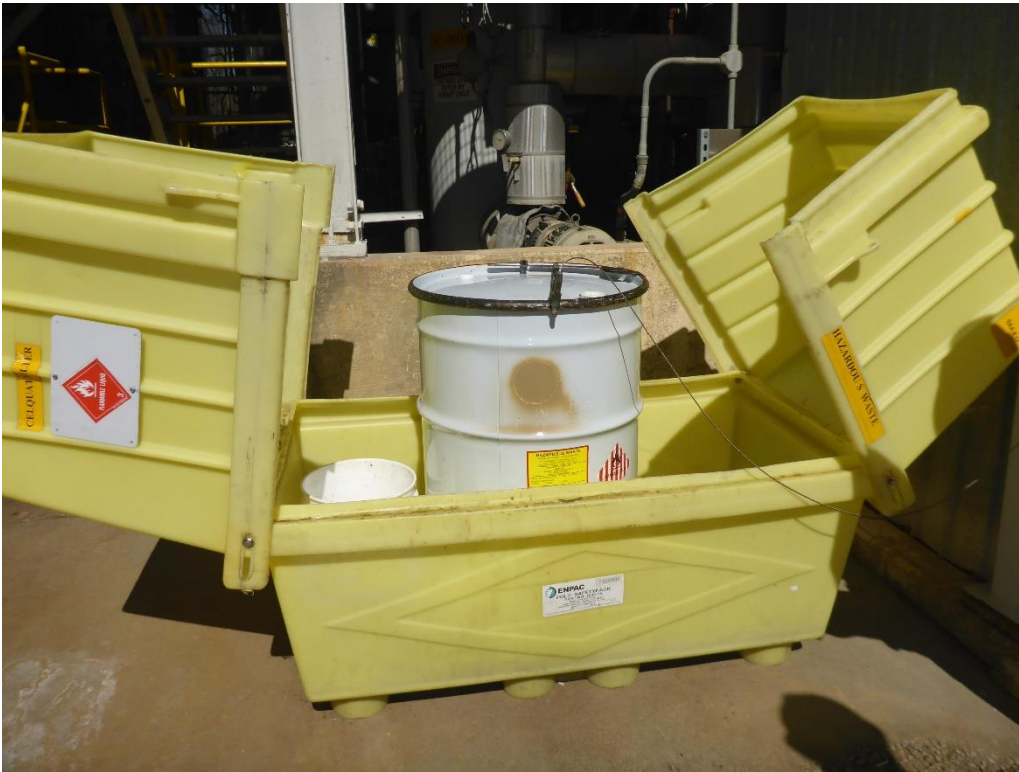
SAA #17 – Cuno Filters in IPA: Nouryon manages a SAA in the IPA Solvent Recovery Area for managing filters that are generated by the CUNO solvent recovery process as D001 hazardous waste (Photo #19). The inspectors observed one 55-gallon drum in this SAA. The clam-shell was identified as SAA #17, labeled as hazardous waste and marked with a flammable liquid DOT hazard placard. The drum was labeled hazardous waste CUNO filters with IPOH and identified with a flammable solid DOT hazard placard.

**Photo 19:** One 55-gallon drum inside a locked, plastic clam-shell secondary containment unit at SAA #17, which is used to accumulate hazardous waste filters that are generated by the CUNO solvent recovery process. The clam-shell was labeled as SAA #17 and marked with a flammable liquid DOT hazard placard. The drum was labeled hazardous waste CUNO filters with IPOH and identified with a flammable solid DOT hazard placard.

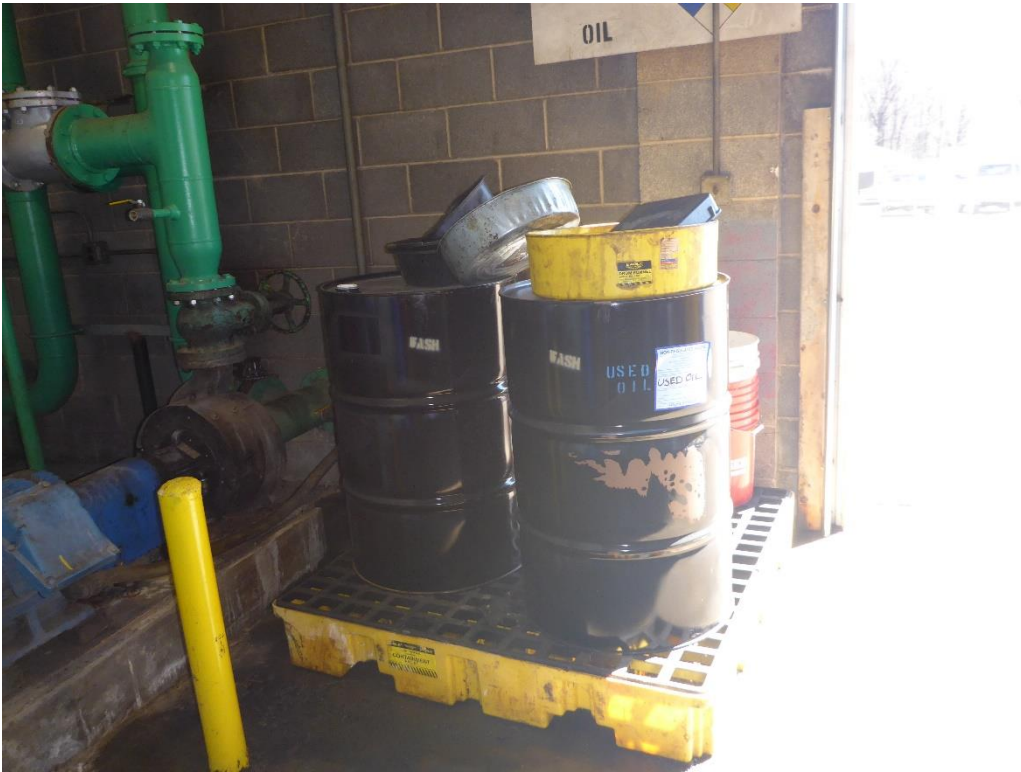
Used Oil Storage: The inspection participants observed three 55-gallon drums of used oil on a portable secondary containment pallet in the Chiller Room (Photo 20). Each drum was labeled as “Used Oil.”

**Photo 20:** Three 55-gallon drums of used oil on a portable secondary containment pallet in the Chiller Room.

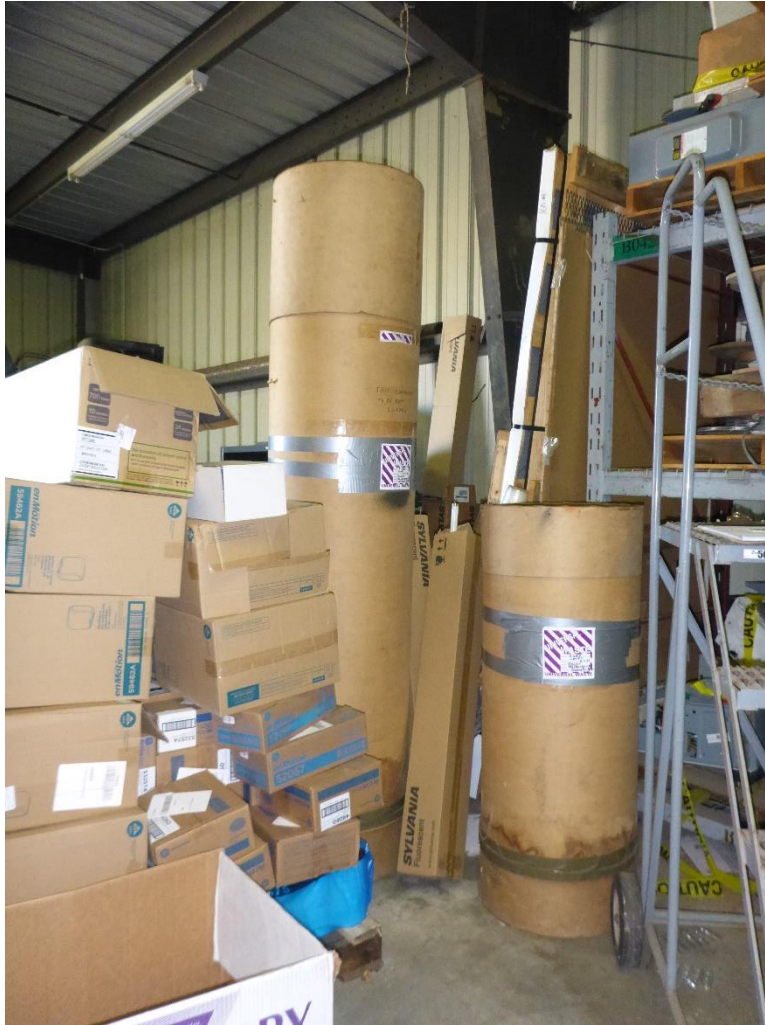
Universal Waste Management: Nouryon manages universal waste lamps in the Blue Building. The inspectors observed one 8-foot cardboard cylinder, one 4-foot cardboard cylinder, three 8-foot cardboard boxes, five 4-foot cardboard boxes, and one square cardboard box, which all appeared to contain either new lamps or universal waste lamps (Photo #21). The cardboard cylinders and two 4-foot boxes appeared to contain universal waste fluorescent lamps, and the cardboard square box appeared to contain universal waste metal halide lamps (Photo #22). The

remaining three 8-foot boxes and three 4-foot boxes appeared to contain either new, broken, or universal waste lamps. The cylinders were each labeled as universal waste lamps and dated 10/07/2020. None of the cardboard boxes were labeled or dated. The square cardboard box was completely open.

**Photo 21:** One 8-foot cardboard cylinder, one 4-foot cardboard cylinder, two 4-foot cardboard boxes and one open, square cardboard box in the foreground, which all appeared to contain universal waste lamps. The cylinders were each labeled as universal waste lamps and dated 10/07/2020. None of the cardboard boxes were labeled or dated. Additional 8-foot cardboard boxes observed behind these containers. Those additional boxes appeared to contain either new or universal waste lamps.

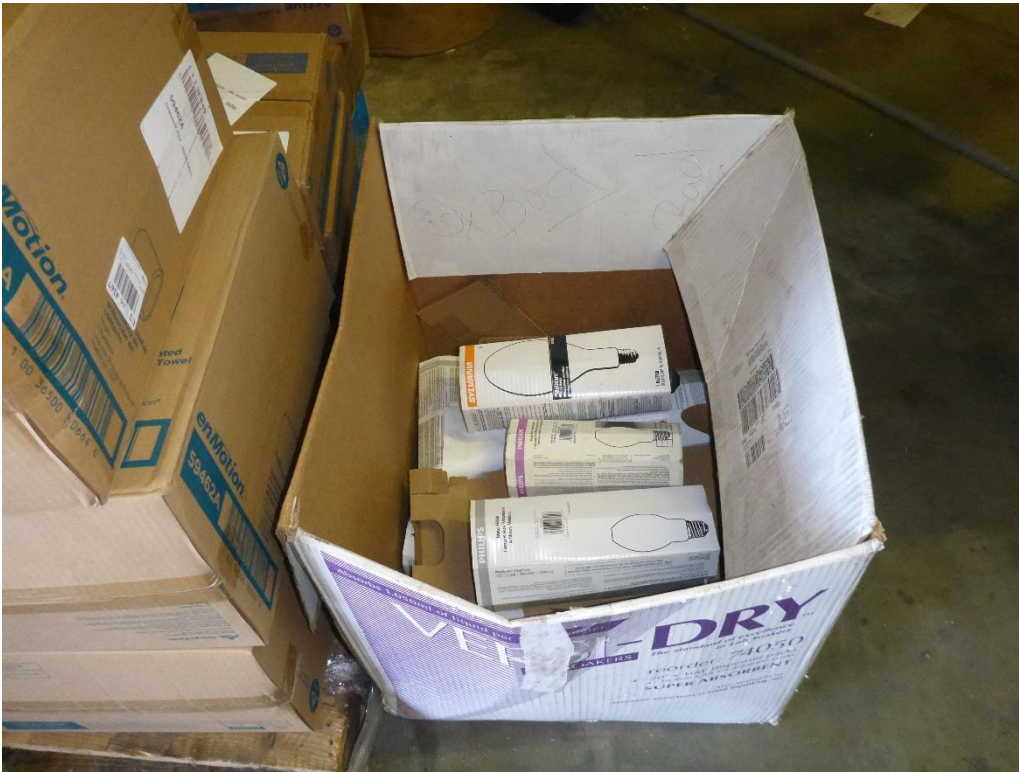
**Photo 22:** One open, square cardboard box of universal waste metal halide lamps. The box was not labeled “universal waste lamps” or marked with an accumulation start date.

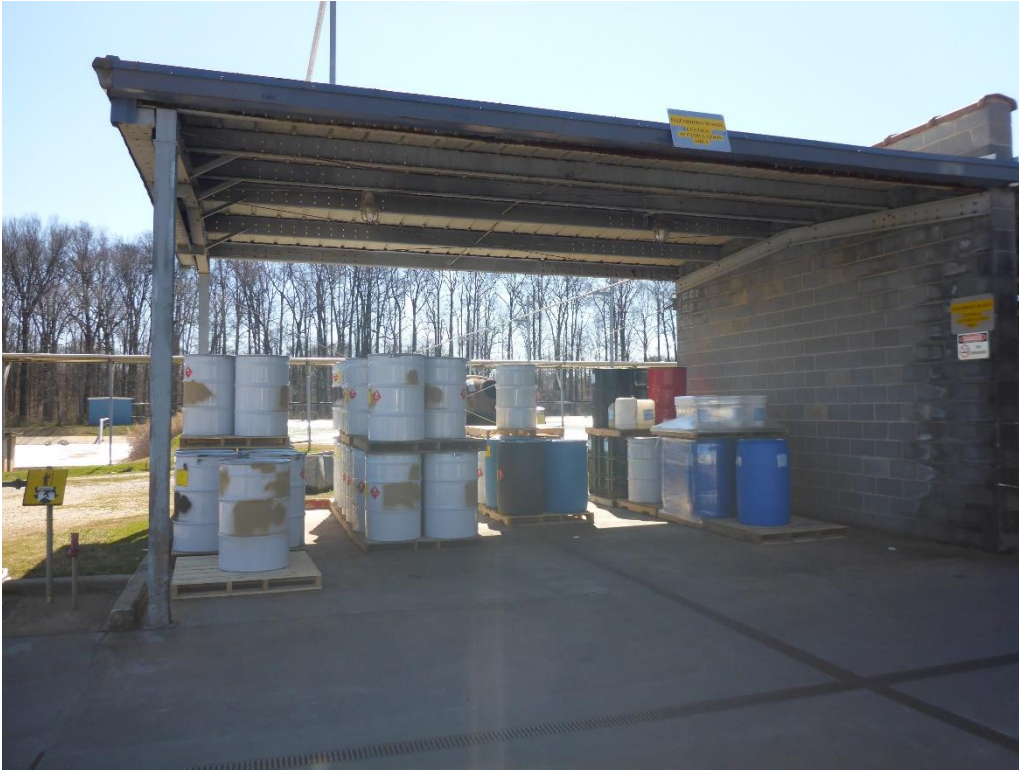
Facility Main CAA: Nouryon manages the main hazardous waste CAA on a curbed concrete pad beneath a metal roof near the wastewater treatment lagoons (Photo #23). The area was identified with a sign which read “hazardous waste central accumulation area.” Nouryon manages ignitable waste in this CAA, and the inspectors observed a “Danger, No Smoking” sign on the concrete wall at the CAA. The area is equipped with a telephone capable of alerting security to employ an internal communications or alarm system to provide emergency instruction to facility personnel and summoning emergency assistance from local police departments, fire departments, or state or local emergency response teams; and it is also equipped with a portable fire extinguisher and spill control equipment.

The inspectors observed over fifty 55-gallon containers staged on wooden pallets in four rows within the CAA. The first row was four pallets long, and two of the pallets were double-stacked. Inspectors observed containers of waste isopar heels, waste IPA heels and waste Cuno filters in this row. The drums were all labeled as hazardous waste, identified with a flammable liquid or a flammable solid (Cuno filters) DOT hazard placard, and marked with an accumulation start date. The oldest drum in this row was dated 01/30/2021.

The second row was three pallets long, and all of the pallets were double-stacked. Inspectors observed containers of waste ethyl acetate, waste isopropyl acetate, and waste IPA heels from reclaim in this row. The drums were all labeled as hazardous waste, identified with a flammable liquid DOT hazard placard, and marked with an accumulation start date. However, the ink used to identify the contents and accumulation start date on four of the drums was severely fading and/or washing away. The oldest legible date observed in this row was 02/04/2021. Facility personnel noted the faded labels and indicated that they would be corrected immediately. Please note that the facility's weekly inspection checklist includes an entry for inspecting labels and dates on containers in this area. When information on the container labels becomes faded or illegible, the condition should be noted on the inspection log and corrective actions should be taken.

The third row was two pallets long, and one of the pallets was double-stacked. Inspectors observed containers of waste PQIP wetcake from V90, MEA waste, SPS sulfonation waste, and waste COD vials in this row. The containers were all labeled hazardous waste and marked with an accumulation start date. The oldest container in this row was dated 02/05/2021. The 55-gallon drums of PQIP wetcake and SPS sulfonation waste were identified with a flammable liquid DOT hazard placard, and the 5-gallon carboy of waste COD vials was identified with a corrosive DOT hazard placard. Two 55-gallon drums of MEA waste were not identified with an indication of the hazards of their contents.

**Photo 23:** Main CAA with hazardous waste containers arranged on four rows of wooden pallets. The area is identified with signs reading “hazardous waste central accumulation area” and “danger, no smoking.”
