NEW ENGLAND REGIONAL LABORATORY  
NORTH CHELMSFORD, MA 01863

**Date:** July 15, 2024

**Subject:** Reconnaissance and Sampling Inspection Report  
Clean Water Act – National Pollutant Discharge Elimination System  
Worcester, MA

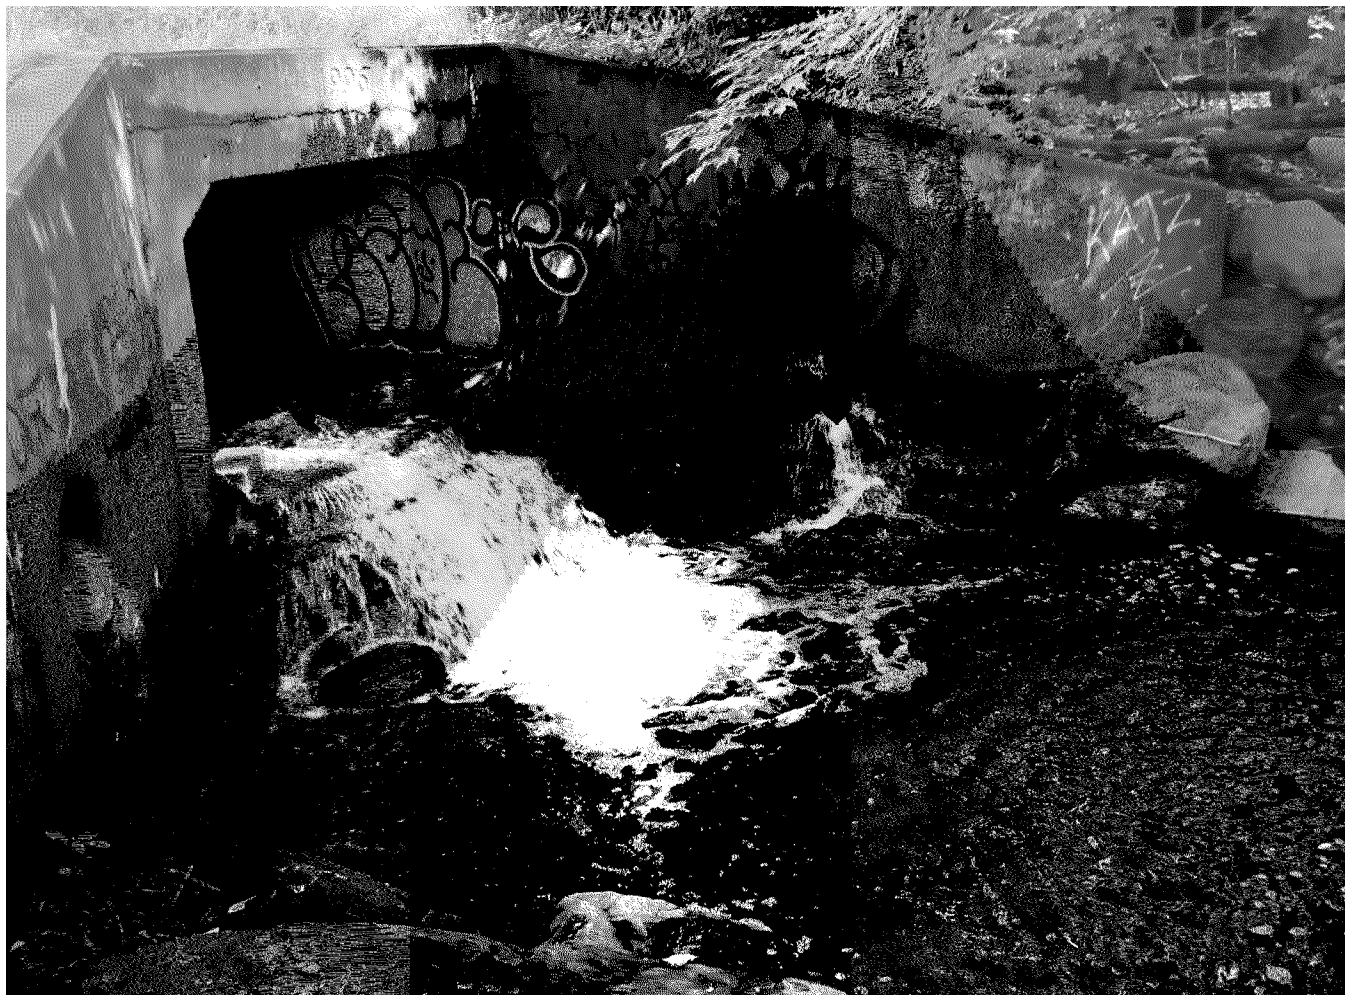
**Photo 1: LQ-01** (photo taken 05/28/2024 at approx. 9:59) Stream located near 616 Plantation St, discharging into Coal Mine Brook, upstream of Lake Quinsigamond. Sample point is indicated by a red X.

- **LQ-01:** One of two circular concrete outfalls on either side of a large rectangular culvert, approximately 3 feet in diameter located at 616 Plantation Street. Discharge flow was approximately 20 gallons per minute (“gpm”) into Coal Mine Brook. Sample was collected at the mouth of the right-side outfall, looking up-stream. A light sewage and musty odor was detected. Color was clear and turbidity was low. No floatables were observed. Dark green algae growth was observed on the inside of the concrete pipe. Trash was observed in the stream directly downstream of the outfall. Outfall sampled was chosen based on the Worcester, MA stormwater sewer system map.
- **LQ-02:** One circular concrete outfall located at the base of a stone wall beside a construction site, approximately 4 feet in diameter located at 382 Plantation Street.

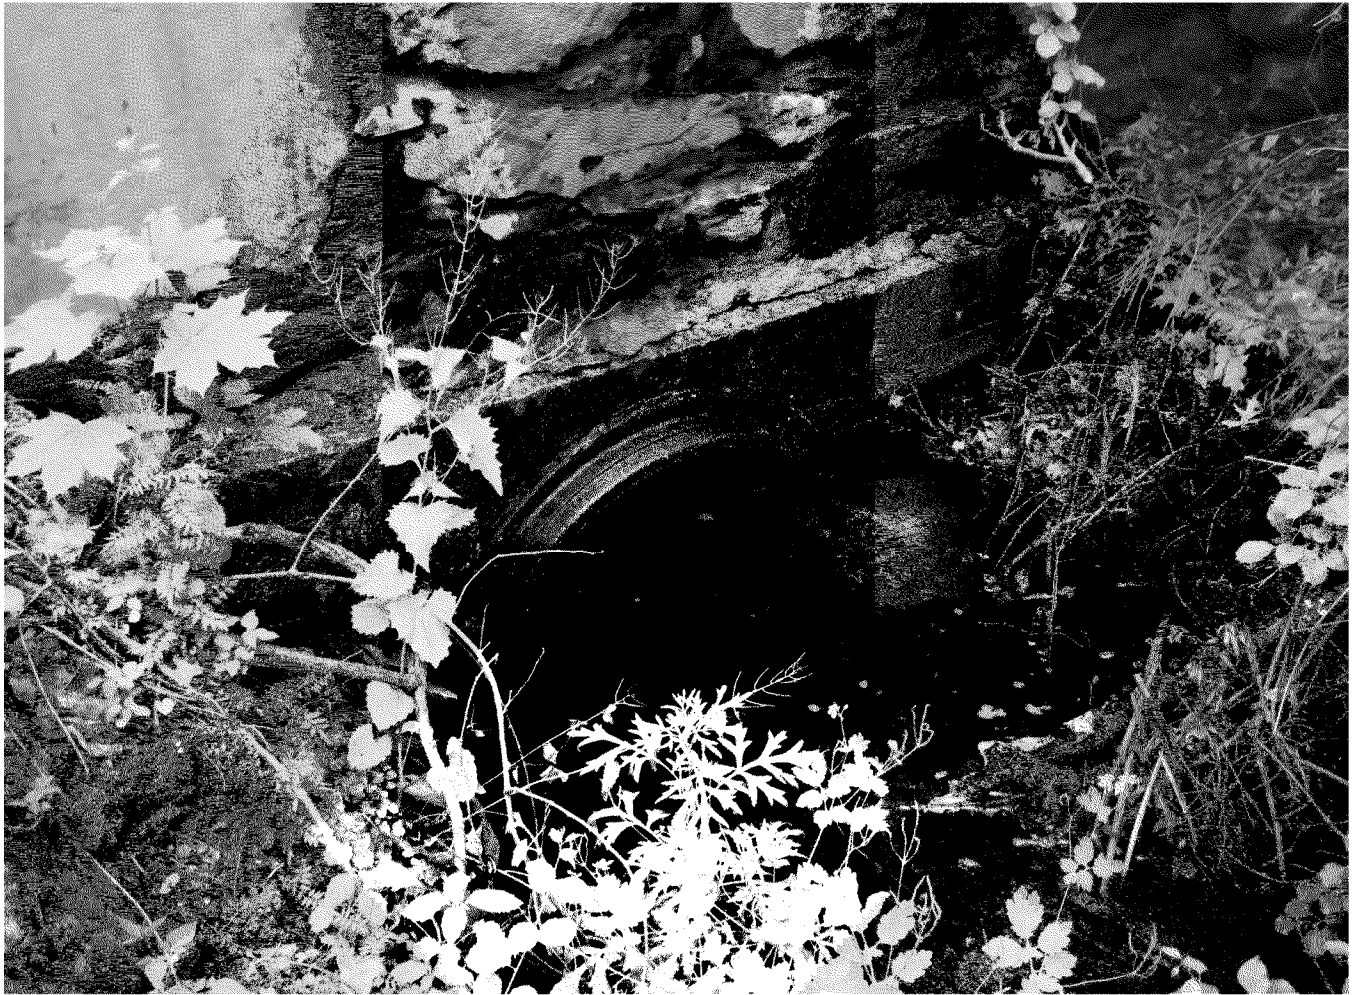
**Photo 2: LQ-02** (photo taken 05/28/2024 at approx. 10:42) Outfall located near 382 Plantation Street, discharging into the unnamed stream uphill of Lake Quinsigamond. Sample points are indicated by a red X.

Discharge flow was approximately 5 gpm into an unnamed stream/brook. Sample was collected at the mouth of the outfall. A musty odor was detected. Color was clear and some particulate matter was observed. Foam clusters were observed coming from the mouth of the outfall. The outfall was three-quarters submerged.

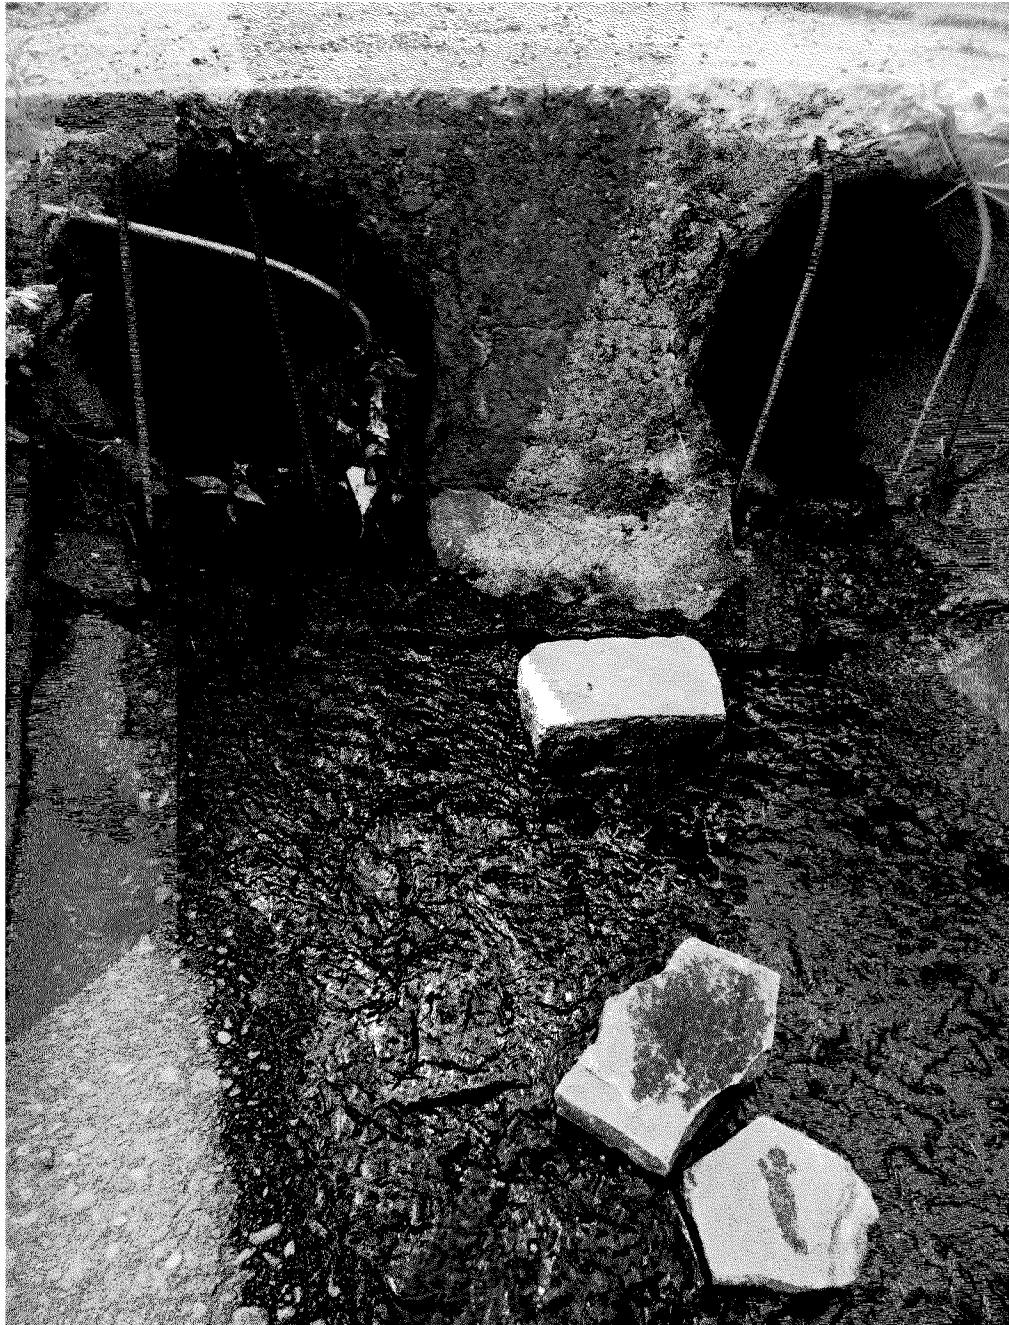
**Photo 5: LQ-05** (photo taken 05/28/2024 at approx. 13:00) Outfall located near 5 Suntaug Road, discharging into Lake Quinsigamond. Sample points are indicated by a red X.

- **LQ-05**: One of two circular concrete outfalls, approximately 2 feet in diameter located at 5 Suntaug Road. Discharge flow was approximately 2 gpm into Lake Quinsigamond. Sample was collected at the mouth of the left-side outfall, looking up-stream. A slight brackish and rank odor was detected. Color was clear and turbidity was low. No floatables were observed. Green algae growth was observed on the inside of the concrete pipe as well as the flume leading directly into Lake Quinsigamond. Outfall sampled was chosen based on the Worcester, MA stormwater sewer system map.

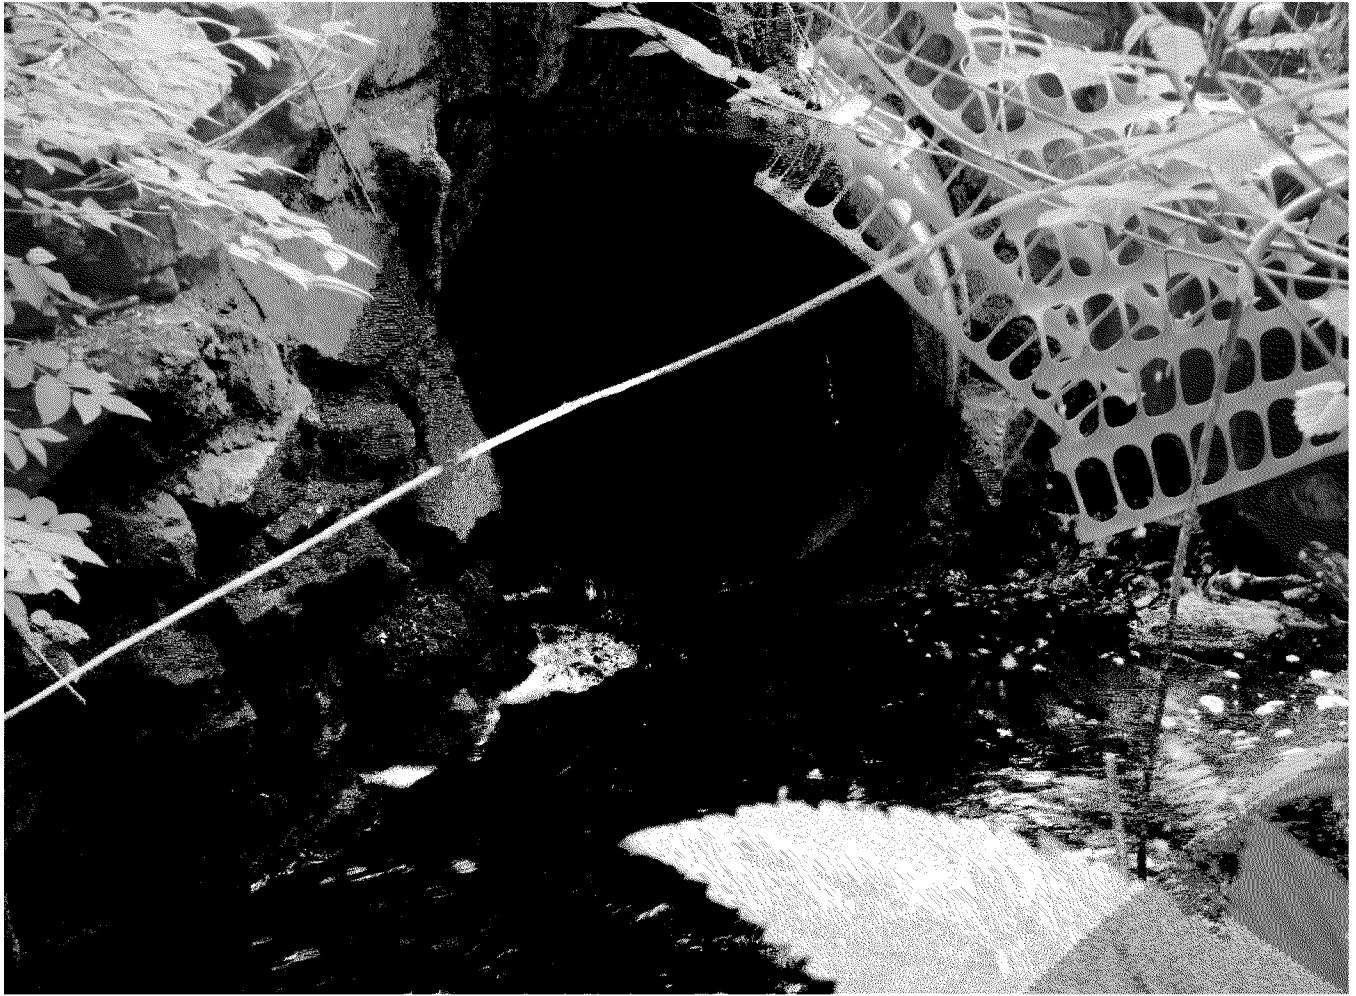
**Photo 6: LQ-06BL** (photo taken 05/28/2024 at approx. 13:48) Outfall located near 10 Crane Street, discharging into an unnamed stream that discharges into Lake Quinsigamond. Sample points are indicated by a red X.

- **LQ-06BL**: One of two circular concrete outfalls on either side of a larger circular concrete culvert, approximately 3 feet in diameter located at 10 Crane Street. Discharge flow was approximately 1 gpm into an unnamed stream discharging into Lake Quinsigamond. Sample was collected at the mouth of the left-side outfall, looking up-stream. No notable odor was detected. Color was clear and some suspended particulates were observed. Off-white foam was observed coming from the outfall and collecting directly downstream of the outfall.
