## RCRA Compliance Evaluation Inspection Report

Peninsula Metal Finishing Inc.  
2550 Dinneen Avenue  
Orlando, FL 32804

August 9, 2023, 10:30 a.m.

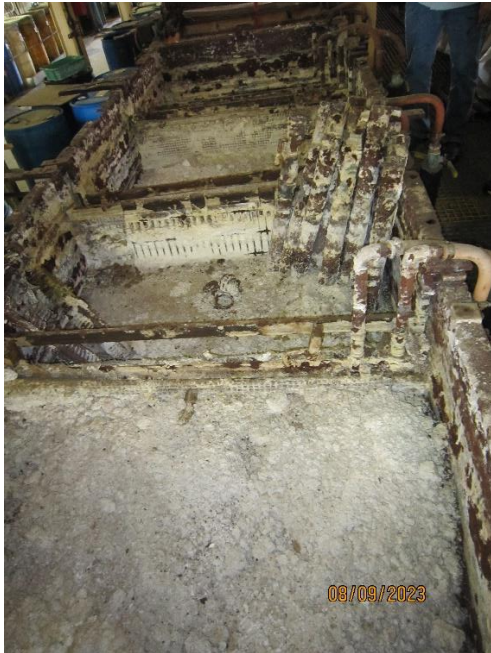
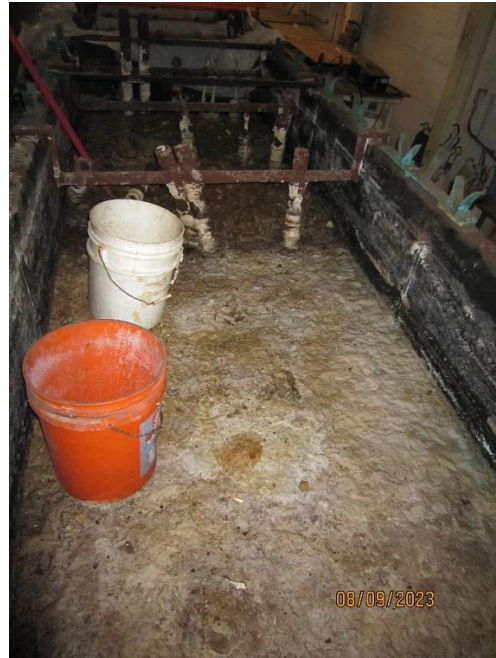
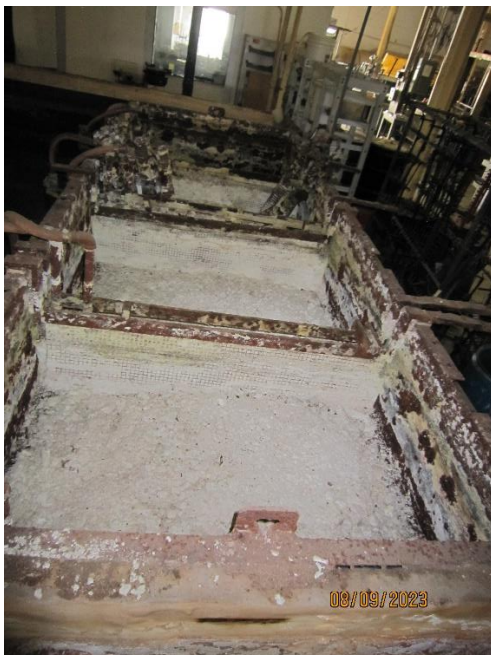
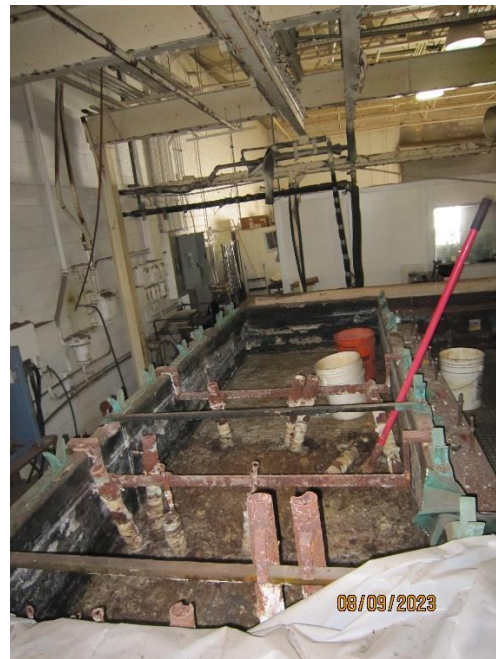
According to Francis Smith Coachman, owner of the facility, the small barrel line is used occasionally. The large barrel zinc plating line has not been used and has been out of operation since approximately beginning of 2019. During the August 9, 2023, EPA/FDEP inspection, the inspectors observed rusted plating tanks in the large barrel line area. The equipment and open plating tanks contained plating solutions, debris, and dried up plating chemicals. It appears that the large barrel line has not been out cleaned out since the July 14, 2021, EPA/FDEP inspection (Photos #1-4). The inspectors informed the Peninsula representative to make a waste determination of the plating solutions/materials left in the large barrel line tanks and dispose of the waste accordingly. Therefore, Peninsula has not addressed the concerns previously identified, including making a waste determination of the plating tank’s waste for more than two years and failed to dispose of the tanks waste accordingly.

Photo #1 – Out of service large barrel plating line tanks.

Photo #2 – Out of service large barrel plating line tanks.

Photo #3 – Out of service large barrel plating line tanks.

Photo #4 – Out of service large barrel plating line tanks.

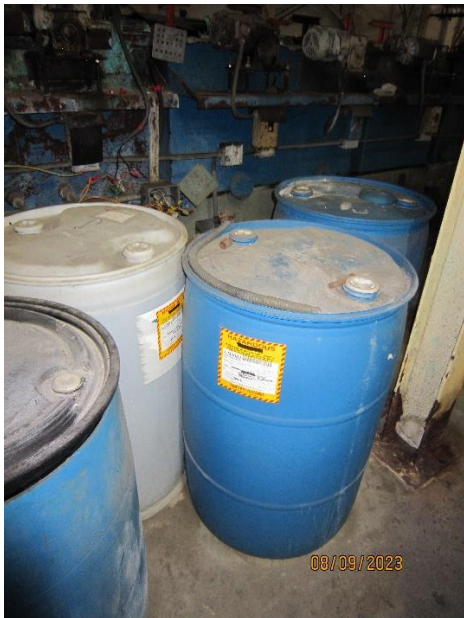
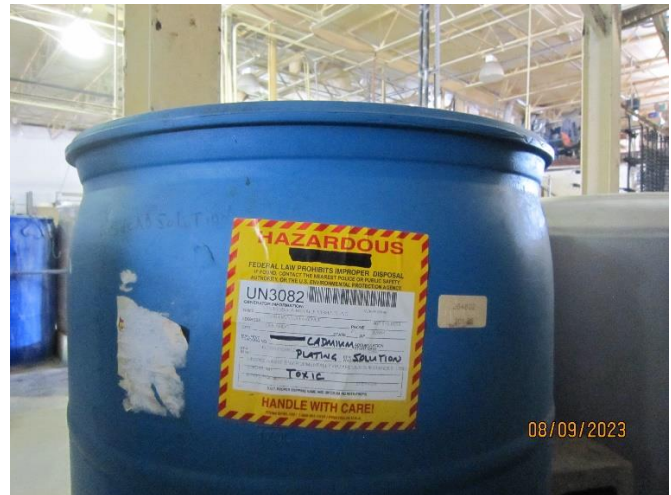
Next to the zinc strip line, inspectors observed the following containers (Photos #5-6):

- Two closed 55-gallon containers of spent cadmium plating solution marked “Hazardous Waste,” and with an indication of the hazards of the contents; and
- Two 55-gallon containers of plating solutions were not marked but the facility stated that containers are spent cadmium plating solution.

- (Page 4) Next to the Zinc strip line, two 55-gallon containers of spent cadmium plating solution were not marked with an accumulation start date and additional two 55-gallon containers of spent cadmium plating solution were not marked with the words “Hazardous Waste,” an indication of the hazards of the contents, and an accumulation start date.

Photo #5 – 55-gallon containers of cadmium plating solution in storage for reuse.

Photo #6 – close-up of Photo #5.

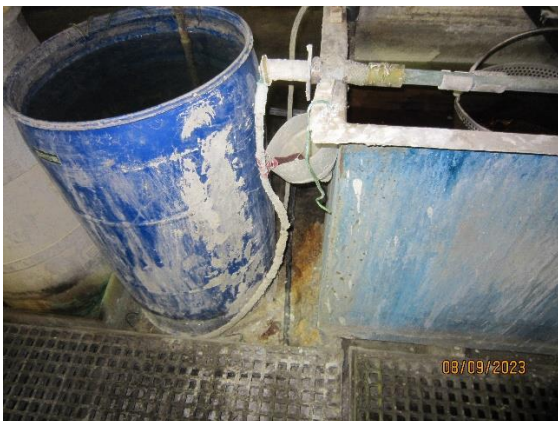
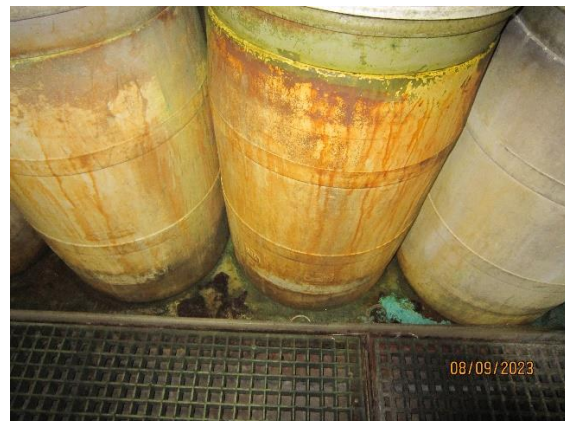
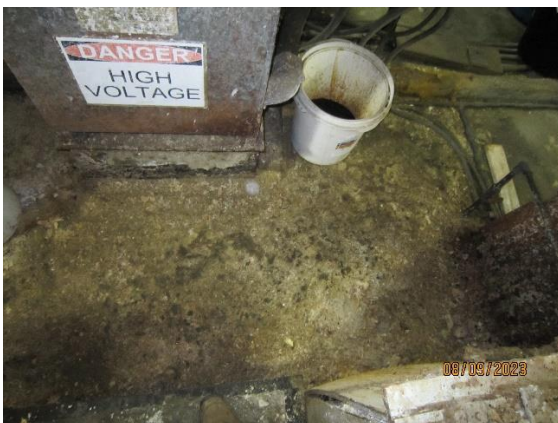
The inspectors observed residual waste on the floor of the cadmium line (Photos #7-9). The inspectors informed Peninsula that residual cadmium waste must be cleaned up and disposed of properly.

Photo #7 – Residual waste on the floor of the the cadmium plating line.

Photo #8 – Residual waste on the floor of the the cadmium plating line.

Photo #9 – Residual waste on the floor of the the cadmium plating line.

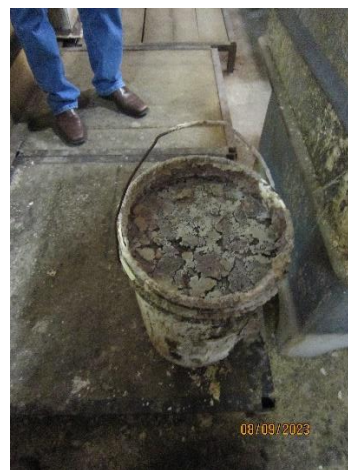
The inspectors observed a 5-gallon container of waste sludge material in a satellite accumulation area (SAA) near the black oxide line (Photo #10). According to Peninsula, the sludge is collected from the bottom of the black oxide tank, and it is potentially high in pH. The container was not labeled or closed, and no waste determination was available for review.

- (Page 5) The inspectors observed a 5-gallon container of waste sludge material in a satellite accumulation area (SAA) near the black oxide line (Photo #10). The sludge is collected from the bottom of the black oxide tank, and it is potentially high in pH. The container was not labeled or closed, and no waste determination was available for review.

Photo #10 – A 5-gallon SAA container of black oxide.

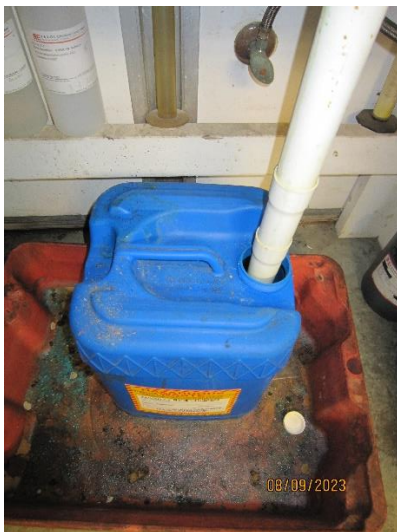
In the chemistry laboratory, plating bath samples are tested for proper concentrations and constituents to ensure optimal plating performance of the processes and quality control. The laboratory's hazardous waste is collected in an open 5-gallon SAA container below a sink (Photo #11). The container was open, marked "Hazardous Waste," and had an indication of the hazards of the contents. There was a closed 1-gallon SAA container of cyanide lab waste marked "Hazardous Waste" and with an indication of the hazards of the contents staged on the lab countertop.

Photo #11 – A 5-gallon SAA container in the lab sink.

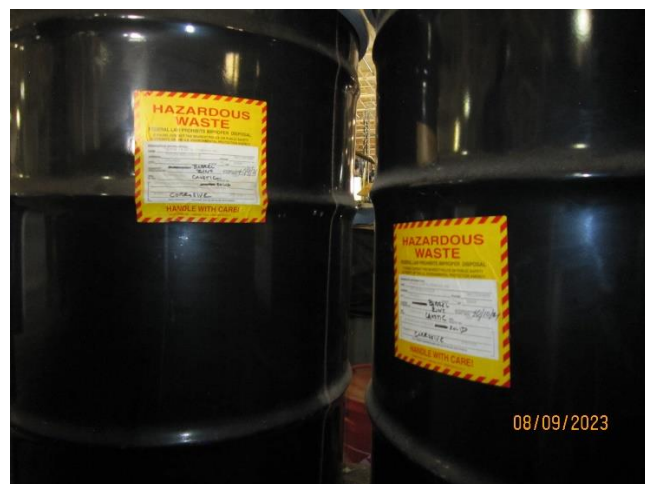
Outside the laboratory, the inspectors observed two closed 55-gallon containers marked "Hazardous Waste," and "Caustic Solid Corrosive" (Photo #12). The containers were dated October 9, 2021, and October 10, 2021, but were not marked with an indication of the hazards of the contents. It appears that Peninsula has been storing hazardous waste containers longer than 90 days, without a permit, interim status, or an extension to the 90-day limit.

- (Page 5) Outside the lab, two 55-gallon containers of hazardous waste were not marked with an indication of the hazards of the contents (Photo# 12).

Photo #12 – Two 55-gallon containers of “Caustic Solid Corrosive” waste.

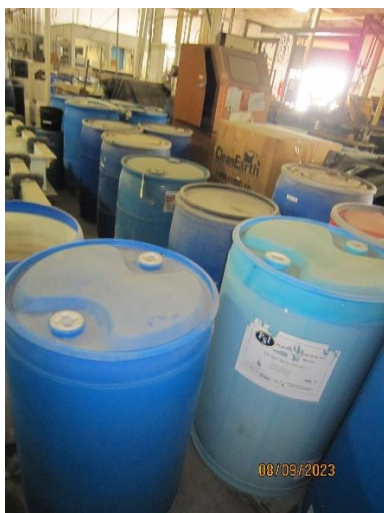
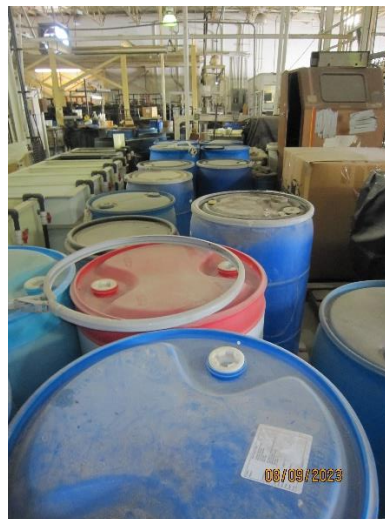
The inspectors proceeded to the chromate conversion coating line in middle of the building. The Peninsula representative stated that this plating line is used episodically. In the anodize plating area, aluminum is etched in order to insert the desired color into the parts. After color insertion a protective coating is applied to the part. The inspectors observed sixteen 55-gallon containers of plating rinse water stored next to the chromate conversion/anodize plating coating line (Photos #13-14). Some of these containers were marked “expired.” There were an additional twenty-two 55-gallon containers of anodize rinse and dye solutions stored for on-site wastewater pre-treatment system. The inspectors could not access most of the 55-gallon containers for inspection due to no aisle space. According to the City of Orlando, Peninsula has been a Significant Non-Complier (SNC) for Industrial User permit #CO3TA since early 2021. It appears that most of the same containers of hazardous waste were observed in storage during the July 14, 2021, inspection. It has been more than two years that Peninsula failed to conduct a waste determination of the rinse water containers and dispose of it properly. Therefore, Peninsula has not addressed the concerns previously identified, including making a waste determination of the twenty-two containers of plating wastewater and sixteen containers of plating wastewater identified during the August 9, 2023, inspection.

- (Page 6) The inspectors observed sixteen 55-gallon containers of plating rinse water stored next to the chromate conversion/anodize plating coating line (Photos #13-14). Some of these containers were marked “expired.” There were additional twenty-two 55-gallon containers of anodize rinse and dye solutions stored for on-site wastewater pre-treatment system. It appears that most of the same containers of hazardous waste were observed in storage during the July 14, 2021, inspection. It has been more than two years that Peninsula failed to conduct a waste determination of the rinse water containers and dispose of it properly.

Photo #13 – Containers stored in the chromate conversion/anodize plating coating line.

Photo #14 - Containers stored in the chromate conversion/anodize plating coating line.

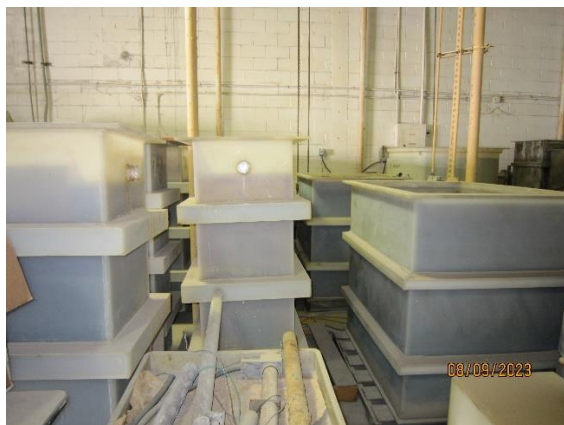
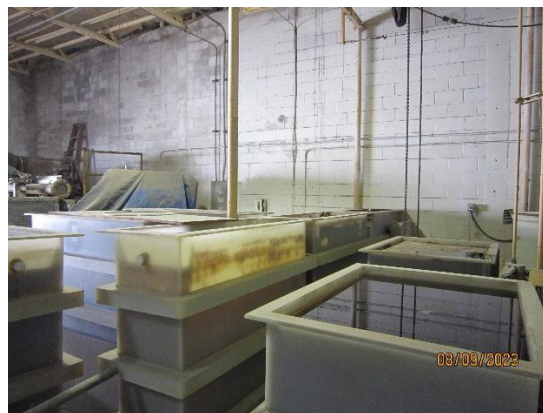
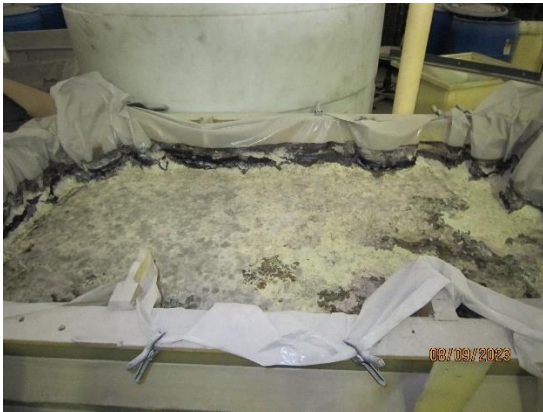
Near the nickel strip plating area, the inspectors observed one cylindrical and ten rectangular poly tanks containing anodize plating waste (Photos #15-17). One open rectangular tank was marked with the words “Hazardous Waste,” “Anodize Black Dye Rinse – pH 1.81 – Acid – Toxic – Corrosive” and dated May 19, 2021 (Photos #18-19). There were several other open poly tanks that appeared to have the same anodize black dye rinse (Photo #20). Ten out of eleven tanks were open, not marked with the words “Hazardous Waste,” no indication of the hazard contents, and no start accumulation date. The Peninsula representative, Francis Smith Coachman, stated that approximately 6,000 gallons of plating waste is stored in this area and some of the poly tanks contained hazardous waste. The inspectors observed the same eleven poly tanks stored during the July 14, 2021, inspection. At the time of July 14, 2021, inspection, the Peninsula representative stated that there is a backlog in the treatment process of wastewater due to the no discharge Order per the City of Orlando. Therefore, spent plating wastewater has been accumulating at the facility at least since 2021. It appears that Peninsula has been storing hazardous wastes in tanks and containers longer than two years. In addition, the inspectors could not access most of poly tanks for inspection due to the lack of sufficient aisle space.

- (Page 7) Near the nickel strip plating area, the inspectors observed one circular round and ten rectangular poly tanks containing anodize plating waste. Ten out of

- eleven tanks were not marked with the words “Hazardous Waste,” no indication of the hazard contents, and no start accumulation date (Photos #15-17 and #20).

Photo #15 – Plating waste stored in the poly tanks.

Photo #16 – Plating waste stored in the poly tanks.

Photo #17 – Plating waste stored in the poly tank.

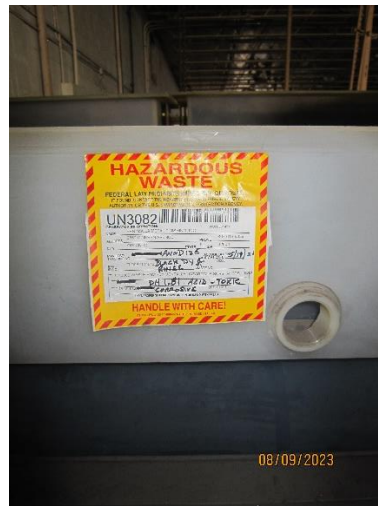
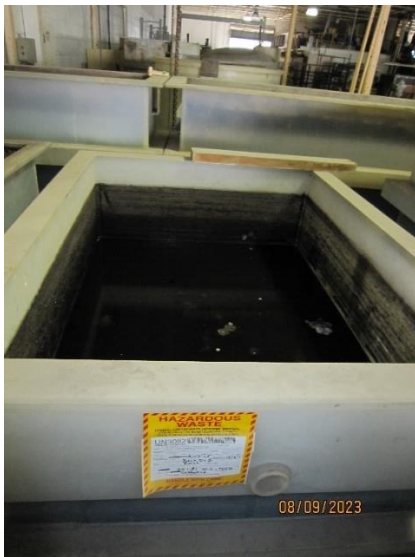
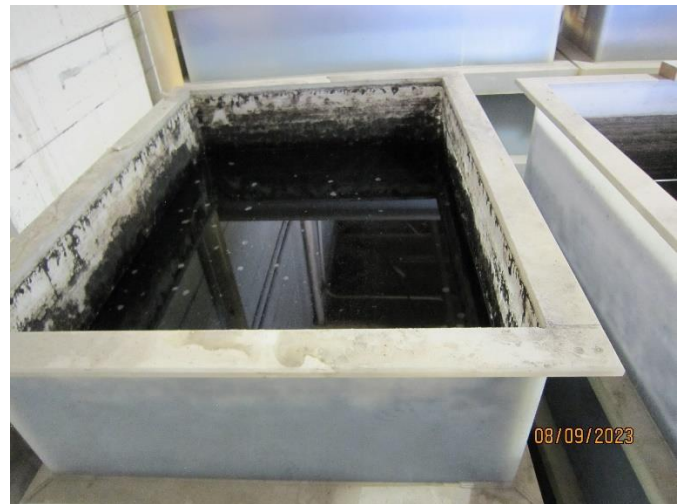
Photo #18 – Plating waste stored in the poly tank.

Photo #19 – Plating waste stored in the poly tank.

Photo #20 – Plating waste stored in the poly tank.

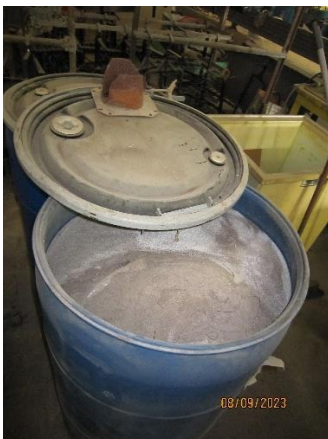
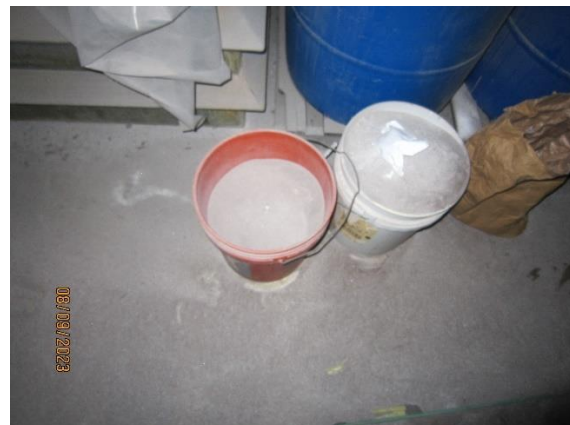
Near the anodize plating waste, the inspectors observed one unmarked 55-gallon and two 5-gallon containers of spent blasting media (Photos #21-22). During the 2021 CEI, the inspectors requested that the facility conduct an analytical test of the spent blast media or apply knowledge of the hazard characteristics of the waste, or the process used to generate the waste, to determine that spent blast media is hazardous or non-hazardous. A LQG must maintain records supporting its hazardous waste determinations, including records that identify whether a solid waste is a hazardous waste, as defined by in Fla. Admin. Code Ann. r. 62-730.030(1) [40 C.F.R. § 261.3]. At the time of the 2023 CEI, records supporting any waste determination on the blast media that had been requested in the 2021 CEI, were not available for review.

- (Page 8) Near the anodize plating waste, the inspectors observed one unmarked 55-gallon and two 5-gallon containers of spent blasting media (Photos #21-22). During the 2021 CEI, the inspectors requested that the facility conduct an analytical test of the spent blast media or apply knowledge of the hazard characteristics of the waste, or the process used to generate the waste, to determine that spent blast media is hazardous or non-hazardous. At the time of the 2023 CEI, records supporting any waste determination on the blast media that had been requested in the 2021 CEI, were not available for review.

Photo #21 – A 55-gallon container spent blasting media.

Photo #22 – Two 5-gallon containers of spent blasting media.

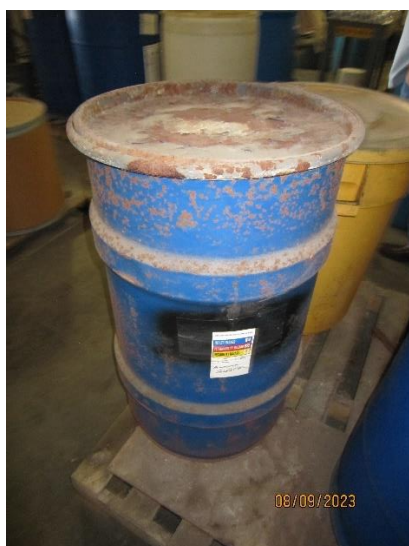
The chemical inventory area was located near the smaller plating lines. There were several rusty containers noted in this area. There was one 55-gallon rusted container of aluminum sulfate (Photo #23). The inspector informed the Peninsula representative to assess the containers for usability and make a proper waste determination. In addition, there was a full 55-gallon hazardous waste container marked “Cadmium Strip,” “Ammonium Nitrate + Water,” and “Toxic” (Photo #24). The container was not dated with a start accumulation date.

- (Page 8) There was one 55-gallon rusted container of aluminum sulfate (Photo #23) and a full 55-gallon hazardous waste container marked “Cadmium Strip,” “Ammonium Nitrate + Water,” and “Toxic” (Photo #24) in the chemical inventory area. The containers were not dated with a start accumulation date.

Photo #23 – Rusted container of aluminum sulfate in the chemical storage area.

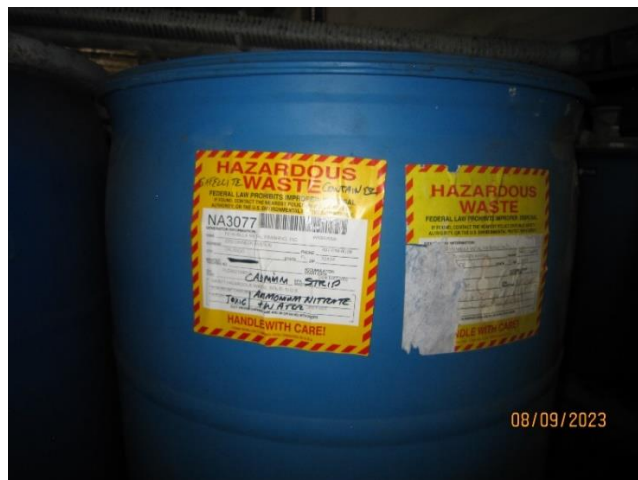
Photo #24 – Hazardous waste container in the chemical storage area.

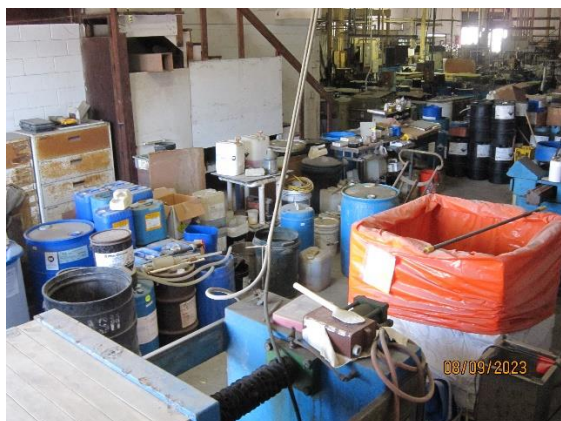
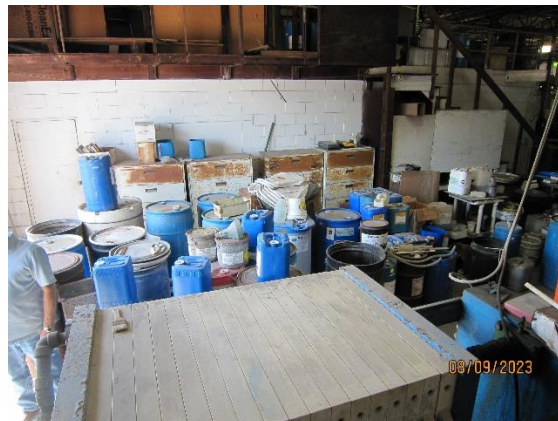
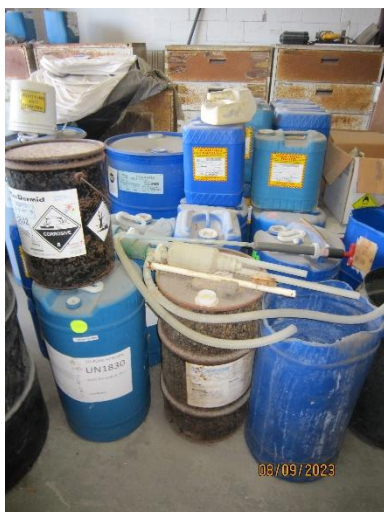
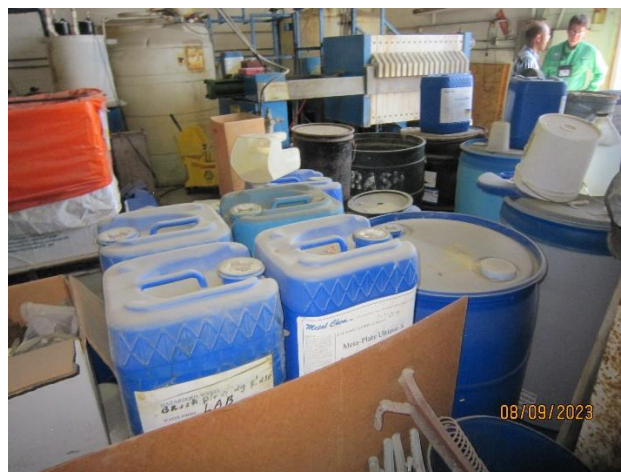
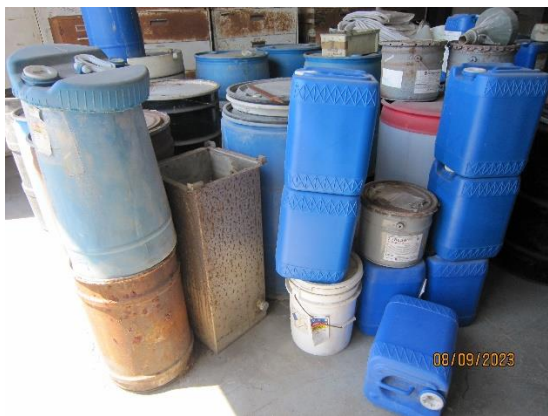
treatment, storage, and disposal facility. The inspectors observed 5, 10, 15, and 55-gallon containers of acid, caustic, corrosive, and toxic hazardous waste stored in this area (Photos #25-29). The inspectors could not access most of the hazardous waste containers for inspection due to a lack of sufficient aisle space. In addition, the inspectors observed that most of the same containers were stored during the July 14, 2021, inspection:

Photo #25 – Hazardous waste containers staged for treatment or disposal.

Photo #26 – Hazardous waste containers staged treatment or disposal.

Photo #27 – Hazardous waste containers staged for treatment or disposal.

Photo #28 – Hazardous waste containers staged treatment or disposal.

Photo #29 – Hazardous waste containers staged for treatment or disposal.

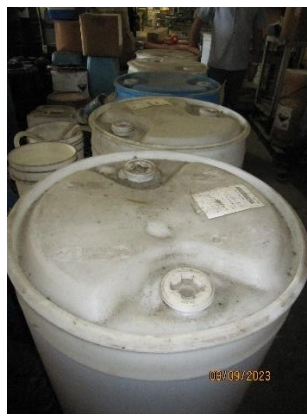
- Seven 55-gallon non-treated plating waste not marked with the words “Hazardous Waste,” no indication of hazards of the contents, and no accumulation start date (Photo #30);

- (Page 9) Seven 55-gallon non-treated plating waste not marked with the words “Hazardous Waste,” no indication of hazards of the contents, and no accumulation start date (Photo #30);

Photo #30 – Seven 55-gallon containers of non-treated plating waste.

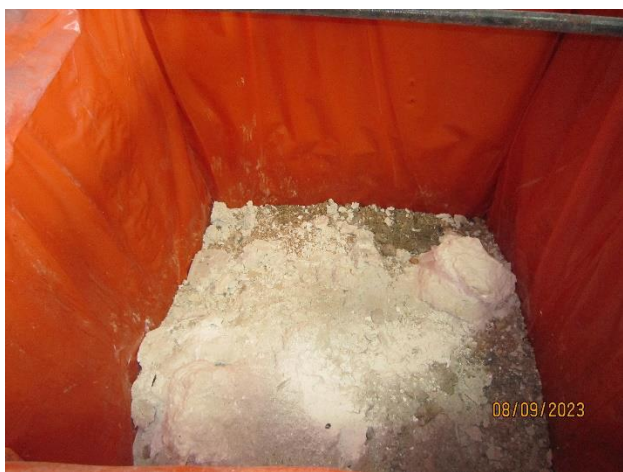
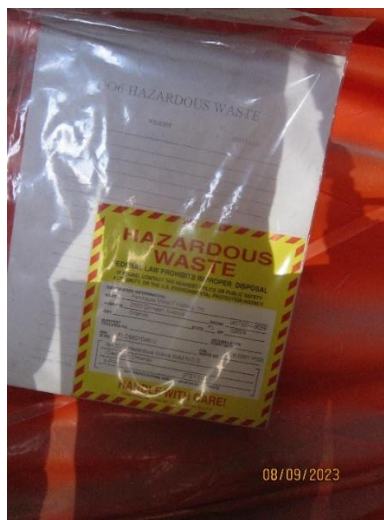
- One open cubic yard gaylord box of plating filter cake (EPA Waste Codes D006, D007, and F006) marked “Hazardous Waste.” The box was not marked with an indication of the hazards of the contents and not marked with an accumulation start date (Photos #31-32). It appears that same cubic yard box of filter cake was stored during the July 14, 2021, EPA/FDEP inspection because to this date Peninsula has not submitted a filter cake hazardous waste manifest;

Photo #31 – Cubic yard box F006 filter cake.

Photo #32 – Hazardous waste Label of Photo #31.

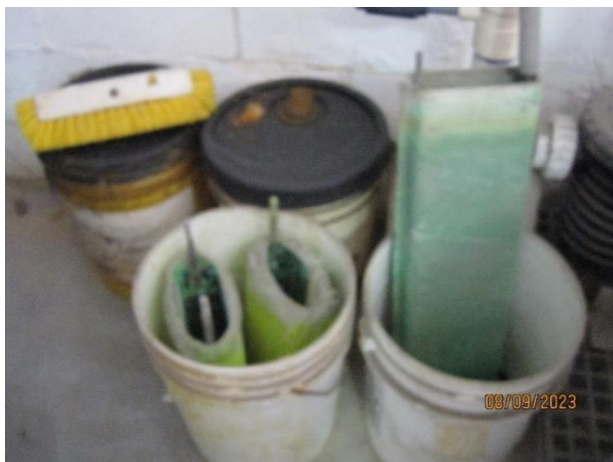
- Two open 5-gallon containers had spent sleeve filters from the chrome plating line (Photo #33). The containers were not marked with the words “Hazardous Waste” and had no indication of the hazards of the contents;

Photo #33 – Open containers of spent chrome filter sleeves.

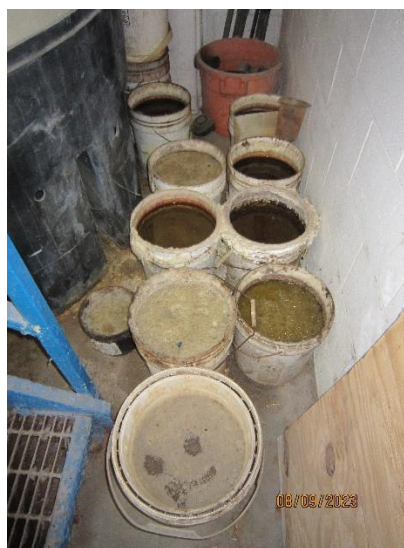
- Behind the WWTS tank stairs, there were ten open 5-gallon containers of black oxide waste solution/sludge (Photo #34). The containers were not marked with the words “Hazardous Waste,” no indication of hazards of the contents, and not marked with an accumulation start date; and

Photo #34 – 5-gallon containers of black oxide solution/sludge.

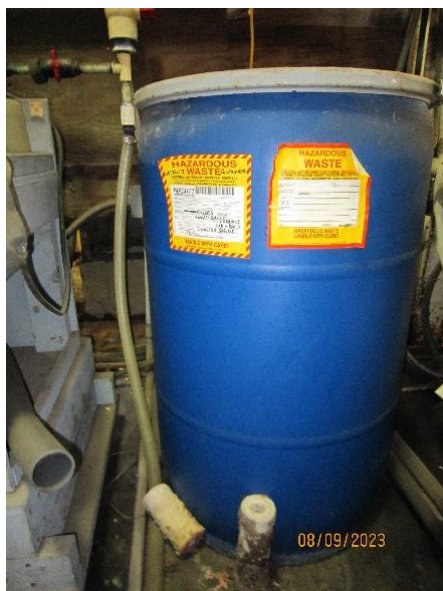
- One closed 55-gallon container of toxic hazardous waste filters, rags, and debris laden with cadmium, brass, and cyanide solids. The container was not marked with an accumulation start date (Photo #35).

Photo #35 – 55-gallon containers of toxic hazardous waste filters.
