## RCRA Compliance Branch INSPECTION REPORT

| <b>Inspection Date(s):</b> | 09/01/2023 | <b>Inspection Announced:</b> No |
| <b>Facility or Site Name:</b> | Amrex Chemical Co., Inc. | |

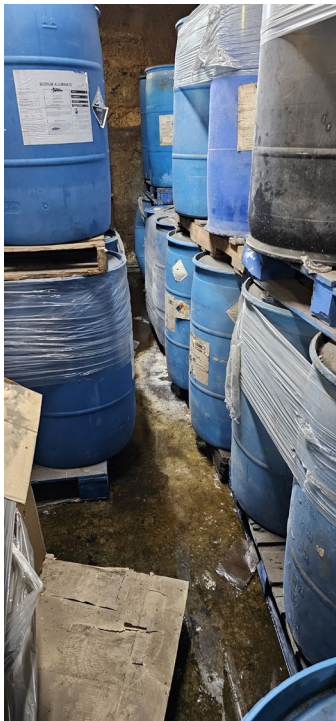
The containers stored on the opposite side of the chemical storage rack were bulk chemicals in-use for consolidation and resale. This area contained ample amounts of free-standing water; the facility representative stated the water intrusion was from rainwater. There were several areas of chemical residues and powders observed on the floor and within the rainwater. (Figure 1-4) The facility stated it was going to sample the materials and determine if these materials were hazardous wastes. The facility also stated they are working to mitigate the rainwater intrusion from this area.

Figure 1 – Freestanding water and various chemical residues and powders observed within the hot room in-storage area.

- d. At the time of the inspection, the hot room in-storage area contained ample amounts of free-standing water, the facility representative stated the water intrusion was from rainwater. There were several areas of chemical residues and powders observed on the floor and within the rainwater.

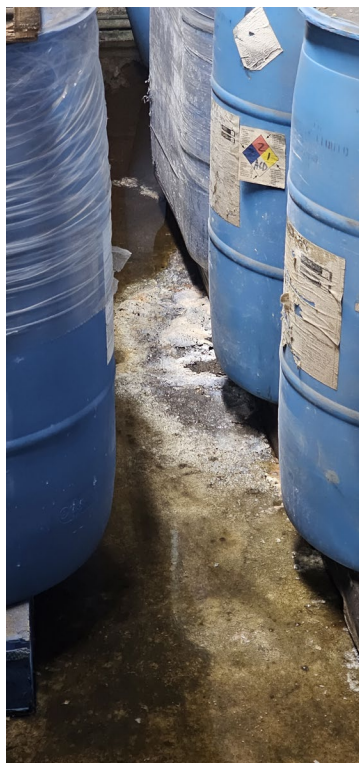
Figure 2 – Another photo of freestanding water and various chemical residues and powders observed within the hot room in-storage area.

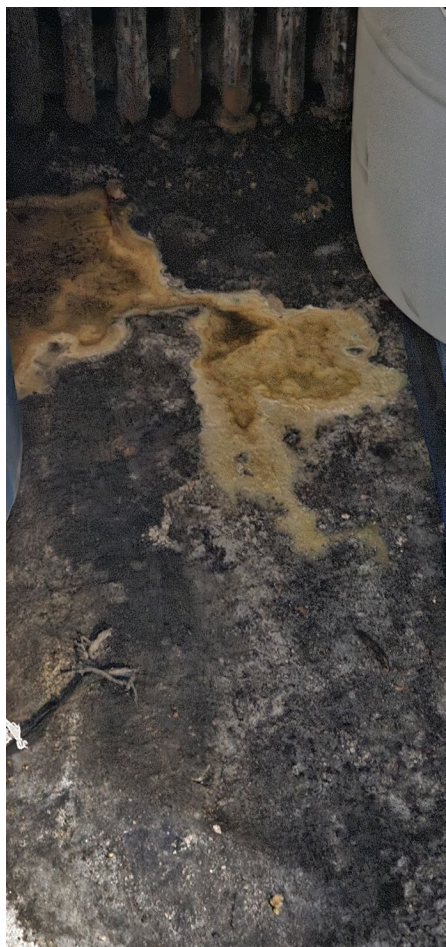
Figure 3 - Another photo of freestanding water and various chemical residues and powders observed within the hot room in-storage area.

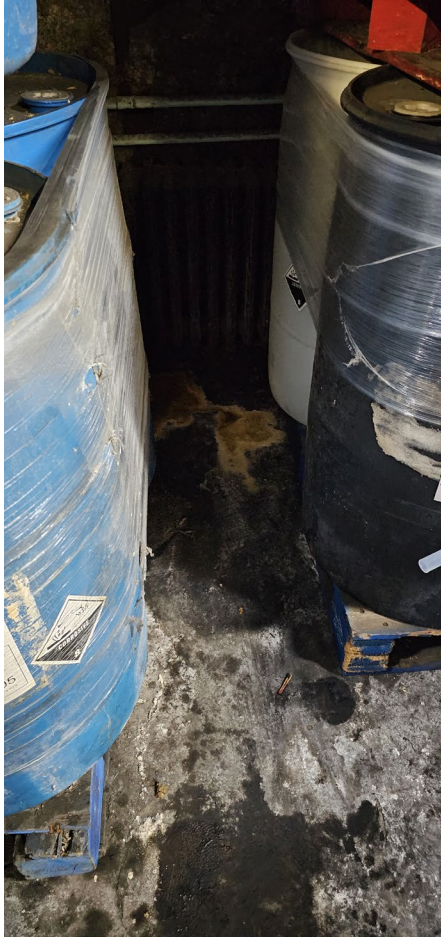
Figure 4 - Another photo of freestanding water and various chemical residues and powders observed within the hot room in-storage area.
