## **RCRA Inspection Report**

Dura Coat Products, Inc.  
26655 Peoples Road  
Madison, AL 35756  
Limestone County  
EPA ID Number: ALR000027383

**COMPLIANCE EVALUATION INSPECTION PHOTOGRAPHS**

**January 23, 2024**

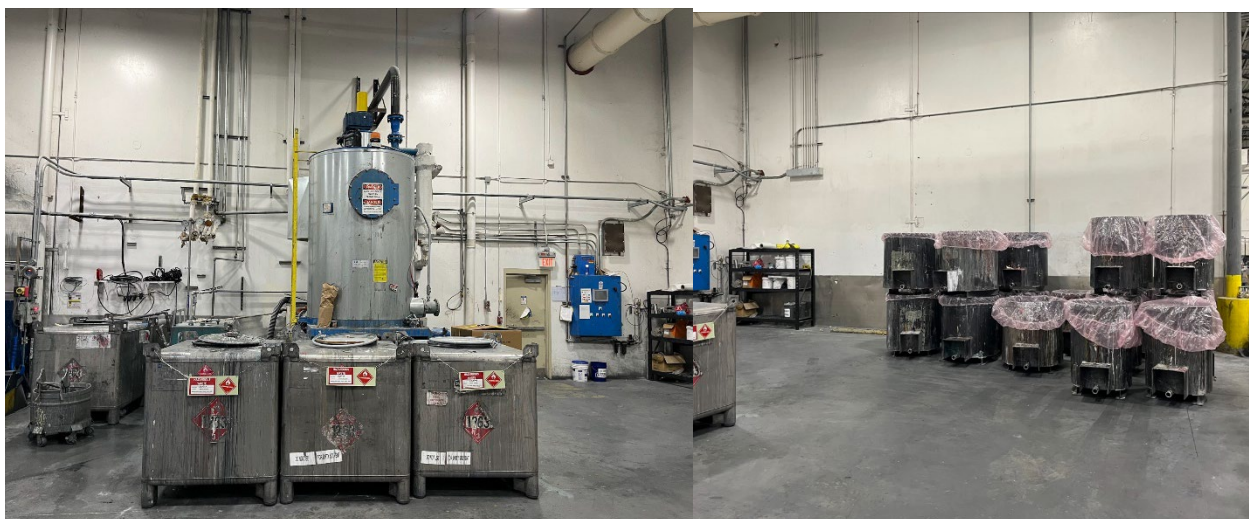
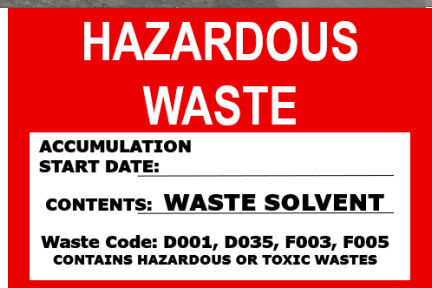
*Here are some more photos in Solvent Recovery Area. As stated in the previous email, the distillation unit is back to normal operation. Therefore, all totes staged in the area had been removed to recover solvents and new totes (three of them) are now staged in front of the distillation unit for a normal recovery operation. Dirty Solvent Totes are labeled and marked with hazard ID and indication as below. Going forward, we will manage the area as 90-day area only when the solvent recovery unit is not operable.*

On March 26, 2024, Mrs. Hong provided via email that “*Updates on Solvent Recovery Area will be sent shortly. The distillation unit is now back to normal operation. Therefore, as of now, the area is not a 90-day area. However, as a satellite accumulation area, we upgraded the labeling and marking on waste holding containers. Will send you some photos from the area. As you recommended, we will treat the area as 90-day area only when the distillation unit is down, and when we are unable to run solvent recovery operation.*

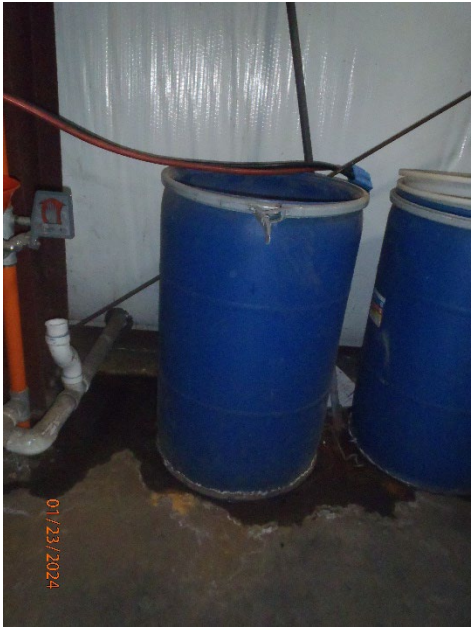
The walk-through began in Shipping and Receiving where all the products and raw materials are stored. The universal waste storage area was located here but at the time of the inspection no universal waste was observed due to a pickup in December. The inspectors observed a blue 55-gallon drum of acid/soda waste beside the battery charging station (Pictures 1-2). The ground around the battery was wet, potentially caused by an overspill. The inspectors asked if the drum was hazardous waste and Mrs. Hong stated that the contents would be tested.

Picture 1 – Battery Charging Station overspill drum

**Pursuant to ADEM Admin. Code r. 335-14-3-.01(2) [40 C.F.R. § 262.11], a person who generates a solid waste, as defined in ADEM Admin. Code r. 335-14-2-.01(2) [40 C.F.R. § 261.2], must make an accurate determination as to whether that waste is a hazardous waste in order to ensure wastes are properly managed according to applicable RCRA regulations articulated in ADEM Admin. Code r. 335-14-3-.01(2) [40 C.F.R. § 262.11].**

On March 26, 2024, Mrs Hong provided via email the analytical test results of the battery clean-up material. Mrs. Hong's email stated *"The Toxic Characteristic Leaching Procedure (TCLP) results show all metals are lower than Regulatory Limits and pH 9.9, which means it is non-hazardous waste since the EPA defines Corrosive wastes are acids or bases (pH less than or equal to 2, or greater than or equal to 12.5)."*

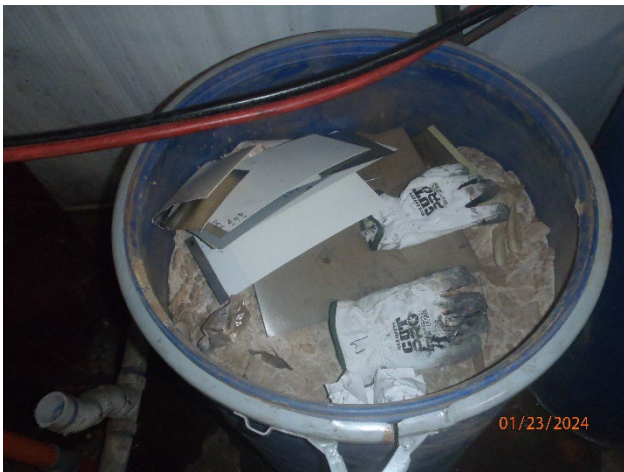
Picture 2 – Battery Charging Station overspill drum

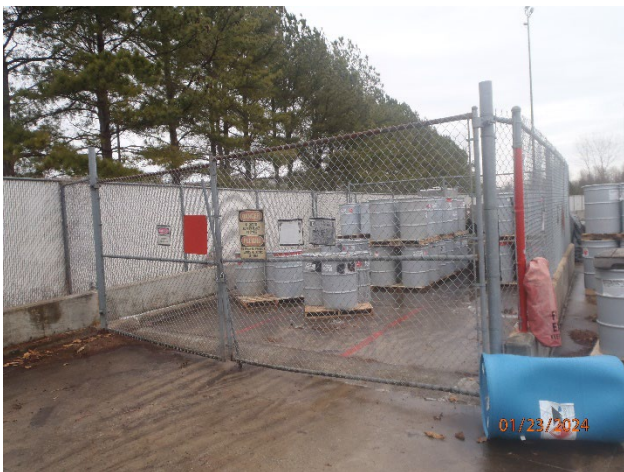
The CAA is located outside and in the rear of the facility. The inspectors observed the CAA was enclosed in a chain fence, locked with signs along the fence (Pictures 3-4). The hazardous waste drums sat on wooden pallets inside a bermed area. The inspectors counted 38 55-gallon drums of hazardous paint waste, solid, liquid and sludge. All containers were observed closed, labeled, and dated.

Picture 3 – 90-Day Storage CAA

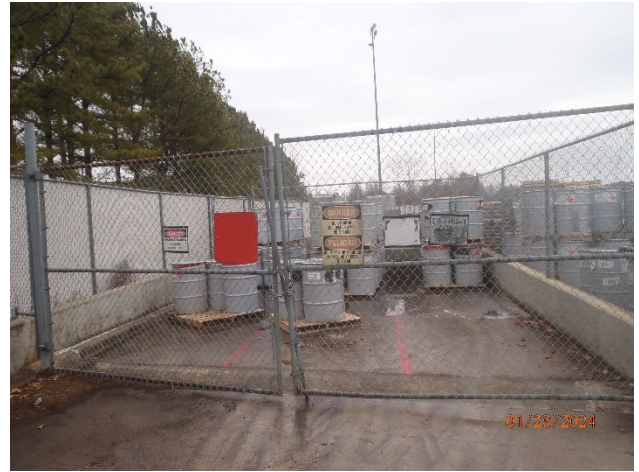
Picture 4 – 90-Day Storage CAA
