**Region 6 - Enforcement & Compliance Assurance Division**  
**INSPECTION REPORT**

| Regulatory Program(s) | NPDES CAFO | |
| Facility Name: | <b>Braum's Dairy</b> | |

Appendix 1 – Photolog: 10 photos taken over two days on September 24 and 26, 2024

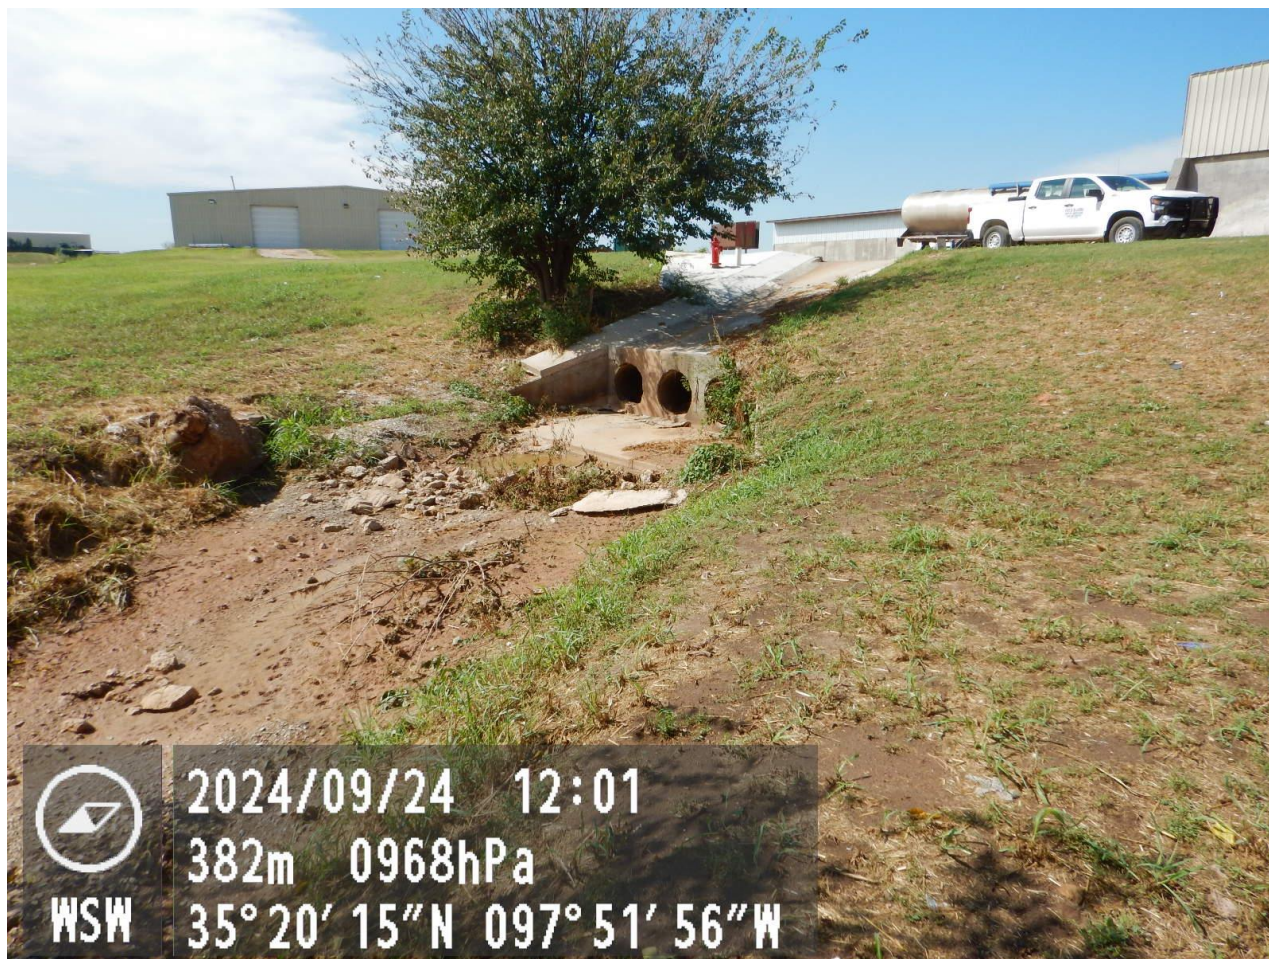
Photo No. 1

Description: The three concrete drainage culverts that would channel runoff from the small roadside pond located near the hay barns and from the drainage area around the feed mill into Snake Creek.

Note: that the small roadside pond is equipped with a dam and a 900 gpm pump that can send water to any land application center pivot (CP), but mostly to D8, D9, D12, D13, and D14, which are fresh water fields. See Photos 25 & 27 from the 7/9-10/2024 inspection report. The view is toward the west-southwest.

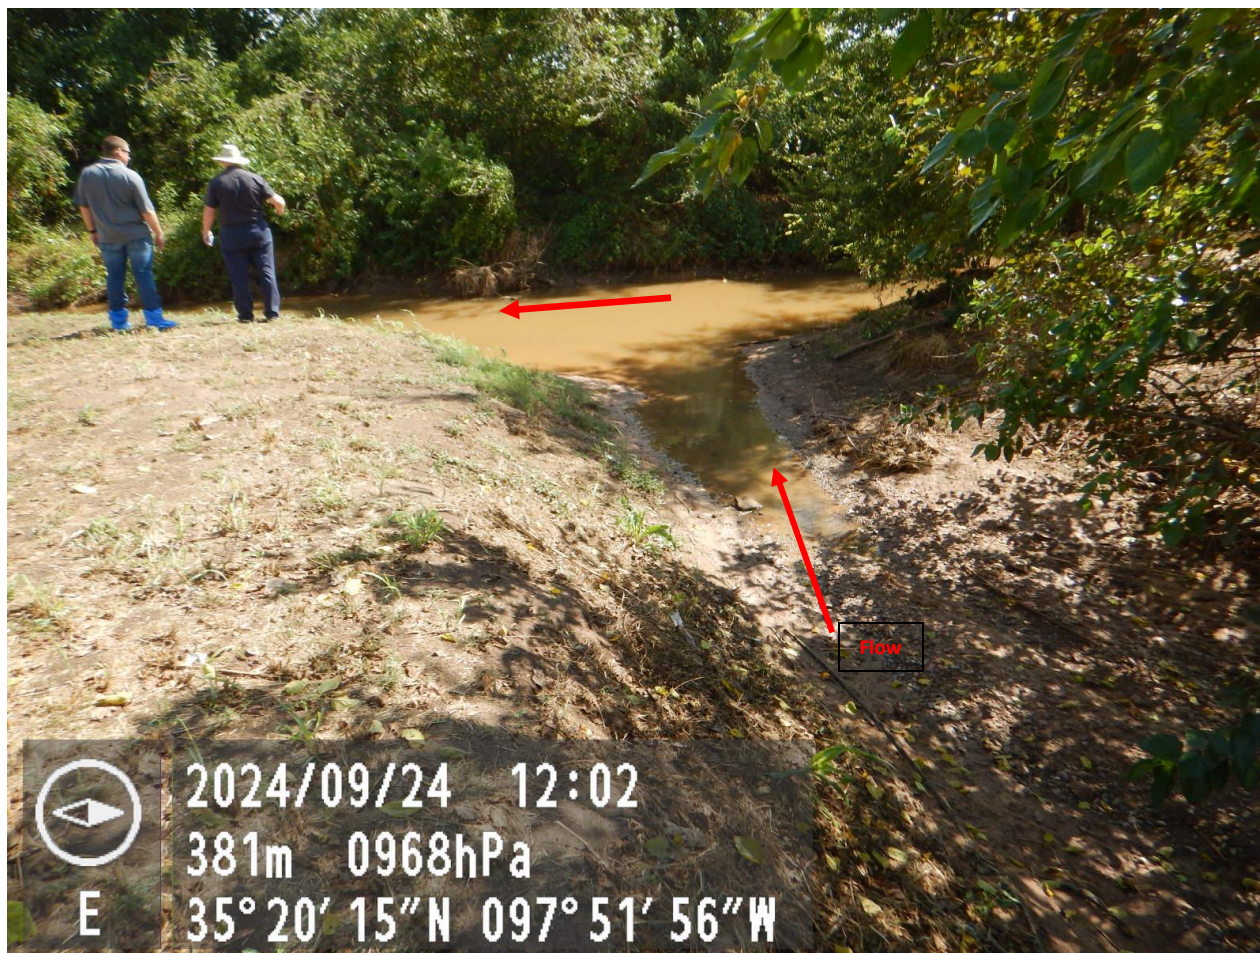
Photo No. 2

Description: The above three concrete culverts discharge thru this channel into Snake Creek, which is shown next to the inspectors. The view is toward the east.

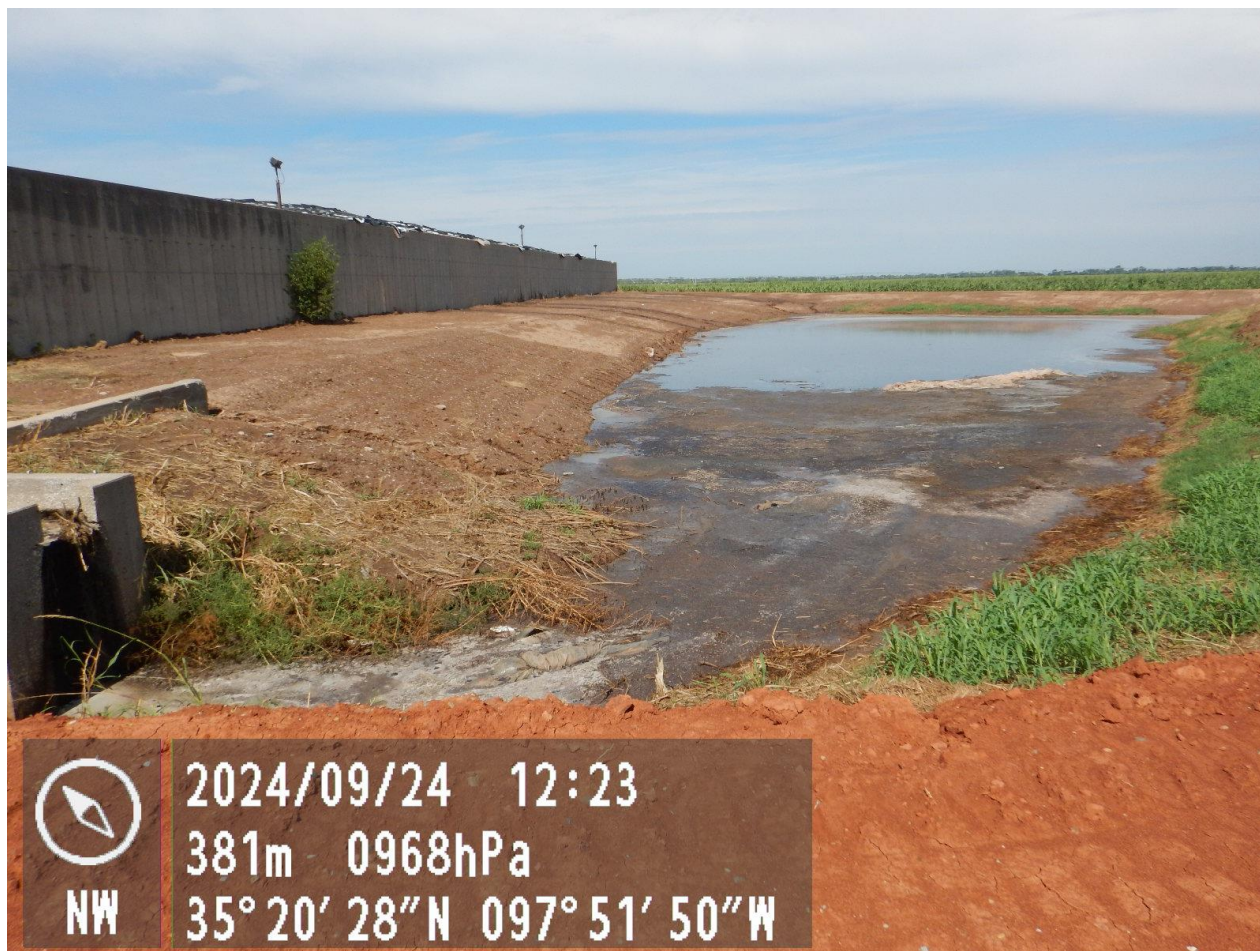
Photo No. 3

Description: Silage bunkers 6 through 12 drain leachate into an unlined pond, which was not discharging at the time of the inspection. It contains high solids and organics. This bunker location is near CP D16. The view is toward the northwest.

- e. Additional ponding adjacent to the east silage storage bunker is comprised of silage liquor discharge. The discharge enters a newly constructed EHP, which is unlined (see Photo 3) and not protective of ground water or protective for the potential for a hydrologic connection to the nearby surface water (Snake Creek). ODAFF CAFO Regulation 35:17-4-16(3) states “Solids, sludges, manure, or other pollutants removed in the course of treatment or control of wastewaters shall be disposed of in a manner designed to prevent pollutants from being discharged to surface or groundwaters of the State.” Additionally, design standards for a lagoon are found in the liner requirements section of the ODAFF CAFO Regulation 35:17-4-11 (a) and the ODAFF CAFO Act Section 20-50 Wastewater Retention Structures Part B, which lists the requirements for lagoon construction.

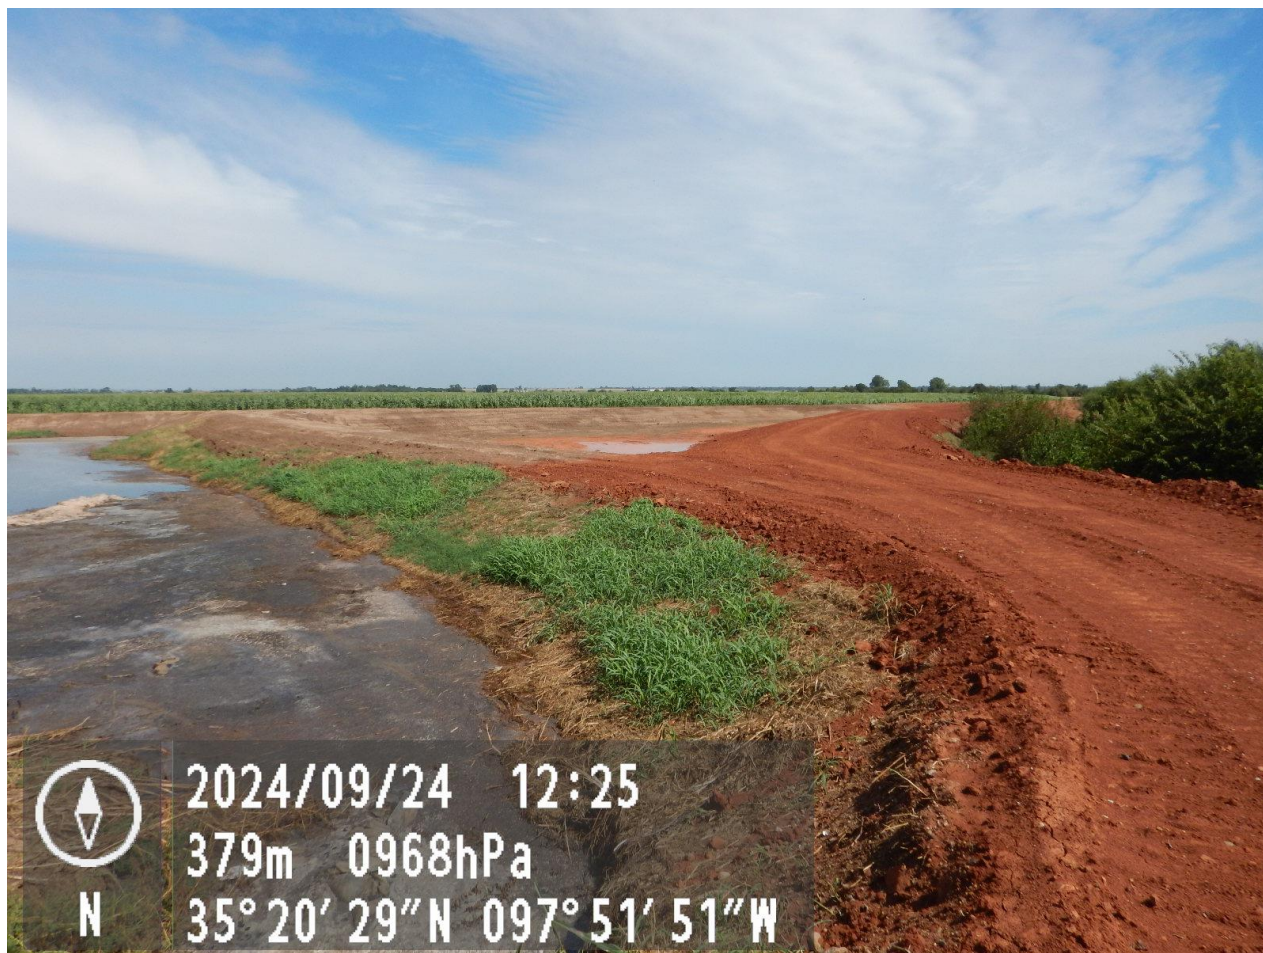
Photo No. 4

Description: A new emergency holding pond (EHP) was constructed on the east side of the silage bunker pond shown in Photo 3 about two weeks prior to the inspection. It is located on the south side of CP D16. It is also unlined and intended to capture CP storm water runoff, but it could also capture overapplication tail water runoff if the field was to receive an over application of CAFO wastewater. The view is toward the north.

- 1) The new EHP containment area for the silage bunker runoff was constructed north of the feed mill. Although this structure is not a lined lagoon structure, it does provide temporary containment to help prevent runoff toward Snake Creek. A discharge of silage bunker runoff into Snake Creek was never documented.
- 2) Berm construction to isolate the land application sites from waterways is ongoing as shown in Photos 4, 8 and 10. Berm isolation construction is expected to be completed in approximately 6 months.
- 3) Language was added to the NMP to prohibit land application of wastewater during rain and freezing weather events.
- 4) The P-Index was completed for all wastewater receiving CP land application sites.

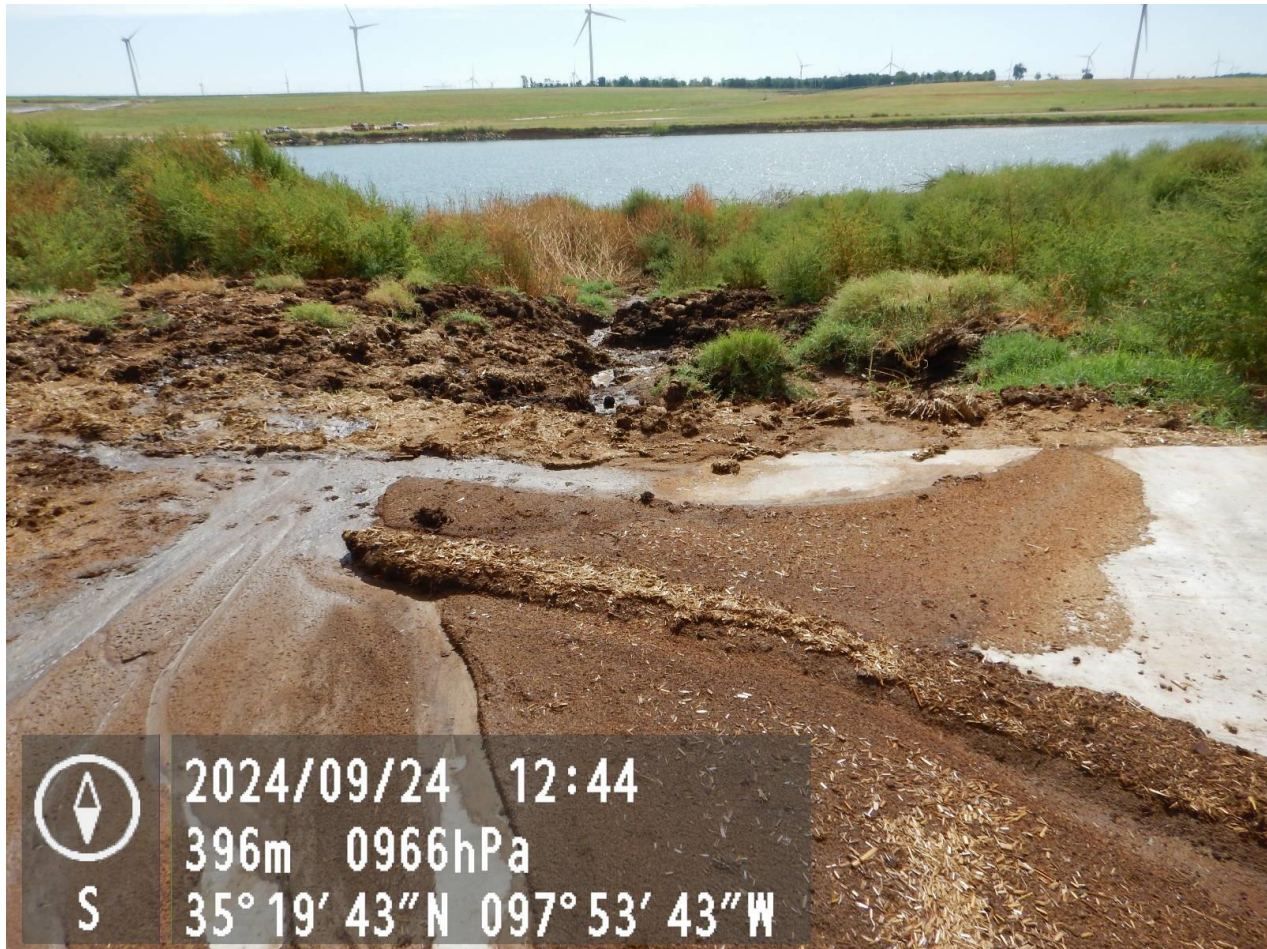
Photo No. 5

Description: Cattle pens located on the southwest side of the RO Pond and discharge into the RO Pond.  
The view is toward the southeast.

- 3) Four cattle pen areas discharging into the two large RO and Snake Creek Ponds or into two other small ponds, rather than into the CAFO lagoon. The dairy's two large fresh-water ponds (the RO Pond and the Snake Creek Pond) each had cattle pens located immediately upslope of the ponds that would discharge contaminated production area storm water runoff into the ponds during a rain event. The RO Pond upslope cattle pens are located on the southwest side the pond (see Photos 5-7). The Snake Creek Pond upslope cattle pens are located on the southwest side of that pond (see Photos 30-32 from the July 9-10, 2024, inspection report). During the inspection, Snake Creek Pond was discharging, having a small rate of flow into Snake Creek, thence the Canadian River. Per the ODAFF CAFO Act Section 20:48 Best Management Practices Part (B)(1) "There shall be no discharge of process wastewater to waters of the state except in accordance with the provisions of the Oklahoma Concentrated Animal Feeding Operations Act."

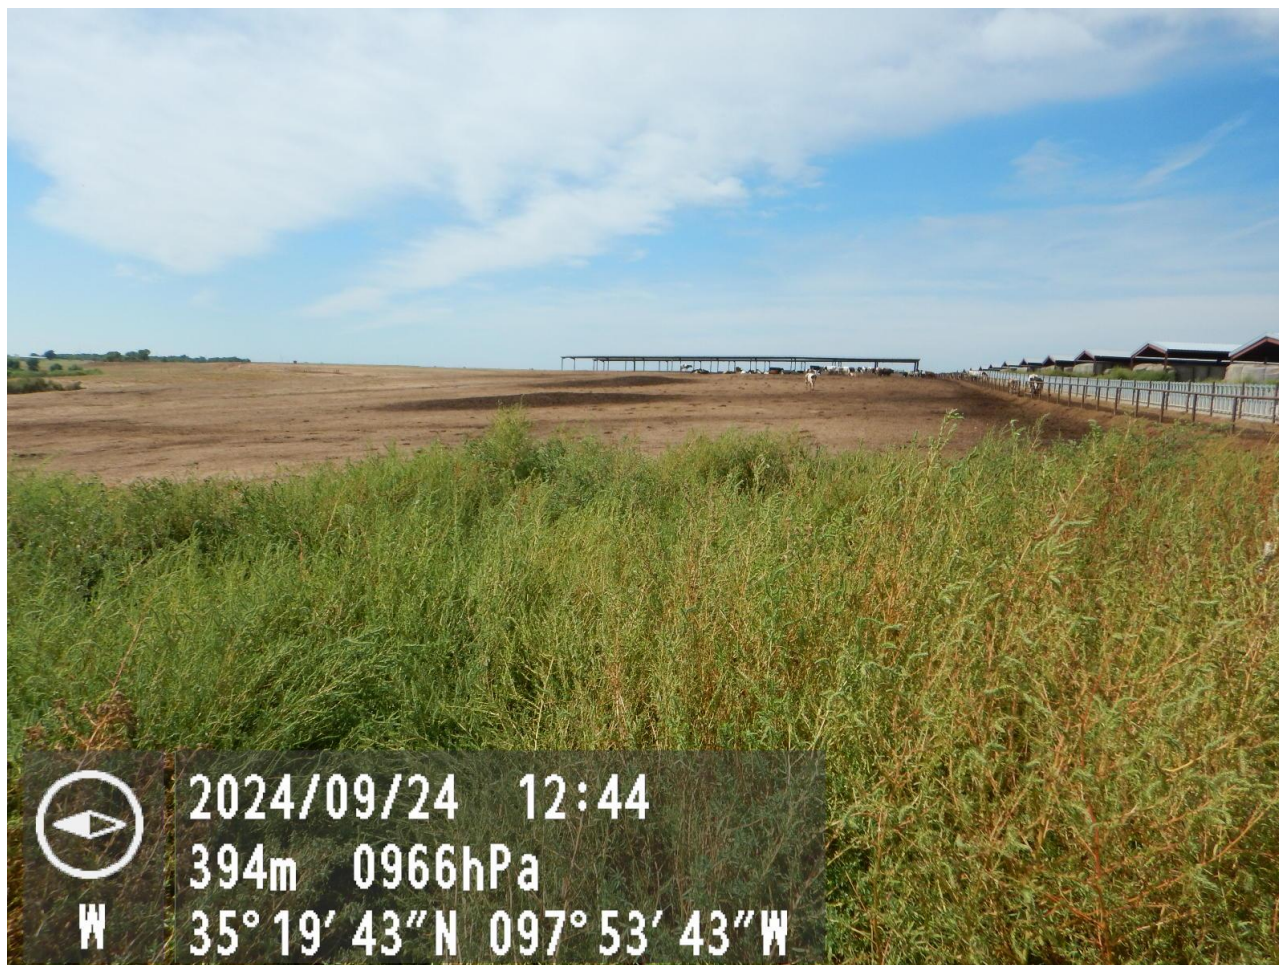
Photo No. 6

Description: Cattle pens located on the southwest side of the RO Pond and discharge into the RO Pond. The photo is taken in the opposite direction of that shown in Photo 5, from about the same location, and the view is toward the west.

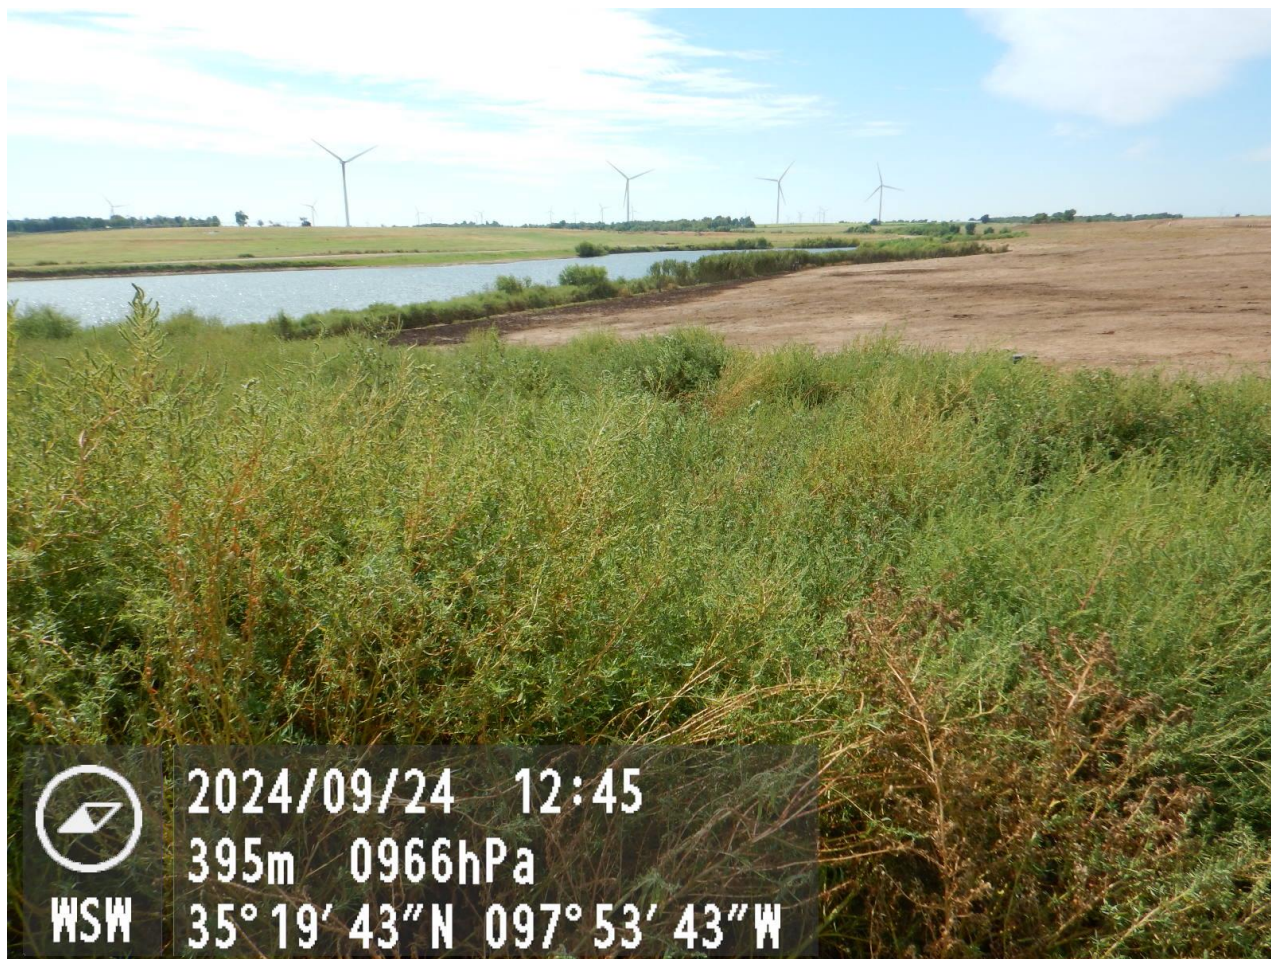
Photo No. 7

Description: Cattle pens shown in Photo 6 discharge downslope toward the RO Pond. This is the most easterly side of the cattle pens located on the west side of the RO Pond. The view is toward the west-southwest.

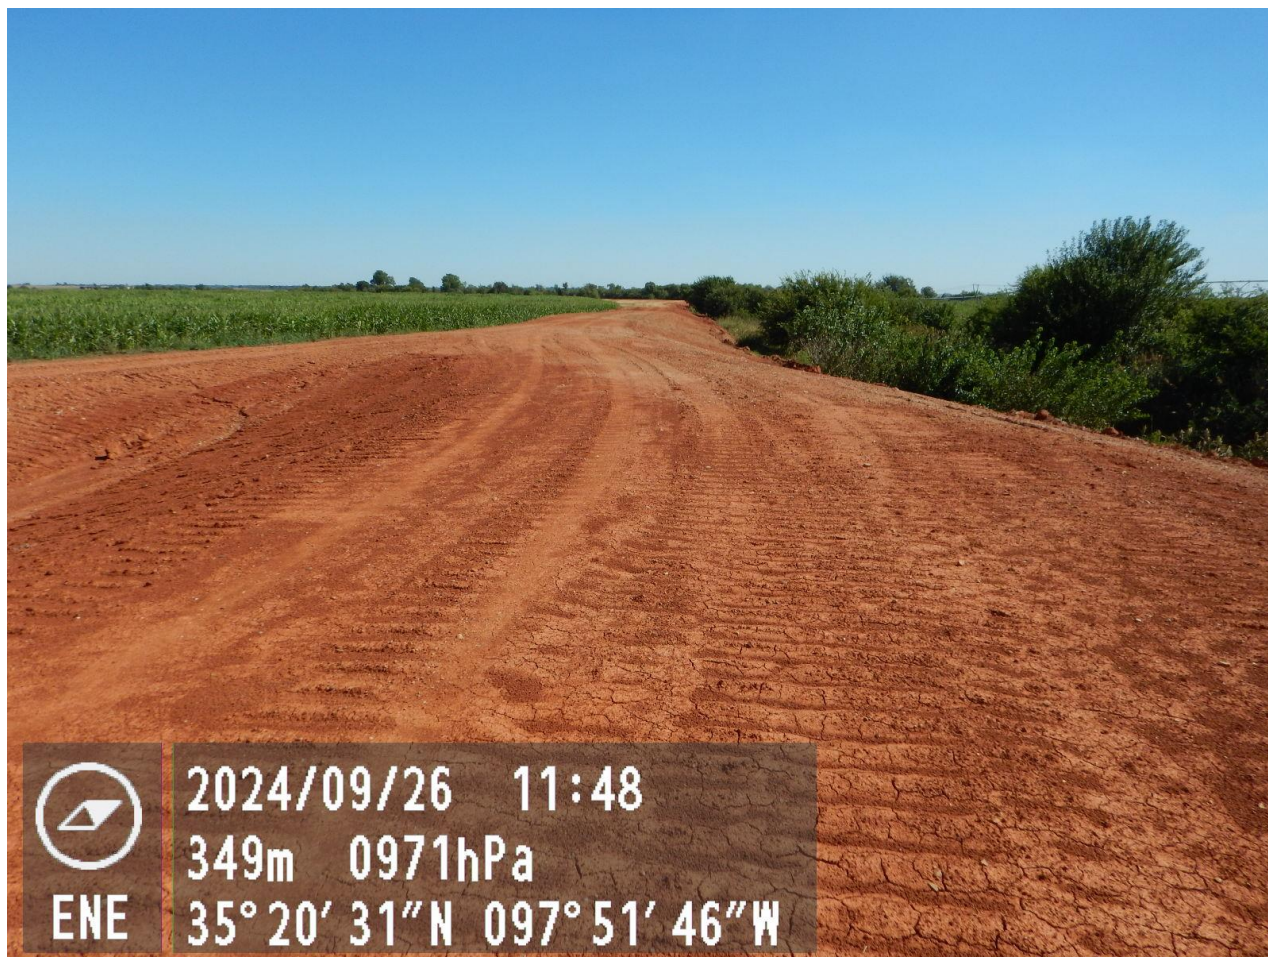
Photo No. 8

Description: This photo was taken east of the location where Photos 3 & 4 were taken. It is representative of the types of berms that Braum's has constructed to prevent runoff from the land application CP sites to adjacent waterways. This berm will be covered with hydro-mulch in the very near future to stabilize the berm. In the distant background, hydro-mulch has already been applied. The view is toward the east-northeast.

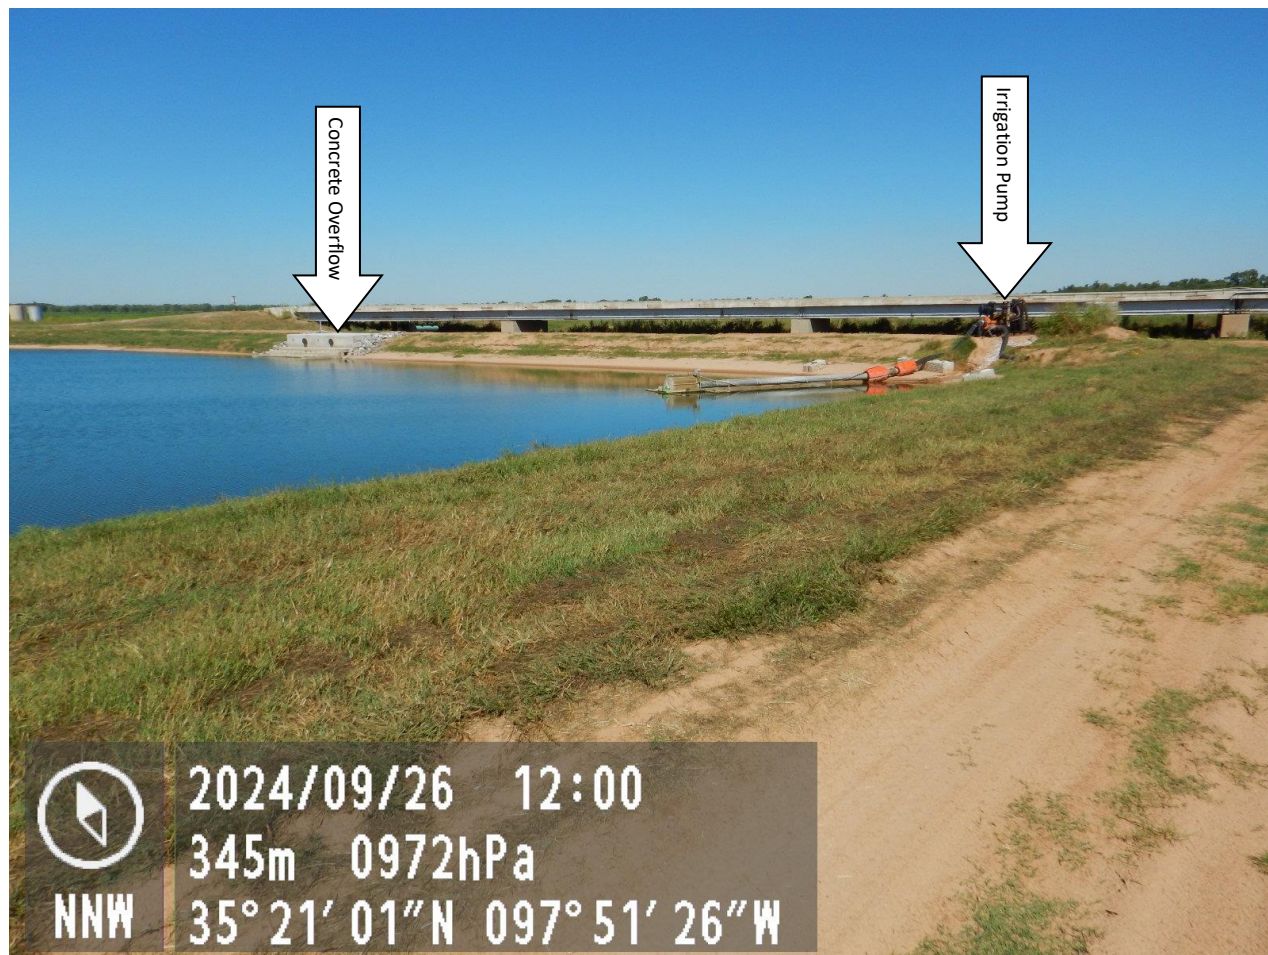
Photo No. 9

Description: The Mustang Bridge Pond containing freshwater drawn from the adjacent Canadian River for land application. Note: that the bridge is a private Braum's bridge and note the irrigation pump. Also, the pond is equipped with a concrete overflow structure (two pipes in the headwall) that leads to the Canadian River. The view is toward the north-northwest.

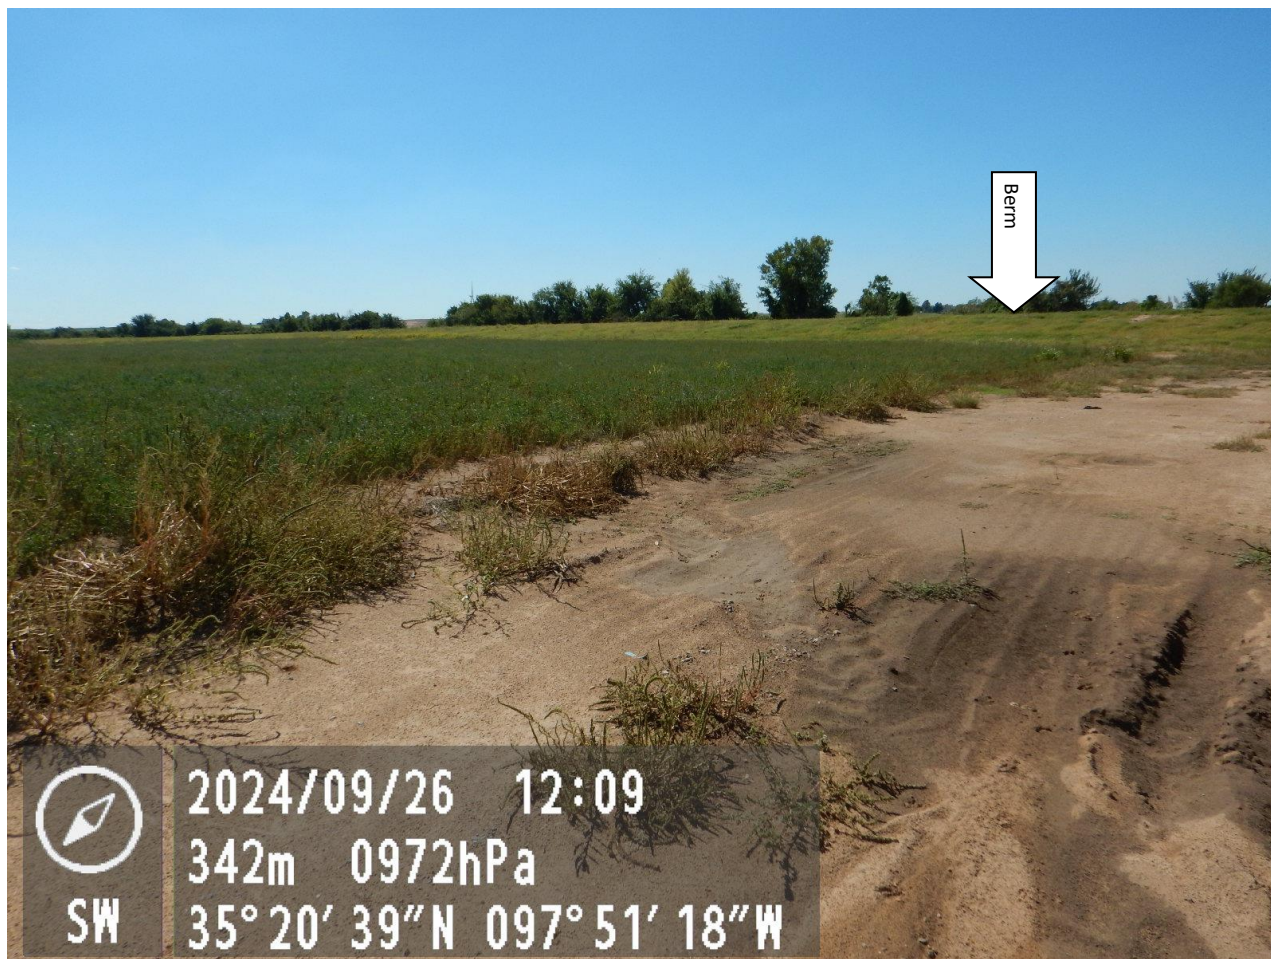
Photo No. 10

Description: The constructed berm located on the southwest side of CP M3 where composting is occurring. Braum's reported that this berm (seen as light green in the background) was hydro-mulched approximately 6 to 9 months ago, and the vegetative cover (maybe something like "is well established"?) has grown well. The view is toward the southwest.
