## **RCRA Inspection Report**

Garrett Aviation Services LLC  
DBA Standard Aero  
1550 Hangar Road  
Augusta, Georgia 30906  
Richmond County

EPA ID# GAD086972718

October 18, 2023

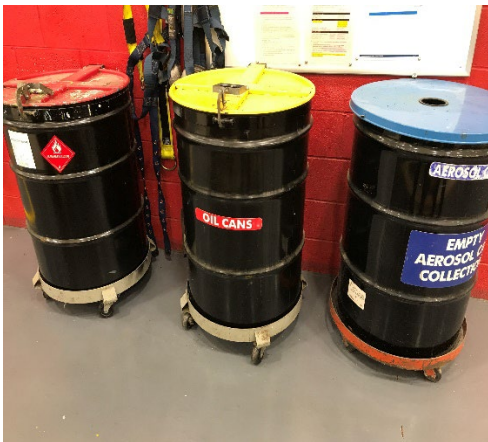
One 55-gallon satellite accumulation area (SAA) drum of waste paint-related material was observed at the time of the inspection (Photo-1). The waste code on the container was noted to be D001, D006, D007, D008, D035, F003 and F005. The container was closed and labeled with the words "Hazardous Waste" and an indication of the hazards of the contents as "Flammable".

Photo-1 SAA Drum Hangar B

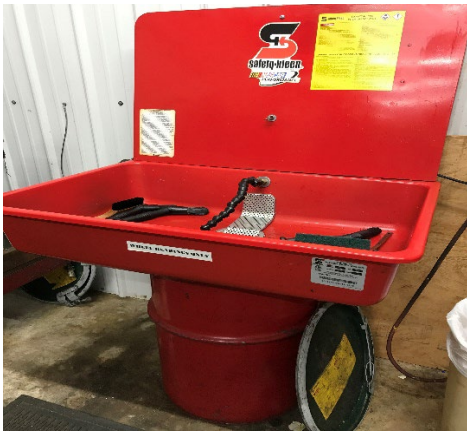
One 55-gallon SAA drum of waste paint-related material was observed at the time of the inspection on a spill pallet (Photo-2). The waste code on the container was noted to be D001, D006, D007, D008, D035, F003 and F005. The container was closed and was labeled with the words "Hazardous Waste" and an indication of the hazards of the contents. The inspector observed a parts washer unit in the same room. The unit was not in operation during the inspection (Photo-3). According to the facility personnel, the parts washer unit is serviced by Safety-Kleen.

Photo-3 Parts Washer, Tool Room

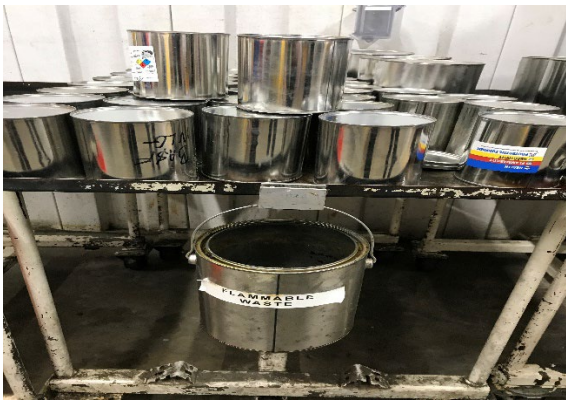
One 1-gallon pail containing flammable (D001) waste was observed hanging from the end of a drip pan at the time of the inspection (Photo-4). The container was not marked with the words "Hazardous Waste". The hazard indication of the contents was labeled as "Flammable Waste". The container was observed to be open and in active accumulation of waste at the time of inspection (Photo-5).

Photo-4 Tool Room, Open SAA Container

**Pursuant to Ga. Comp. R. and Regs. 391-3-11-.08(1) [40 C.F.R. § 262.15(a)(4)], which is a condition of the SAA Permit Exemption, a generator is required to keep containers of hazardous waste closed at all times during accumulation, except when adding, removing, or consolidating waste; or when temporary venting of a container is necessary for the proper operation of equipment, or to prevent dangerous situations, such as build-up of extreme pressure.**

**Pursuant to Ga. Comp. R. and Regs. 391-3-11-.08(1) [40 C.F.R. § 262.15(a)(5)], which is a condition of the SAA Permit Exemption, a generator is required to mark or label its containers (i) with the words “Hazardous Waste” and (ii) with an indication of the hazards of the contents.**

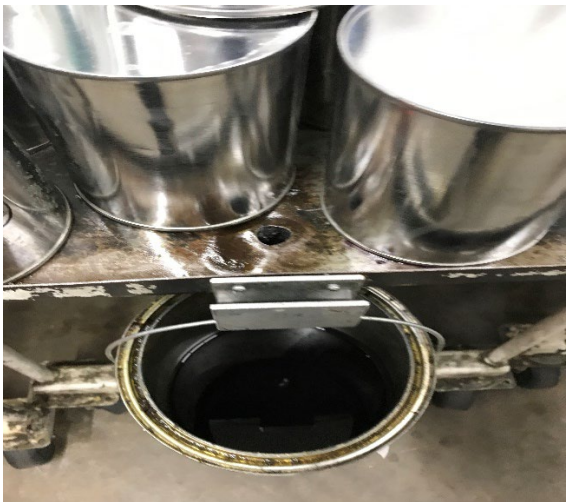
Photo-5 Tool Room, Waste Accumulation

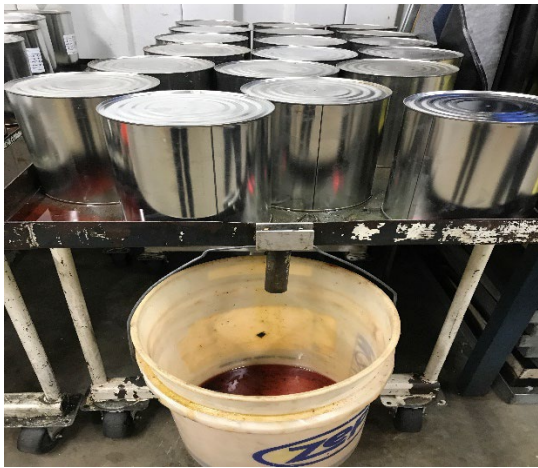
The inspectors observed an open 5-gallon white colored pail hanging from a drip pan actively accumulating waste draining from a drip pan (Photo-6). The inspectors observed waste flammable (D001) liquid in the drip pan as well as D001 waste liquid in the 5-gallon pail. The container was not labeled with the words “Hazardous Waste” or with an indication of the hazards of the contents.

Photo-6 Tool Room, Open Container with waste accumulation

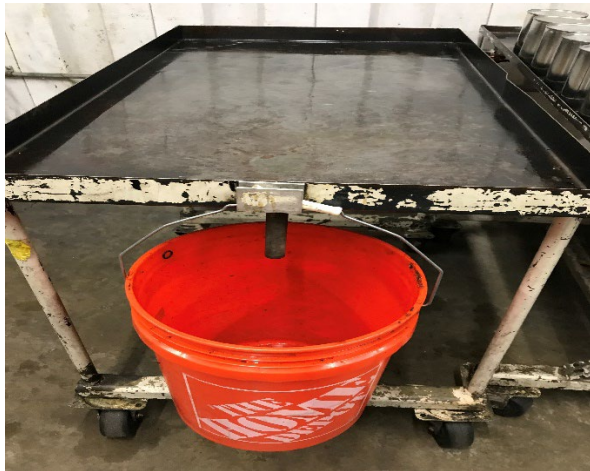
There was one 5-gallon orange colored open and unlabeled pail with no hazard indication was also hanging from the end of a drip pan in an adjacent cart (Photo-7). The pail was observed to be empty. There was no accumulation of waste observed during the inspection. The inspectors recommended to the facility personnel that if the pail was used to collect hazardous waste, the container of hazardous waste shall be kept closed except when adding, removing, or consolidating waste and marked with the words “Hazardous Waste” and with an indication of the hazards of the content. The inspectors recommended to the facility personnel that if the pail was used to collect hazardous waste, the container of hazardous waste shall be kept closed except when adding, removing, or consolidating waste and marked with the words “Hazardous Waste” and with an indication of the hazards of the contents.

Photo-7 Tool Room, Empty Pail

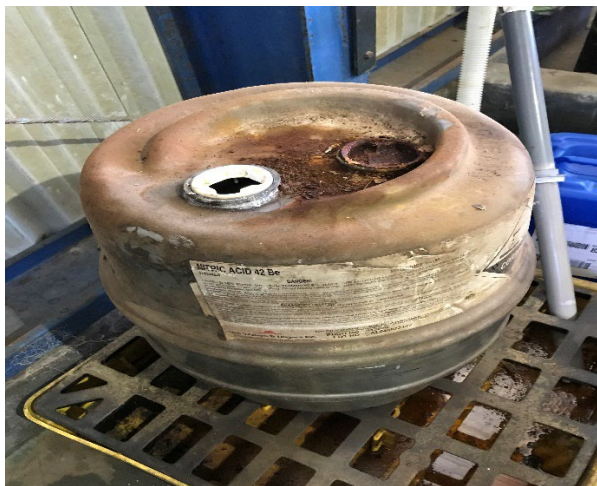
At the time of the inspection, a 20-gallon container of waste nitric acid (D002) was open and was not labeled with the words “Hazardous Waste” and with no indication of hazards of the contents (Photo-8). The open container of D002 waste was closed at the time of the inspection. There was D002 waste liquid in the secondary containment (Photo-8).

Photo-8 CAA Open D002 Waste Container, D002 Waste in Secondary Containment

**Pursuant to Ga. Comp. R. and Regs. 391-3-11-.08(1) [40 C.F.R. § 262.17(a)(1)(iv)], which is a condition of the LQG Permit Exemption, (A) a container holding hazardous waste must always be closed during accumulation, except when it is necessary to add or remove waste; and (B) A container holding hazardous waste must not be opened, handled, or stored in a manner that may rupture the container or cause it to leak.**

**Pursuant to Ga. Comp. R. and Regs. 391-3-11-.08(1) [40 C.F.R. § 262.17(a)(5)(i)], which is a condition of the LQG Permit Exemption, a generator must mark or label its containers with the following: the words “Hazardous Waste”; an indication of the hazards of the contents; and the date upon which each period of accumulation begins clearly visible for inspection on each container.**

**Pursuant to Ga. Comp. R. and Regs. 391-3-11-.08(1) [40 C.F.R. § 262.17(a)(6)], which incorporates Ga. Comp. R. and Regs. 391-3-11-.08(1) [40 C.F.R. § 262.251], and is a condition of the LQG Permit Exemption, a generator is required to maintain and operate its facility to minimize the possibility of a fire, explosion, or any unplanned sudden or non-sudden release of hazardous waste or hazardous waste constituents to air, soil, or surface water which could threaten human health or the environment.**

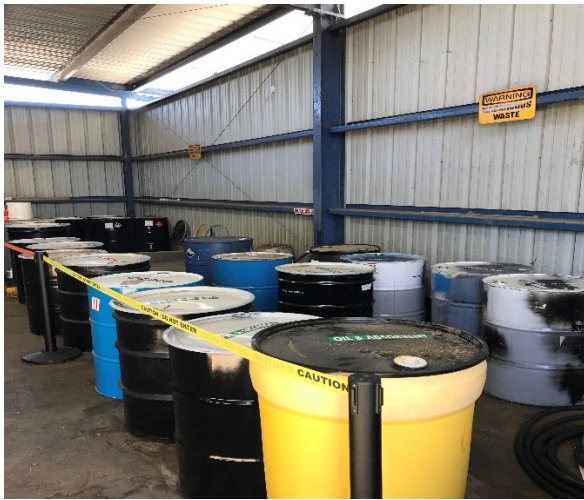
Additionally, at the time of the inspection, the inspectors observed that there was insufficient aisle space in the CAA (Photo-9). The inspectors had difficulty accessing the containers stored in the CAA for the purpose of conducting the inspection.

Photo-9 CAA-Inadequate Aisle Space

**Pursuant to Ga. Comp. R. and Regs. 391-3-11-.08(1) [40 C.F.R. § 262.17(a)(6)], which incorporates Ga. Comp. R. and Regs. 391-3-11-.08(1) [40 C.F.R. § 262.255], and is a condition of the LQG Permit Exemption, a generator is required to maintain aisle space to allow the unobstructed movement of personnel, fire protection equipment, spill control equipment, and decontamination equipment to any area of facility operation in an emergency, unless aisle space is not needed for any of these purposes.**

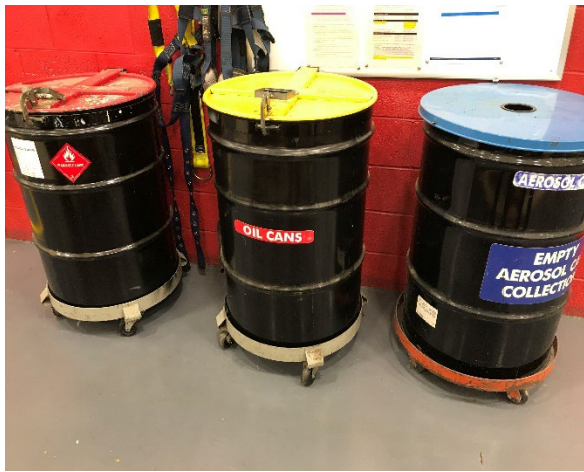
One 55-gallon drum of empty oil cans (Photo-10) was observed adjacent to a SAA drum. The drum was closed and labeled as “oil cans”.

Photo-10 Hangar B, Oil Cans

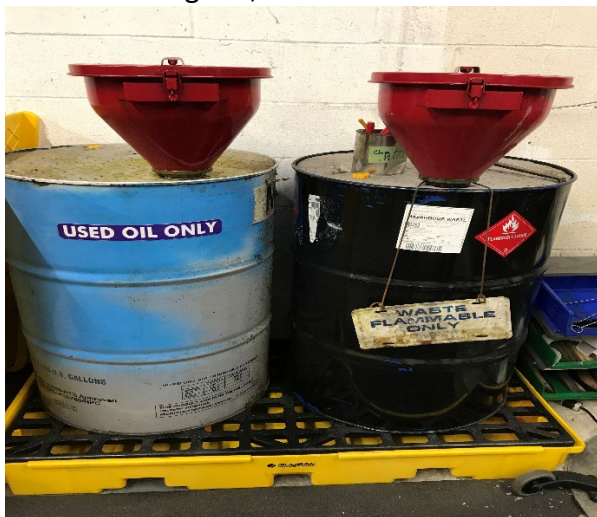
The inspectors observed a 55-gallon drum labeled as “used oil”. The drum was closed and staged on a spill pallet adjacent to a SAA drum (Photo-11).

Photo-11 Tool Room Used Oil

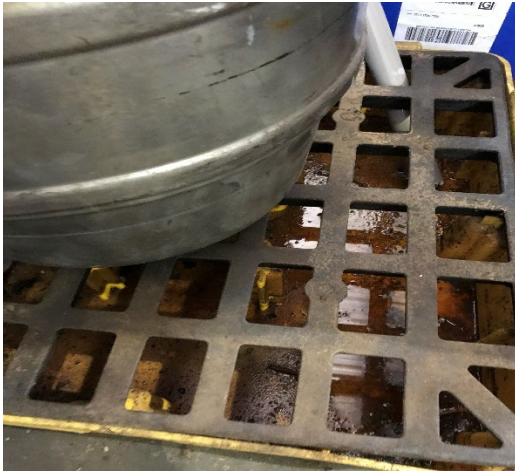
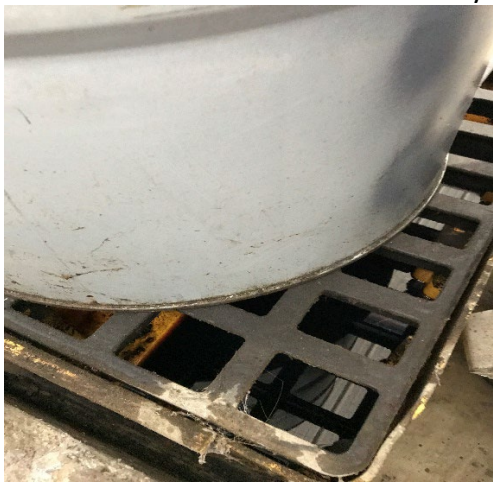
At the time of the inspection, there were two used oil drums in the CAA that had oil in the secondary containment below the drums (Photo-12 and Photo-13). **This is an area of concern. Any oil in the secondary containment shall be cleaned up and managed properly to prevent release of used oil to the environment.**

Photo-12 CAA- Used Oil in Secondary Containment

Photo-13 CAA- Used Oil in Secondary Containment

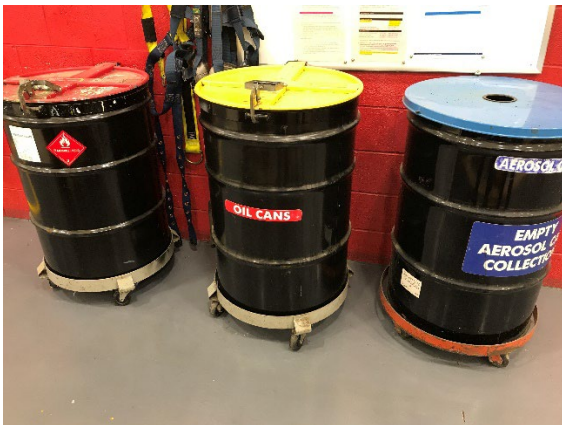
There was one 55-gallon closed drum labeled as “Empty Aerosol Cans Collection” adjacent to drum containing oil cans near the SAA container (Photo-14). Upon review of the Safety Data Sheets (SDS) for a spent aerosol can observed in this drum, O’Reilly Break Parts Cleaner was

Photo-14 Hangar B Empty Aerosol Can Collection

**Pursuant to Ga. Comp. R. and Regs. 391-3-11-.08(1) [40 C.F.R. § 262.11], a person who generates a solid waste, as defined in O.C.G.A. §12-8-62(20) [40 C.F.R. § 261.2], must make an accurate determination as to whether that waste is a hazardous waste in order to ensure wastes are properly managed according to applicable RCRA regulations articulated in Ga. Comp. R. and Regs. 391-3-11-.08(1) [40 C.F.R. § 262.11].**

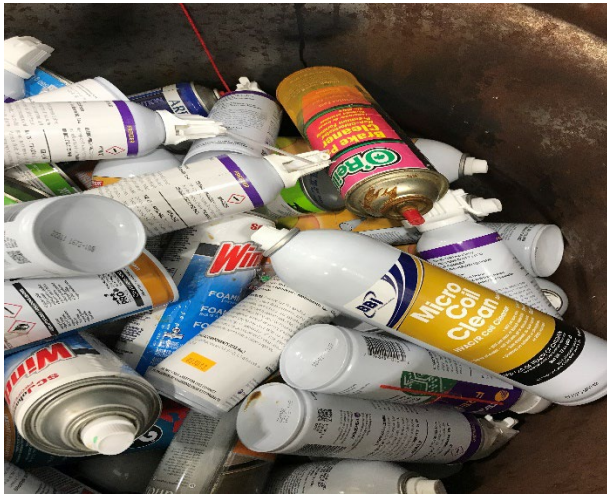
shown to be a flammable (D001) waste, this waste was not properly characterized as hazardous waste (Photo-15).

Photo-15 Hangar B Spent Aerosol Cans (O'Reilly)

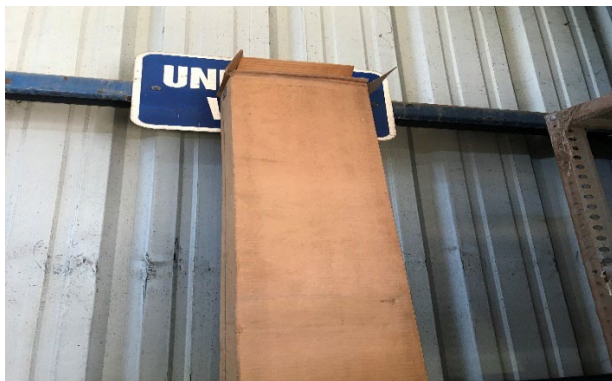
All containers of universal waste were closed and labeled with the words “Universal Waste” and with an accumulation start date, with the exception of one 8-foot universal waste lamp box. The 8-foot universal waste lamp box was observed to be open, unlabeled and with no accumulation start date. The 8-foot box was closed, labeled, and dated at the time of the inspection (Photo-17).

Photo-17 Universal Waste Lamp Box(Open)

Pursuant to Ga. Comp. R. and Regs. 391-3-11-.18 [40 C.F.R. § 273.14(e)], a SQHUW must label or mark each lamp or container of lamps clearly with one of the following phrases: “Universal Waste-Lamp(s),” or “Waste Lamp(s),” or “Used Lamps.”

Pursuant Ga. Comp. R. and Regs. 391-3-11-.18 [40 C.F.R. § 273.13(d)], a SQHUW must manage universal waste lamps in a way that prevents releases of any universal waste or component of a universal waste to the environment.

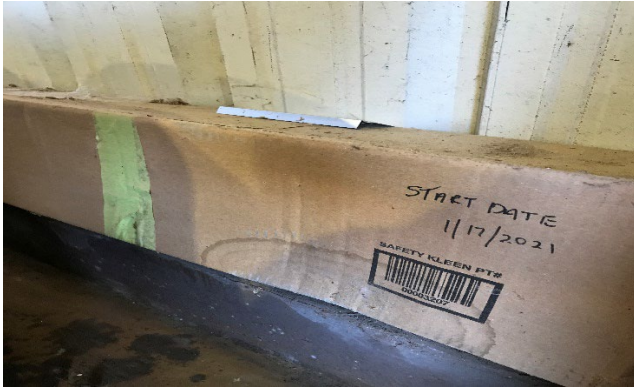
Additionally, the accumulation start date for the other 8-foot universal waste lamps container had an accumulation start date of January 17, 2021, which had exceeded the one-year accumulation time limit (Photo-18).

Photo-18 Universal Waste Lamp  
Accumulation Start Date in excess of one year.

Pursuant to Ga. Comp. R. and Regs. 391-3-11-.18 [40 C.F.R. § 273.15(a) and (c)], a SQHUW may accumulate universal waste no longer than one year and must to be able to demonstrate the length of time that the universal waste has accumulated from the date that it became a waste or was received.
