## **RCRA Inspection Report**

Mississippi Air National Guard (MS ANG) Combat Readiness Training Center (CRTC)  
4715 Hewes Avenue  
Gulfport, Mississippi 39501  
EPA ID No.: MS6570090013

November 17, 2021

**COMPLIANCE EVALUATION Inspection**

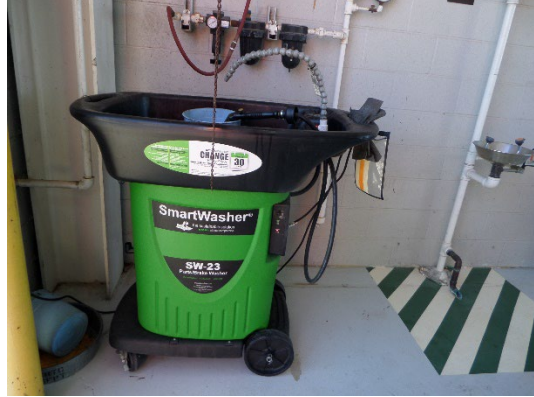
The Aerospace Ground Shop provides maintenance and servicing support for various aircraft equipment. There is no painting activity conducted on site. The inspectors observed a Smart Washer, SW-23 Model, Parts/Brake equipment (Photo-10). The equipment was not in service at the time of inspection. The equipment used a biodegradable solution for parts washing. The cleaning fluid was determined to be nonhazardous. In the same area, the inspectors observed an unlabeled parts washer in the service area (Photo-11). The equipment was not in use at the time of inspection. The maintenance personnel stated that the facility had a contract with Safety-Kleen Systems Inc. for servicing the parts washer equipment. The equipment was later labeled before the end of the inspection.

Photo-10 Nonhazardous Parts Washer Unit

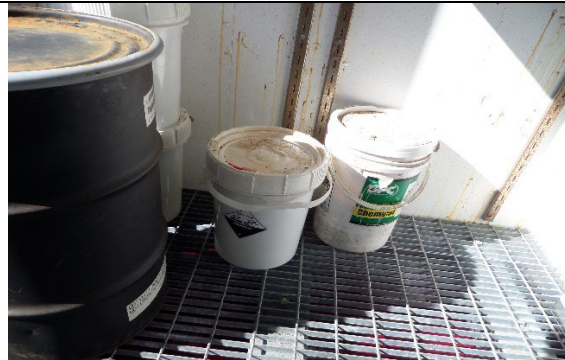
The Central Accumulation Point storage is a separate building with a sign at the entrance indicating the building use and emergency contact information (Picture-13). The storage area was equipped with fire protection equipment. The waste streams stored in the storage included corrosives, universal waste, and nonregulated waste. The inspectors observed one 55-gallon drum labeled as “Nonhazardous Waste” and one empty 30-gallon container. In addition, the inspectors observed three unlabeled and undated 5-gallon buckets containing spent batteries. One of the 5-gallon bucket containing spent batteries had a corrosive label on it (Picture-14).

**Pursuant to 11 Miss. Admin. Code Pt. 3, R. 1.3 [40 C.F.R. § 273.14(a)], a SQHUW must label or mark each Universal Waste battery or container or tank in which the batteries are contained clearly with one of the following phrases: “Universal Waste - Battery(ies),” or “Waste Battery(ies),” or “Used Battery(ies).”**

**Pursuant to 11 Miss. Admin. Code Pt. 3, R. 1.3 [40 C.F.R. § 273.15(a) and (c)], a SQHUW may accumulate universal waste no longer than one year and must be able to demonstrate the length of time that the universal waste has accumulated from the date that it became a waste or was received.**

Photo-14 Spent Batteries with hazard indication

An email was later sent indicating that all the buckets containing spent batteries were labeled, dated, and moved to the universal waste storage shed. The inspectors observed bright reddish colored fluid on the grated floor of the storage building. Mr. Akozbek suspected the liquid to be antifreeze fluid. He said that he was in the process of making a waste determination prior to disposing of the unknown liquid (Photo-15). The inspectors requested Mr. Akozbek to provide a copy of the manifest and/or a bill of lading for the unknown liquid for disposal.
