## RCRA Inspection Report

Advanced Environmental Options, Inc.  
25 Stan Perkins Road  
Spartanburg, Spartanburg County  
South Carolina 29307

June 18, 2024, at 9:00 a.m.

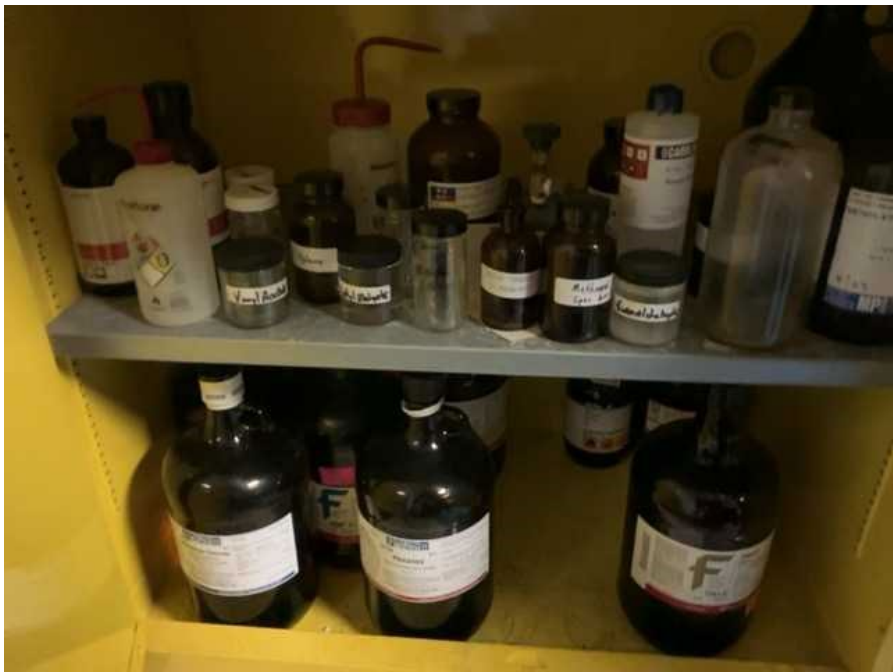
In a side laboratory, the inspectors observed several containers of laboratory chemicals, chemical solutions and possible samples in a flammable cabinet ranging in volume from approximately several millimeters to several liters. The inspectors observed liter containers of laboratory chemicals labeled with the words methanol, sodium hydroxide, toluene, and methyl ether. The inspectors observed several containers of chemical solutions and possible samples ranging in volume from approximately several milliliters to a quart marked or labeled with the words vinyl alcohol, methanol, formaldehyde, sodium nitrate, and xylene. Some of the containers were not clearly marked and labeled with words that could be read (Photographs 2 and 3).

| In a side laboratory, the inspectors observed several containers of laboratory chemicals, chemical solutions, and possible samples in a flammable cabinet | | | |

At the time of the CEI, inspectors observed that an accurate waste determination was not available.

**Pursuant to S.C. Code Ann. Regs. 61-79.262.11 [40 C.F.R. § 262.11], a person who generates a solid waste, as defined in S.C. Code Ann. Regs. 61-79.261.2 [40 C.F.R. § 261.2], must use the steps articulated in S.C. Code Ann. Regs. 61-79.262.11 [40 C.F.R. § 262.11] to make an accurate determination as to whether that waste is a hazardous waste in order to ensure wastes are properly managed according to applicable RCRA regulations.**

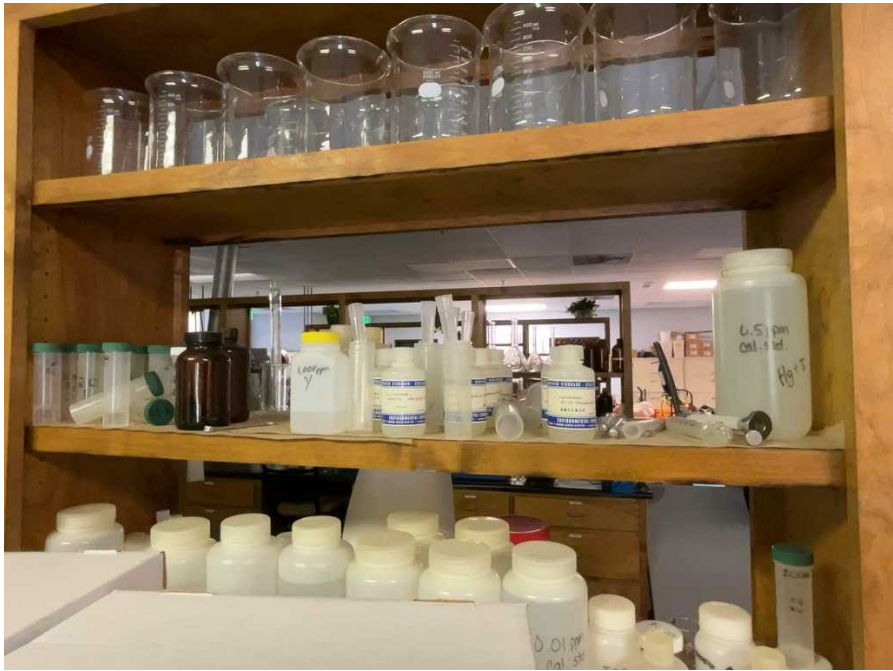
In the main Laboratory inspectors observed several laboratory chemicals and chemical solutions on benches and on shelves ranging in size from several millimeters to several liters. Near the rear of the Laboratory on a shelf the inspectors observed several 100 milliliter bottles of chemical standards containing the metals arsenic, barium, cadmium, selenium, or silver in two percent nitric acid. The standards were marked with the date May 13, 2011. The standard for cadmium was not marked with a date. On the same shelf the inspectors observed a 0.5-liter bottle of chemical reagent marked with the words “6.5 ppm Cal. Std. Hg”. The number next to the abbreviated chemical symbol Hg could not be read. (Photographs 5, 6, 7, and 8).

| Near the rear of the laboratory on a shelf the inspectors observed several 100 milliliter bottles of chemical standards containing the metals arsenic, barium, cadmium, selenium, or silver in two percent nitric acid. | | | |

At the time of the CEI, inspectors observed that an accurate waste determination was not available.

**Pursuant to S.C. Code Ann. Regs. 61-79.262.11 [40 C.F.R. § 262.11], a person who generates a solid waste, as defined in S.C. Code Ann. Regs. 61-79.261.2 [40 C.F.R. § 261.2], must use the steps articulated in S.C. Code Ann. Regs. 61-79.262.11 [40 C.F.R. § 262.11] to make an accurate determination as to whether that waste is a hazardous waste in order to ensure wastes are properly managed according to applicable RCRA regulations.**

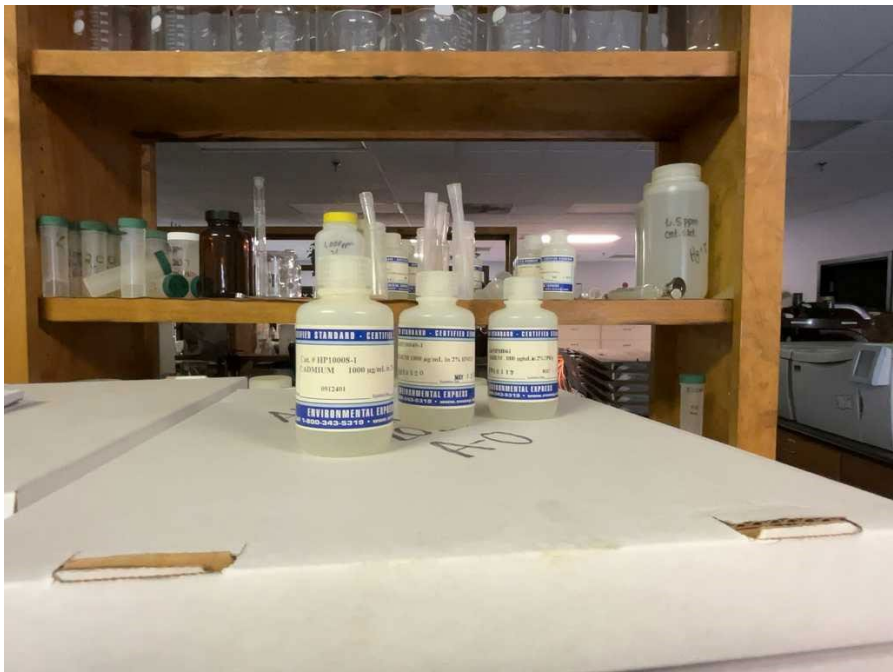
| Near the rear of the laboratory on a shelf the inspectors observed several 100 milliliter bottles of chemical standards containing the metals arsenic, barium, cadmium, selenium, or silver in two percent nitric acid. On the same shelf the inspectors observed a 0.5-liter bottle of chemical reagent marked with the words “6.5 ppm Cal. Std. Hg”. | | | |

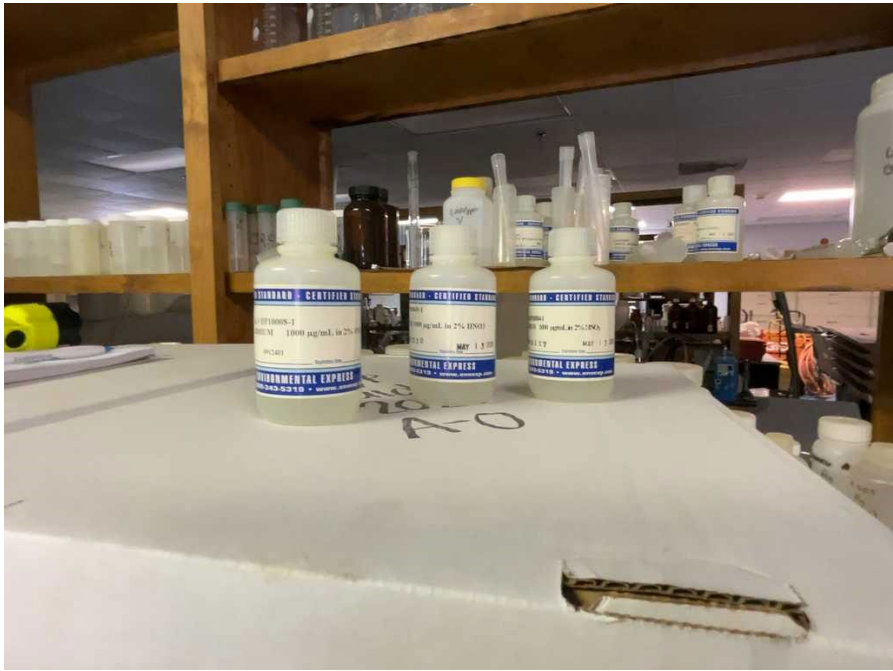
| Near the rear of the laboratory on a shelf the inspectors observed several 100 milliliter bottles of chemical standards containing the metals arsenic, barium, cadmium, selenium, or silver in two percent nitric acid. | | | |

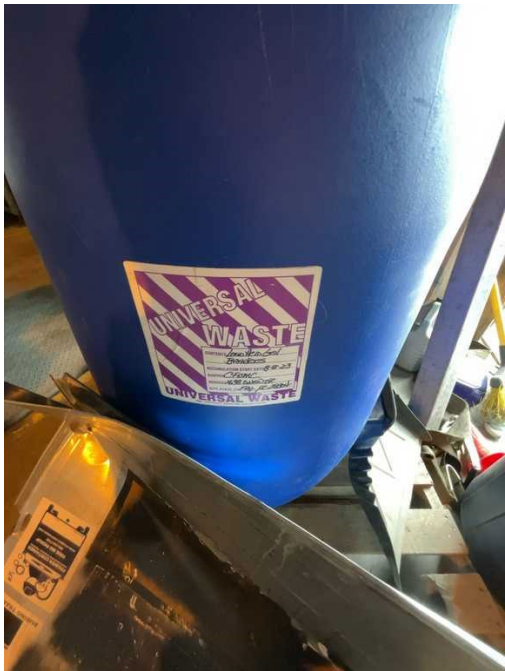
On the north side of the Warehouse AEO operates a Universal Waste Storage Area. The inspectors observed a 55-gallon container on a wooden pallet storing lead acid gel batteries next to a loading dock. The container was closed, in good condition, labeled with the words universal waste, and marked with the date August 8, 2023. The inspectors observed material in a plastic bag on top of the container, some housekeeping equipment and other miscellaneous material on the floor next to the container of universal waste (Photographs 9 and 10). The facility should keep the area surrounding the container clear of material.

| The inspectors observed a 55-gallon container on a wooden pallet storing lead acid gel batteries. Material stored on top of container. | | | |

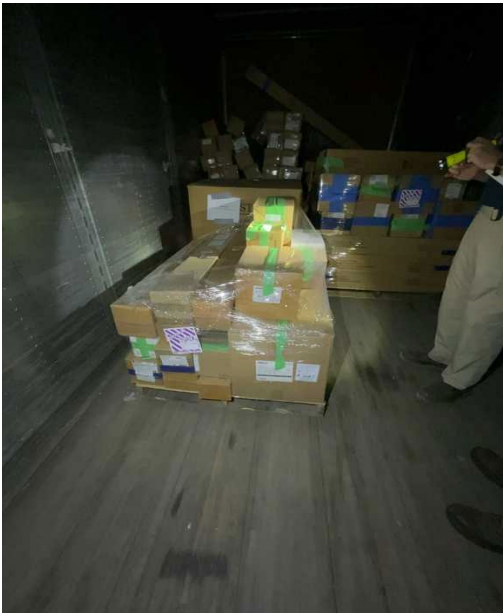
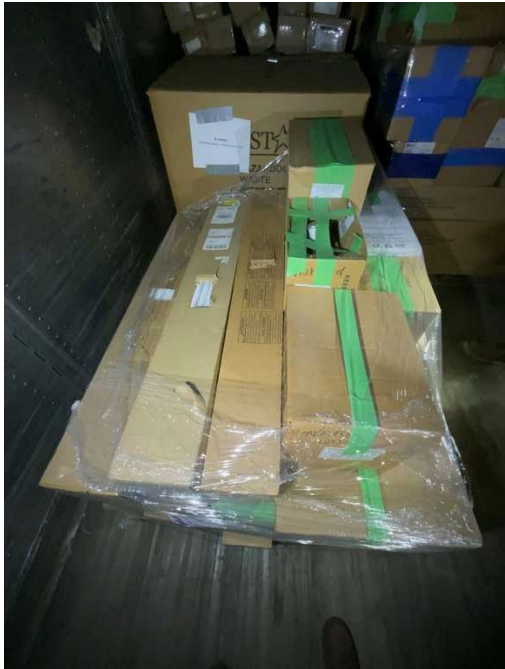
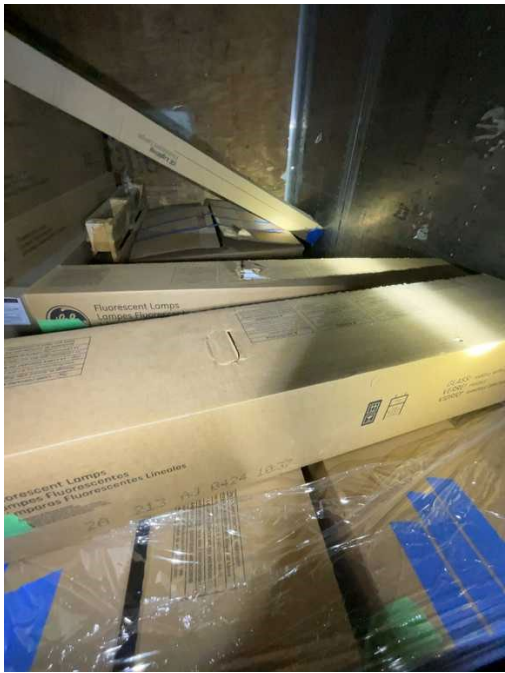
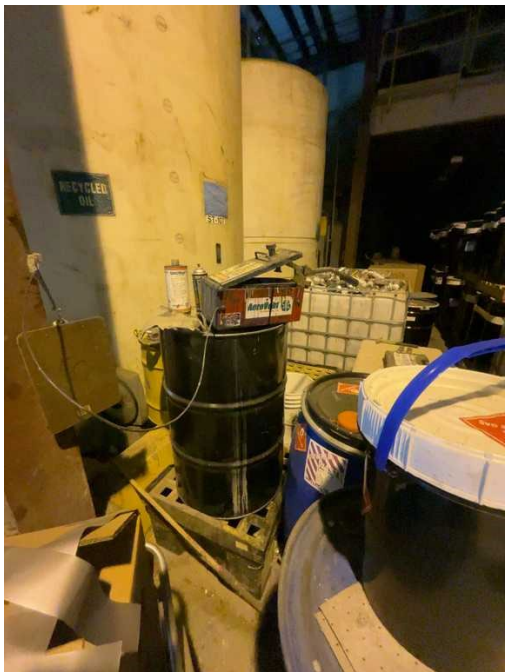
| The inspectors observed one container storing lamps labeled with the words universal waste and marked with the date May 24, 2024. The inspectors observed the container was wrapped in green tape and was not closed. | | | |

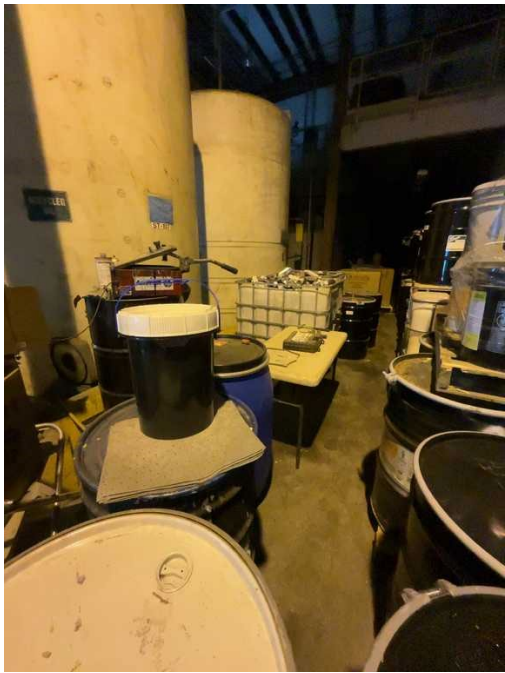
| The inspectors observed the container was not closed, was not marked, or labeled with the words hazardous waste, and not marked or labeled with an indication of the hazards. | | | |

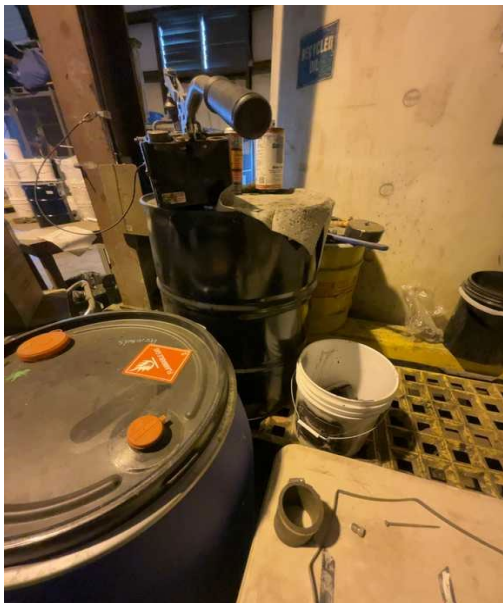
| Stan Perkins Site/Warehouse Aerosol Can Area - Photograph 16 | | | 35.03338554, -81.87327479 |

| The inspectors observed the container was not closed, was not marked, or labeled with the words hazardous waste, and not marked or labeled with an indication of the hazards. | | | |

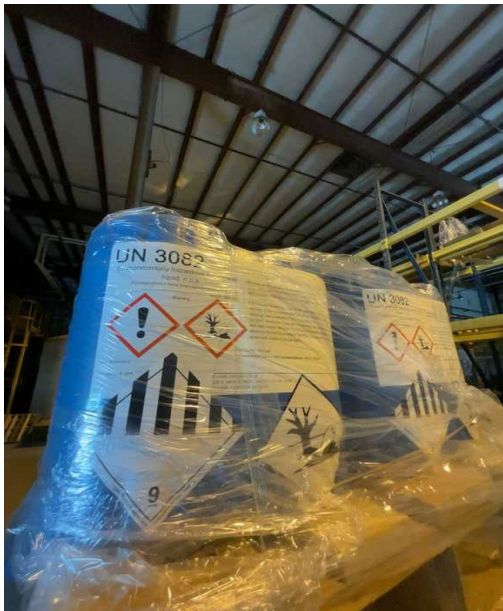
| Stan Perkins Site/Warehouse Aerosol Can Area - Photograph 17 | | | 35.03338491, -81.87327452 |

| The inspectors observed the container was not closed, was not marked, or labeled with the words hazardous waste, and not marked or labeled with an indication of the hazards. | | | |

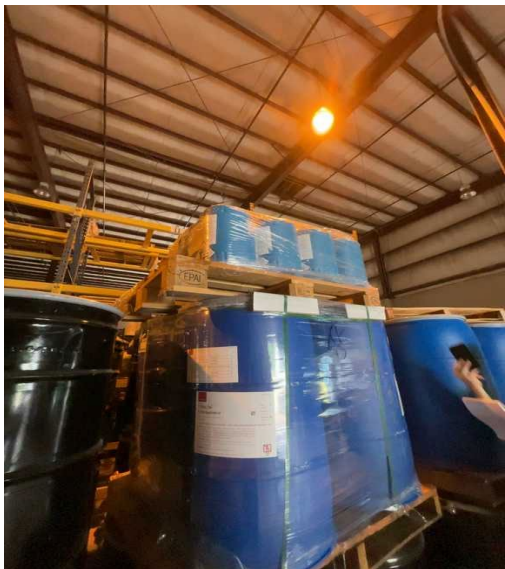
The inspectors observed eight five-gallon containers of unused hazardous material from Pureon Company and several containers of unused environmentally hazardous substance, liquid, NOS (pentaerythritol tetra (mercaptopropionate)) (Photograph 18). The inspectors observed 55-gallon containers storing the following; glycol solids and glycol liquids (Auriga Polymers, Inc), oil and debris (Que Medical QMD), paint and rags and lab pack material (Anderson University Theater), potassium hydroxide and water (William Barnet and Sons, LLC), liquid formaldehyde (Celligent Diagnostic EPA ID # NCR0001831145) (Photographs 20 and 21), non-DOT non-RCRA material (Old Castle ARG), and paint thinner and rags (Converse College).

| The inspectors observed 200 to 300 55-gallon containers and totes stored. The inspectors observed eight five-gallon containers of unused hazardous material from Pureon Company and several containers of unused environmentally hazardous substance, liquid, NOS. Solids and liquids managed as non-hazardous waste and consolidated and shipped to AEO 3 to be solidified. | | | |

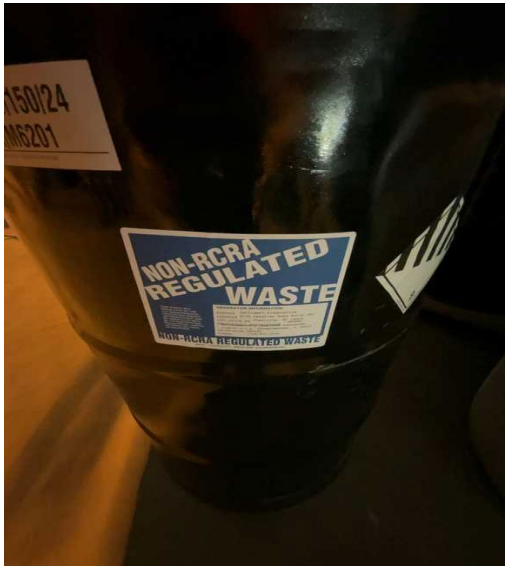
| The inspectors observed 200 to 300 55-gallon containers and totes stored. The inspectors observed eight five-gallon containers of unused hazardous material from Pureon Company and several containers of unused environmentally hazardous substance, liquid, NOS. Solids and liquids managed as non-hazardous waste and consolidated and shipped to AEO 3 to be solidified. | | | |

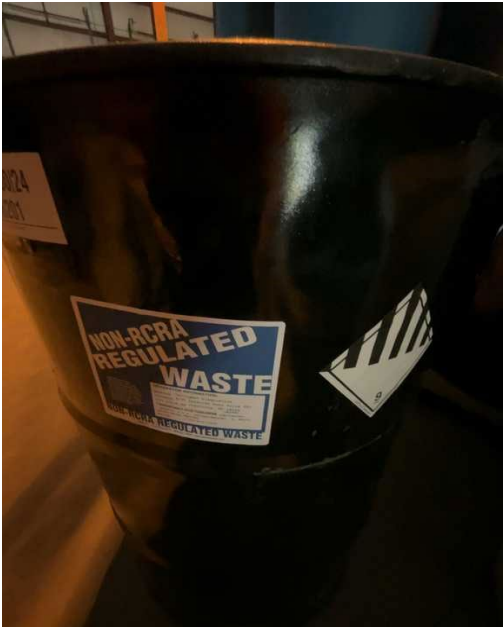
| The inspectors observed 200 to 300 55-gallon containers and totes stored. The inspectors observed several containers of non-hazardous waste. Solids and liquids managed as non-hazardous waste and consolidated and shipped to AEO 3 to be solidified. | | | |

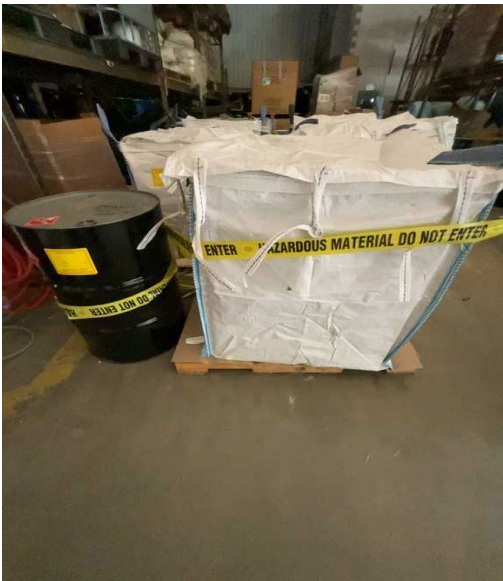
| The inspectors observed 200 to 300 55-gallon containers and totes stored. The inspectors observed several containers of non-hazardous waste. Solids and liquids managed as non-hazardous waste and consolidated and shipped to AEO 3 to be solidified. | | | |

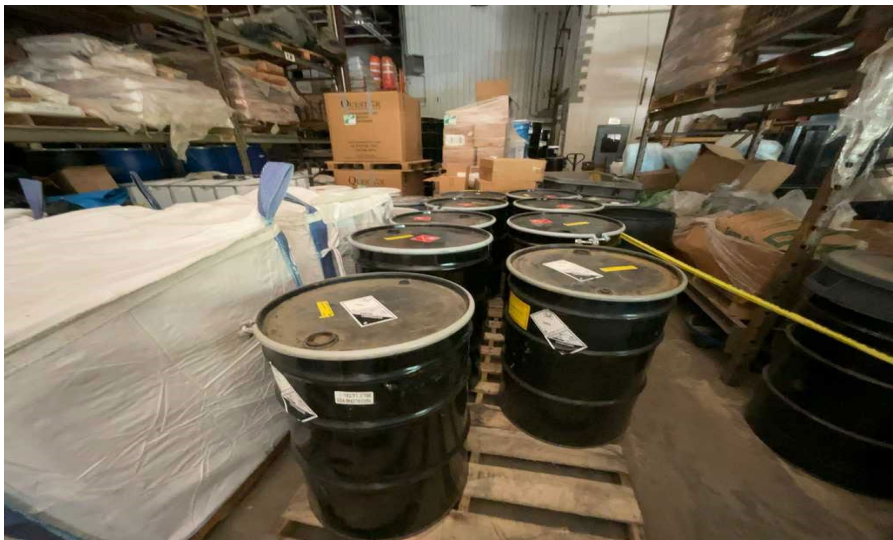
| Stan Perkins Site/Warehouse Extended 10- Day Transfer Facility – Photograph 22 | | | 35.03338915, -81.87327041 |

Several containers could not be inspected to observe if they were closed, in good condition, labeled with the words hazardous waste, and dated, because aisle space was not maintained (Photographs 22, 23, 24, 25, 26, 27, 28, and 29).

| The inspectors did not observe spill kits or emergency equipment located near the storage area. The inspectors did not observe “no smoking” signs posted in this area from ignitable or reactive waste. Not maintaining aisle space. | | | |

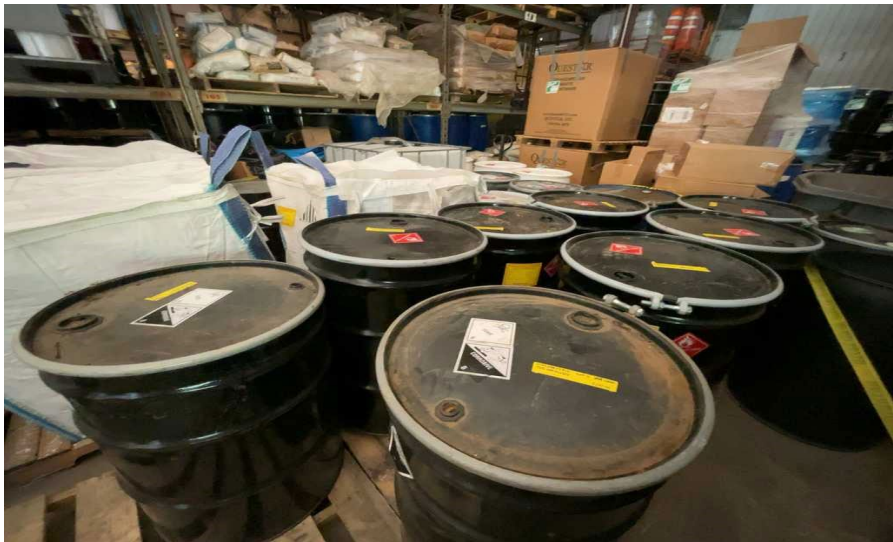
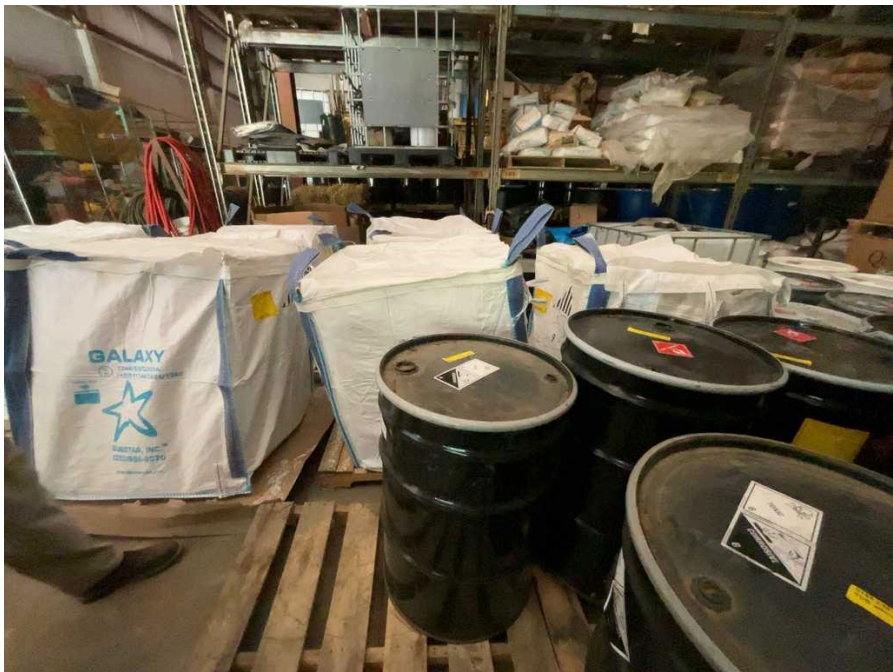
| The inspectors observed approximately 19 55-gallon and six one-cubic yard sacks storing hazardous waste. The sacks were labeled with a miscellaneous class 9 hazard indicator and not cler marked with a date. The inspectors observed approximately five 55-gallon containers were marked with the date June 11, 2024. The inspectors observed one 55-gallon container of hazardous waste was marked with the generator date of March 14, 2024, and marked with the transporter date of June 6, 2024. | | | |

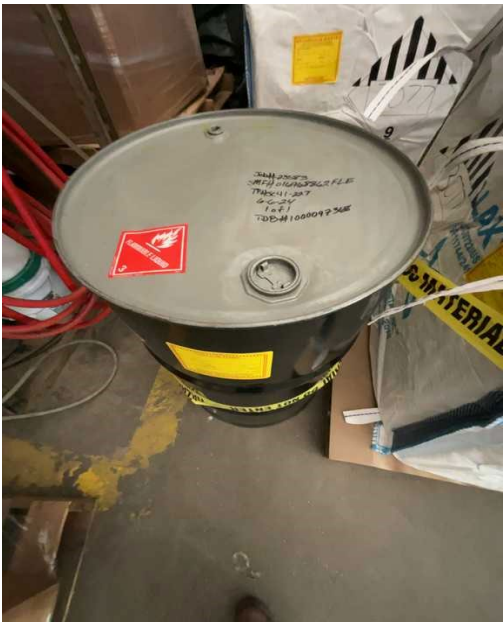
| The inspectors observed six one-cubic yard sacks were labeled with a miscellaneous class 9 hazard indicator and not clearly marked with a date. | | | |

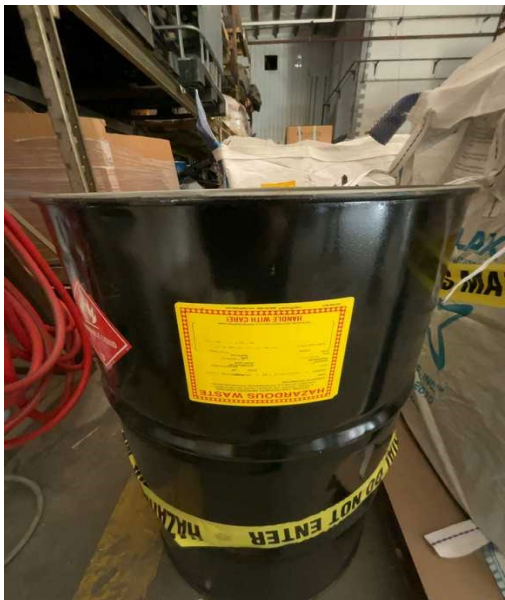
| The inspectors observed approximately five 55-gallon containers were marked with the date June 11, 2024. The inspectors observed one 55-gallon container of hazardous waste was marked with the generator date of March 14, 2024, and marked with the transporter date of June 6, 2024. | | | |

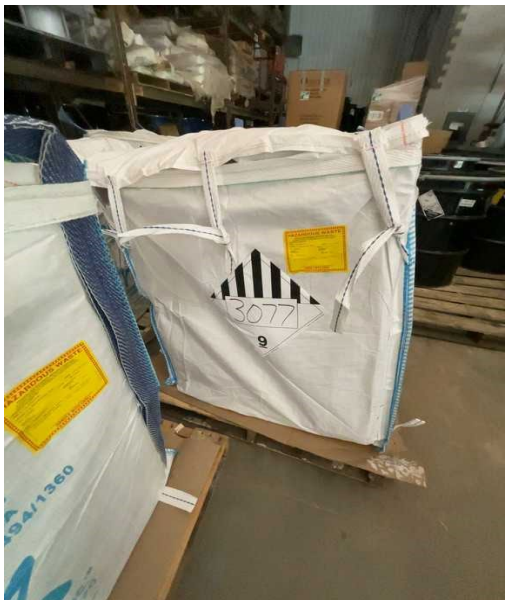
| The inspectors observed approximately five 55-gallon containers were marked with the date June 11, 2024. The inspectors observed one 55-gallon container of hazardous waste was marked with the generator date of March 14, 2024, and marked with the transporter date of June 6, 2024. | | | |

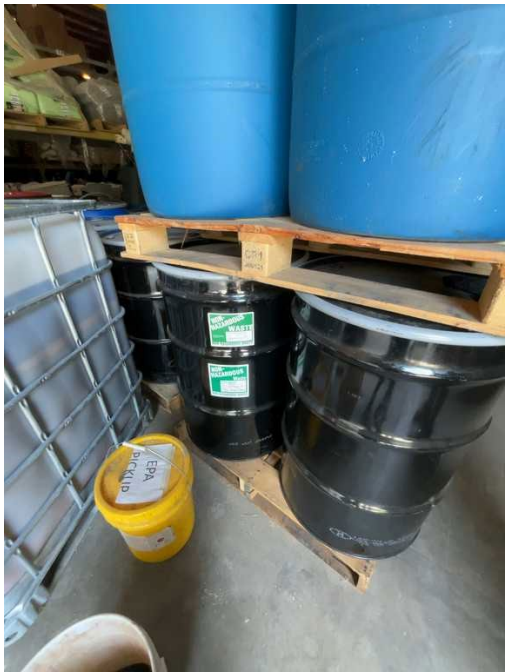
| The inspectors observed approximately six one-cubic yard sacks storing hazardous waste labeled with a miscellaneous class 9 hazard indicator and not clearly marked with a date. | | | |

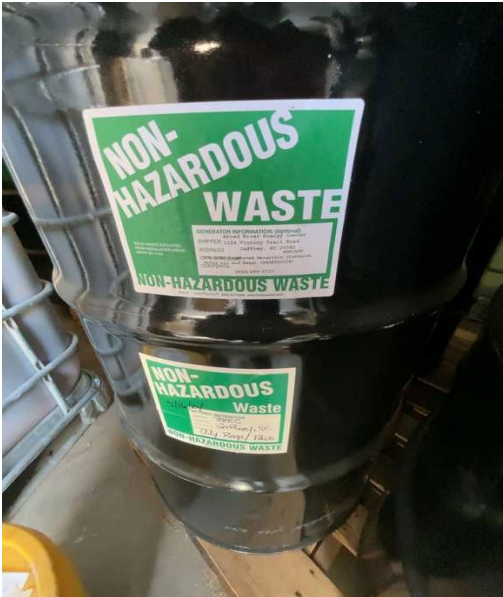
The inspectors observed two 55-gallon containers labeled with the words non-hazardous waste generated by Broad River Energy Center. One container was storing motor oil and rags and the second container was storing oil rags and pads, marked with the date May 16, 2024 (Photographs 30 and 31).

| The inspectors observed two 55-gallon containers labeled with the words non-hazardous waste generated by Broad River Energy Center. One container was storing motor oil and rags and the second container was storing oil rags and pads, marked with the date May 16, 2024. | | | |

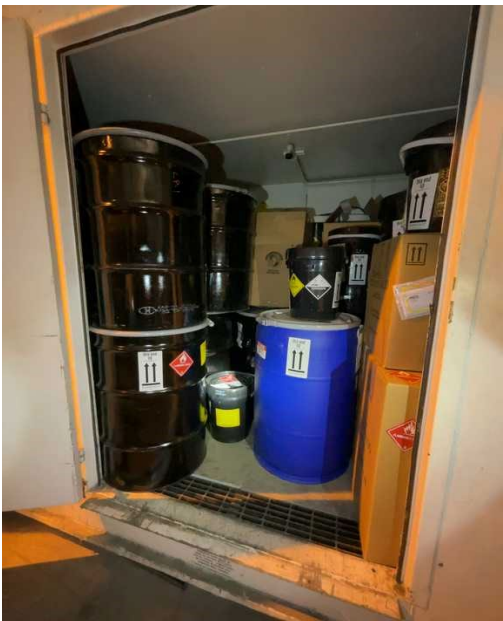
| The inspectors observed signage posted on the exterior wall of the storage locker that included DOT placards and a no smoking sign. The inspectors did not observe spill kits or emergency equipment located near the storage area. | | | |

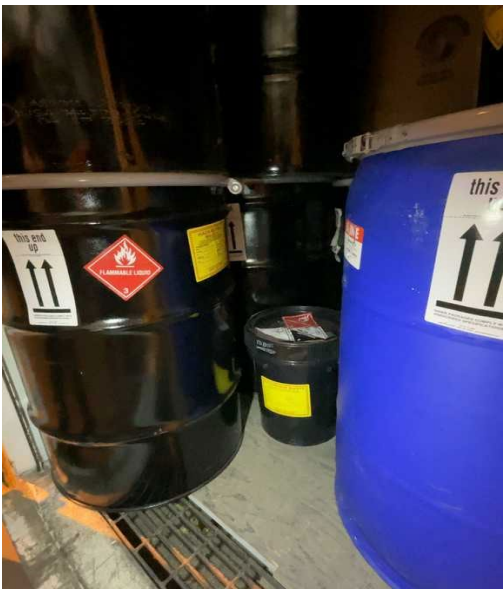
| Stan Perkins Site/Warehouse Container Storage Locker - Photograph 33 | | | 35.03340001, -81.87327789 |

| The inspectors could not inspect each container because of the number of containers and the lack of aisle space in the storage locker Photograph 34. | | | |

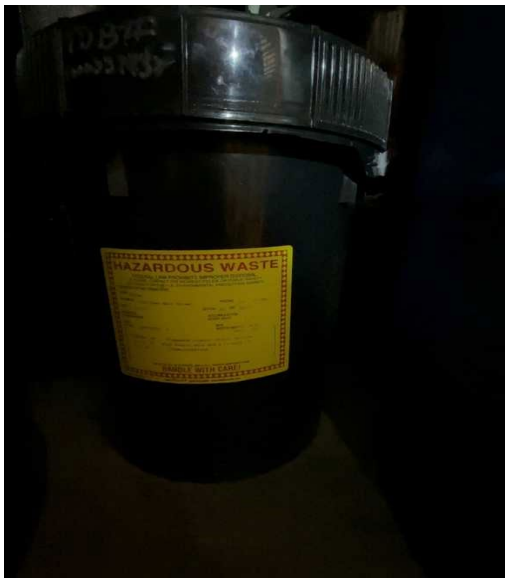
| The inspectors could not inspect each container because of the number of containers and the lack of aisle space in the storage locker. The inspectors observed one five-gallon container labeled with the words hazardous waste (D001, D002, F002, F003), labeled with a flammable and corrosive indication of the hazards, and not marked with a date. | | | |

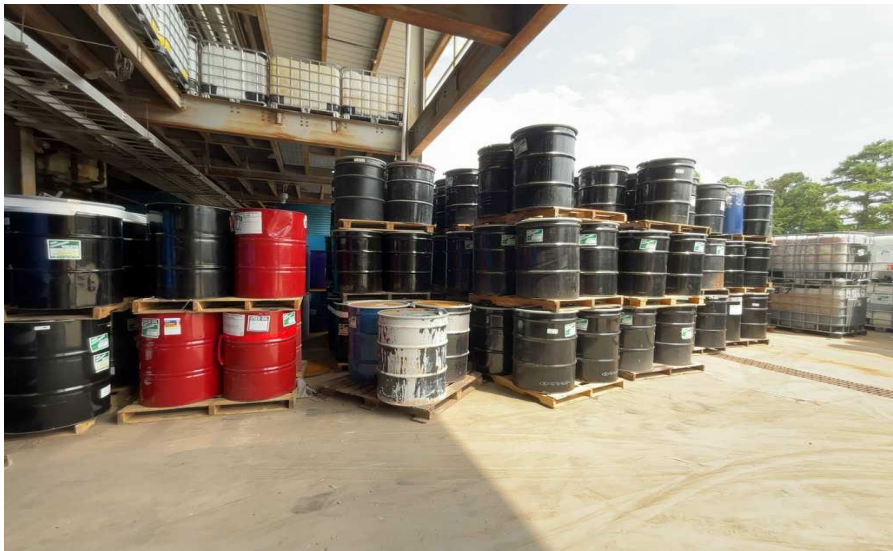
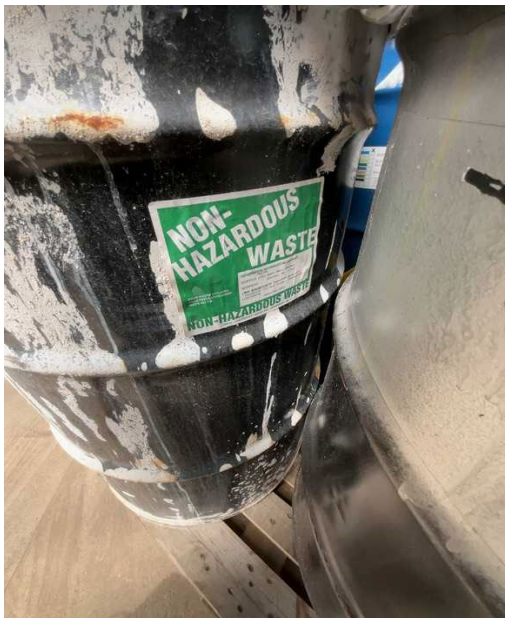
| AEO representatives indicated approximately 350 to 400 55-gallon containers and totes were stored in this area. The inspectors observed the containers were labeled with the words non-RCRA regulated waste or non-hazardous waste and closed. The inspectors observed a 55-gallon container (MOCOM) was covered with dried material on its exterior surface. | | | |

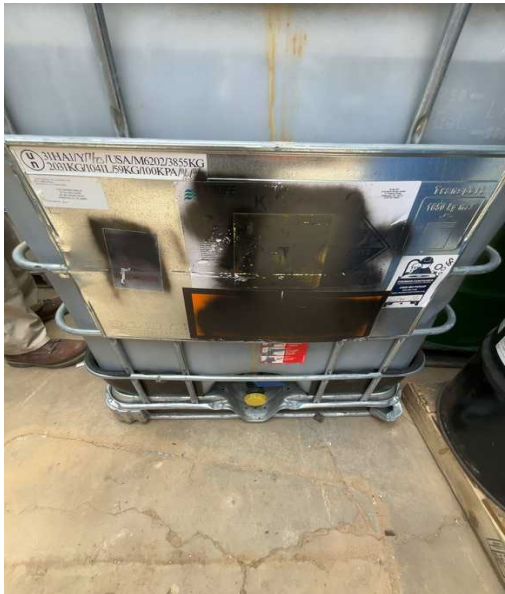
| Stan Perkins Site/Outdoor Mezzanine Container Storage/Wastewater Holding – Photograph 39 | | | 35.03339299, -81.87325745 |

The inspectors observed a 55-gallon container labeled with the words non-hazardous waste storing oil and sludge generated by MOCOM, waste profile PROF015942. The container was covered with dried material on its exterior surface. No release was observed to the concrete pad (Photograph 39).

| The inspectors observed a 55-gallon container labeled with the words non-hazardous waste storing oil and sludge generated by MOCOM, waste profile PROF015942. The container was covered with dried material on its exterior surface. | | | |

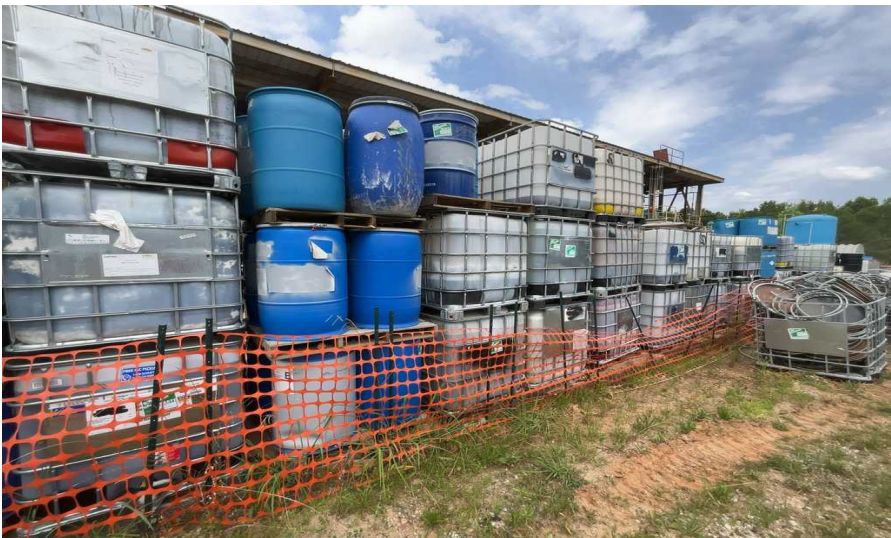
| Stan Perkins Site/Outdoor Mezzanine Container Storage/Wastewater Holding – Photograph 41 | | | 35.03336233, -81.87321049 |

| AEO representatives indicated approximately 350 to 400 55-gallon containers and totes were stored in this area. The inspectors observed the containers were labeled with the words non-RCRA regulated waste or non-hazardous waste and closed. | | | |

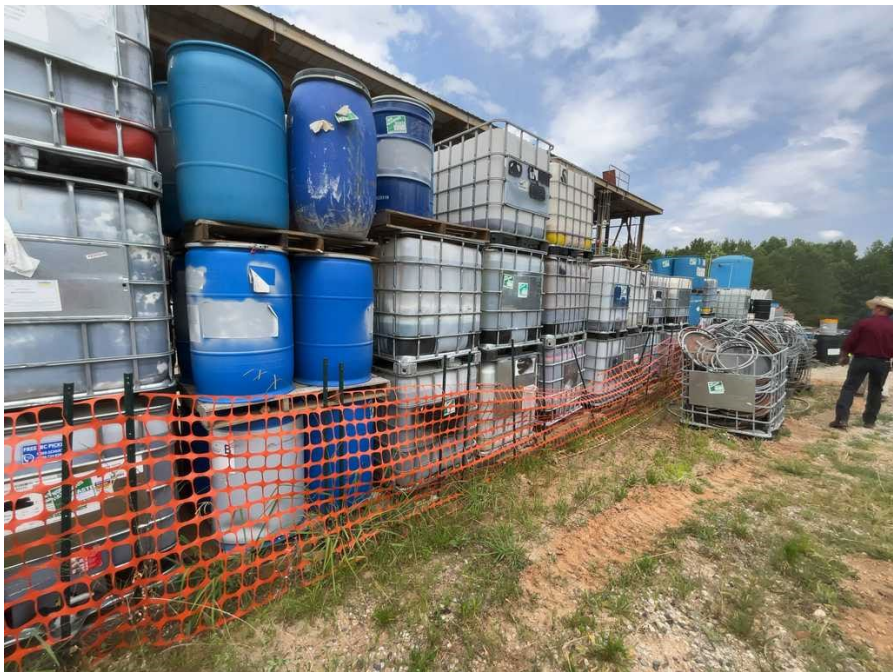
| AEO representatives indicated approximately 350 to 400 55-gallon containers and totes were stored in this area. The inspectors observed the containers were labeled with the words non-RCRA regulated waste or non-hazardous waste and closed. Empty containers. | | | |

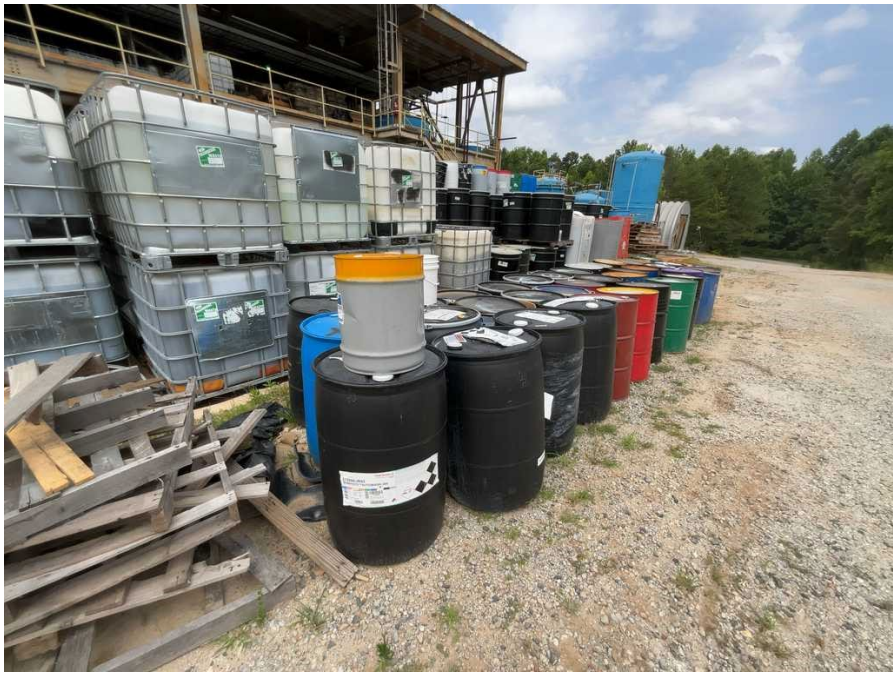
| The inspectors observed the containers and totes outside the concrete containment pad were empty. | | | |

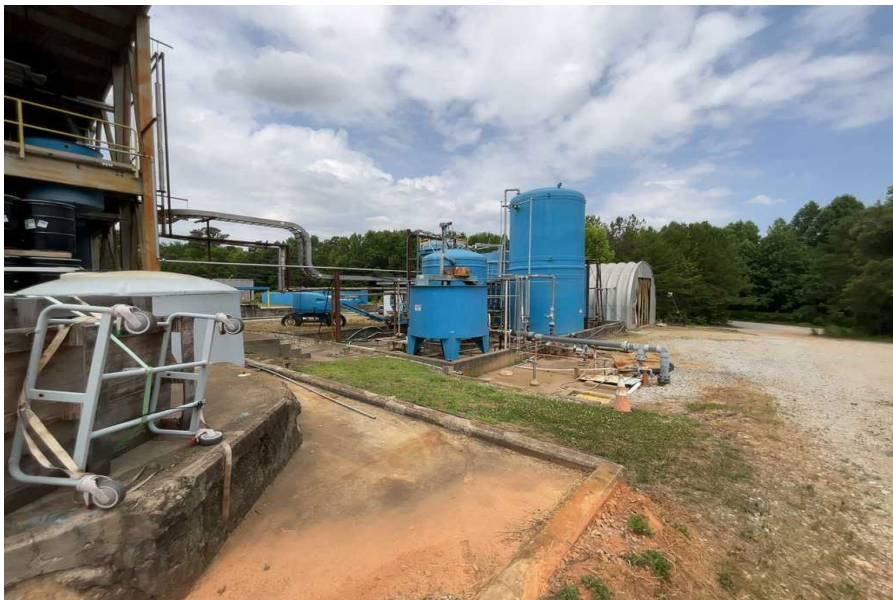
| Stan Perkins Site/Outdoor Mezzanine Container Storage/Wastewater Holding – Photograph 44 | | | 35.03342505, -81.87326764 |

The inspectors observed the containers and totes outside the concrete containment pad were empty (Photograph 43 and 44). The inspectors observed several totes in the second level Mezzanine. AEO representative indicated the totes were empty (Photograph 46). This area was not inspected.

| The inspectors observed the containers and totes outside the concrete containment pad were empty. | | | |

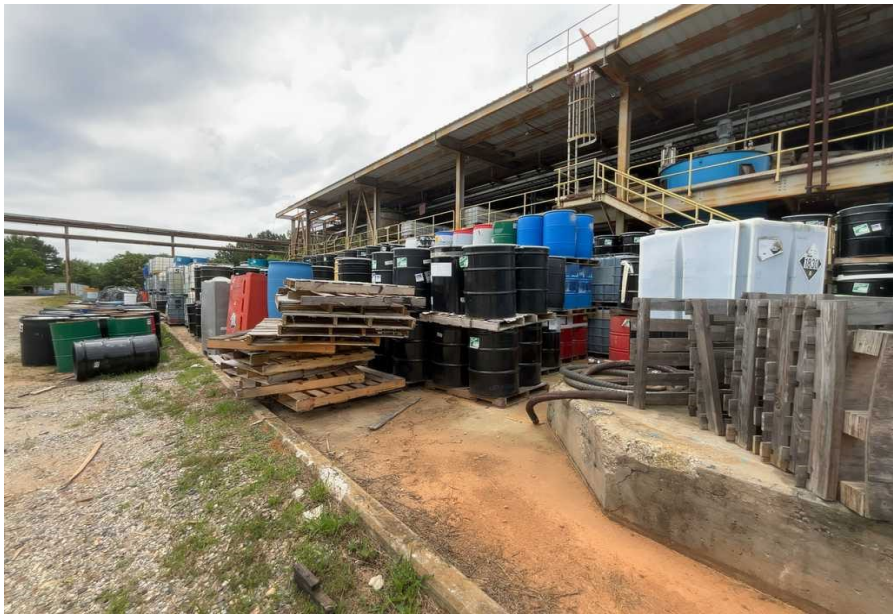
| Stan Perkins Site/ Wastewater Treatment Facility – Photograph 45 | | | 35.03342505, -81.87326764 |

indicated they self-monitor the batch treatment process and submit monthly monitoring reports to the City of Spartanburg (Photograph 45).

| AEO conducts batch treatment of wastewater using oil and water separation, clarification, chemical treatment, and solids retention. The wastewater effluent is discharged to a publicly owned treatment works (POTW). | | | |

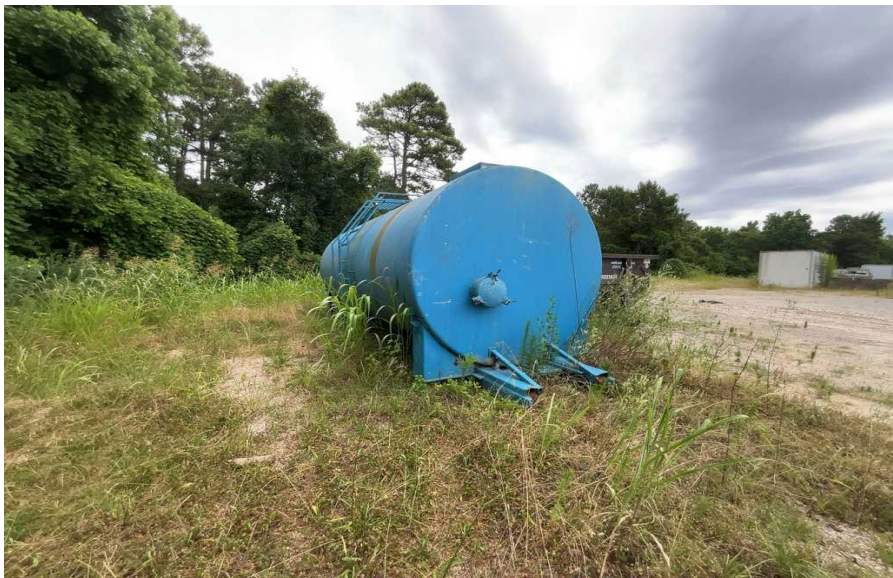
| Stan Perkins Site/Outdoor Aboveground Storage Tank - Photograph 47 | | | 35.03347204, -81.8733194 |

The outdoor aboveground storage tank (AST) holds about 8,000 gallons and is located across from the WWTF. The inspectors observed the AST appeared to be on a skid, was not marked or labeled and on the ground without secondary containment (Photographs 47 and 48).

| The outdoor aboveground storage tank (AST) holds about 8,000 gallons and is located across from the WWTF. The inspectors observed the AST appeared to be on a skid, was not marked or labeled and on the ground without secondary containment. | | | |

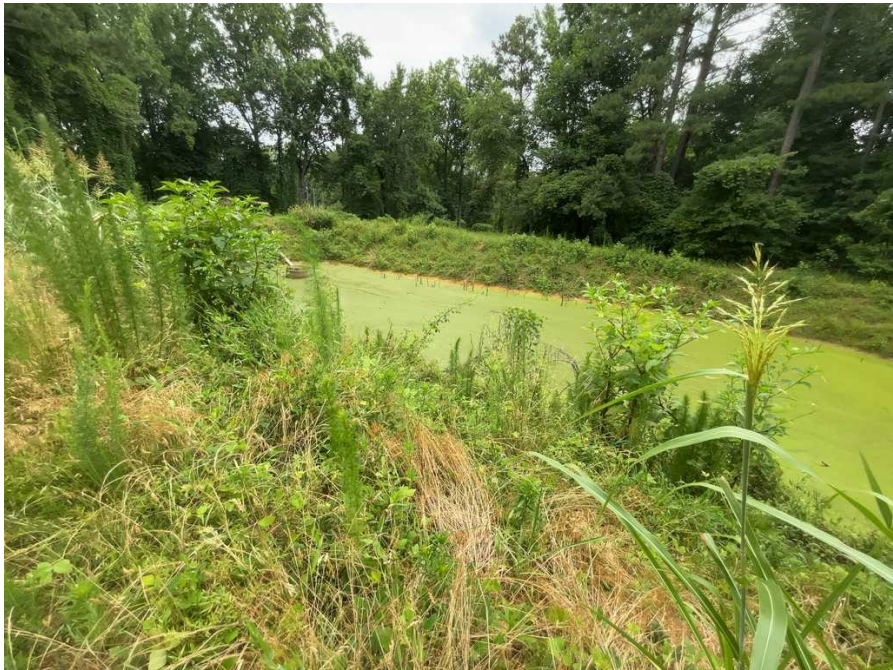
| Stan Perkins Site/Stormwater Pond - Photograph 49 | | | 35.03371268, -81.87318655 |

The inspectors observed the surface of the stormwater pond covered in algae (Photographs 49 and 50).

| The inspectors observed the surface of the stormwater pond covered in algal. | | | |

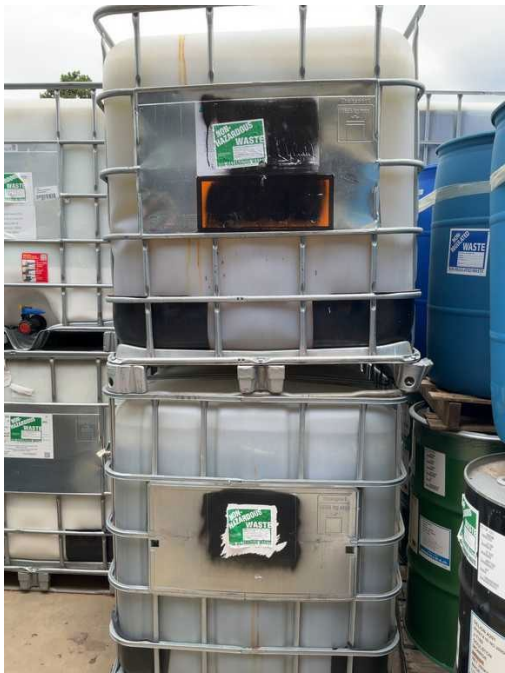
| Stan Perkins Site/Tote Storage Area – Photograph 51 | | | 35.0337208, -81.87317821 |

The Tote Storage Yard is on the north edge of the property at the end of the entrance drive. The inspectors observed totes stored on the asphalt approximately 12 rows deep by four rows wide by five rows high. The totes that could be observed appeared empty. The totes that are in good condition are sold and unusable totes are shredded (Photograph 51).

| The inspectors observed totes stored on the asphalt approximately 12 rows deep by four rows wide by five rows high. The totes that could be observed appeared empty. | | | |

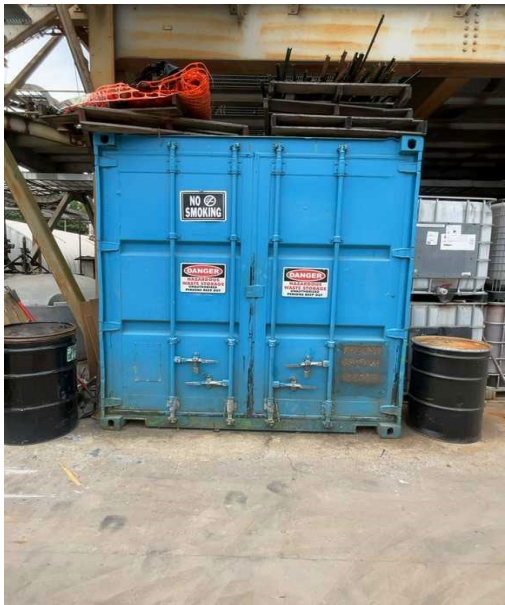
| The inspectors observed one 55-gallon container storing waste xylene (D001, F003) generated by Celligent Diagnostics (NCR000183145) not marked with a date on the hazardous waste label. The inspectors observed the top of the 55-gallon container was marked with the date May 9, 2024. | | | |

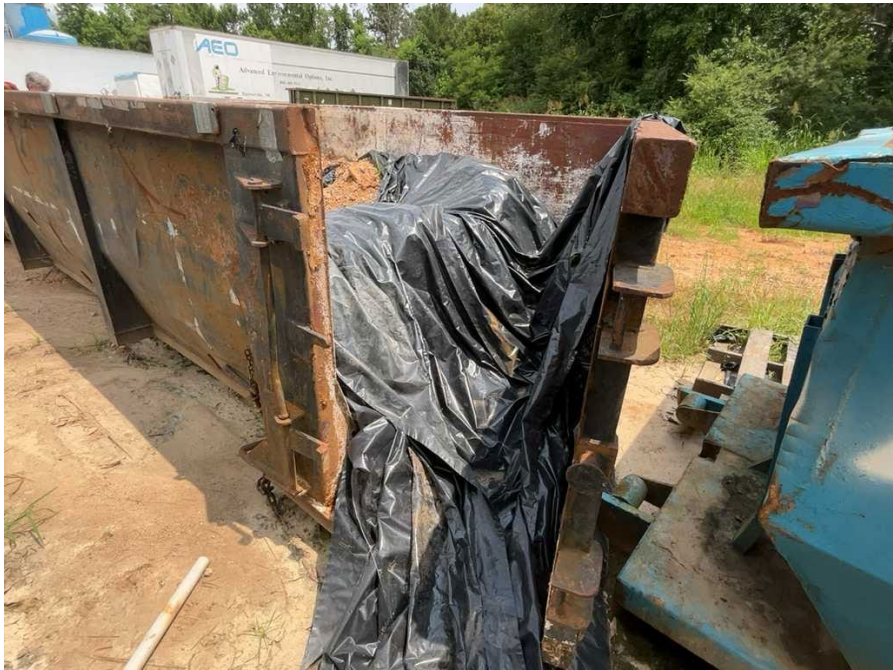
| Stan Perkins Site/Gravel Yard – Photograph 61 | | | 35.03345043, -81.87329149 |

The inspectors observed staining on the ground surrounding the 20-cubic yard containers (Photographs 61, 63, 64, and 65). At the time of the CEI, inspectors observed that an accurate waste determination was not available.

| The inspectors observed staining on the ground surrounding the 20-cubic yard containers. | | | |

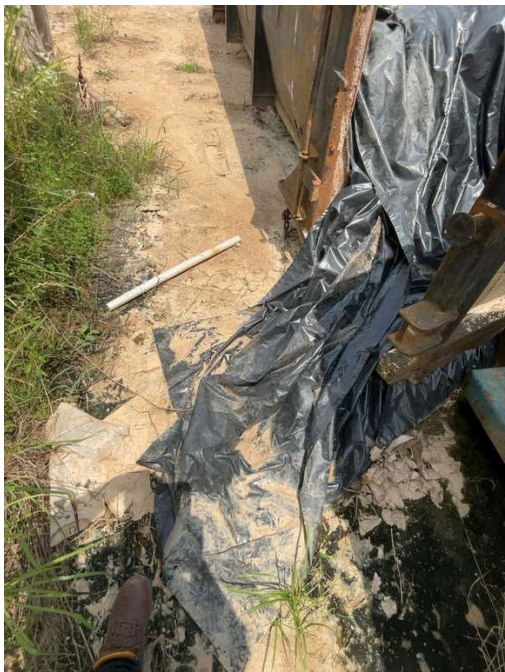
The inspectors observed several 20-cubic yard containers in the Gravel Yard. The inspectors observed one 20-cubic yard container was storing soil contaminated with gas, oil, and glycol generated from several remediated off-site spills. The contaminated soil was either generated off-site or stored at AEO at least since February 2024 (Photographs 62 and 67). One 20-cubic yard container was storing an unknown material (Photograph 66).

| The inspectors observed several 20-cubic yard containers in the gravel yard. The inspectors observed one 20-cubic yard container was storing soil contaminated with gas, oil, and glycol generated from several remediated off-site spills. The contaminated soil was either generated off-site or stored at AEO at least since February 2024. | | | |

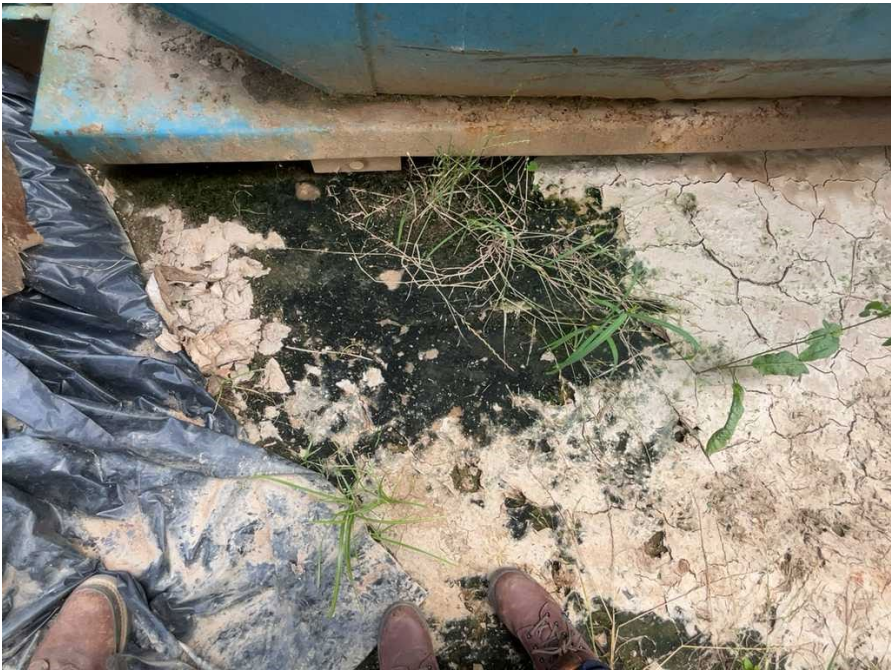
| Stan Perkins Site/Gravel Yard – Photograph 63 | | | 35.03345043, -81.87329149 |

| The inspectors observed staining on the ground surrounding the 20-cubic yard containers. | | | |

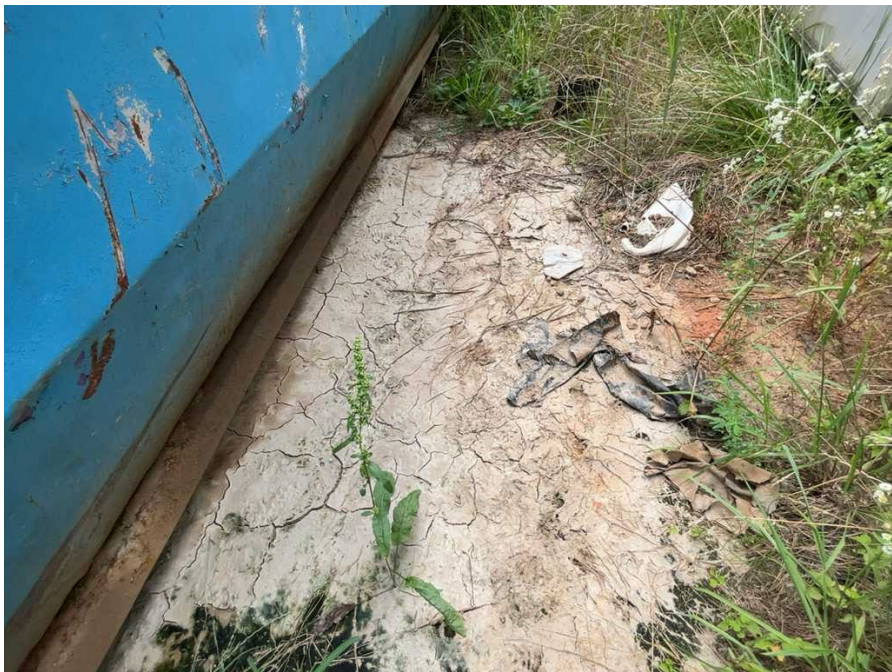
| Stan Perkins Site/Gravel Yard – Photograph 64 | | | 35.03345043, -81.87329149 |

| The inspectors observed staining on the ground surrounding the 20-cubic yard containers. | | | |
