## RCRA Inspection Report

Advanced Environmental Options, Inc.  
25 Stan Perkins Road  
Spartanburg, Spartanburg County  
South Carolina 29307

June 18, 2024, at 9:00 a.m.

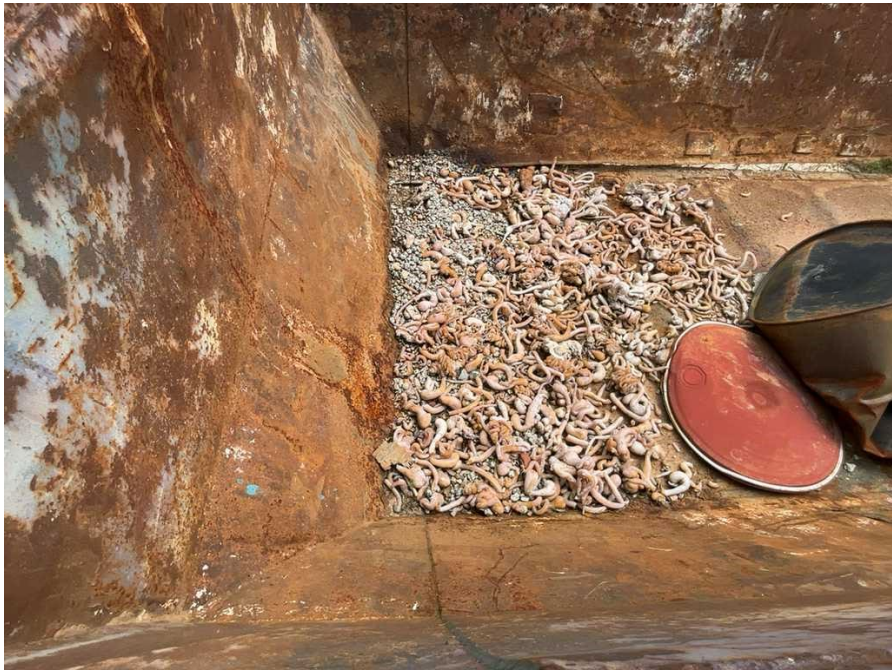
| Stan Perkins Site/Gravel Yard – Photograph 65 | | | 35.03345043, -81.87329149 |

The inspectors observed staining on the ground surrounding the 20-cubic yard containers (Photographs 61, 63, 64, and 65). At the time of the CEI, inspectors observed that an accurate waste determination was not available.

| The inspectors observed staining on the ground surrounding the 20-cubic yard containers. | | | |

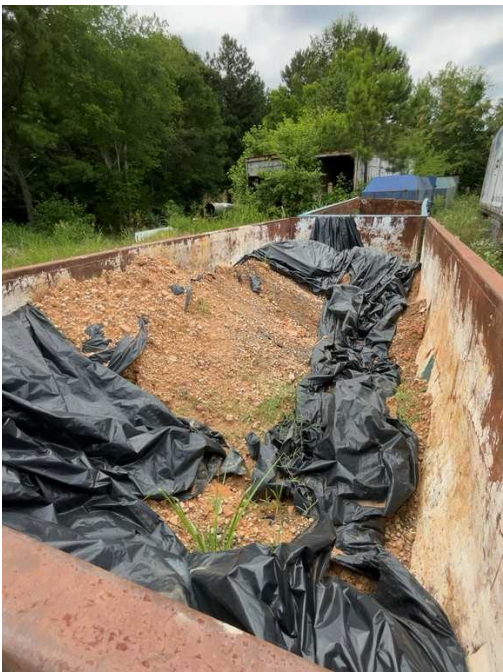
| Stan Perkins Site/Gravel Yard – Photograph 66 | | | 35.03345043, -81.87329149 |

The inspectors observed several 20-cubic yard containers in the Gravel Yard. The inspectors observed one 20-cubic yard container was storing soil contaminated with gas, oil, and glycol generated from several remediated off-site spills. The contaminated soil was either generated off-site or stored at AEO at least since February 2024 (Photographs 62 and 67). One 20-cubic yard container was storing an unknown material (Photograph 66).

| The inspectors observed one 20-cubic yard container was storing an unknown material. | | | |

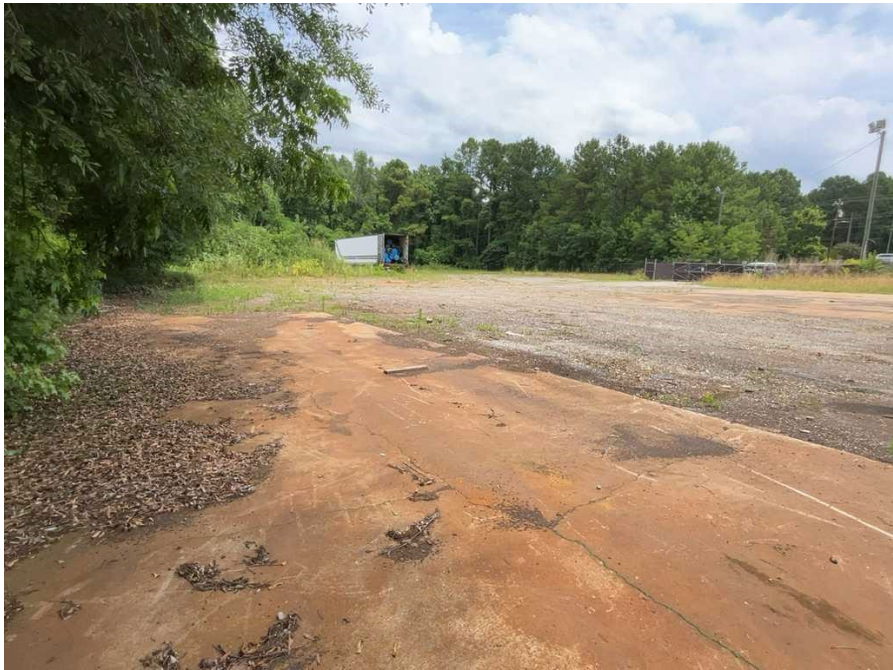
| 150 Poly Deck Way – Photograph 69 | | | 35.03266089, -81.87013619 |

| The inspectors observed staining on the concrete pad and on the soil and gravel. | | | |

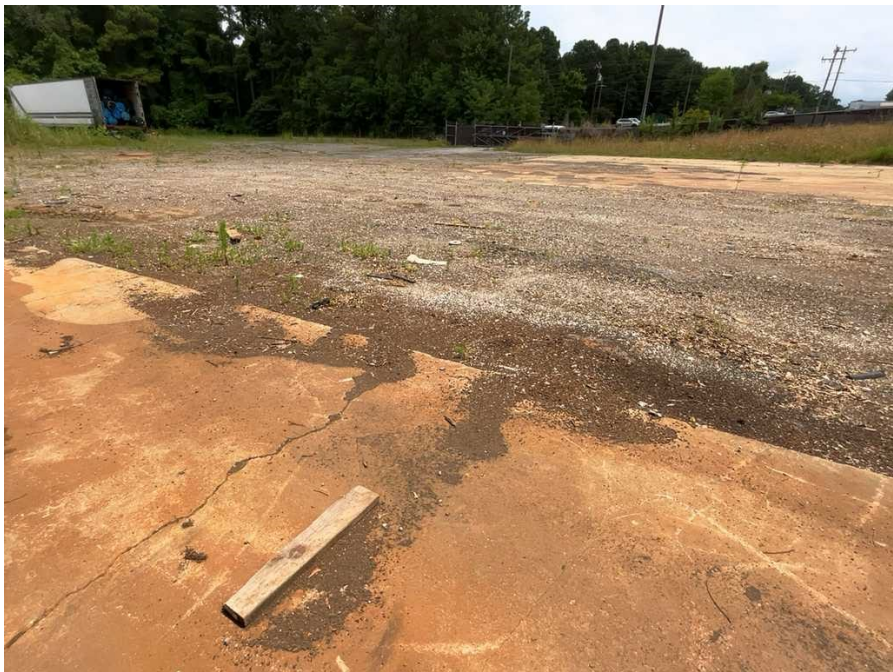
| 150 Poly Deck Way – Photograph 70 | | | 35.03266089, -81.87013619 |

| The inspectors observed staining on the concrete pad and on the soil and gravel. | | | |

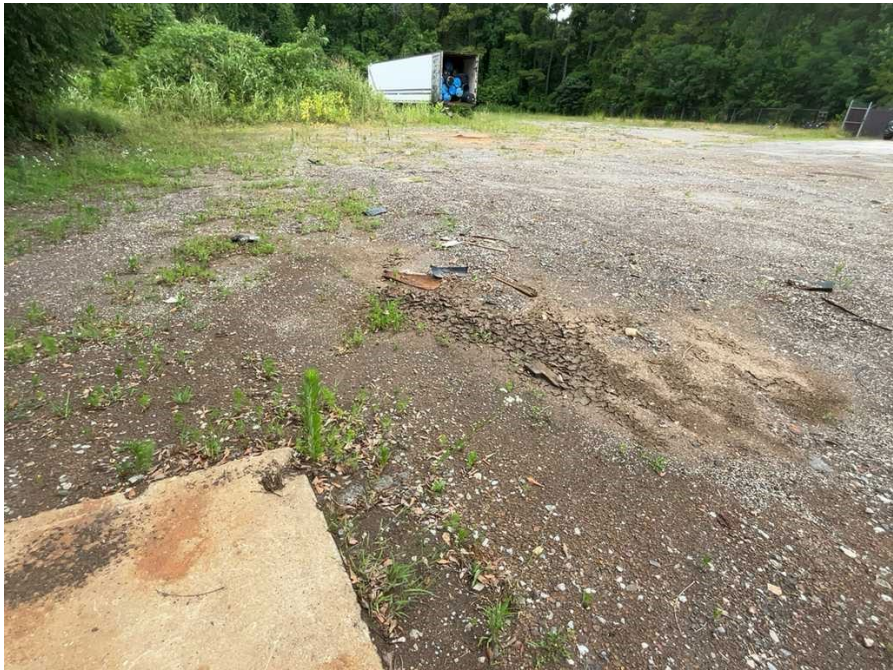
| 150 Poly Deck Way – Photograph 71 | | | 35.03266089, -81.87013619 |

| The inspectors observed staining on the concrete pad and on the soil and gravel. | | | |

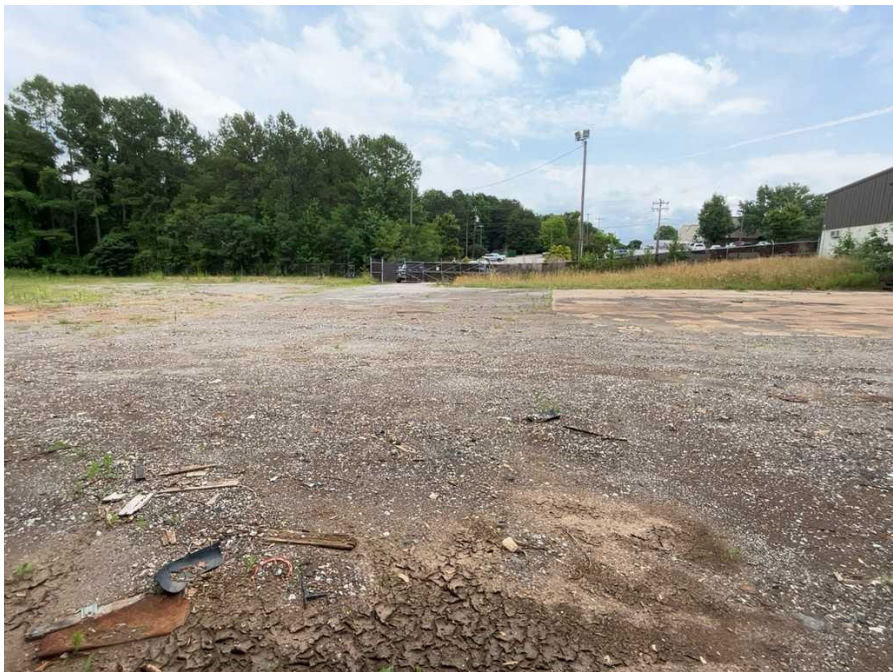
| The inspectors observed staining on the soil and gravel. | | | |

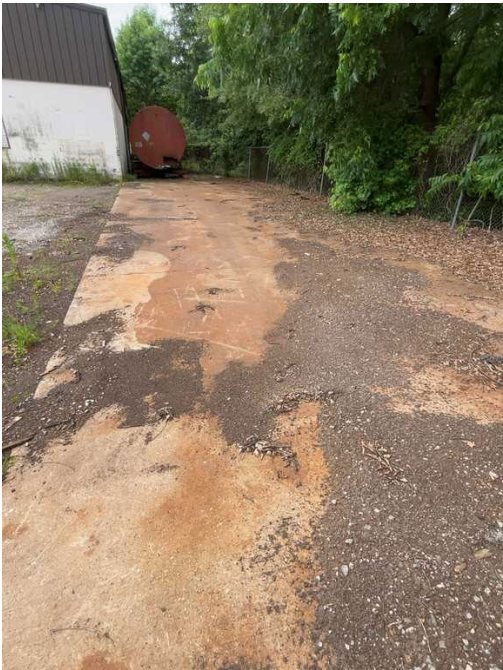
| 150 Poly Deck Way - Photograph 73 | | | 35.03266089, -81.87013619 |

| The inspectors observed staining on the soil and gravel. | | | |

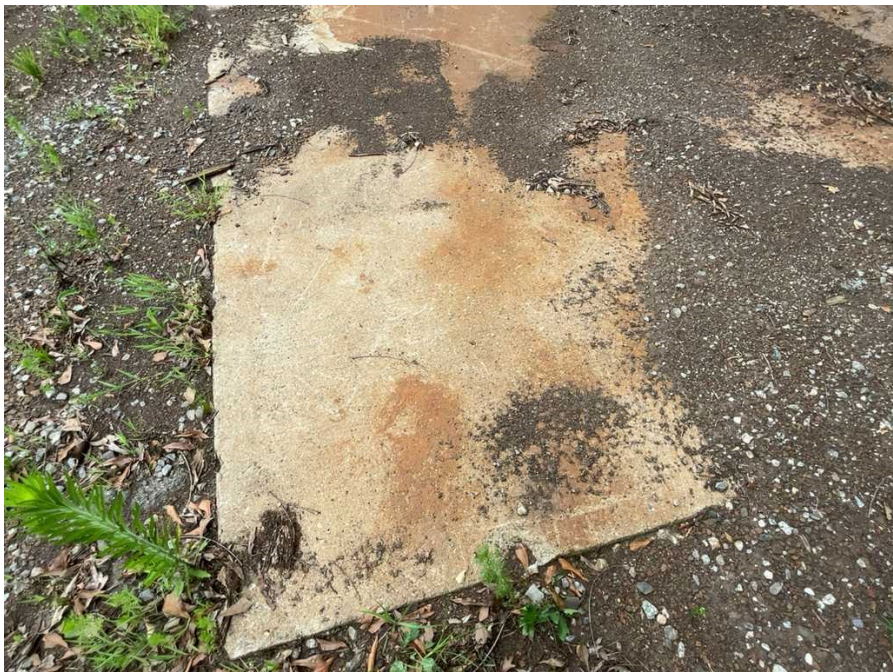
| 150 Poly Deck Way – Photograph 74 | | | 35.03266089, -81.87013619 |

| The inspectors observed a disconnected aboveground tank on the concrete pad behind the building that appeared empty. | | | |

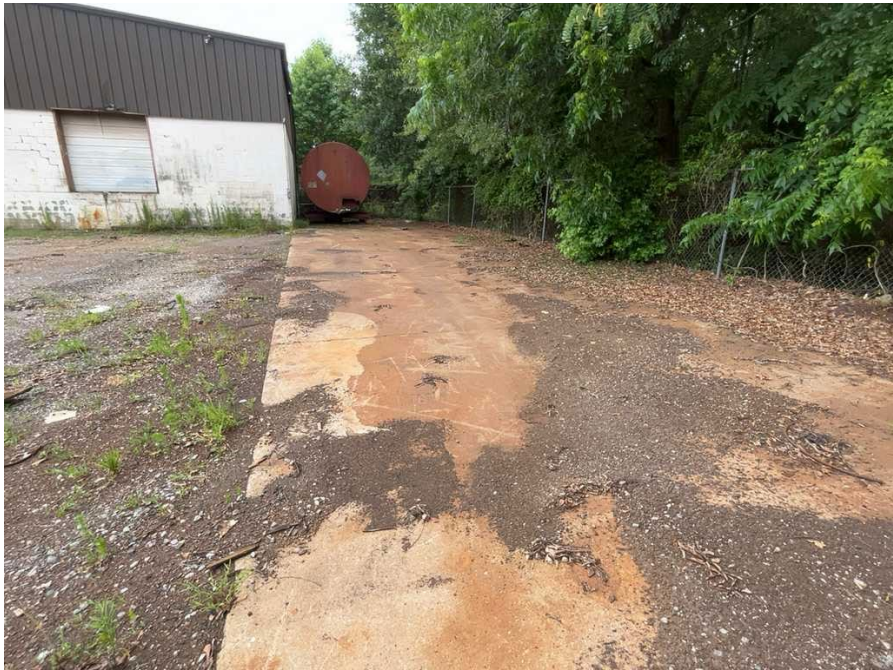
| 150 Poly Deck Way – Photograph 75 | | | 35.03266089, -81.87013619 |

| The inspectors observed staining on the concrete pad and on the soil and gravel. | | | |

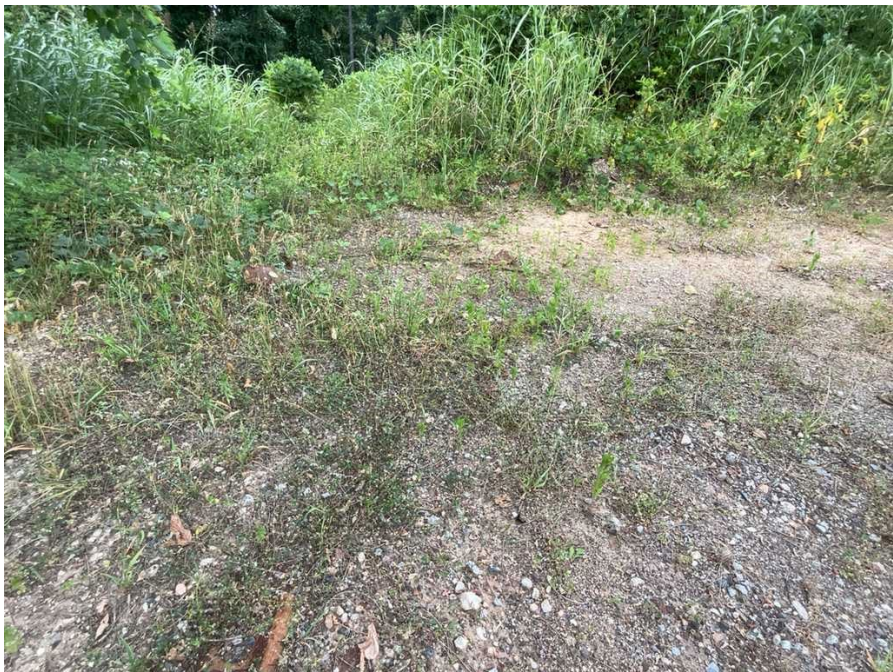
| 150 Poly Deck Way – Photograph 76 | | | 35.03266089, -81.87013619 |

| The inspectors observed a disconnected aboveground tank on the concrete pad behind the building that appeared empty. The inspectors observed staining on the concrete pad. | | | |

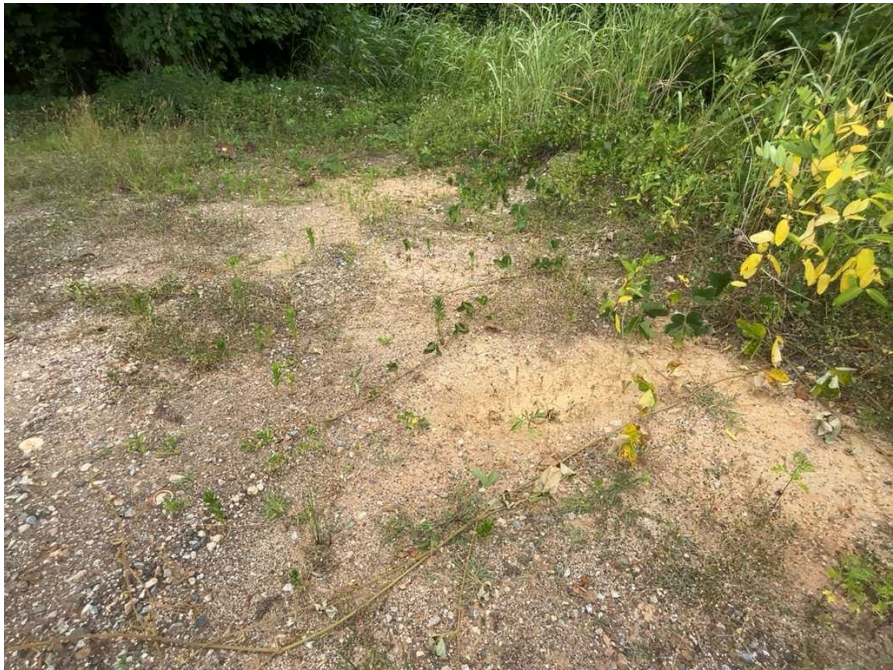
| 150 Poly Deck Way – Photograph 77 | | | 35.03266089, -81.87013619 |

| The inspectors observed staining on the soil and gravel. | | | |

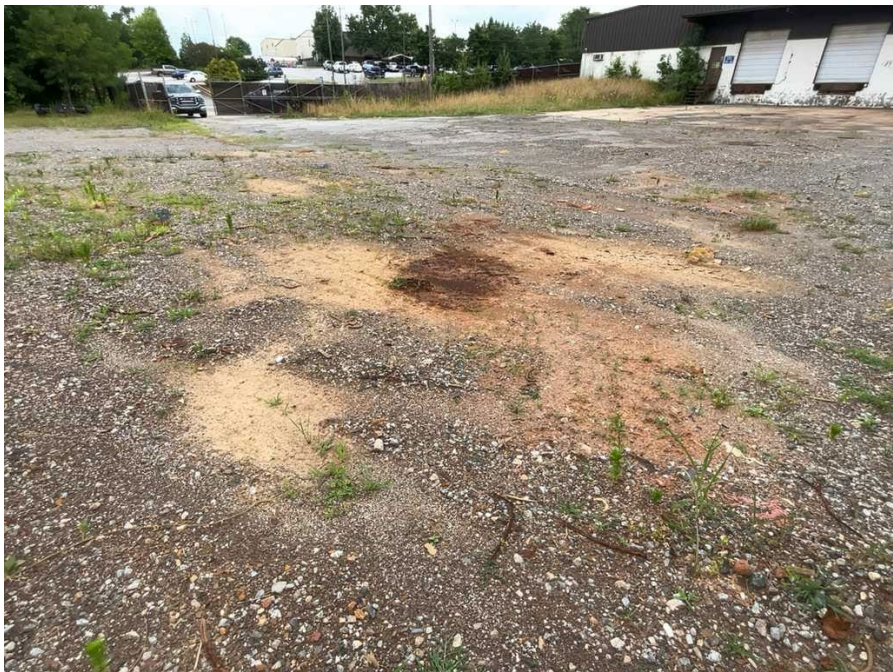
| 150 Poly Deck Way – Photograph 78 | | | 35.03266089, -81.87013619 |

| The inspectors observed staining on the soil and gravel. | | | |

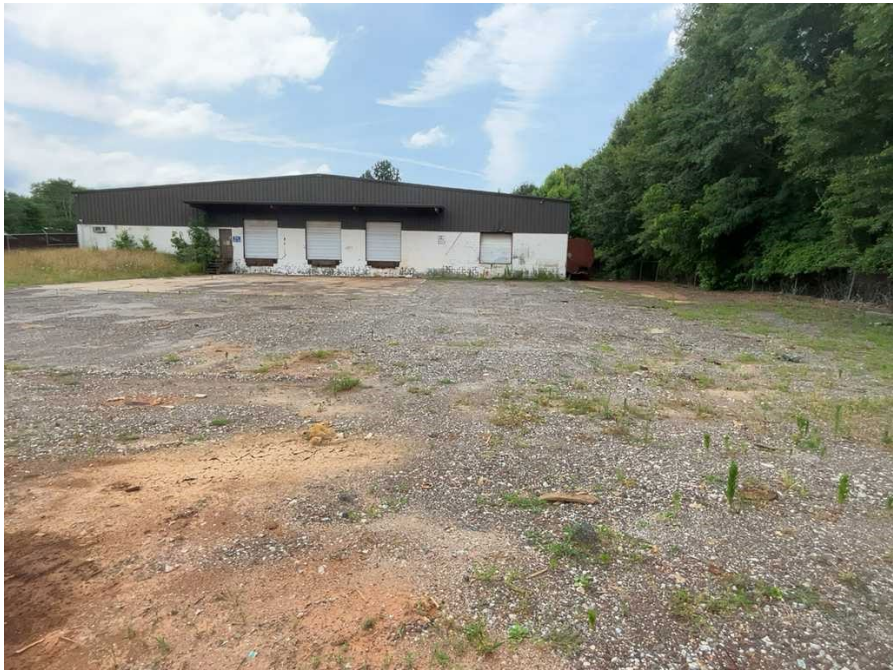
| 150 Poly Deck Way – Photograph 79 | | | 35.03266089, -81.87013619 |

AEO indicated that the building is currently occupied by the local government, possibly the local Sheriff’s office. The property is secured by a fence and locked gate. The inspectors observed a large building with a sign on the front of the building with the words “Advanced Environmental Options, Inc”. The property consists of some asphalt paving and unpaved soil and gravel, with a concrete pad in the rear of the property. The inspectors observed a disconnected aboveground tank on the concrete pad behind the building that did not appear to be in use (Photographs 74 and 76). The inspectors observed a trailer storing 55-gallon containers (Photographs 83, 84, 85, 86, and 87). AEO representatives indicated the containers were empty. AEO representatives indicated approximately 1,500 to 2,000 containers were shipped off-site for recycling in July and August 2022. AEO representatives indicated no records of the container shipments were available. The inspectors observed staining on the concrete pad (Photographs 69, 70, 71, 74, 75, and 76), on the soil and gravel (Photographs 71, 72, 73, 77, 78, 79, 80, 86 through 92), a pile of unknown residue on the ground (Photographs 79, 81, and 82), and a pile of scrap metal on the

| The inspectors observed staining on the soil and gravel. The inspectors observed a pile of unknown residue on the ground. | | | |

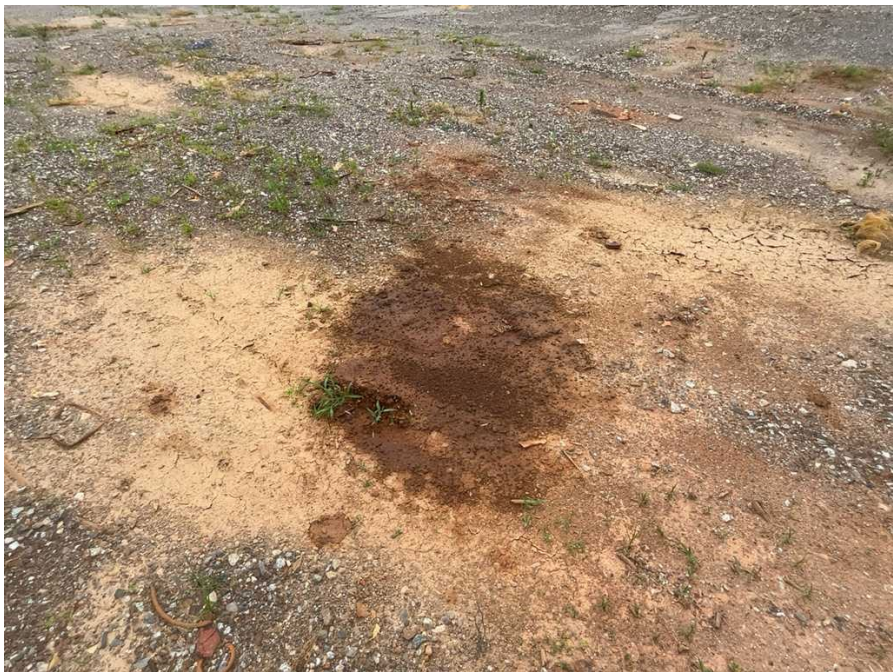
| 150 Poly Deck Way – Photograph 80 | | | 35.03266089, -81.87013619 |

| The inspectors observed staining on the soil and gravel. | | | |

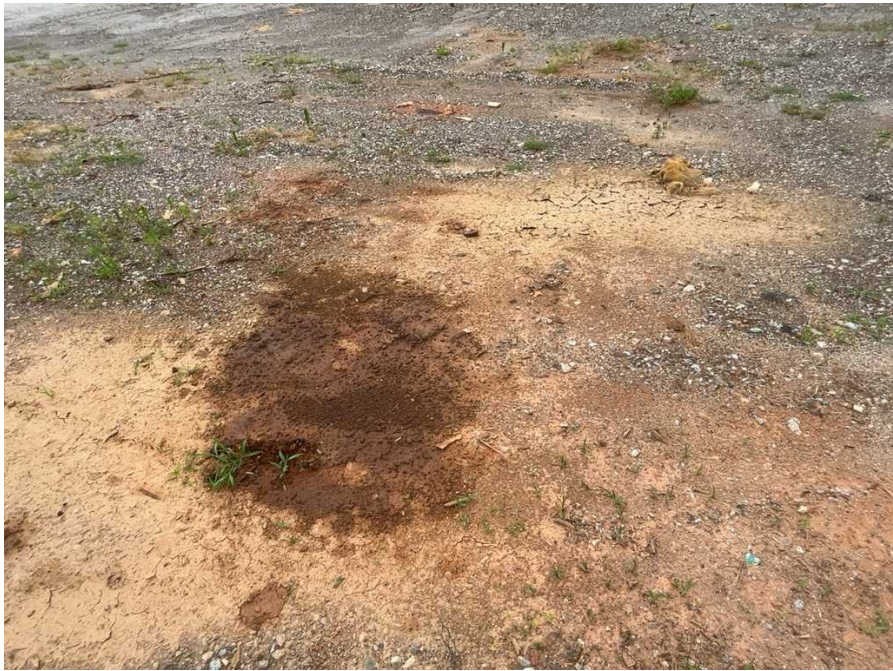
| 150 Poly Deck Way – Photograph 81 | | | 35.03266089, -81.87013619 |

| The inspectors observed a pile of unknown residue on the ground. The inspectors observed staining on the soil and gravel. | | | |

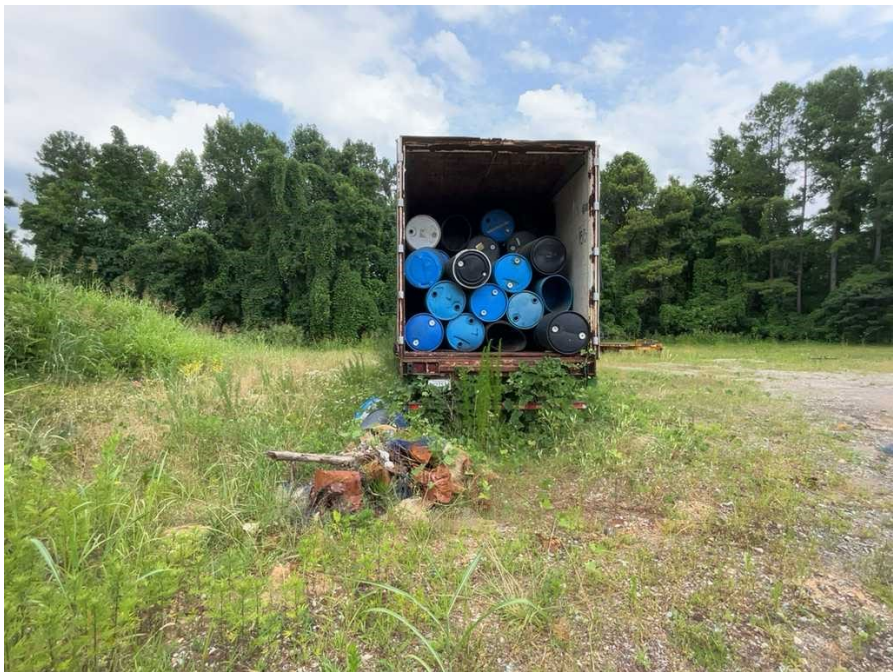
| 150 Poly Deck Way – Photograph 82 | | | 35.03266089, -81.87013619 |

| The inspectors observed a pile of unknown residue on the ground. The inspectors observed staining on the soil and gravel. | | | |

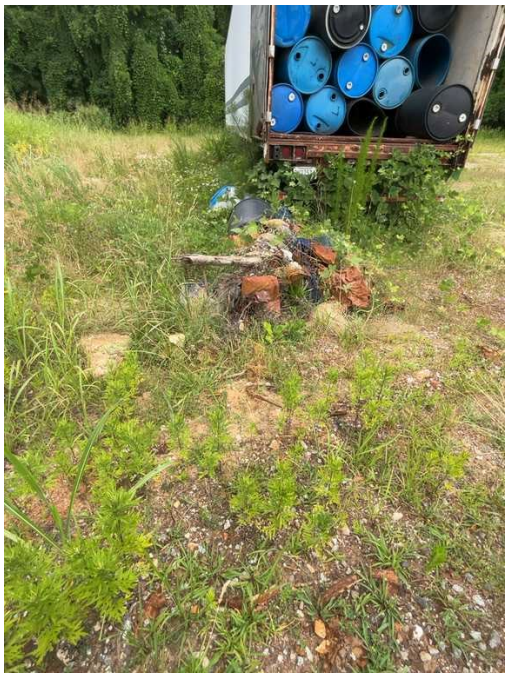
| 150 Poly Deck Way – Photograph 83 | | | 35.03266089, -81.87013619 |

ground near the trailer (Photographs 83, 84, and 85). The inspectors observed no other vehicles on the property.

| The inspectors observed a trailer storing 55-gallon containers. The inspectors observed and a pile of scrap metal on the ground near the trailer. | | | |

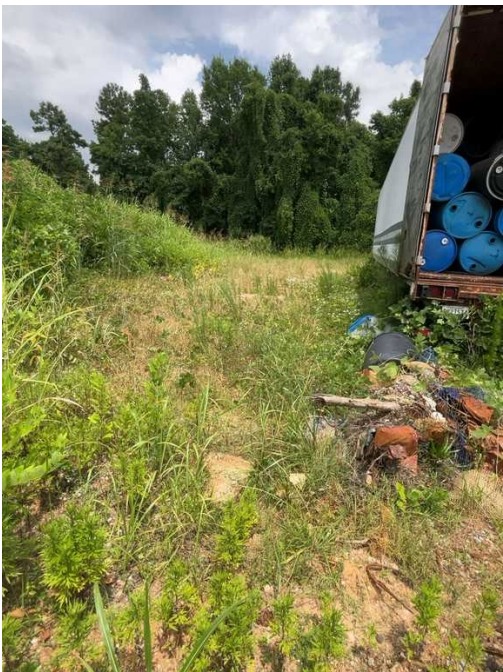
| 150 Poly Deck Way – Photograph 84 | | | 35.03266089, -81.87013619 |

| The inspectors observed a trailer storing 55-gallon containers. The inspectors observed and a pile of scrap metal on the ground near the trailer. | | | |

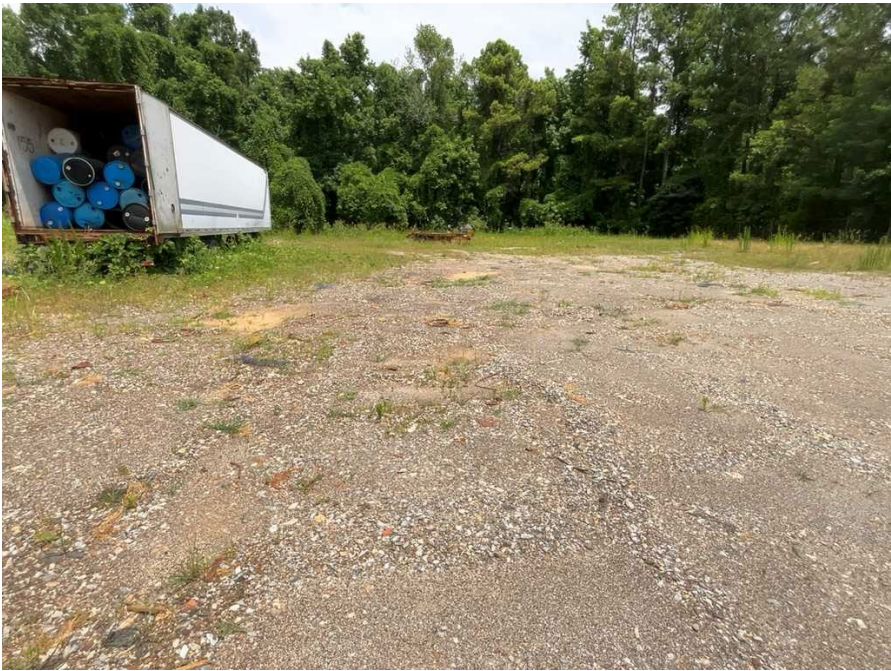
| 150 Poly Deck Way – Photograph 85 | | | 35.03266089, -81.87013619 |

| The inspectors observed a trailer storing 55-gallon containers. The inspectors observed and a pile of scrap metal on the ground near the trailer. | | | |

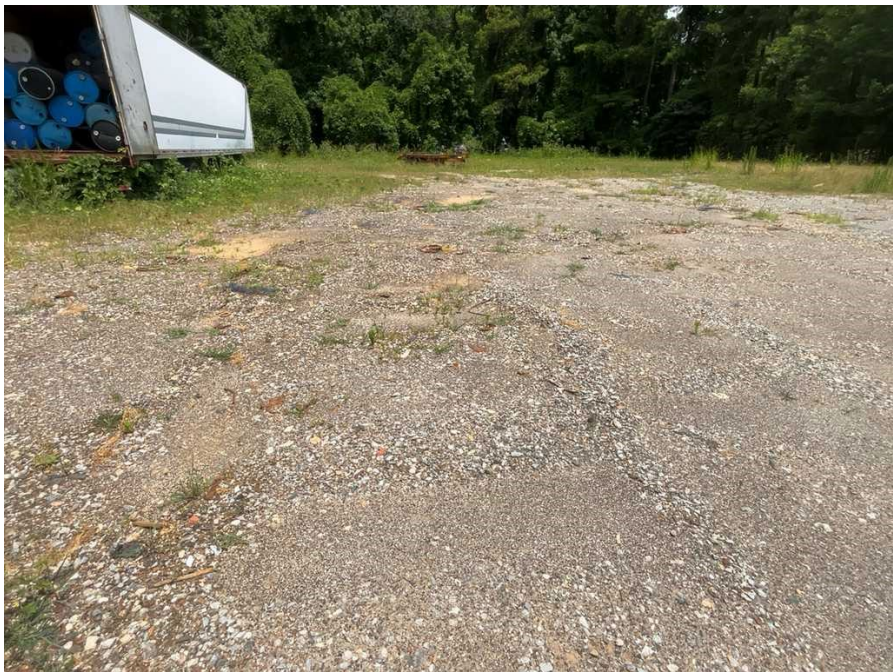
| 150 Poly Deck Way – Photograph 86 | | | 35.03266089, -81.87013619 |

| The inspectors observed a trailer storing 55-gallon containers. The inspectors observed staining on the soil and gravel. | | | |

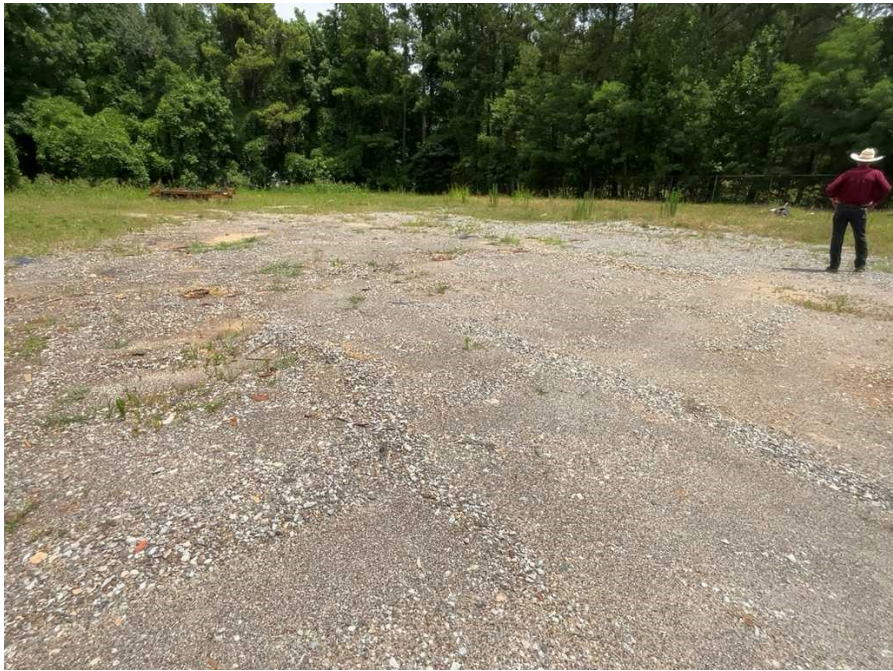
| 150 Poly Deck Way – Photograph 87 | | | 35.03350527, -81.87027502 |

| The inspectors observed a trailer storing 55-gallon containers. The inspectors observed staining on the soil and gravel. | | | |

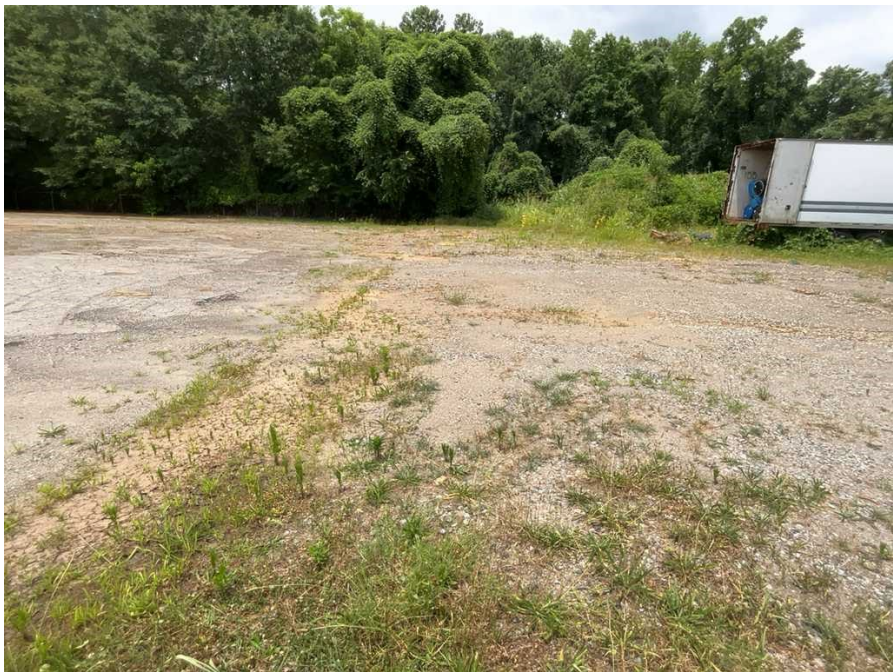
| 150 Poly Deck Way – Photograph 88 | | | 35.03347024, -81.87023746 |

| The inspectors observed staining on the soil and gravel. | | | |

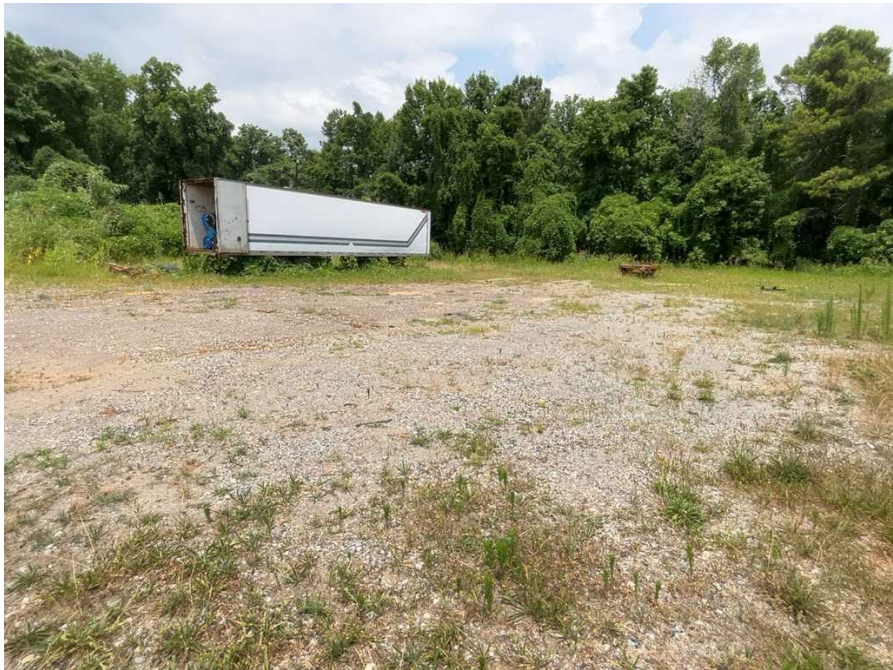
| 150 Poly Deck Way – Photograph 89 | | | 35.03343259, -81.87019709 |

| The inspectors observed staining on the soil and gravel. | | | |

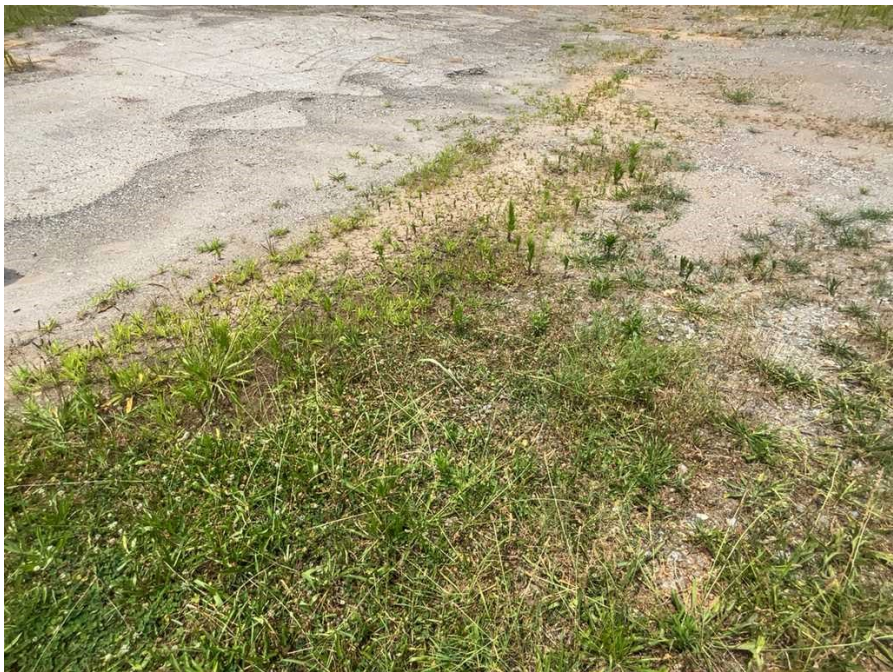
| 150 Poly Deck Way – Photograph 90 | | | 35.03343259, -81.87019709 |

| The inspectors observed staining on the soil and gravel. | | | |

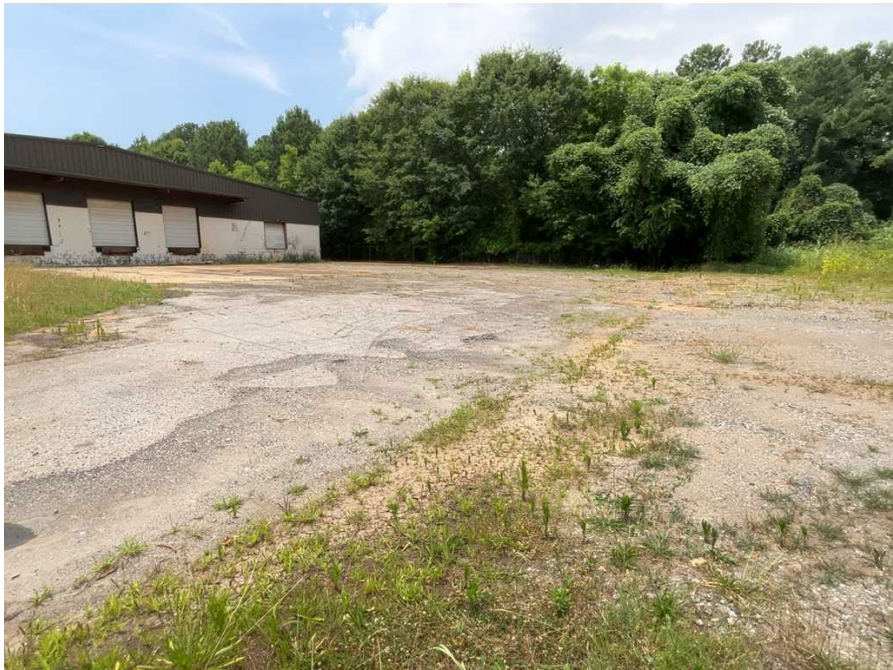
| 150 Poly Deck Way – Photograph 91 | | | 35.03373241, -81.87051855 |

| The inspectors observed staining on the soil and gravel. | | | |
