INSPECTION REPORT

| Type of Inspection | Focused Compliance Inspection (FCI) | | | |
| Facility or Site Name | Valero Bill Greehey Refineries East | | | |

Valero Corpus Christi Refinery – East Plant  
EPA RCRA Inspection on March 14, 2024  
Areas of Concern Response

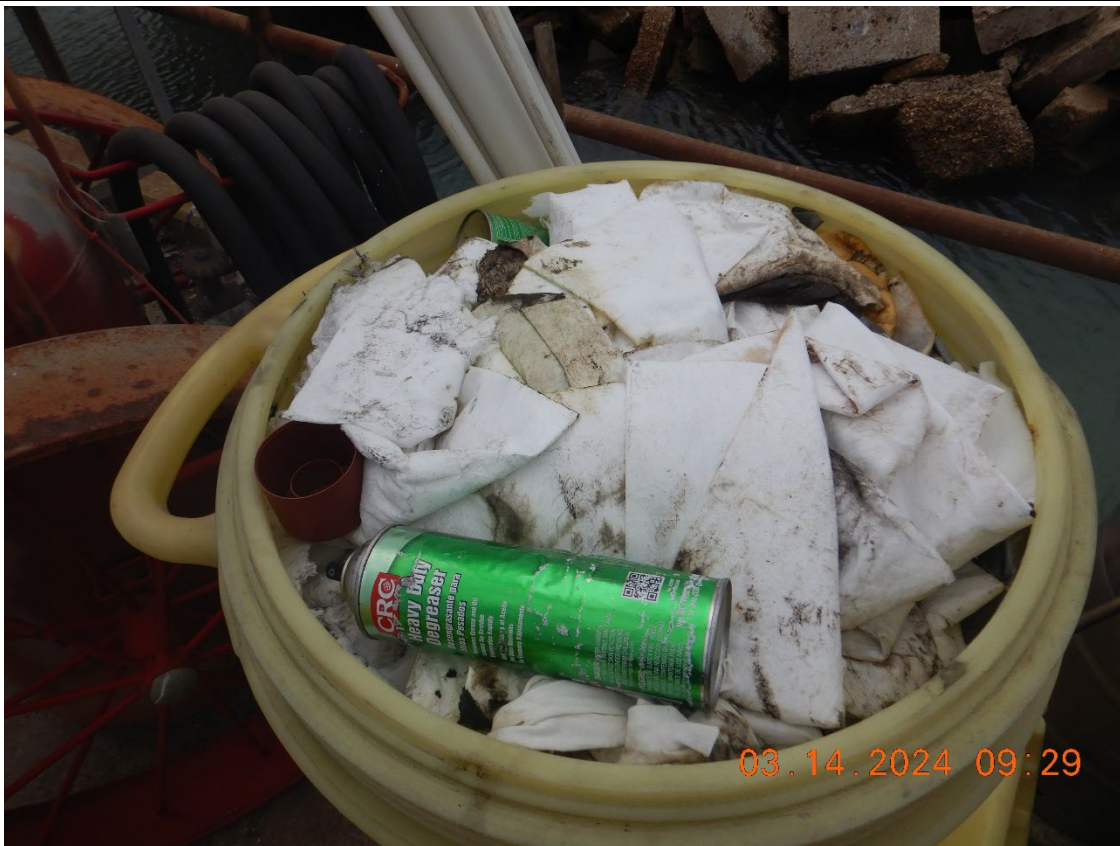
Photo No. 1

| <b>Tenant:</b> Valero Bill Greehey Refineries (East) | | |
|---|---|---|
| <b>AOC #1</b> – Valero did not clearly label its containers as “Hazardous Waste” or indicate the hazardous contents. | <b>Citation:</b> 40 CFR 262.15 (a)(5) | Section: 2.1 |

Description: View of unlabeled drum designated for oil rags containing an unpunctured aerosol can at Oil Dock 6.

On 3/14/2024, aerosol cans that were found in the yellow oily trash bin were separated from the oily trash and transported to the puncture station to safely puncture, drain, and recycle the puncture aerosol cans. A new satellite accumulation area (SAA) was set up at Oil Dock 6 for aerosol can management. A 55-gallon drum with a latching lid was placed in the SAA, with a yellow hazardous waste label, to store the emptied aerosol cans.

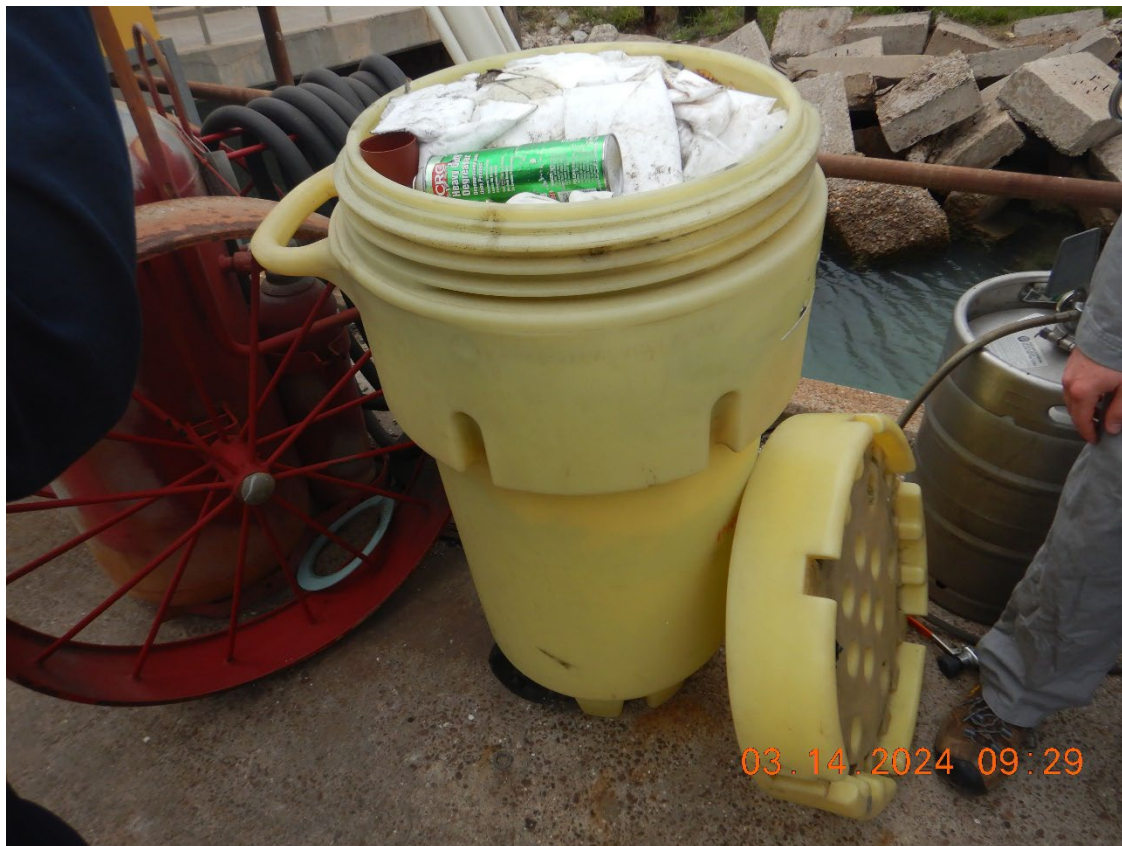
Photo No. 2

Description: View of an unlabeled drum designated for oil rags containing an unpunctured aerosol can at Oil Dock 6.

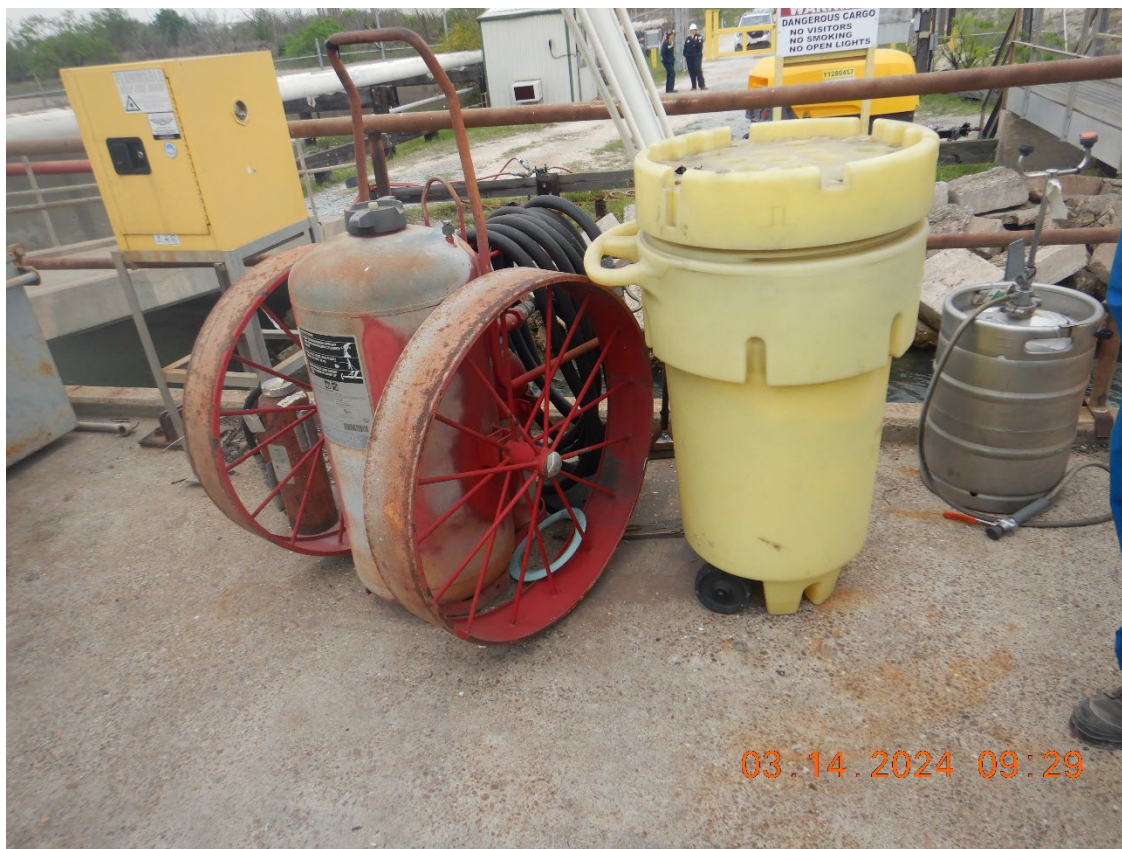
Photo No. 3

Description: View of an unlabeled drum designated for oil rags containing an unpunctured aerosol can at Oil Dock 6.

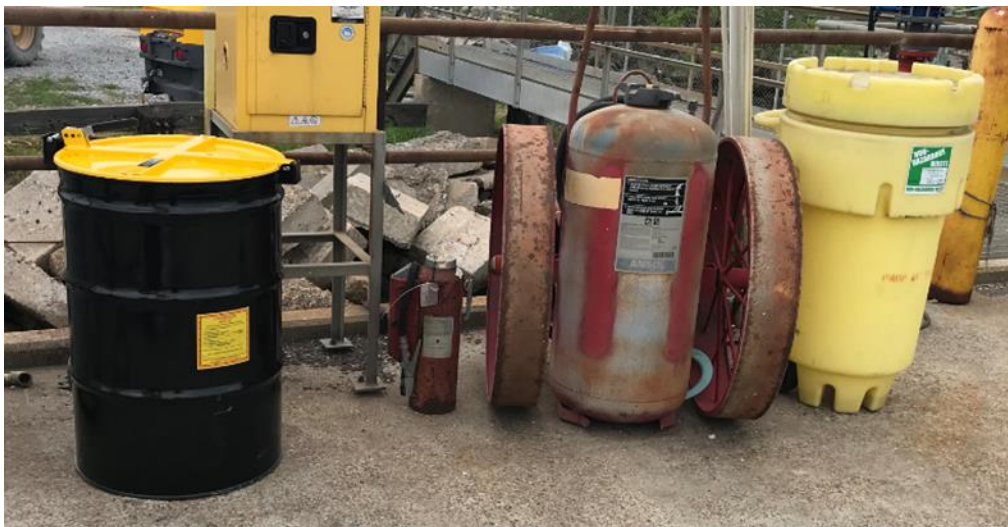
The photo below shows the completed follow up.
