## Region 6 Compliance Assurance and Enforcement Division

### INSPECTION REPORT

| Facility Name: | Farmington Wastewater Treatment plant | | |
| Identification/Permit Number: | NM0020583 | | |

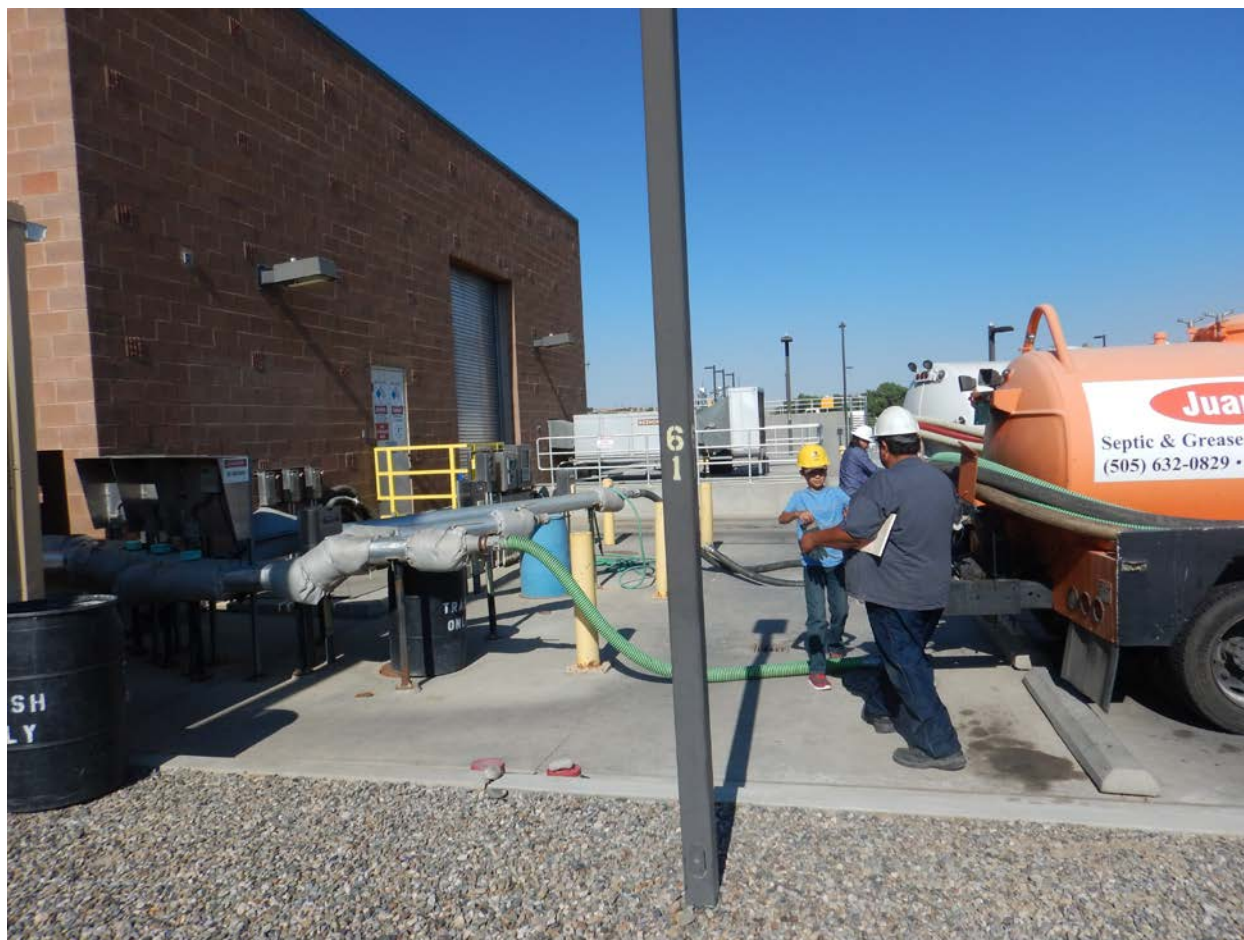
Photo No. 1

View of the City of Farmington's septage receiving location at the entrance of the WWTP. July 10, 2018 9:15 AM (DSCN0855).

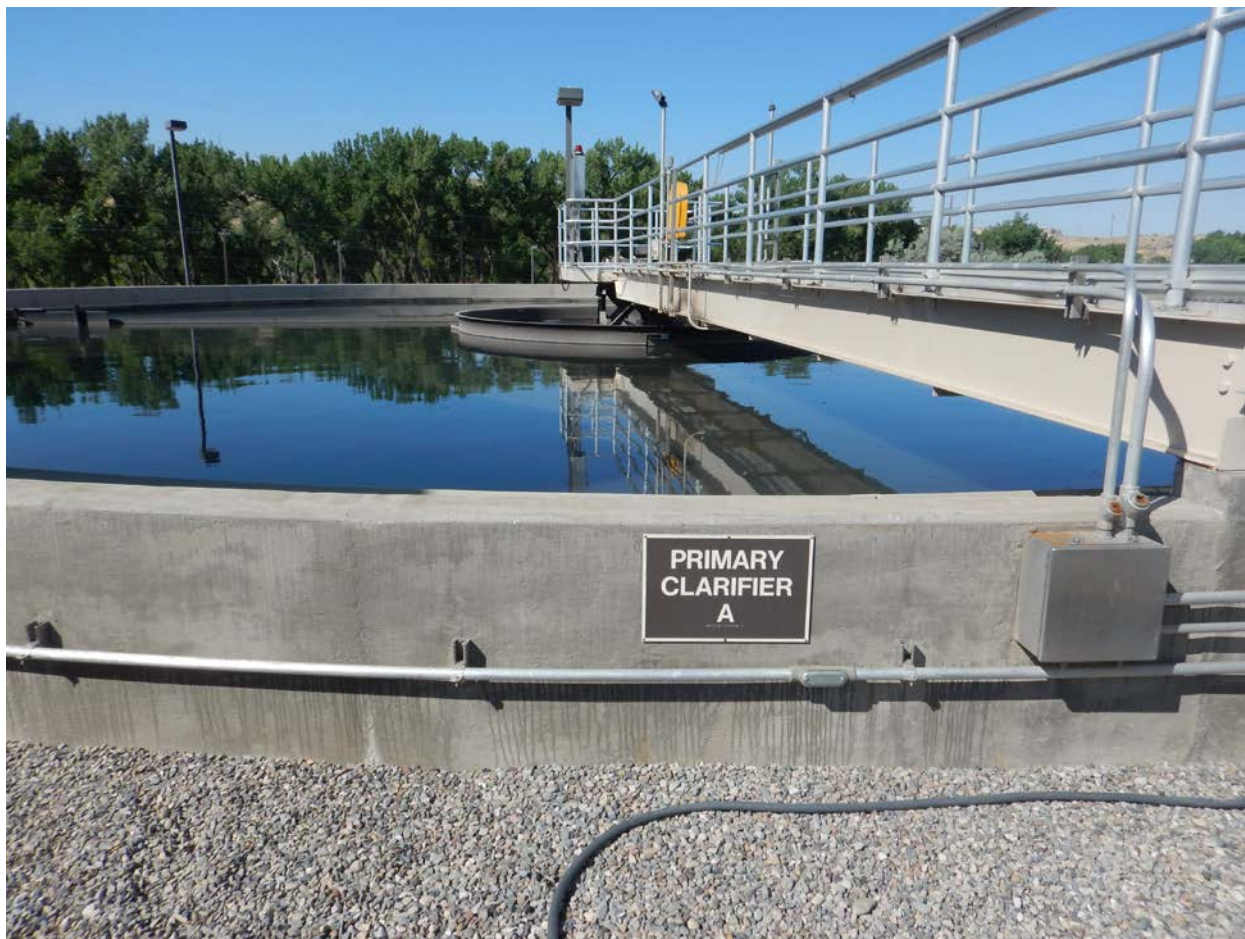
Photo No. 2

Primary clarifiers A and B receive the influent flow after passing through the parallel aerated grit basins and other WWTP screening process where solids are disposed of in the San Juan County Landfill. July 10, 2018 9:49 AM (DSCN0868).

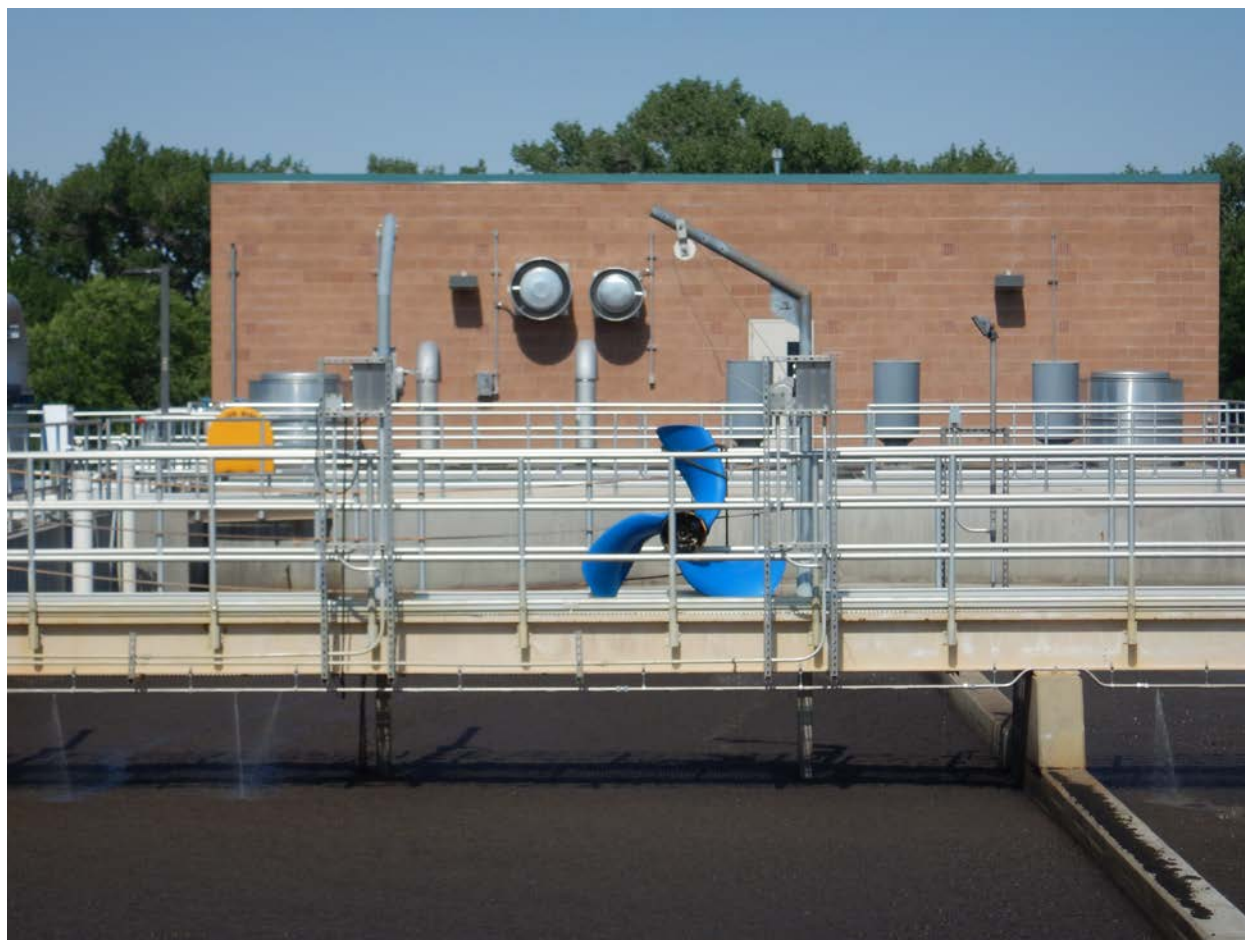
Photo No. 3

View of removed "banana blade" from one (1) of the Medium Rate Activated Sludge (MRAS) basins. July 10, 2018 10:15 AM (DSCN0879).

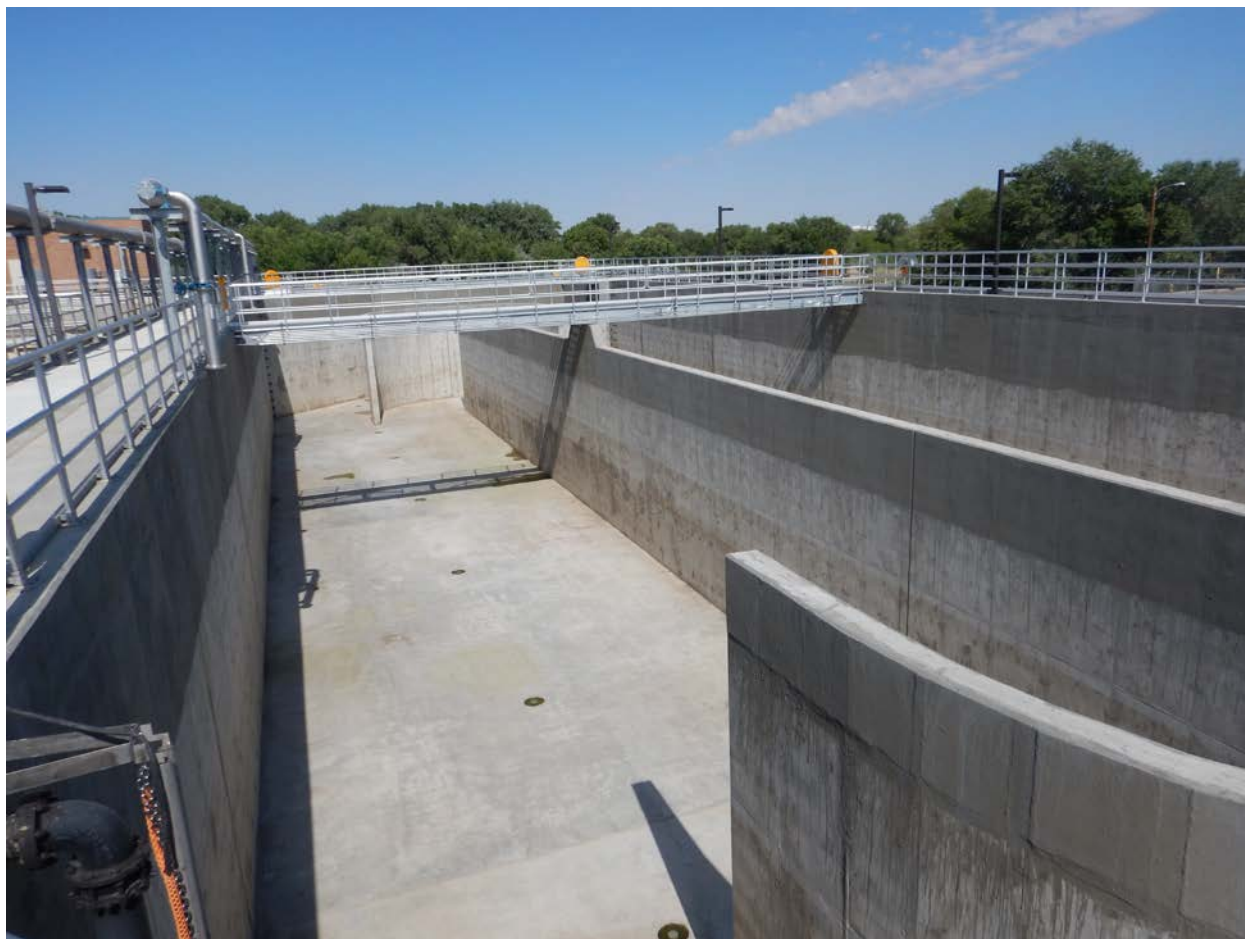
Photo No. 4

View of the newly constructed third MRAS structure awaiting equipment installation (diffusers). July 10, 2018 10:17 AM (DSCN0880).

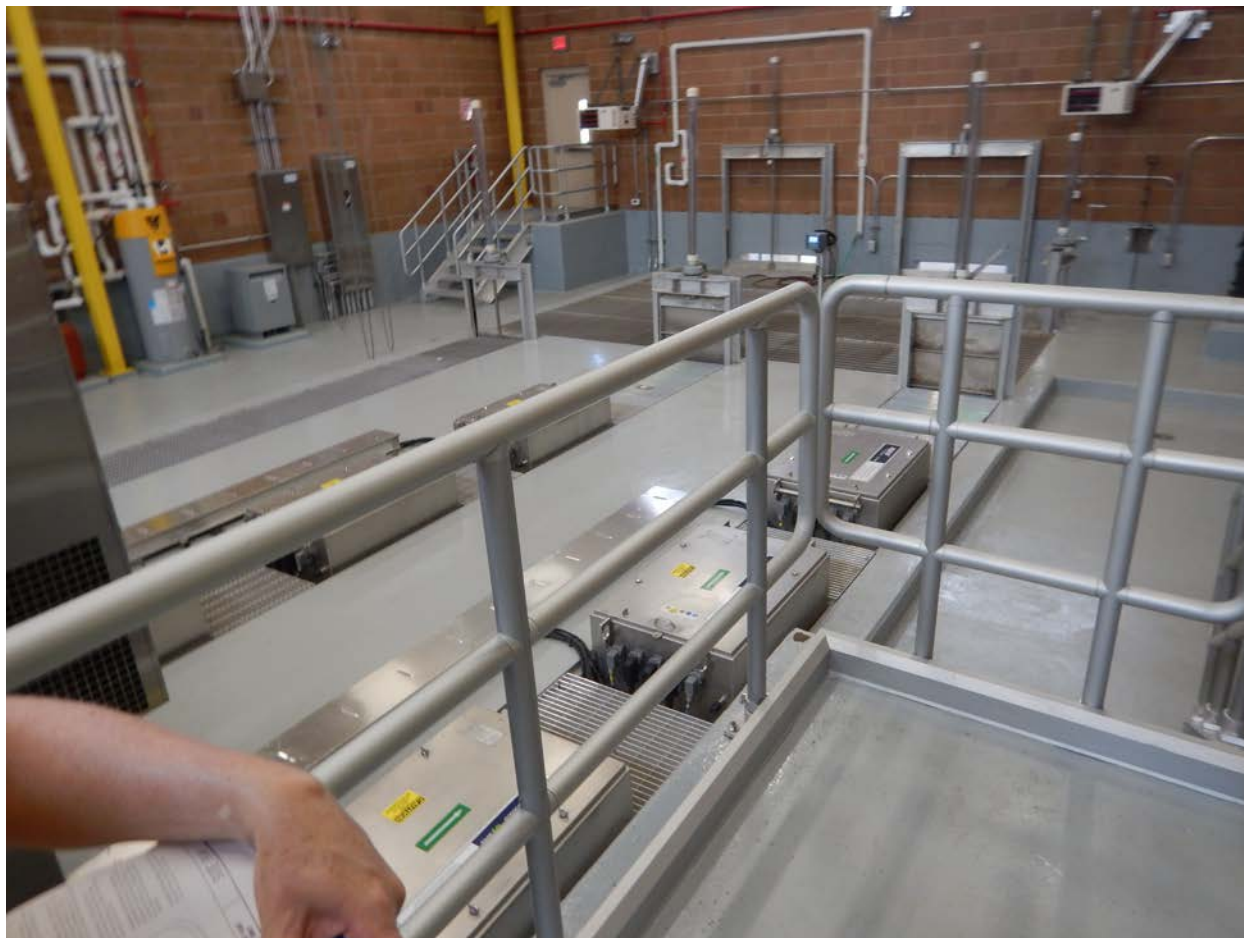
Photo No. 5

The flow from both secondary clarifiers is combined and routed to the ultraviolet (UV) treatment building for disinfection. The UV process consists of 2 channels of 3 banks and can be operated independently of each other. July 10, 2018 11:08 AM (DSCN0898).

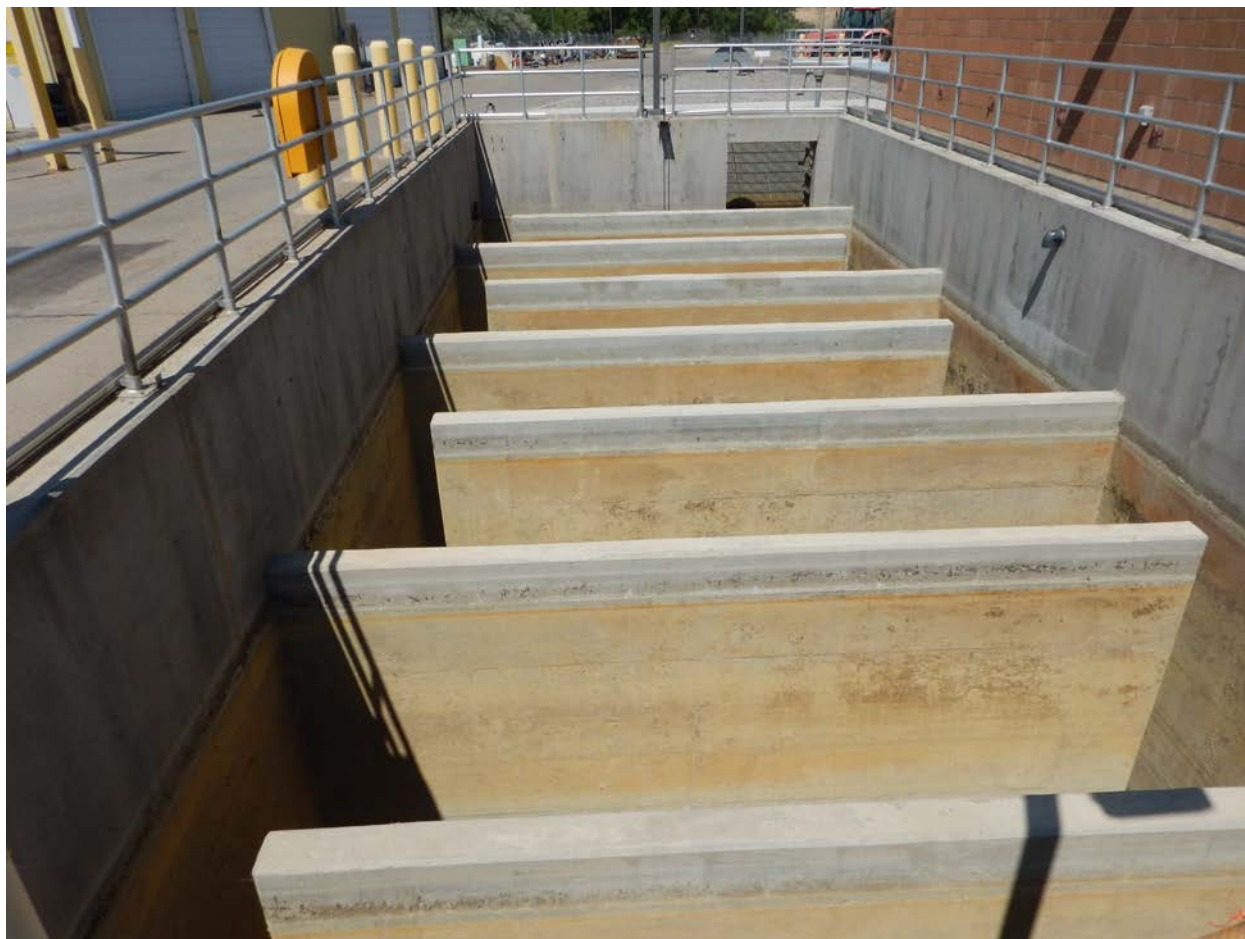
Photo No. 6

View of the previously used Chlorine Contact Basin 1 in the disinfection process. July10, 2018 11:16 AM (DSCN0901).

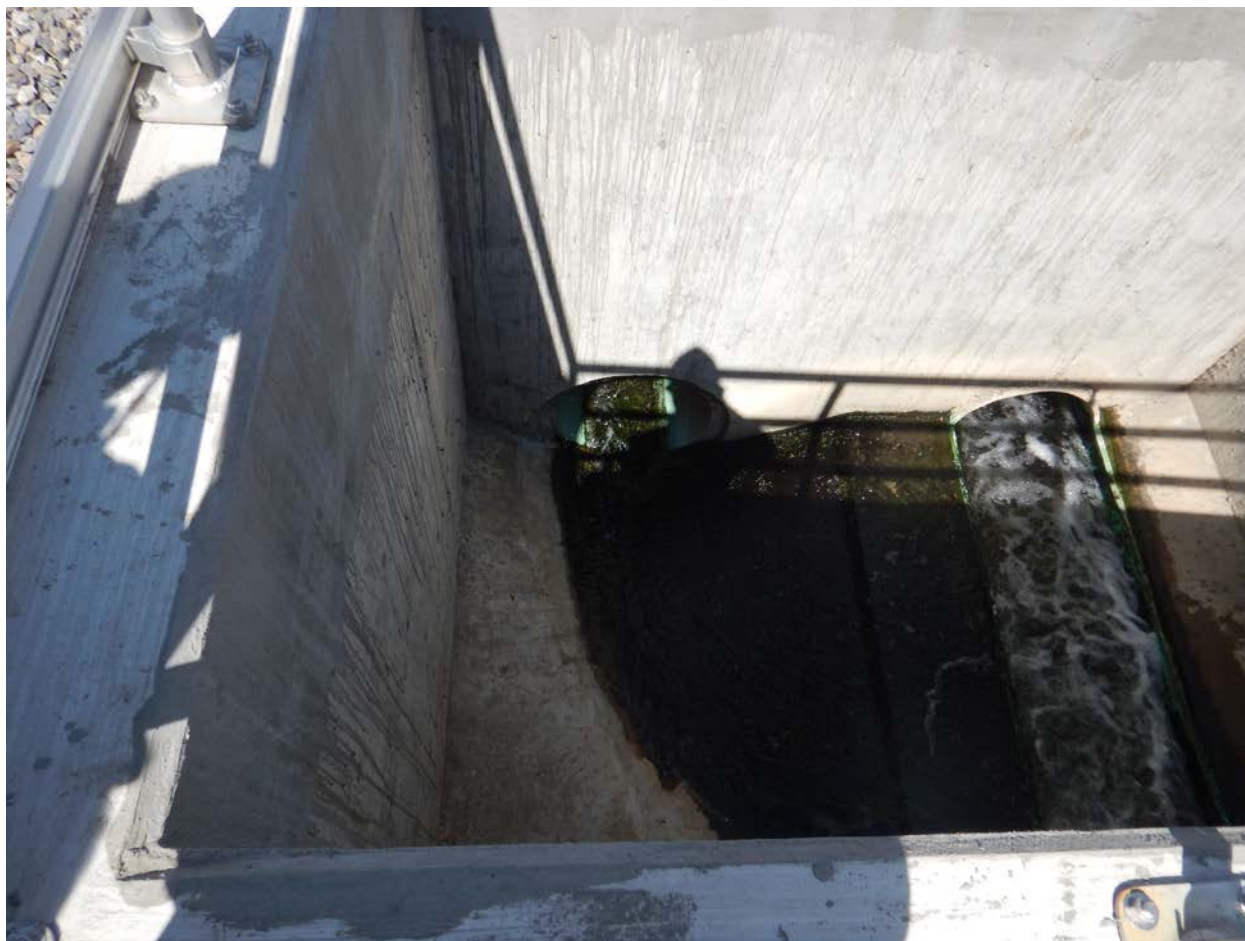
Photo No. 7

Effluent flow at Out 001 appeared to be clear. No foam, aromatics, discoloration, or stressed vegetation was observed (Appendix 1 Photograph #7, #8 and #9).

View of effluent flow prior to entering the closed conduit piping for discharge at Out 001. The closed conduit traverses approximately 1,000-feet northwest of the WWTP prior to discharging. July 10, 2018 10:58 AM (DSCN0894).

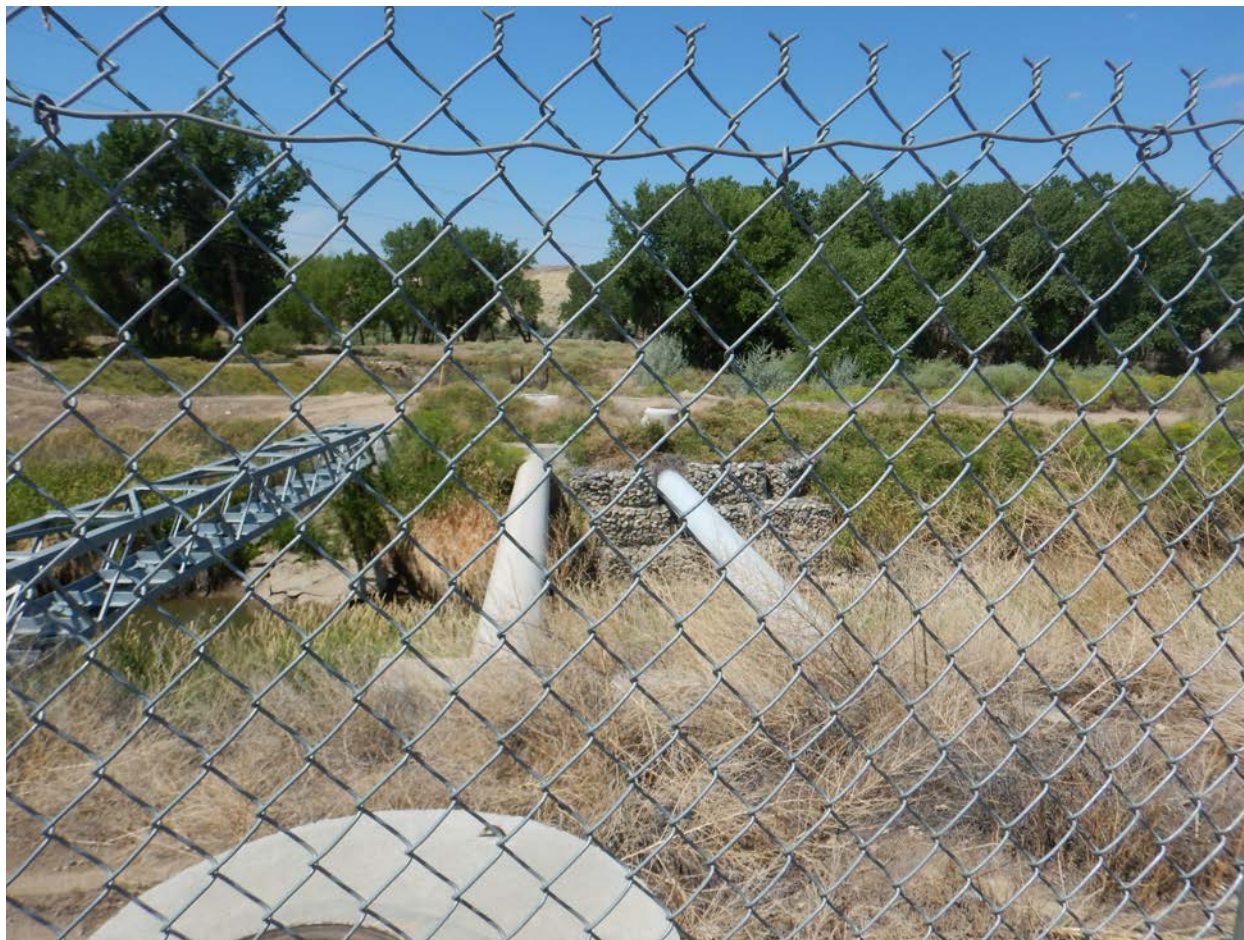
Photo No. 8

View of the 24-inch and 27-inch closed conduit effluent conveyance piping. After exiting the WWTP the two (2) parallel piping structures combine at a manhole into one (1) 24-inch line, thence traversing to Outfall 001 and discharging into the San Juan River. July 10, 2018 10:55 AM (DSCN0892).

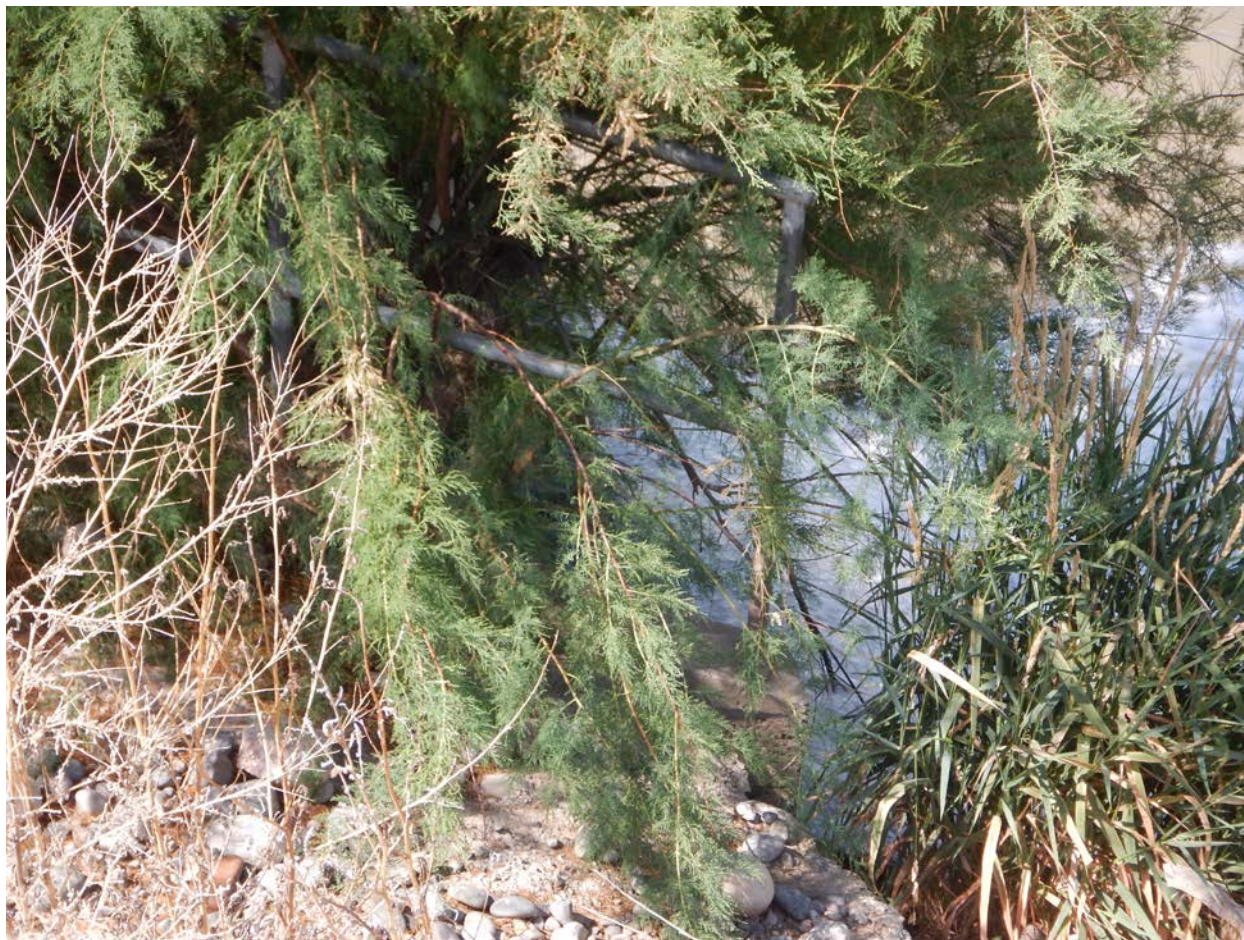
Photo No. 9

Effluent flow at Out 001 appeared to be clear. No foam, aromatics, discoloration, or stressed vegetation was observed. July 10, 2018 10:44 AM (DSCN0891).

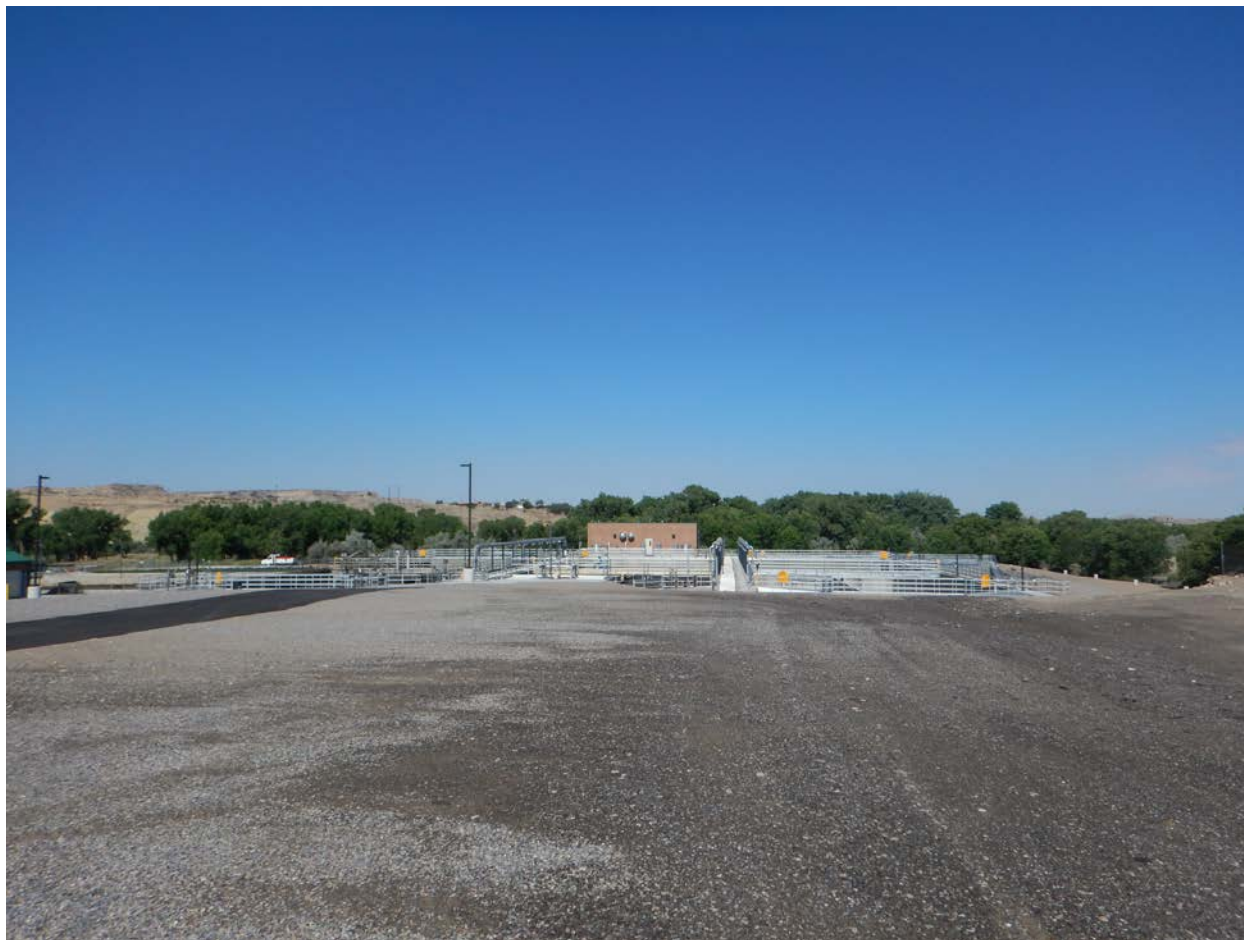
Photo No. 10

The overall WWTP's operations and maintenance (O&M), and general facility housekeeping appeared to be in good order, except for bullet item 6 above. Updates and contractor operations had just recently (approximately 1-week ago) been completed (bullet item 2 above) and grading (site leveling/contouring)/gravel placement was being completed (Appendix 1 Photograph #10).

Updates and contractor operations had just recently (approximately 1-week ago) been completed and grading (site leveling/contouring)/gravel placement was being completed. July 10, 2018 9:40 AM (DSCN0865).
