NPDES Pretreatment Compliance Sampling Inspection Report

Agri-Mark

39 McCadam Lane
Chateaugay, New York 12920

Inspection Dates: September 19-20, 2023

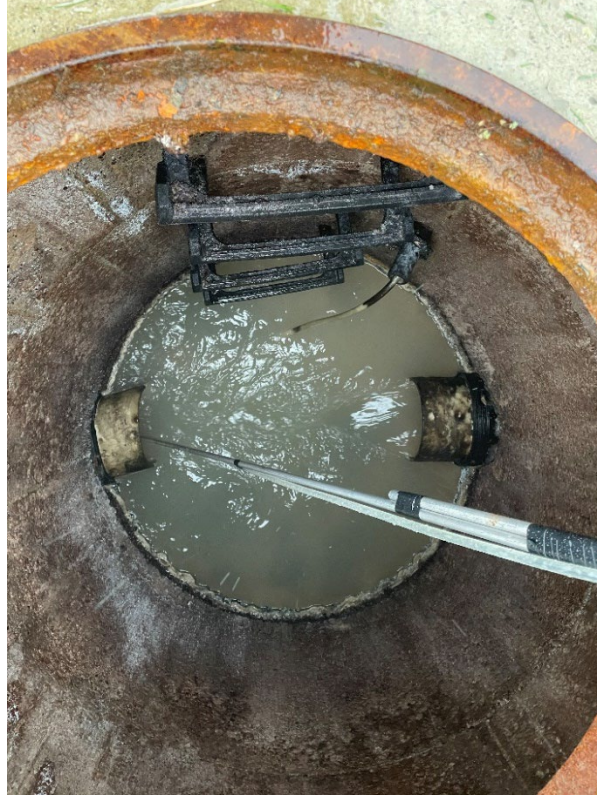
Photo #1. Samples were collected from the discharged pipe in the monitoring manhole.

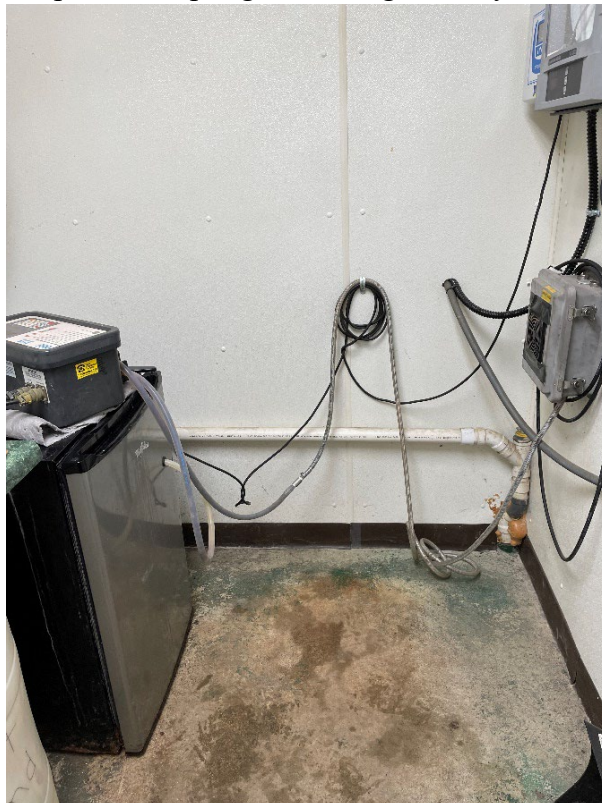
6.2.2 The sampling assemblage consists of the composite sample container, sampling tube, and sampling probe was observed to be dirty and/or contains algal growth. In addition, the sampling probe was observed covered with accumulated growth when raised above the discharging flow. It also felt the sampling probe was resting at the bottom of the monitoring manhole when it was lower back in. At any point in the sampling event and/or during the purging cycle, dirt and/or algal growth could potentially become dislodged and be part of the sample. Hence, the analytical result could be bias high. The sampling assemblage should be clean and/or replaced. Furthermore, the sampling probe should be positioned in the middle of the flow at mid-depth. According to Section 9.1(b) – Monitoring, Recording, and Reporting in Part – II General Condition of the SIU Discharge Permit, it states, *“Samples and measurements taken to meet monitoring requirements specified in this permit shall be representative of the quantity and character of the monitored discharge....”* Furthermore 40 CFR Part 403.12(b)(5)(ii) of the General Pretreatment Regulations for Existing and New Sources of Pollution, it states, *“ In addition, the User shall submit the results of sampling and analysis identifying the nature and concentration (or mass, where required by the Standard or Control Authority) of regulated pollutants in the Discharge from each regulated process. Both daily maximum and average concentration (or mass, where required) shall be reported. The sample shall be representative of daily operations....”*

Photo #2. The facility's composite sampling assemblage is dirty and/or contains algal growth.

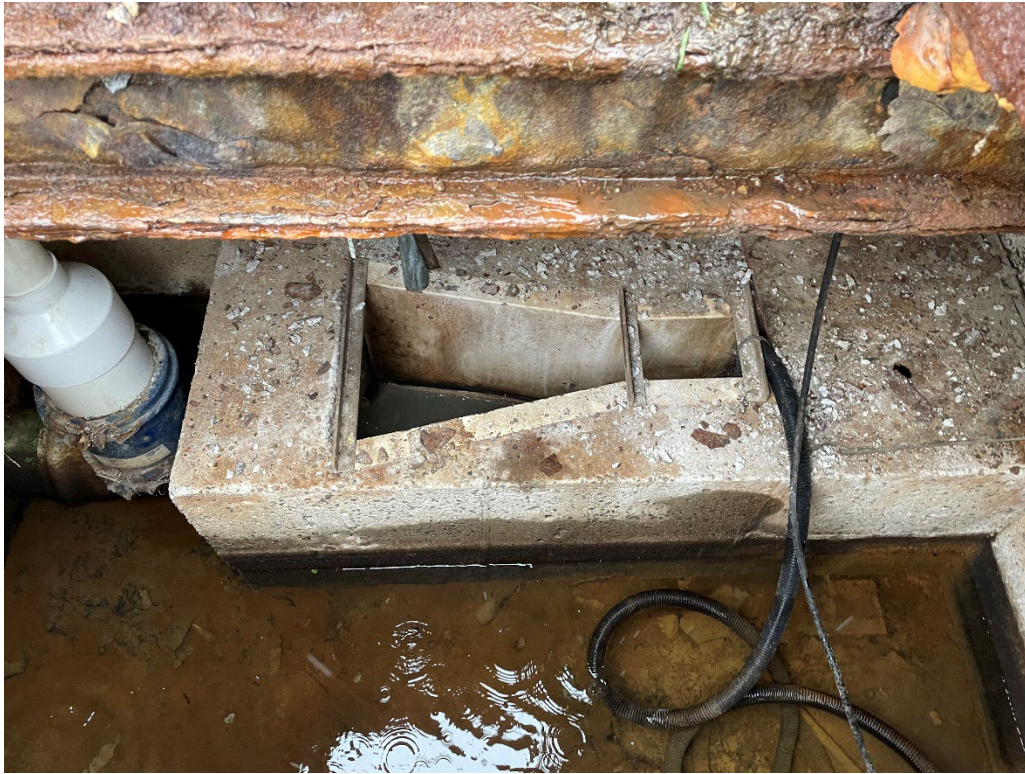
6.2.1 The approaching flow to the Parshall flume is turbulence. As a result, the Ultrasonic flow sensor is recording high flow. According to the ISCO Open Channel Flow Measurement Handbook, Fifth Edition, Page 73 of Chapter 4: Flumes, it states, *“The approaching flow should enter the converging section reasonably well distributed across the entrance width, and the flowlines should be essentially parallel to the flume centerline. Surges and waves of any appreciable size should be eliminated. Also, the flow at the flume entrance should be free of “white” water and free from turbulence in the form of visible surface boils.”* Furthermore, Section 10.1(b) – Disposal System Operation and Daily Quality Control in Part – II General Condition of the SIU Discharge Permit, it states, *“The permittee shall at all times, properly operate and maintain all facilities and system control (and related appurtenances) which are installed or used by the permitted to achieve compliance with the conditions of this permit...”*

Photo #3. The Parshall flume w/ the flow sensor is recording high flow due to turbulence.

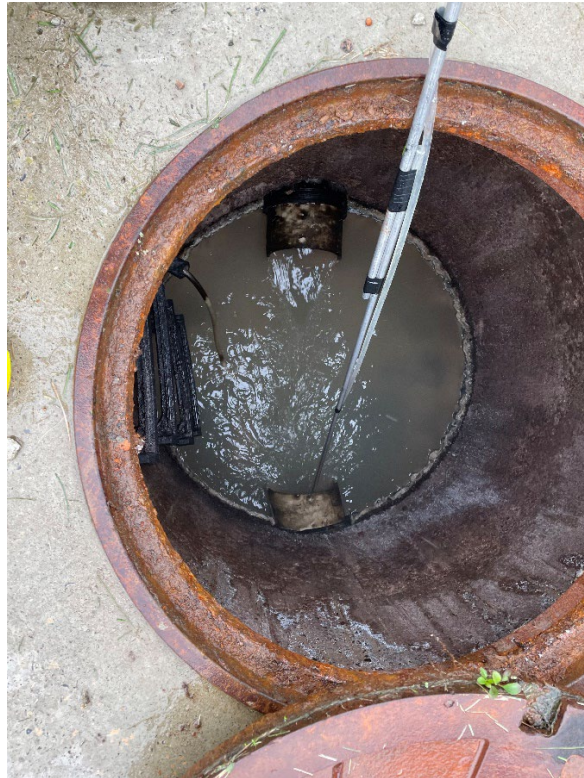
Photo #4. The facility's sampling probe was resting at the bottom of the monitoring manhole.
