NEW ENGLAND REGIONAL LABORATORY  
NORTH CHELMSFORD, MA 01863

**Subject:** Reconnaissance and Sampling Inspection Report  
Clean Water Act – National Pollutant Discharge Elimination System  
West Haven, CT

## **VIII. Description of Sampling Locations (in order of collection time)**

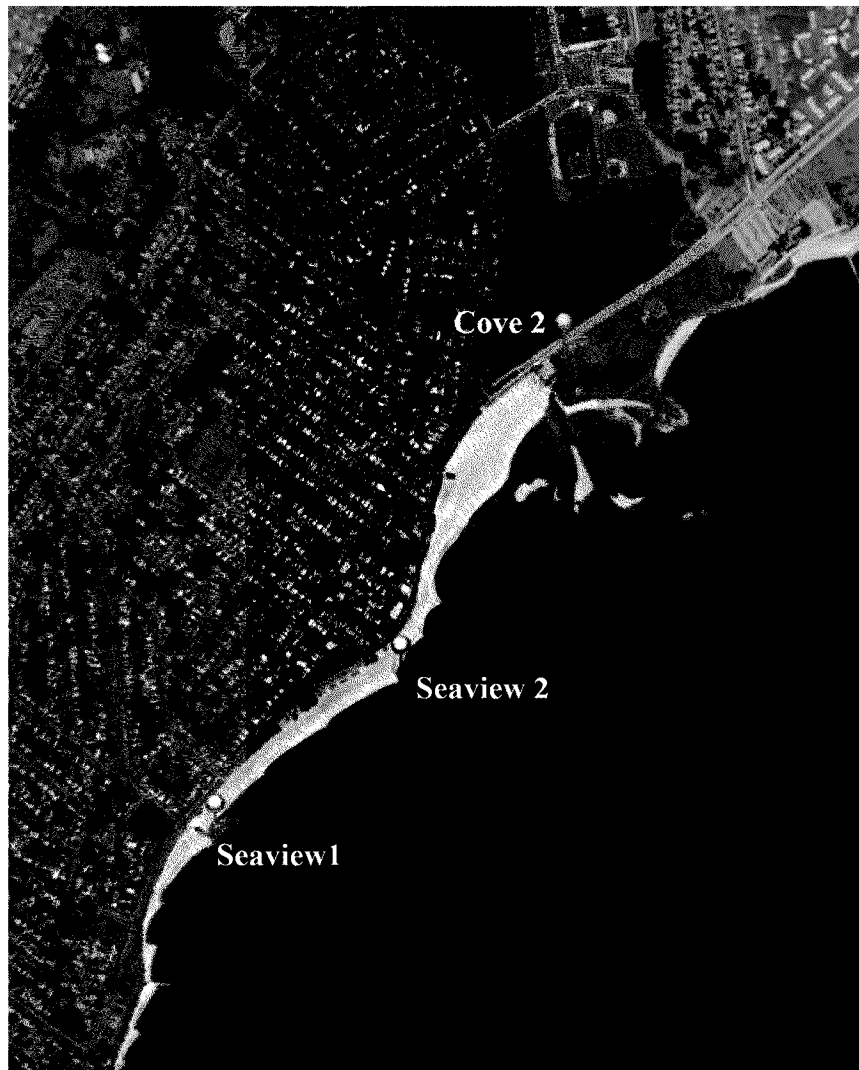
### Map of Sample Locations

Note: the locations on the map were estimated using Google Earth and are used for display purposes only.

Seaview 2: No flow. Outfall was partially submerged.

Cove 2: No flow. Outfall was partially submerged.

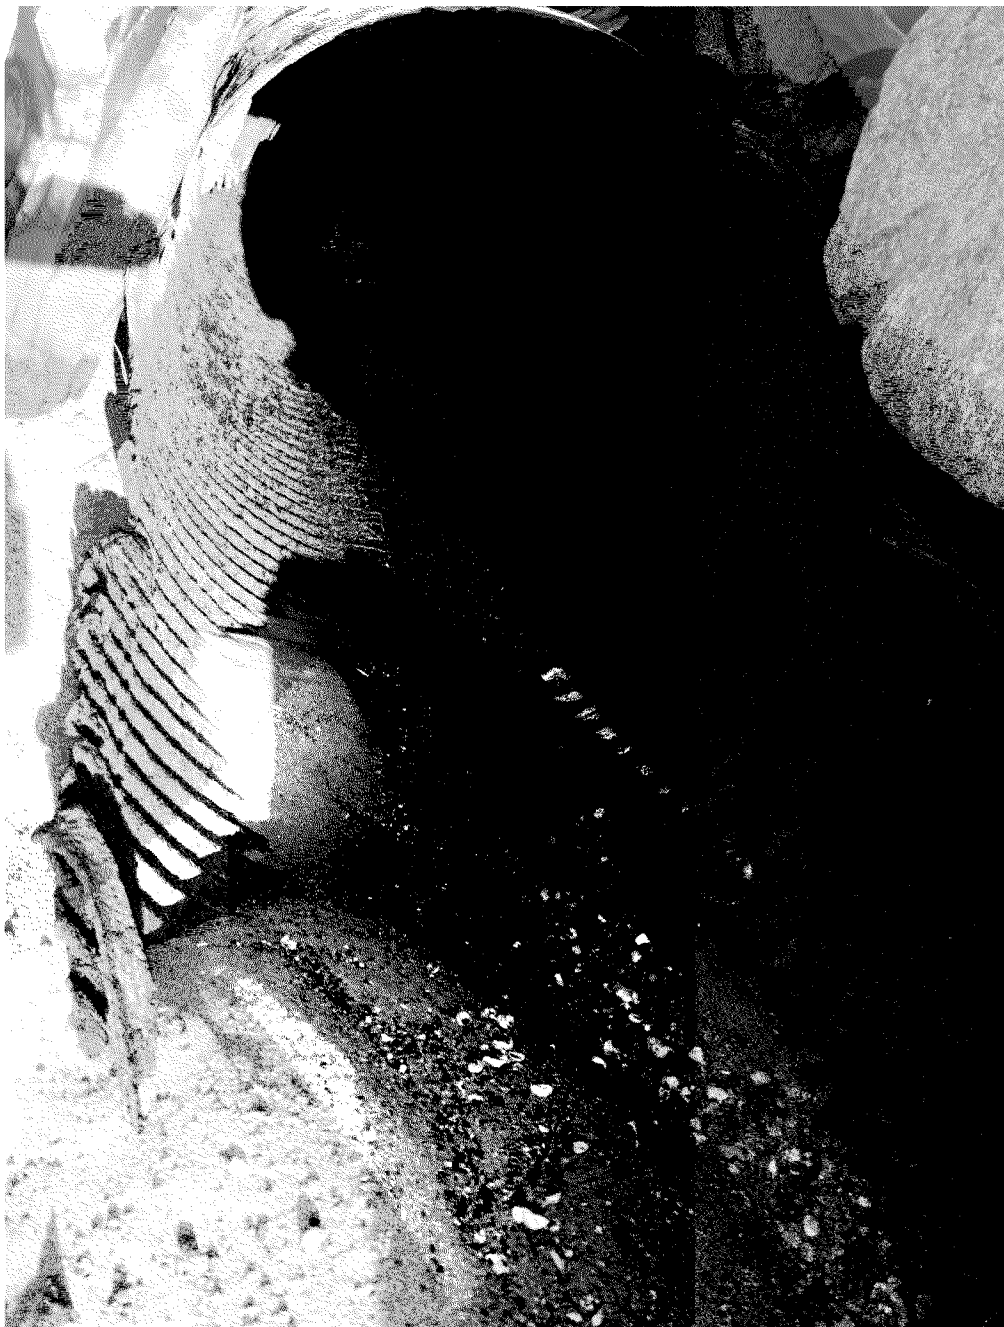
- **Seaview1**: One circular corrugated metal outfall approximately 4 feet in diameter, located at 700 Ocean Ave and at the end of a man-made rock jetty. Discharge flow was approximately 4 gallons per minute (“gpm”) into the Long Island Sound. Sample was collected at the mouth of the outfall. A briny odor was detected. Color was clear and turbidity was low. No overt floatables were observed. Dark green algae growth was observed on the sides of the metal outfall. The structural integrity of the outfall was observed to be deteriorating, with a section of the pipe caved in.

**Photo 1: Seaview1** (photo taken 10/22/2024 at approx. 8:14) Outfall located near 700 Ocean Ave, discharging into the Long Island Sound. Sample point is indicated by a red X.

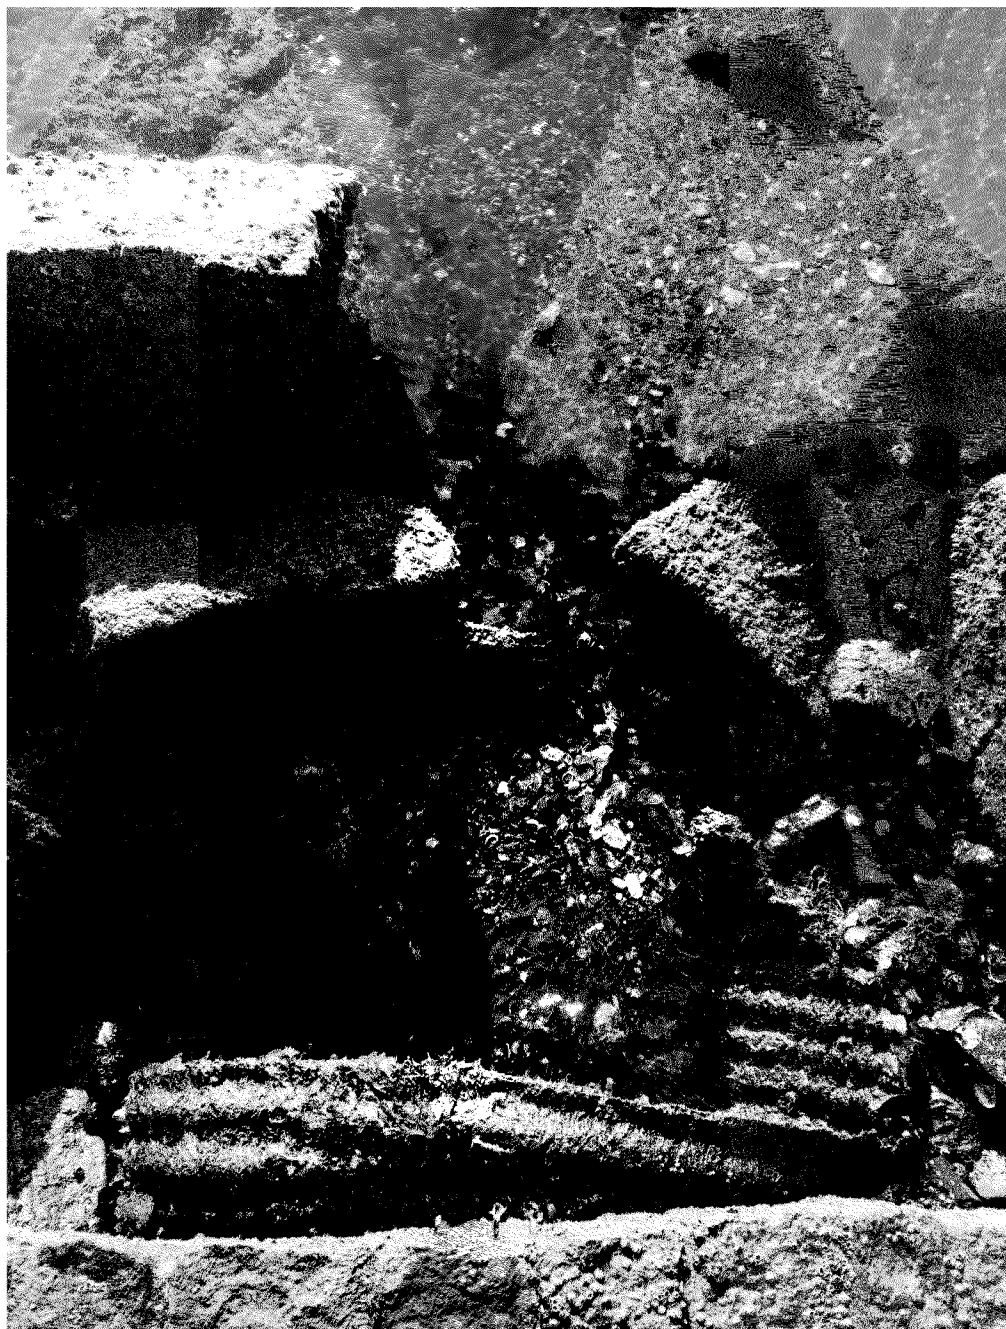
- **Seaview2:** One circular corrugated metal outfall approximately 4 feet in diameter, located at the end of a jetty, located at Ocean Ave. and Opp Dawson Ave. At low tide, discharge flow was not observed, due to the partial submergence of the outfall by the tide. The outfall pipe was heavily degraded, with observed holes further up the pipe.
- **Cove2:** One oblique concrete outfall, approximately 2 feet in diameter, preceding a roughly 3- foot concrete flume, located at 1083 Ocean Ave. The outfall is located on the left bank, looking upstream, preceding Long Island Sound. The water was stagnant with no discharge observed and the outfall was mostly submerged. Dead oysters were observed around the outfall and directly downstream.

**Photo 2: Seaview2** (photo taken 10/22/2024 at approx. 8:44) Outfall located near Ocean Ave. and Opp Dawson Ave. No sample was collected at this location. (Note: Time stamp on photo is incorrect)
