## **RCRA Inspection Report**

Brenntag Mid-South, Inc.  
1405 KY 136 W  
Henderson, Kentucky 42420

12/6/2023 at 9:00 a.m.

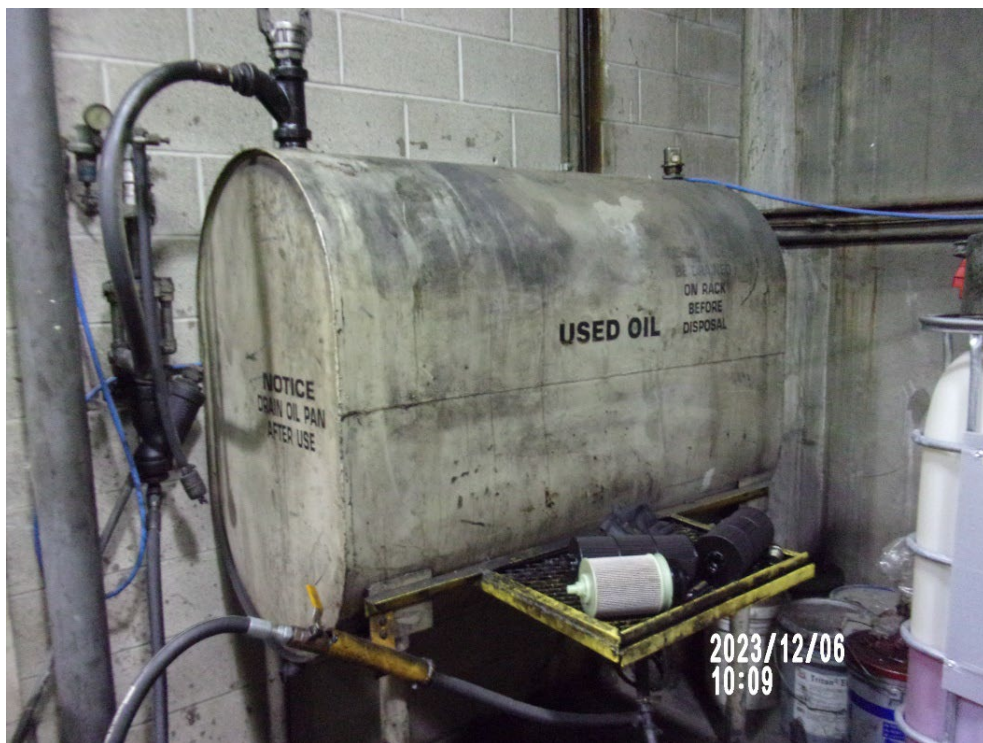
The inspectors first went to the warehouse area where truck maintenance is performed. Used oil is collected in a steel used oil tank. The tank was appropriately labeled as "Used Oil" (Photograph 1). Brenntag is also an authorized hazardous waste transporter. The transportation of hazardous waste was discussed. Brenntag primarily transports its own hazardous waste when needed and has a limited service for a small portion of its customers. An aerosol can puncturing device, on top of a 55-gallon satellite accumulation container, was observed. The container was appropriately marked and labeled but was open (Photograph 2). Facility staff immediately closed the container (Photograph 3).

Photograph 1: Used Oil Container.

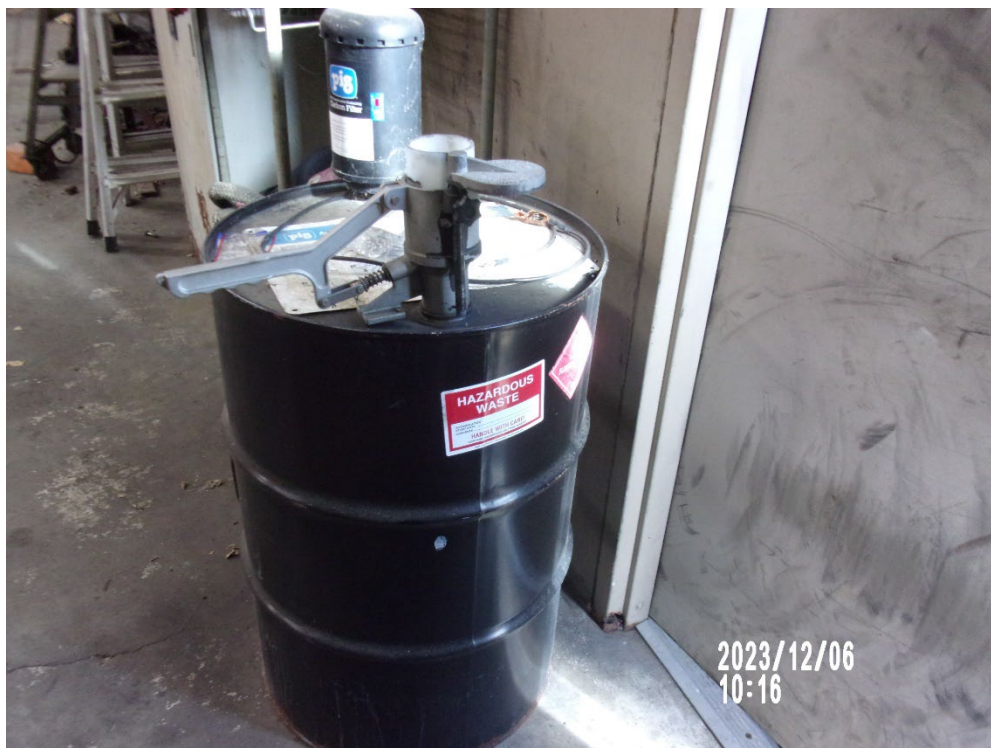
**Pursuant to 401 KAR 39:080, Section 1(1)[40 C.F.R. § 262.15(a)(4)], which is a condition of the SAA Permit Exemption, a generator is required to keep containers of hazardous waste closed**

**at all times during accumulation, except when adding, removing, or consolidating waste; or when temporary venting of a container is necessary for the proper operation of equipment, or to prevent dangerous situations, such as build-up of extreme pressure.**

Photograph 2: Open Satellite Accumulation Container.

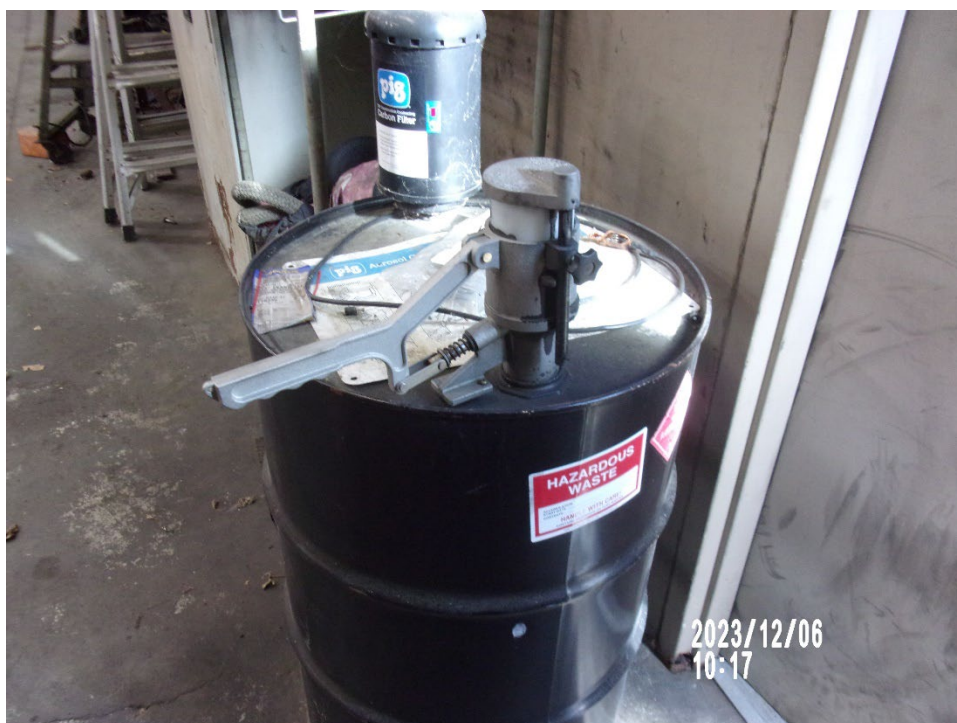
Photograph 3: Corrected Satellite Accumulation Container (by closing).

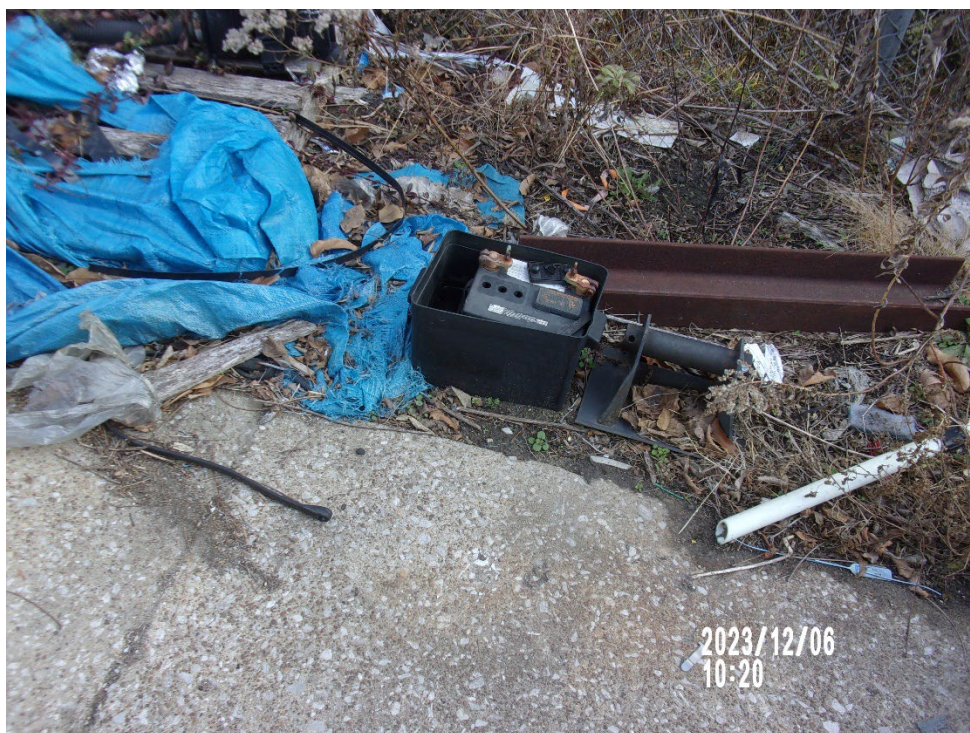
During the walk-through of this area a single vehicle battery, without a cap, was observed (Photograph 4). Some small house-keeping issues were observed of vehicle fluid (oil) containers, and a partially full aerosol can, that were outside the door of the building (Photographs 5 and 6). The facility was advised that it would be better to keep the containers inside the building. The facility personnel located the battery cap and placed the battery with the rest of the vehicle batteries that are being recycled (Photograph 7). Brenntag Mid-South is managing its spent lead-acid vehicle batteries under the provisions of 401 KAR 39:090, Section 3 [40 C.F.R. § 266 Subpart G].

Photograph 4: Battery Outside of the Warehouse area missing cap. Battery was immediately closed and put in collection area.

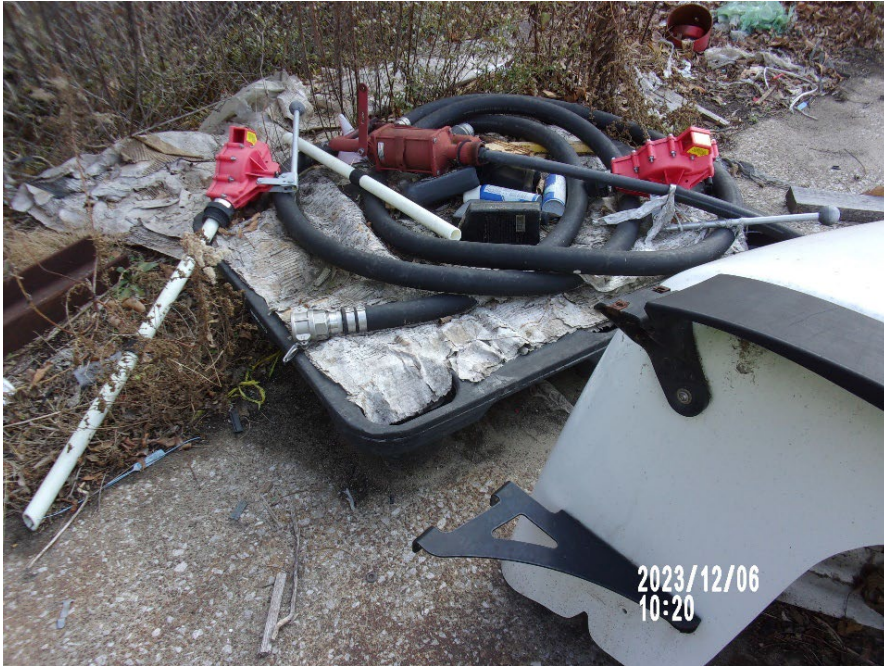
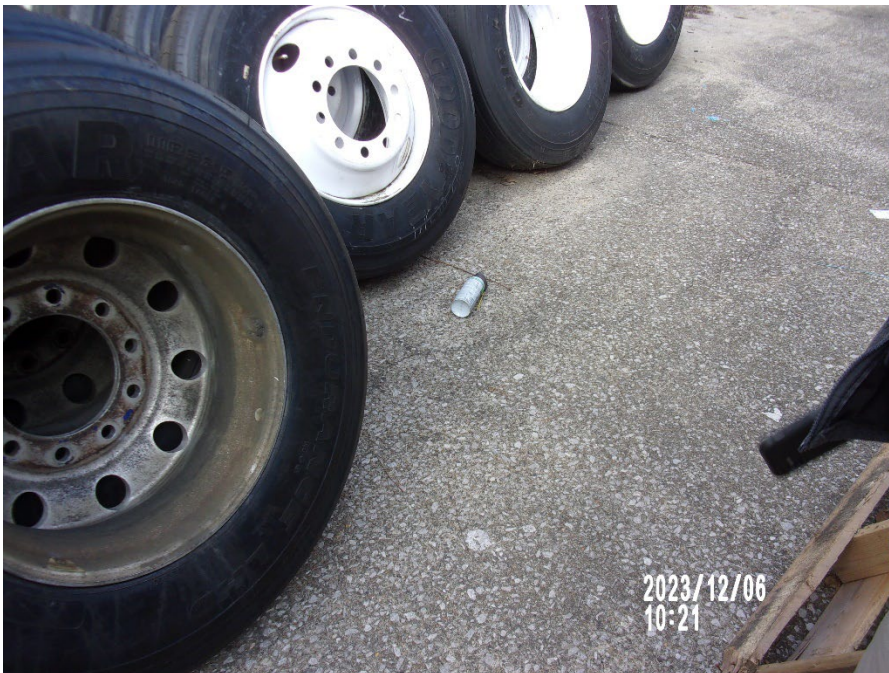
Photograph 5: One quart oil containers outside of the warehouse. Appeared to have product in them.

Photograph 6: Aerosol can, substantially full, misplaced by tires.

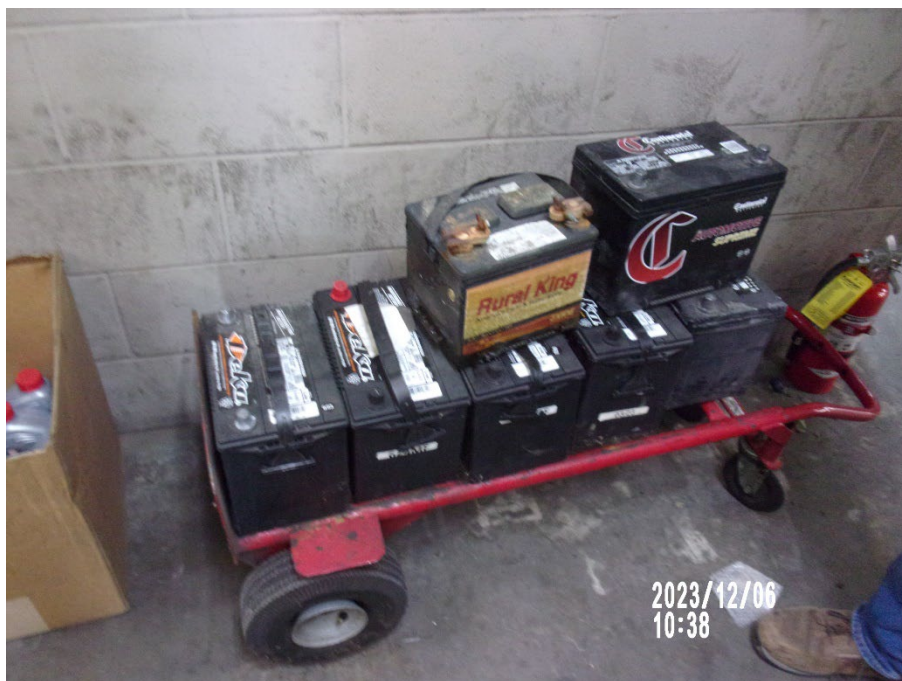
Photograph 7: Batteries collected for recycling.

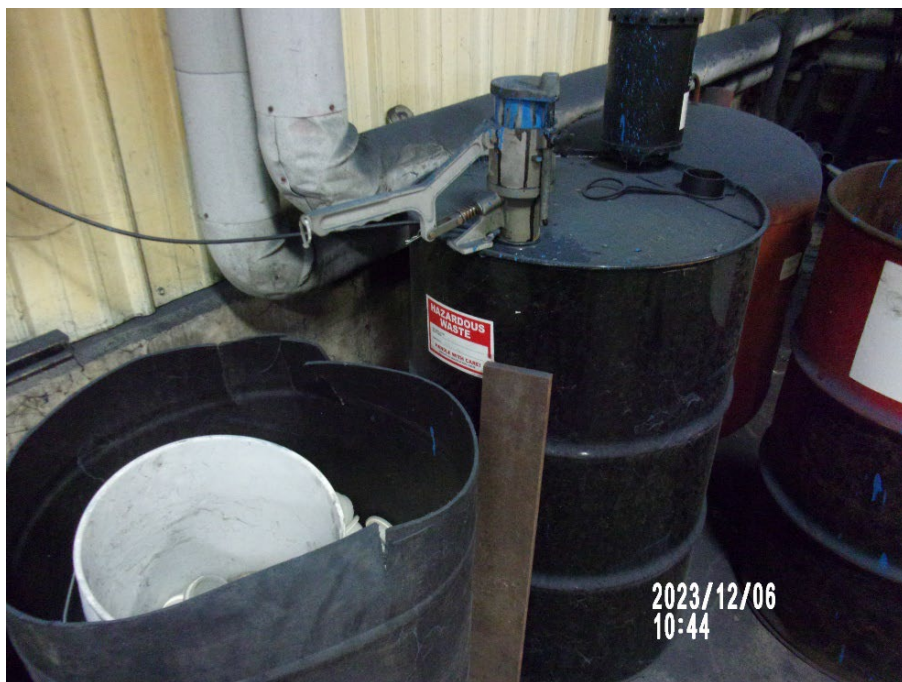
In this building returned compressed gas cylinders are reconditioned. The facility will sometimes use aerosol can spray paint on the cylinders. The facility operates an acid and caustic wash bay and the effluent from this process is pH adjusted and discharged to the plant's wastewater treatment plant (WWTP) before being discharged to the city Publicly Owned Treatment Works (POTW). In this area a can puncturing device, on top of a 55-gallon satellite accumulation container, was observed that had recently been put in operation. The container had a hazardous waste label but was missing the hazard indicator marking (Photograph 8). Facility personnel immediately affixed an appropriate hazard indicator marking (Photograph 12).

**Pursuant to 401 KAR 39:080, Section 1(1) [40 C.F.R. § 262.15(a)(5)(ii)], which is a condition of the SAA Permit Exemption, a generator must mark or label its container with the following: (ii) An indication of the hazards of the contents (examples include, but are not limited to, the applicable hazardous waste characteristic(s) (i.e., ignitable, corrosive, reactive, toxic); hazard communication consistent with the Department of Transportation requirements at 49 CFR part 172 subpart E (labeling) or subpart F (placarding); a hazard statement or pictogram consistent with the Occupational Safety and Health Administration Hazard Communication Standard at 29 CFR 1910.1200; or a chemical hazard label consistent with the National Fire Protection Association code 704).**

Photograph 8: Aerosol Can Puncturing Device and Satellite Accumulation Container.

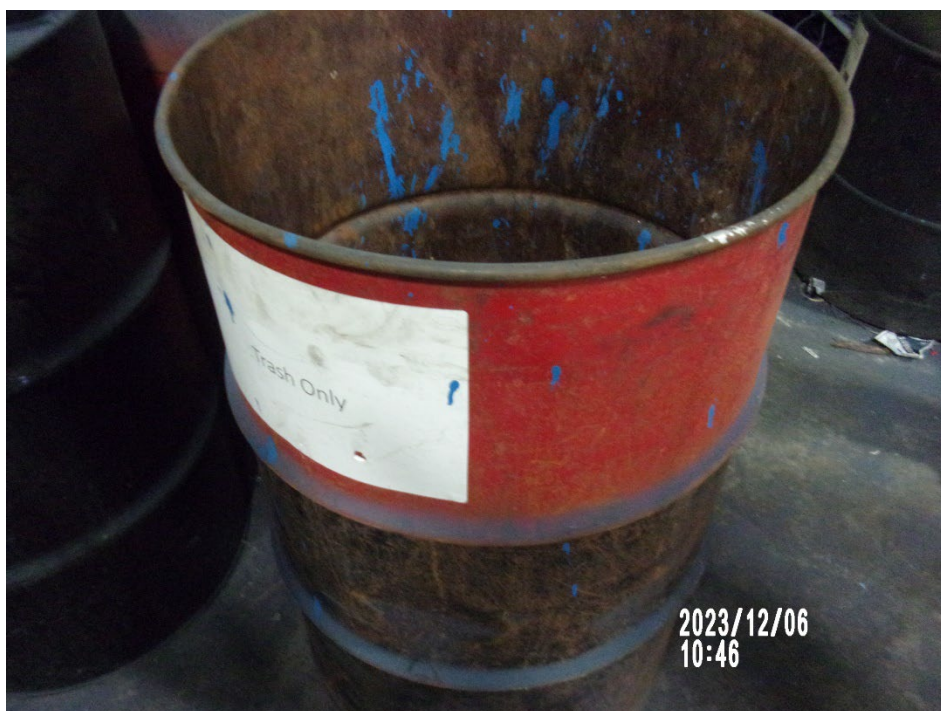
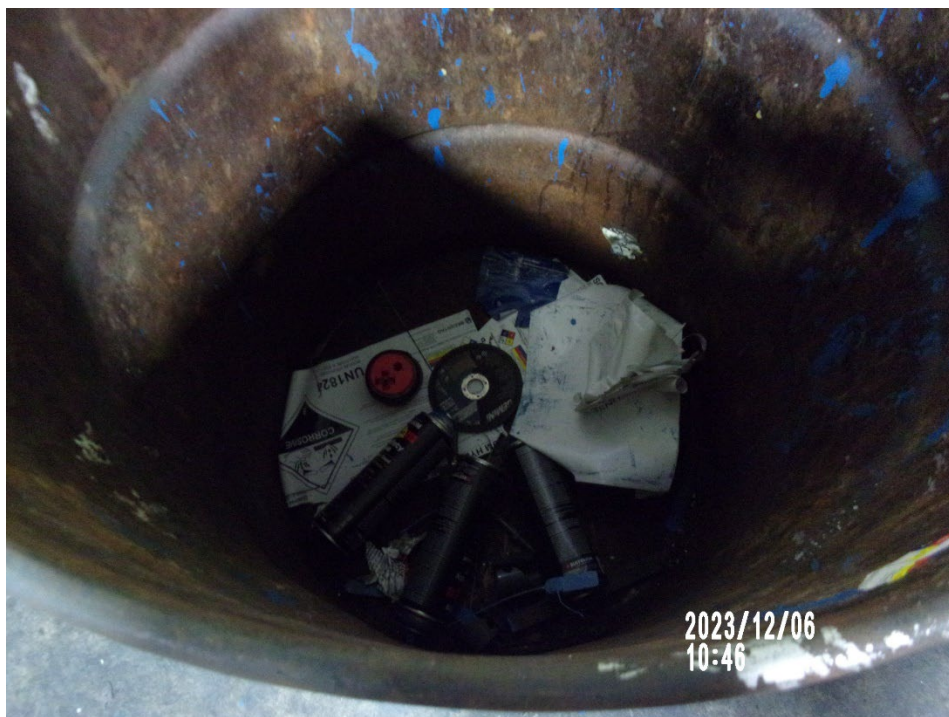
The container for the punctured cans had a few punctured cans in it but was inappropriately labeled as "Trash Only" (Photograph 9). The facility staff briefed that it was their intent to recycle the pierced cans. Several pierced cans were observed in a drum labeled as "Trash Only" (Photograph 10). The facility was briefed that if cans are pierced, the can must be recycled, or piercing is considered treatment of Hazardous Waste. The facility advised the inspectors that the drum was mislabeled. The facility was briefed that the punctured cans, for this exclusion, are required to be recycled as scrap metal and that the cans can be typically managed with a facility's other scrap metal. The facility staff immediately relabeled the container as "Scrap Metal" (Photograph 11).

Photograph 9: Collection Container for Punctured Aerosol Cans Inappropriately labeled as "Trash Only".

Photograph 10: Punctured aerosol cans in the Container.

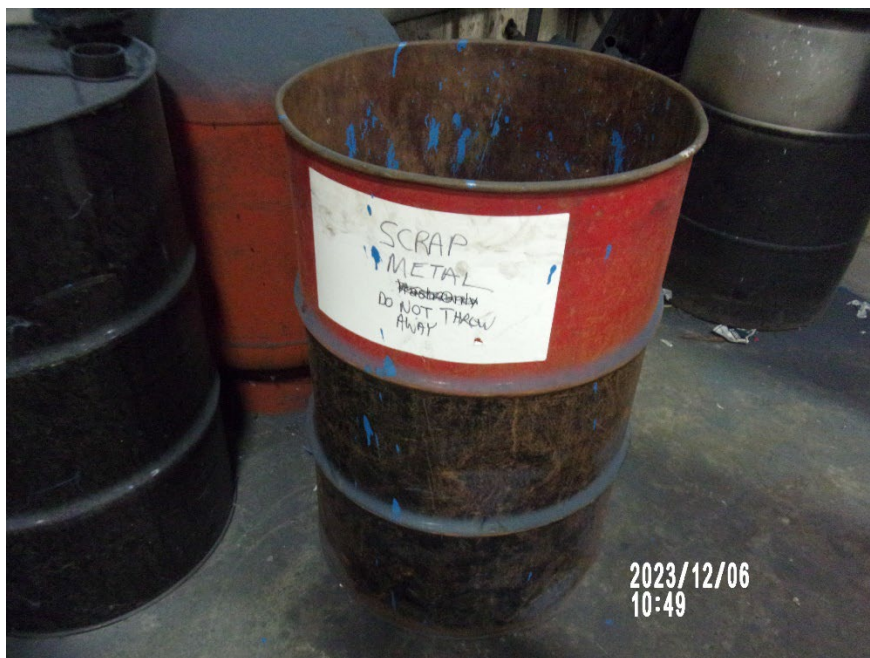
Photograph 11: Corrected labeling on the punctured aerosol can collection container.

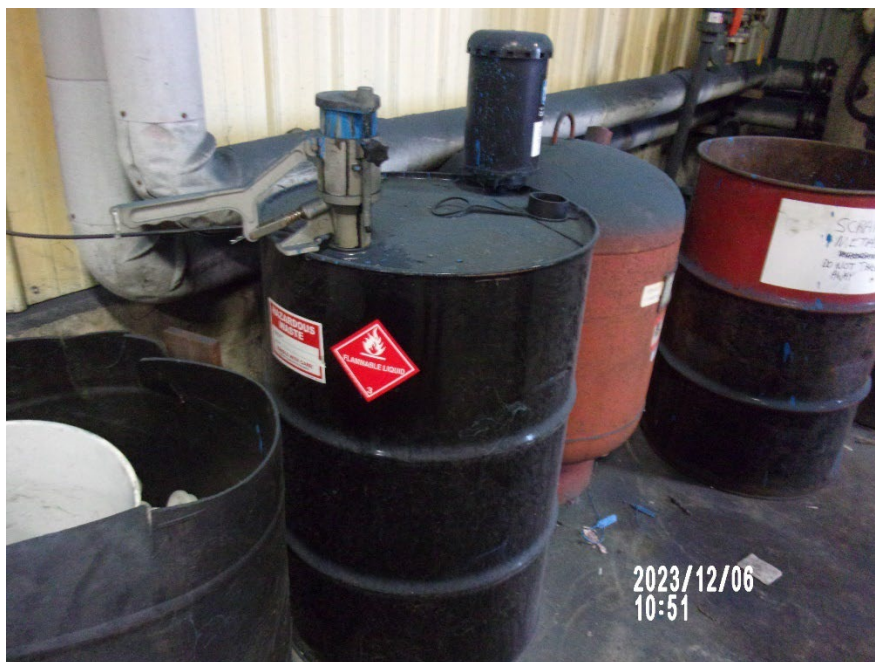
Photograph 12: Corrected container with new hazard indicator marking.

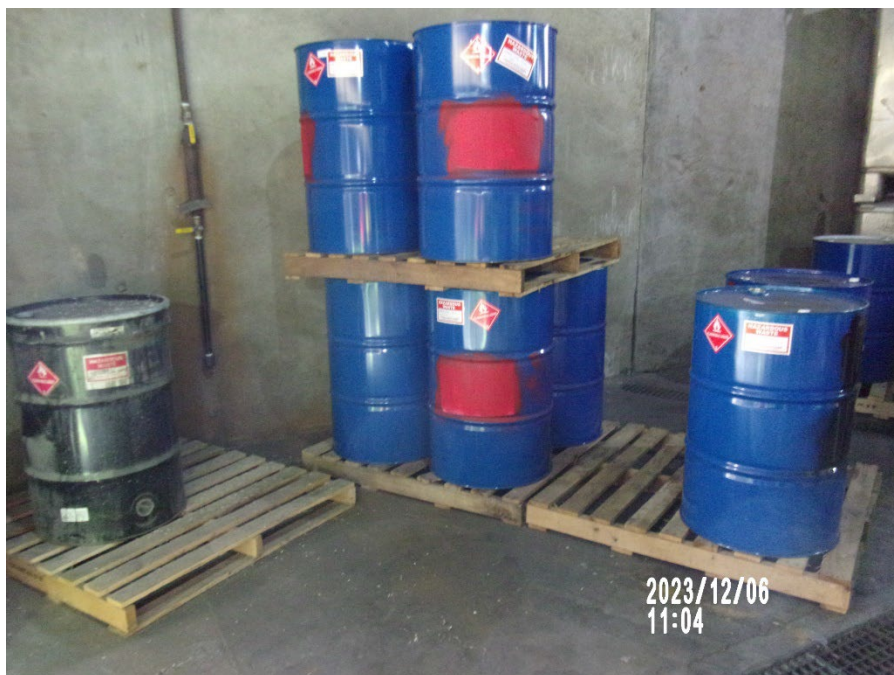
This area had signage to identify the area. Ten 55-Gallon drums of hazardous waste were present (Photograph 13). The containers were all properly labeled and had hazard markings. The containers were on pallets, appeared to be in good condition, and no leaks or releases were observed. The oldest date recorded in this area was 10/23/2023. Seven 55-gallon drums of waste styrene and toluene were dated 10/23/2023, two 55-gallon containers of waste styrene and toluene were dated 11/10/2023, and one 55-gallon container of waste paint solvent was dated 12/1/2023. The company noted that yellow hazardous waste labels for transport are affixed when the transporter arrives.

Photograph 13: 55-Gallon Hazardous Waste Containers in the Central Accumulation Area (CAA).

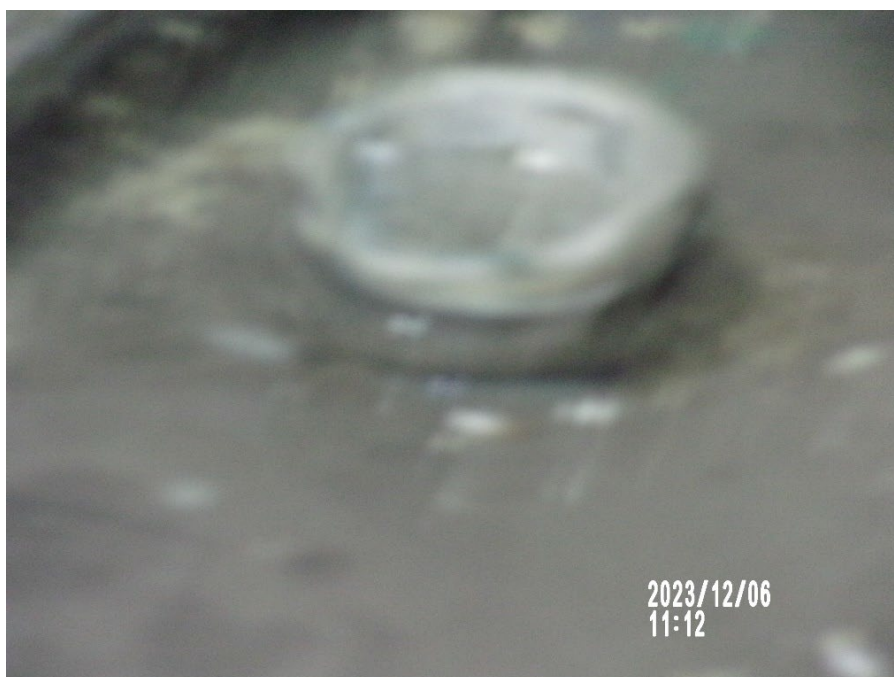
The 55-gallon container of waste paint solvent, dated, 12/1/2023, was observed to have a defective bung hole cap. A small opening (gap) between the defective cap and container was observed under approximately a third of the cap with a gap of approximately an eighth to a quarter of an inch (Photograph 14). Facility personnel obtained a new bung hole cap and this item was immediately corrected (Photograph 15).

**Pursuant to 401 KAR 39:080, Section 1(1) [40 C.F.R. § 262.17(a)(1)(iv)(A)], which is a condition of the large quantity generator permit exemption, A container holding hazardous waste must always be closed during accumulation, except when it is necessary to add or remove waste. Pursuant to 401 KAR 39:080, Section 1(1) [40 C.F.R. § 262.17(a)(1)(i)], which is a condition of the large quantity generator permit exemption, (1) Accumulation of hazardous waste in containers. If the hazardous waste is placed in containers, the large quantity generator must comply with the following: (i) Air emission standards. The applicable requirements of subparts AA, BB, and CC of 40 CFR 265.**

**Pursuant to 401 KAR 39:090, Section 2(1) [40 C.F.R. § 265.1087(c)], which is a condition of the large quantity generator permit exemption, (1) A container using Container Level 1 controls is one of the following: (i) A container that meets the applicable U.S. Department of Transportation (DOT) regulations on packaging hazardous materials for transportation as specified in paragraph (f) of this section. (ii) A container equipped with a cover and closure devices that form a continuous barrier over the container openings such that when the cover and closure devices are secured in the closed position there are no visible holes, gaps, or other open spaces into the interior of the container. The cover may be a separate cover installed on the container (e.g., a lid on a drum or a suitably secured tarp on a roll-off box) or may be an integral part of the container structural design (e.g., a "portable tank" or bulk cargo container equipped with a screw-type cap).**

Photograph 14: One container has a very small opening due to a defective bung cap (could not fully close).

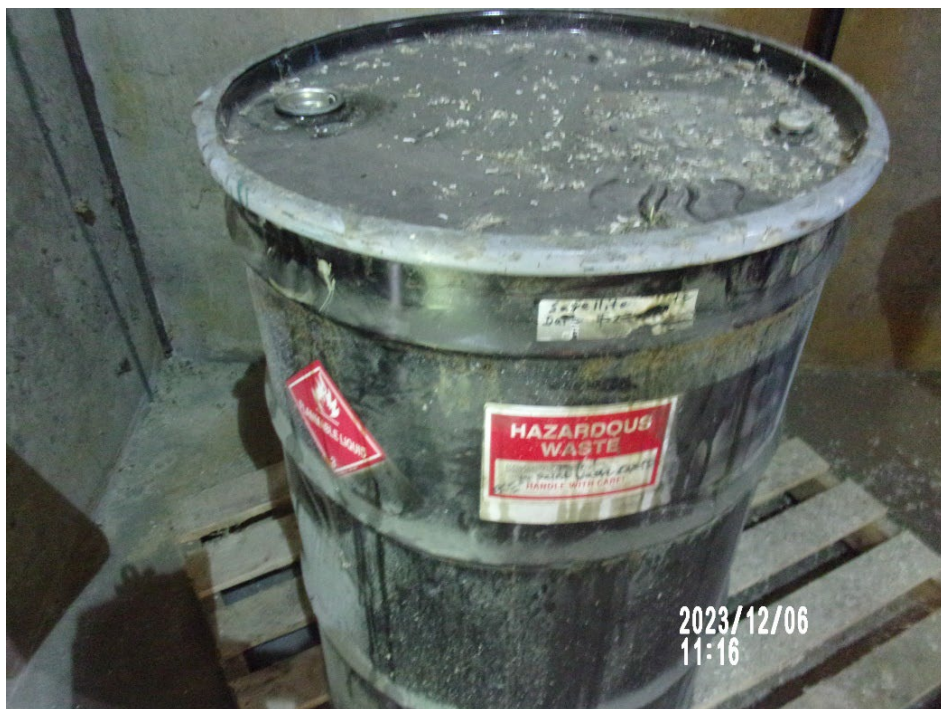
Photograph 15: A new bung hole cap has been inserted. Container is not closed.

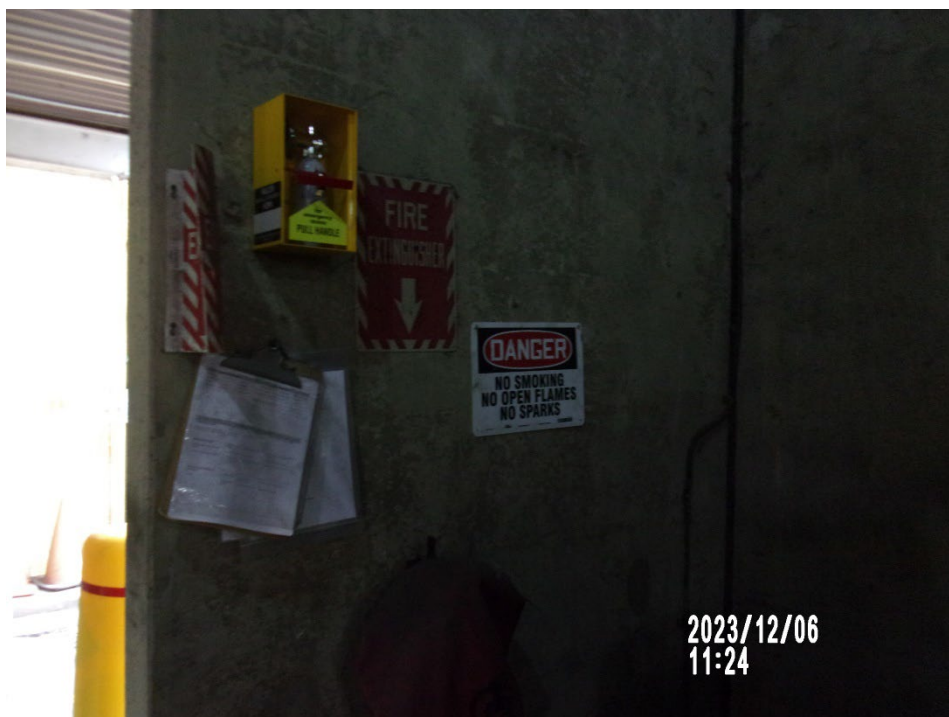
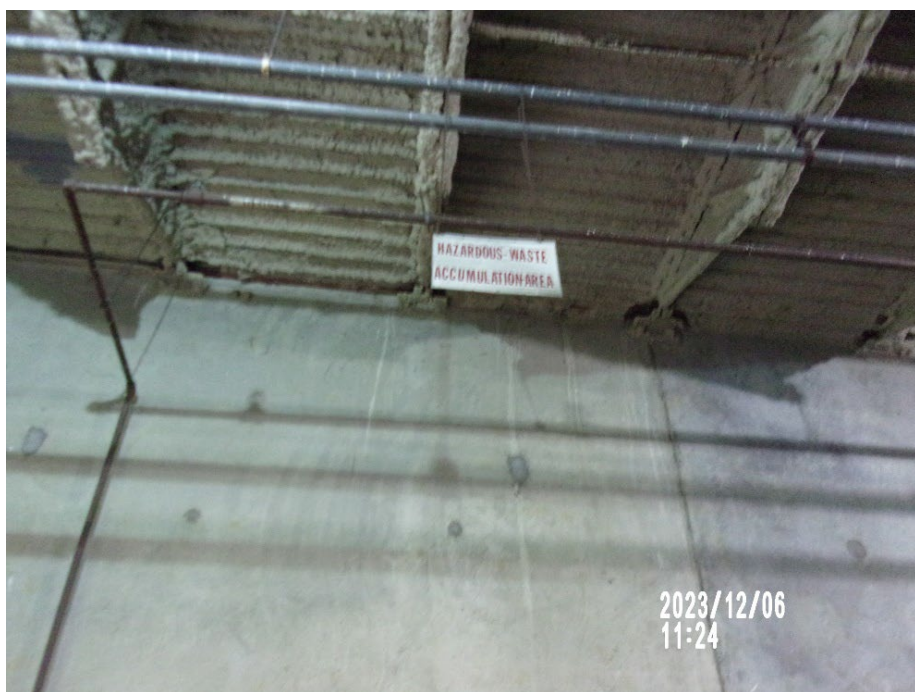
The CAA is equipped with a device capable of summoning emergency assistance from local police departments, fire departments, or state or local emergency response teams; it is equipped with portable fire extinguishers, fire control equipment, spill control equipment, and

decontamination equipment; and the building is equipped with water to supply water hose streams, or foam producing equipment, or automatic sprinklers, or water spray system (Photographs 16 and 17).

Photograph 16: Labeling in Central Accumulation Area.

Photograph 17: Labeling in Central Accumulation Area.

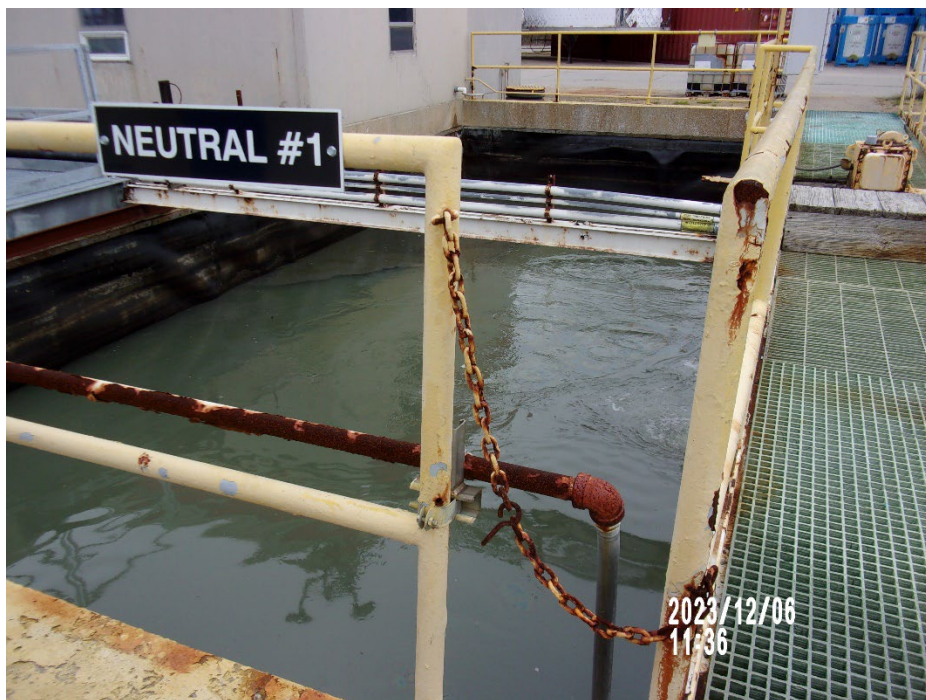
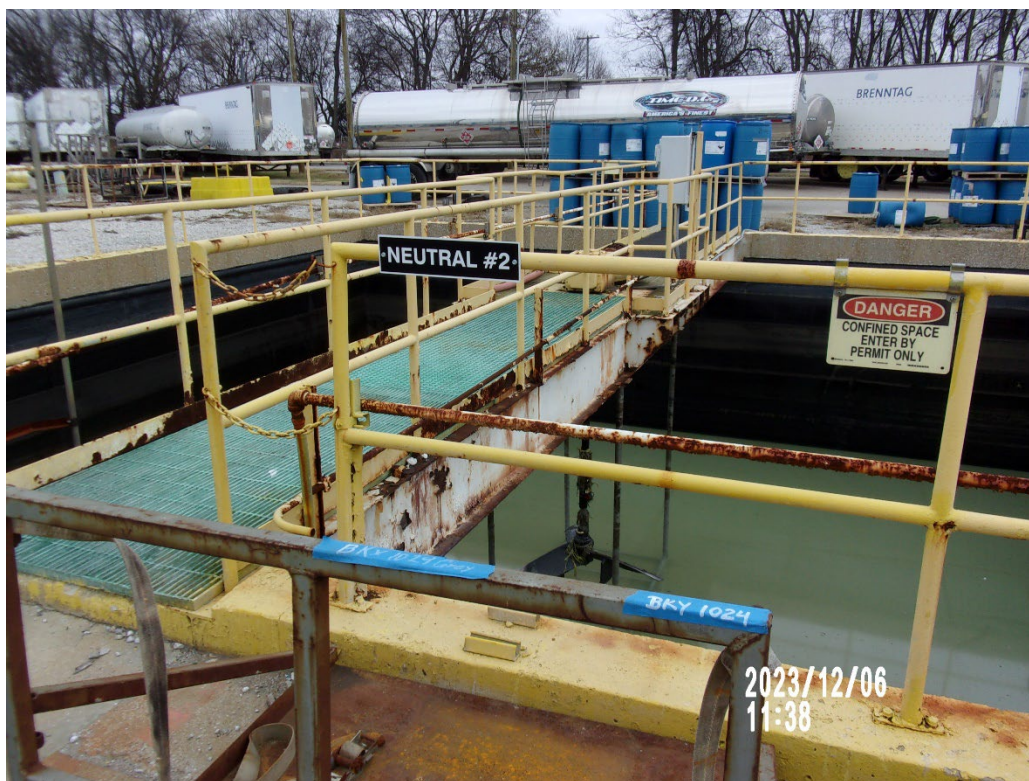
The WWTP area was visited to observe if there were any hazardous waste issues present. The WWTP has two separate neutralization tanks (Photographs 18 and 19). No solid waste streams were observed in this area. It appeared that the only solids that would be generated would be from periodic tank cleanouts. The facility's staff briefed that no tank shutdowns and cleaning had occurred in the past six years. No generation or management of solid or hazardous waste solids was evident at the time of the inspection.

Photograph 18: Wastewater treatment area neutralization tank #1.

Photograph 19: Wastewater treatment area Neutralization Tank #2.
