## **RCRA Inspection Report**

MS ANG CRTC Small Arms Range  
224 10<sup>th</sup> Avenue  
Gulfport, Mississippi 39507  
EPA ID No.: MSR000107672

November 17, 2021

**COMPLIANCE EVALUATION INSPECTION**

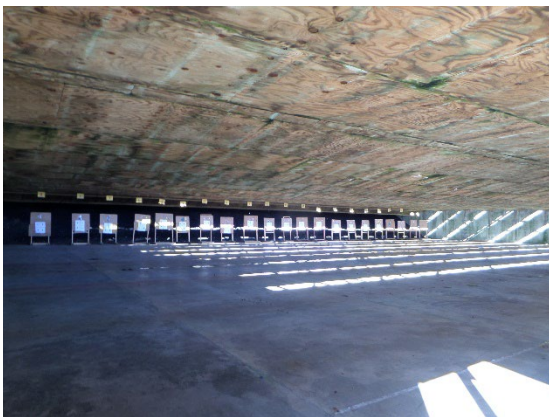
The MS ANG CRTC Small Arms Range facility comprises of a building whose sides are made of reinforced concrete and slated wood panels as roof. The size of the range is approximately 250 feet in length and 200 feet wide (Photo-1). There are seventeen shooting lanes. The types of ammunition used at the firing range for practice include 9 mm, 5.56 mm, .223 mm and 12 gauge.

Photo 1 – MS ANG Small Arms Range

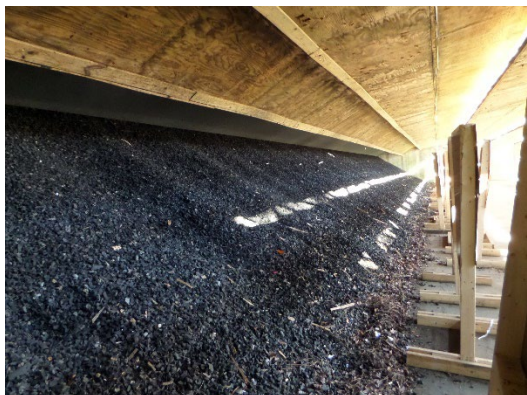
The range is equipped with an impervious rubber barrier (Photo-2). Every three years the barrier is remediated by a contractor arriving onsite to sift the lead bullets from the rubber containment. The empty brass shells are collected in a container and recycled.

Photo 2 – Impervious Rubber Barrier

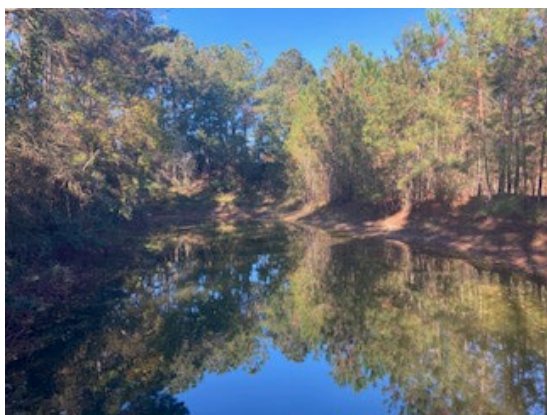
According to MS ANG CRTC personnel, the Small Arms Range facility is not impervious to rain. The rainwater enters the building through the slated roof and washes down the range into a drain system that discharges to the two lagoons located behind the building (Photo-3). During a heavy rain event, the spillover from the both the lagoons floods the low-lying areas near the Small Arms Range facility. MS ANG CRTC personnel mentioned that the facility was waiting for the sample results from a recent sampling event conducted on the two lagoons for hazardous waste constituents. In response to a recent enquiry regarding the lab results, MS ANG CRTC personnel confirmed that the facility had still not received the lab results. Based on the lab results, MS ANG CRTC plans on taking necessary corrective action comprising of constructing a permanent metal roof with a storm drain system to prevent storm water wash out inside the Small Arms Range facility.

Photo 3 – Stormwater Lagoon

The inspectors expressed concern regarding potential lead contamination from the stormwater runoff to the lagoons and the surrounding site. The inspectors stated to the MS ANG personnel to coordinate their activities with the State to address the stormwater matter inside the building and to determine their generator status option based on the amount of hazardous waste generated at their facility. MS ANG CRTC personnel stated that they would provide a copy of the lab results and coordinate their activities regarding stormwater and hazardous waste generator status with MDEQ. After the closing conference, the inspection was concluded.
