## Clean Water Act Section 404: Site Visit/Case Development

| Site Name | Stormy Hill Properties, LLC | | | | | | |

| Inspection Purpose | Initial site visit | | |

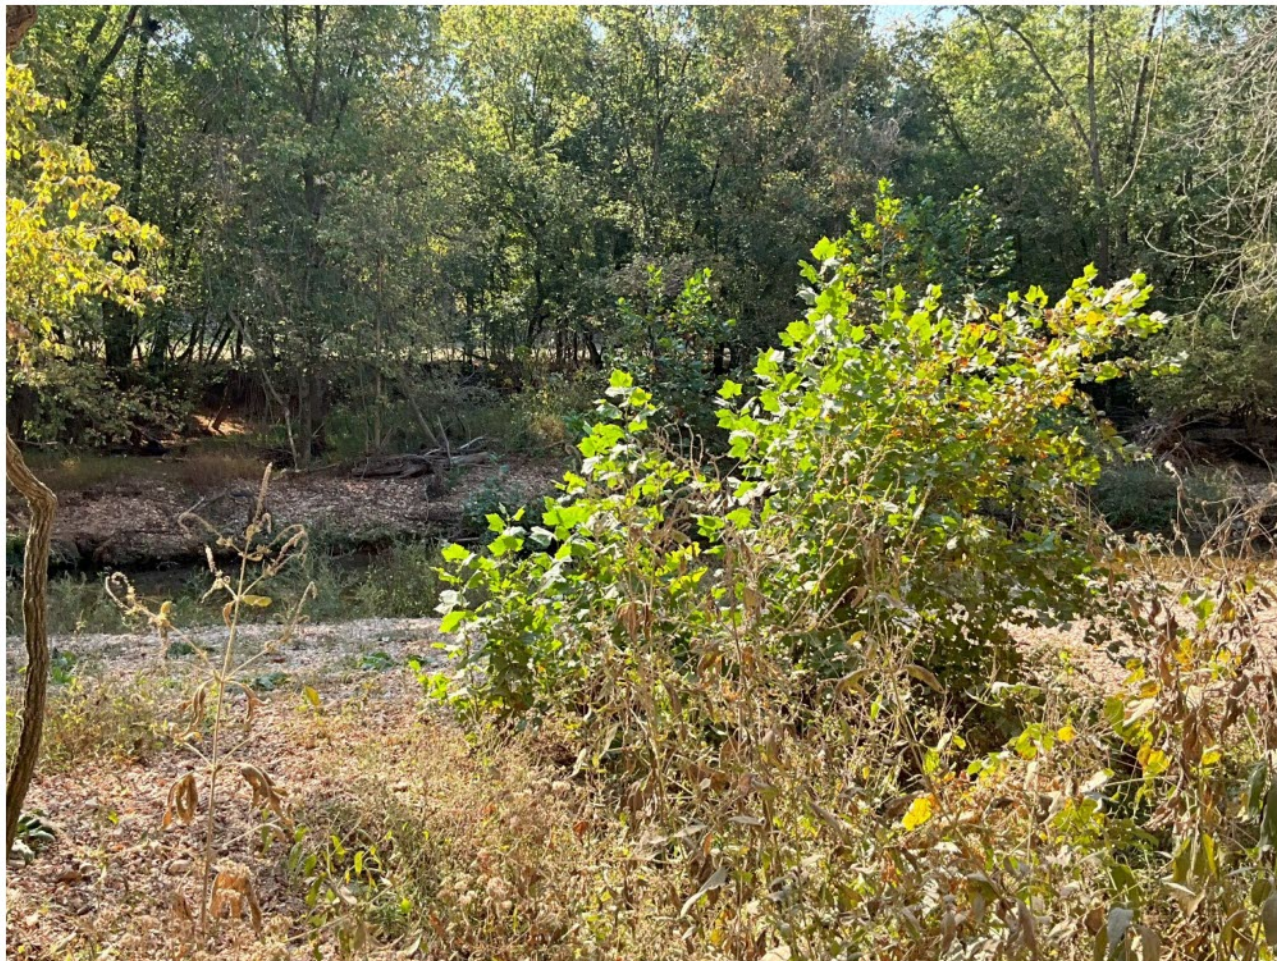
Photo No. 1

| Photo File Name | Date and Time of Photo | Photographer | Description |
|---|---|---|---|
| IMG_0053.JPG | 10/09/2024, 11:24 AM | Chelsey Sherwood | Showing Little Sugar Creek at the upstream point of the property. Picture taken facing south towards river left bank. |

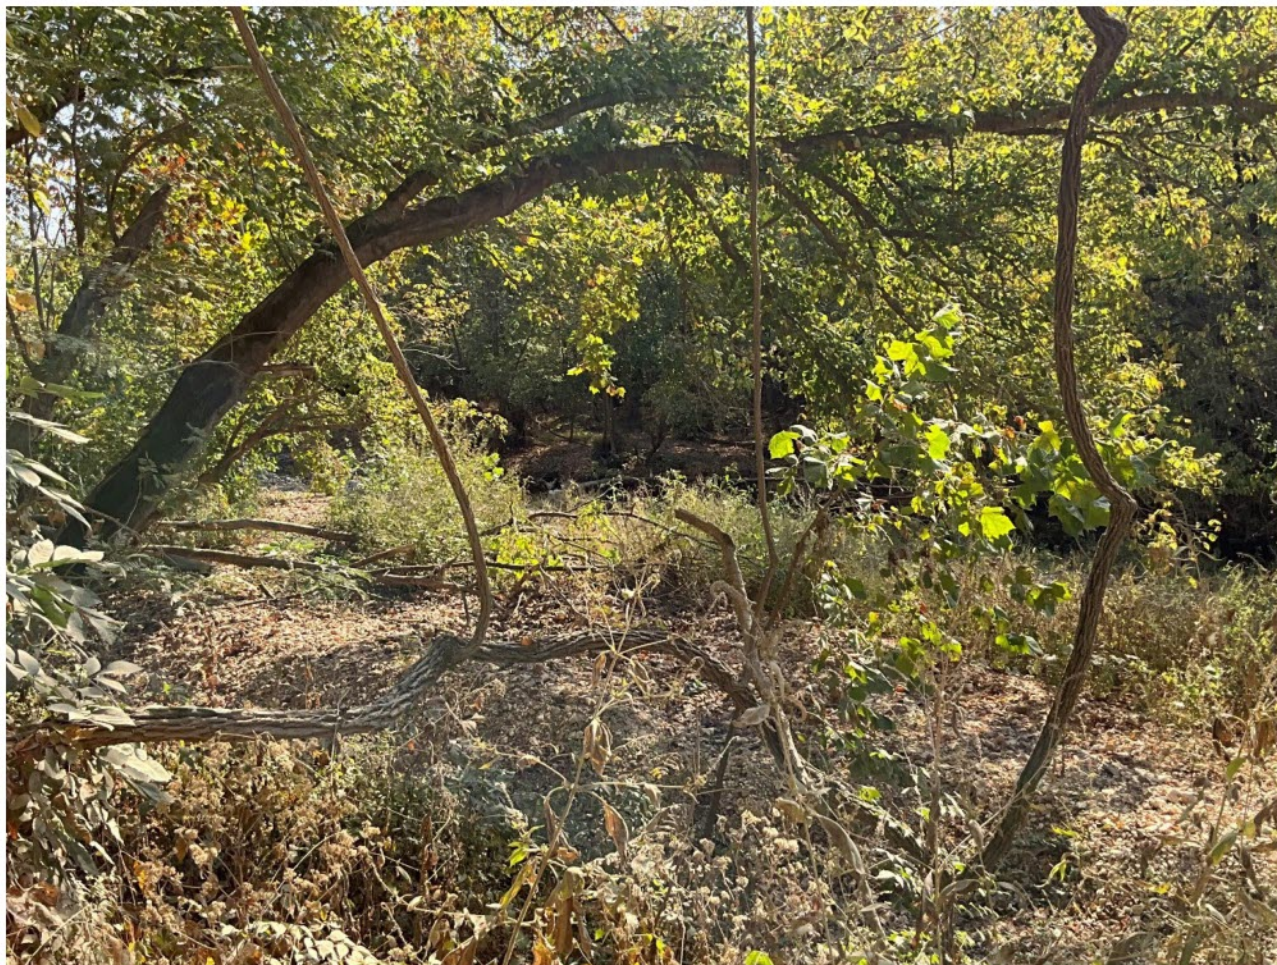
Photo No. 2

| Photo File Name | Date and Time of Photo | Photographer | Description |
|---|---|---|---|
| IMG_0054.JPG | 10/09/2024, 11:24 AM | Chelsey Sherwood | Showing Little Sugar Creek facing upstream. Picture taken facing east. |

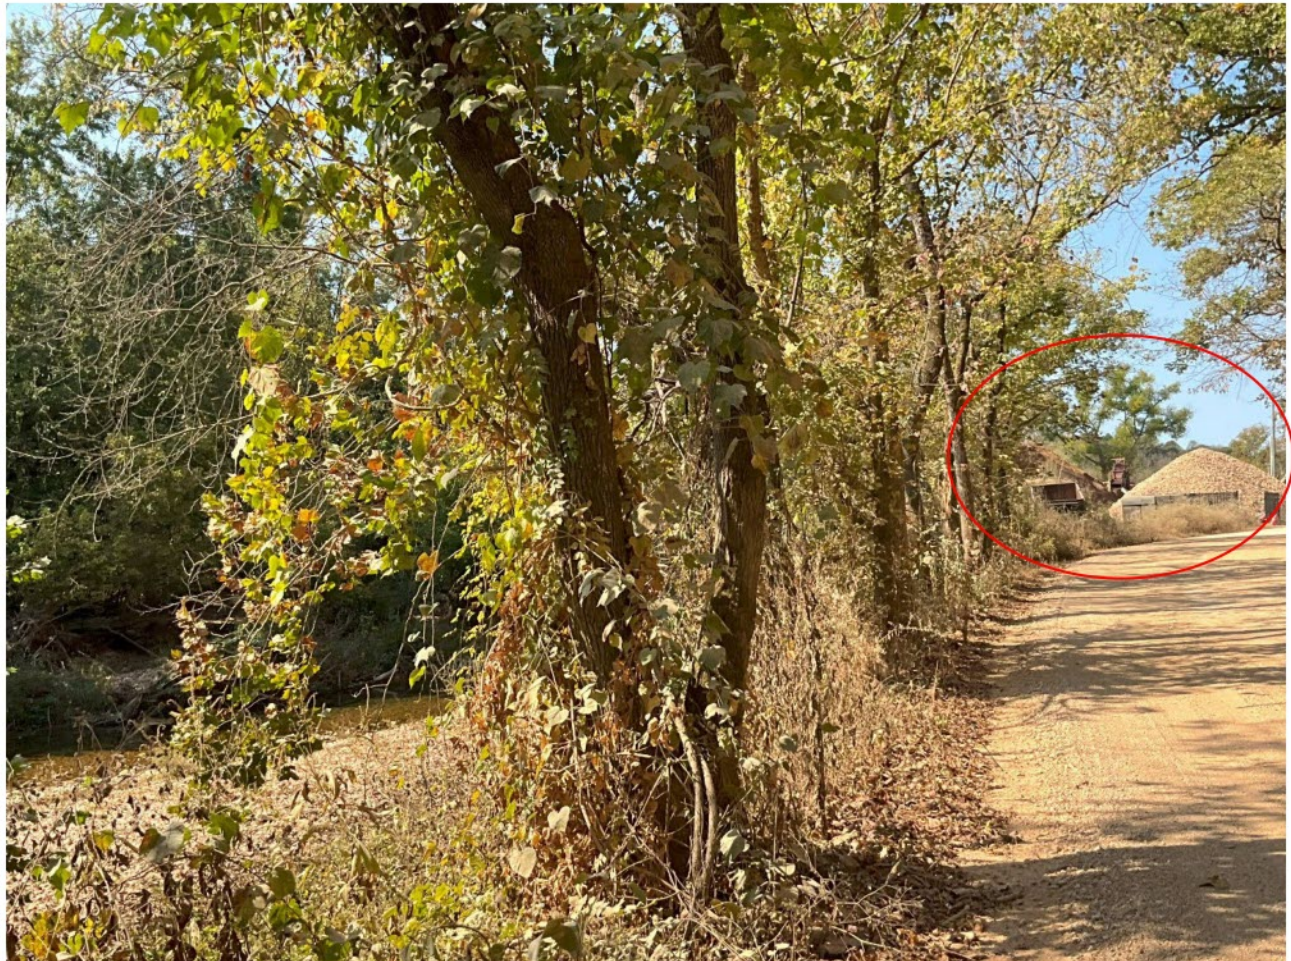
Photo No. 3

| Photo File Name | Date and Time of Photo | Photographer | Description |
|---|---|---|---|
| IMG_0055.JPG | 10/09/2024, 11:24 AM | Chelsey Sherwood | Showing Little Sugar Creek facing downstream and mining operation circled in red. Picture taken facing west. |

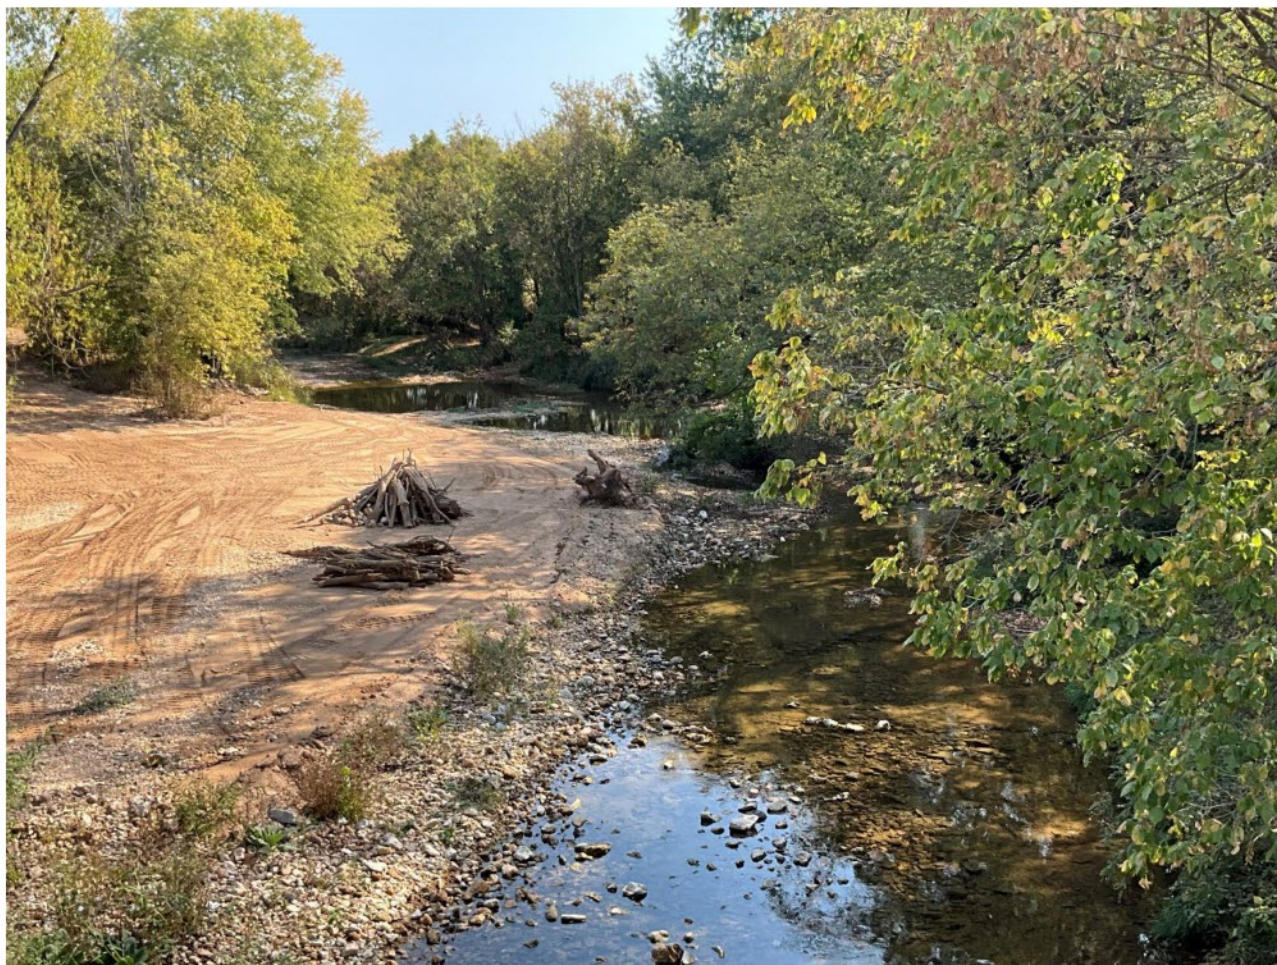
Photo No. 4

| Photo File Name | Date and Time of Photo | Photographer | Description |
|---|---|---|---|
| IMG_0056.JPG | 10/09/2024, 11:30 AM | Chelsey Sherwood | Showing the graded stream bank and fill below the Ordinary High Water Mark in Little Sugar Creek. Note: all the tire tracks. Picture taken facing east. |

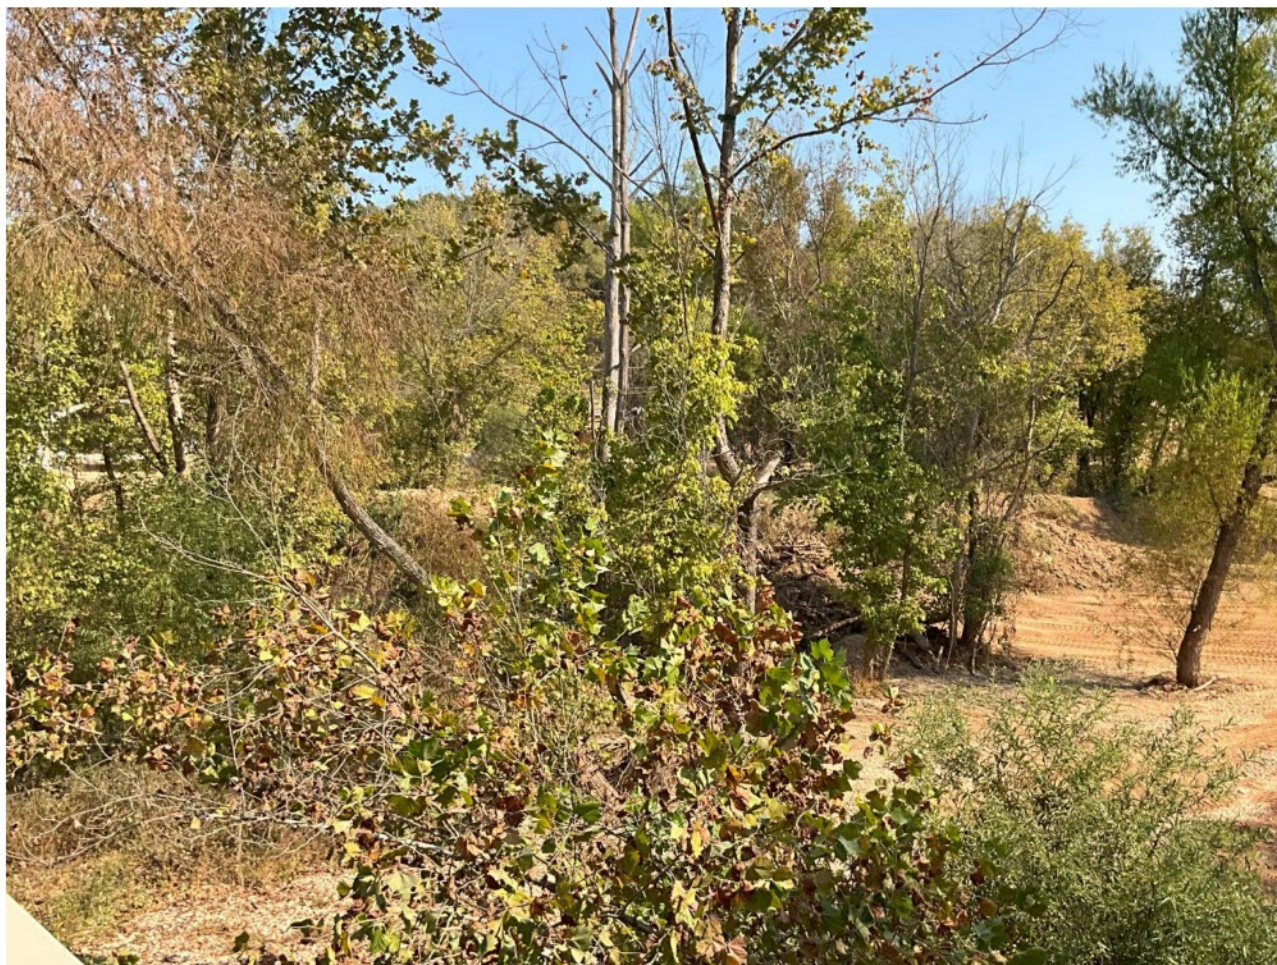
Photo No. 5

| Photo File Name | Date and Time of Photo | Photographer | Description |
|---|---|---|---|
| IMG_0057.JPG | 10/09/2024, 11:30 AM | Chelsey Sherwood | Showing mining site and spoil piles along river right bank of Little Sugar Creek. Picture taken facing northeast. |

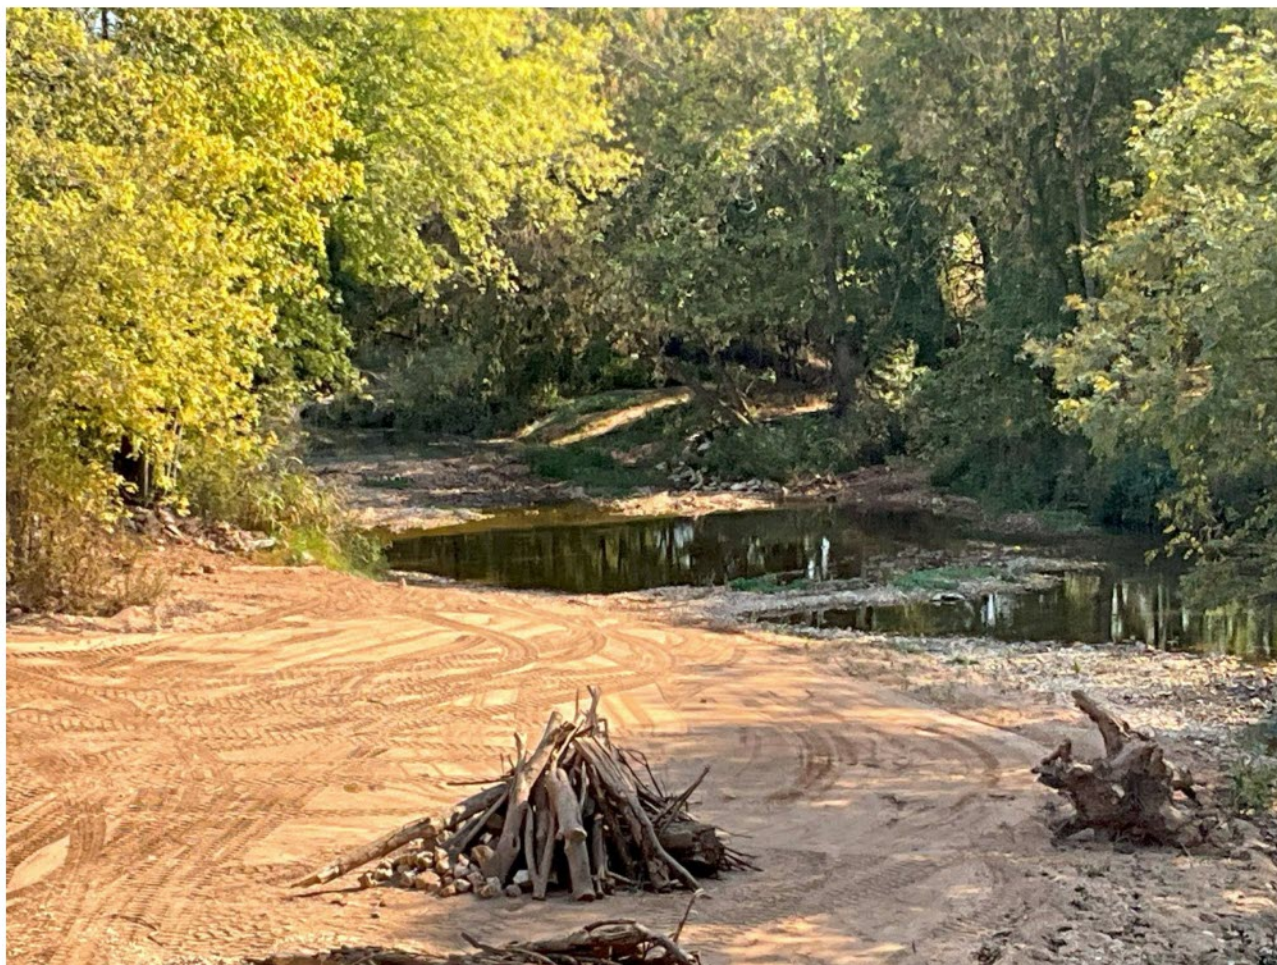
Photo No. 6

| Photo File Name | Date and Time of Photo | Photographer | Description |
|---|---|---|---|
| IMG_0058.JPG | 10/09/2024, 11:30 AM | Chelsey Sherwood | Showing area that fill material is extended into stream channel and there appears to be a dam built across Little Sugar Creek impeding flow. Picture taken facing east, upstream. |
