INSPECTION REPORT

| Type of Inspection | CEI - Compliance Evaluation Inspection | |
| Facility or Site Name | Los Alamos County Wastewater Treatment Plant | |
| Permit Number(s) (If Applicable) | NM0020141 | |

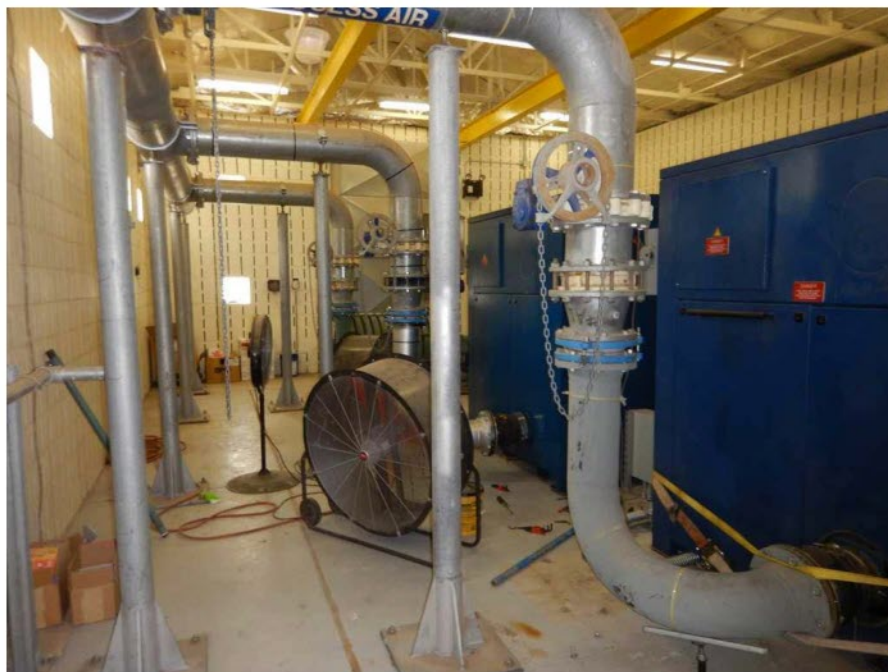
| [Title] | DSCN1446.JPG | |

| <p>A blower boot blew off of the pipe overnight last night, but did not trip the alarm because the blower was still on. Operators found the issue this morning. Operators stated that the effluent at the plant "doesn't usually look this bad." Operator stated that they noticed the DO values on the graph plummeted this morning, but there is no alarm on the DO meter.</p> <p>A transducer for the plant drain lift station and two DO meters were hit by a lightning surge a few weeks ago. Have one more DO meter in the plant that is still functional. The SCADA system is constantly alarming for a "Drain sump low level alarm" because of this transducer - operators have learned to ignore the alarm.</p> <p>Operator stated that the plant cannot waste when the digester is full. Approximately once a month they need to dewater the aerobic digester for three days, and they are unable to waste during this time. Ideally they would waste daily.</p> <p>The algae brush on the clarifier isn't contacting the weirs fully. Operators are required to do weekly manual cleanings on Fridays to compensate. Too much algae buildup is preventing even flow over the weirs.</p> | | |

| <b>AOC:</b> <p>A blower boot blew off of the pipe overnight last night but did not trip the alarm because the blower was still on. Operators found the issue this morning. Operators stated that the effluent at the plant "doesn't usually look this bad." Operator stated that they noticed the DO values on the graph plummeted this morning, but there is no alarm on the DO meter.</p> <p>A transducer for the plant drain lift station and two DO meters were hit by a lightning surge a few weeks ago. Have one more DO meter in the plant that is still functional. The SCADA system is constantly alarming for a "Drain sump low level alarm" because of this transducer - operators have learned to ignore the alarm.</p> <p>Operator stated that the plant cannot waste when the digester is full. Approximately once a month they need to dewater the aerobic digester for three days, and they are unable to waste during this time. Ideally they would waste daily.</p> <p>The algae brush on the clarifier isn't contacting the weirs fully. Operators are required to do weekly manual cleanings on Fridays to compensate. Too much algae buildup is preventing even flow over the weirs.</p> | |

**Additional Notes:** Significant operational issues were caused by not having an alarm to catch drastic changes in process flow conditions. Having an alarm constantly going off makes it less likely that operators will notice and properly react to a new alarm.

| Plant blower room, with the blower boot that had slipped off in the lower right corner of the photo. | | |

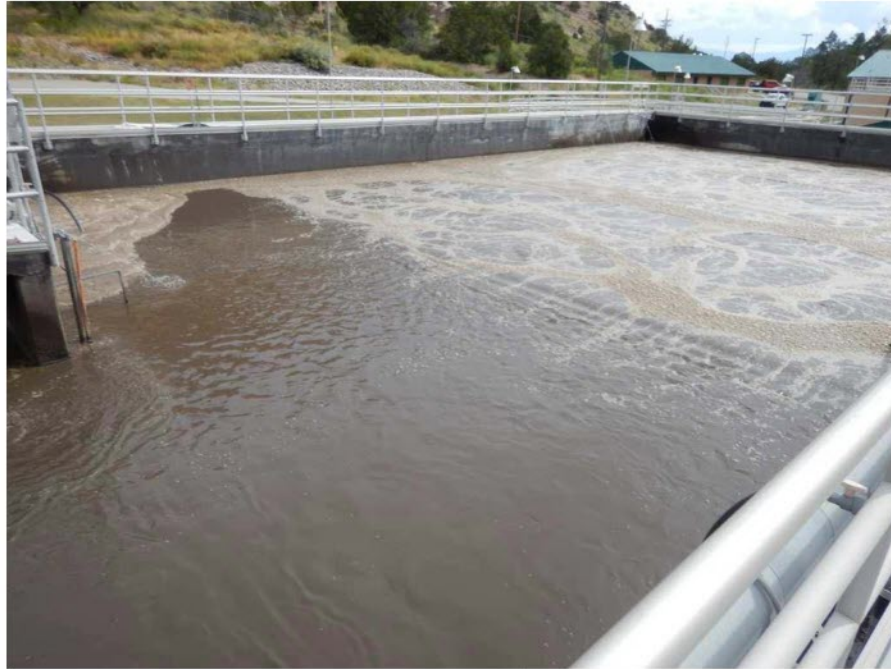
| [Title] | | DSCN1457.JPG | |

| Aeration basin | | | |

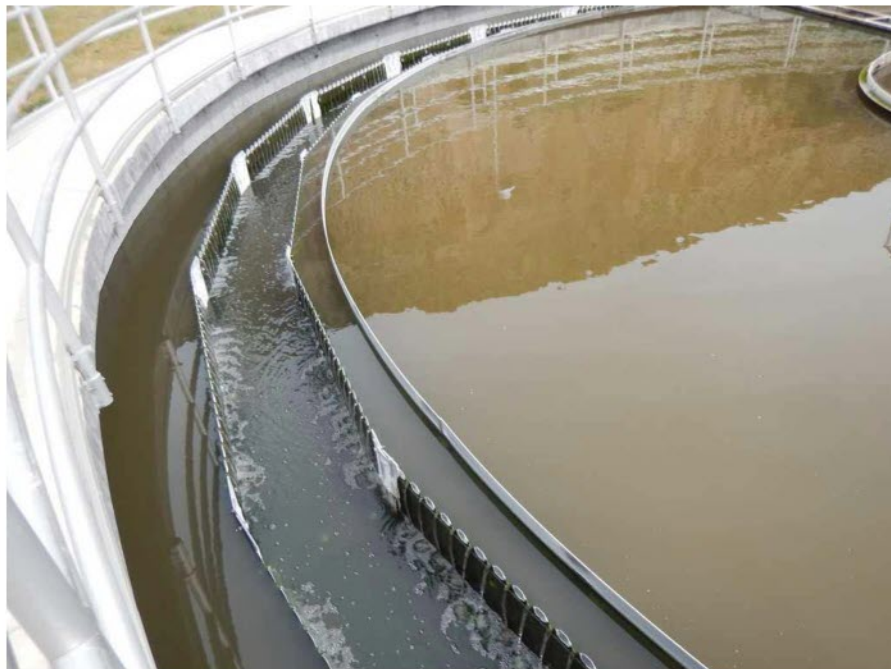
| [Title] | | DSCN1462.JPG | |

Inspector returned the following day to observe clarity of effluent after blower boot had been fixed and aeration treatment had been returned to normal. Effluent quality had visually improved however there was still significant algae buildup in secondary clarifier.

| Clarifier | | | |

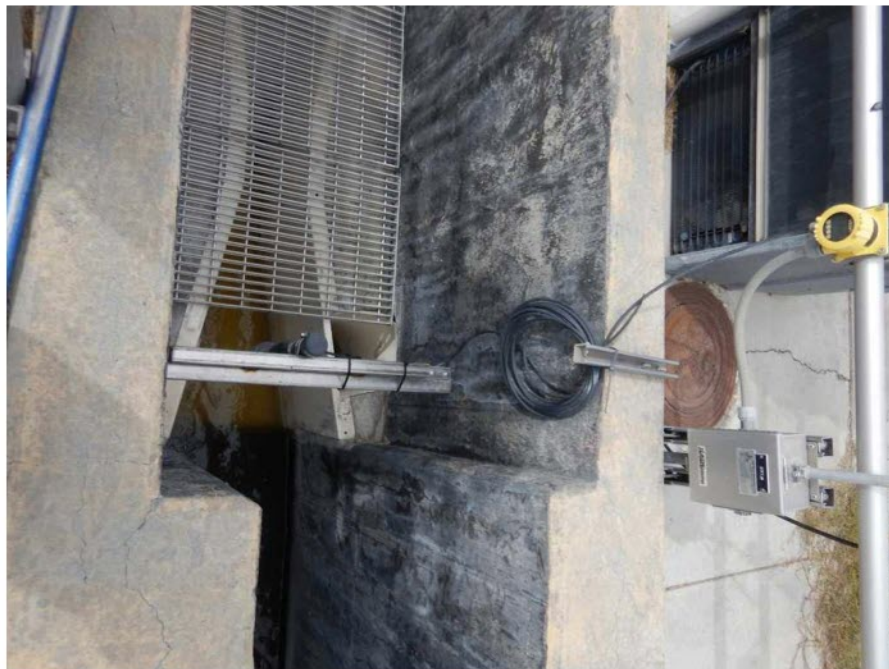
| [Title] | DSCN1484.JPG | |

| <p>Both influent and effluent flow meters are 9-inch Parshall Flumes. The influent flow meter has a radar secondary measurement meter located over the stilling well. The effluent meter has a radar secondary measurement meter located over the throat of the Flume. The flow in the effluent flow meter is not laminar. The secondary effluent flow meter took a lightning surge a few weeks ago and the values are now wandering. Operators are manually reading the staff gauge every 12 hours or so on the daily walk-through sheet. On the day of the inspection, the effluent staff gauge read 0.45 feet.</p> <p>Outfall 001 does not feed directly into the river, it generally soaks into the ground before meeting other waters. There are no known fish or frogs living at the outfall.</p> | | |

| AOC Reference #: AA2-OB-002 | Location: 3. Flow meters & Outfall |
|---|---|
| The flow in the effluent flow meter is not laminar. The secondary effluent flow meter took a lightning surge a few weeks ago and the values are now wandering. | |

| Effluent flow meter showing non-laminar flow below the secondary flow meter. | | |

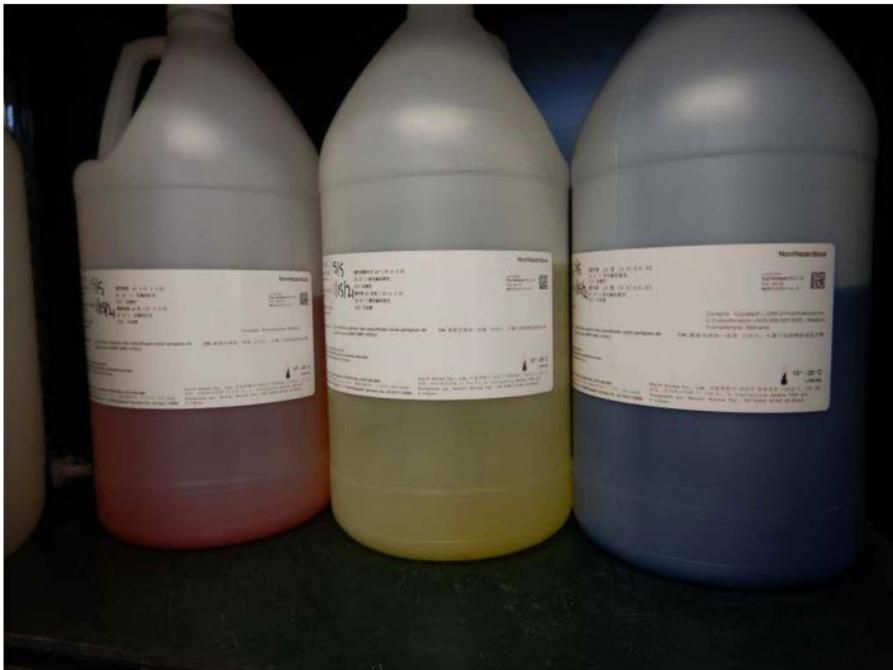
| [Title] | DSCN1516.JPG | |

Laboratory reagents were not properly labeled with expiration dates. There was a date written on the bottles, but it was not clear if this was a opened-on date or a received-on date. The permittee is using pH buffers manufactured by Hach. Operator stated that Hach reagents and probes are backordered. According to Hach "Shelf life of a bottle once opened is impossible to determine due to environmental variations specific to the customer location and storage standard operating procedures. (Elevation/pressure for example.) We recommend that the date the bottle is opened is written on the bottle and that the standards be used within six months for pH 4 and 7 buffers, or three months for pH 10 buffer."

| AOC Reference #: AA2-OB-003 | Location: 5. Laboratory |
|---|---|
| Laboratory reagents were not properly labeled with expiration dates. There was a date written on the bottles, but it was not clear if this was a opened-on date or a received-on date. | |
| <b>Additional Notes:</b> Expired reagents make it impossible to confirm proper calibration, and therefore the validity of the sample results. | |

| pH buffers | | |
