**Region 6 - Enforcement & Compliance Assurance Division**  
**INSPECTION REPORT**

| Company Name: | <b>H.R. Collier</b> | |
| Facility Name: | <b>Osage Happy Hollow Lease</b> | |

EPA Region 6 Inspector, Matthew Allen, arrived at the H.R. Collier - Osage Happy Hollow Lease (EPA ID No. OKU002220) at 10:20 AM on 08/04/2025 for a follow-up inspection in response to a spill inspection conducted 7/30/2025 (NRC# 1438334). The inspection was conducted by the authority of the Clean Water Act (CWA) to determine compliance with Environmental Protection Agency (EPA) regulations. There was no company representative present during the inspection. There was no other federal, state, or local agency representative present at the time of the inspection.

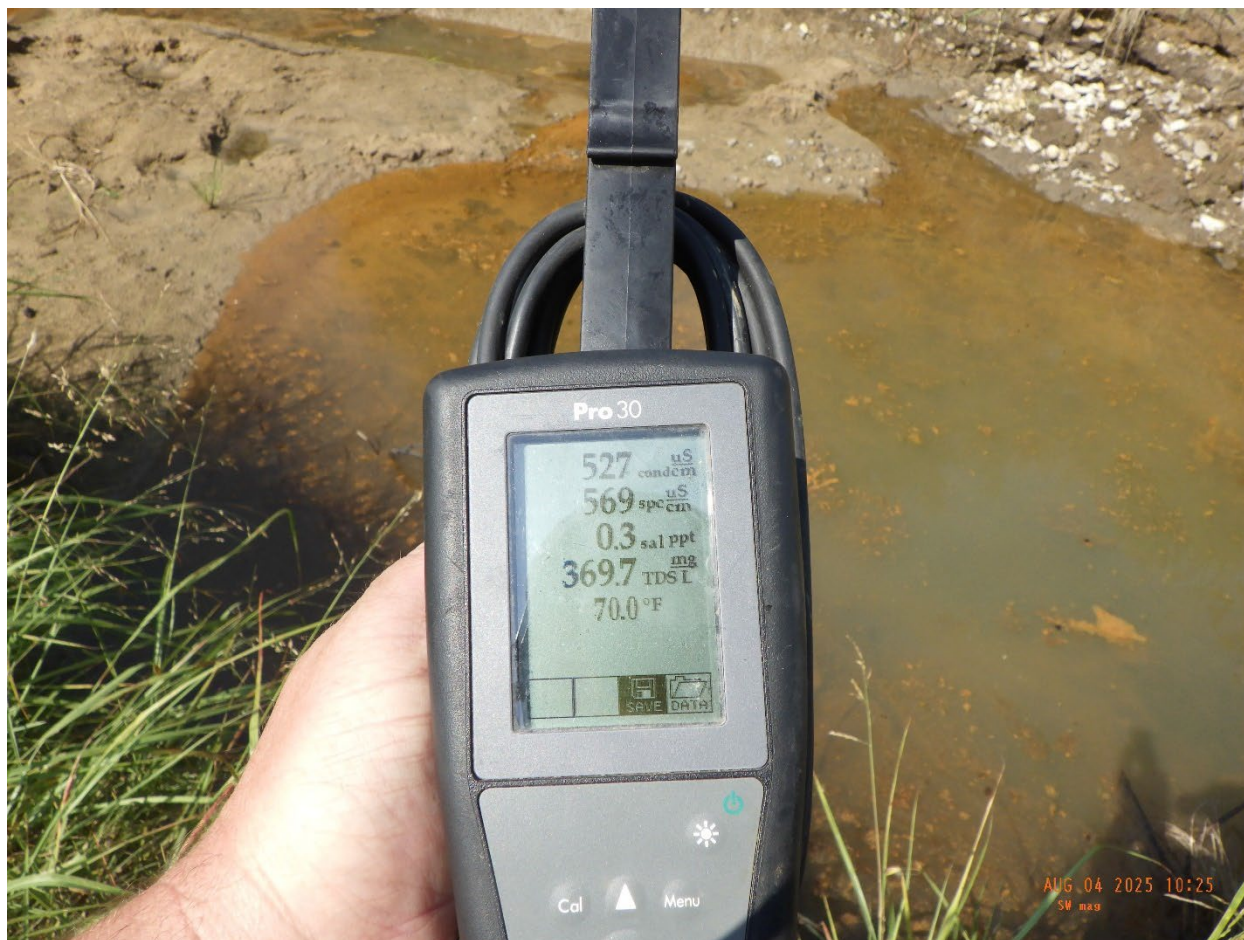
Photo No. 1

I observed the first pool of impacted water along the unnamed tributary of Little Hominy Creek. A TDS field reading of 369.7 mg/L was observed. See photo No. 1 and 2. For additional GPS location information and photo metadata, please see Appendix 1 (photo log) attached to this report.

**Description:** This was a TDS field reading of 369.7 mg/L observed in the first pool of water along the impacted tributary of Little Hominy Creek, downstream from the point of entry (POE) into the tributary.

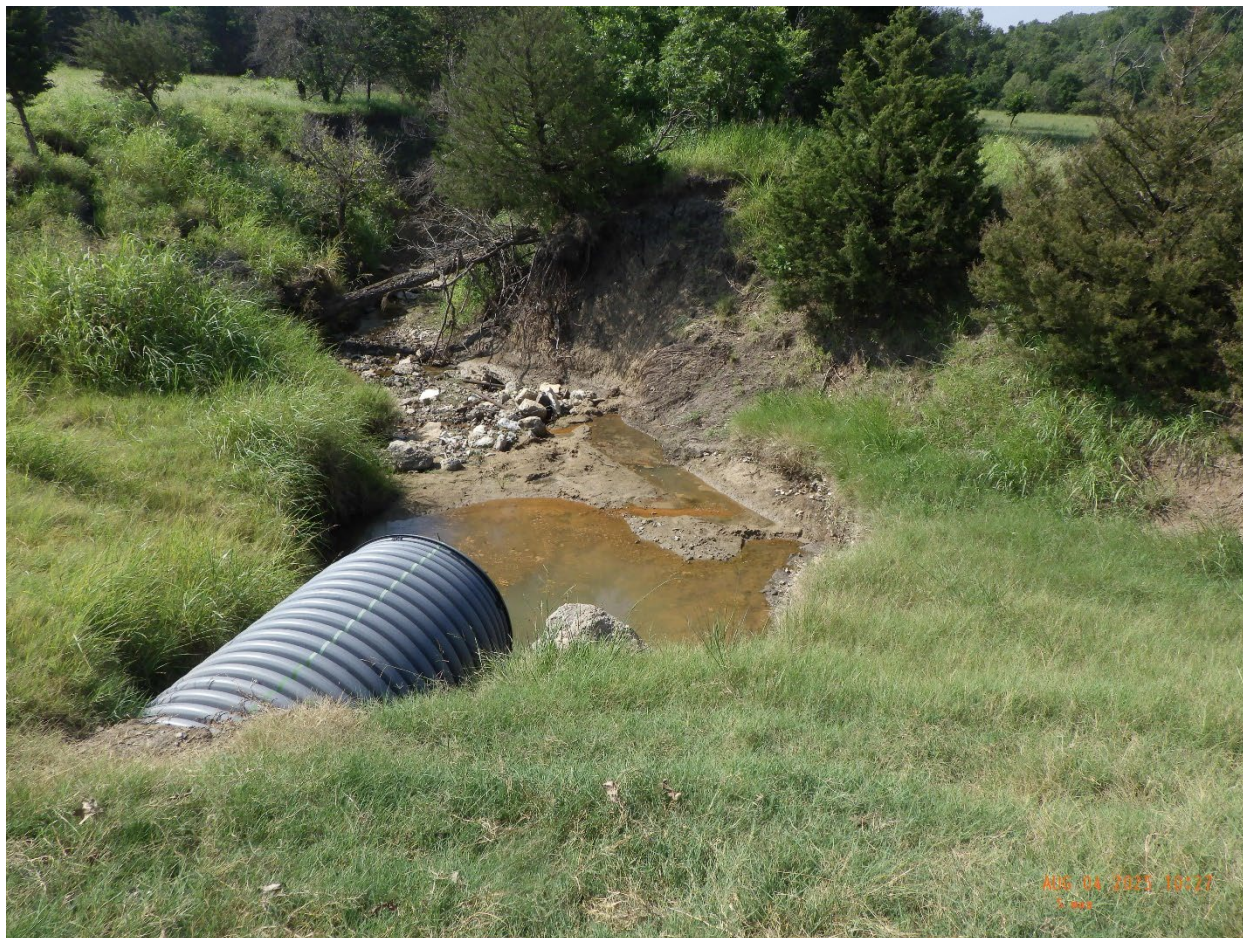
Photo No. 2

**Description:** This was the location where the TDS field reading from photo No. 1 was observed. This was the first pool of water along the impacted tributary of Little Hominy Creek.

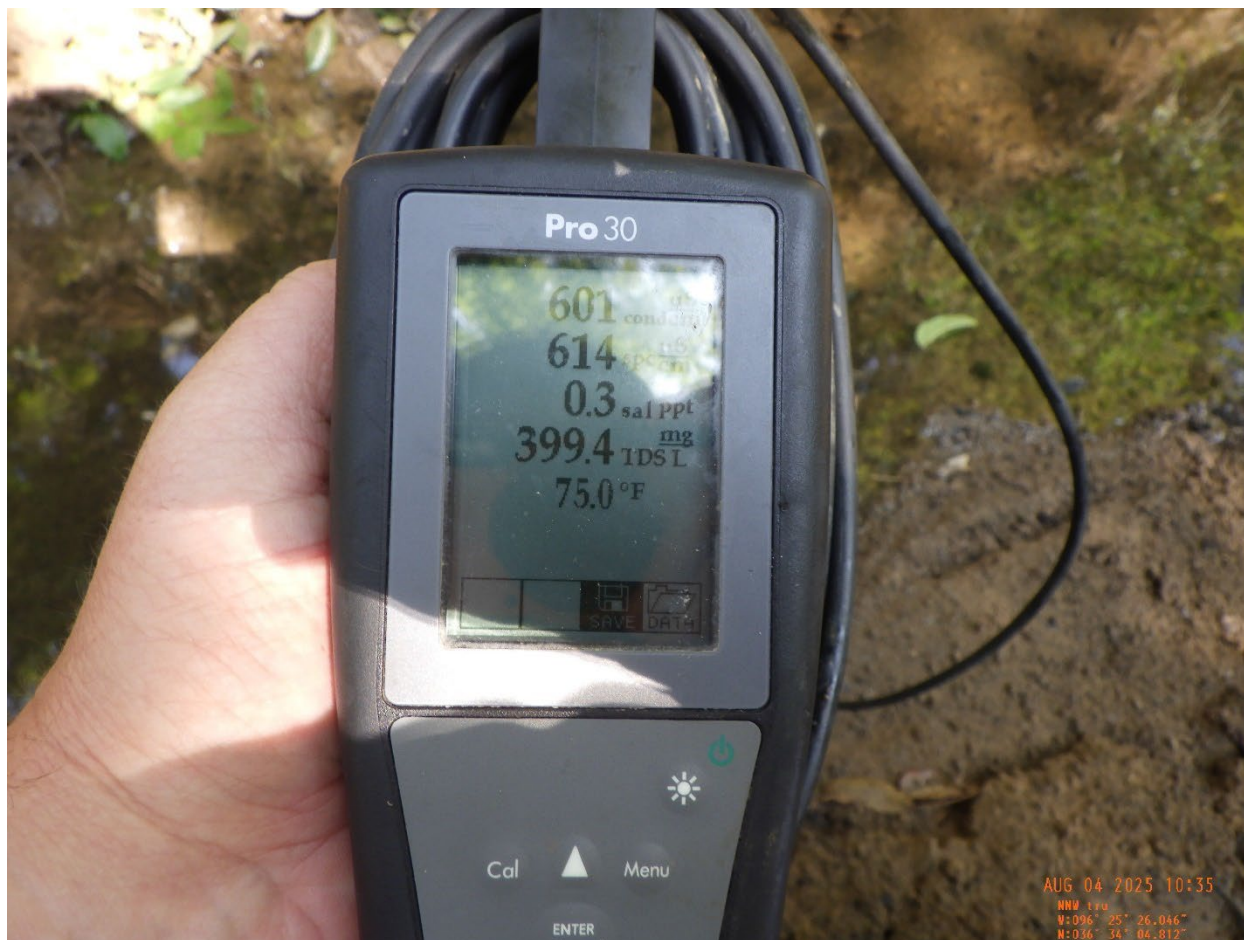
Photo No. 3

I observed a TDS field reading of 399.4 mg/L at the mouth of the impacted tributary, immediately upstream from the confluence with Little Hominy Creek. At the same location, I observed an oil absorbent boom installed across the impacted tributary. At the time of the inspection, the boom was collecting a small amount of oil. See photo No. 3 and 4.

**Description:** This was a TDS field reading of 399.4 mg/L observed at the mouth of the impacted tributary just before the confluence with Little Hominy Creek.

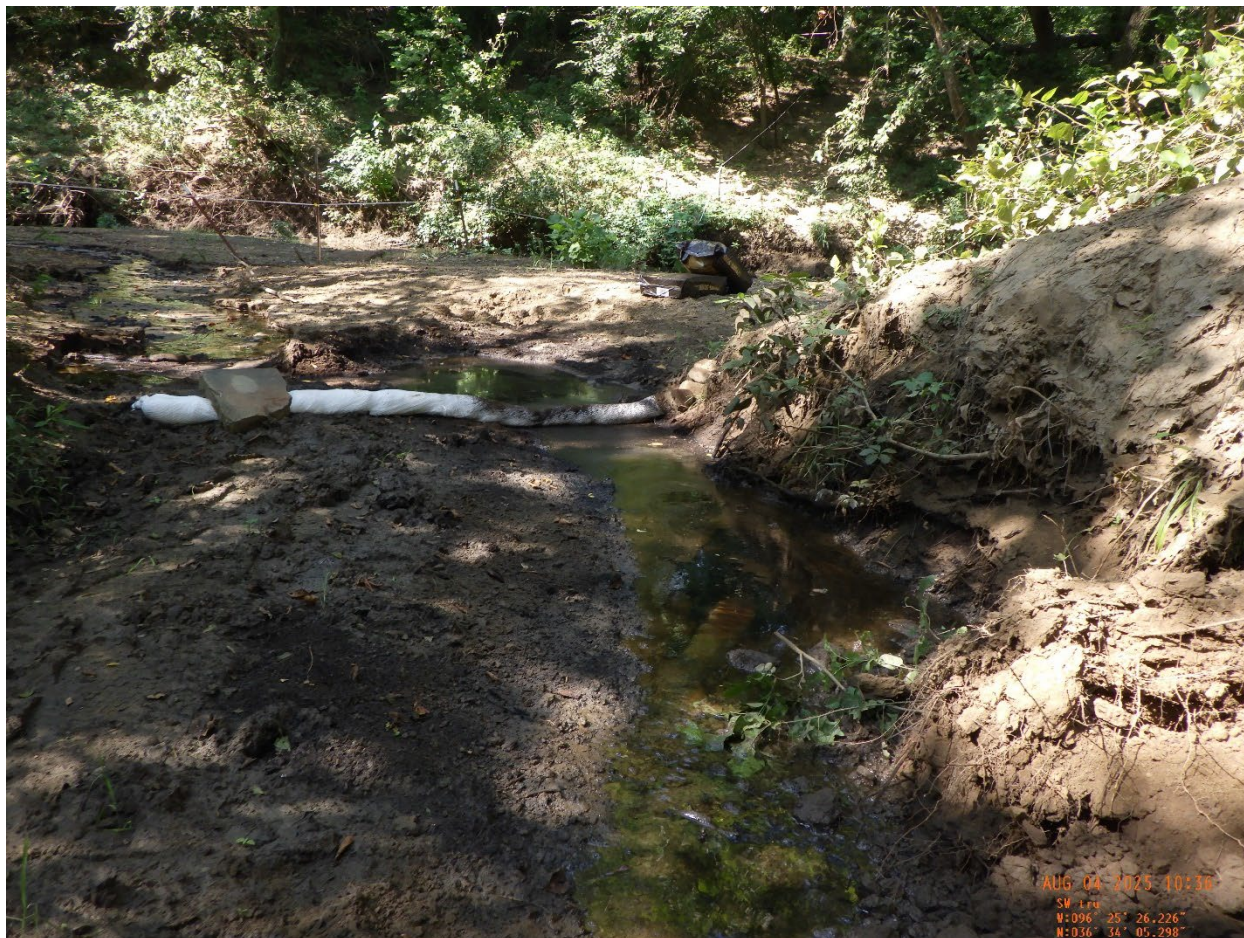
Photo No. 4

The primary area of concern was the small amount of oil present at the oil absorbent boom near the confluence of the impacted tributary and Little Hominy Creek.

**Description:** This was the mouth of the unnamed tributary, immediately upstream from the confluence with Little Hominy Creek. This is the same location where the TDS reading from photo No. 3 was observed. At the time of the inspection, there was an oil absorbent boom installed across the tributary and there was a small amount of oil being collected by the boom.

EPA inspector will conduct follow-up calls, field meetings and inspections to ensure the impacted area is returned to “pre-spill” condition.

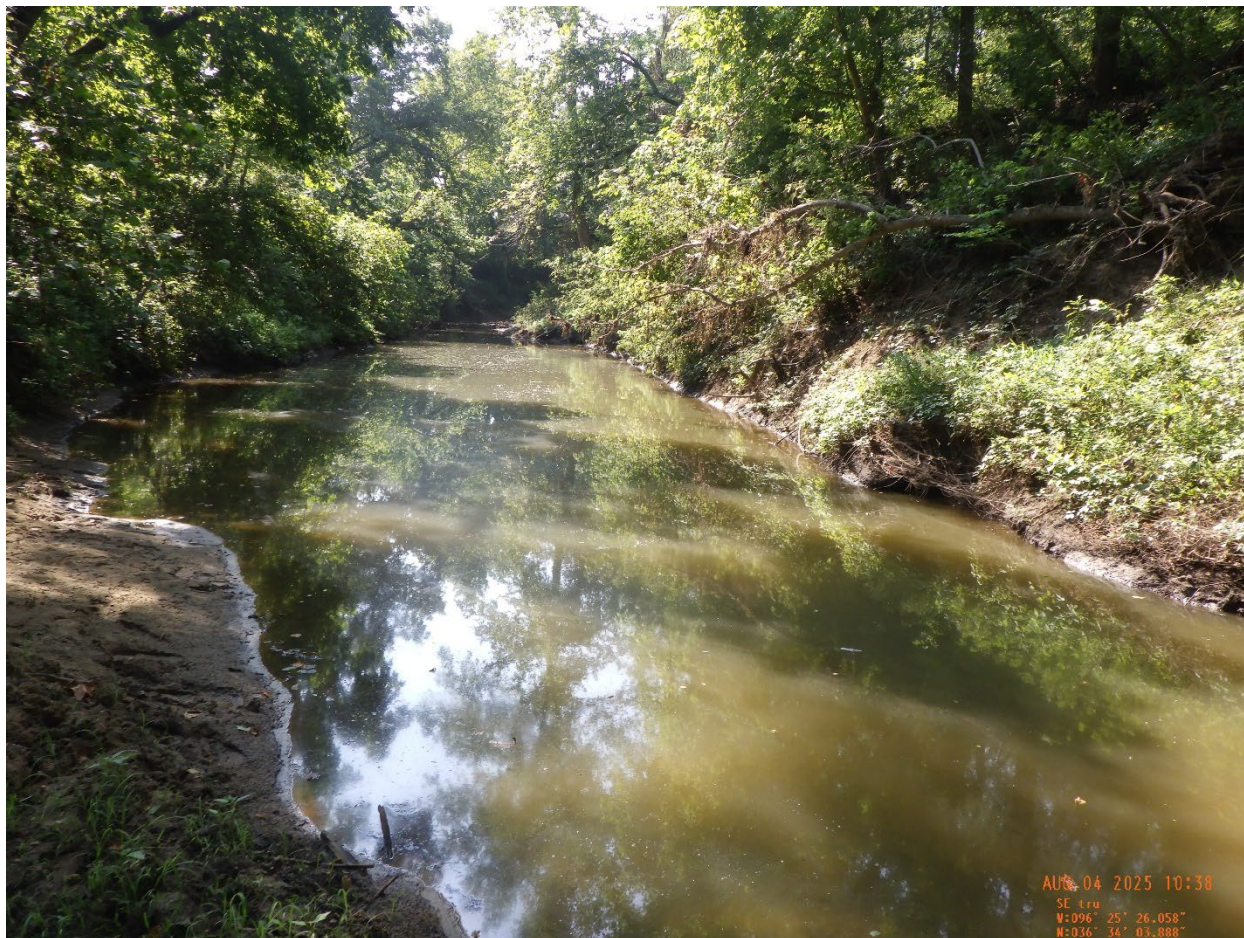
Photo No. 5

I observed the impacted section of Little Hominy Creek. At the time of the inspection, there was no oil, sheen, oil-stained banks, or oil-stained vegetation/debris present in Little Hominy Creek. See photo No.5.

**Description:** This was a photo immediately downstream from the POE into Little Hominy Creek. This is the main channel of Little Hominy Creek. At the time of the inspection, all oil and sheen were removed from the creek. There was no oil staining present on the banks or vegetation.
