**Class I and II Well Inspection Form**  
**US Environmental Protection Agency – Region 4**  
**Underground Injection Control Program**  
61 Forsyth Street SW, MC 9T25, Atlanta, Georgia, 30303  
Phone: (404)562-9424

Well Name & #: *Curtis B. Lowery #10-E* \_\_\_\_\_  
Well Type (see table): *Enhanced Recovery (EOR)* \_\_\_\_\_ State Permit: API # *0911320125* \_\_\_\_\_  
Latitude (°N): *30.870125°N* \_\_\_\_\_ Longitude (°W): *-87.12829°W* \_\_\_\_\_ Elevation (ft): *NA* \_\_\_\_\_  
Injection Method (check applicable): ☐ Casing Injector; ☒ Tubing & Packer; ☐ Cemented Injection Tubing

**Site Photographs**  
**Curtis B. Lowery #10-E:**  
September 13, 2022

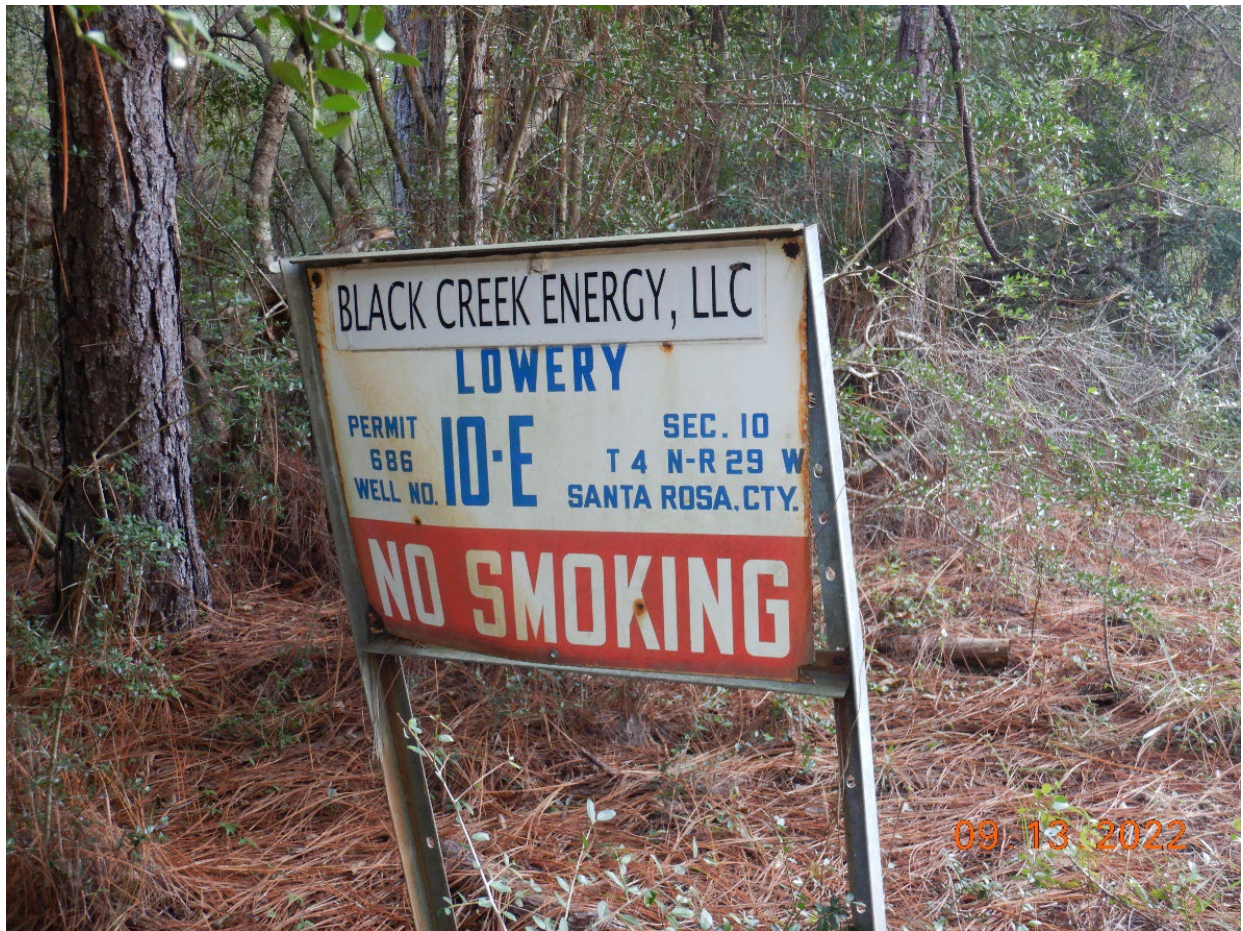
Description: *Looking east, Curtis B. Lowery #10-E sign alongside access road.* \_\_\_\_\_

**Photograph 1:** Looking east, Curtis B. Lowery #10-E sign alongside access road.

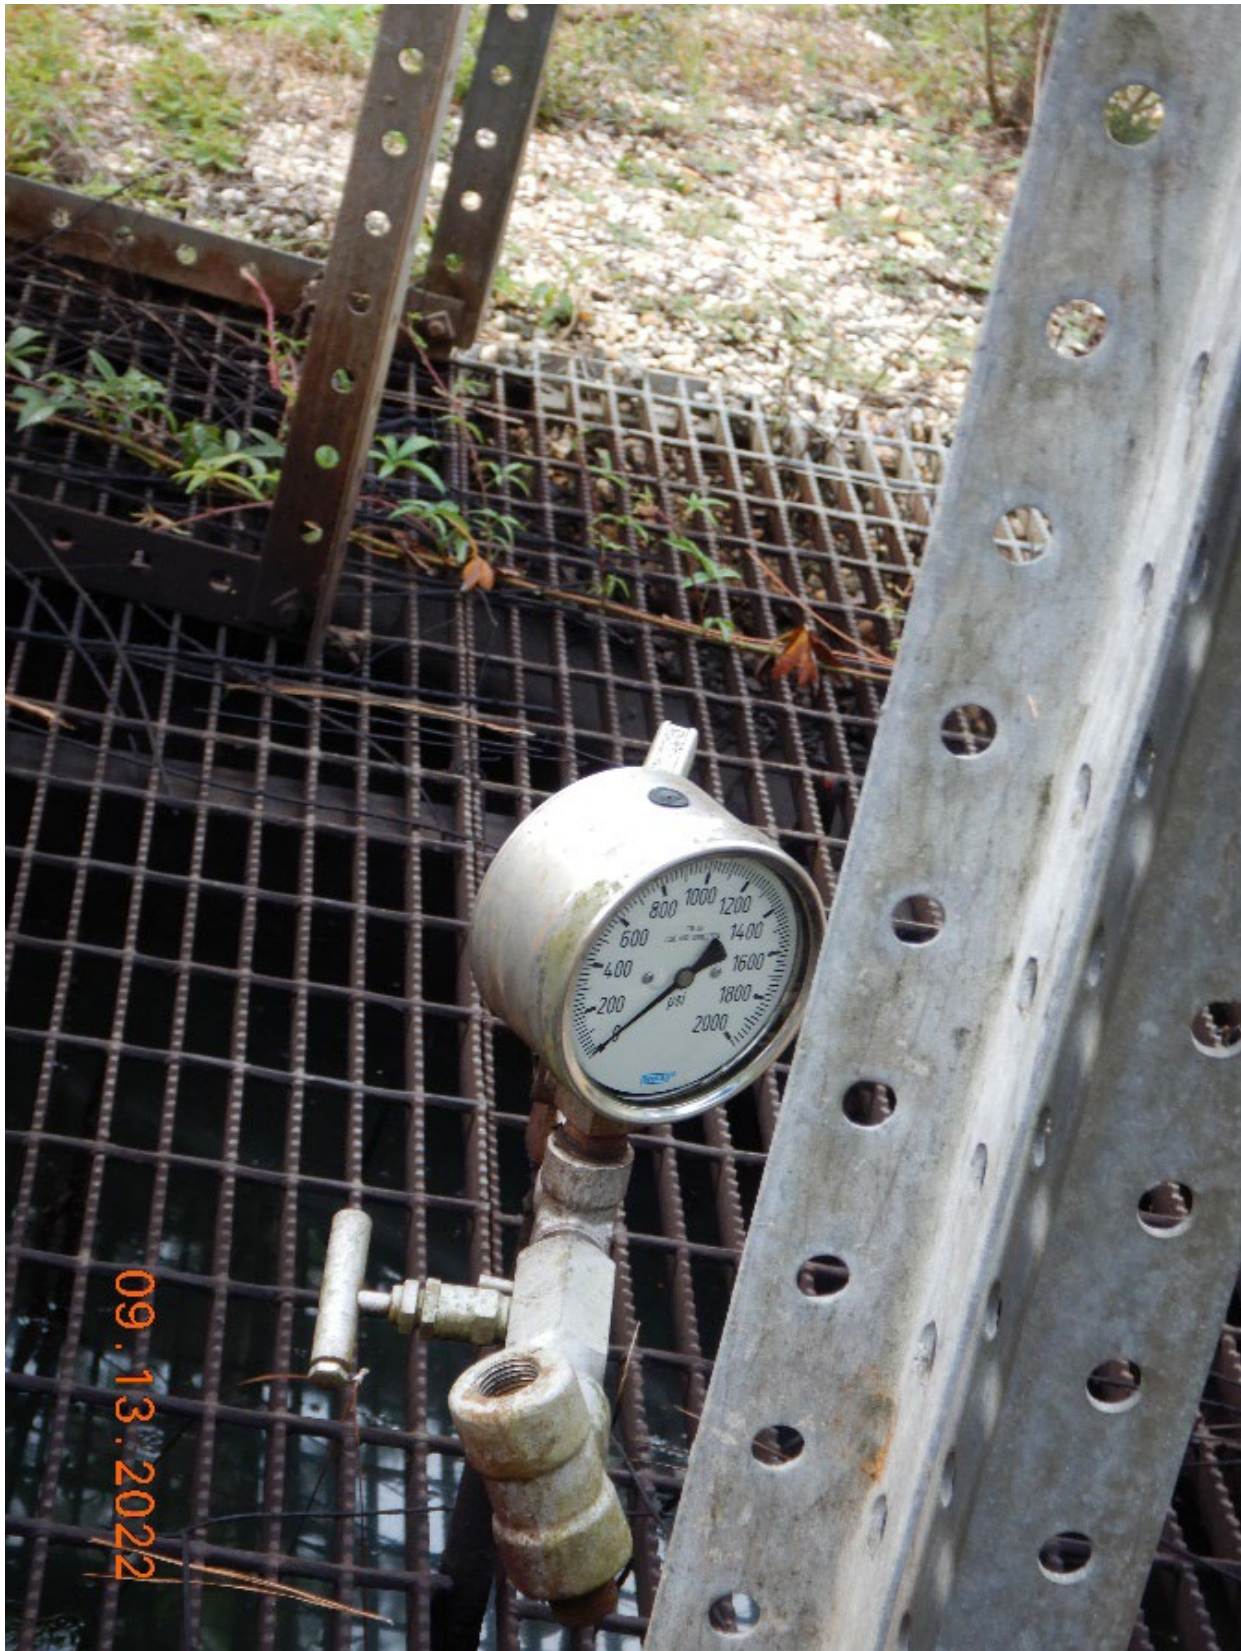
Description: *Looking south, closeup view of surface casing pressure gauge reading 0 psi.* \_\_\_\_\_

**Photograph 2:** Looking south, closeup view of surface casing pressure gauge reading 0 psi.

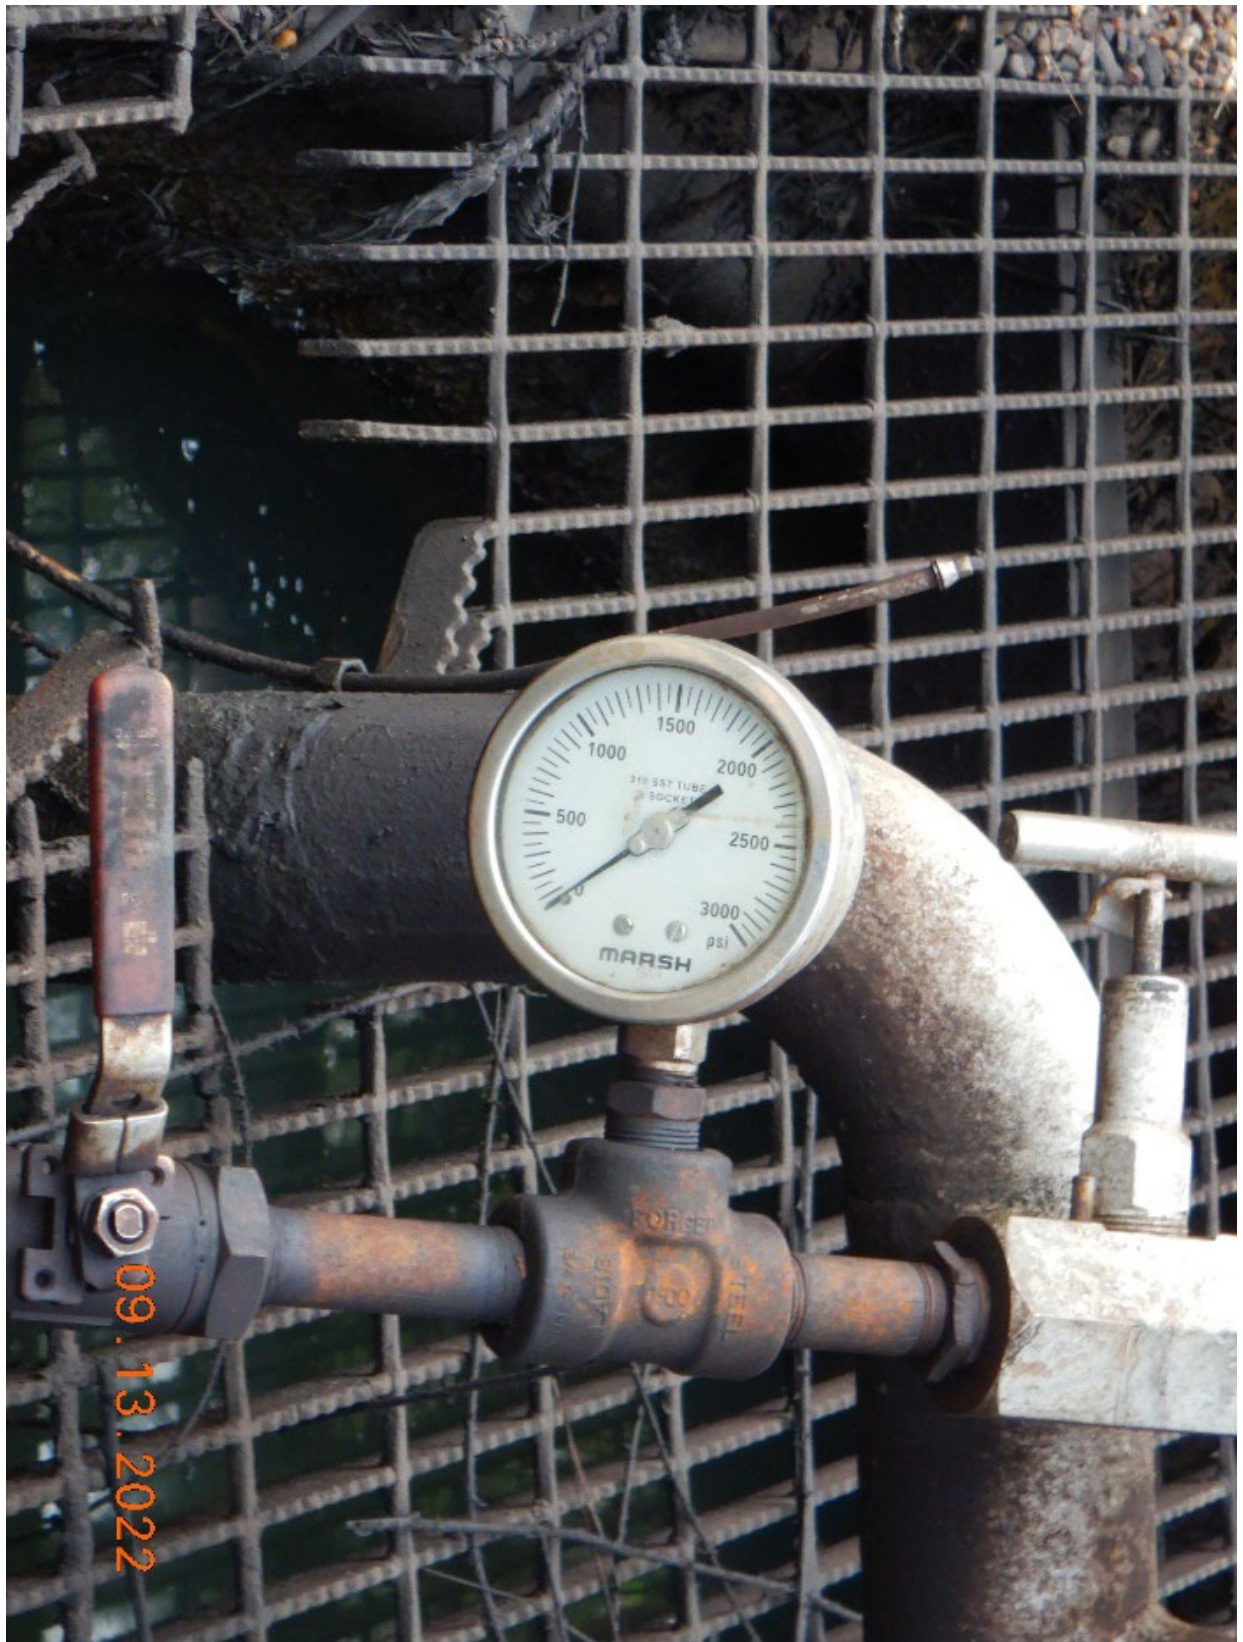
Description: *Looking south, closeup view of casing pressure relief gauge reading 0 psi.* \_\_\_\_\_

**Photograph 3:** Looking south, closeup view of casing pressure relief gauge reading 0 psi.

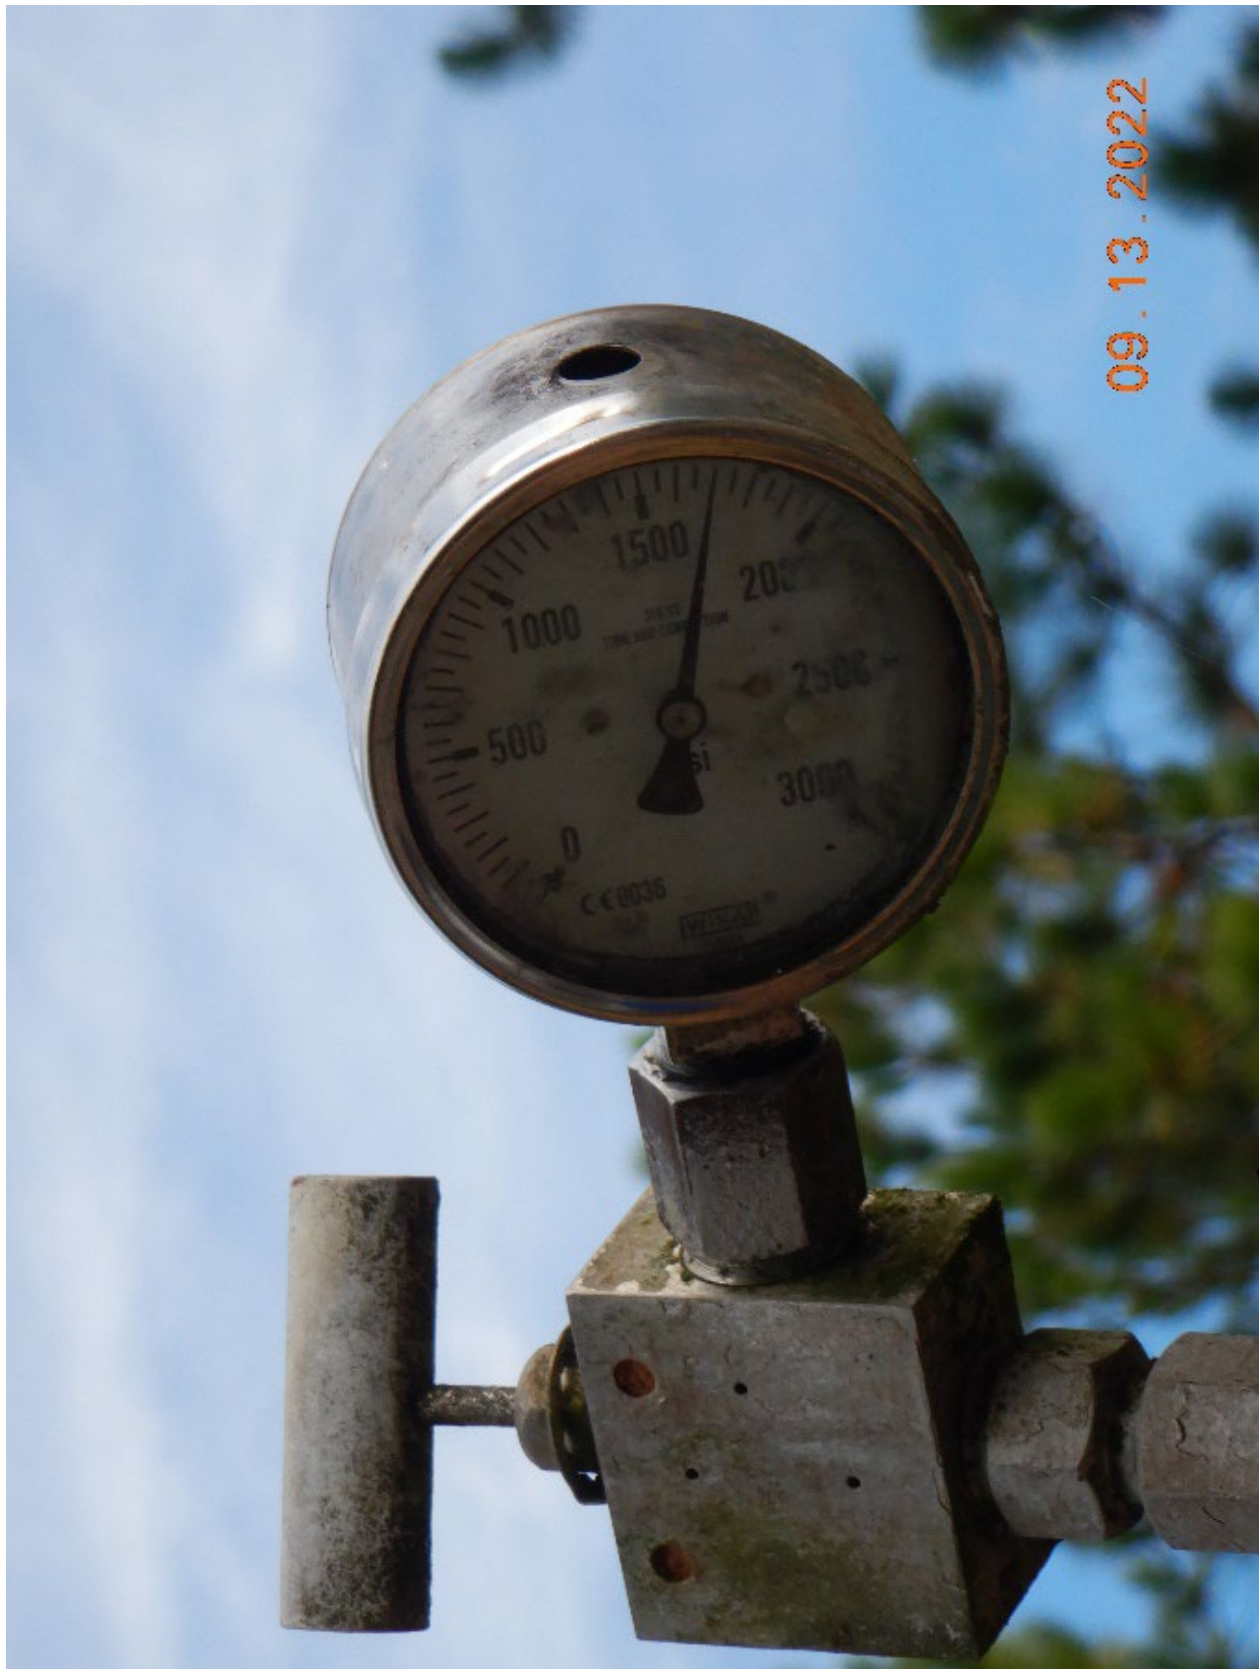
Notes & Comments (include discrepancies from database values): *Internal pressure reading was 1,700 psi. DEP indicated this well was formerly equipped with a nitrogen release to release pressure back to the plant, instead of bursting the well. DEP indicated that the connection has been disconnected and sealed off. The operator confirmed this statement. The EPA Inspection Team's visual inspection confirmed that it appears to be disconnected and sealed off. The site was clean and well-maintained. There was no evidence of leaks or excessive corrosion.*  
Perfs (see well schematics):  
*15,870-15905' perf 4 SPF GR 7/23/1976*  
*Reperf 15,886'-906' GR 4/84*

Description: *Looking north, closeup view of internal pressure gauge reading 1,700 psi.* \_\_\_\_\_

**Photograph 4:** Looking north, closeup view of internal pressure gauge reading 1,700 psi.

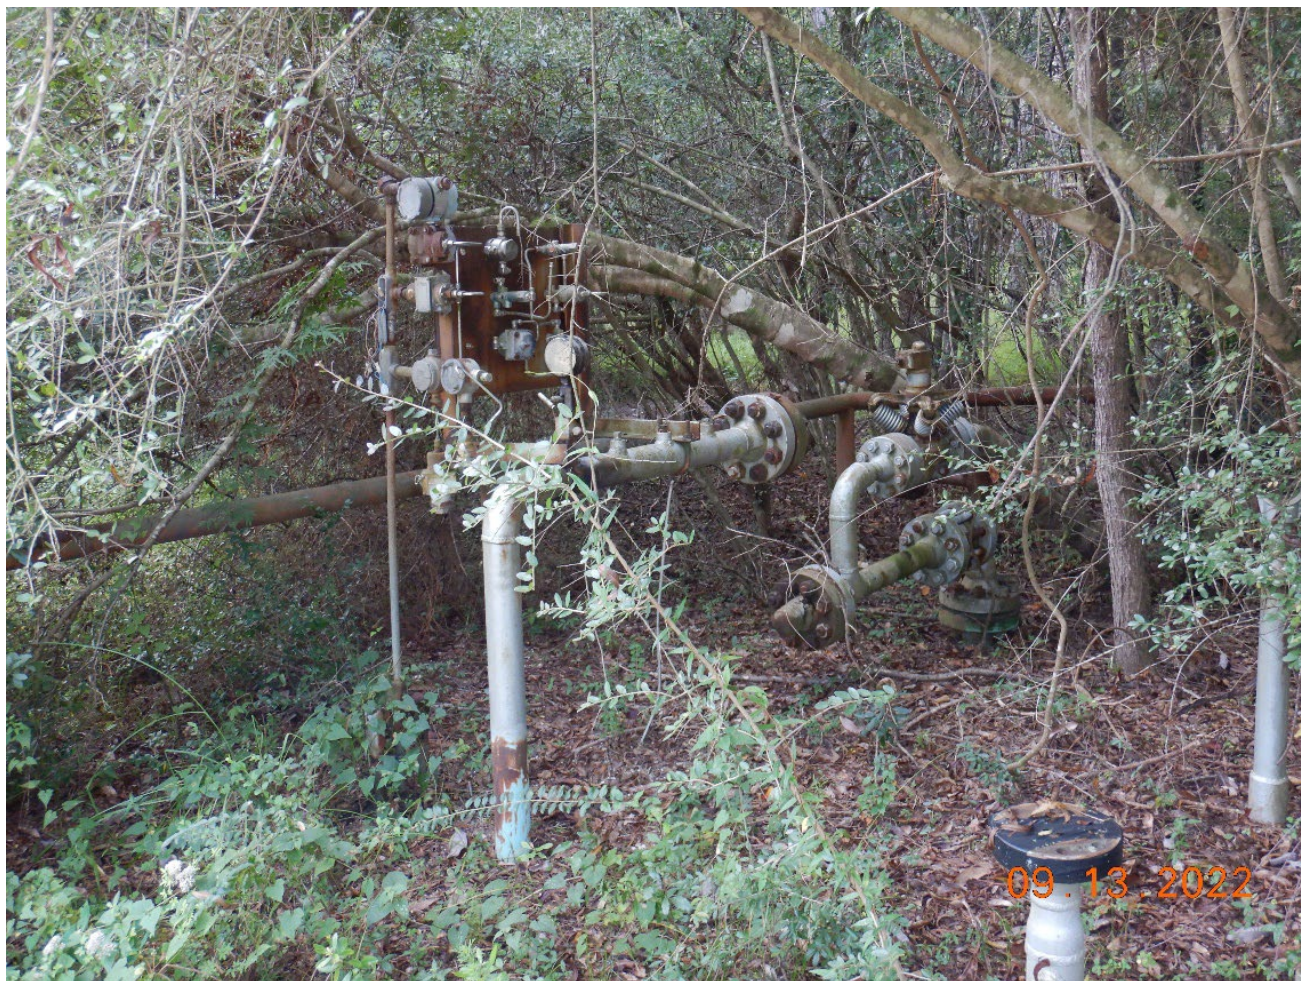
Description: *View, looking south, of formerly-used casing pressure relief system. These lines are no longer connected to the well, and are sealed.*

**Photograph 5:** View, looking south, of formerly-used casing pressure relief system. These lines are no longer connected to the well, and are sealed.
