**Well Inspection**  
**Osage DNR / Environmental Protection Agency**  
**1201 Elm Street, Suite 500**  
**Dallas, Texas 75270**

| <b>Operator Info</b> | Short Oil Company | <b>Inventory ID</b> OS1138000 | | | | |
| | Tulsa, OK 74105 | <b>Lease Name</b> ATLANTIC | | | | |
| | Phone: 918-747-8200 | <b>Well ID</b> 13 | | | | |

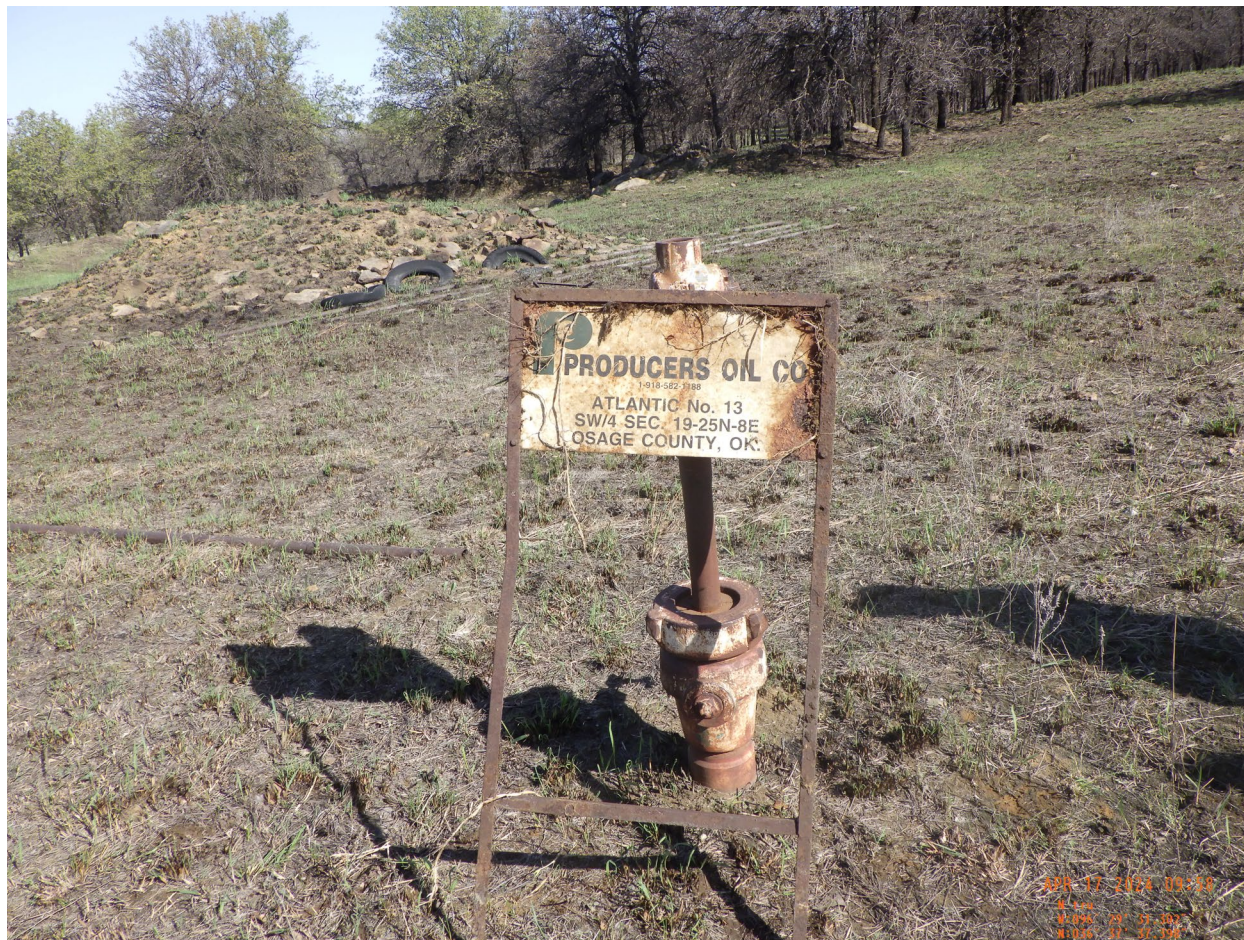
Photo No. 1

**Description:** This photo was taken looking N showing the well sign.

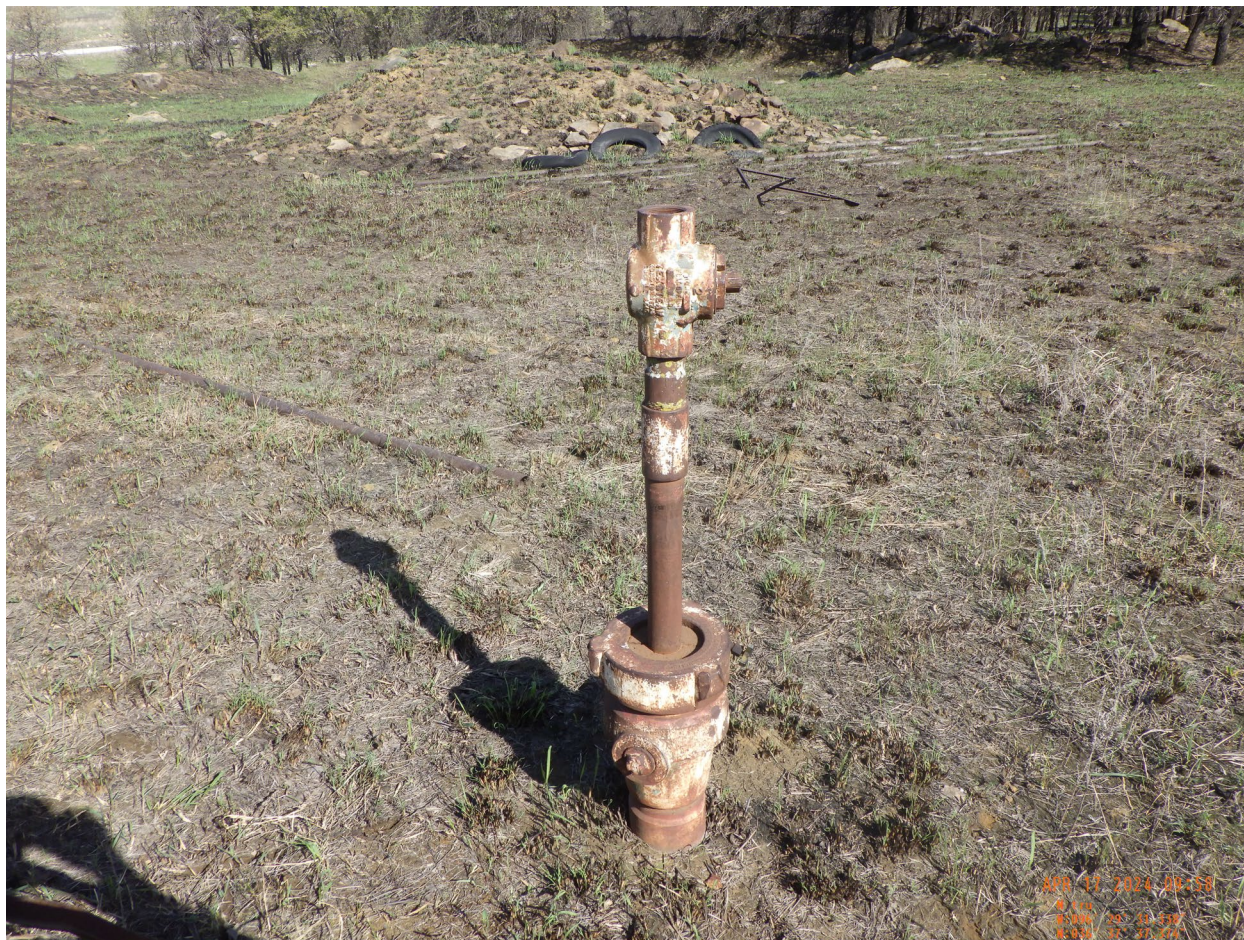
Photo No. 2

| <b>Inspection Comments</b> | | The well was not accessible during the time of the inspection on 4/17/2024. Areas of concern during the inspection include the valves rusted shut, the threading rusted out, and quarterly fluid reports still being sent in. Two photographs were taken during the inspection and can be seen in the Inspection Photo Log. | | | | |

**Description:** This photo was taken looking N showing the well and inaccessible valves.
